**REPORT NUMBER: NCAP-MGA-2014-033**

**NEW CAR ASSESSMENT PROGRAM (NCAP)  
Frontal Barrier Impact Test**

**GENERAL MOTORS LLC  
2014 Chevrolet Silverado 1500 4WD Double Cab  
NHTSA No.: M20140111**

**MGA RESEARCH CORPORATION  
5000 Warren Road  
Burlington, WI 53105**

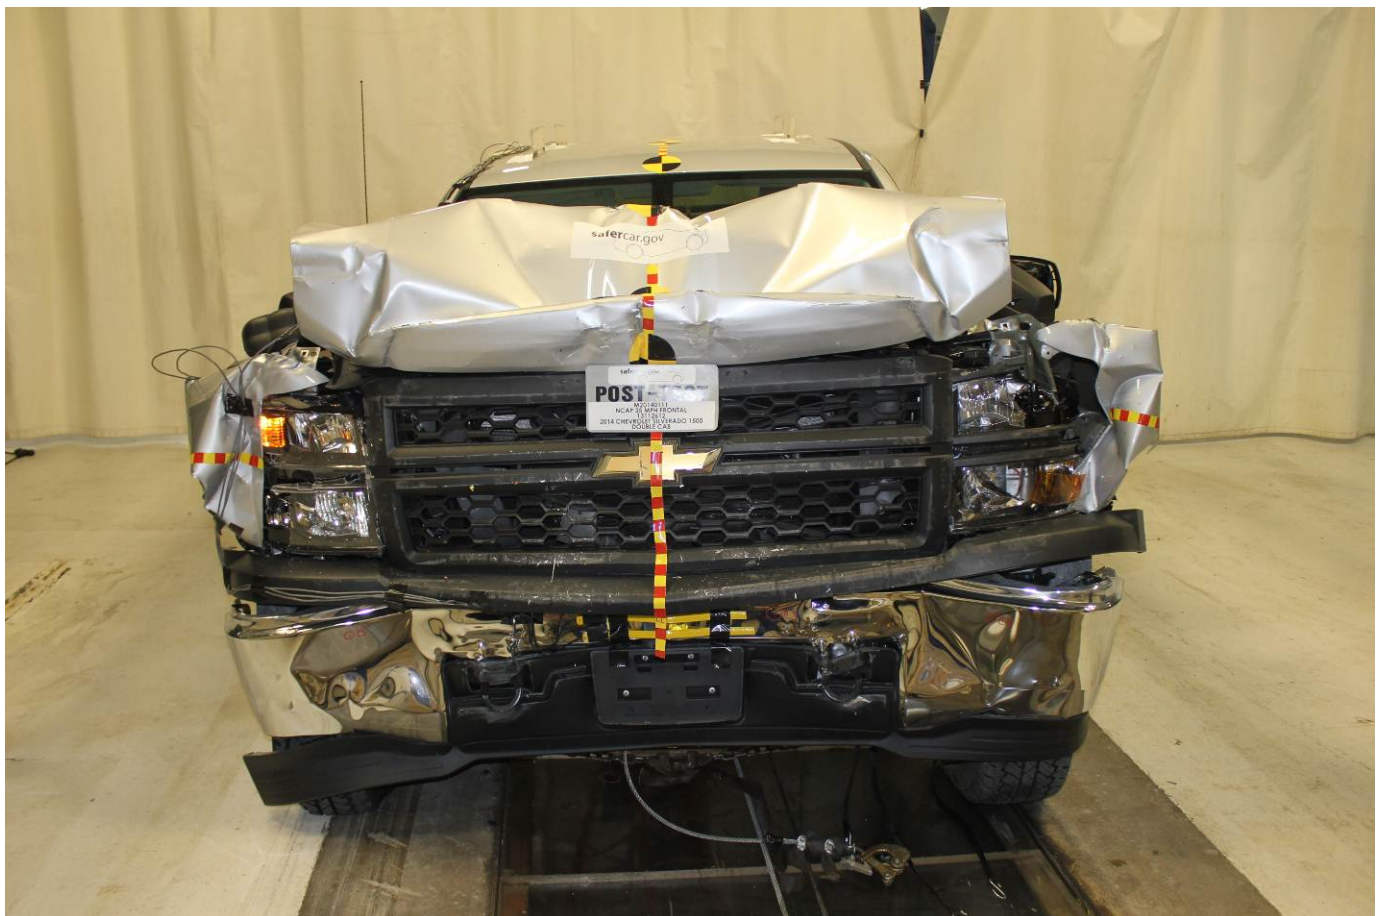
The maximum static crush of the vehicle was 657 mm and both the driver and passenger side doors remained closed during the impact event and were operable after the impact.

Post-Test Front View of Test Vehicle

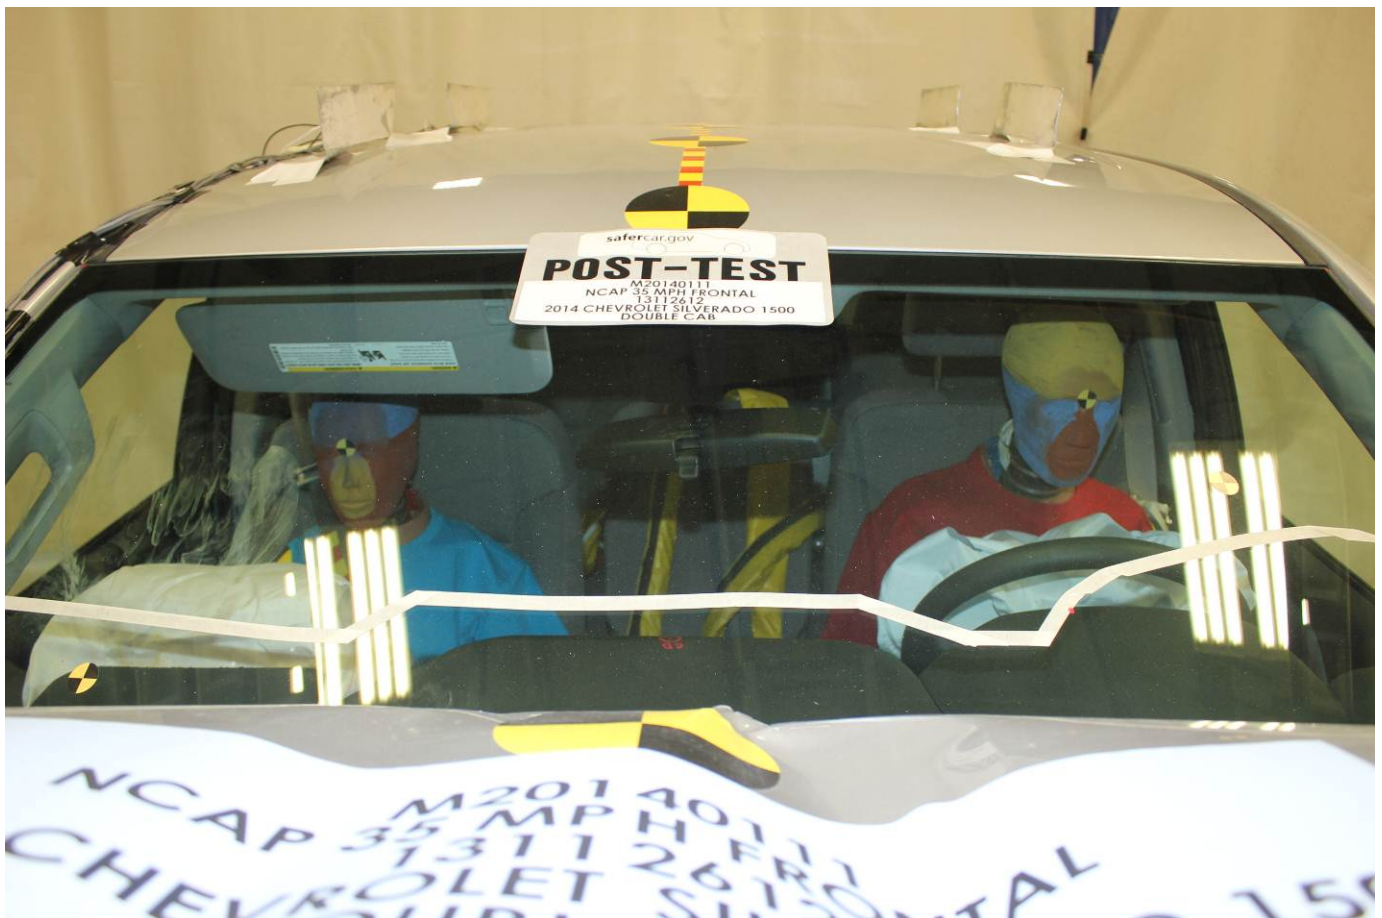
There was 100 percent windshield retention and no intrusion into the protected zone of the windshield during the event. There was no Stoddard Solvent leakage after the event or during any phase of the static rollover.

Post-Test Windshield View

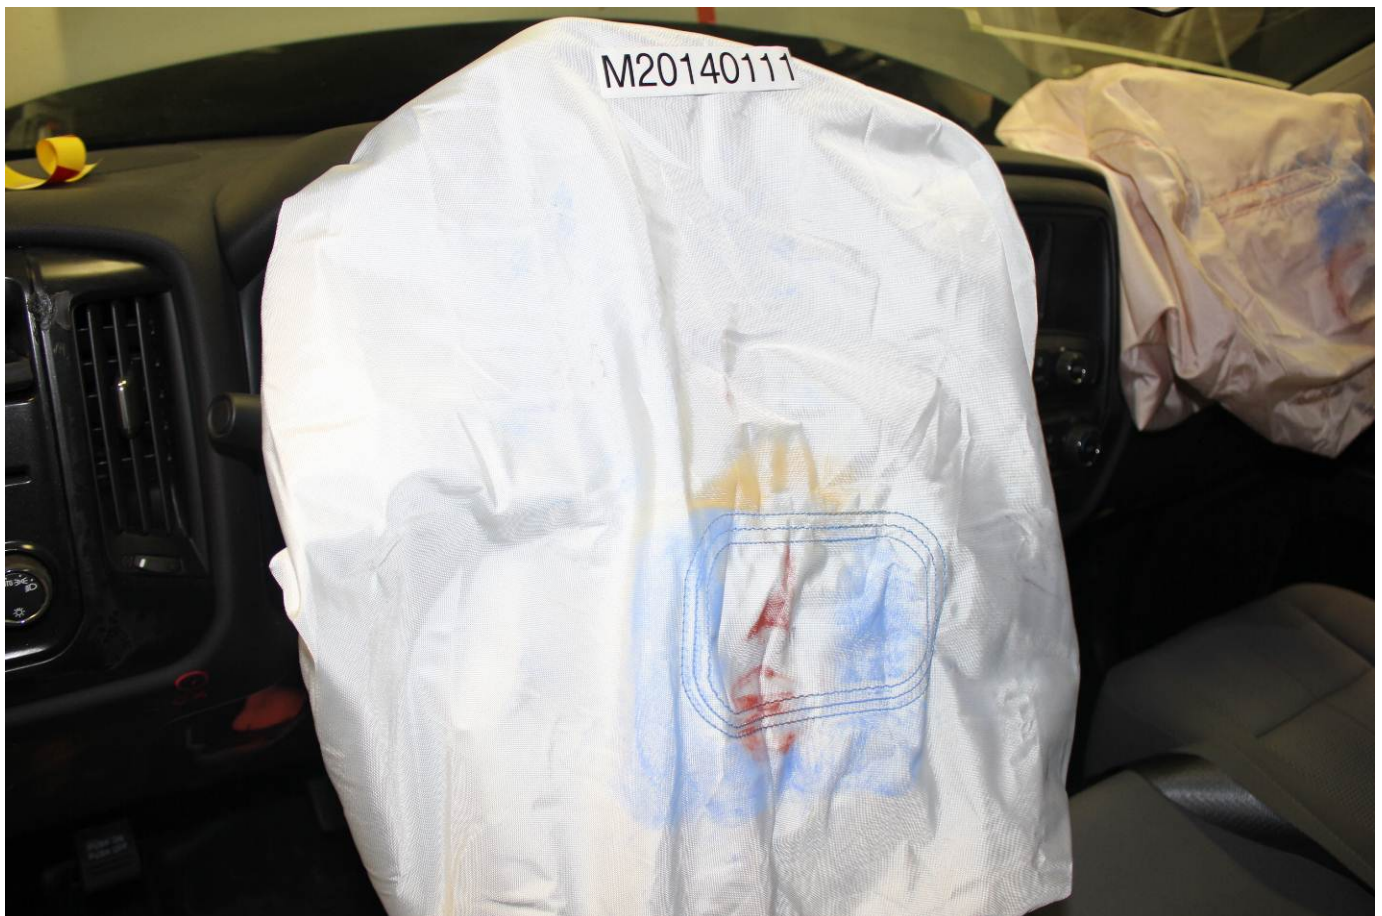
The driver's visible contact points were as follows: The driver's head and chest contacted the airbag. The driver's head also contacted the headrest. The driver's knees contacted the knee bolster. The passenger's visible contact points were as follows: The passenger's head and chest contacted the airbag. The passenger's head also contacted the headrest. The passenger's knees contacted the glovebox.

Post-Test Driver Dummy Contact with Airbag

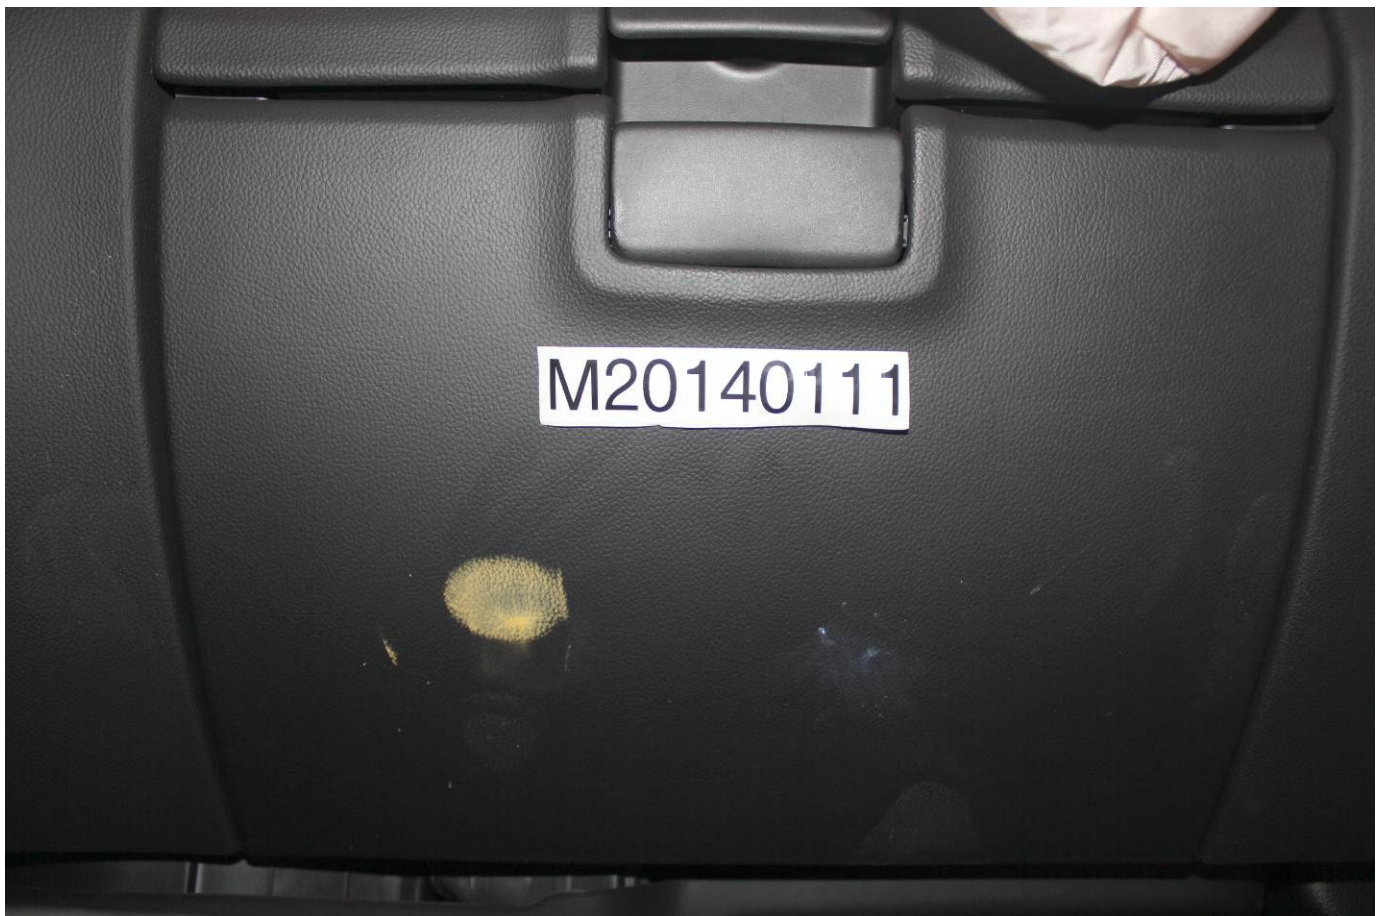
Post-Test Passenger Dummy Contact with Glovebox

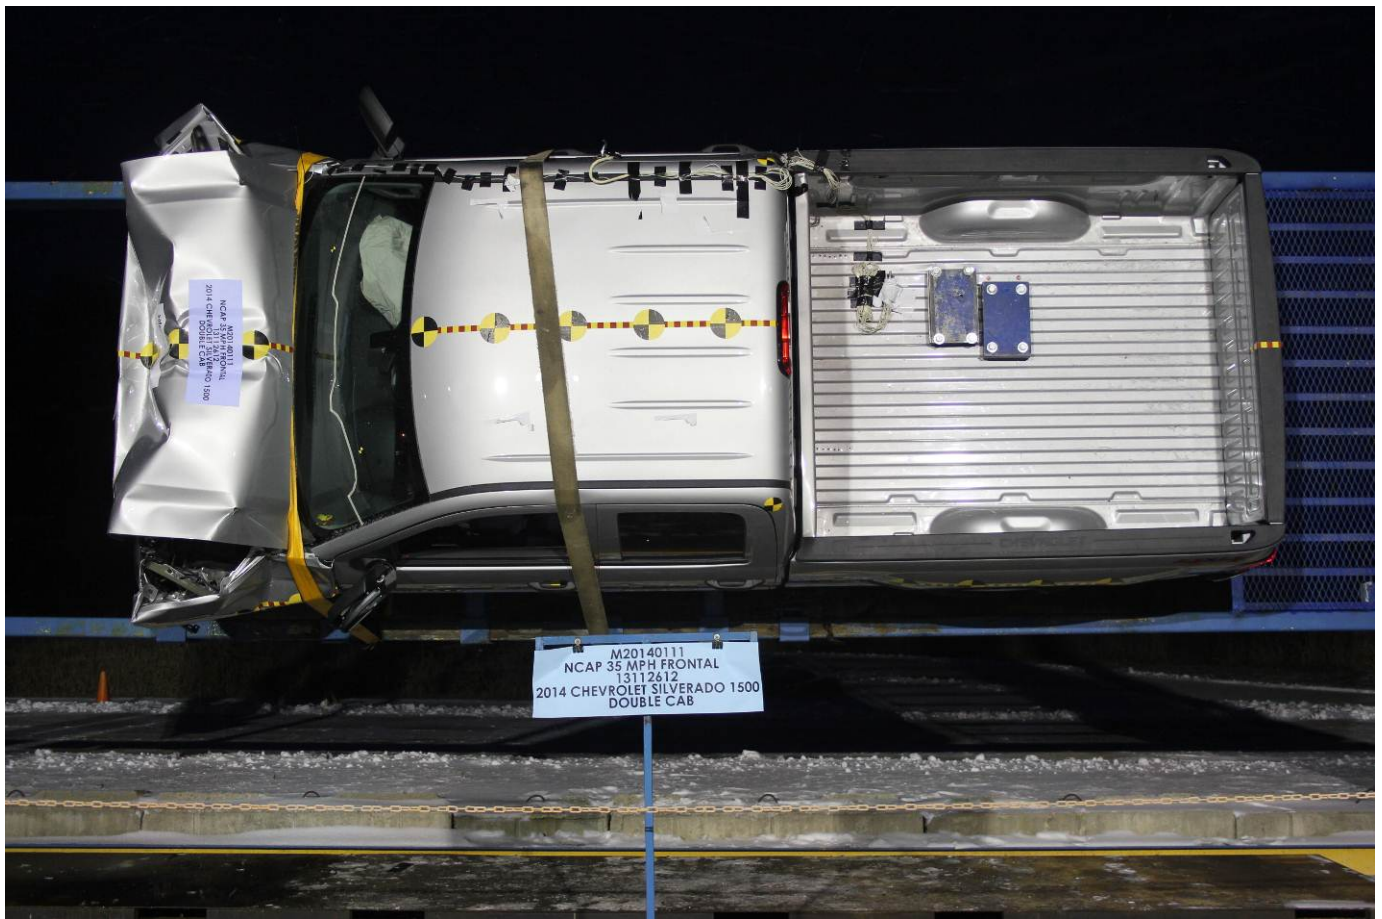
Vehicle at 90 Degrees on Static Rollover Device
