**REPORT NUMBER: NCAP-CAL-14-003**

**NEW CAR ASSESSMENT PROGRAM (NCAP)  
FRONTAL BARRIER IMPACT TEST**

**Chrysler Group LLC  
2014 Dodge Durango  
4 Door SUV**

**NHTSA No: M20140301**

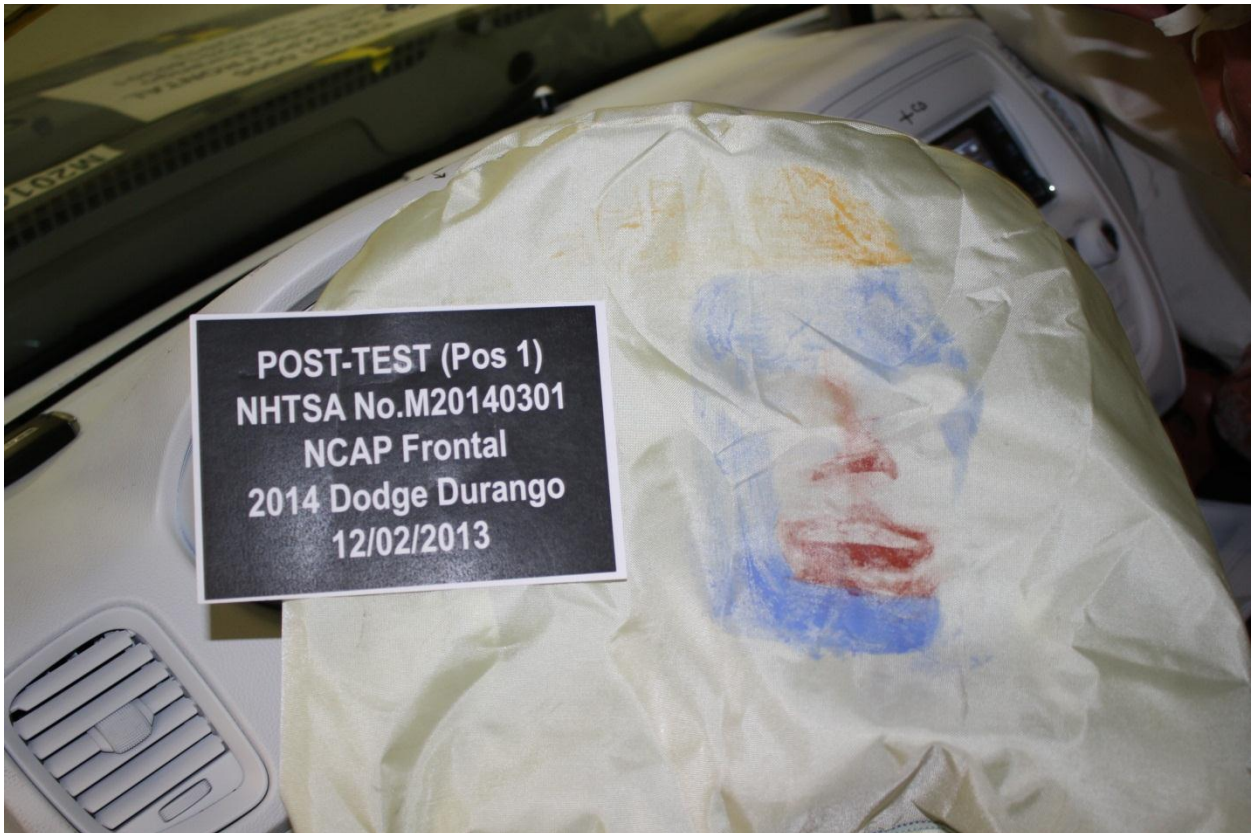
**Figure A-46: Post-Test Driver Dummy Contact With Airbag**

The driver's visible contact points were as follows: The driver's head contacted the frontal airbag and then the head restraint. The upper torso contacted the frontal airbag. Both knees contacted the knee airbag.

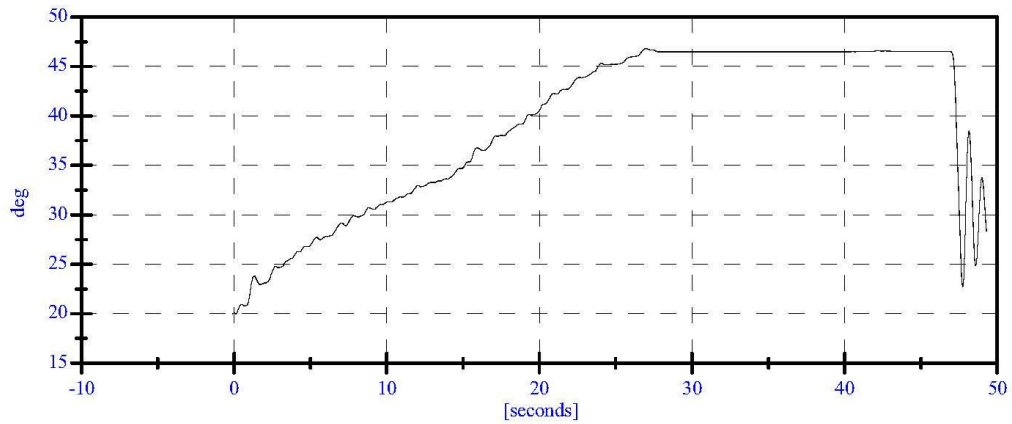
**LUMBAR SPINE FLEXION TEST**

<u>TEST PARAMETER</u>	<u>SPECIFICATION</u>	<u>TEST RESULTS</u>	<u>STATUS</u>
Lab Temperature:	18.9-25.6 C	21.8 C	Passed
Lab Humidity:	10-70 %	48.00 %	Passed
Initial Angle:	0.00-20.00 Deg	20.00 Deg	Passed
Force at 45 Deg	320.00-390.00 N	332.80 N	Passed
Return Angle	8 Deg Max from Initial	25.70 deg	Passed
