REPORT NUMBER: SINCAP-MGA-2014-034

**NEW CAR ASSESSMENT PROGRAM (NCAP)
Moving Deformable Barrier Side Impact Test**

**KIA MOTORS CORPORATION
2014 Kia Soul SUV
NHTSA No.: O20144205**

FINAL REPORT

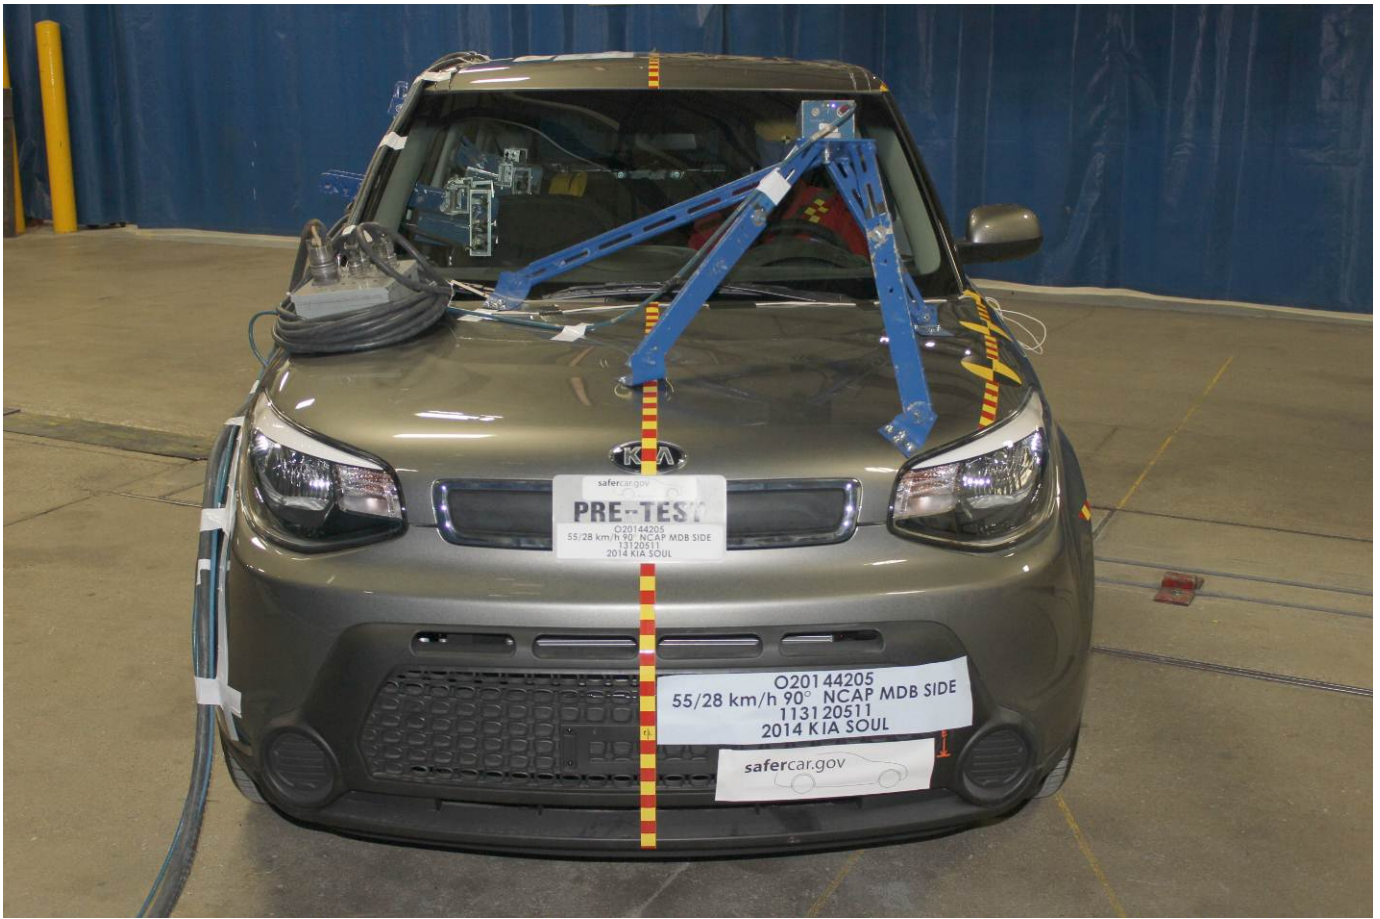
Pre-Test Frontal View of Test Vehicle

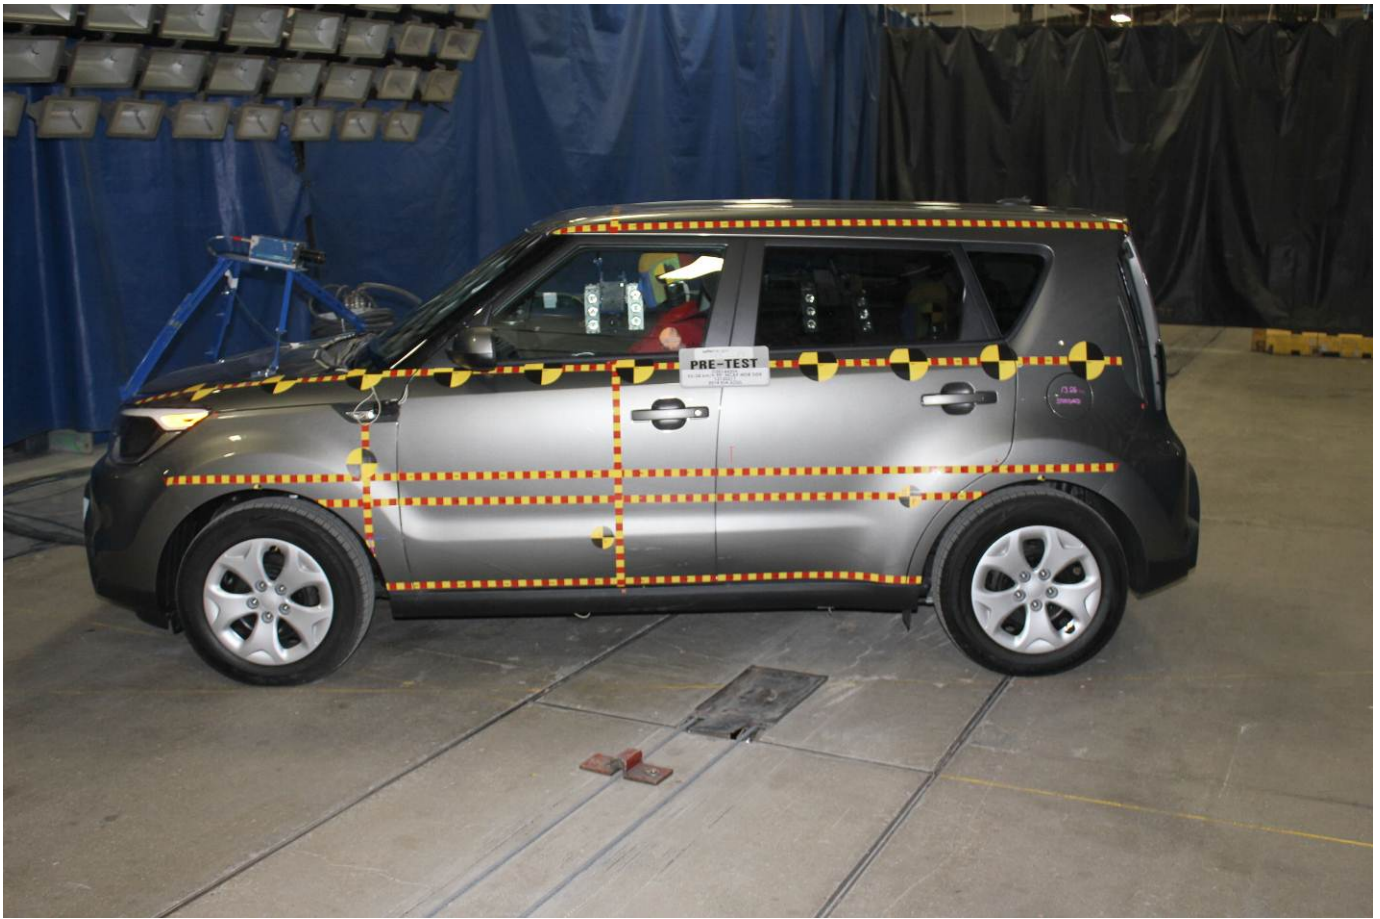
Pre-Test Left Side View of Test Vehicle

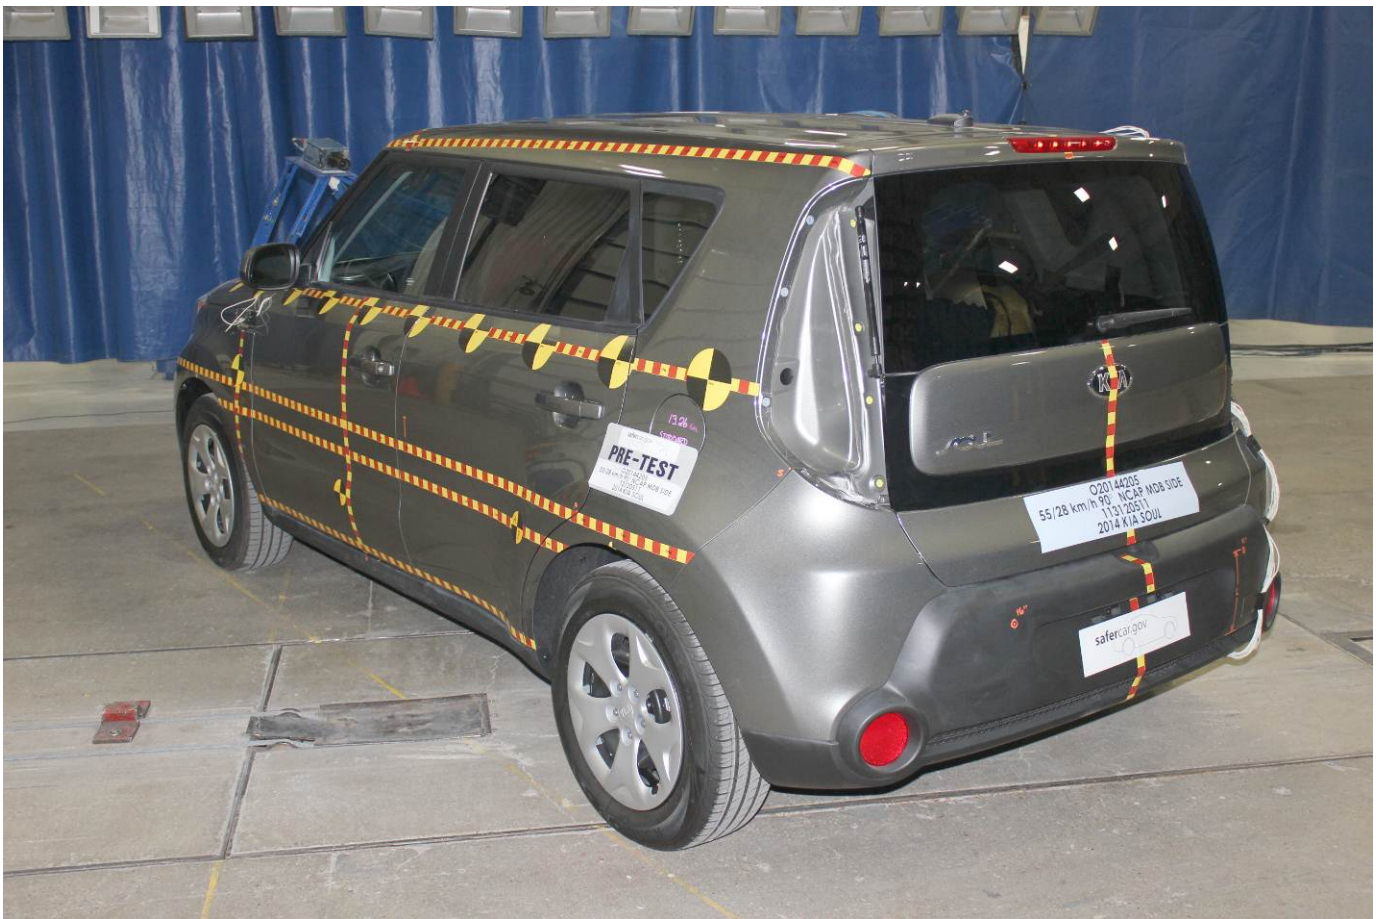
Pre-Test Left Three-Quarter Rear View of Test Vehicle

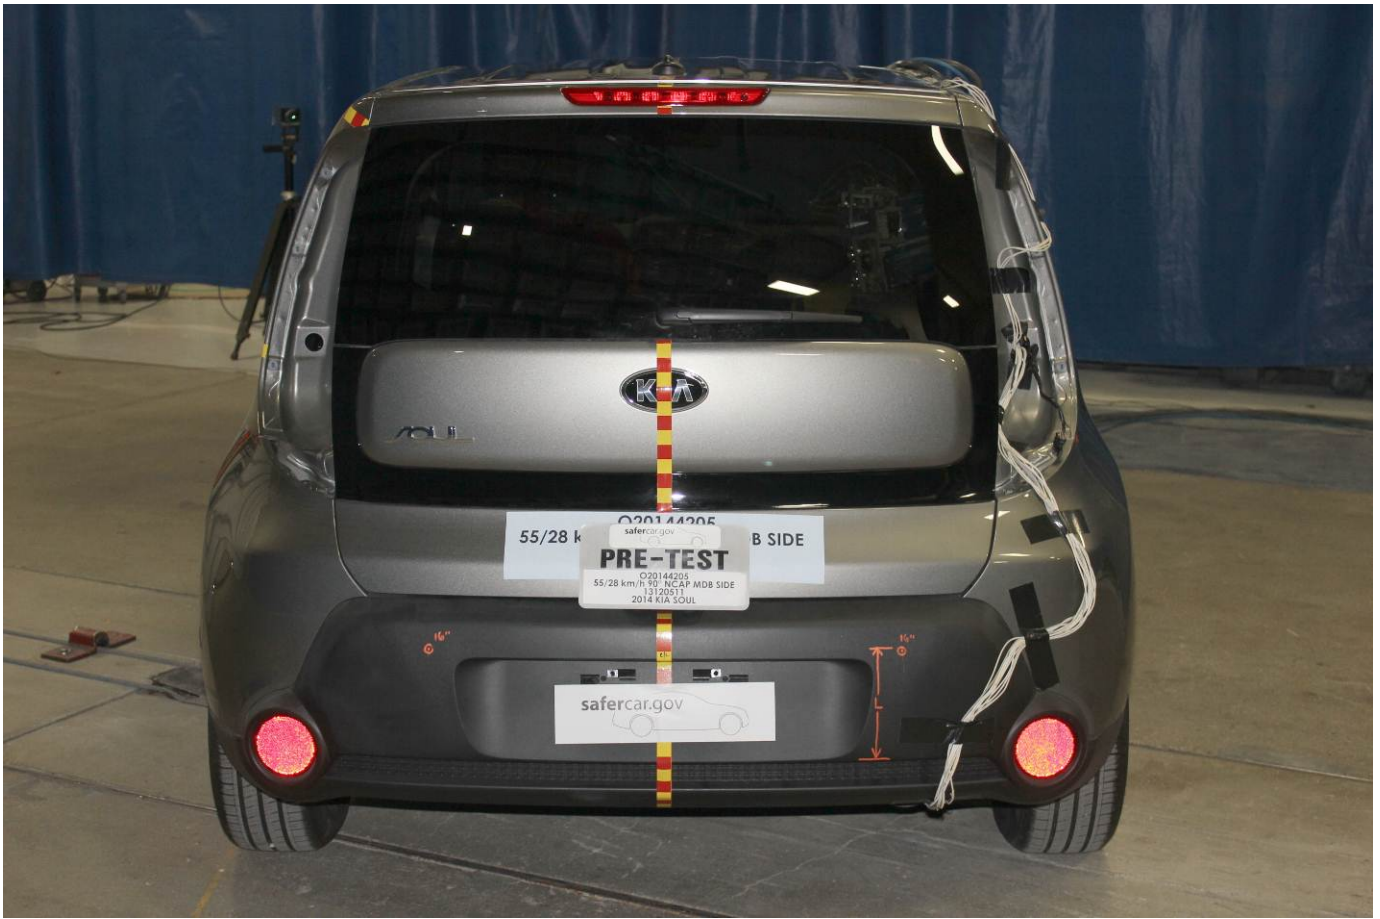
Pre-Test Rear View of Test Vehicle

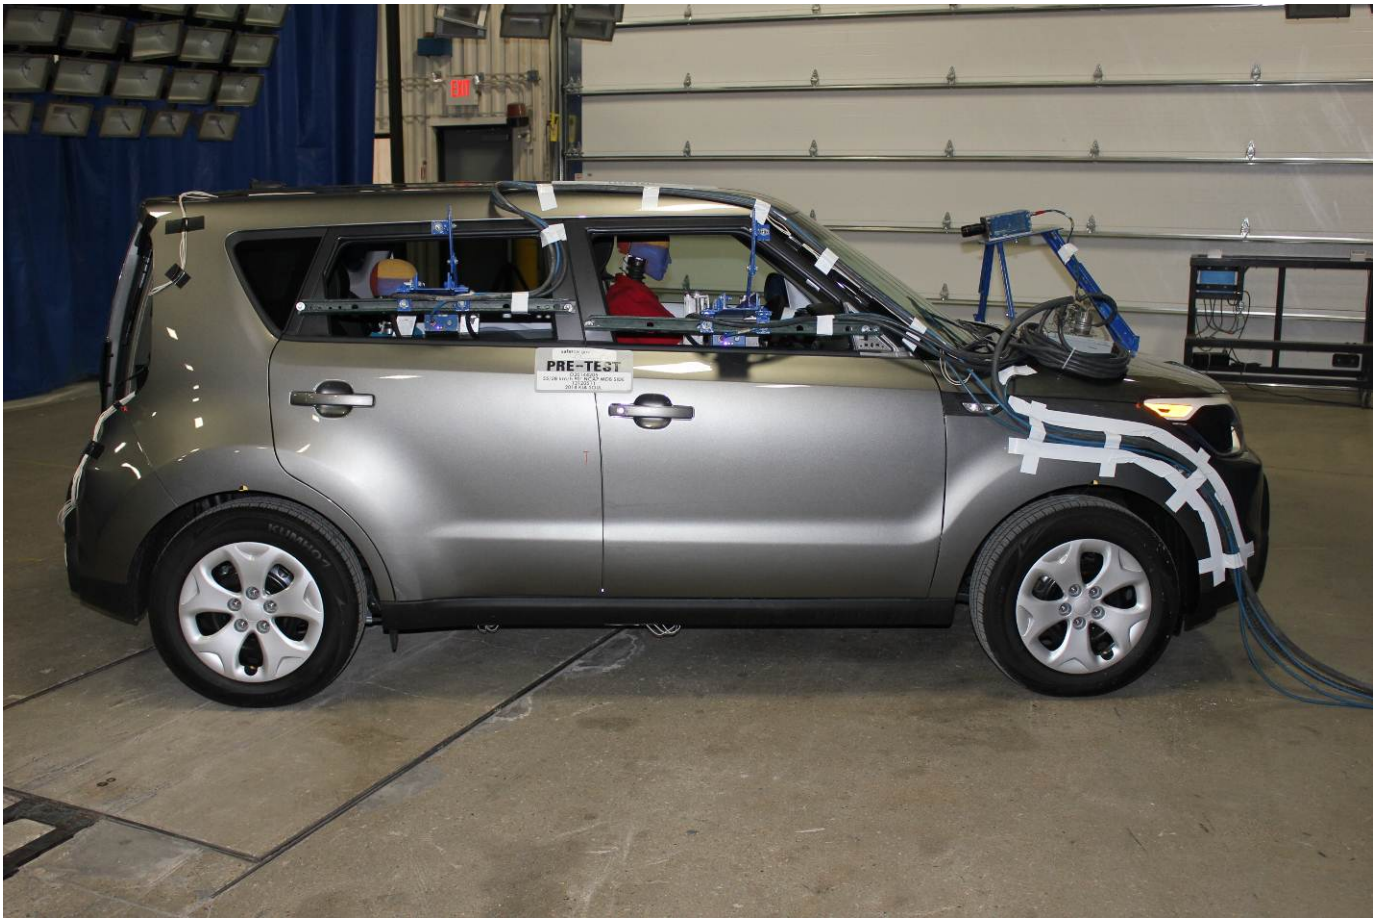
Pre-Test Right Side View of Test Vehicle

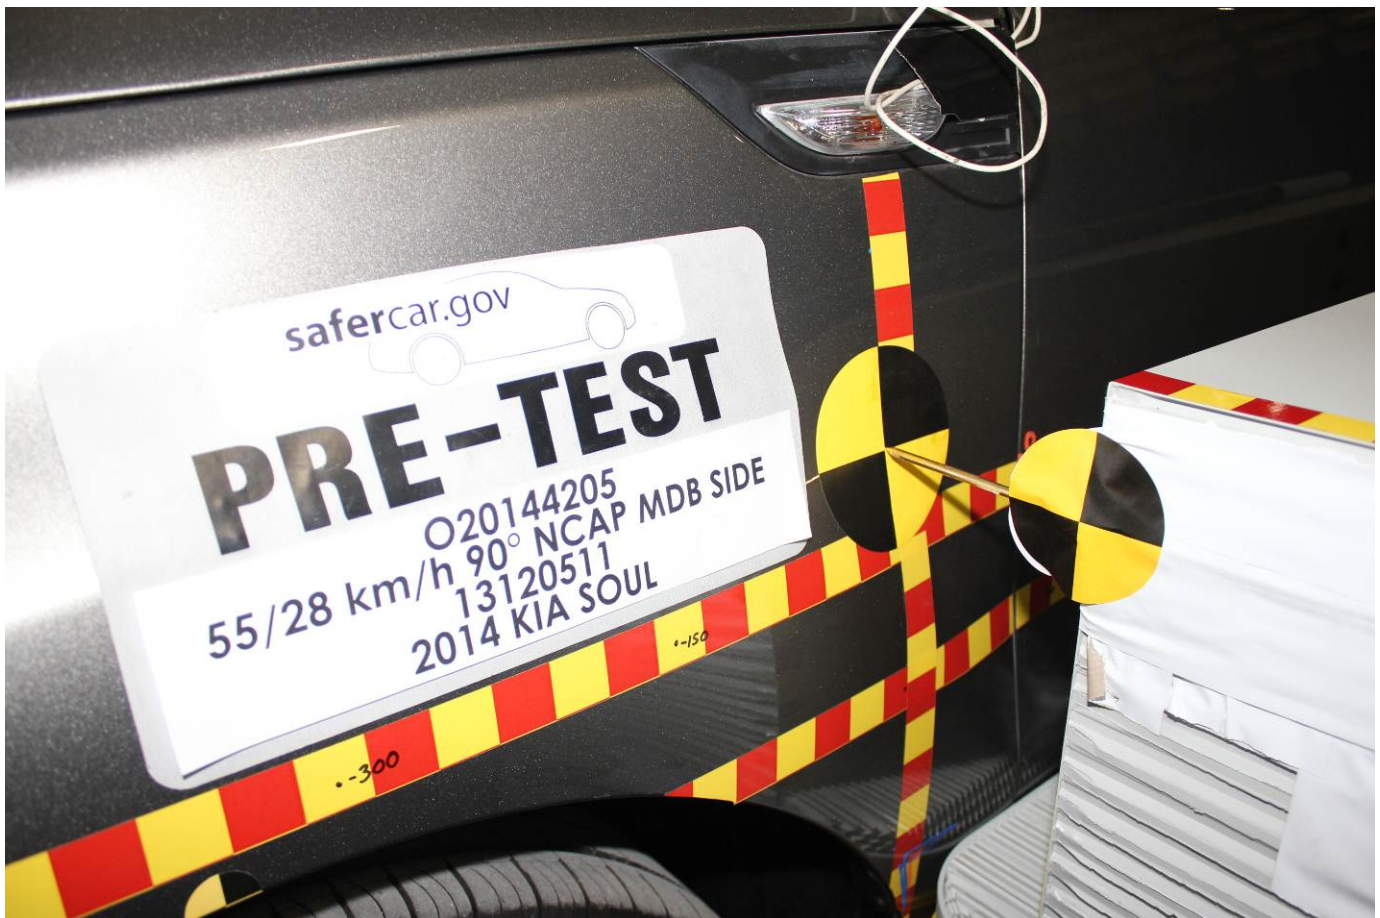
Pre-Test Close-Up View of Impact Point Target

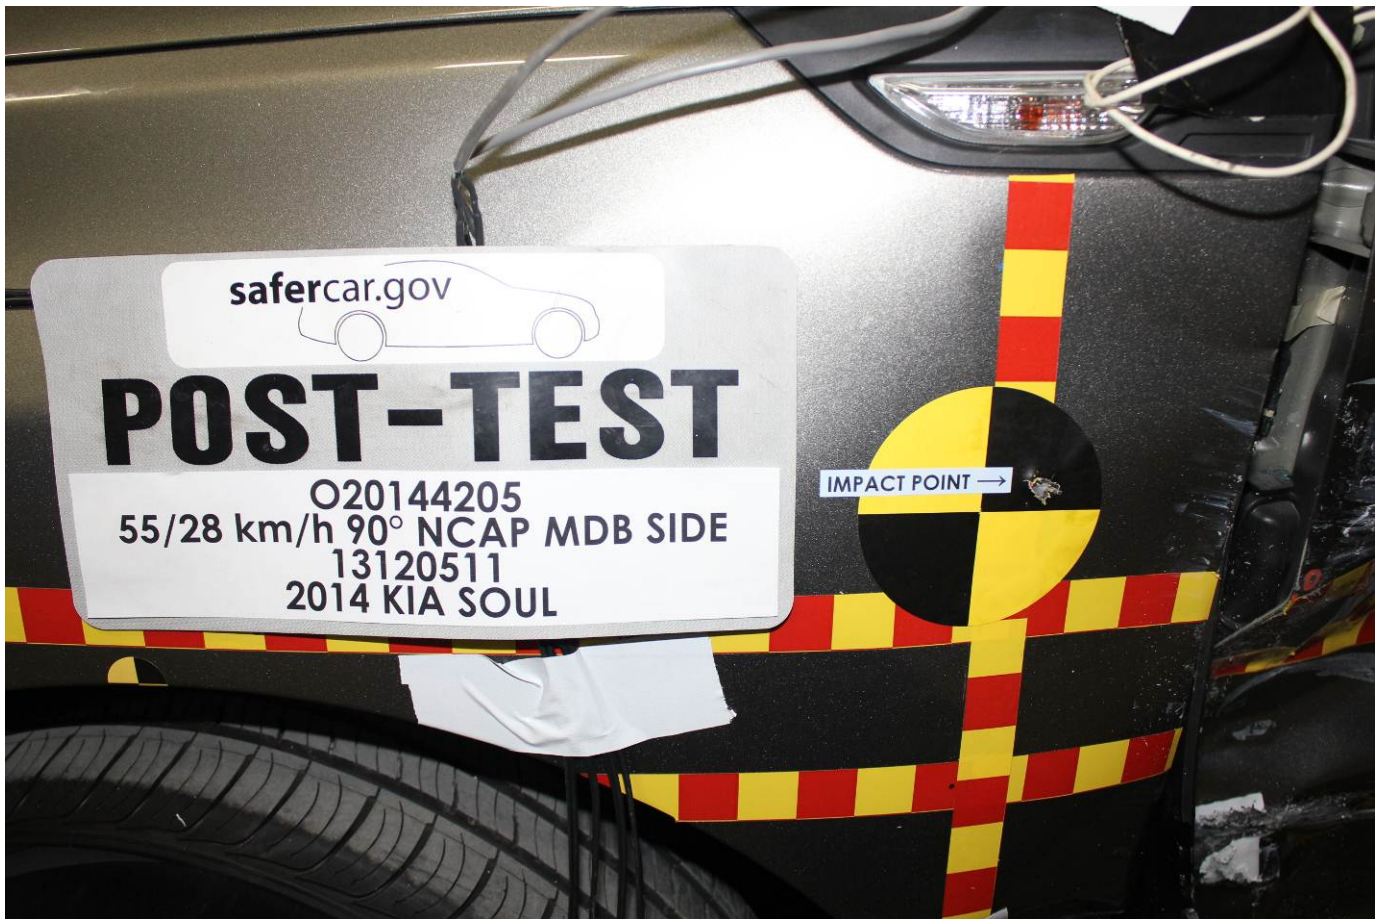
Post-Test Close-Up View of Impact Point Target

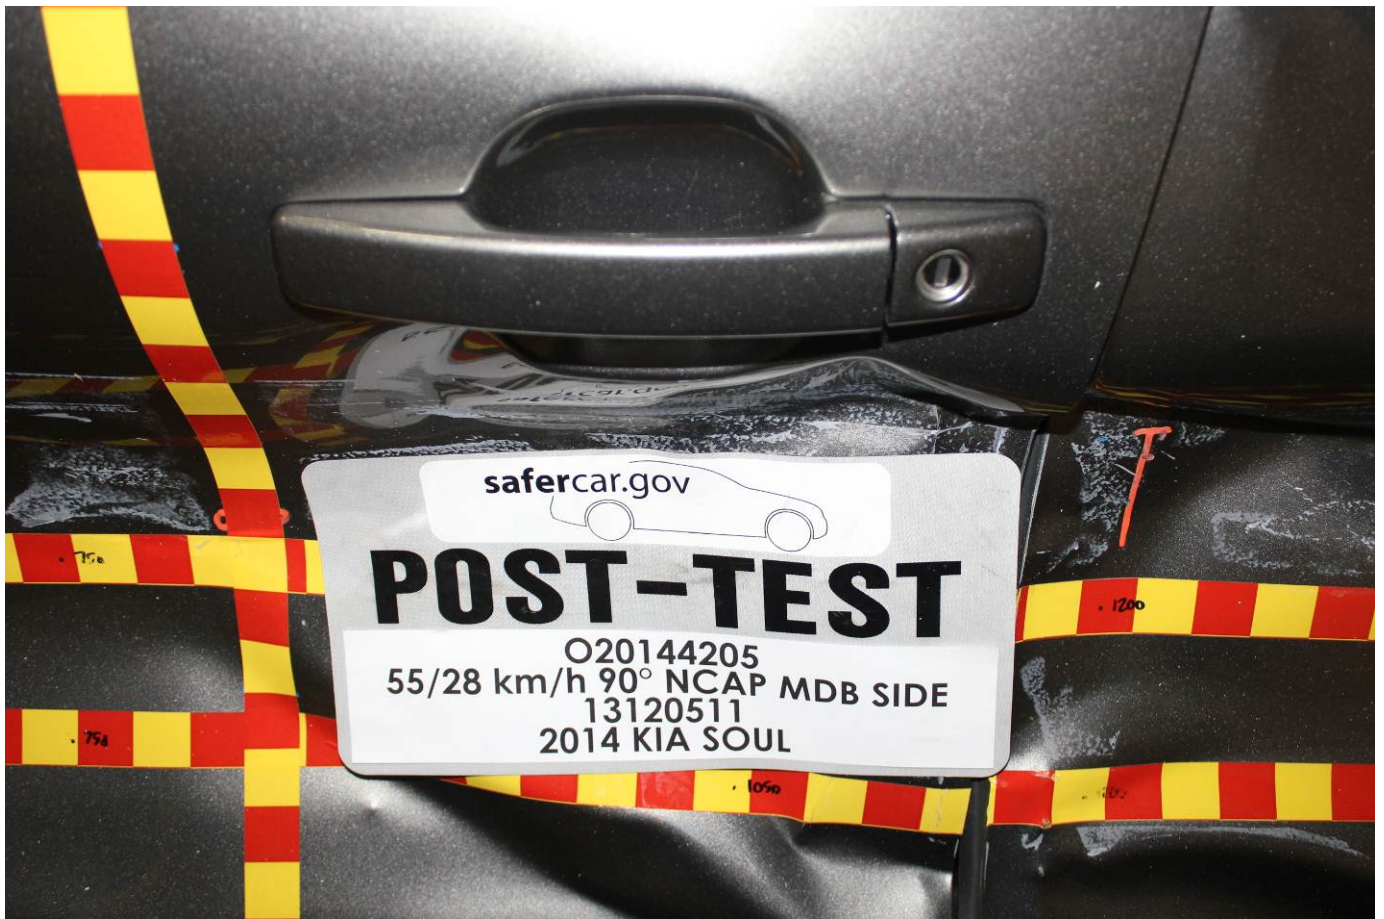
Post-Test Left Front Door Latch Close-Up

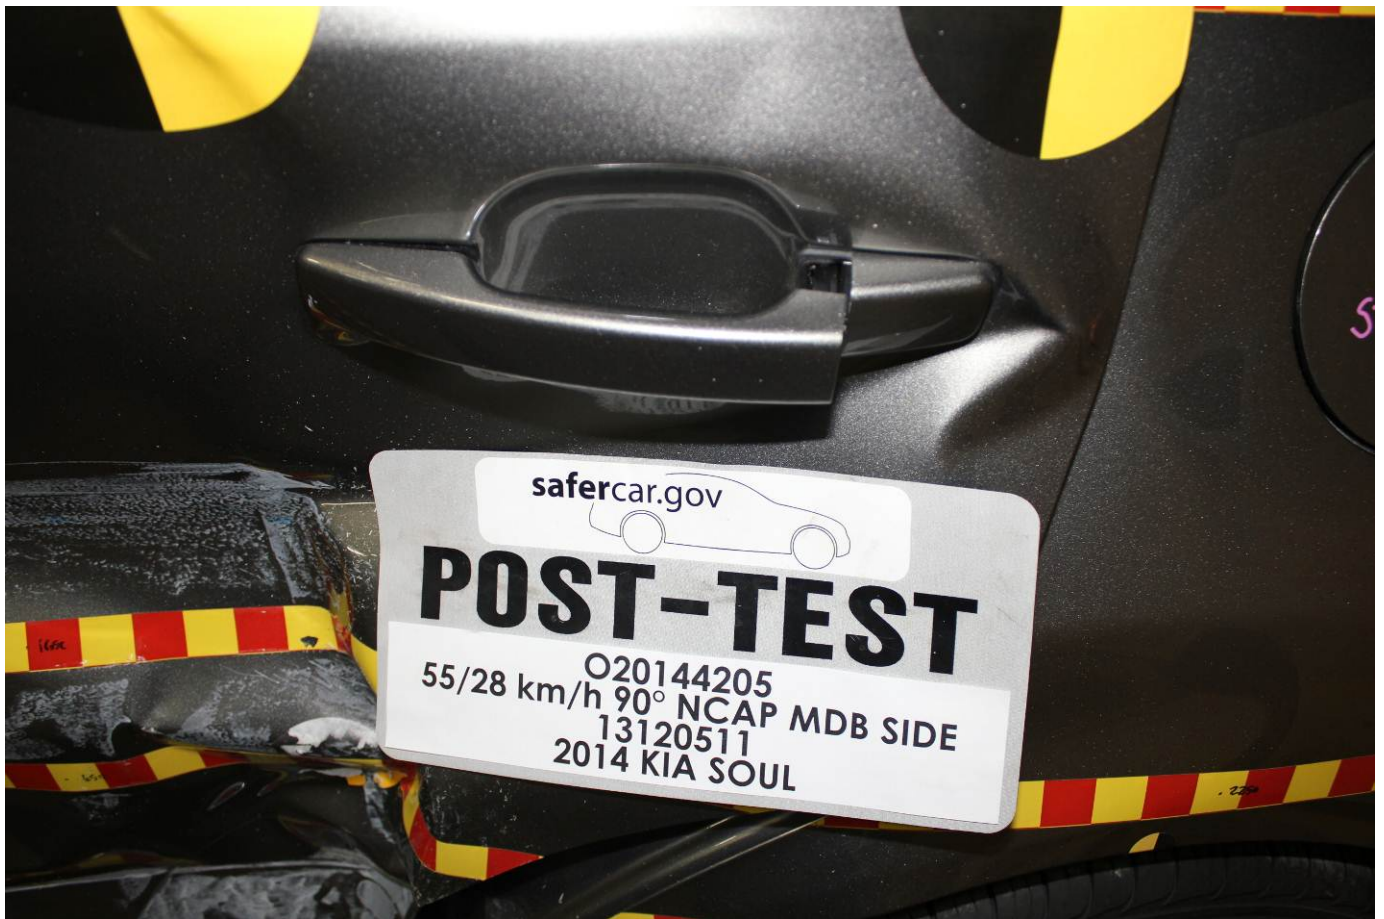
Post-Test Left Rear Door Latch Close-Up

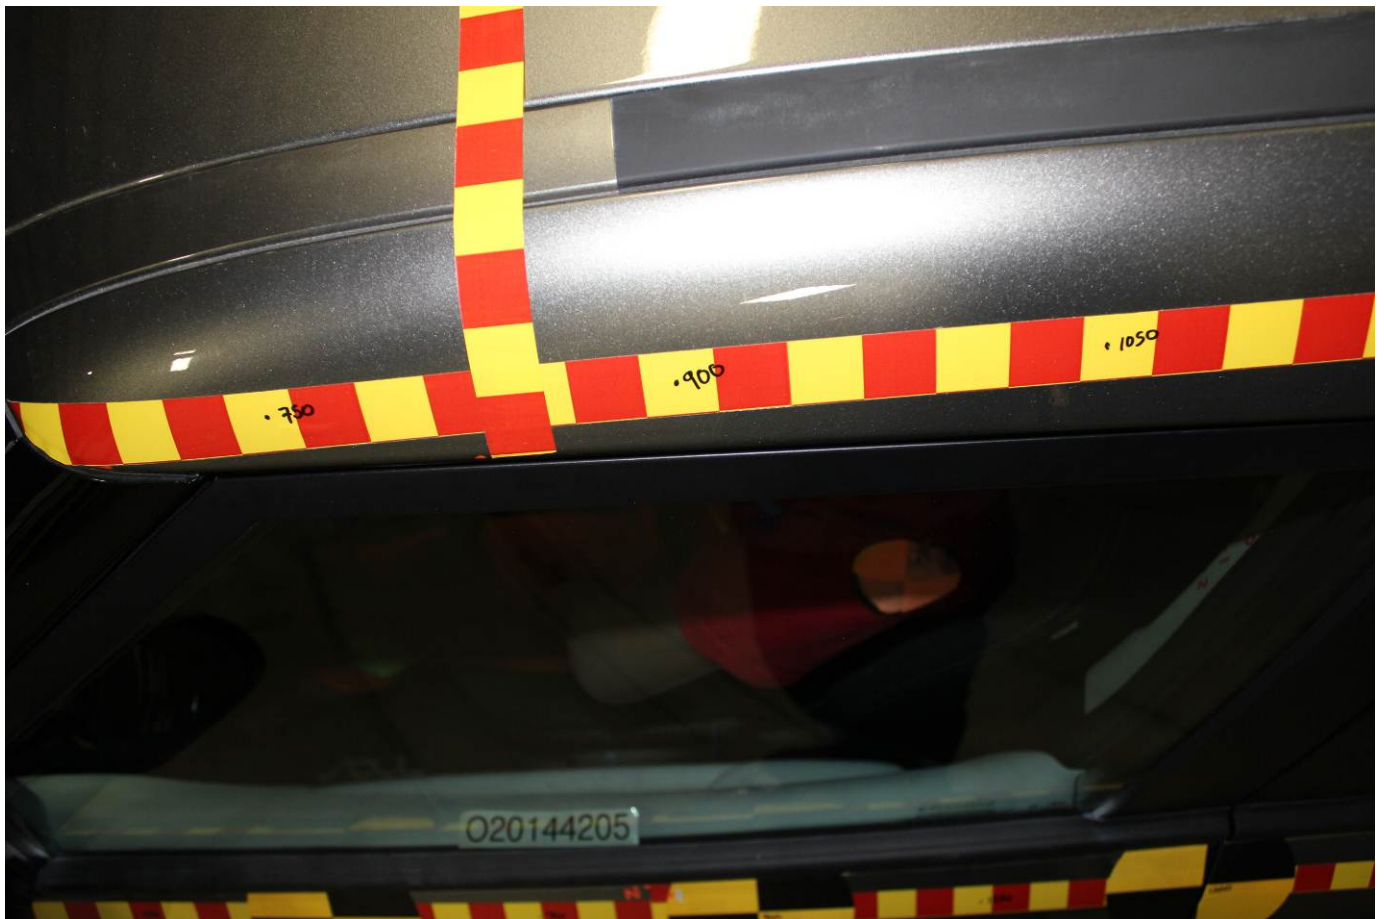
Pre-Test Driver Dummy and Door Clearance View

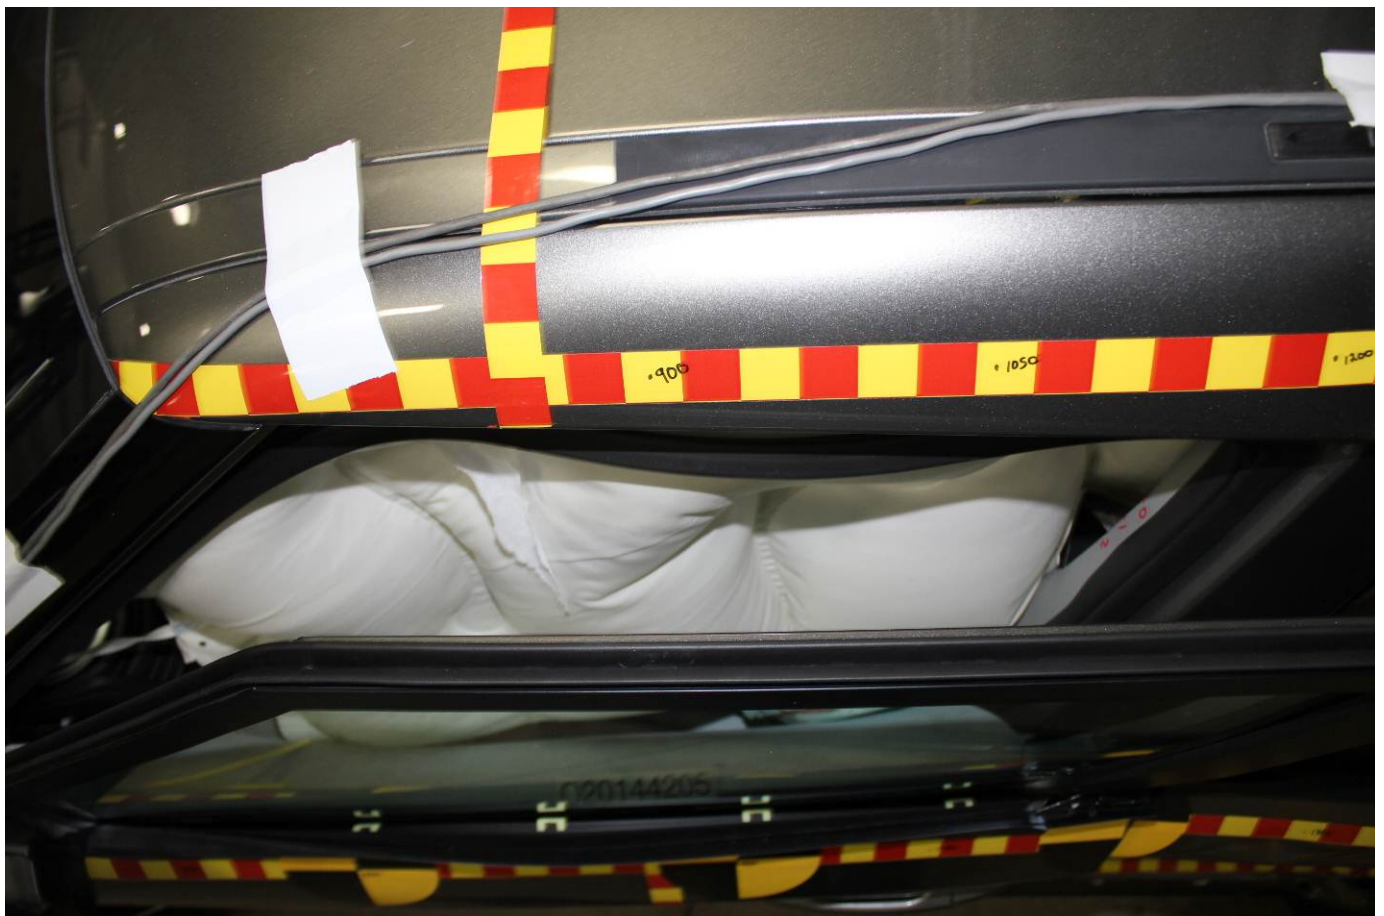
Post-Test Driver Dummy and Door Clearance View

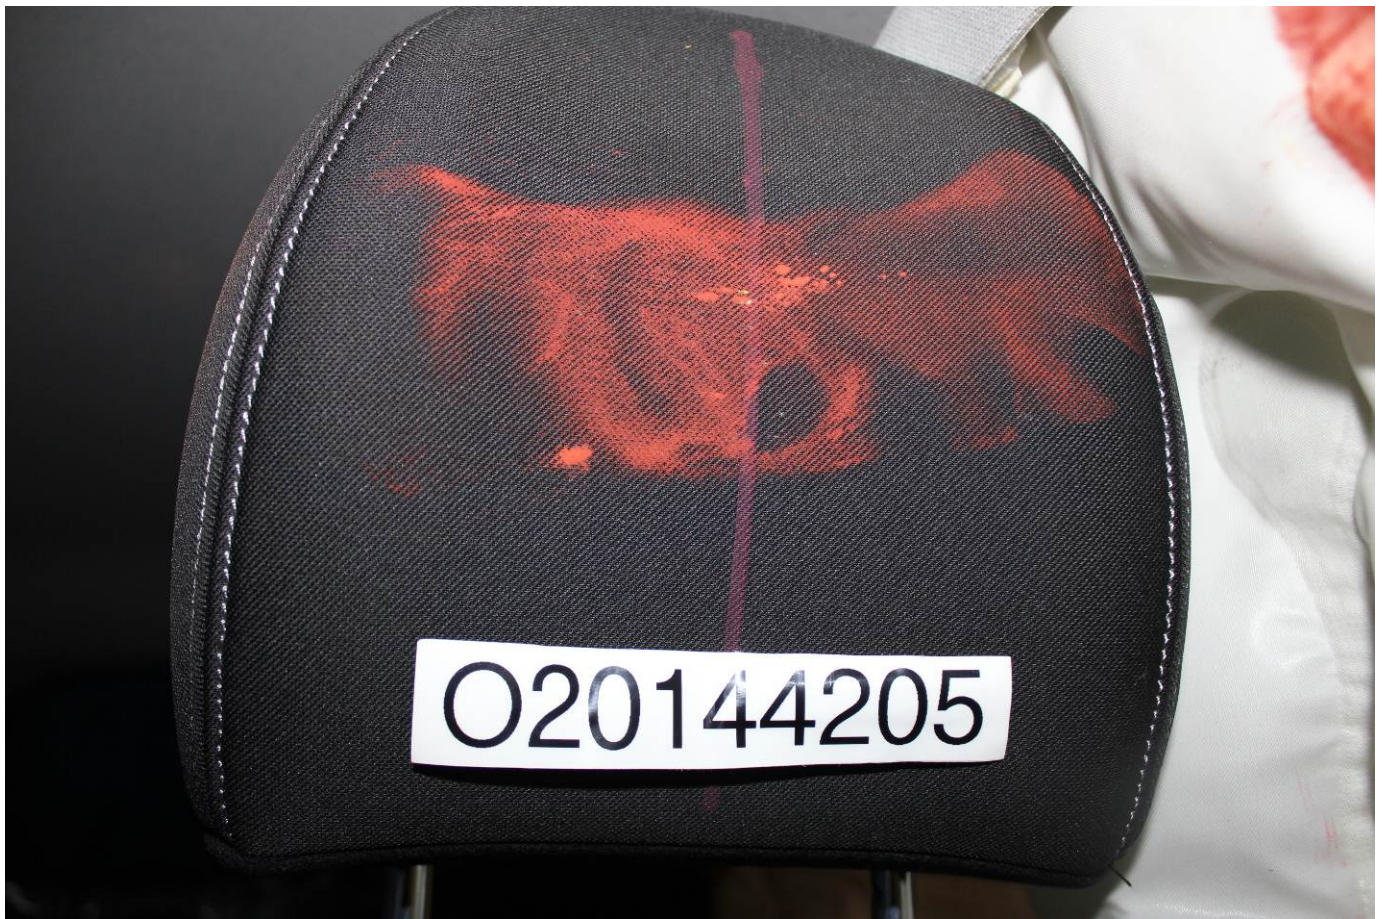
Post-Test Driver Dummy Close-up Head Contact with Vehicle Interior View

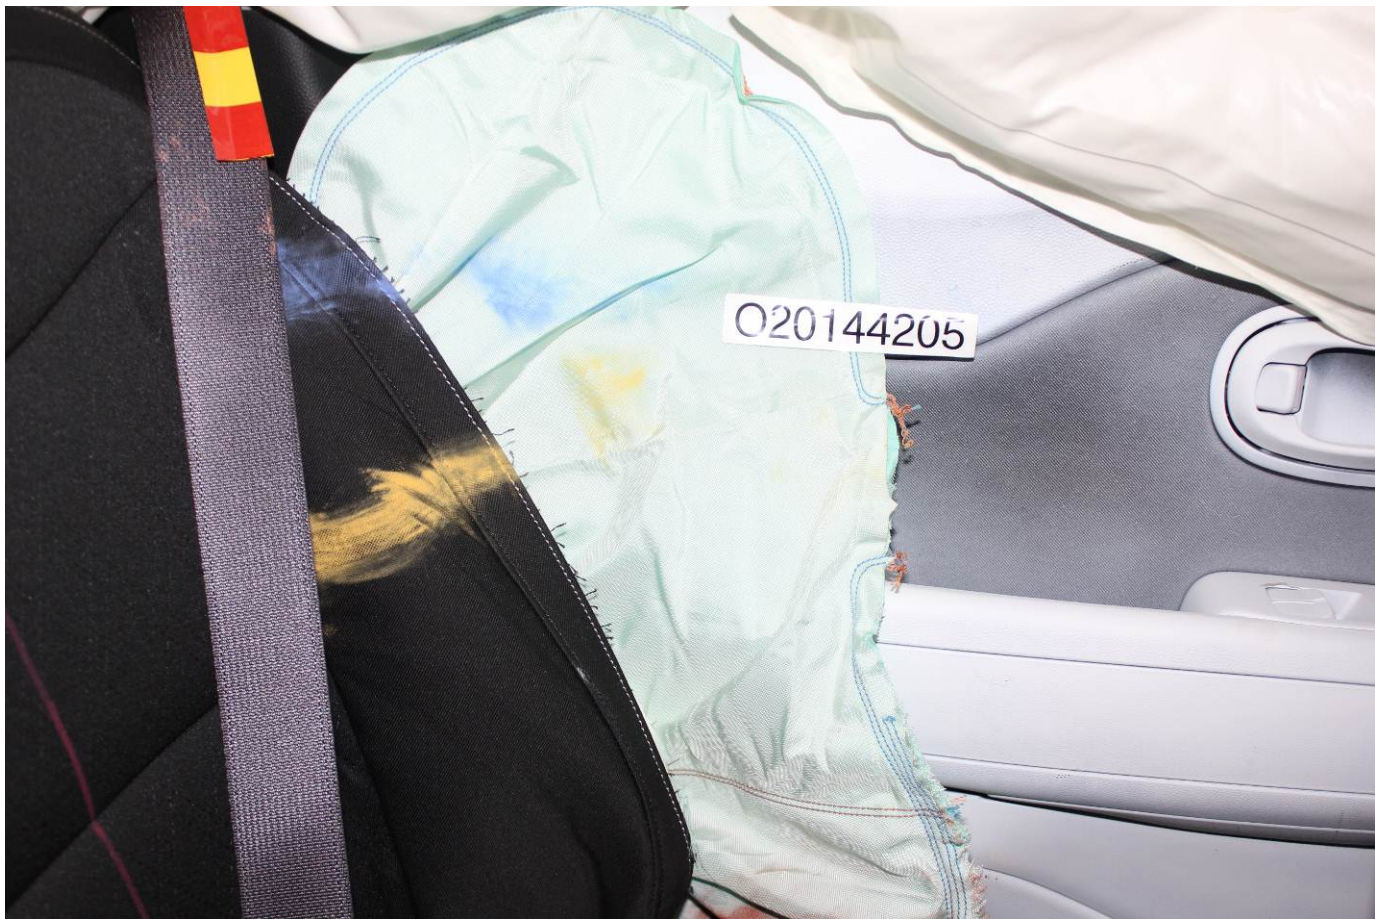
Post-Test Driver Dummy Close-up Torso Contact with Side Airbag View

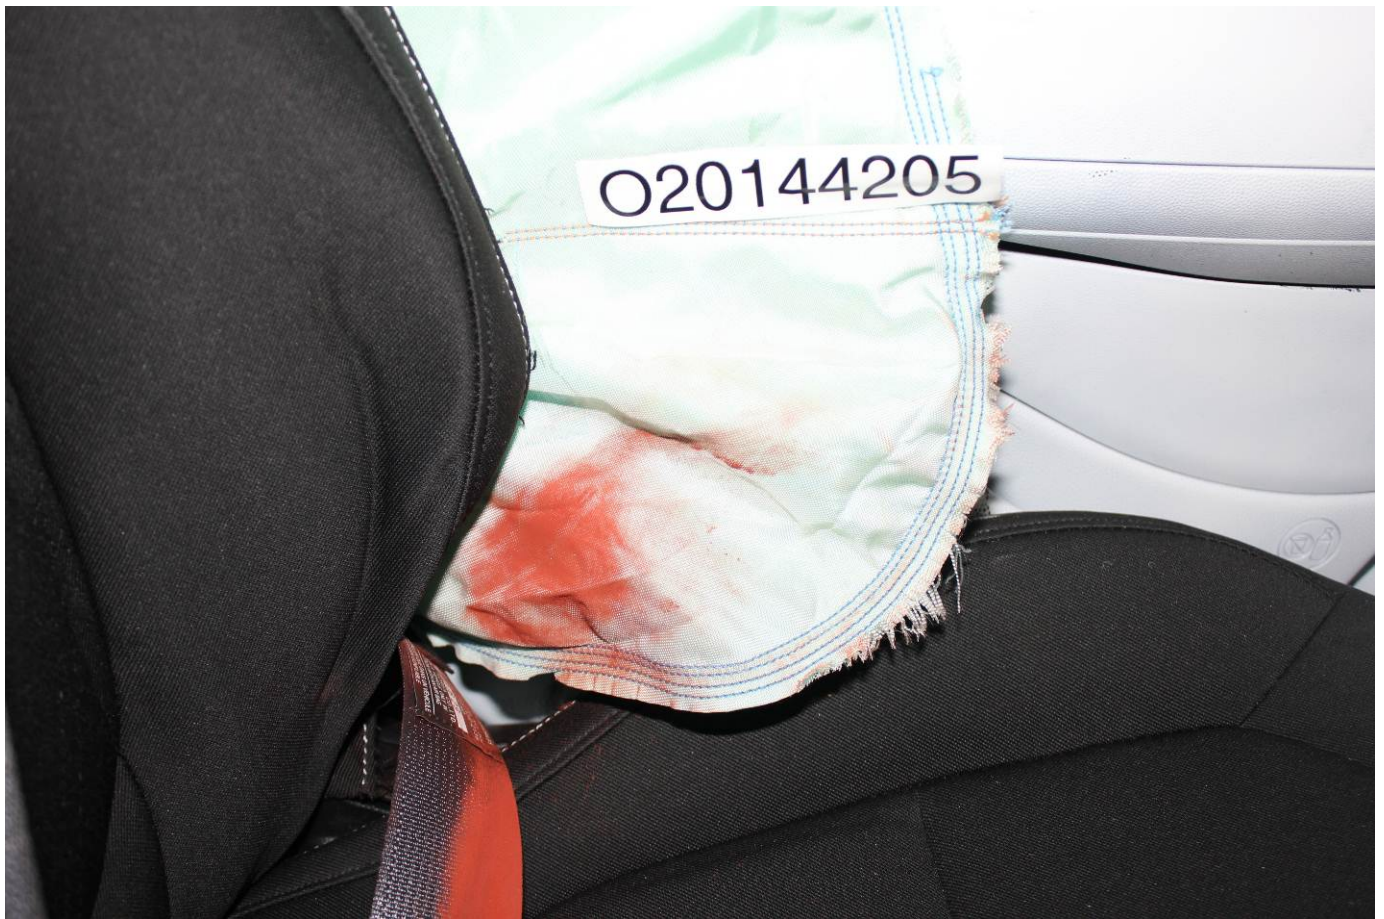
Post-Test Driver Dummy Close-up Pelvis Contact with Side Airbag View

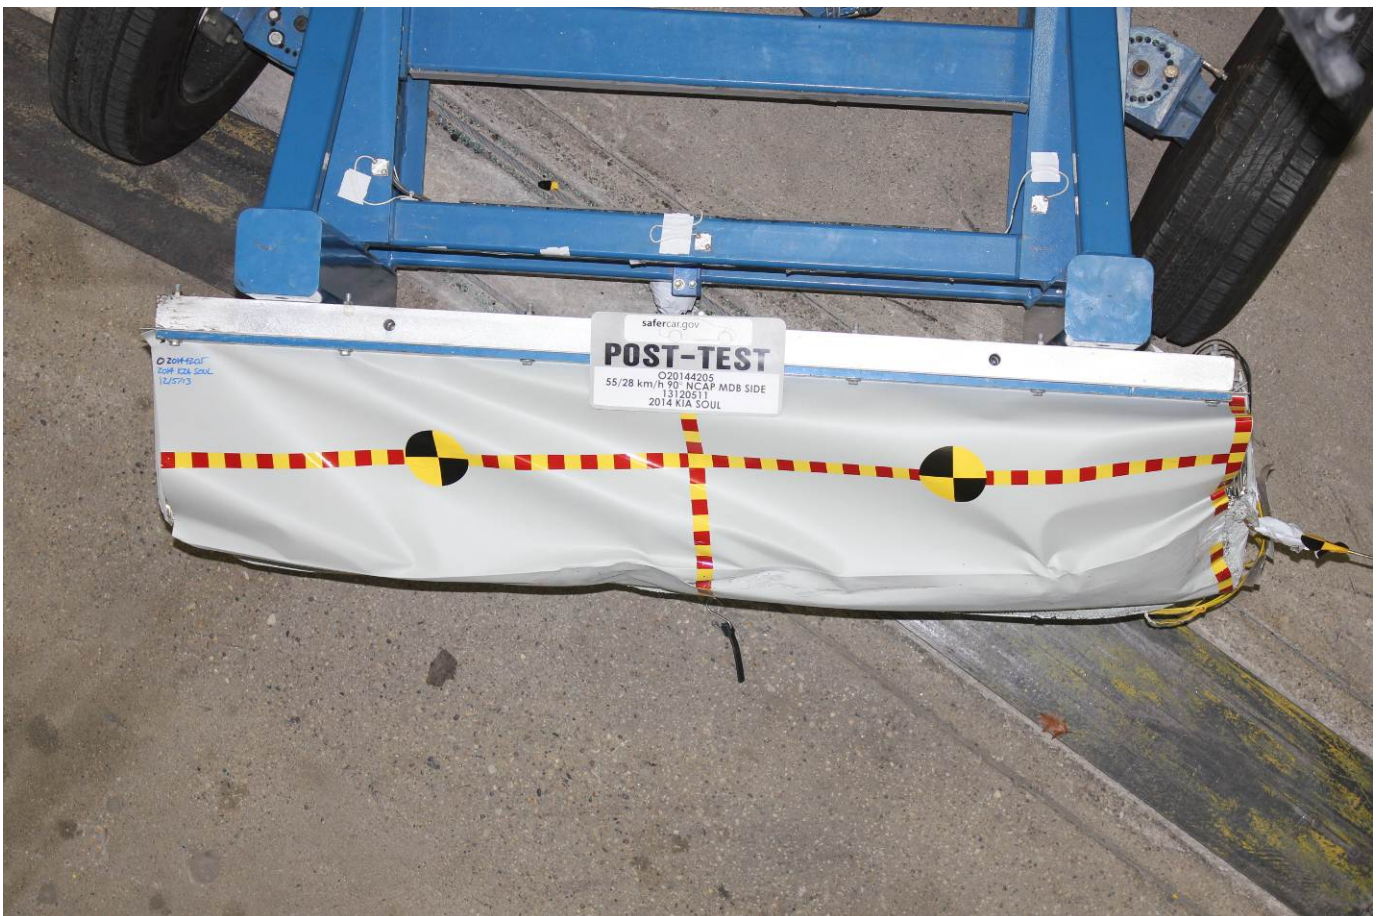
Post-Test Top View of MDB Impactor Face

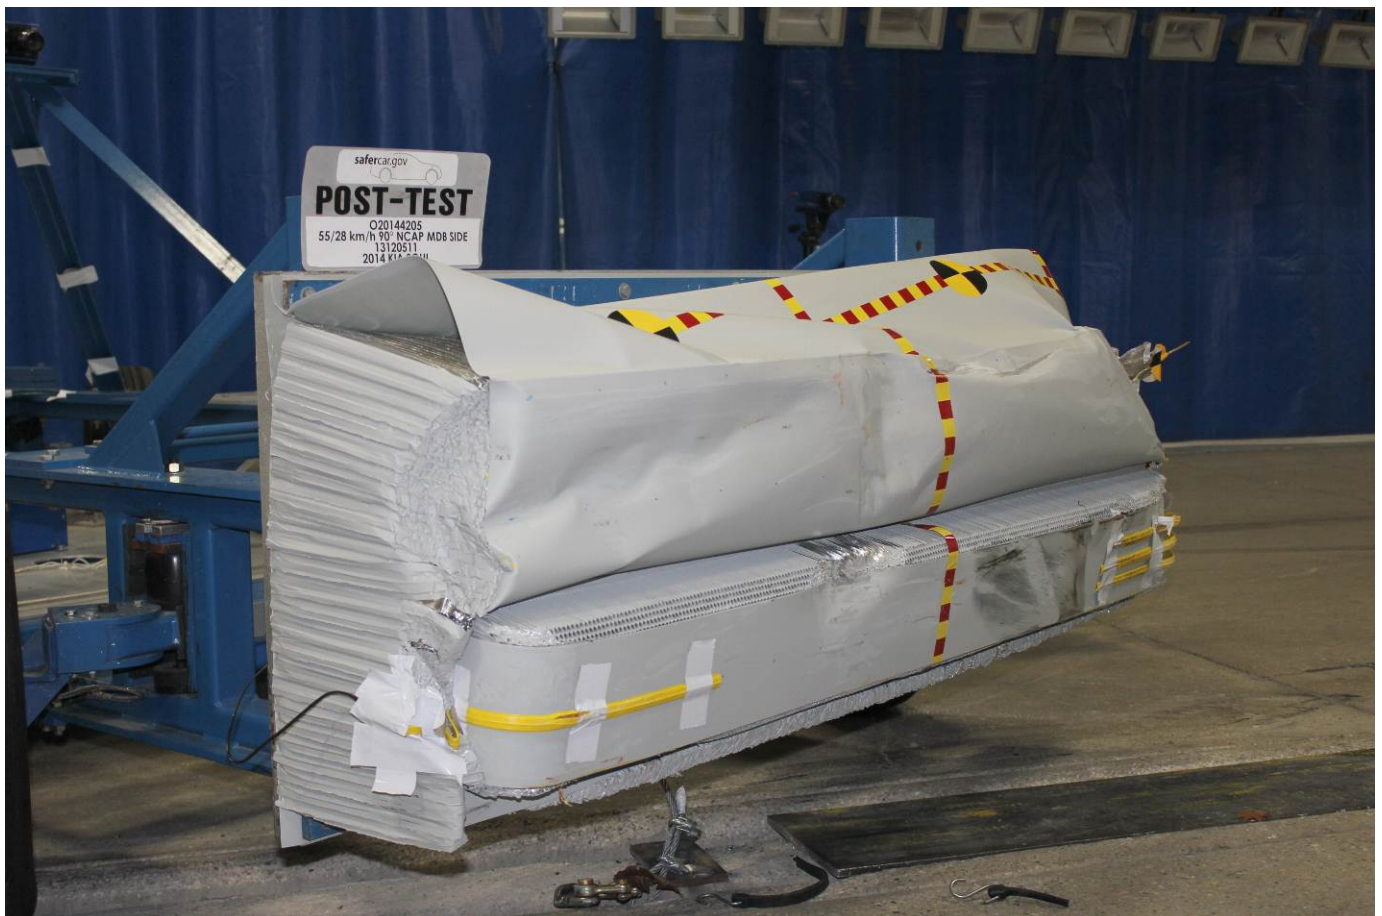
Post-Test Right Side View of MDB Impactor Face

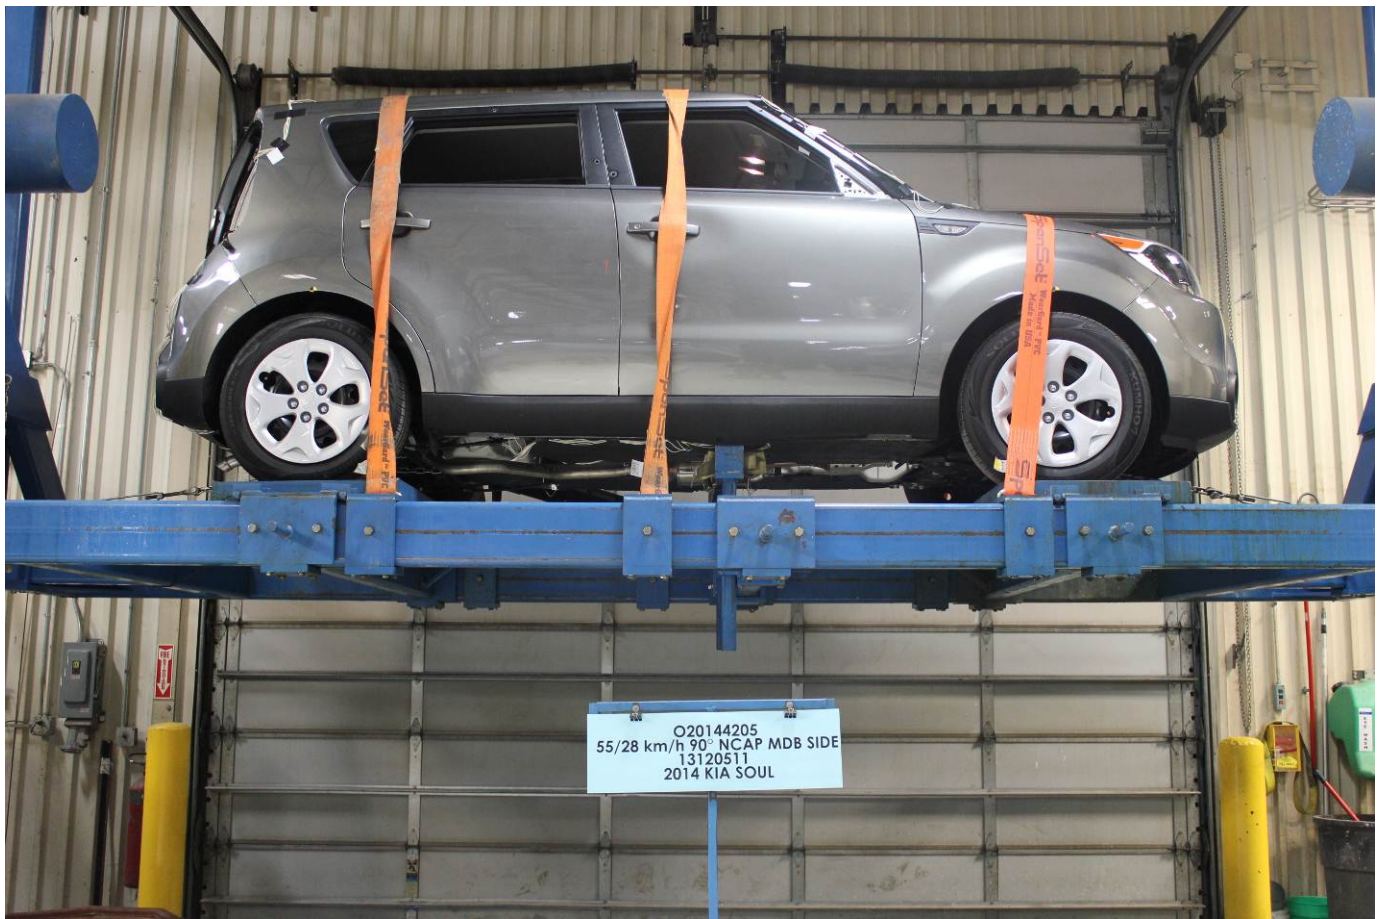
FMVSS No. 301 Static Rollover 0 Degrees
