**REPORT NUMBER: SPNCAP-KAR-14-011**

**NEW CAR ASSESSMENT PROGRAM (NCAP)  
SIDE IMPACT POLE TEST**

**TOYOTA MOTOR CORPORATION  
2014 TOYOTA PRIUS 5-DOOR HATCHBACK**

**NHTSA No: M20145113**

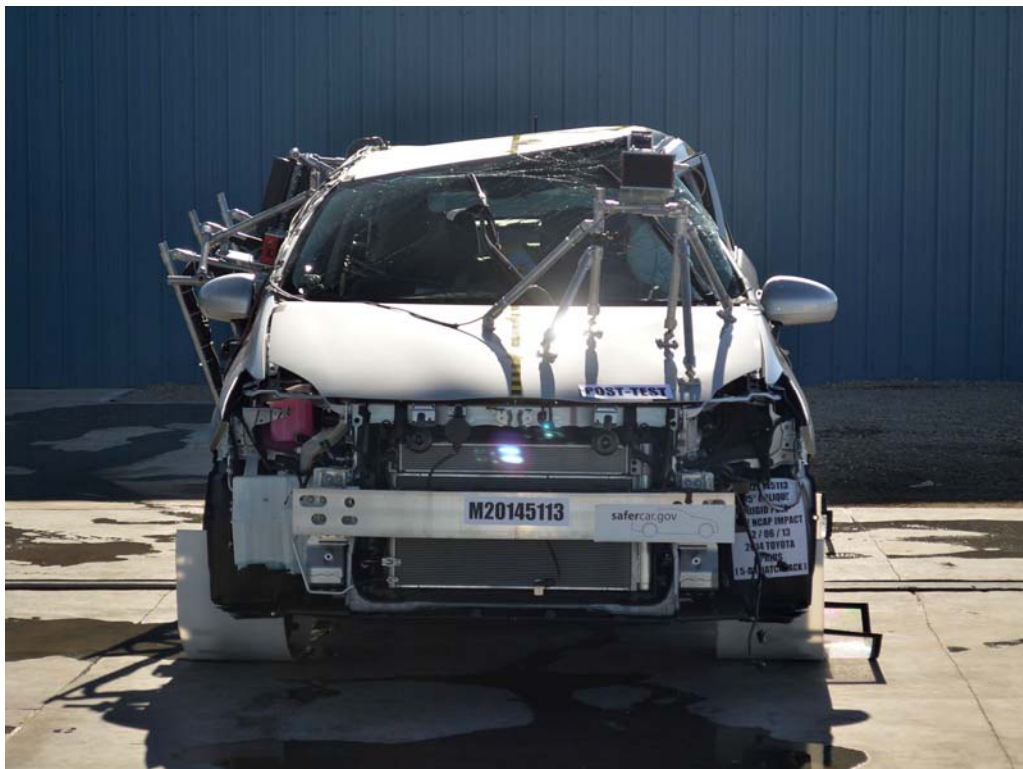
FIGURE 4. Post-Test Frontal View of Test Vehicle

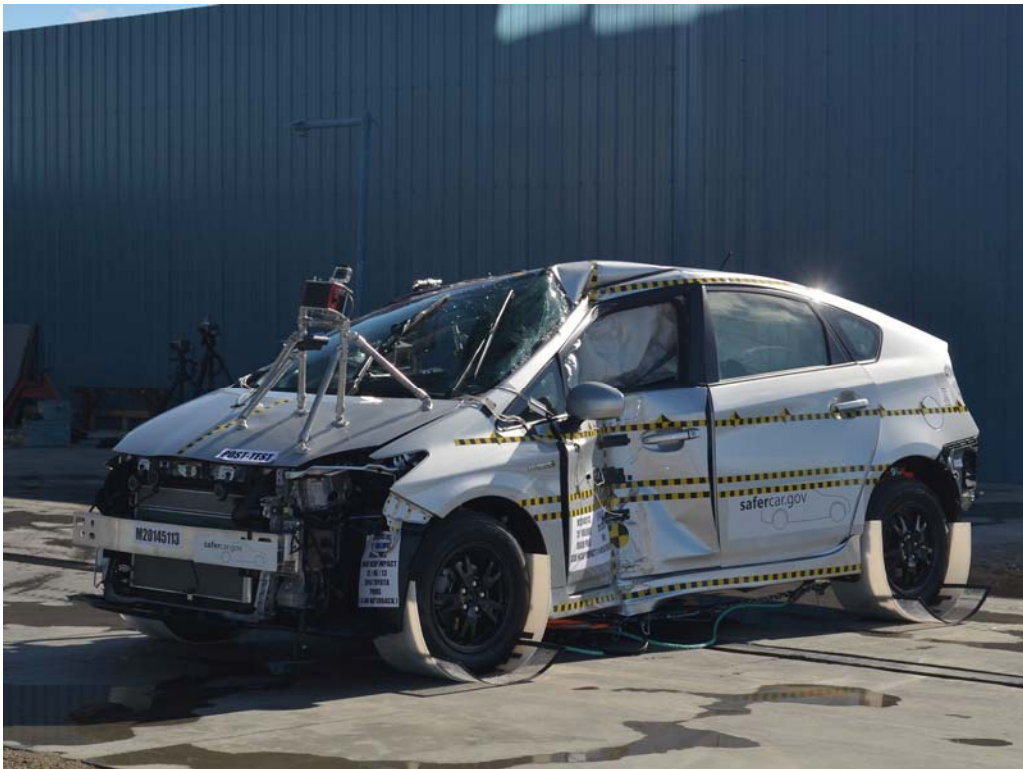
FIGURE 6. Post-Test Left Front  $\frac{3}{4}$  View of Test Vehicle

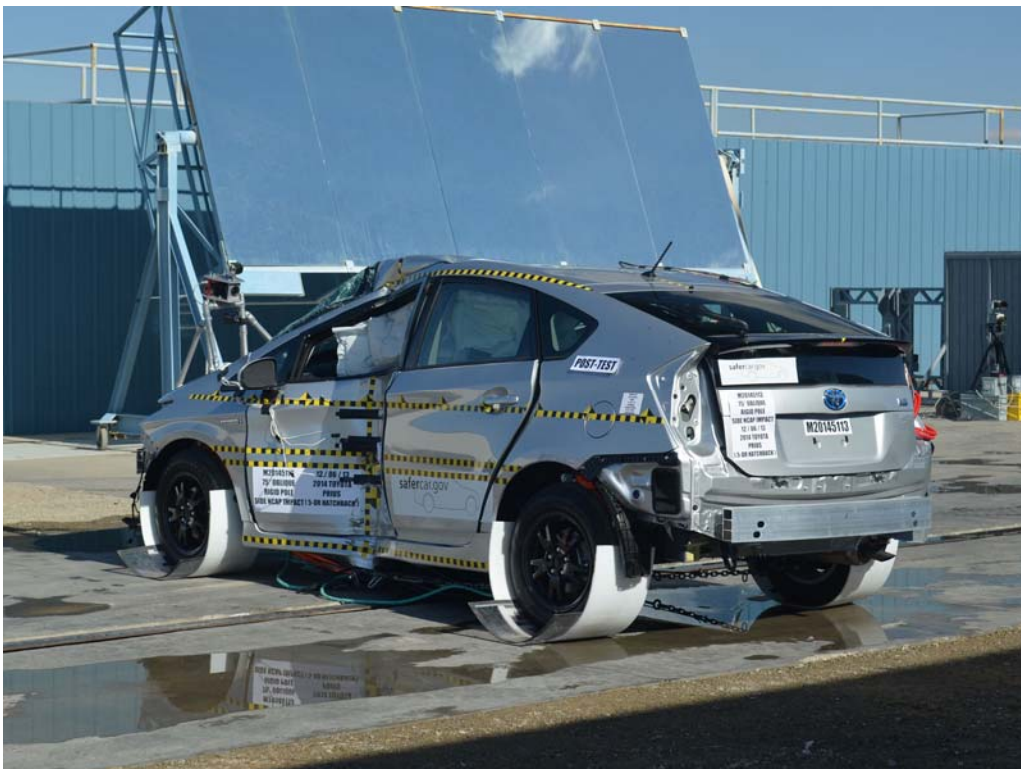
FIGURE 10. Post-Test Left Rear  $\frac{3}{4}$  View of Test Vehicle

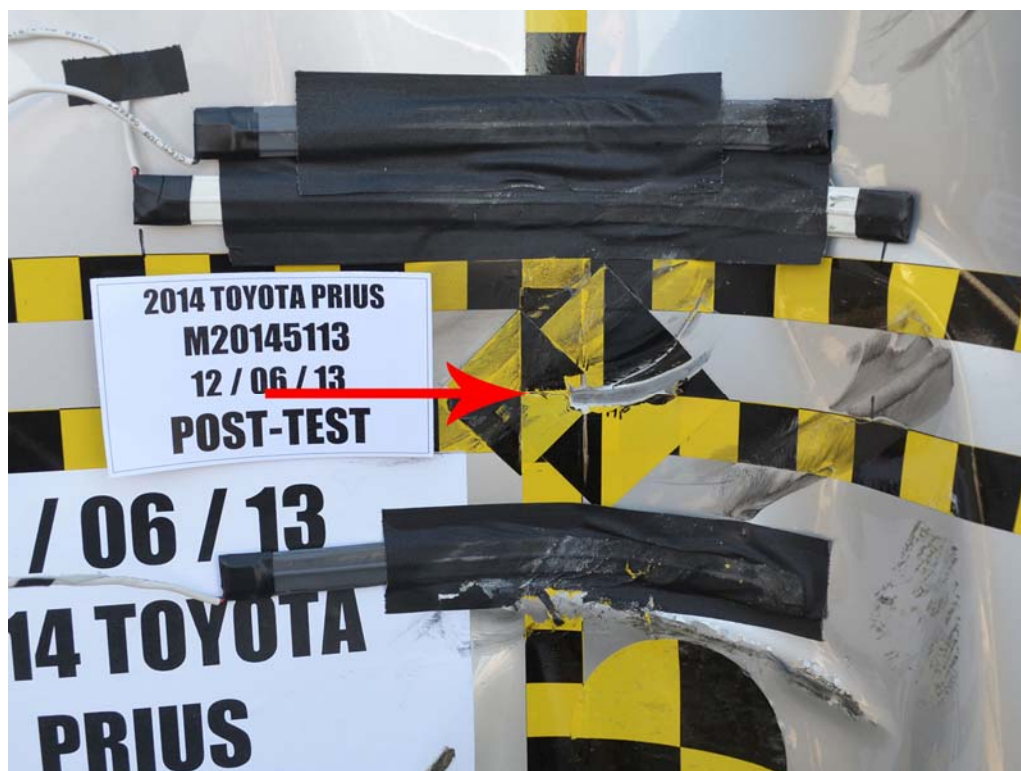
FIGURE 20. Post-Test Close-Up View of Impact Point Target  
Showing Impact Location

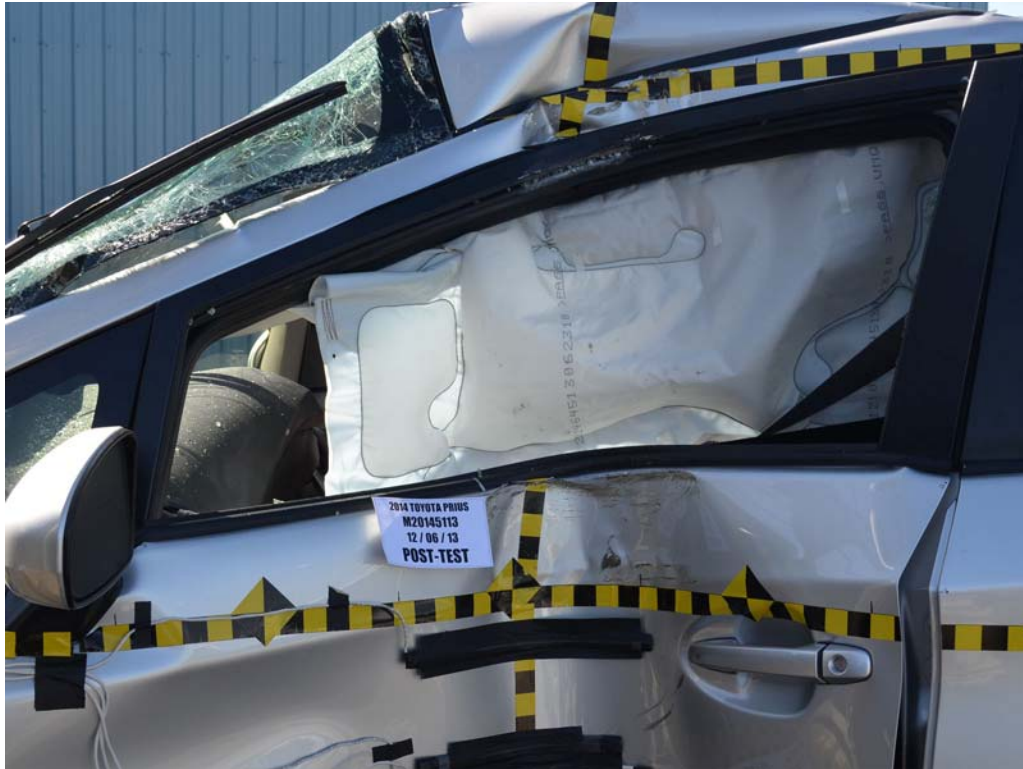
FIGURE 25. Post-Test Left Side View of Dummy Shoulder and Door Top View

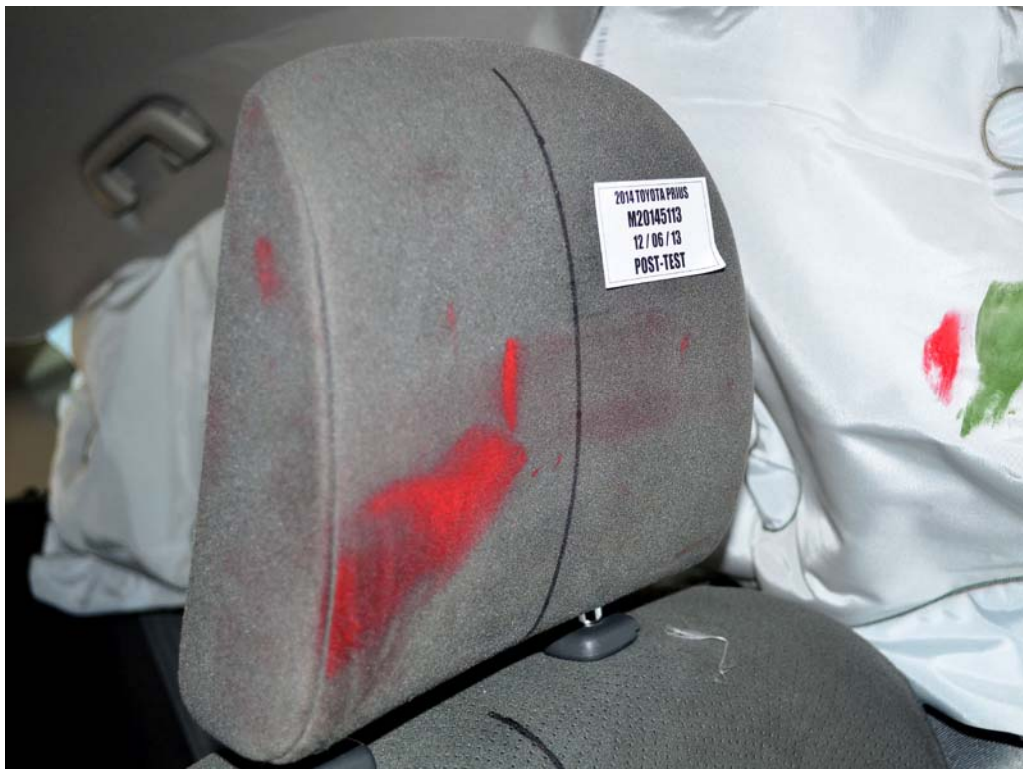
FIGURE 46. Post-Test Dummy Close-Up Head Contact with Vehicle Interior View

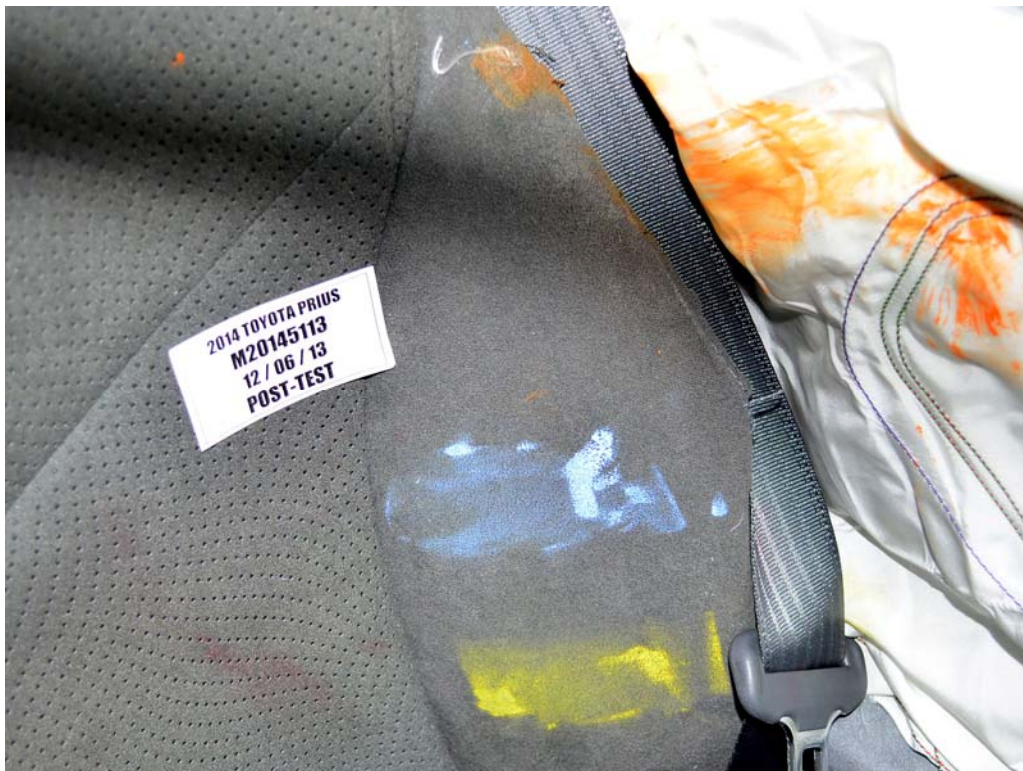
FIGURE 48. Post-Test Dummy Close-Up Torso Contact With Vehicle Interior View

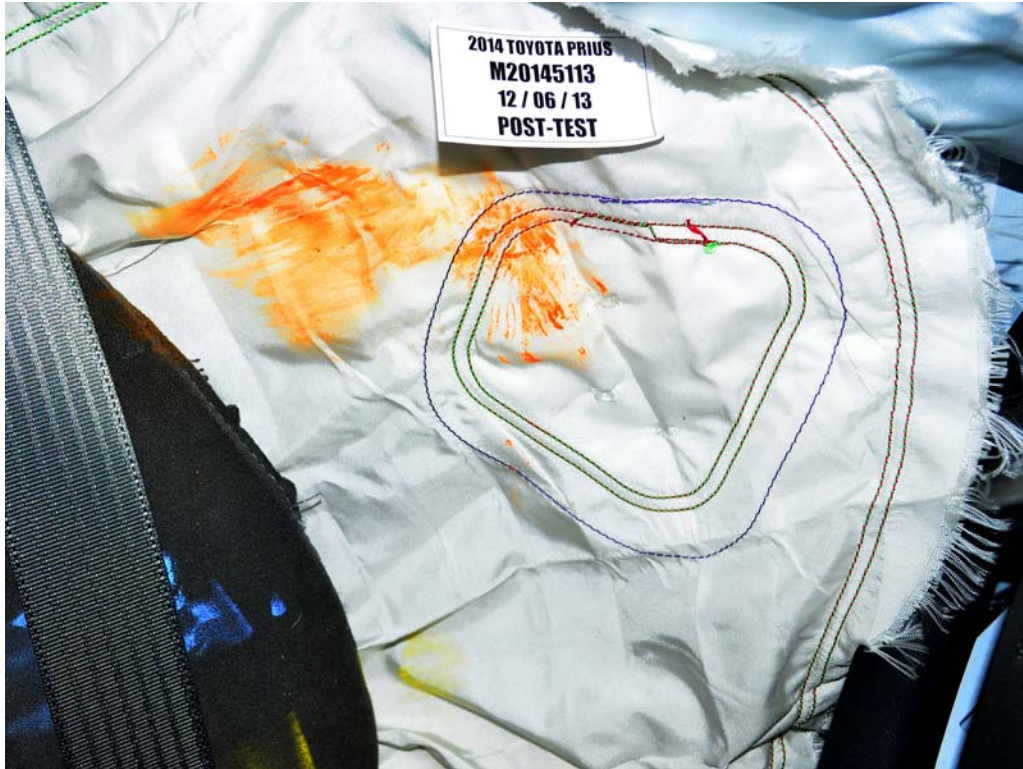
FIGURE 49. Post-Test Dummy Close-Up Torso Contact With Side Airbag View

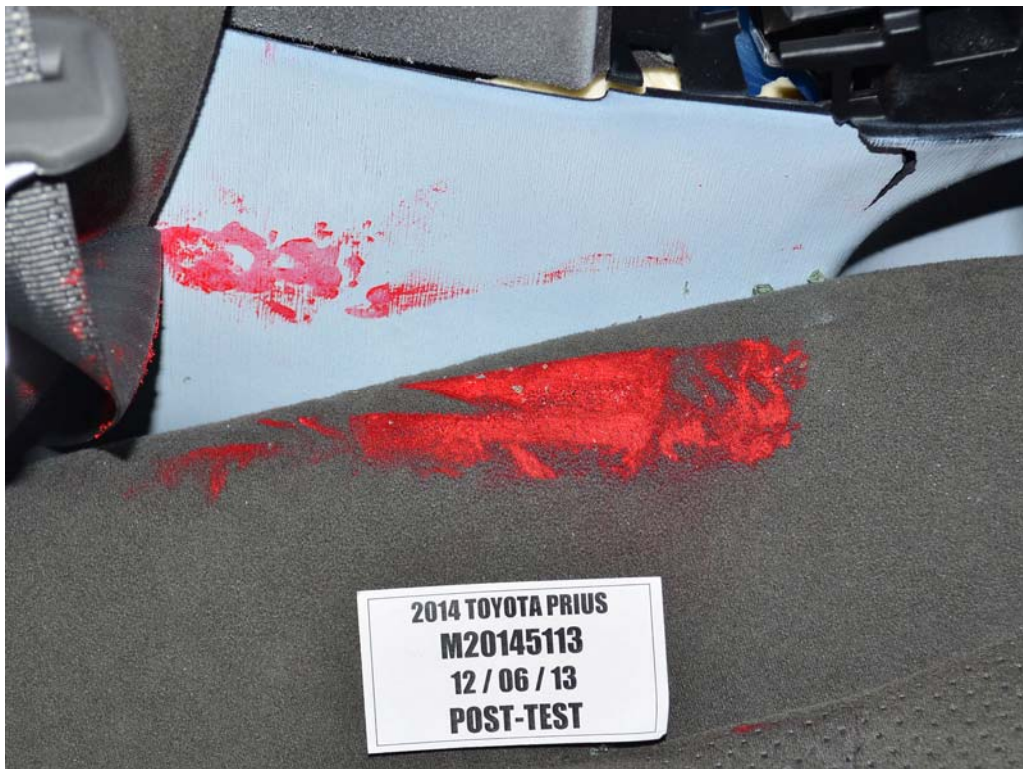
FIGURE 50. Post-Test Dummy Close-Up Pelvis Contact With Vehicle Interior View

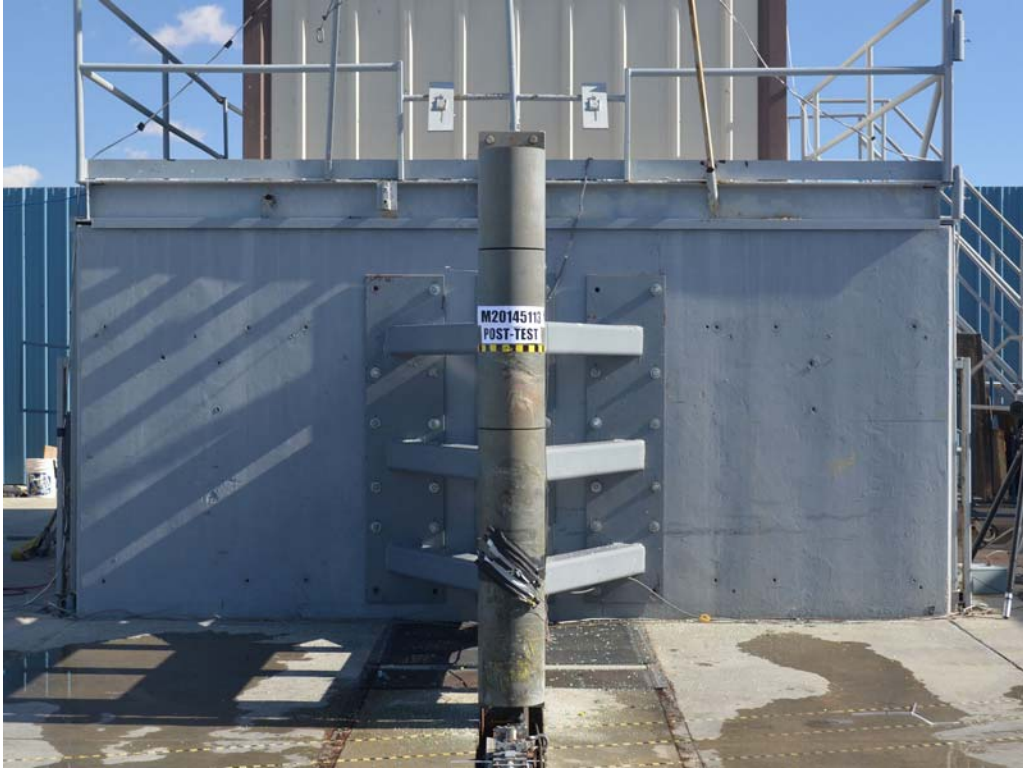
FIGURE 58. Post-Test Pole Barrier Front View

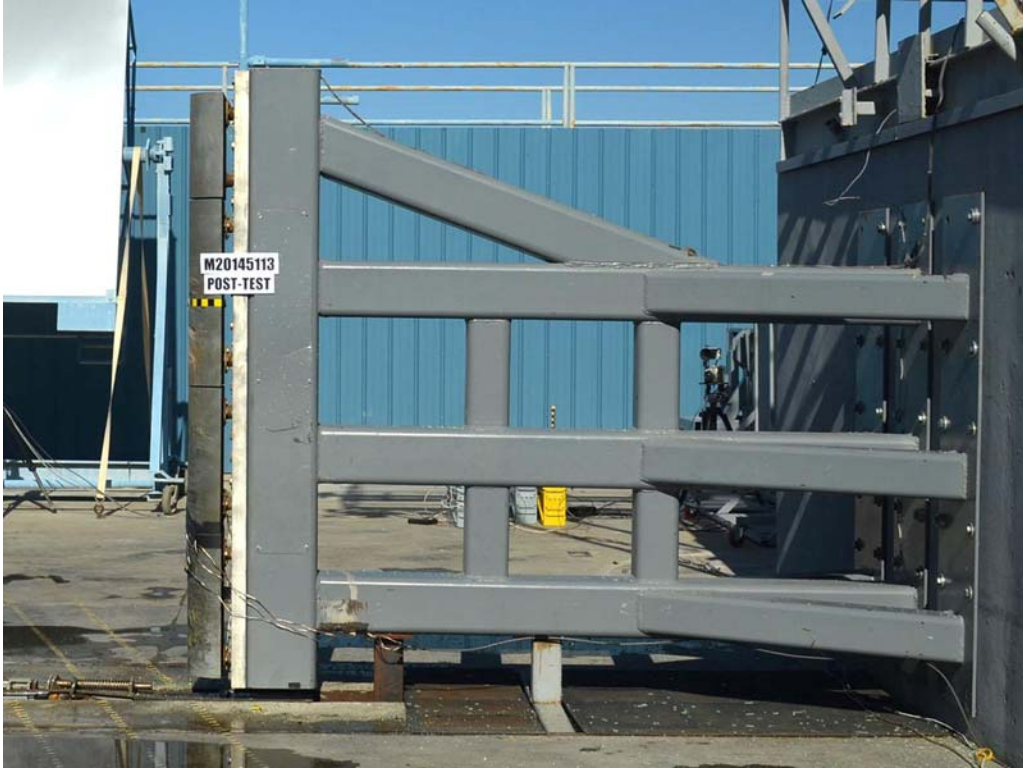
FIGURE 60. Post-Test Pole Barrier Side View

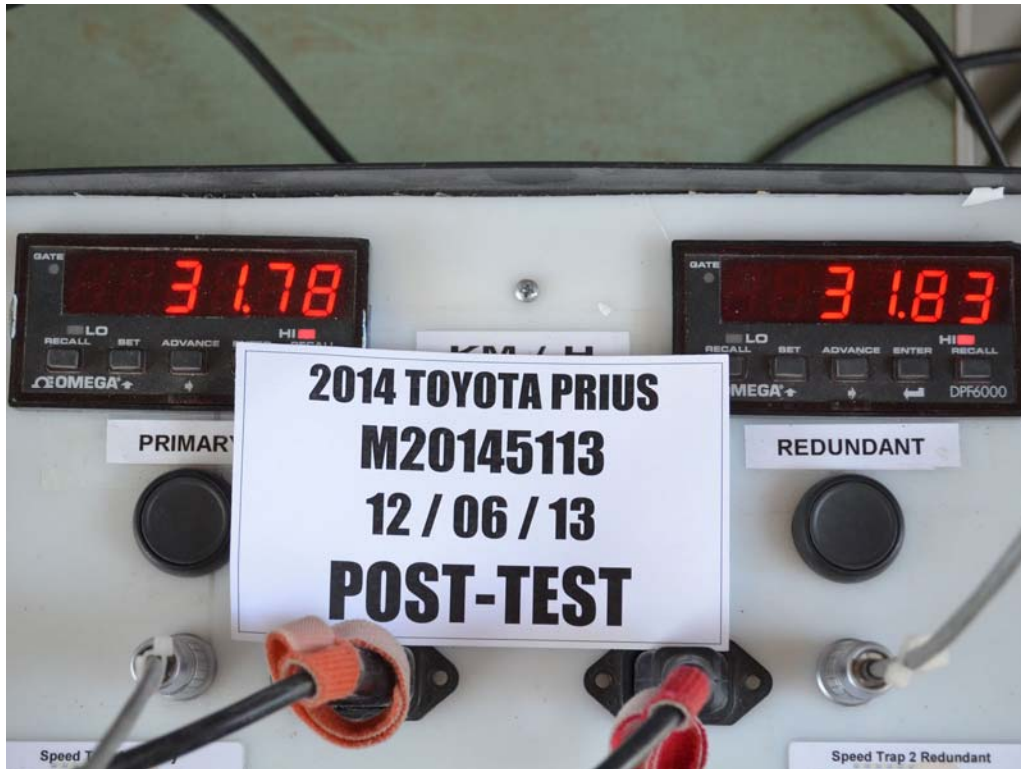
FIGURE 62. Post-Test Primary and Redundant Speed Trap Read-Out
