**REPORT NUMBER: NCAP-MGA-2014-036**

**NEW CAR ASSESSMENT PROGRAM (NCAP)  
Frontal Barrier Impact Test**

**KIA MOTORS CORPORATION  
2014 Kia Soul SUV  
NHTSA No.: O20144203**

**MGA RESEARCH CORPORATION  
5000 Warren Road  
Burlington, WI 53105**

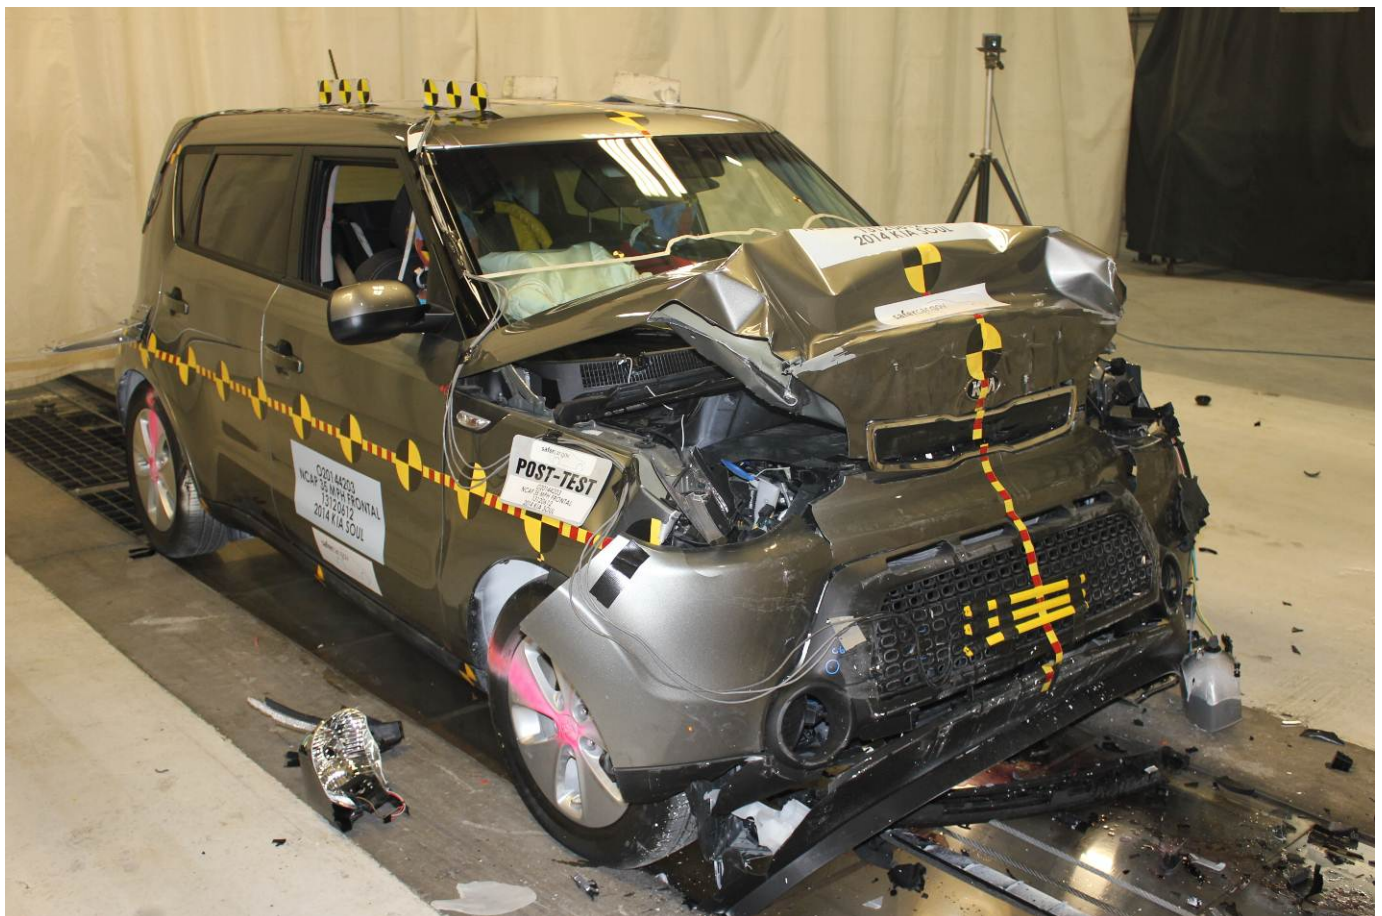
Post-Test Right Front 3-4 View

The maximum static crush of the vehicle was 452 mm and both the driver and passenger side doors remained closed during the impact event and were operable after the impact.

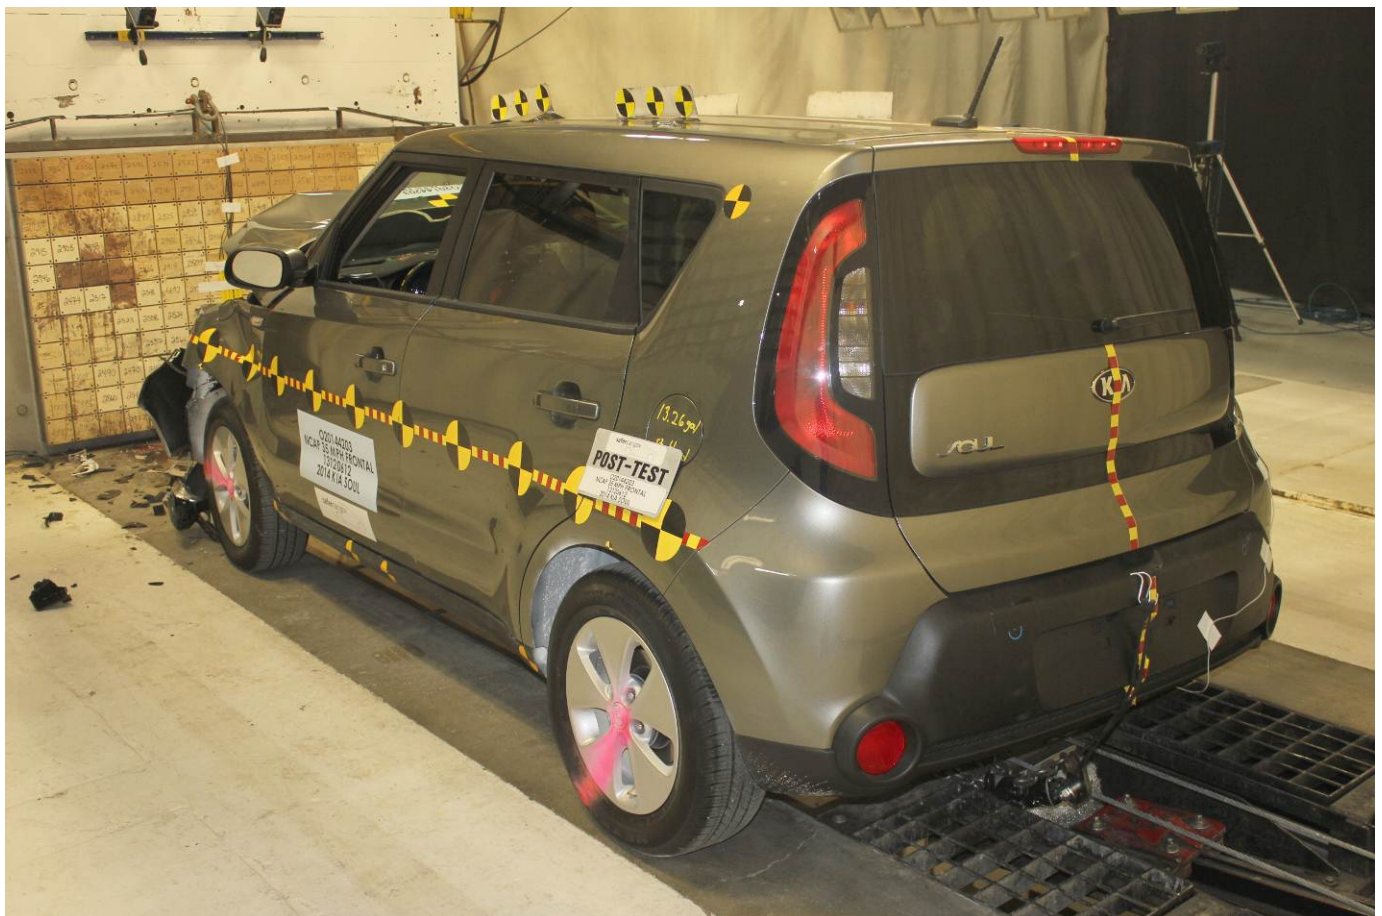
Post-Test Left Rear 3-4 View

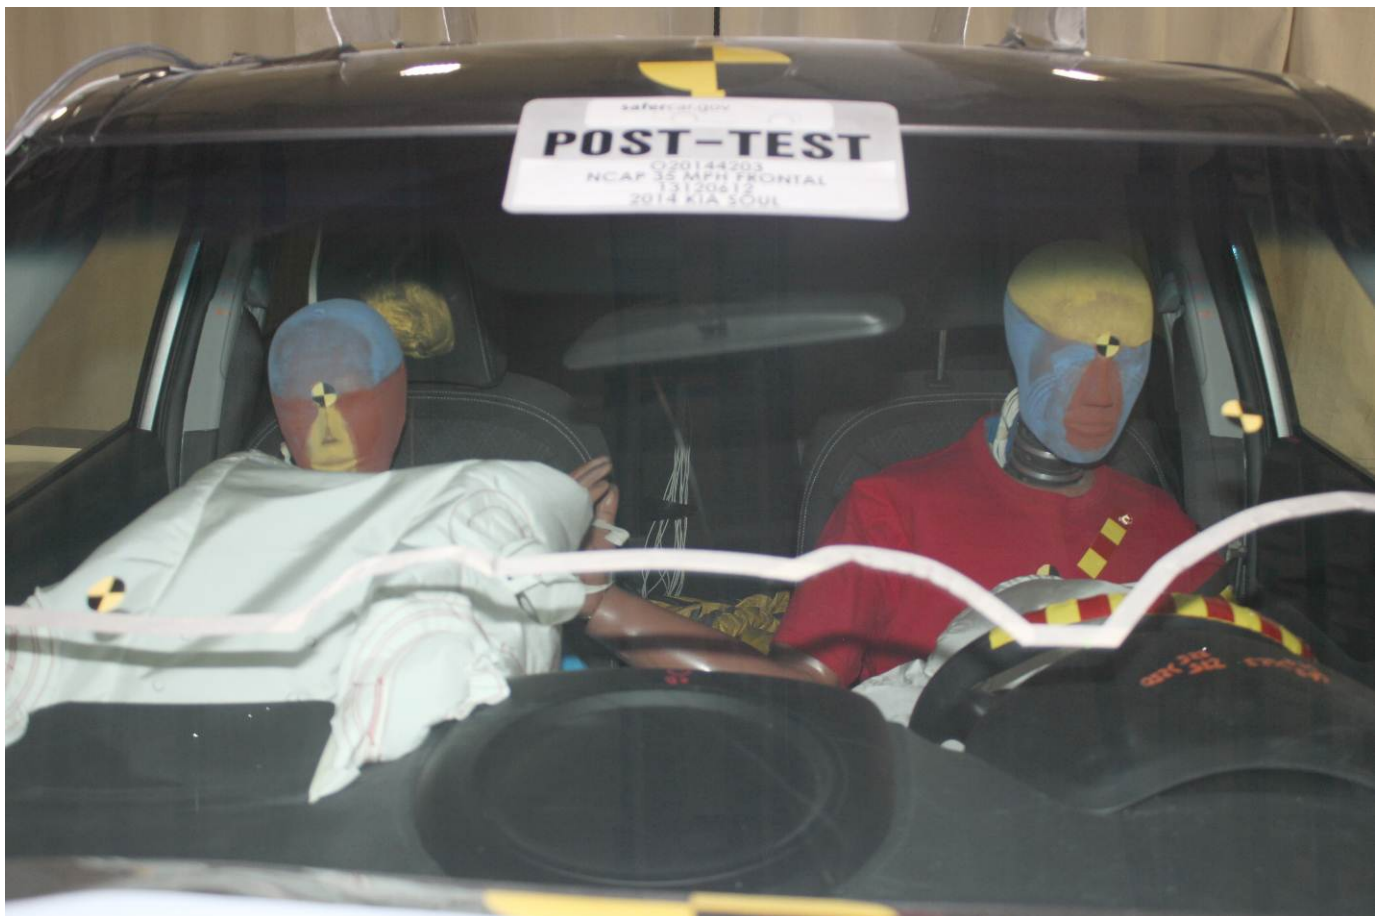
Post-Test Windshield View

There was 100 percent windshield retention and no intrusion into the protected zone of the windshield during the event. There was no Stoddard Solvent leakage after the event or during any phase of the static rollover.

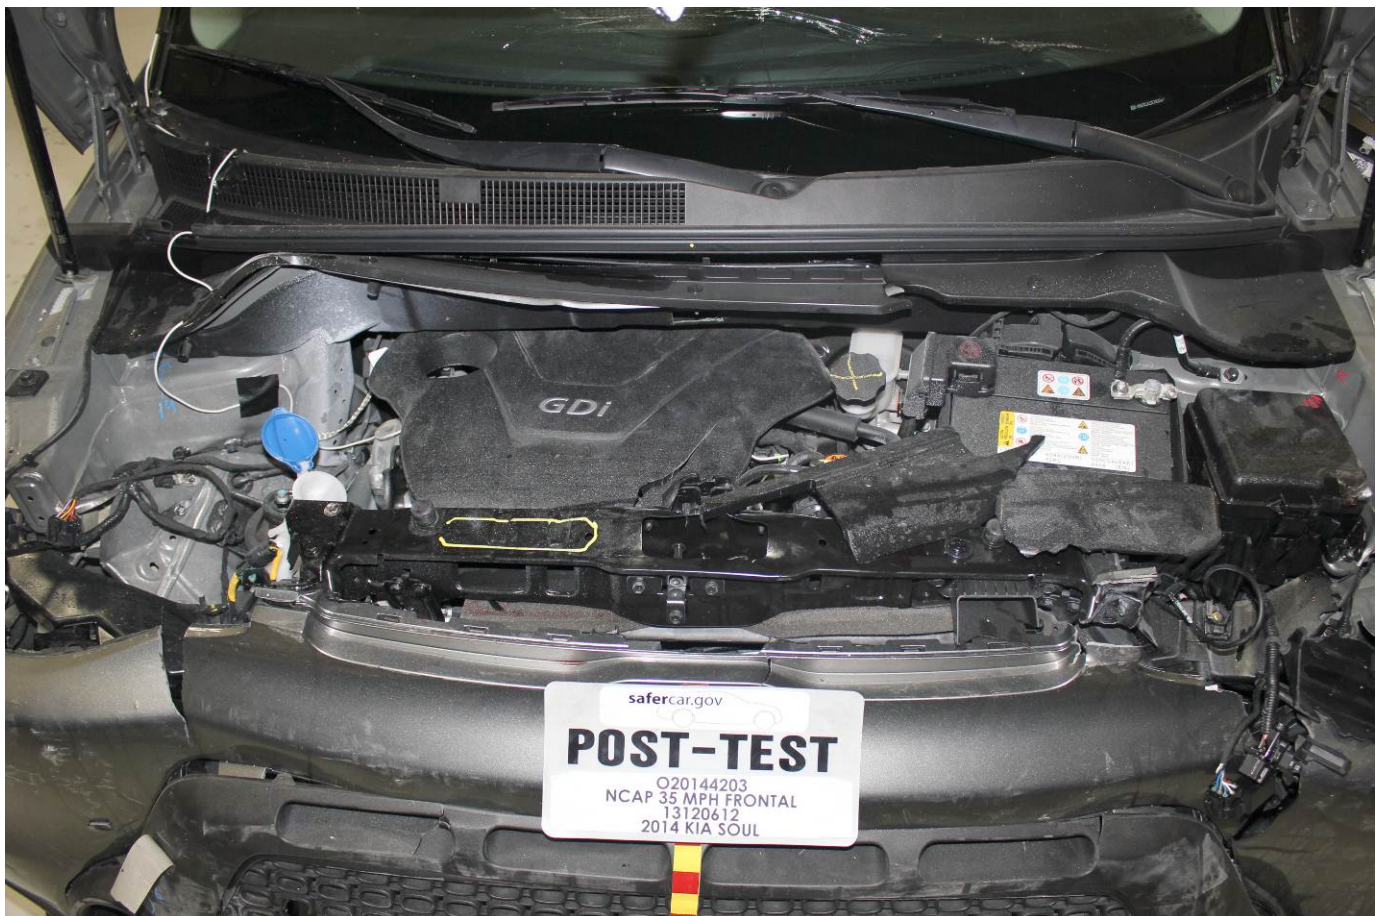
Post-Test Engine Compartment View

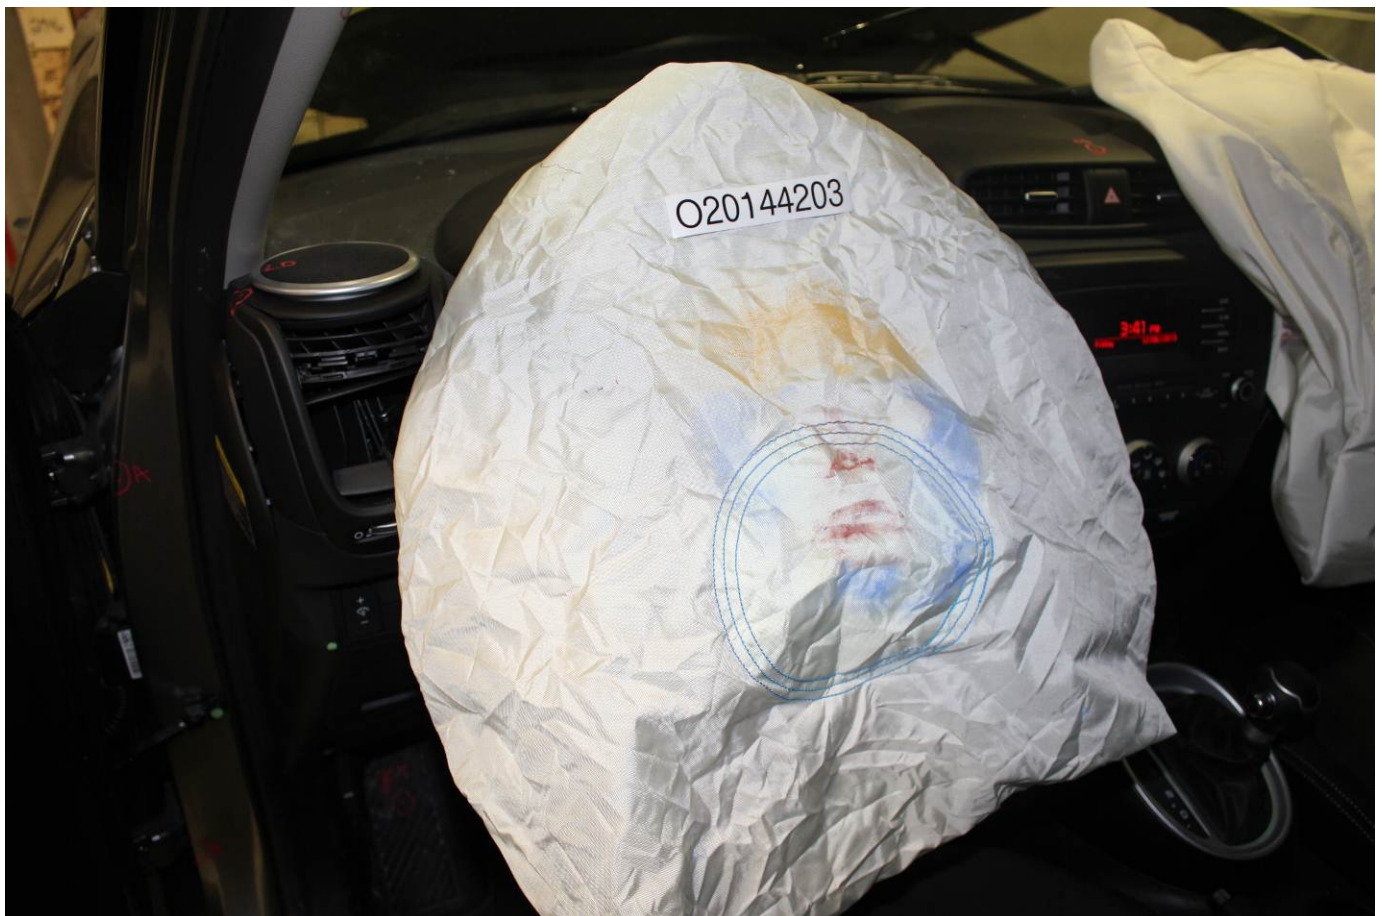
Post-Test Driver Dummy Contact with Airbag

The driver's visible contact points were as follows: The driver's head and chest contacted the airbag. The driver's head also contacted the headrest. The driver's left knee contacted the knee bolster and the right knee contacted the steering column. The passenger's visible contact points were as follows: The passenger's head and chest contacted the airbag. The passenger's head also contacted the headrest. The passenger's knees contacted the glovebox.

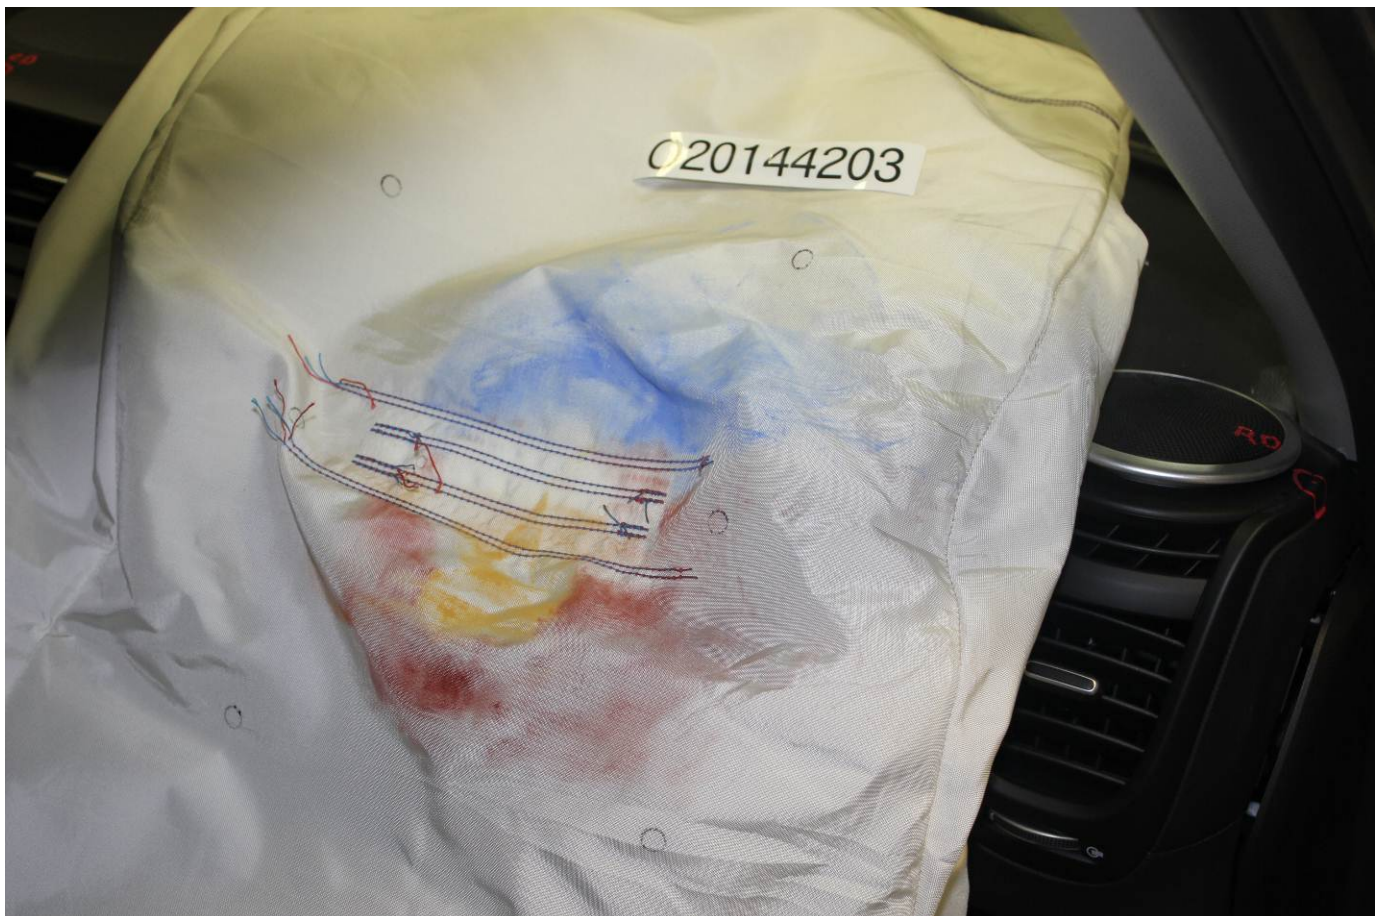
Post-Test Passenger Dummy Contact with Airbag

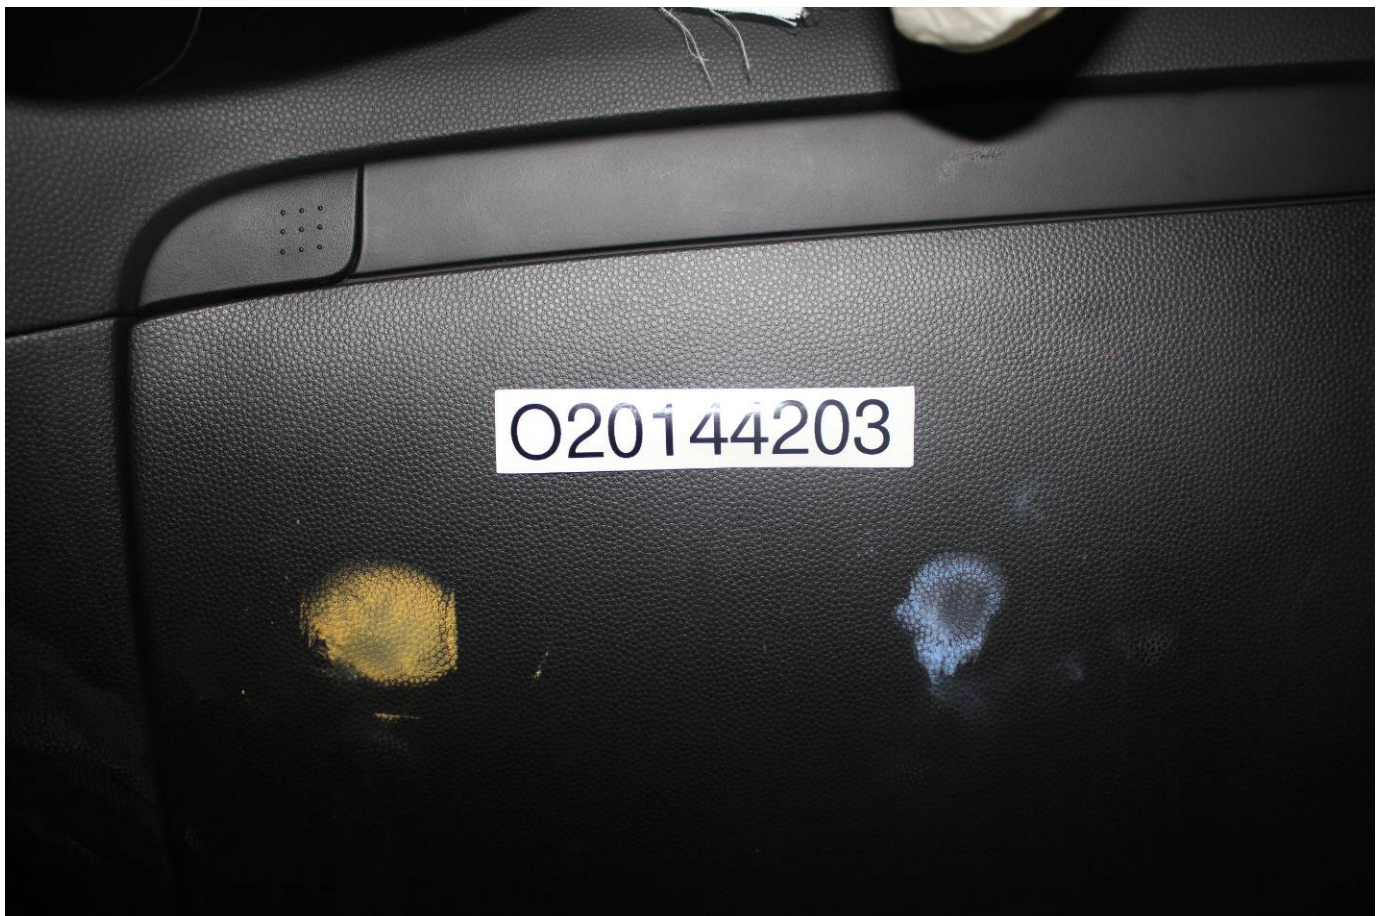
Post-Test Passenger Dummy Contact with Glovebox

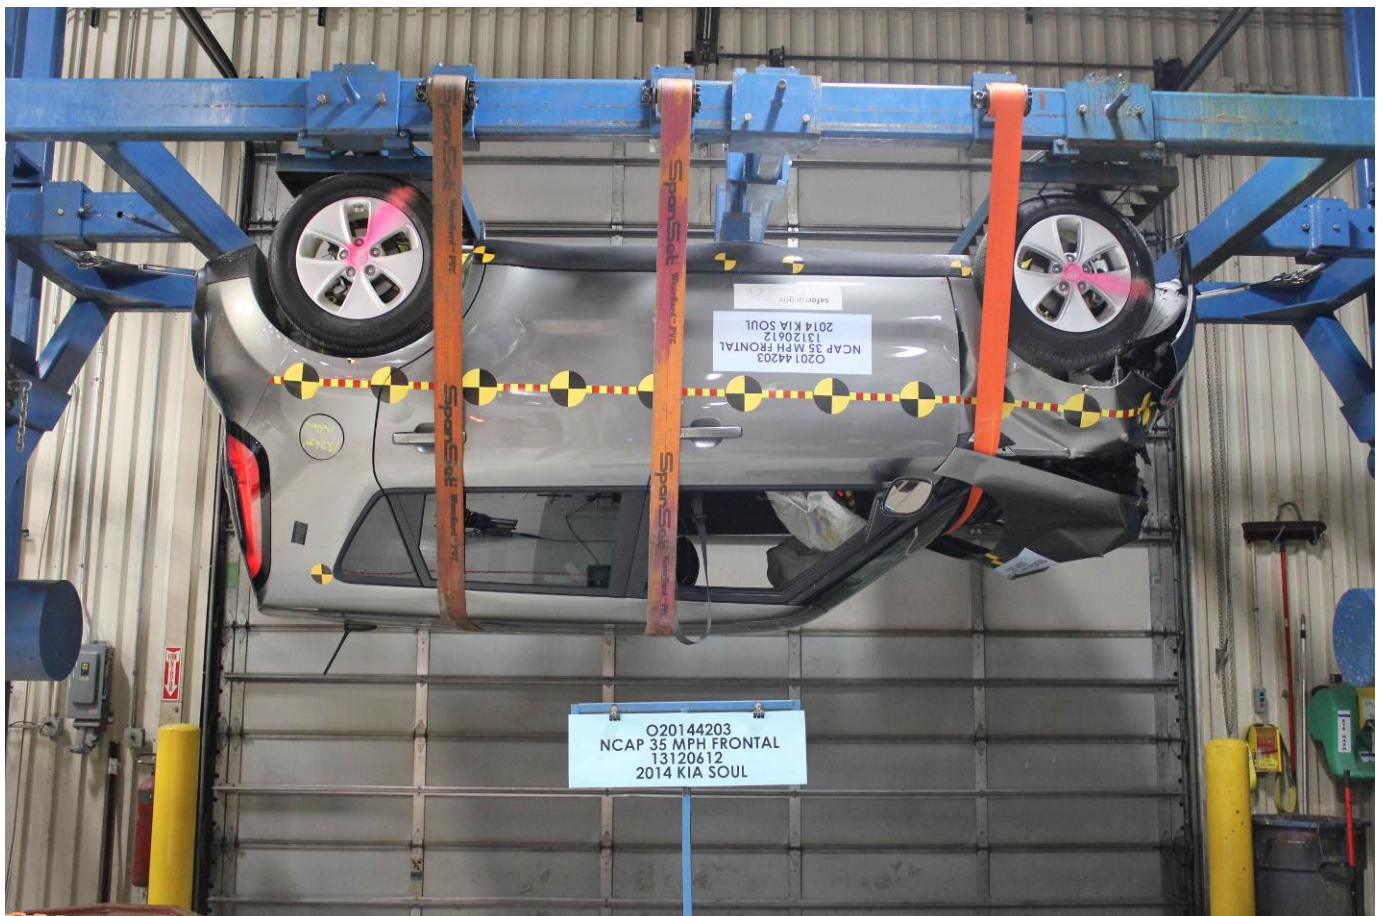
Vehicle at 180 Degrees on Static Rollover Device

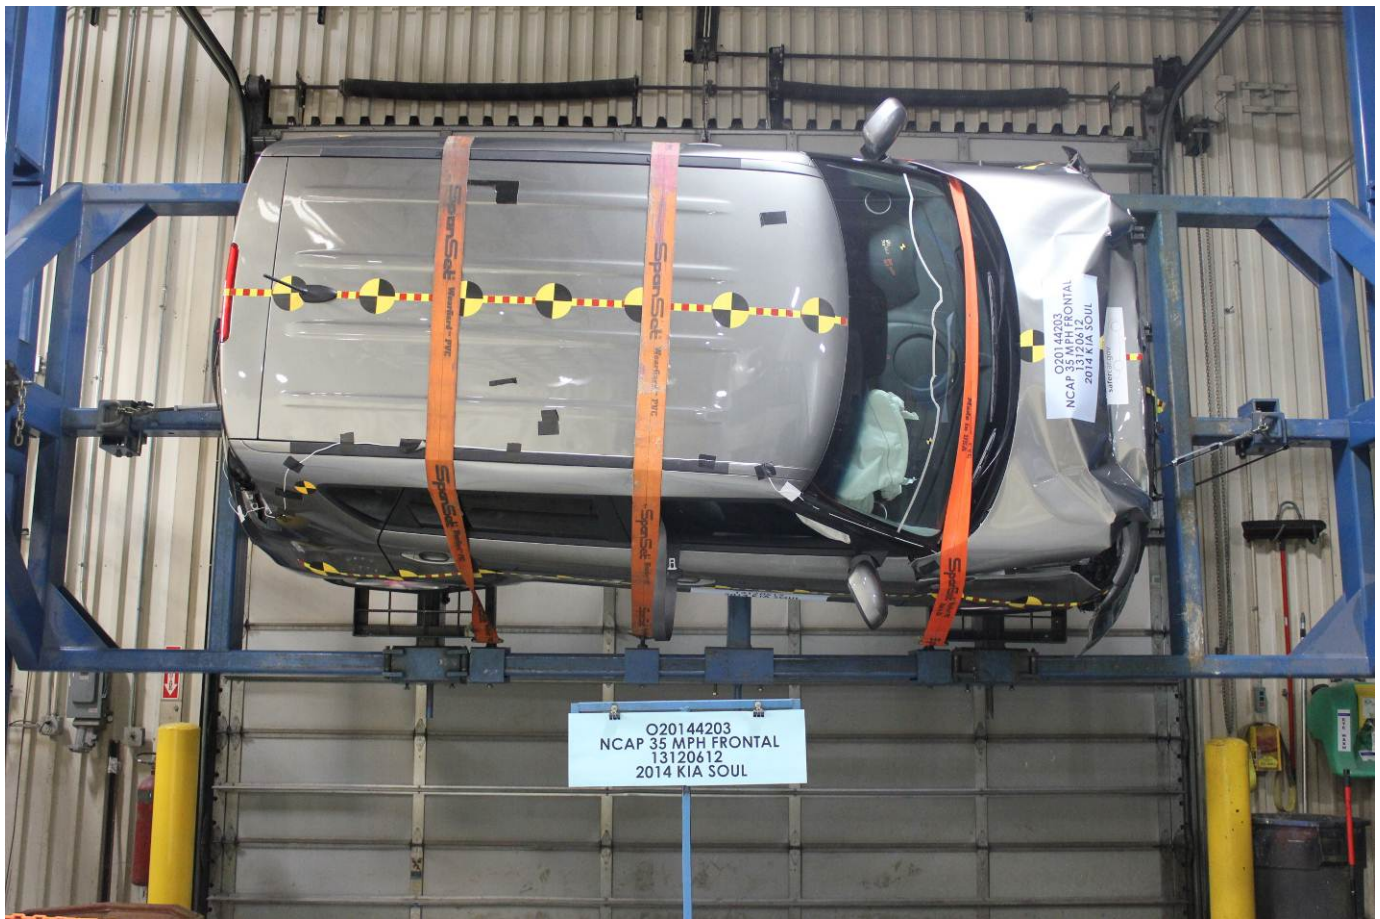
Vehicle at 270 Degrees on Static Rollover Device
