**REPORT NUMBER: SINCAP-MGA-2014-037**

**NEW CAR ASSESSMENT PROGRAM (NCAP)  
Moving Deformable Barrier Side Impact Test**

**NISSAN MOTOR CO., LTD.  
2014 Nissan Pathfinder S SUV  
NHTSA No.: O20145202**

**FINAL REPORT**

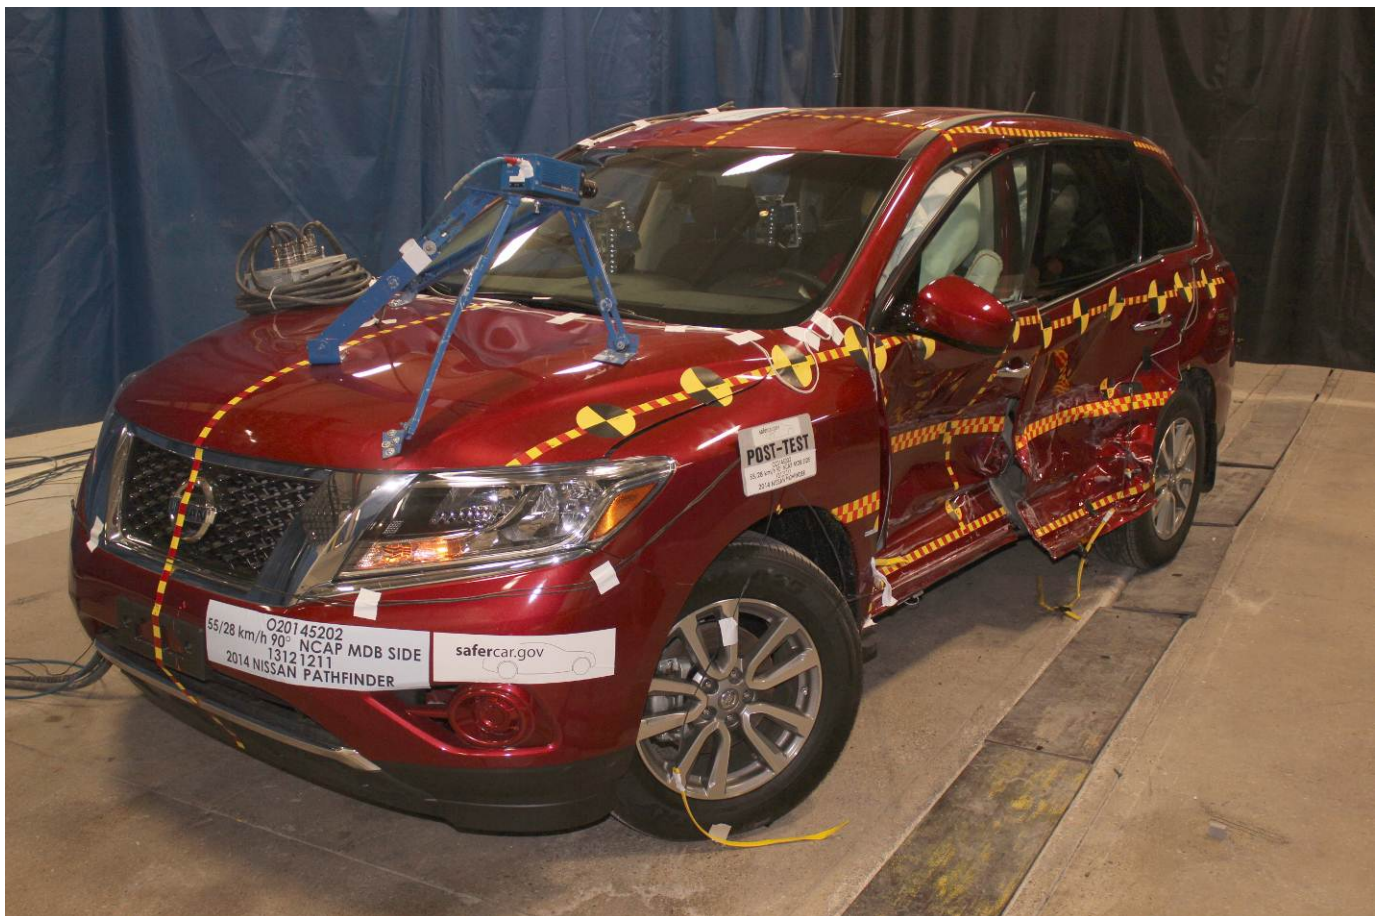
Post-Test Left Front Three-Quarter View of Test Vehicle

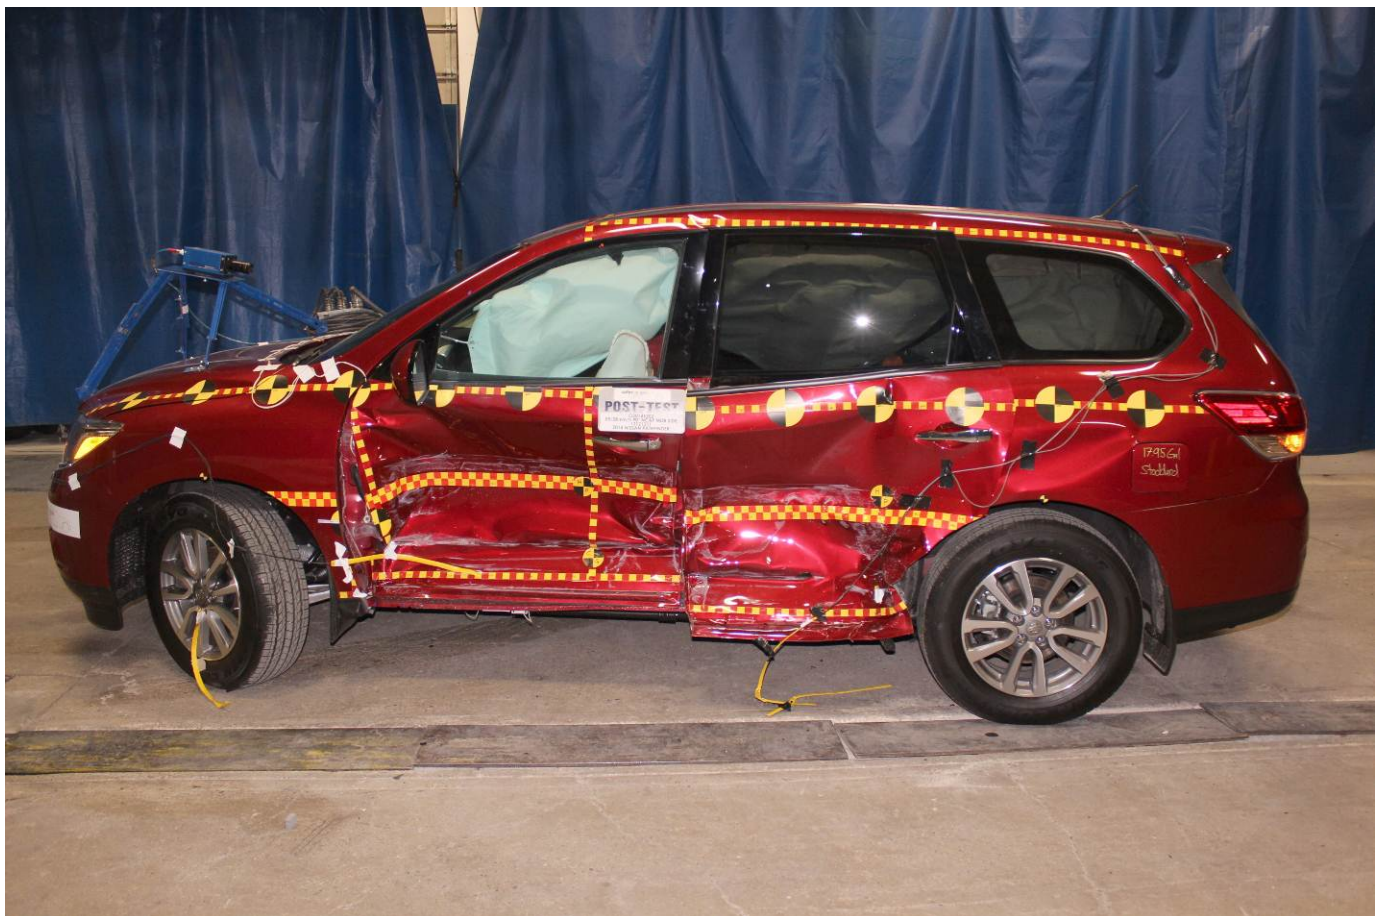
Post-Test Left Side View of Test Vehicle

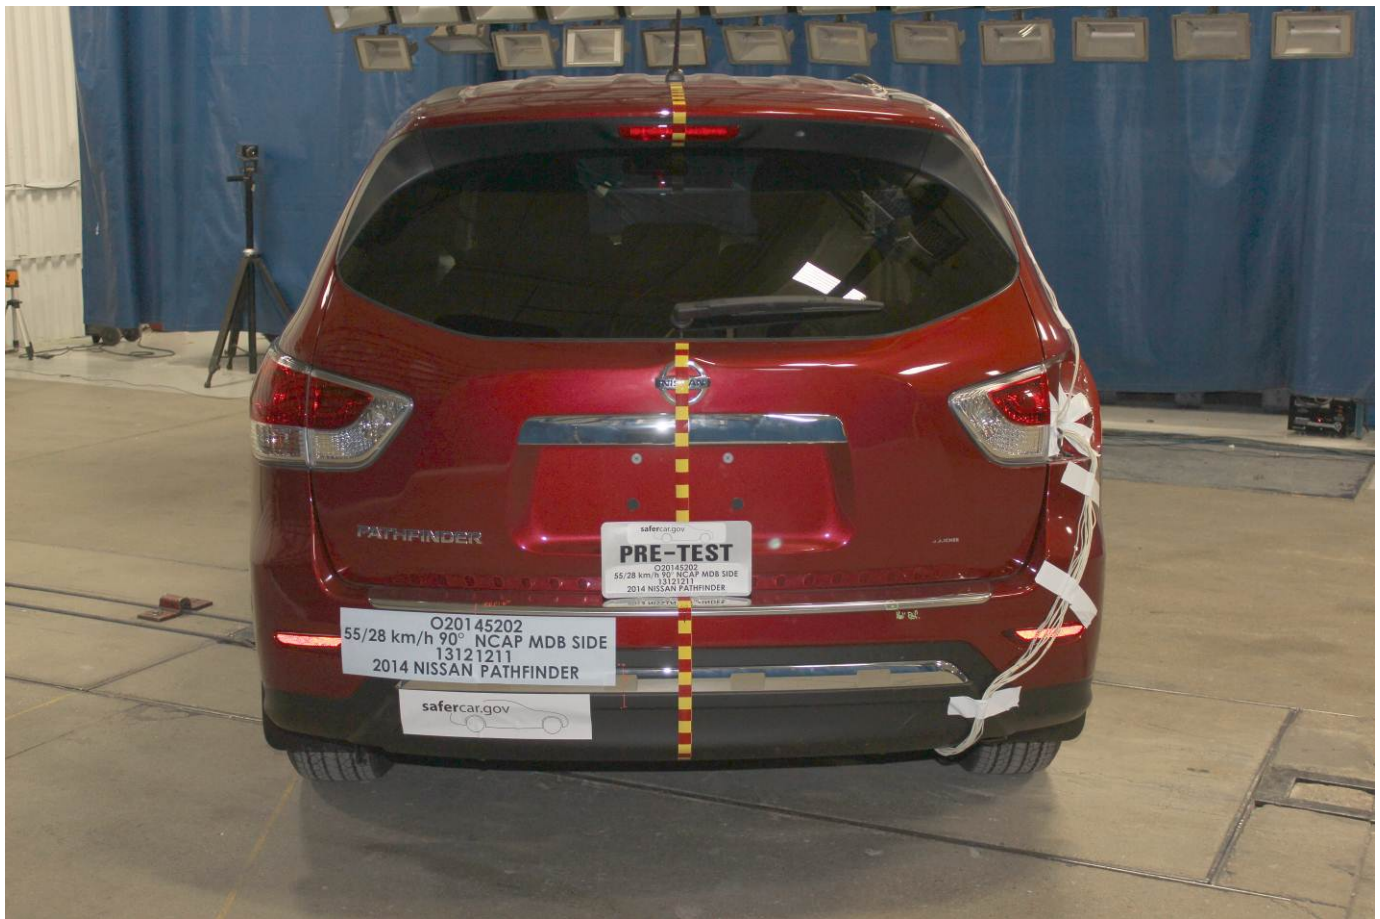
Pre-Test Rear View of Test Vehicle

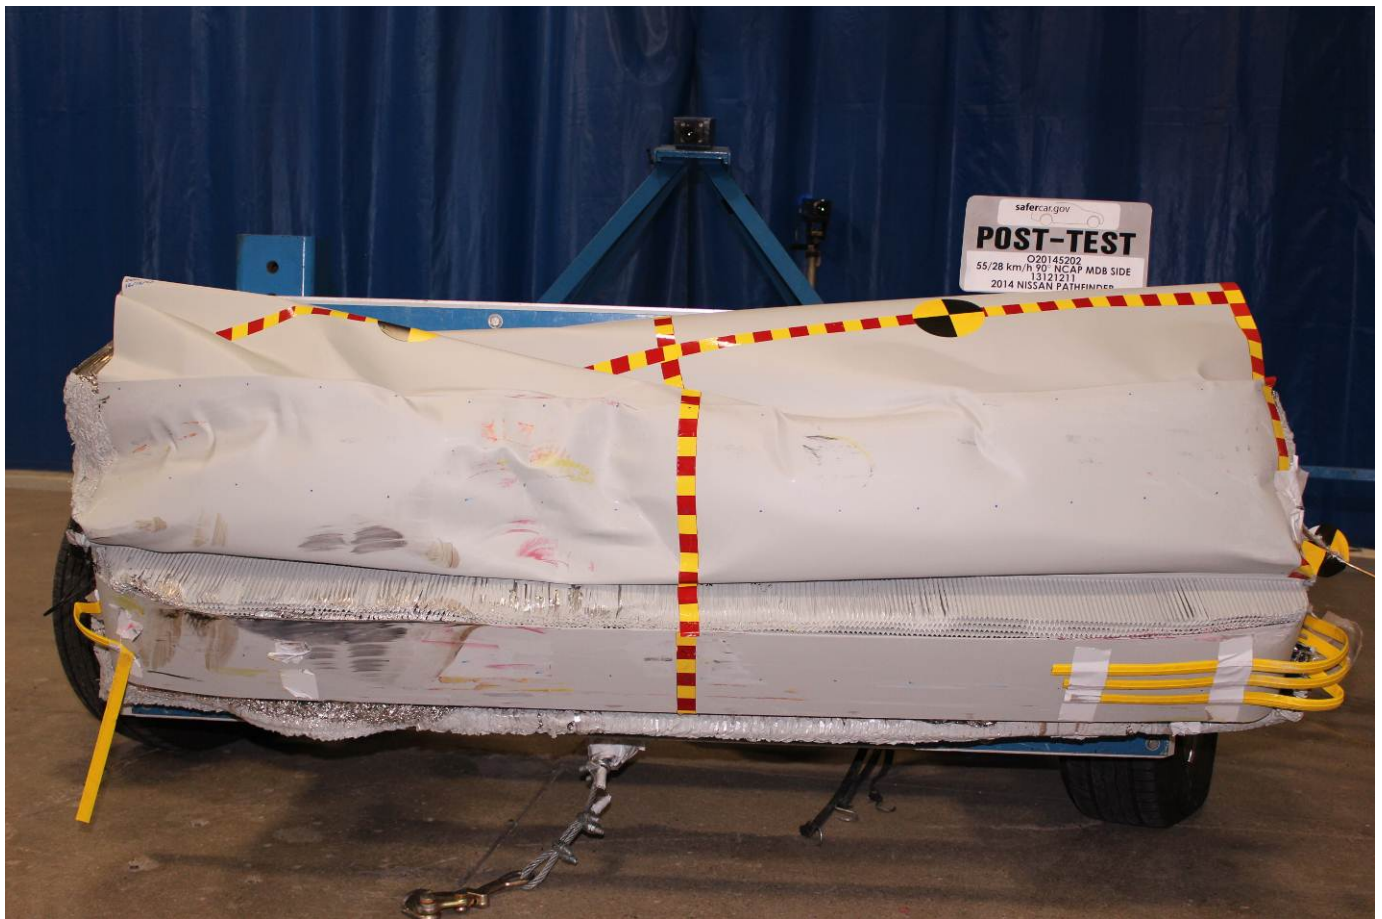
Post-Test Front View of MDB Impactor Face
