REPORT NUMBER: NCAP-MGA-2014-039

**NEW CAR ASSESSMENT PROGRAM (NCAP)
Frontal Barrier Impact Test**

**NISSAN MOTOR CO., LTD.
2014 Nissan Pathfinder S 4X4 SUV
NHTSA No.: O20145200**

**MGA RESEARCH CORPORATION
5000 Warren Road
Burlington, WI 53105**

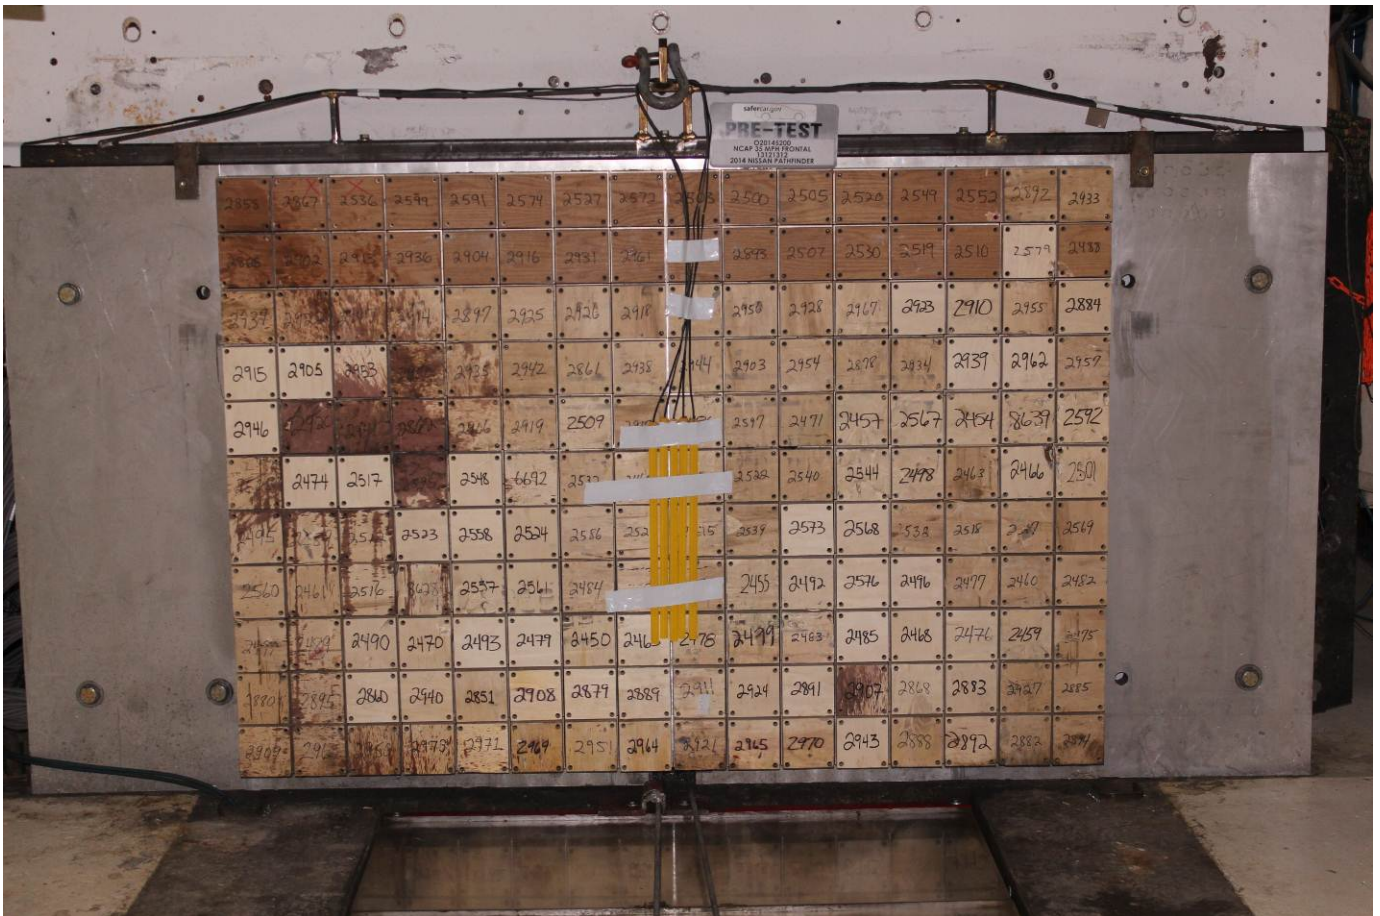
Load Cell Wall

A load cell barrier consisting of 176 load cells was impacted by a 2014 Nissan Pathfinder S 4X4 SUV at a velocity of 56.6 km/h. The test was performed at MGA Research Corporation on December 13, 2013. Pre-test and post-test photographs of the vehicle and dummies can be found in Appendix A.

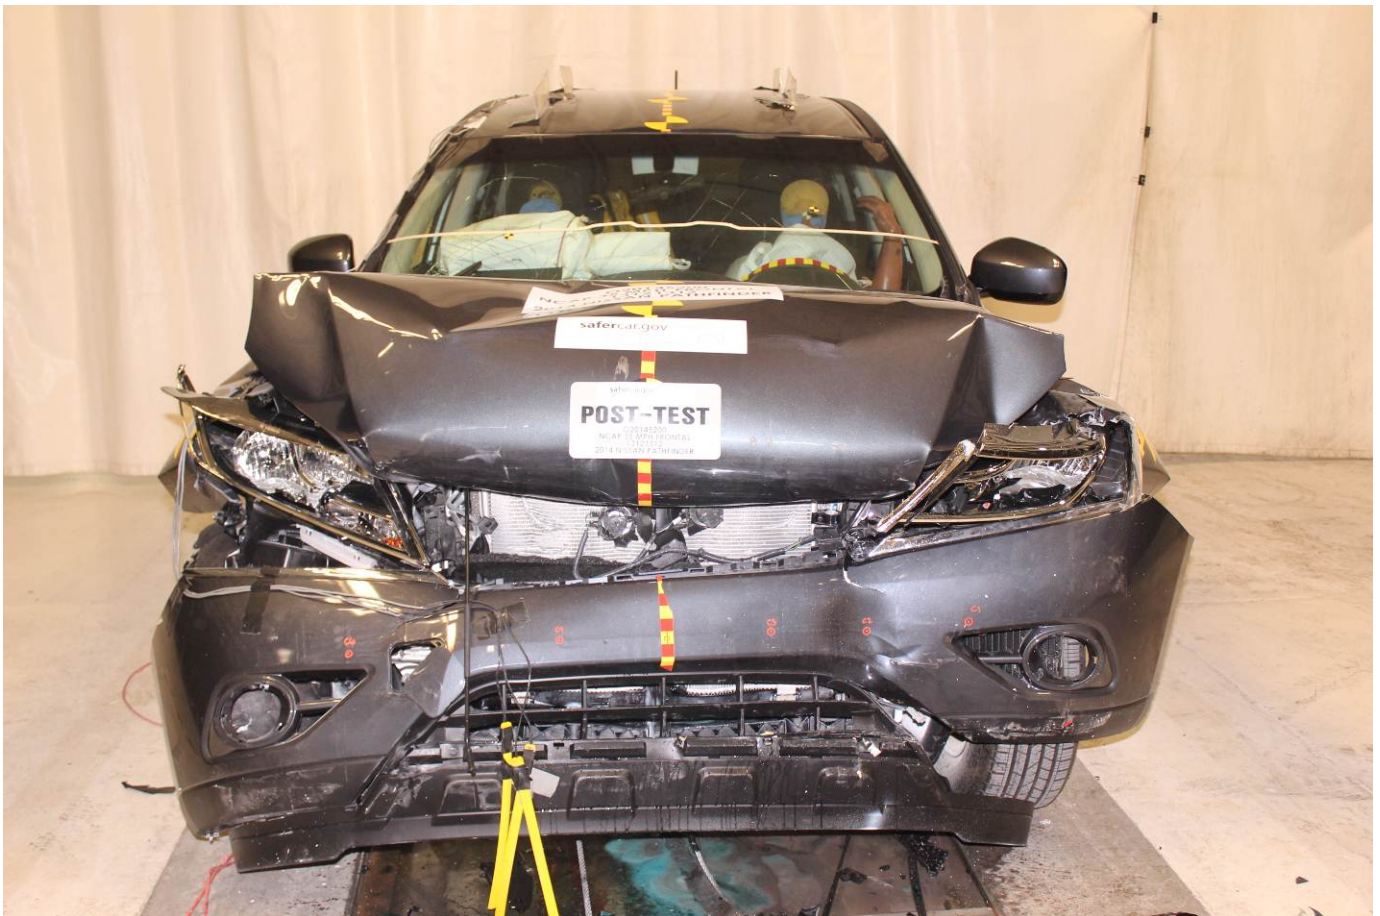
Post-Test Front View of Test Vehicle

The maximum static crush of the vehicle was 527 mm and both the driver and passenger side doors remained closed during the impact event and were operable after the impact.

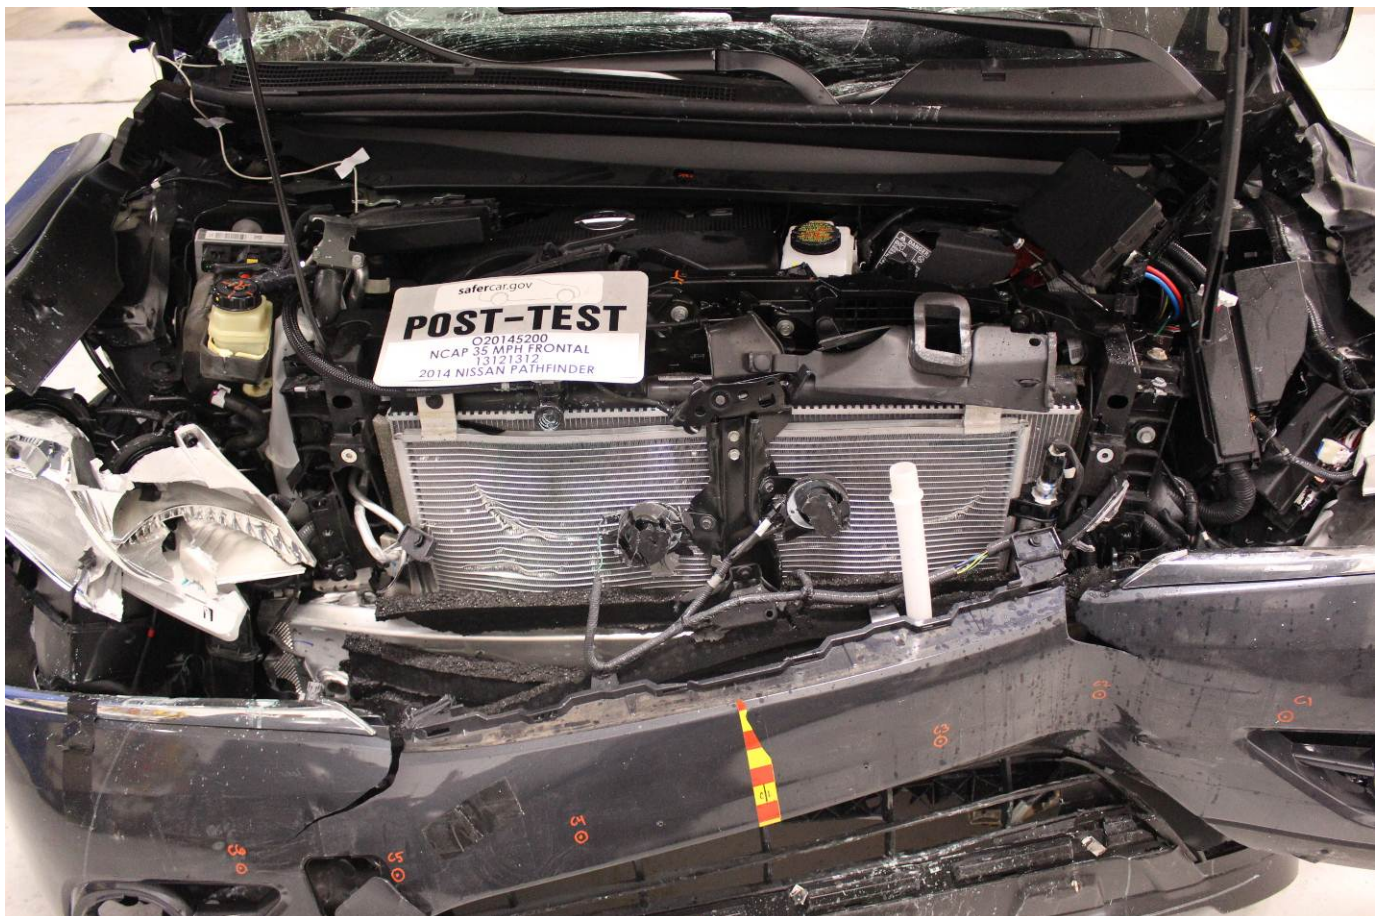
Post-Test Engine Compartment View

Critical Areas of Performance	Observations and Conclusions
Windshield Damage	None
Window Damage	None
Other Notable Effects	Hood became unlatched during impact.

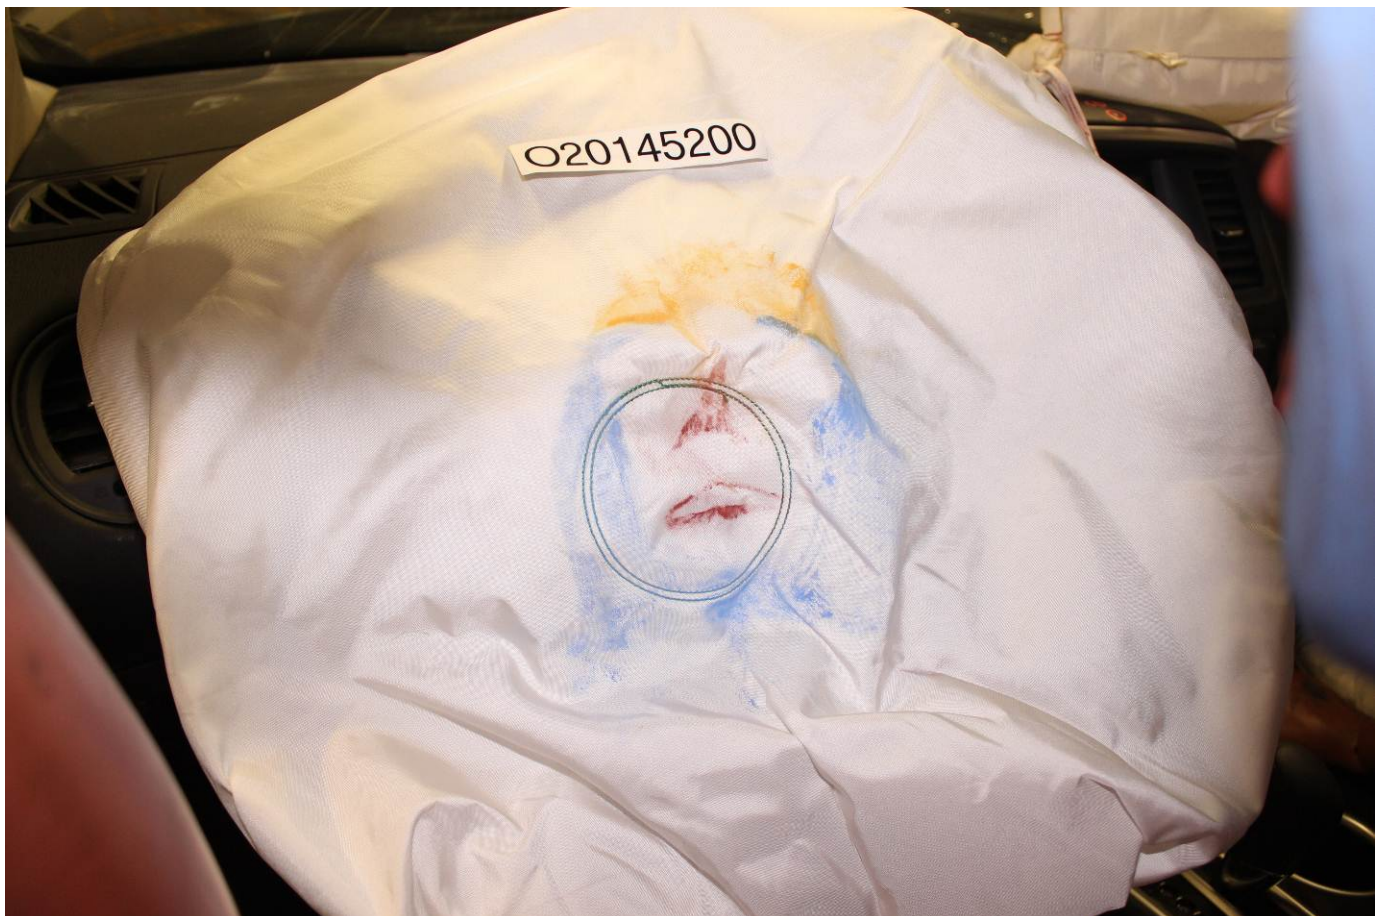
Post-Test Driver Dummy Contact with Airbag

The driver's visible contact points were as follows: The driver's head and chest contacted the airbag. The driver's head also contacted the headrest. The driver's knees contacted the knee bolster. The passenger's visible contact points were as follows: The passenger's head and chest contacted the airbag. The passenger's head also contacted the headrest. The passenger's knees contacted the glovebox.
