**FINAL REPORT NUMBER: SPNCAP-TRC-14-003**

**NEW CAR ASSESSMENT PROGRAM (NCAP)  
SIDE IMPACT POLE TEST**

**General Motors LLC  
2014 Chevrolet Malibu 1LS 4-Door Sedan  
NHTSA NUMBER: M20140109**

**PREPARED BY:  
Transportation Research Center Inc.  
10820 State Route 347  
P. O. Box B-67  
East Liberty, OH 43319**

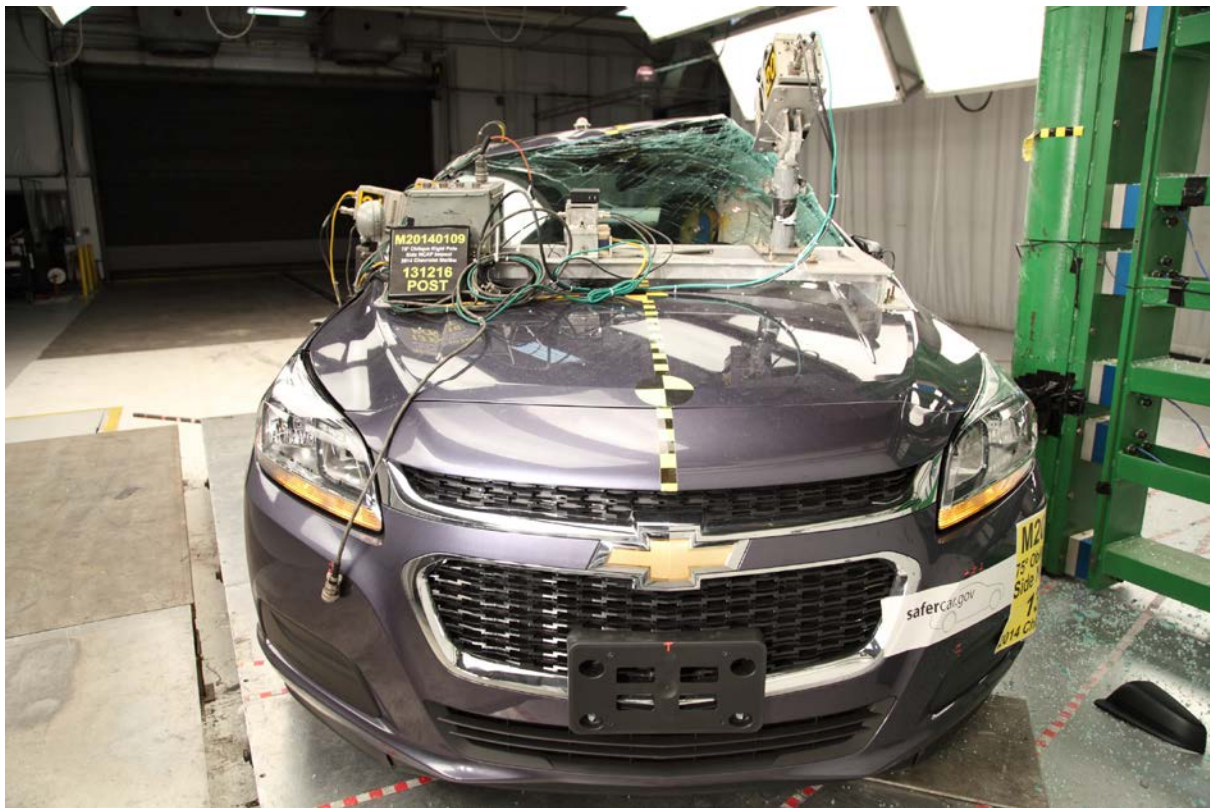
**004** Post-Test Frontal View of Test Vehicle

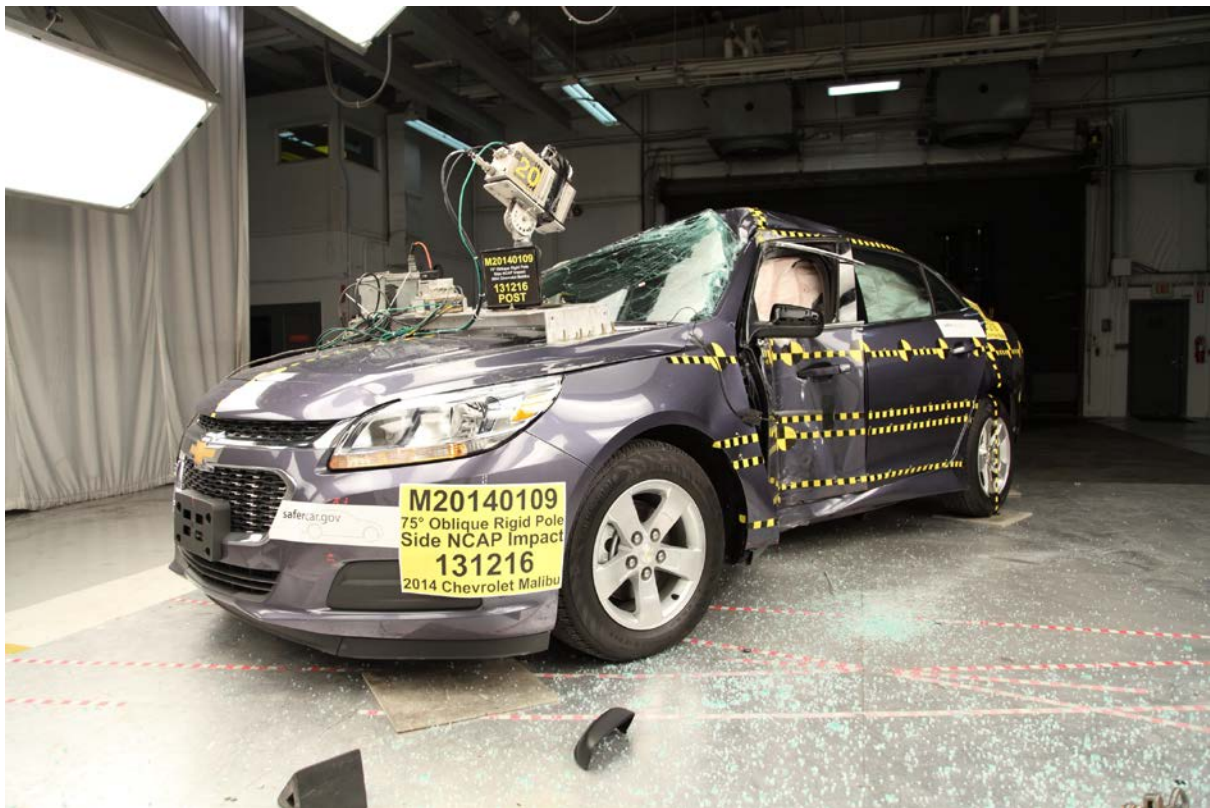
**006** Post-Test Left Front 3-4 View of Test Vehicle

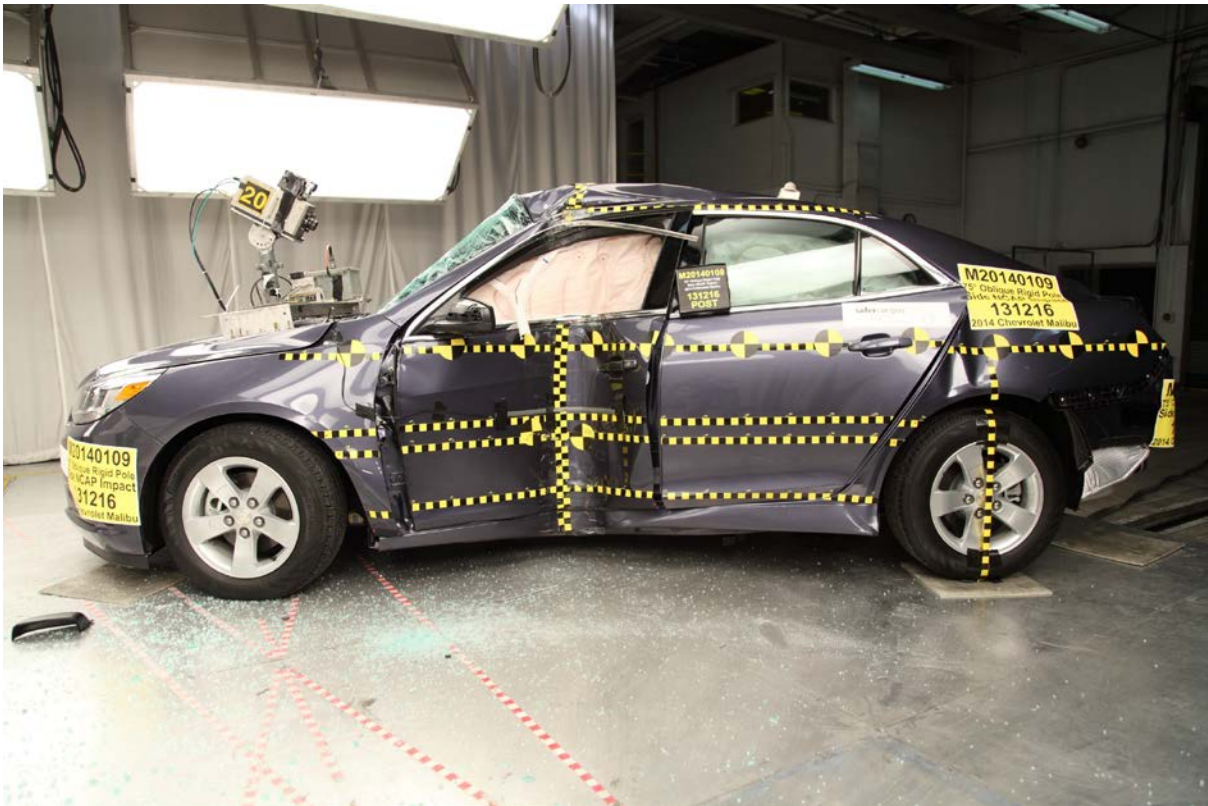
**008** Post-Test Left Side View of Test Vehicle

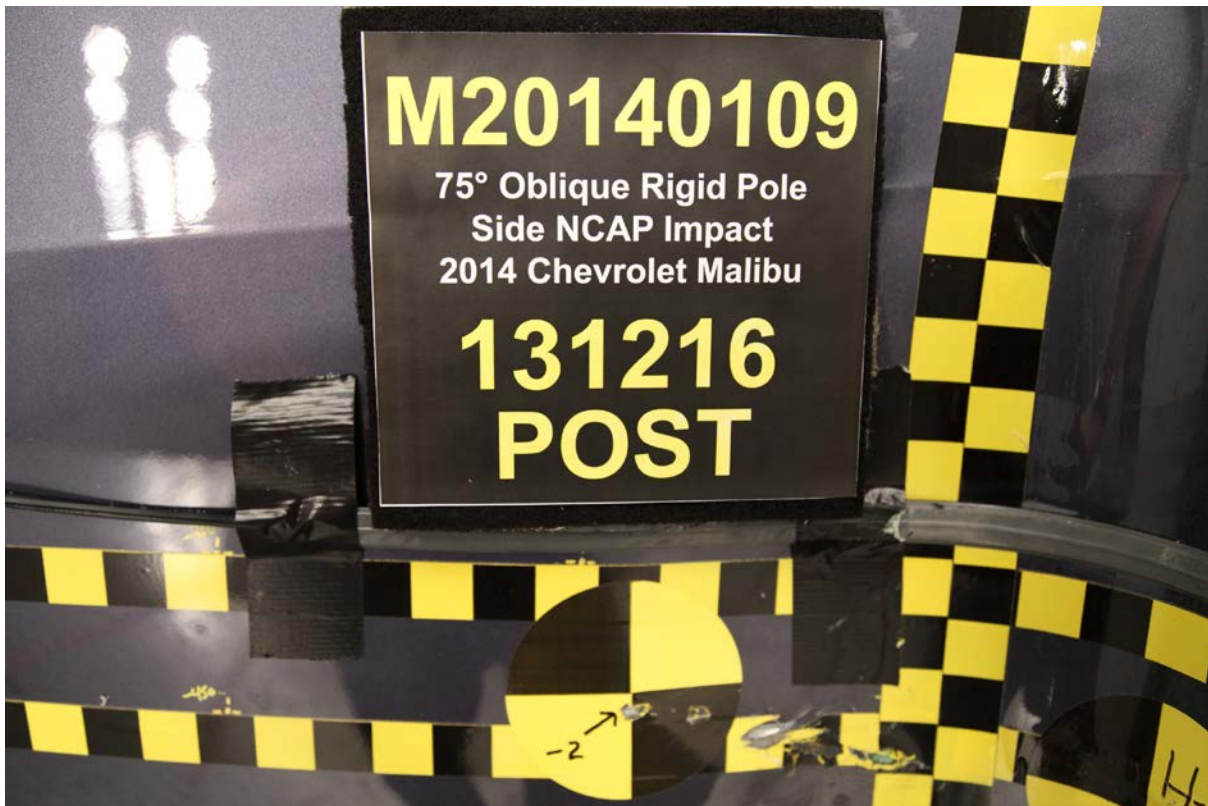
**020** Post-Test Close-Up View of Impact Point Target Showing Impact Location

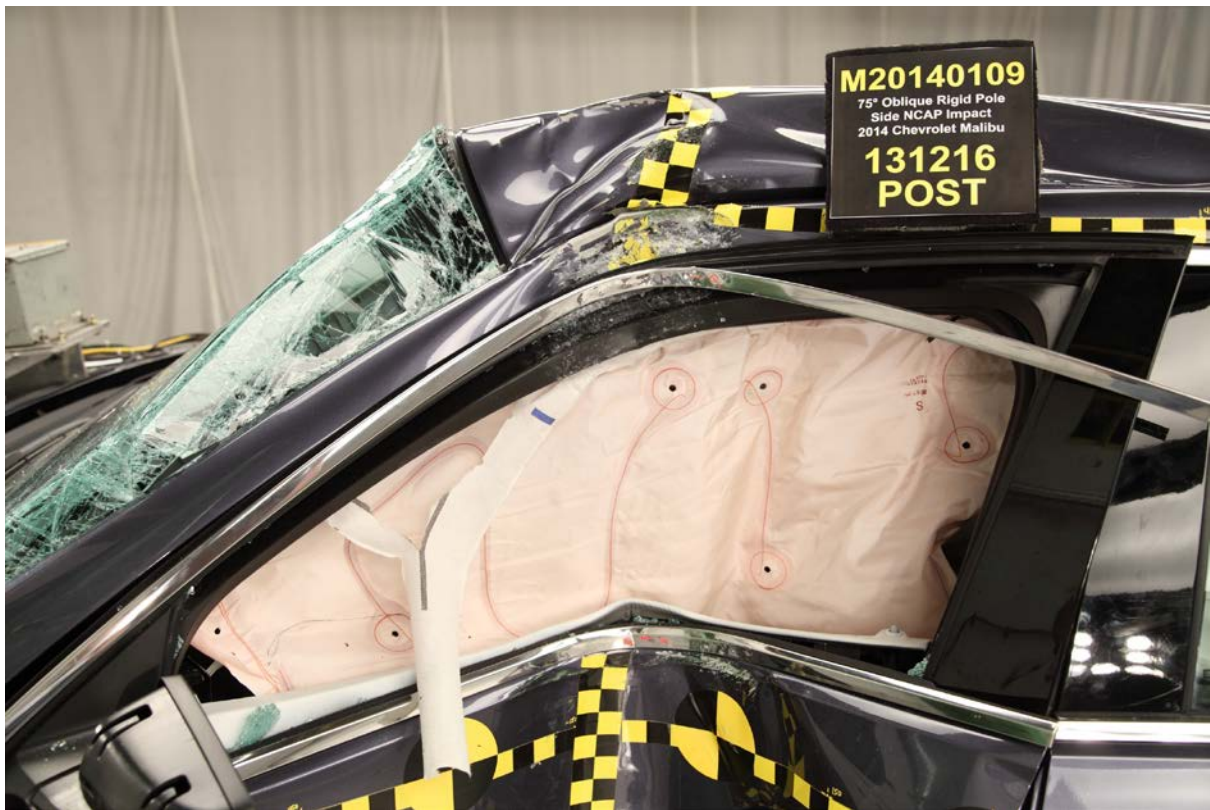
**025** Post-Test Left Side View of Dummy Shoulder and Door Top View

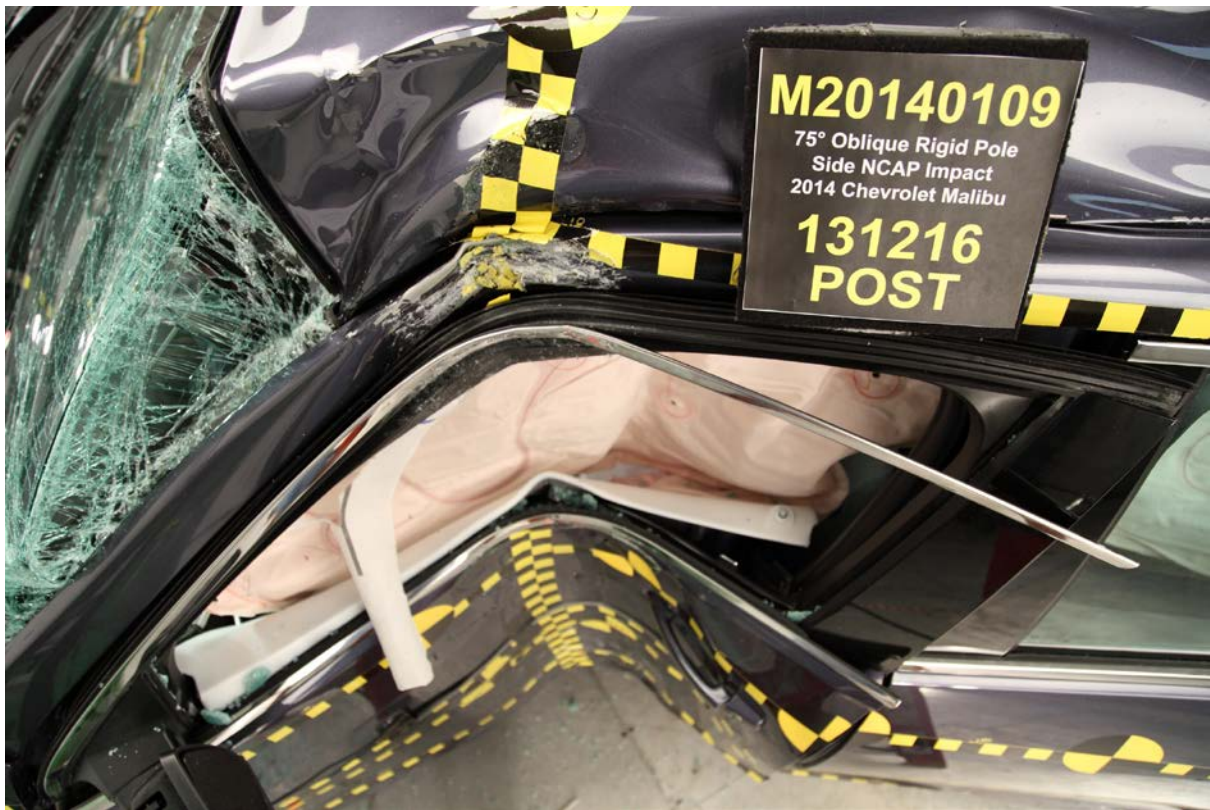
**041** Post-Test Dummy and Door Clearance View

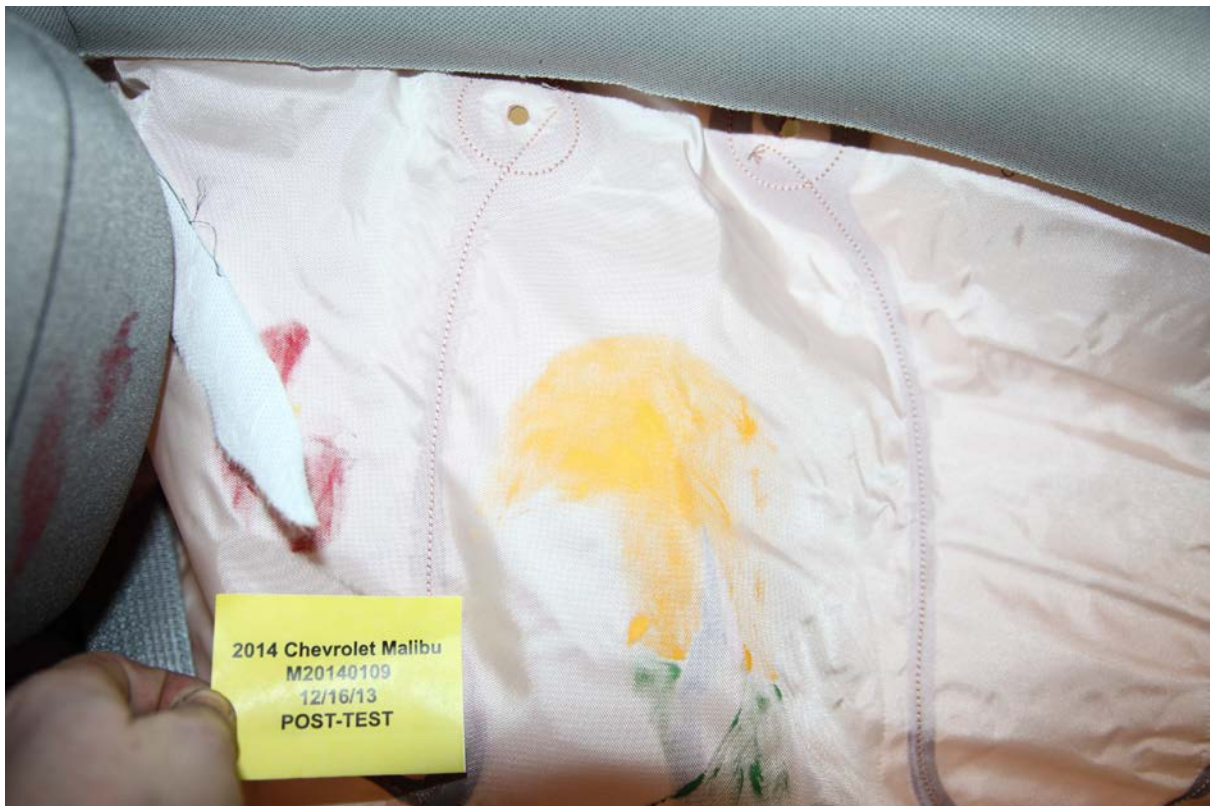
**046** Post-Test Dummy Close-Up Head Contact with Vehicle View

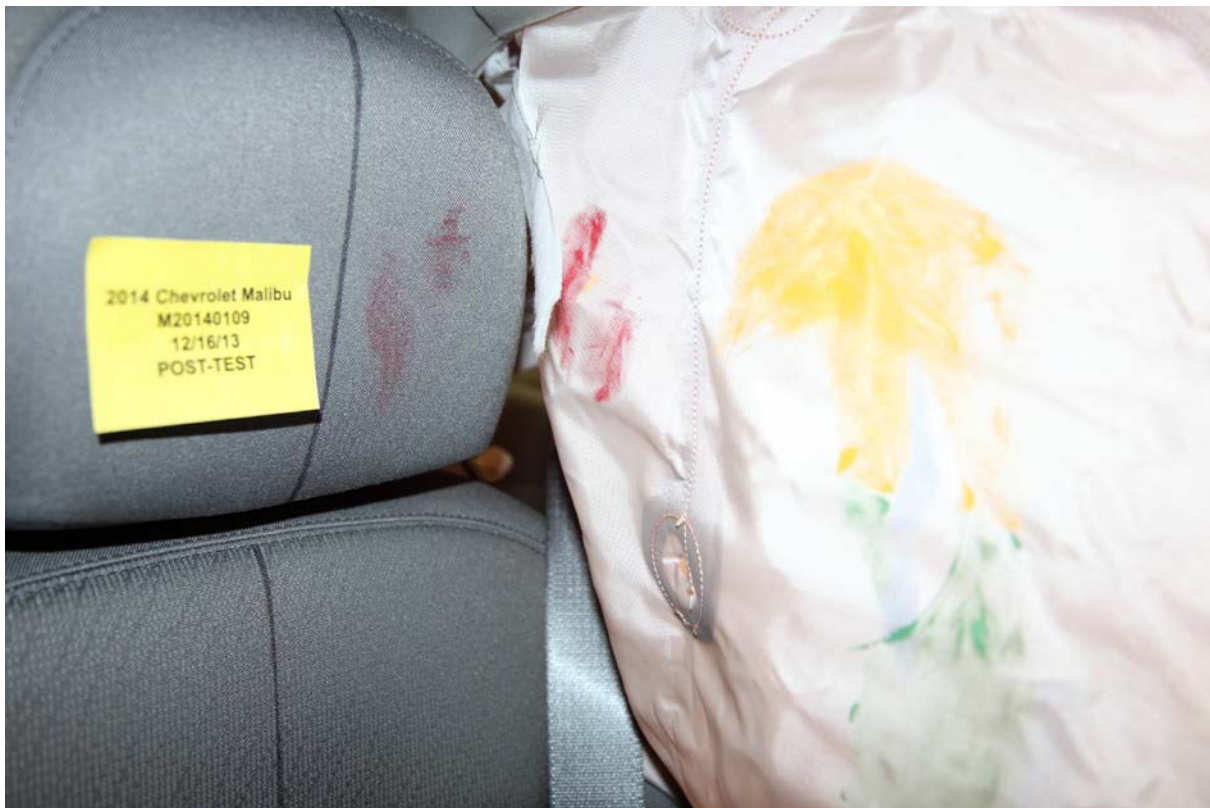
**047** Post-Test Dummy Close-Up Head Contact with Side Airbag View

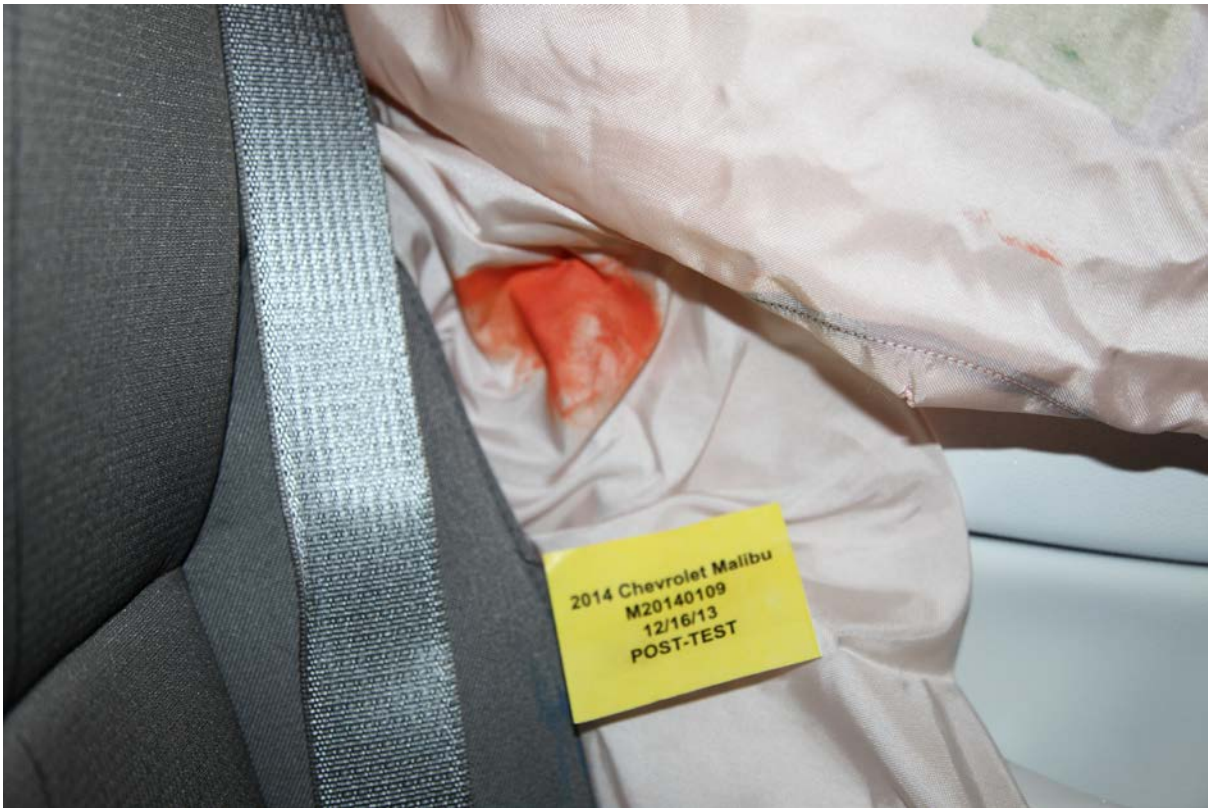
**049** Post-Test Dummy Close-Up Torso Contact with Side Airbag View

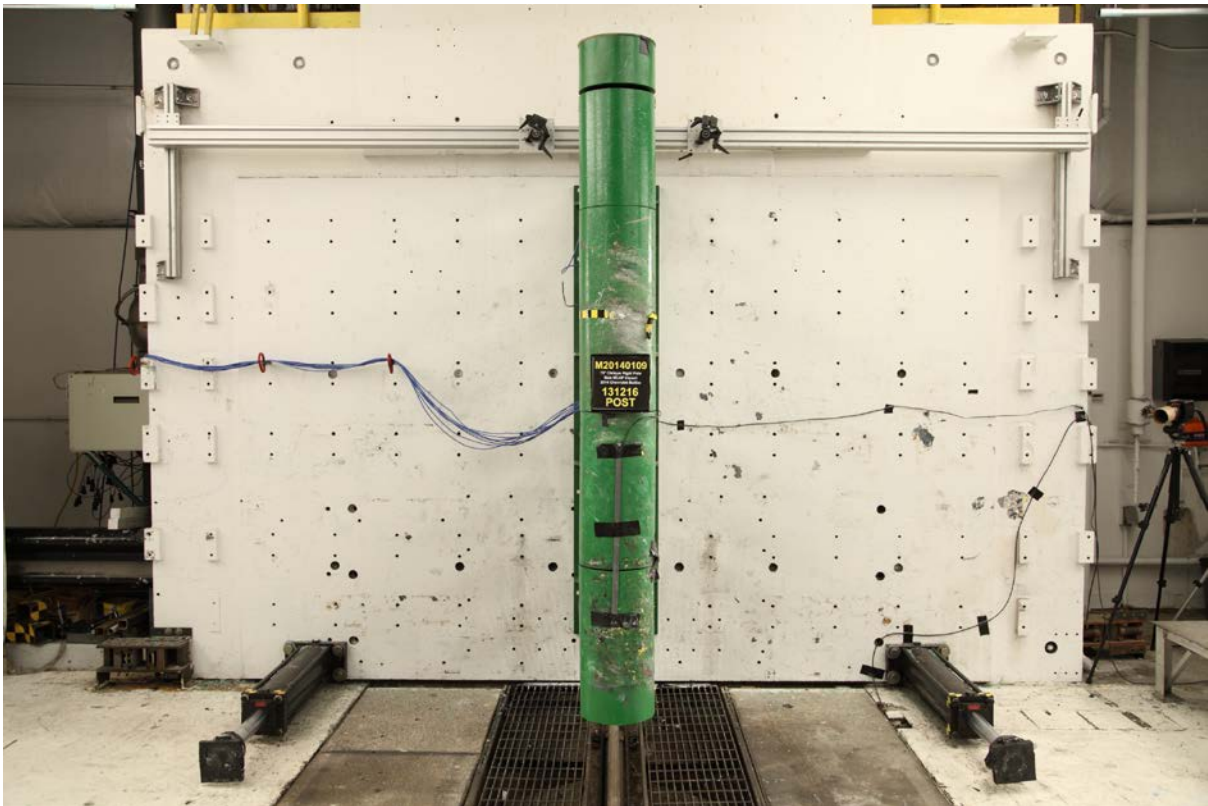
**058** Post-Test Pole Barrier Front View

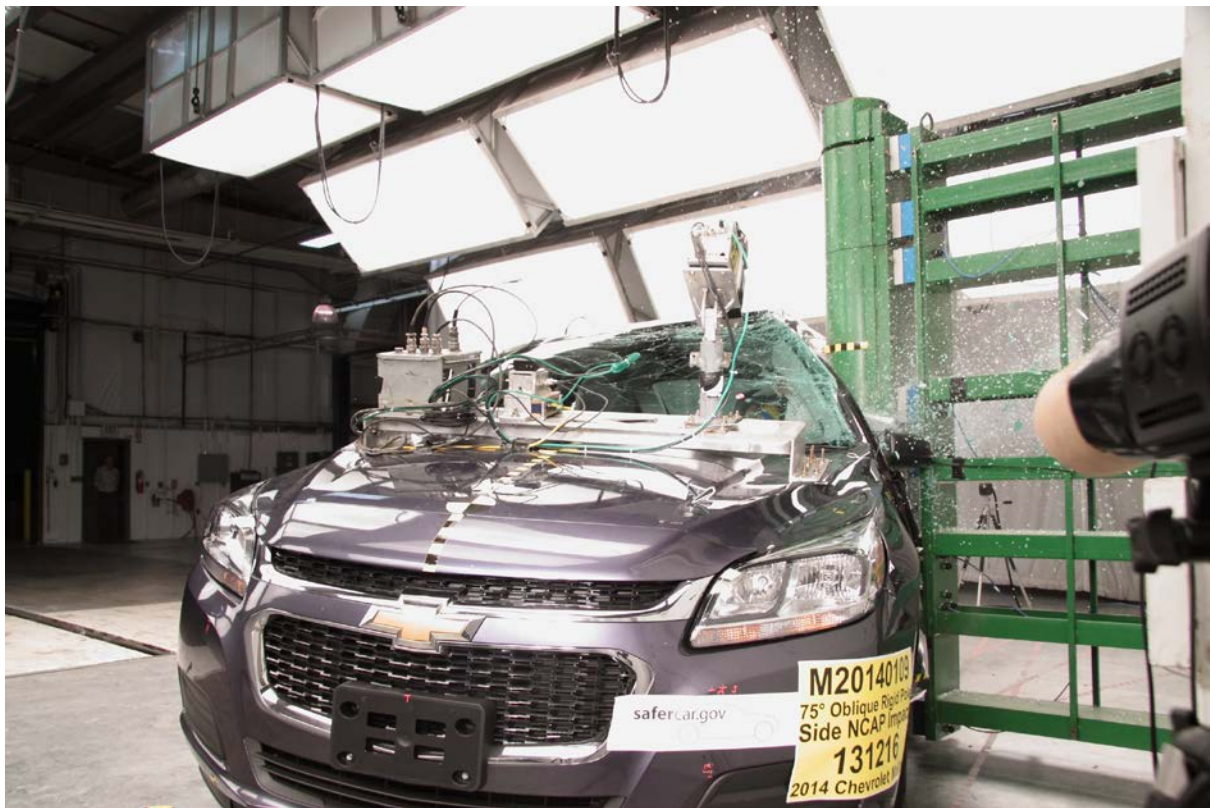
**068** Impact Event
