**REPORT NUMBER: SINCAP-MGA-2014-040**

**NEW CAR ASSESSMENT PROGRAM (NCAP)  
Moving Deformable Barrier Side Impact Test**

**CHRYSLER GROUP LLC  
2014 Ram 2500 Crew Cab  
NHTSA No.: M20140314**

**MGA RESEARCH CORPORATION  
5000 Warren Road  
Burlington, WI 53105**

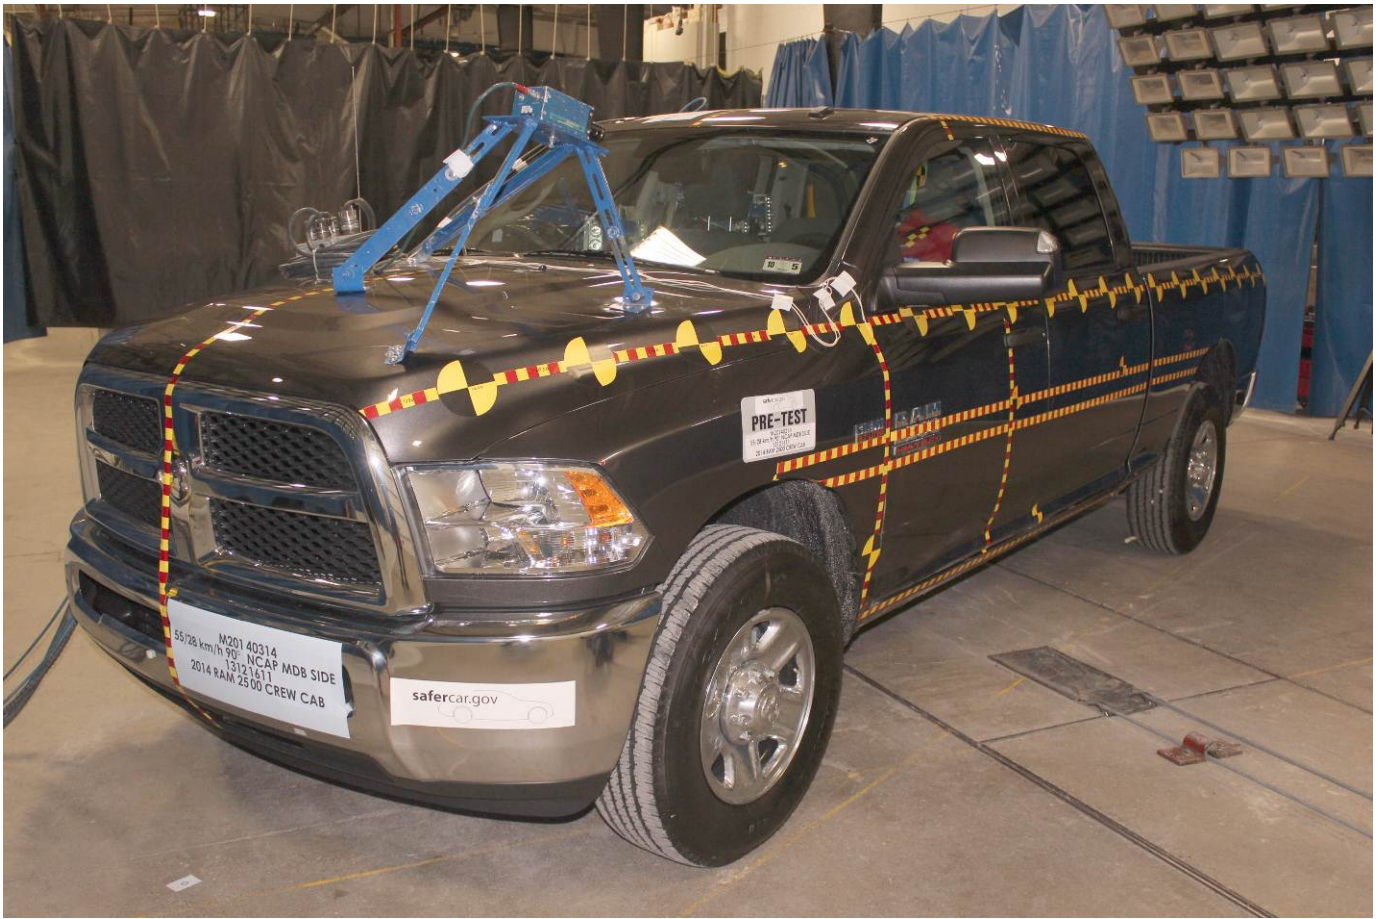
Pre-Test Left Front Three-Quarter View of Test Vehicle

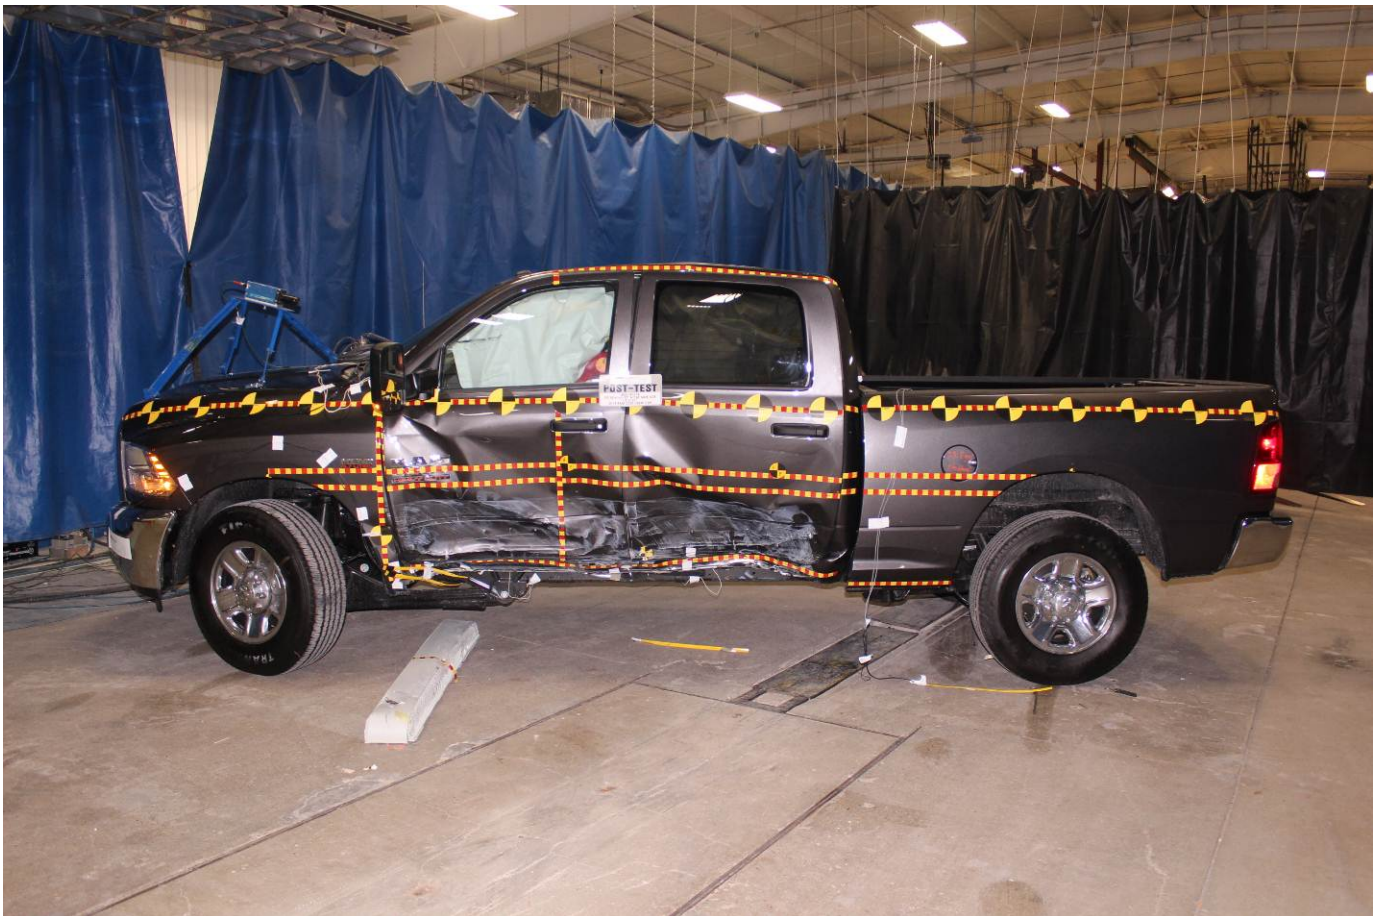
Post-Test Left Side View of Test Vehicle

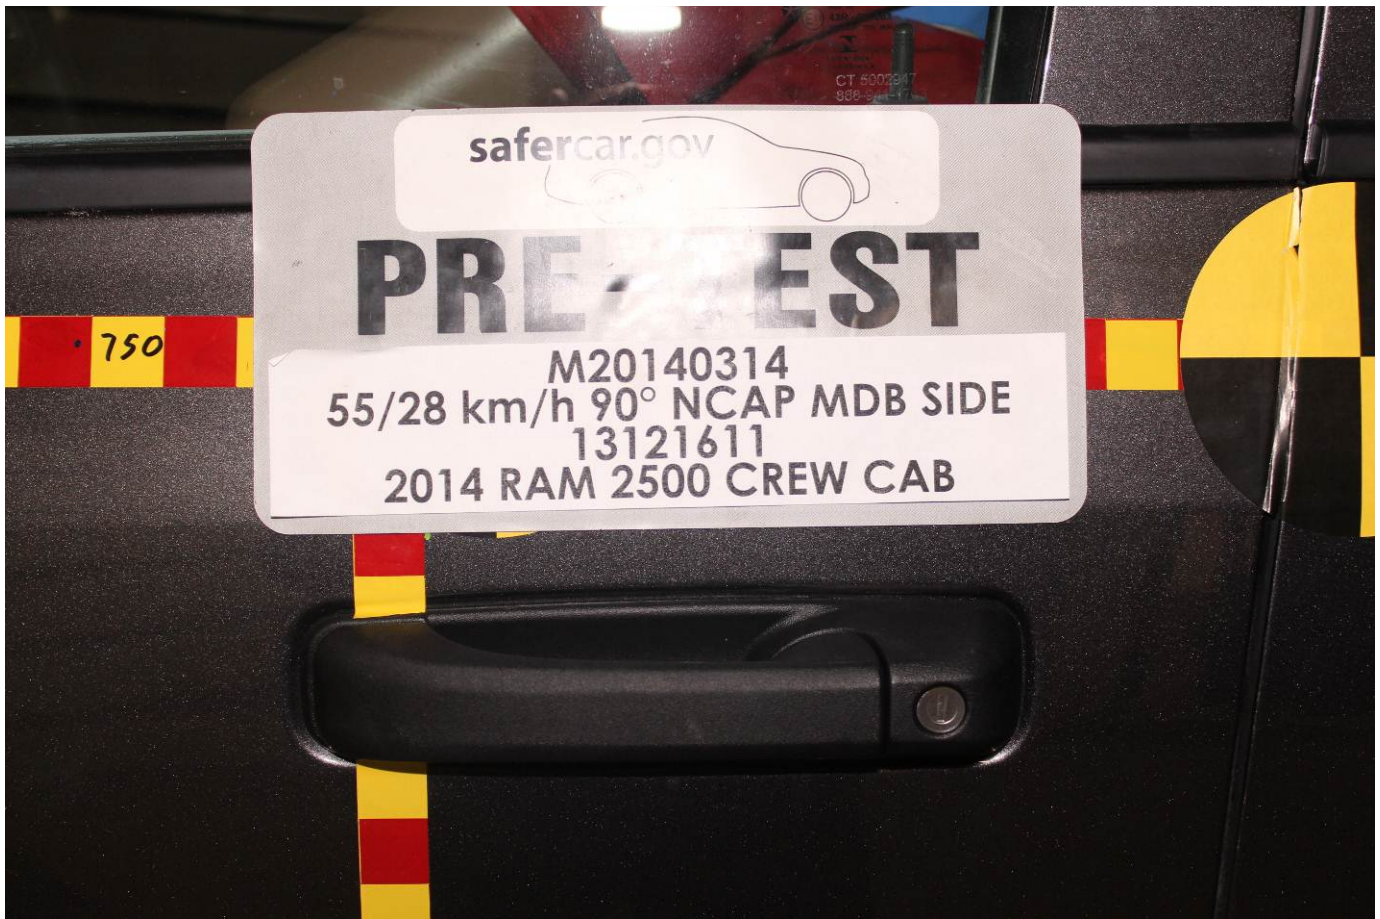
Pre-Test Left Front Door Latch Close-Up

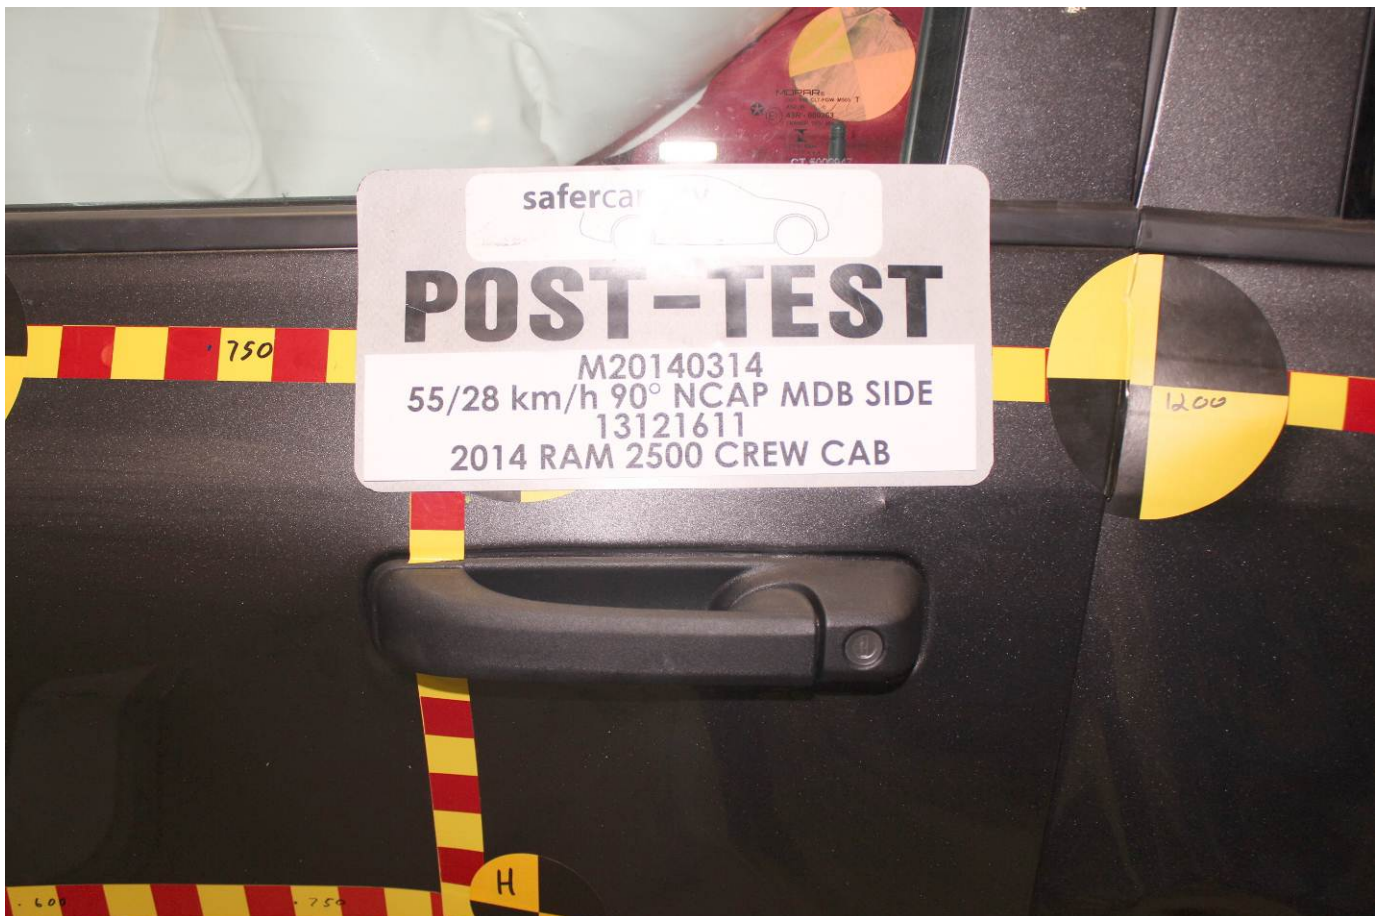
Post-Test Left Front Door Latch Close-Up

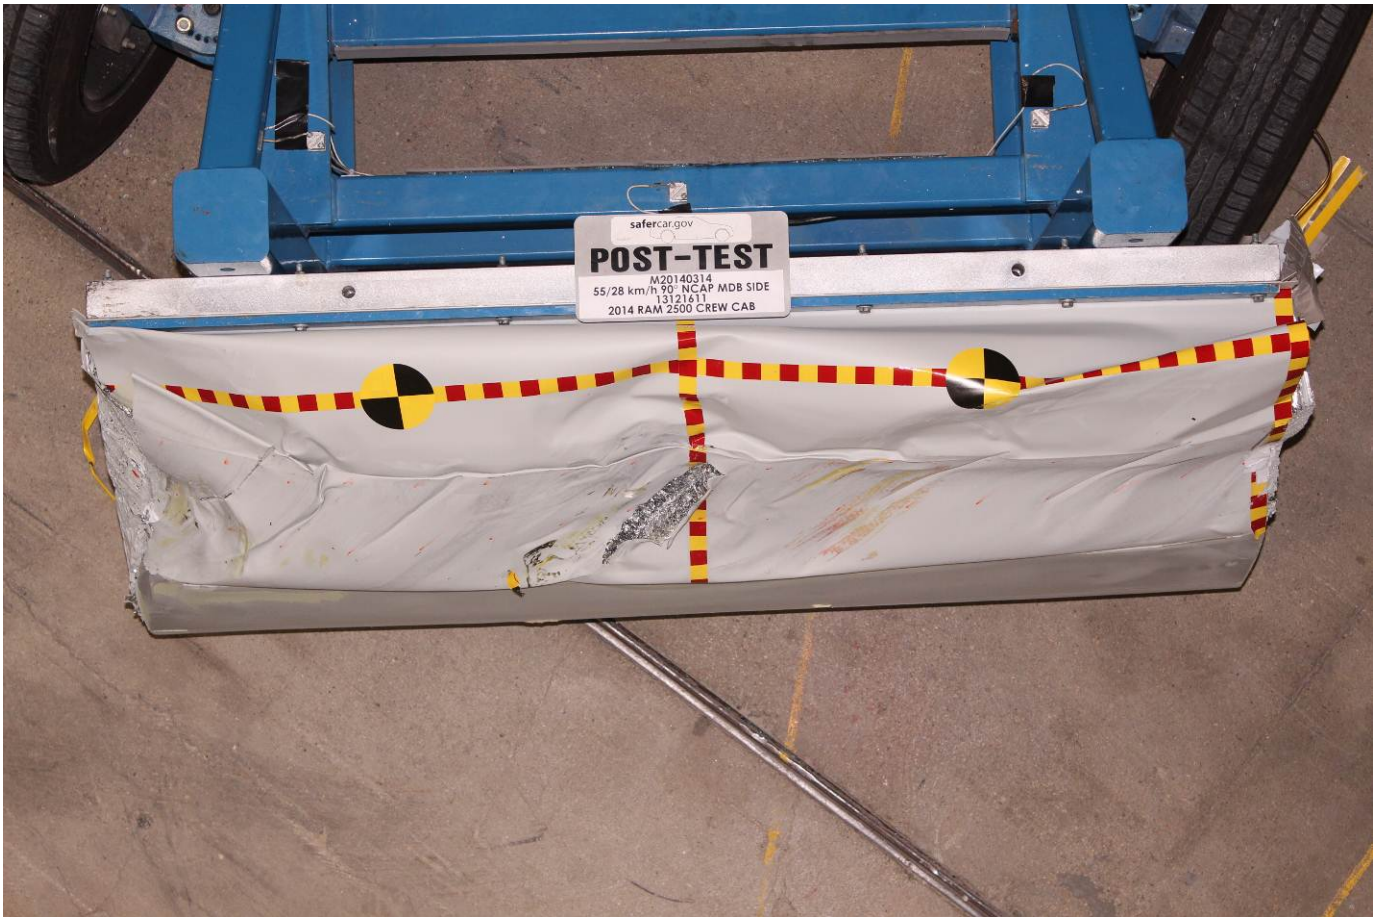
Post-Test Top View of MDB Impactor Face

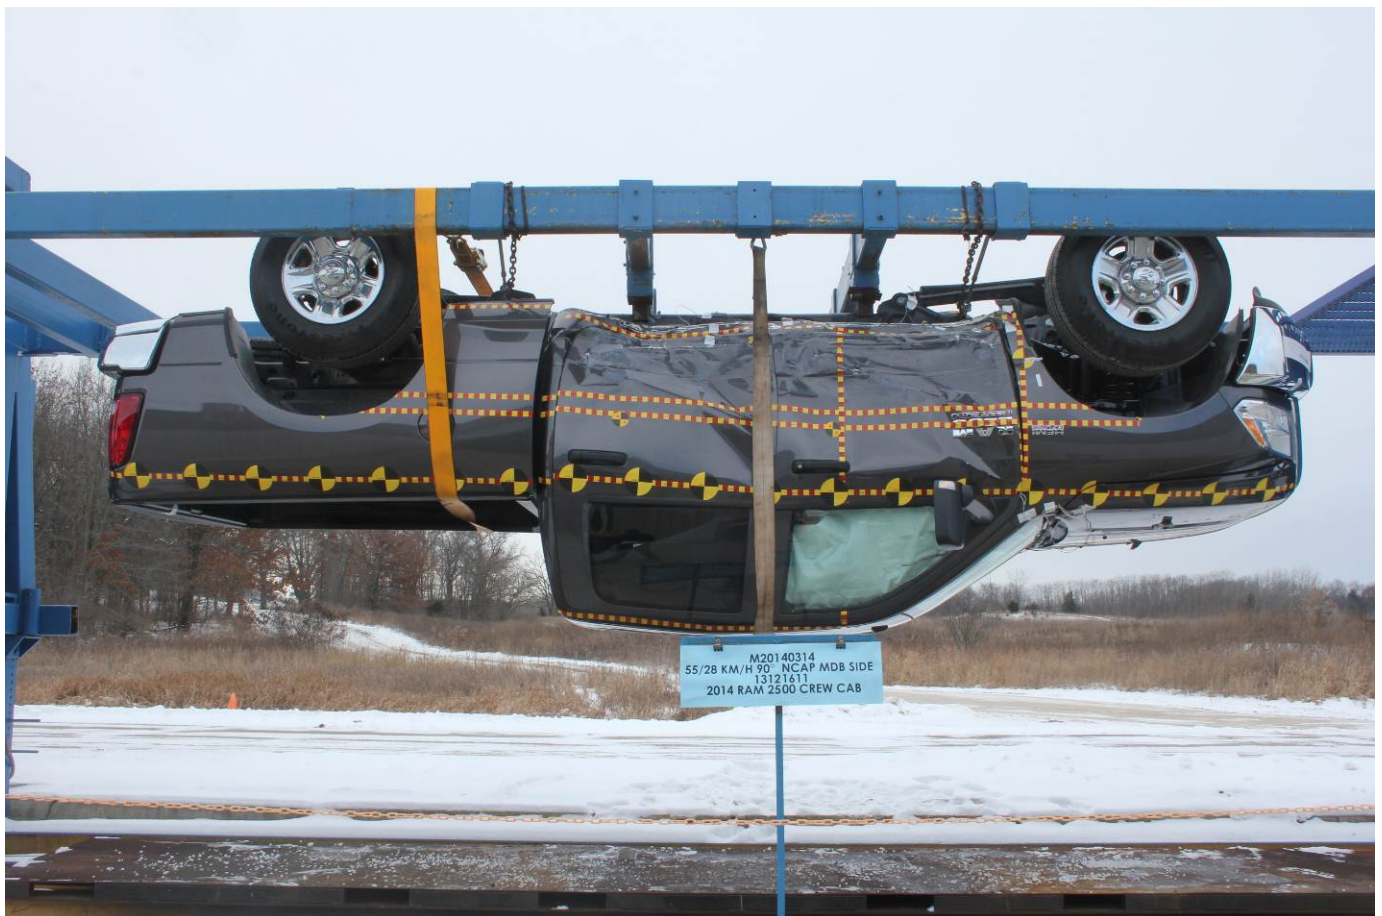
FMVSS No. 301 Static Rollover 180 Degrees

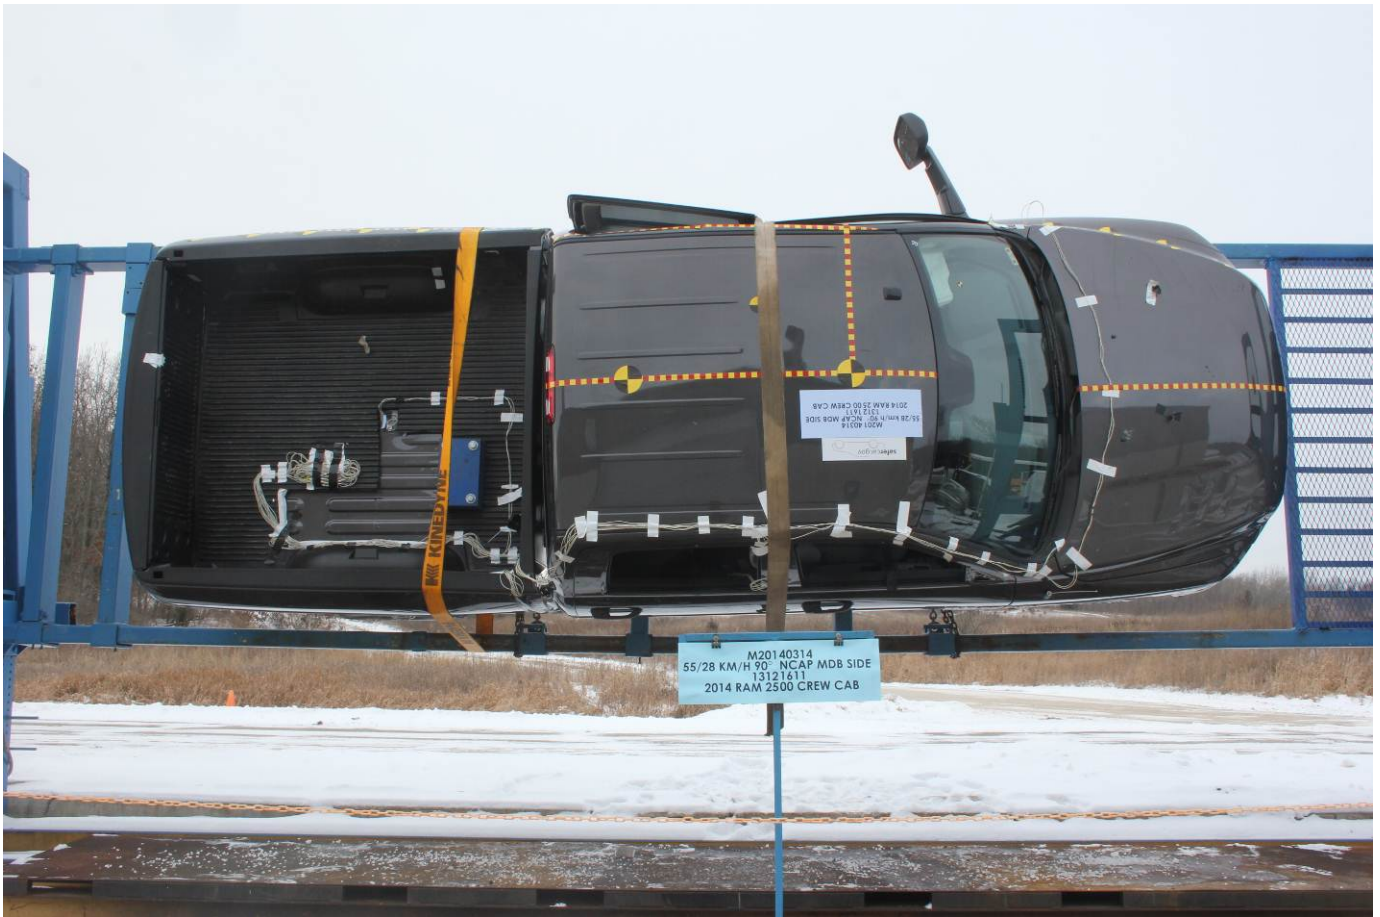
FMVSS No. 301 Static Rollover 270 Degrees
