**REPORT NUMBER: SINCAP-MCW-14-009**

**NEW CAR ASSESSMENT PROGRAM (NCAP)  
MOVING DEFORMABLE BARRIER SIDE IMPACT TEST**

**FUJI HEAVY INDUSTRIES LTD.  
2014 SCION FR-S 2-DOOR COUPE  
NHTSA NUMBER: M20145123**

**PREPARED BY:  
MEDICAL COLLEGE OF WISCONSIN  
5000 WEST NATIONAL AVENUE  
RESEARCH 151  
MILWAUKEE, WISCONSIN 53295**

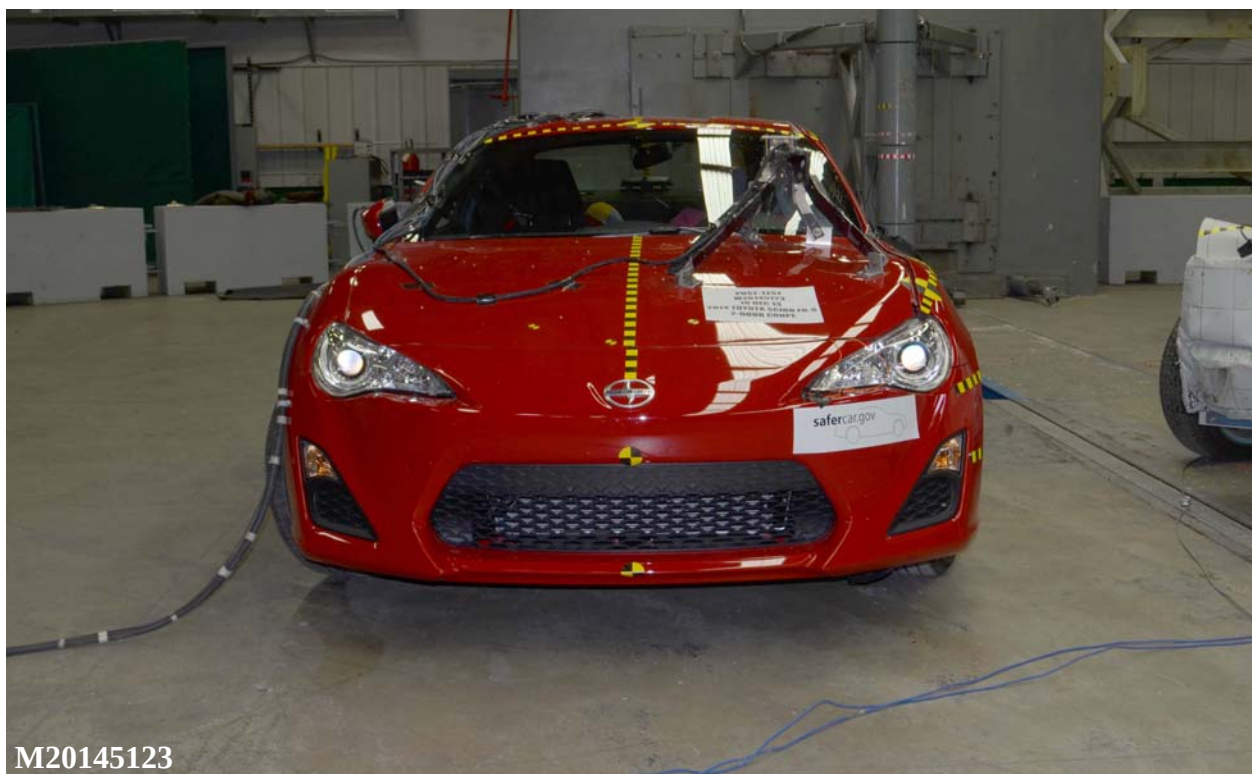
Figure A-4: Post-Test Frontal View of Test Vehicle

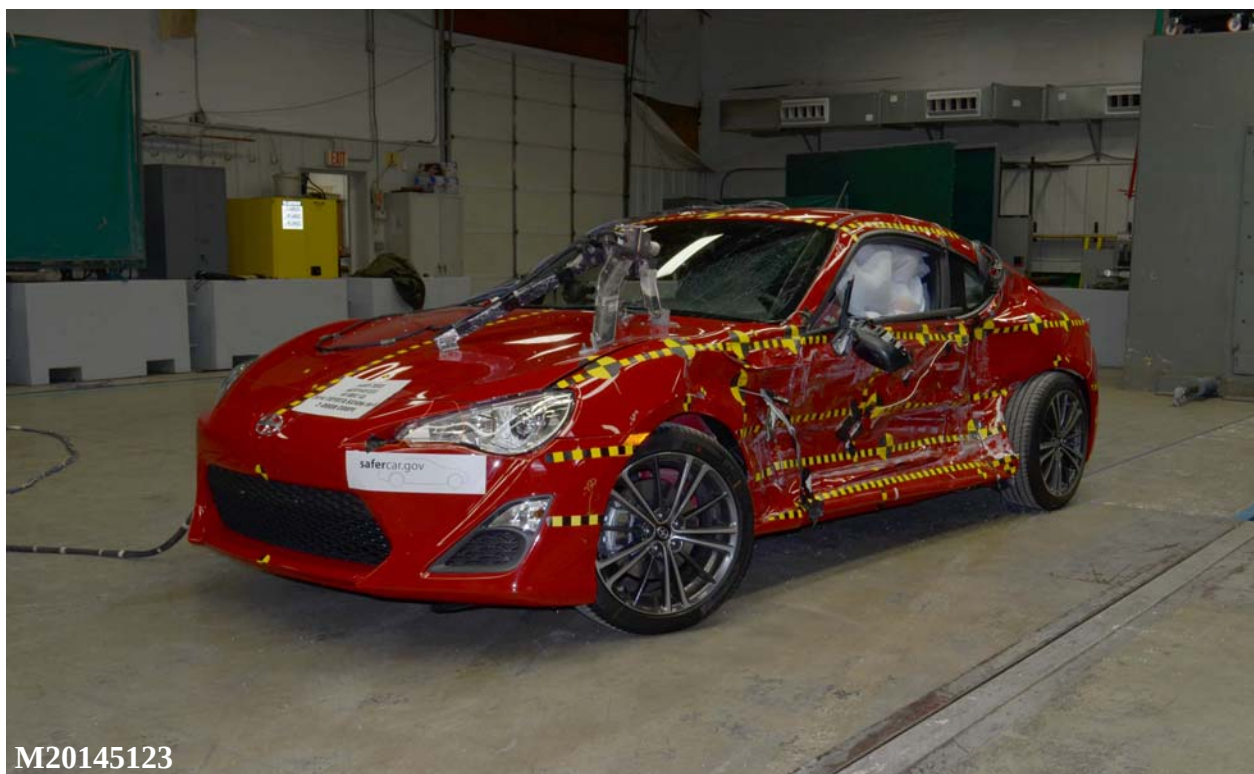
Figure A-6: Post-Test Left Front 3-4 View of Test Vehicle

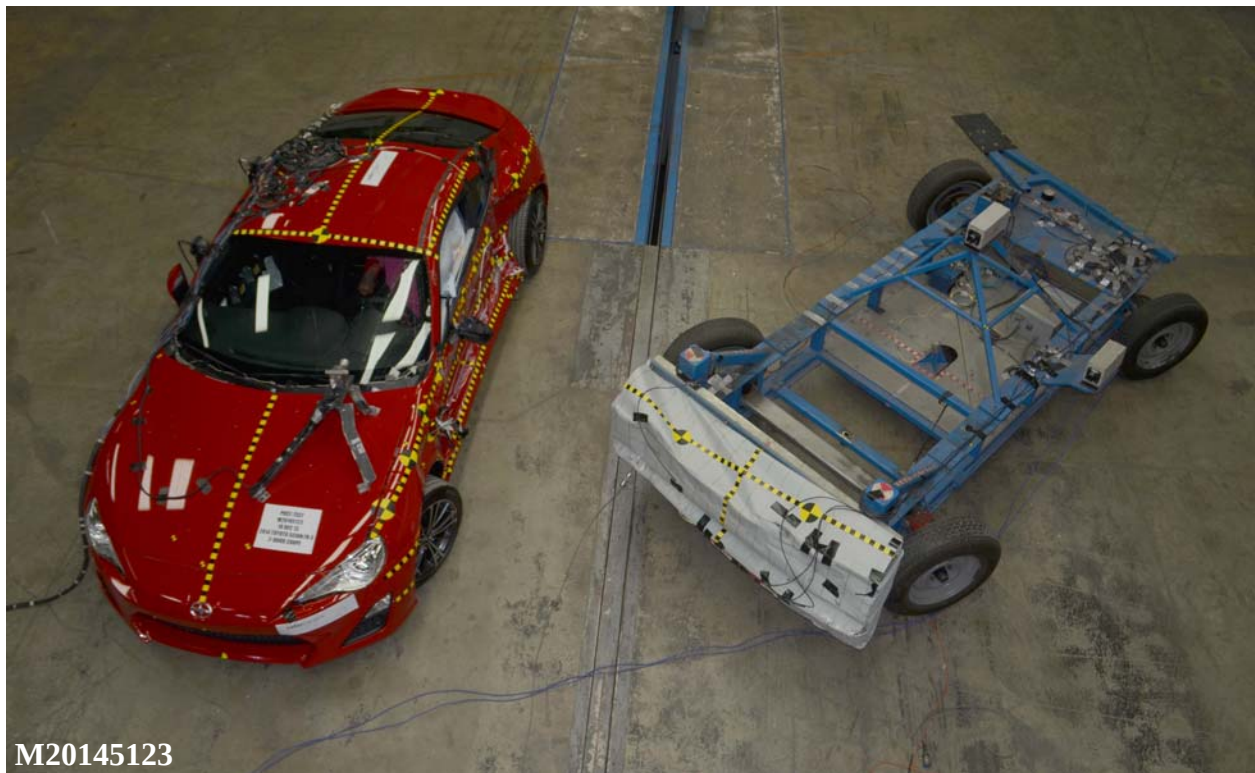
Figure A-16: Post-Test Overhead View of Test Area

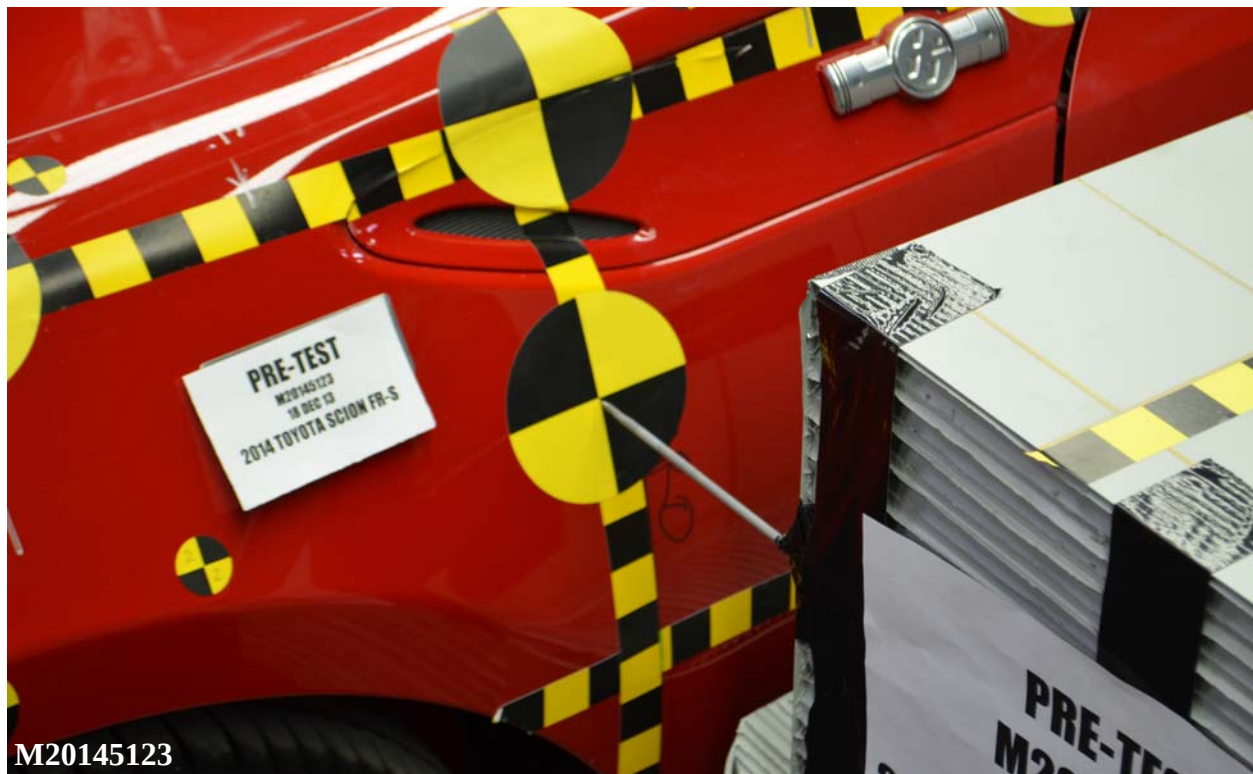
Figure A-19: Pre-Test Close-Up View of Impact Point Target

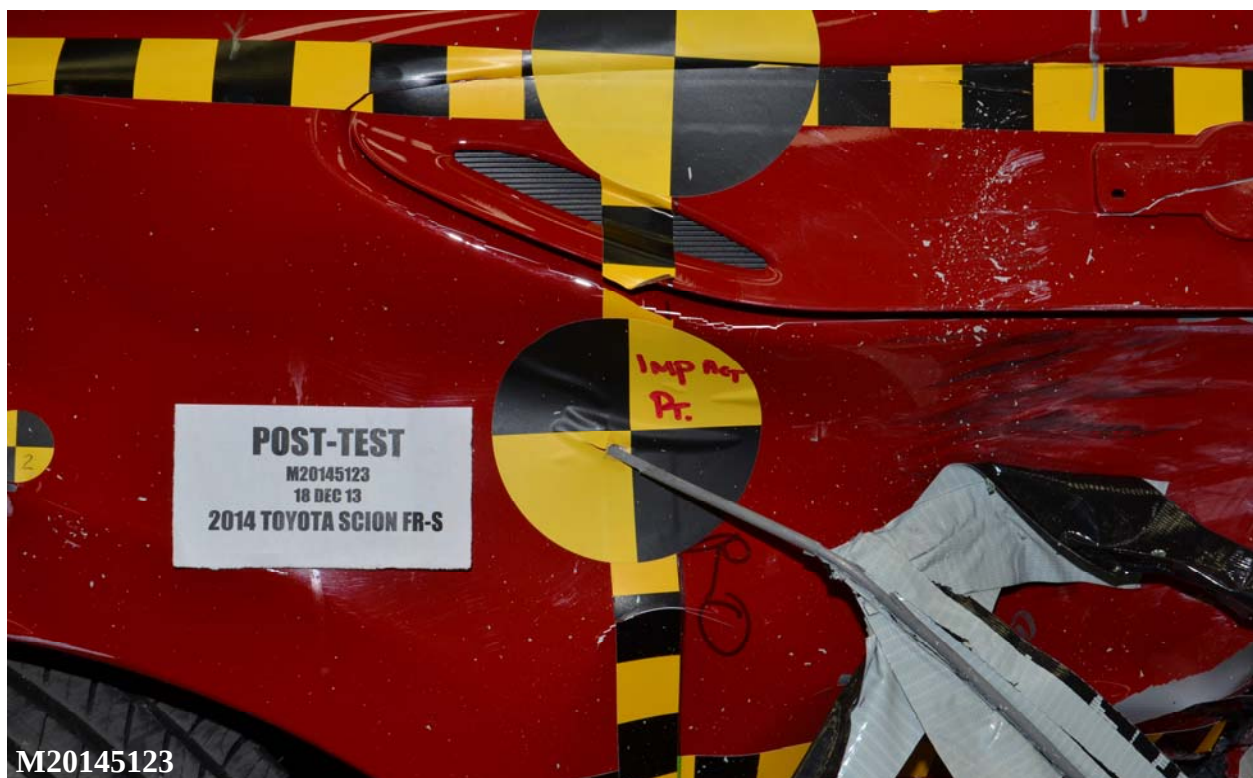
Figure A-20: Post-Test Close-Up View of Impact Point Target

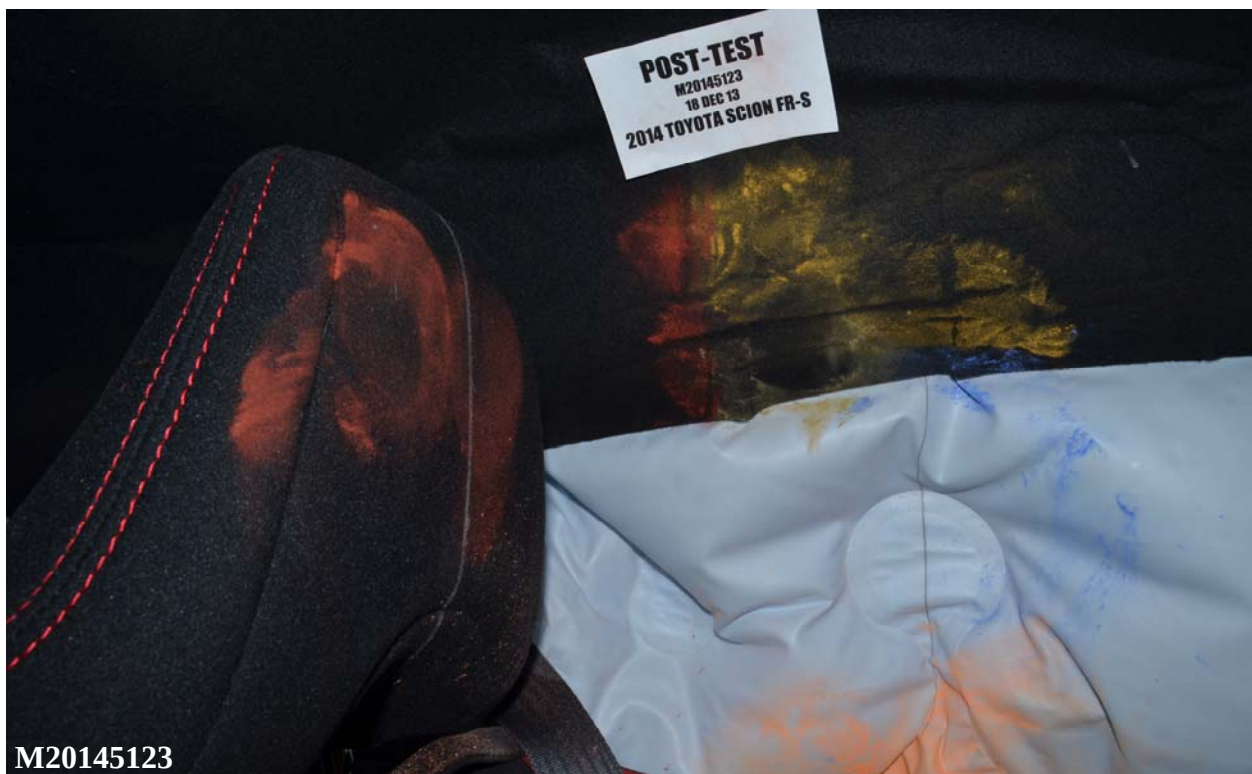
Figure A-48: Post-Test Driver Dummy Close-Up Head Contact With Vehicle Interior View

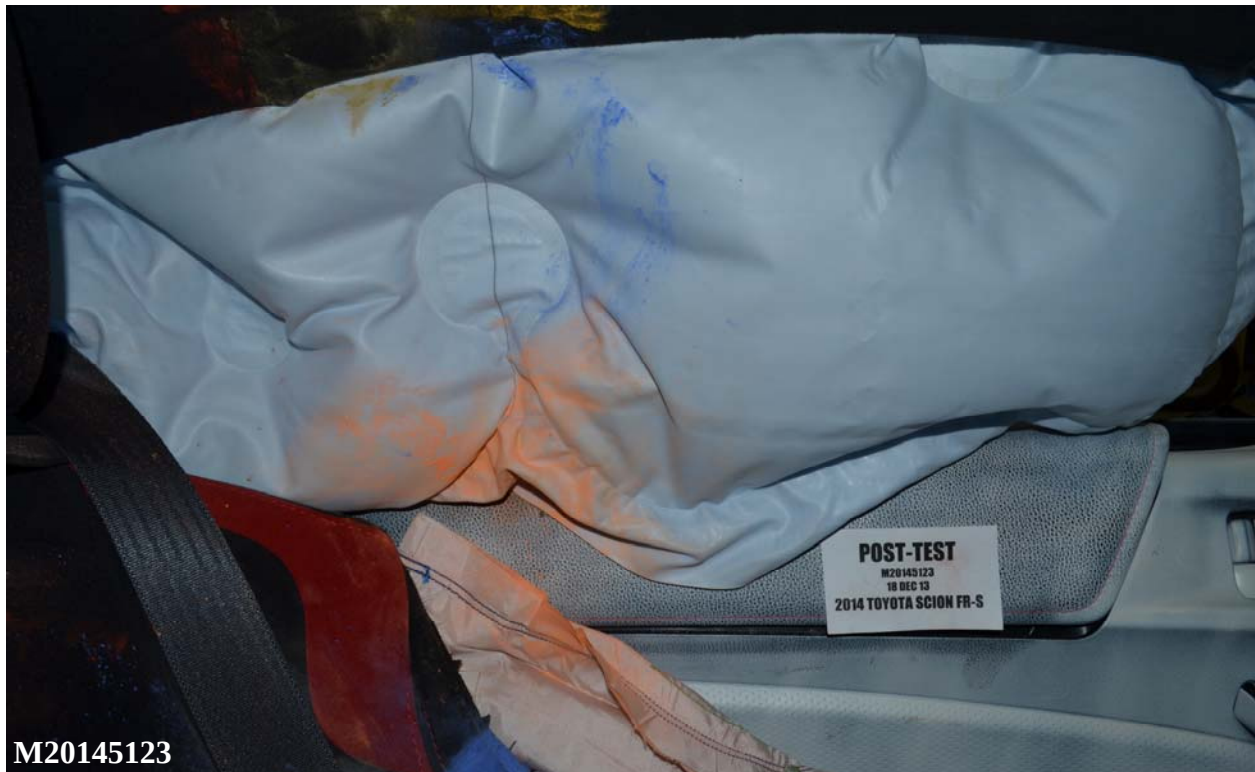
Figure A-49: Post-Test Driver Dummy Close-Up Head Contact with Side Airbag View

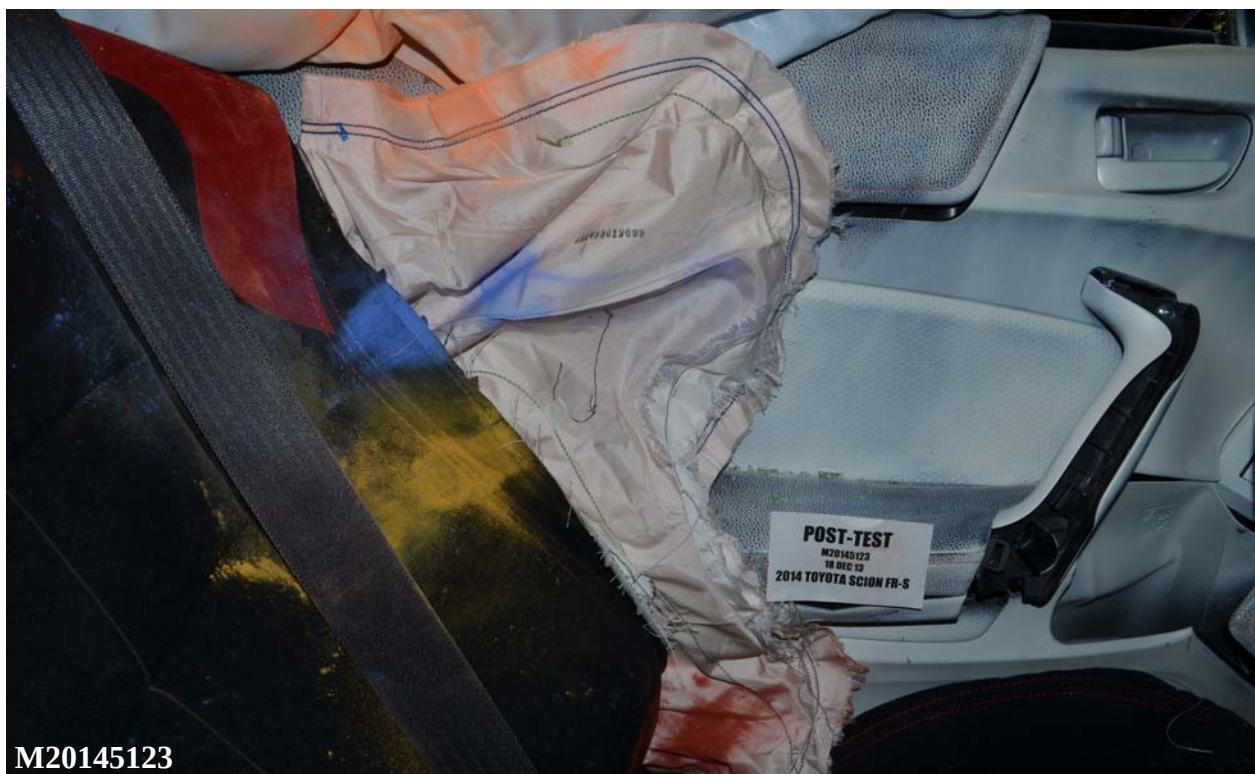
Figure A-50: Post-Test Driver Dummy Close-Up Torso Contact with Vehicle Interior View

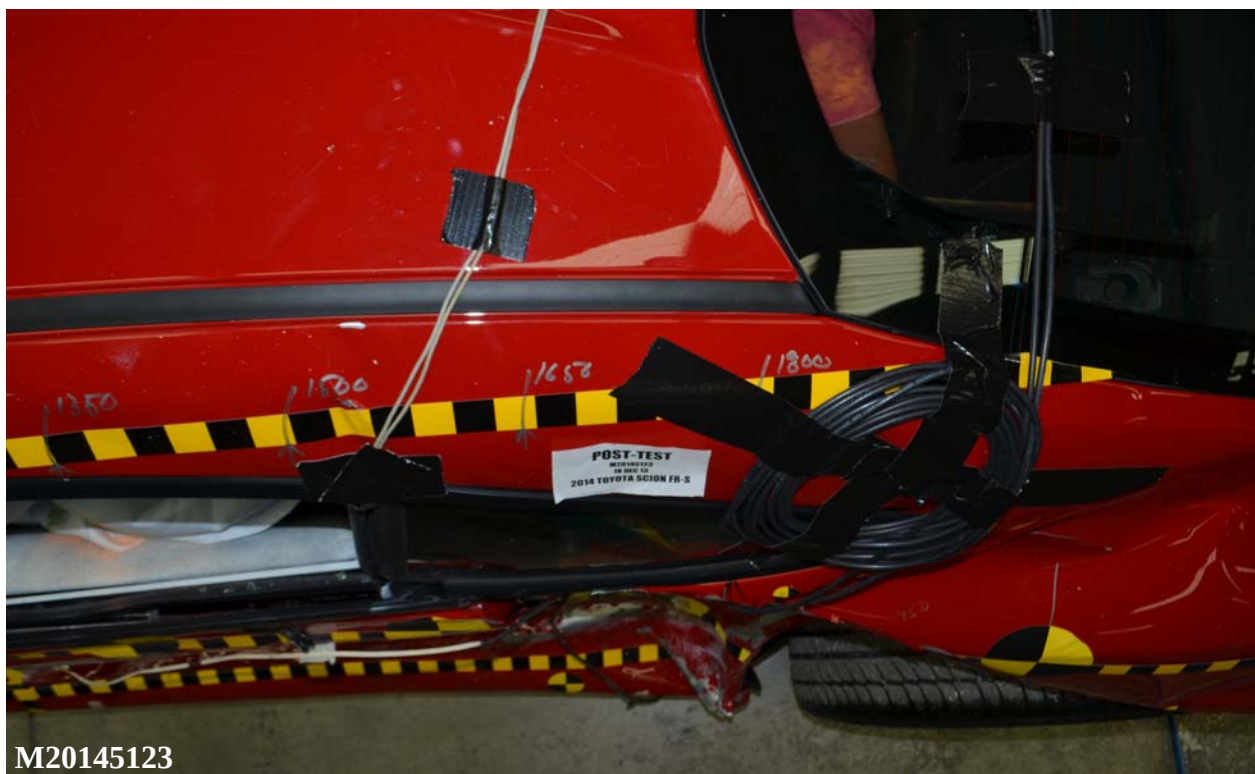
Figure A-70: Post-Test Rear Passenger Dummy and Door Clearance View

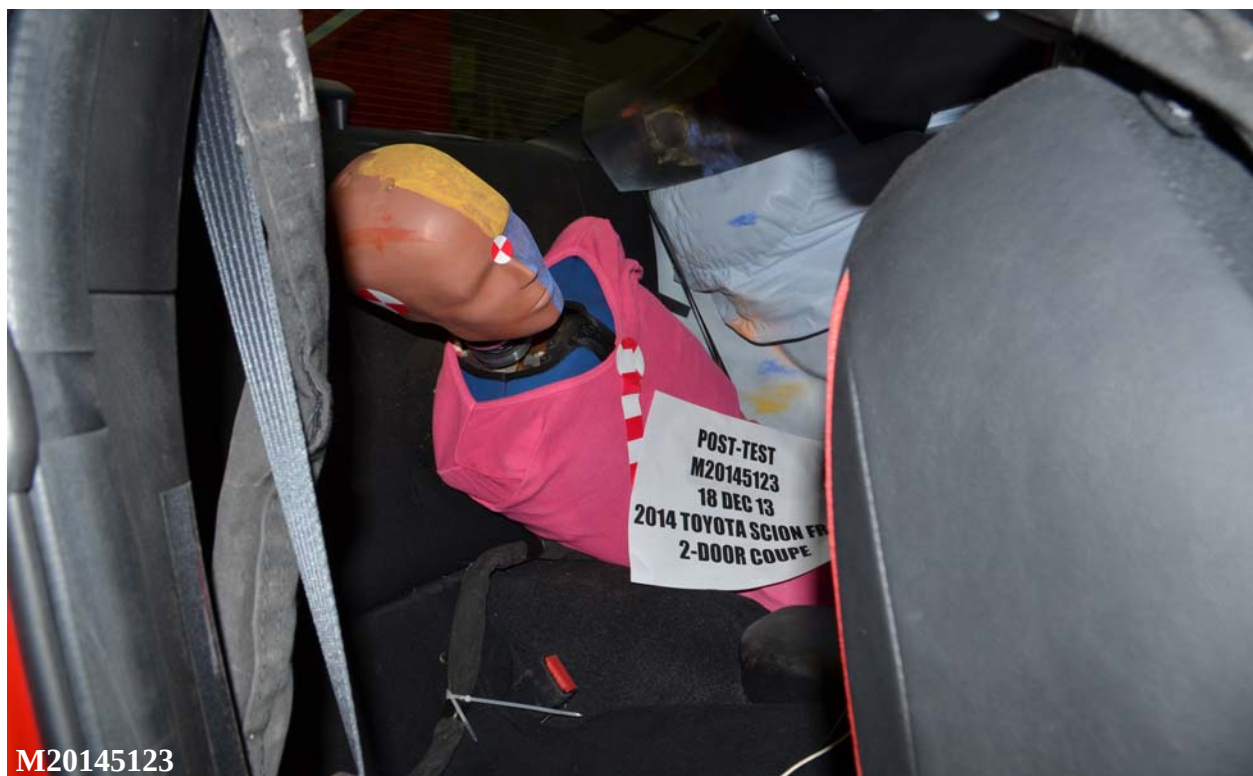
Figure A-72: Post-Test Right Side View of Rear Passenger Dummy and Rear Seat Occupant Compartment

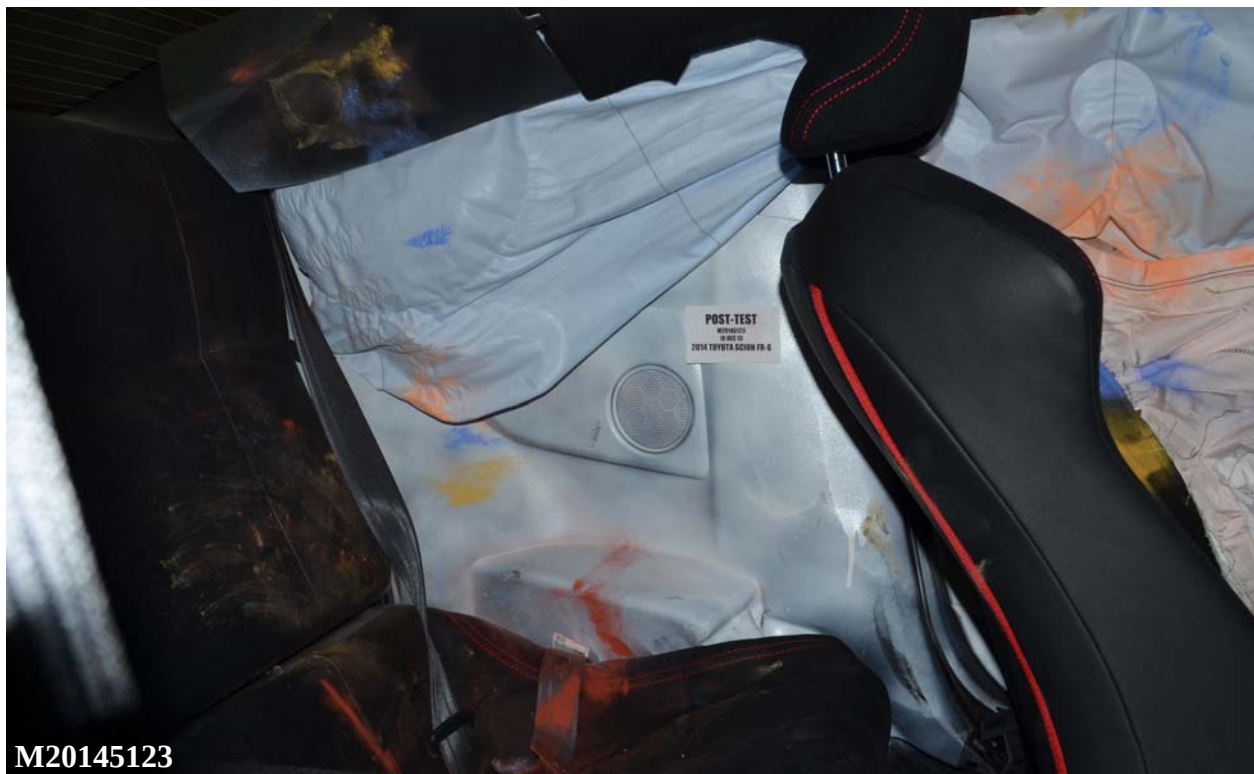
Figure A-74: Post-Test Rear Passenger Inner Door Panel View Showing Dummy Contact Locations

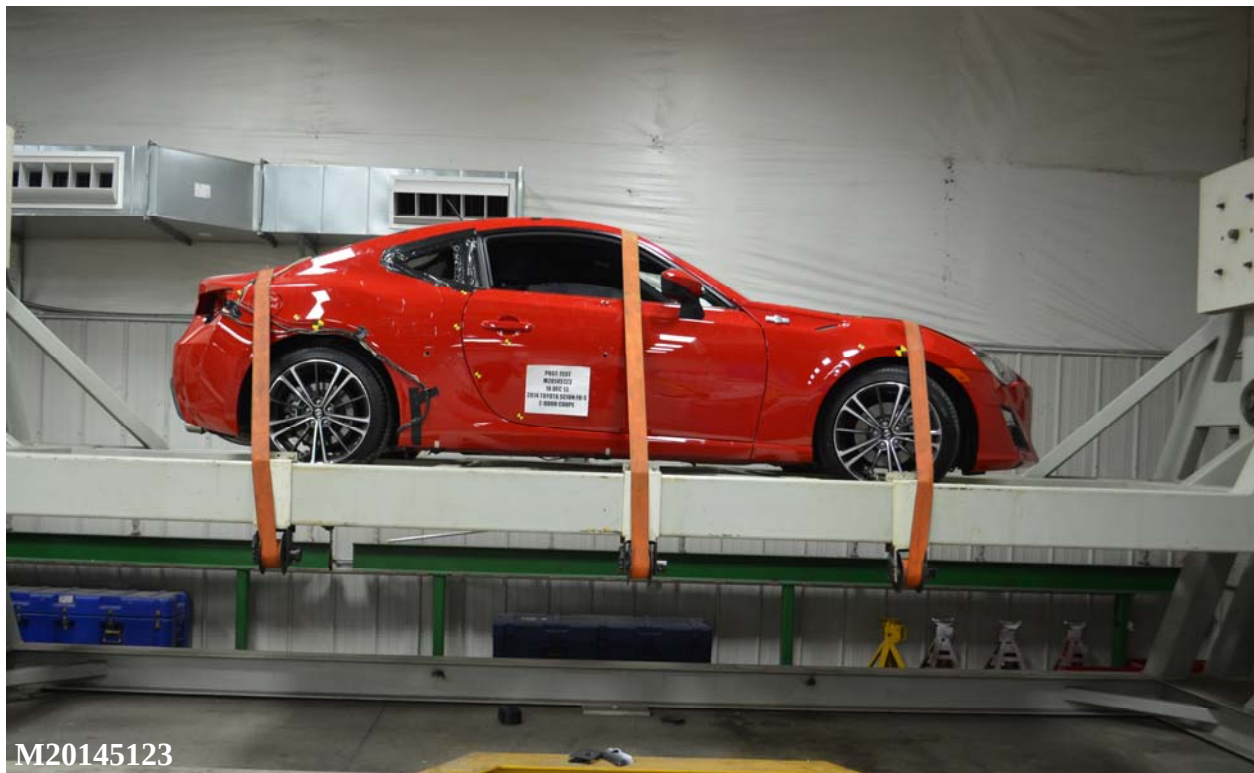
Figure A-100: FMVSS No. 301 Static Rollover 360 Degrees

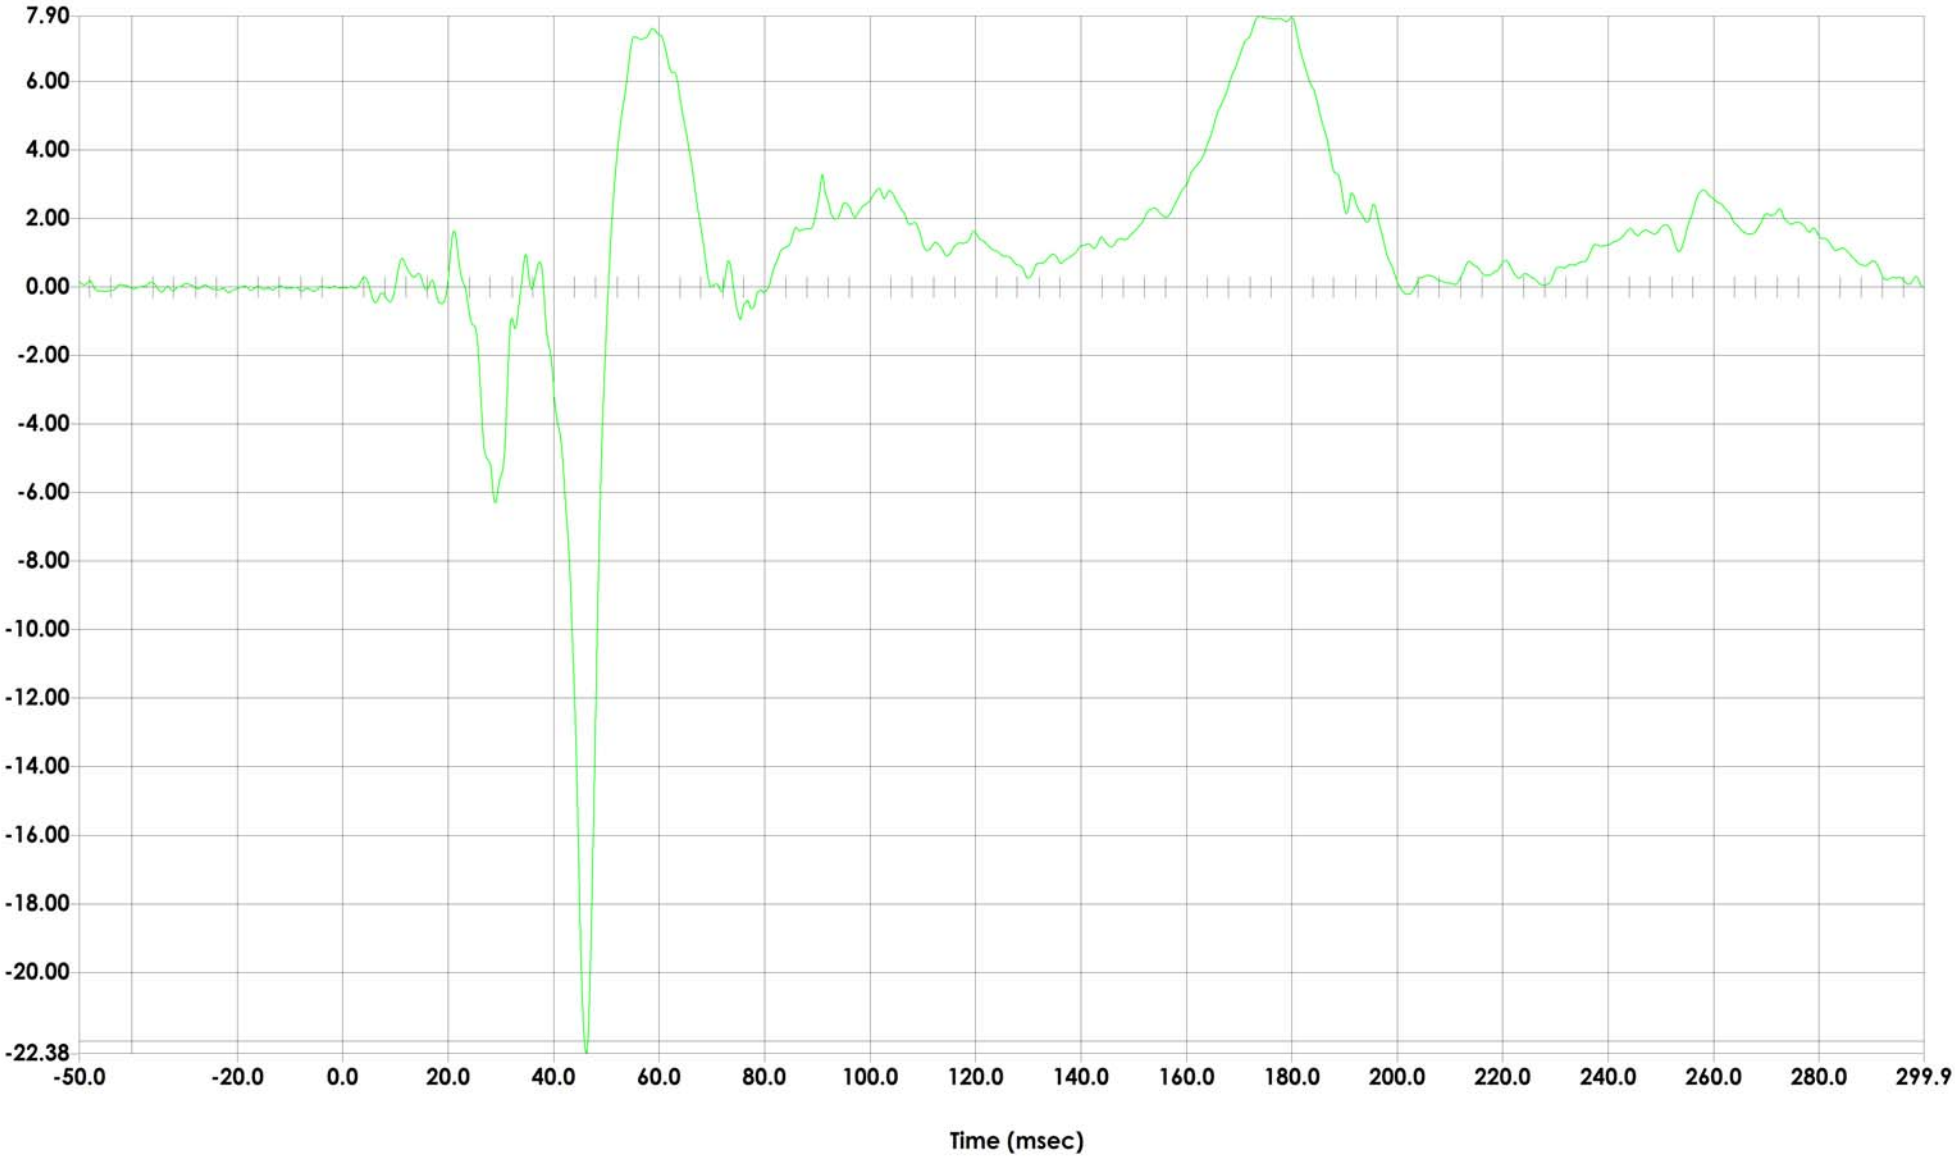
Passenger Lower Spine T12 Acceleration (X) vs. Time
