REPORT NUMBER: R&D-CAL-13-001

**MOVING BARRIER TO VEHICLE CRASH TEST IN SUPPORT OF NHTSA'S
FRONTAL OBLIQUE OFFSET PROGRAM
RESEARCH MOVING DEFORMABLE BARRIER INTO LEFT FRONT OF A**

2013 DODGE DART

90.1KPH, 15 DEGREE ANGLE, 35% OVERLAP

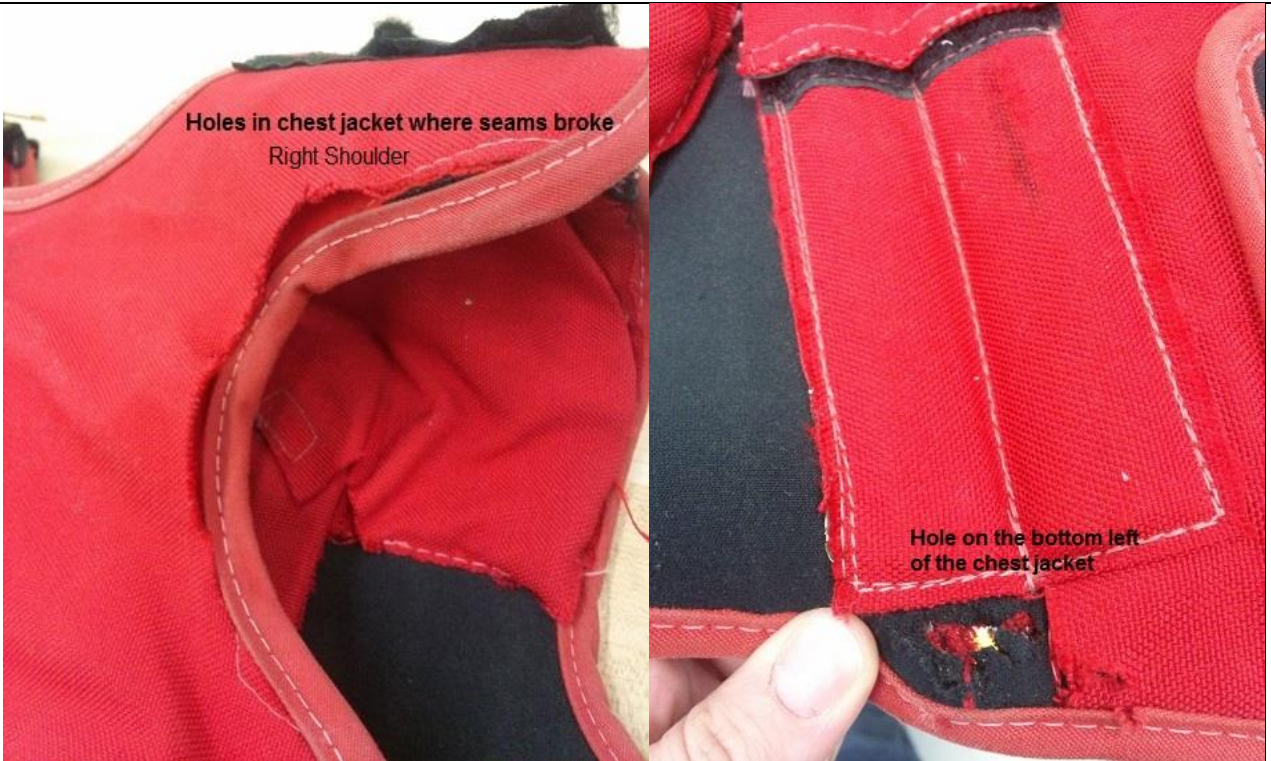
Y / N Rib stiffeners show no sign of permanent deformation
One of the left rib stiffeners has damage to the outer coating that goes all the way around, also, the rib stiffeners were severely bent when we received 0015.

Many of the seams of the jacket are coming undone, and there is a hole on the bottom left side along with stains all over the jacket.

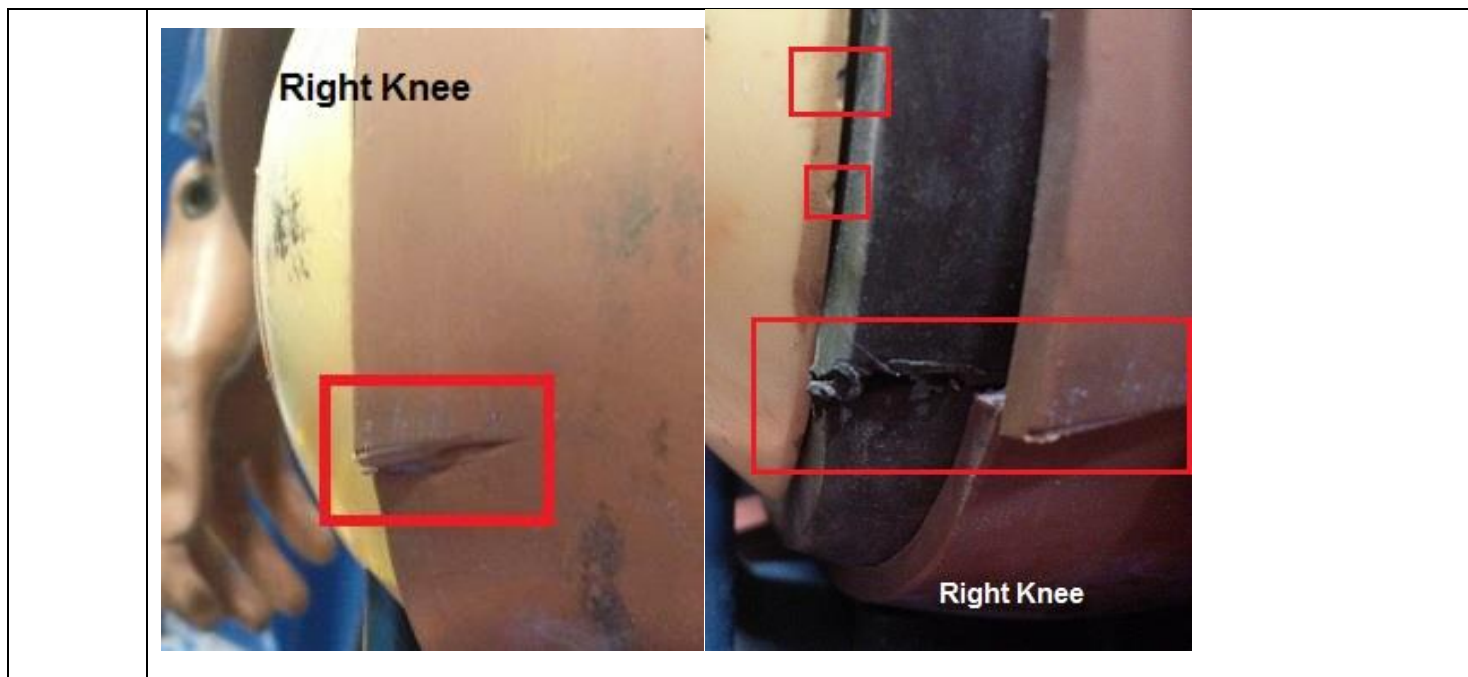
Y / **N** No evidence of deformation of knee slider bump stop
Damage to the inside of the right knee

Some damage done to the outer left knee, inside right knee sustained more damage

Y / **N** No cuts, tears, or scuffing of knee flesh
Right knee flesh, and rubber insert were cut, chips is white area

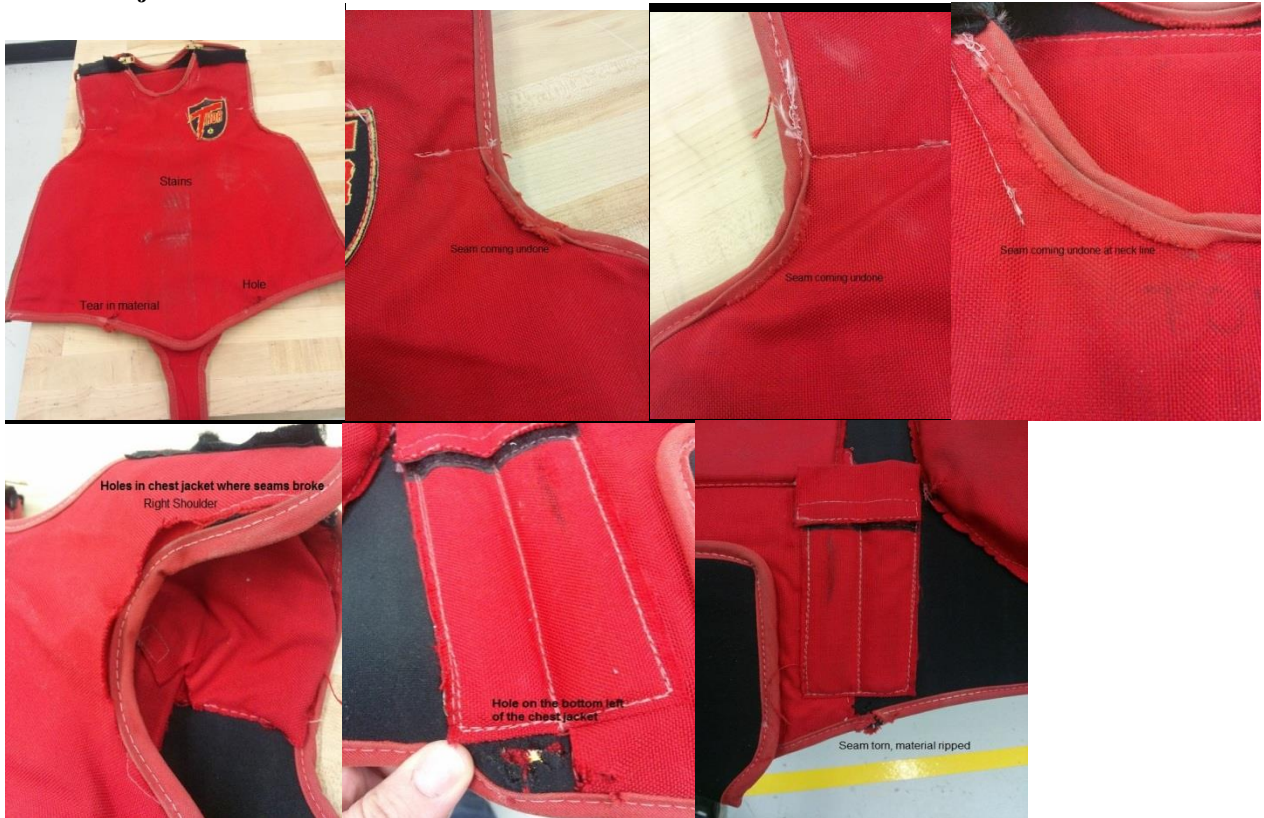
JACKET	
Y / N	<p>Rib stiffeners show no sign of permanent deformation</p> <p>One of the left rib stiffeners has damage to the outer coating that goes all the way around, also, the rib stiffeners were severely bent when we received 0015.</p>

No evidence of tears or holes in jacket fabric, Velcro, or zippers
Many of the seams of the jacket are coming undone, and there is a hole on the bottom left side along with stains all over the jacket.

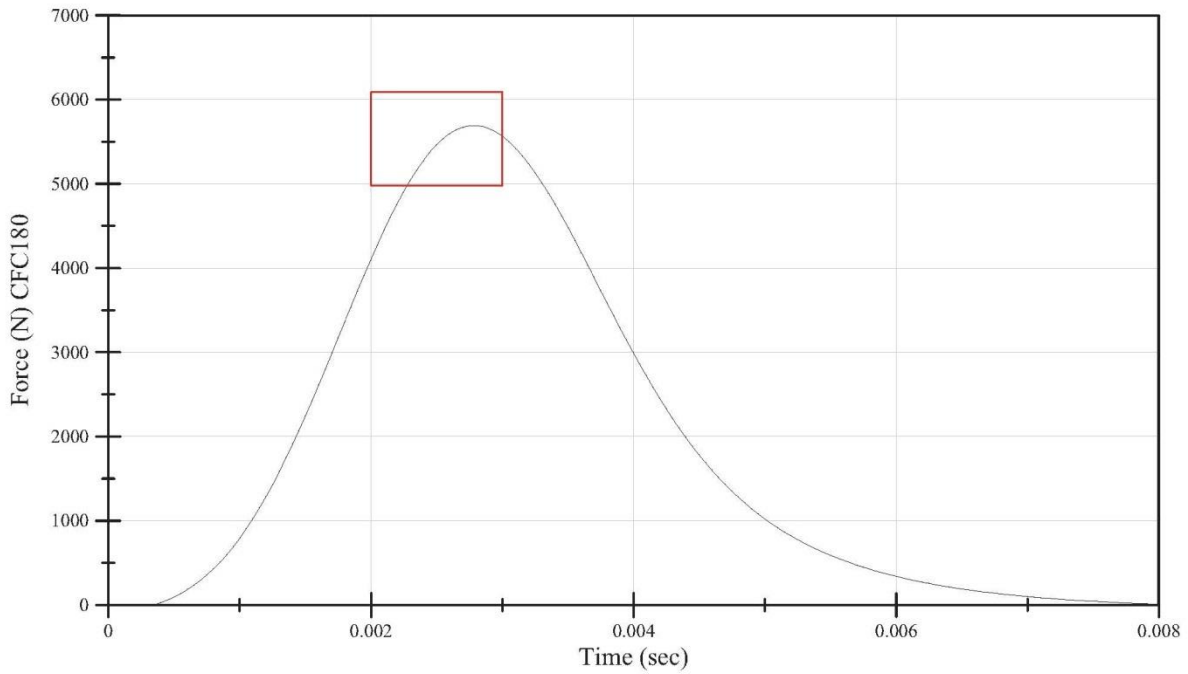
Test Temperature: 70 degrees
Relative Humidity: 49%
Test Velocity: 1.98 m/s

THOR Head Impact Certification
Probe Force
Serial Number: T016

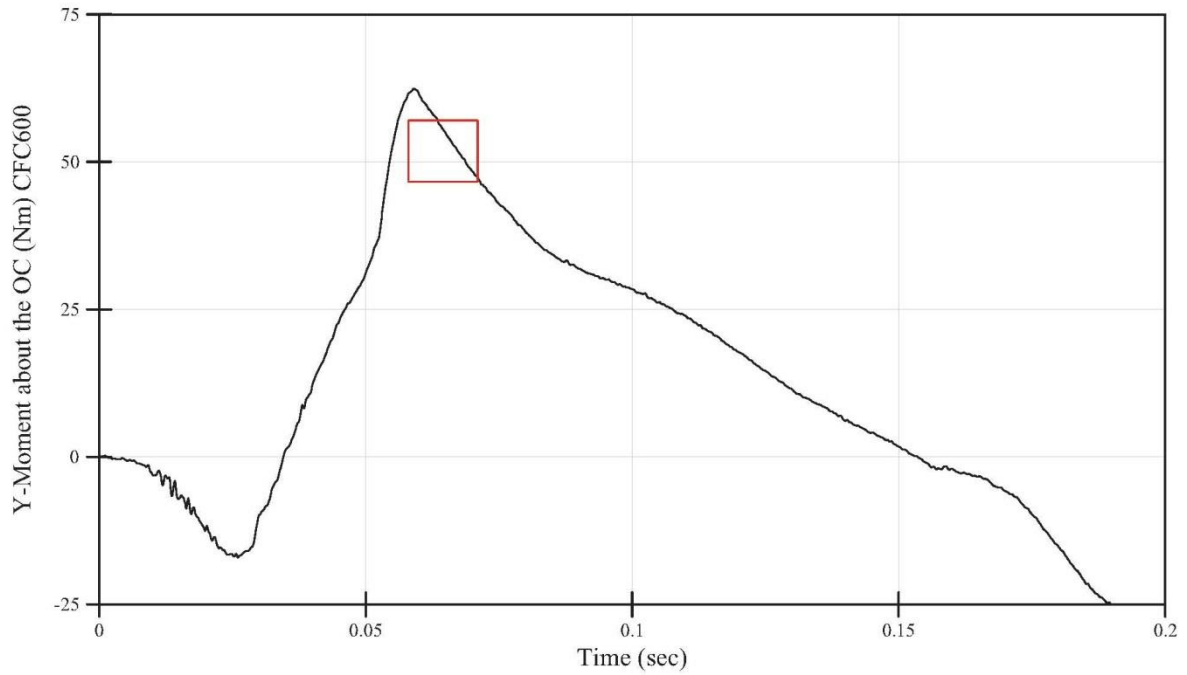
Test Temperature: 71 degrees
Relative Humidity: 49%
Test Velocity: 3.83 m/s

THOR Neck Flexion Certification
Y-Moment
Serial Number: T016

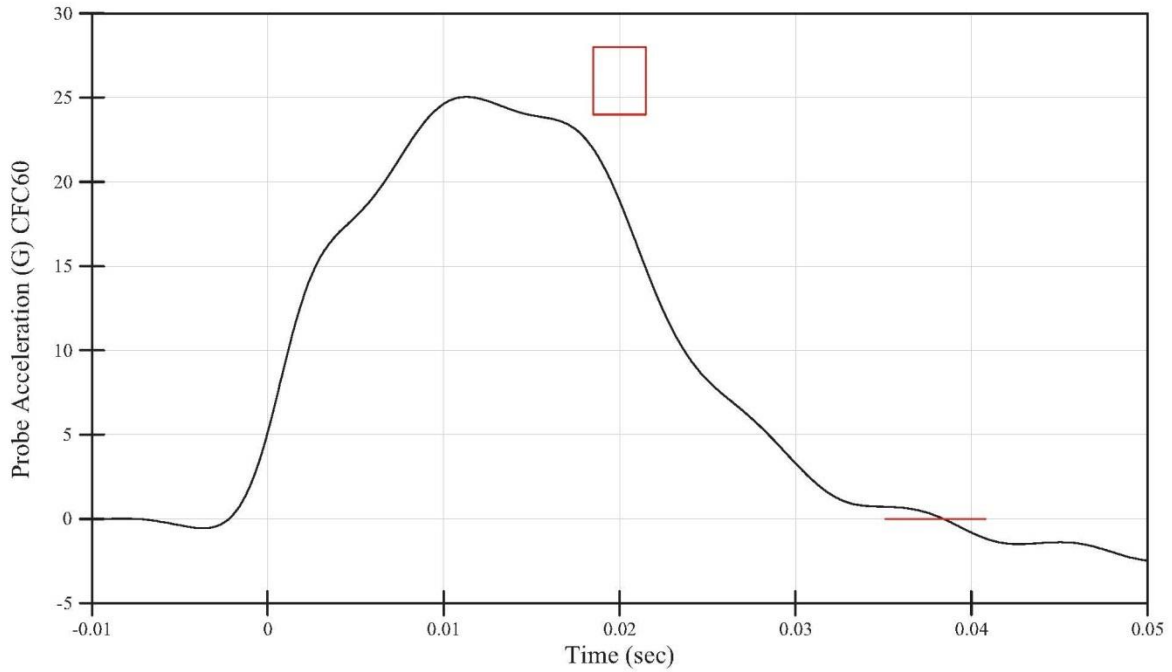
Test Temperature: 71 degrees
Relative Humidity: 49%
Test Velocity: 3.83 m/s

THOR Neck Flexion Certification
Probe Acceleration
Serial Number: T016

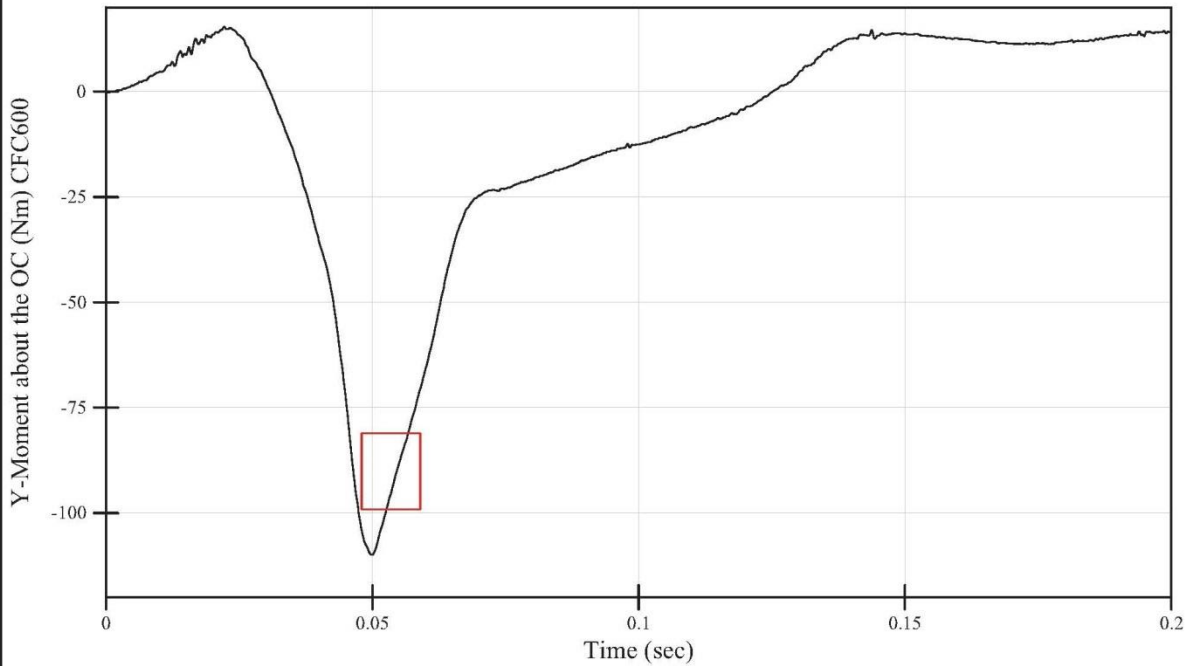
Test Temperature: 71 degrees
Relative Humidity: 49%
Test Velocity: 3.73 m/s

THOR Neck Extension Certification
Y-Moment
Serial Number: T016

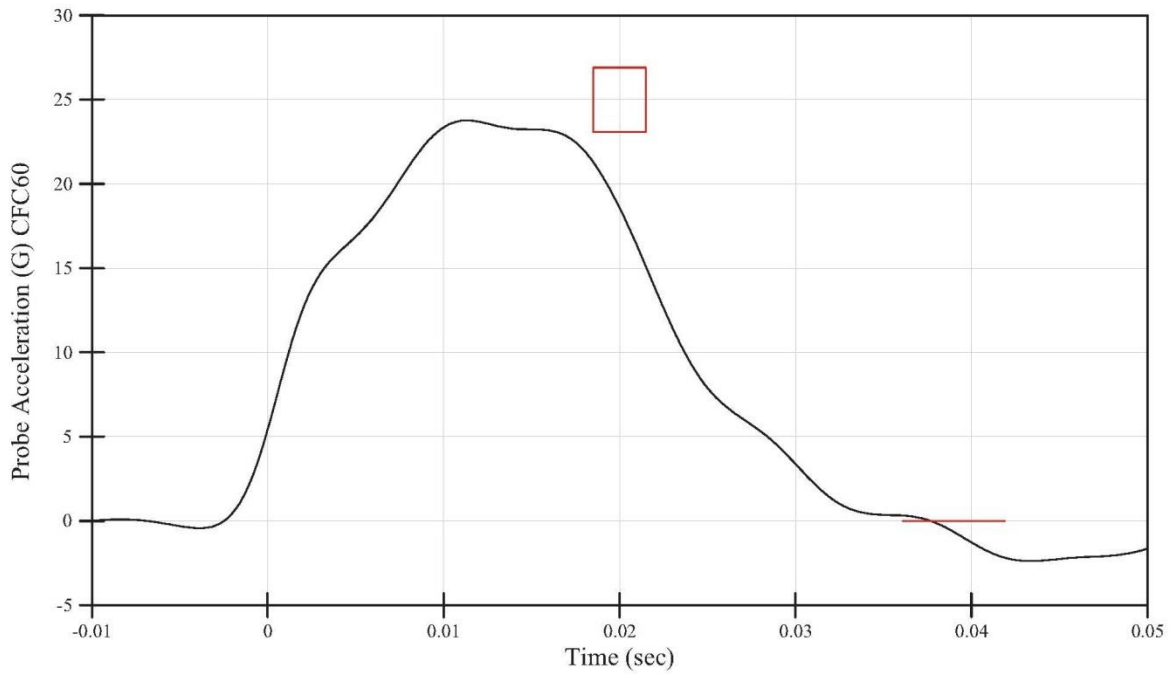
Test Temperature: 71 degrees
Relative Humidity: 49%
Test Velocity: 3.73 m/s

THOR Neck Extension Certification
Probe Acceleration
Serial Number: T016

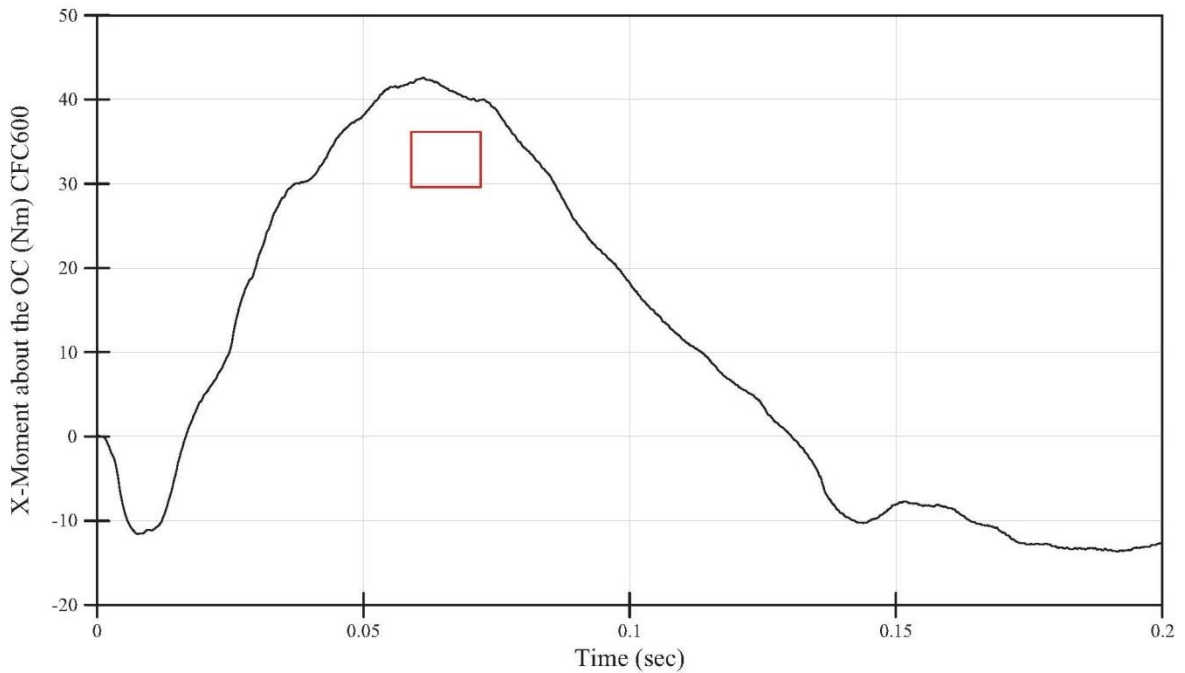
Test Temperature: 71 degrees
Relative Humidity: 49%
Test Velocity: 2.91 m/s

THOR Neck Left Lateral Flexion Certification
X-Moment
Serial Number: T016

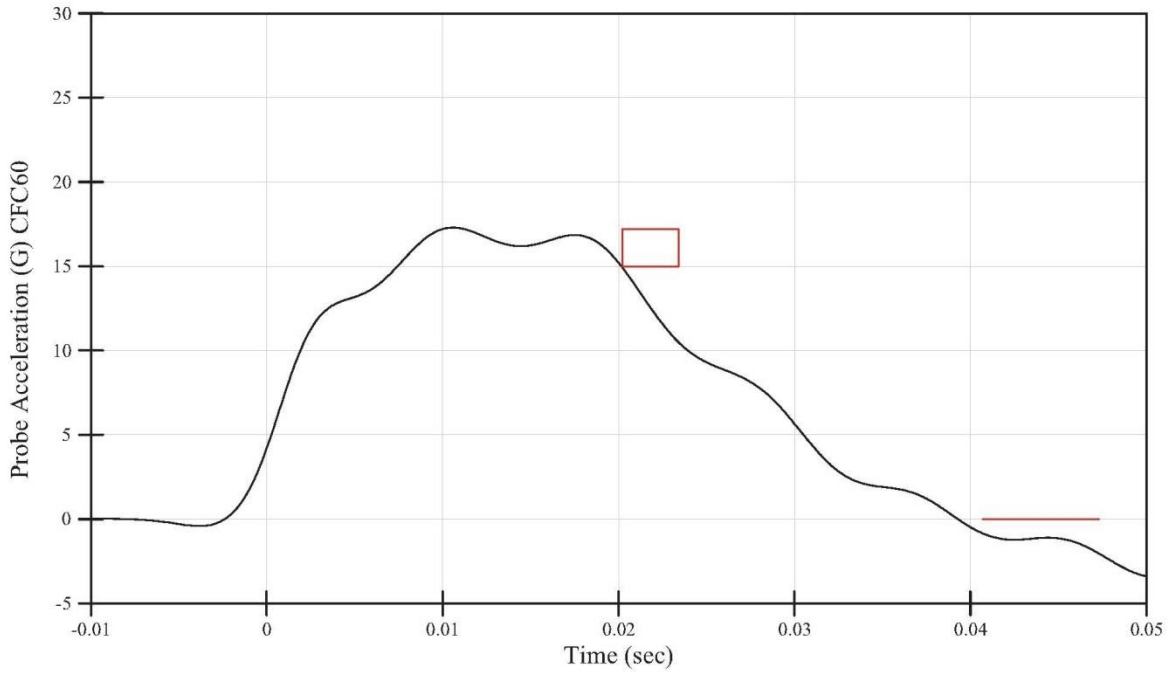
Test Temperature: 71 degrees
Relative Humidity: 49%
Test Velocity: 2.91 m/s

THOR Neck Left Lateral Flexion Certification
Probe Acceleration
Serial Number: T016

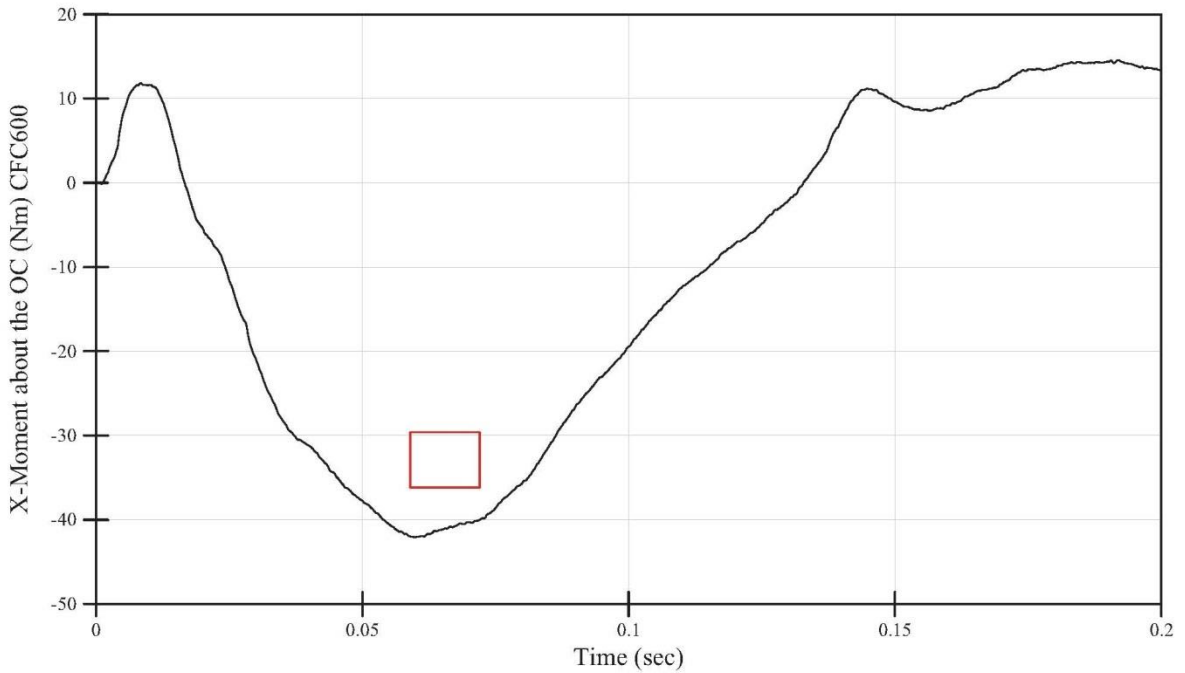
THOR Neck Right Lateral Flexion Certification
X-Moment
Serial Number: T016

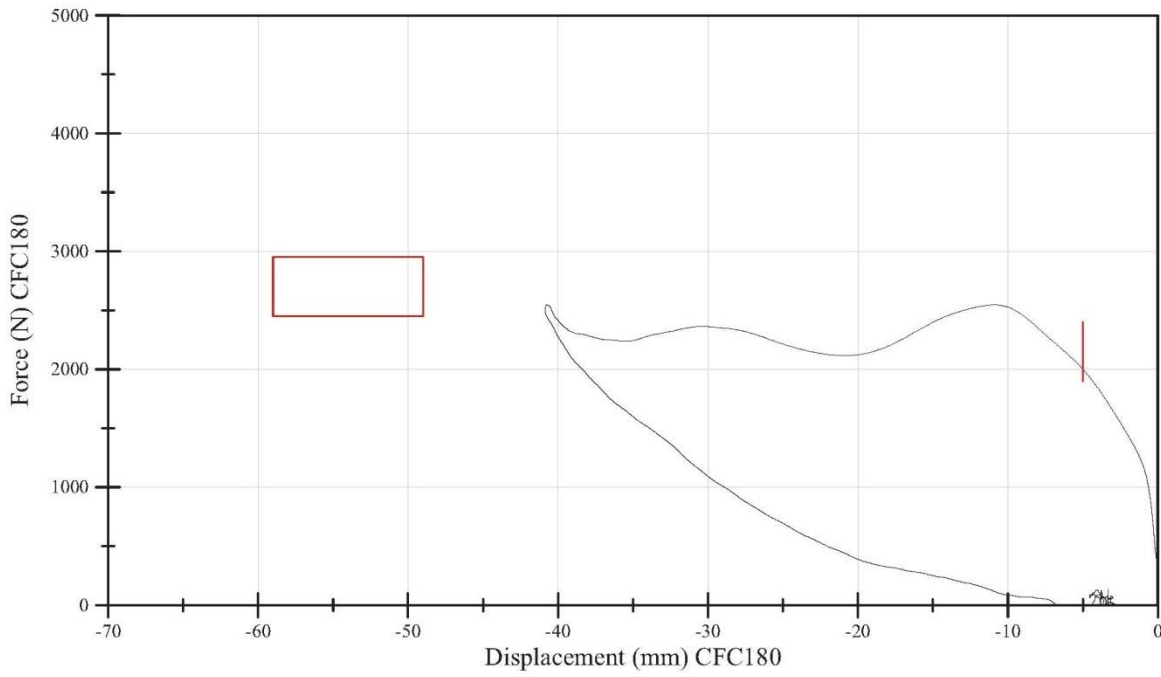
THOR Upper Thorax Certification
Thorax Displacement vs. Probe Force
Serial Number: T016

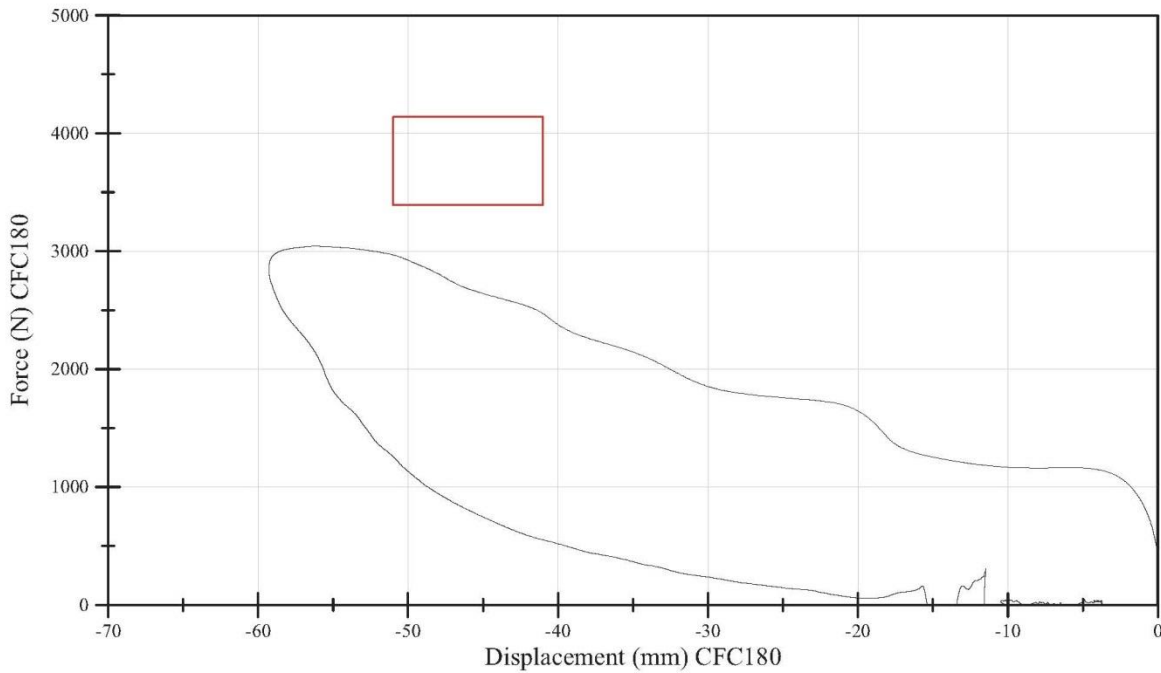
THOR Lower Left Oblique Thorax Certification
Thorax Displacement vs. Probe Force
Serial Number: T016

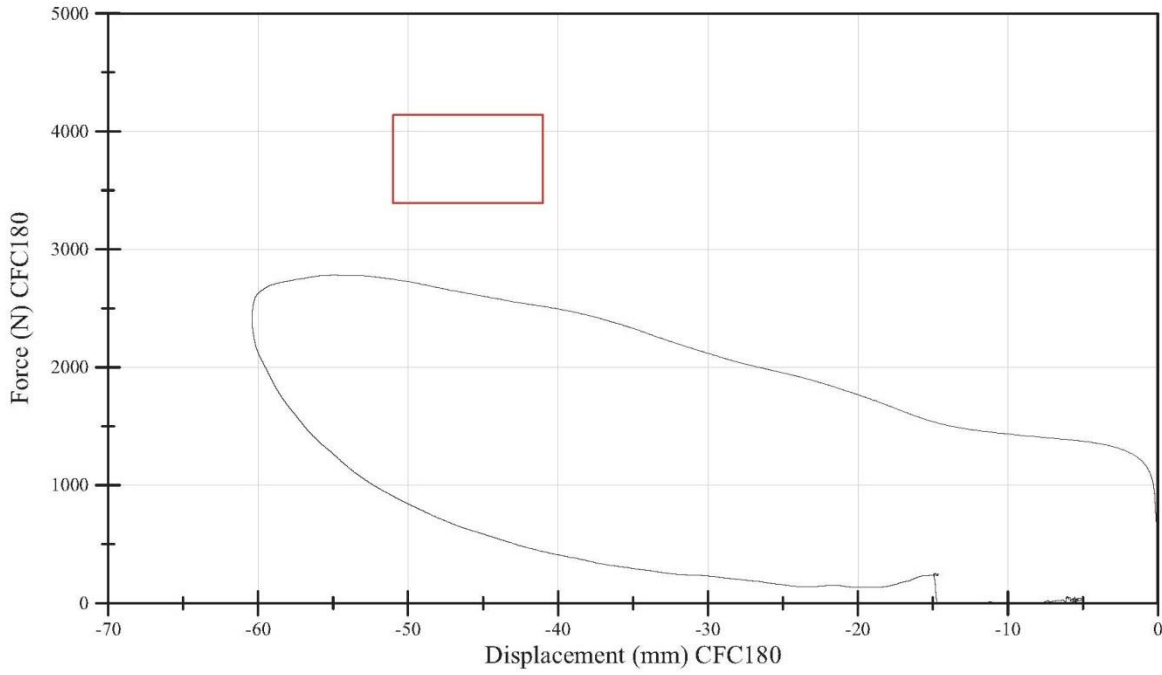
THOR Lower Right Oblique Thorax Certification
Thorax Displacement vs. Probe Force
Serial Number: T016

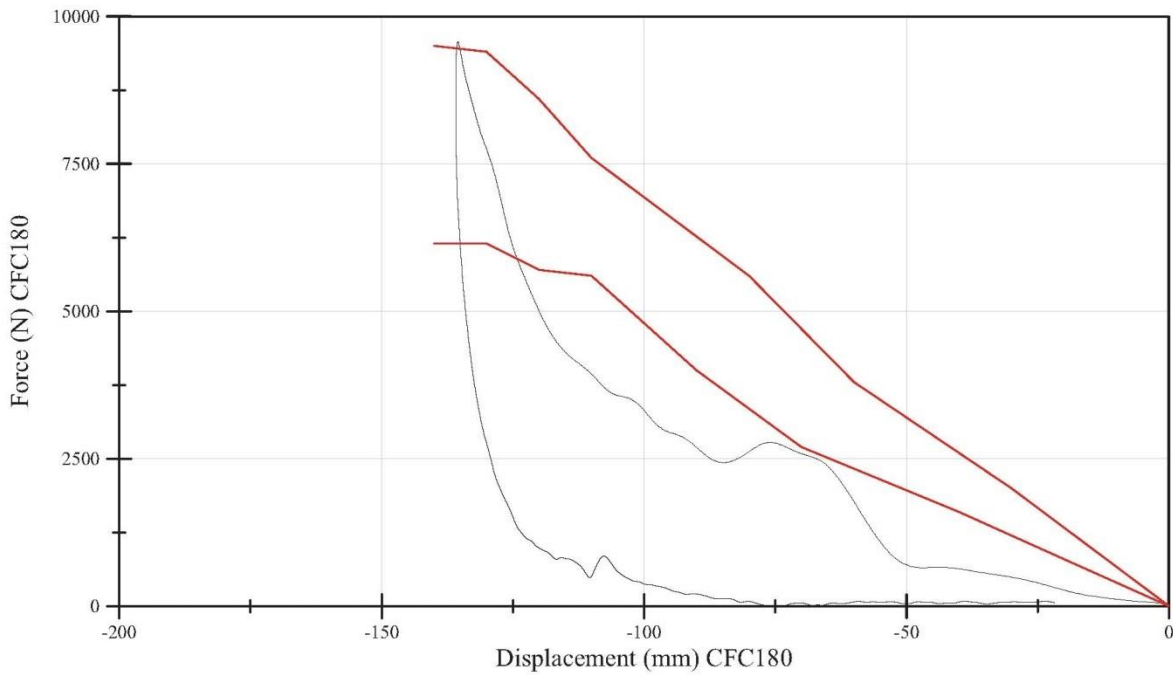
THOR Upper Abdomen Certification
Abdomen Displacement vs. Probe Force
Serial Number: T016

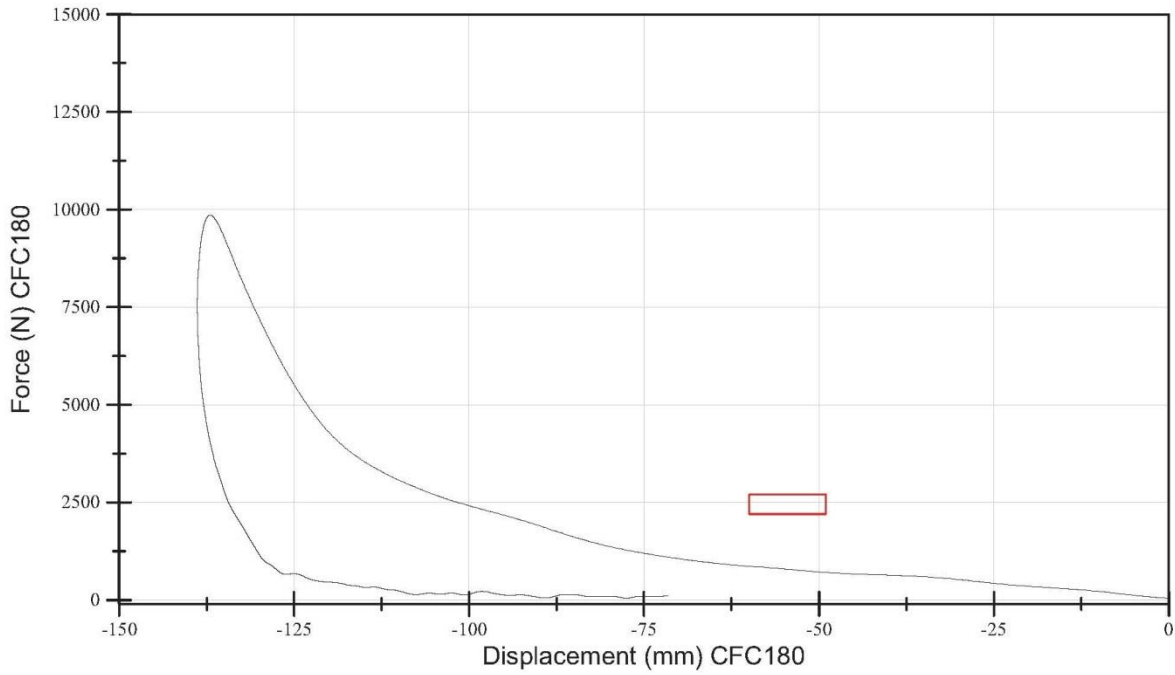
THOR Lower Abdomen Certification
Lower Abdomen Deflection (via PENXG and T12XG) vs. Probe Force
Serial Number: 016

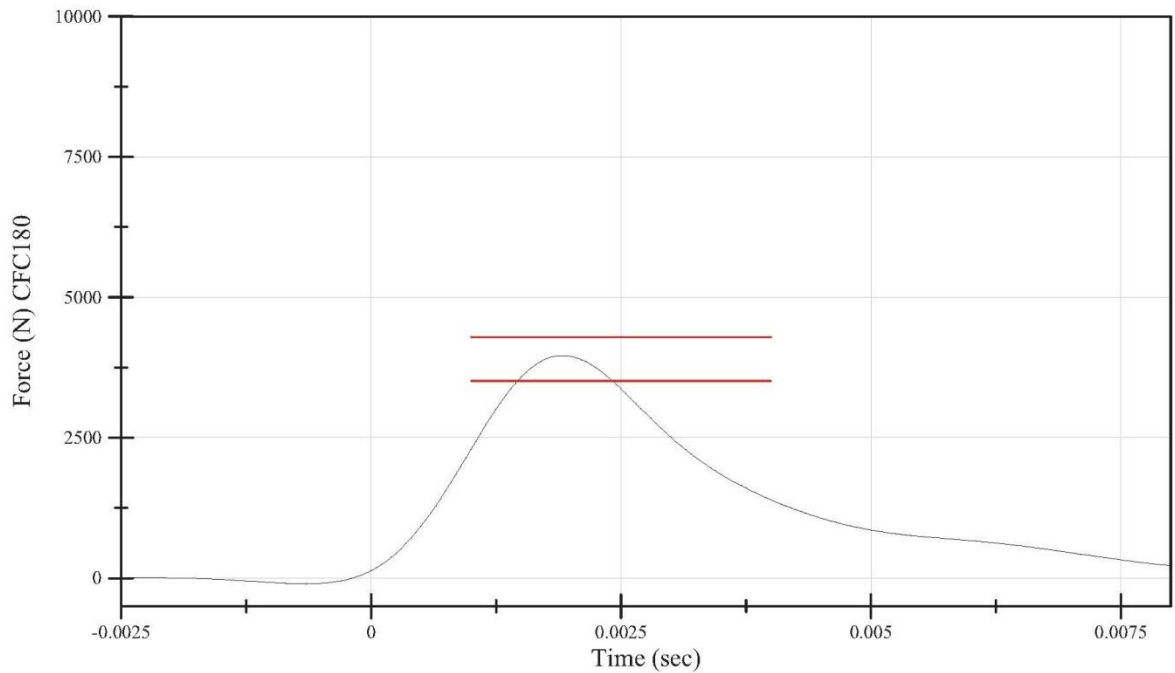
THOR Left Femur Certification
Probe Force
Serial Number: T015

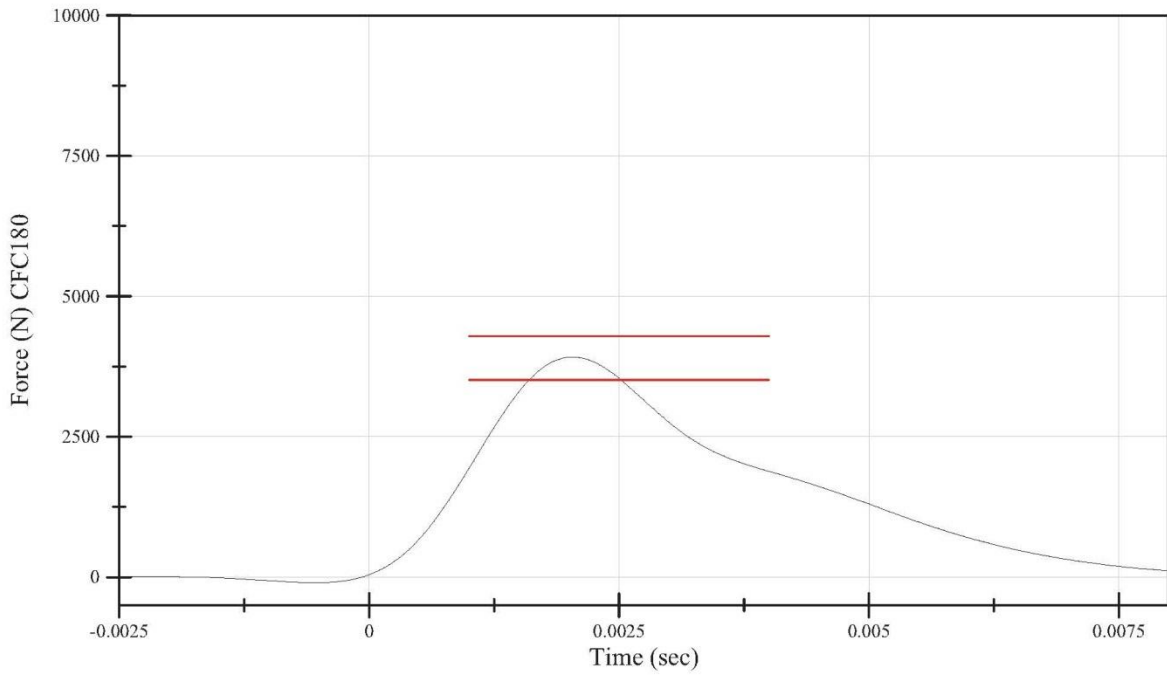
THOR Right Femur Certification
Probe Force
Serial Number: T015

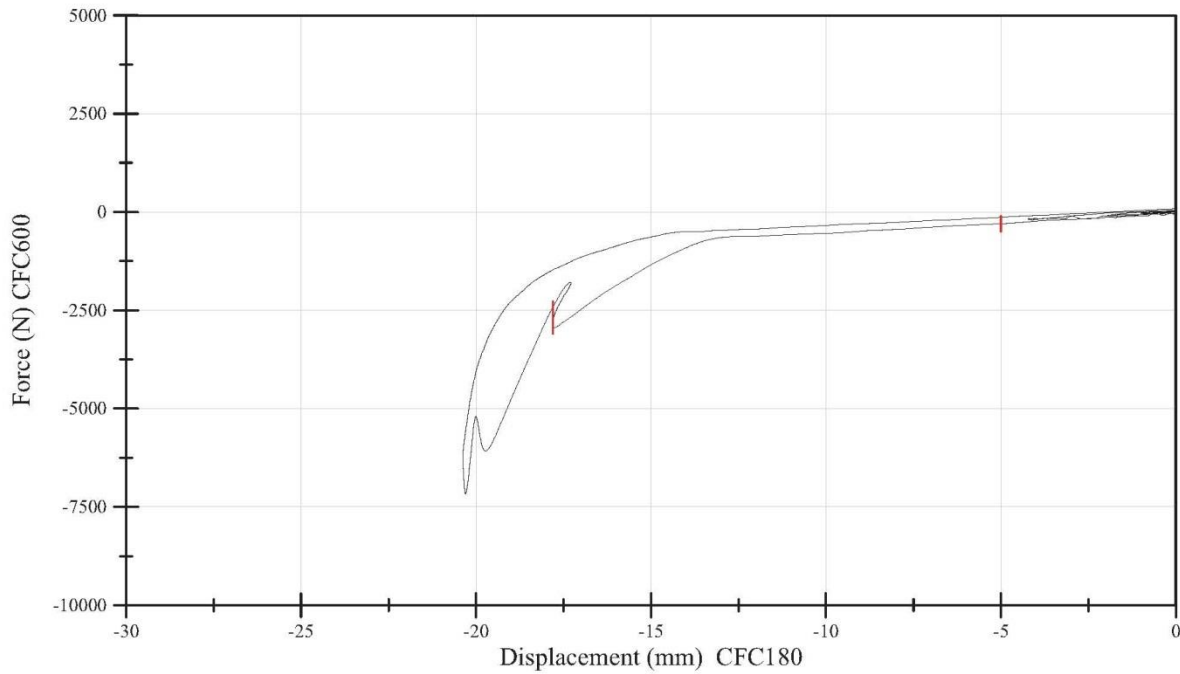
THOR Left Knee Certification
Femur Force vs. Knee Displacement
Serial Number: LX0019

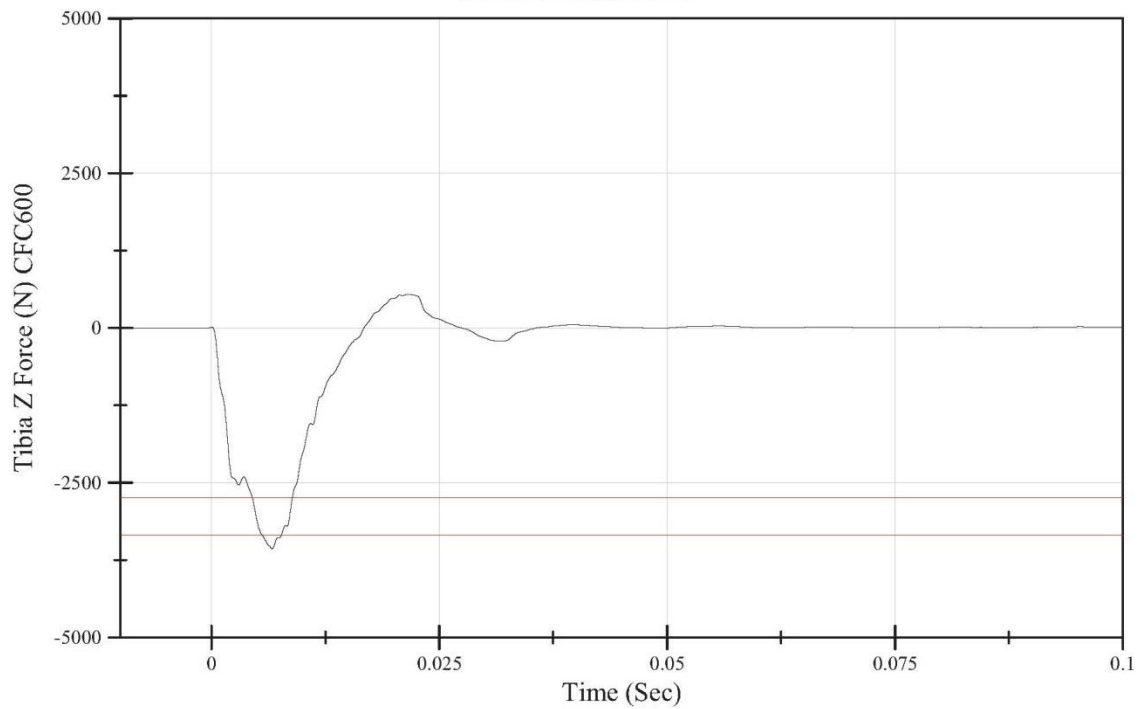
THOR Left Foot Heel Certification
Tibia Load
Serial Number: LX0019

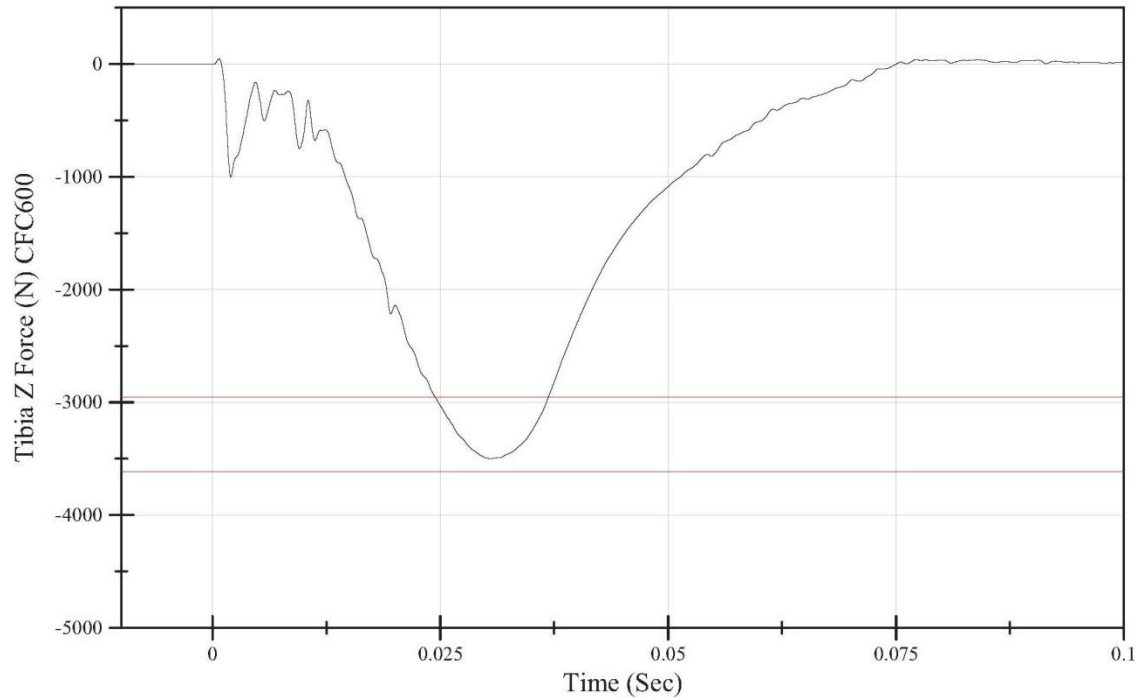
THOR Left Foot Dorsiflexion Certification
Tibia Load
Serial Number: LX0019

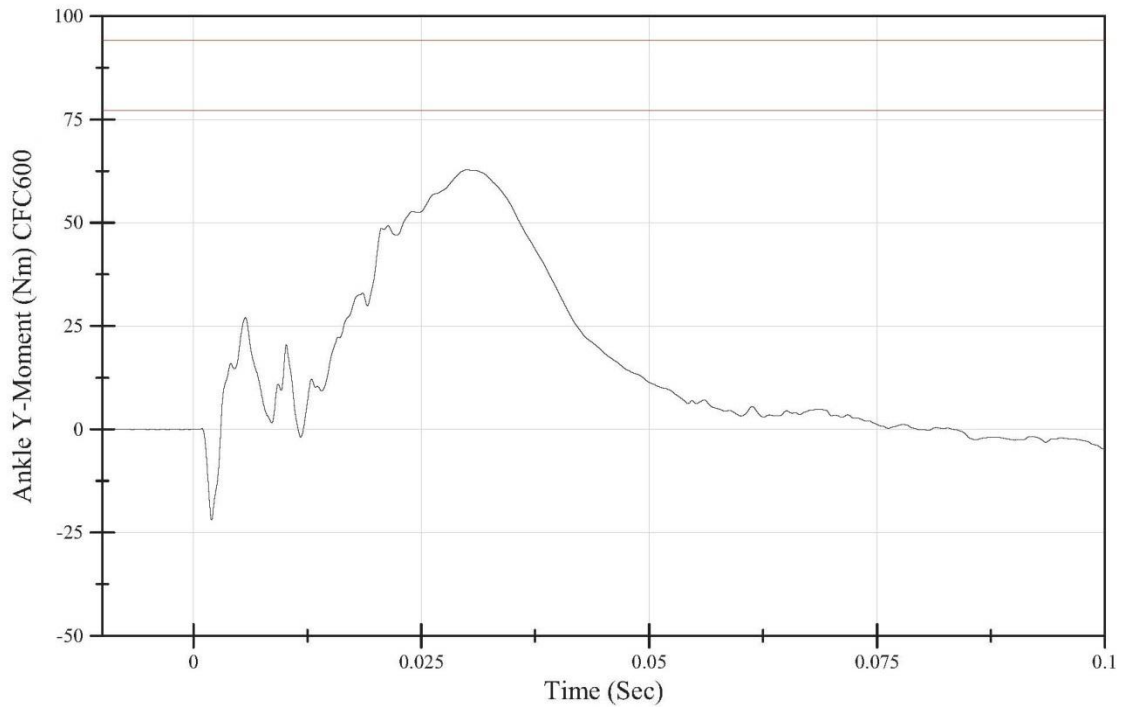
THOR Left Foot Dorsiflexion Certification
Ankle Y-Moment
Serial Number: LX0019

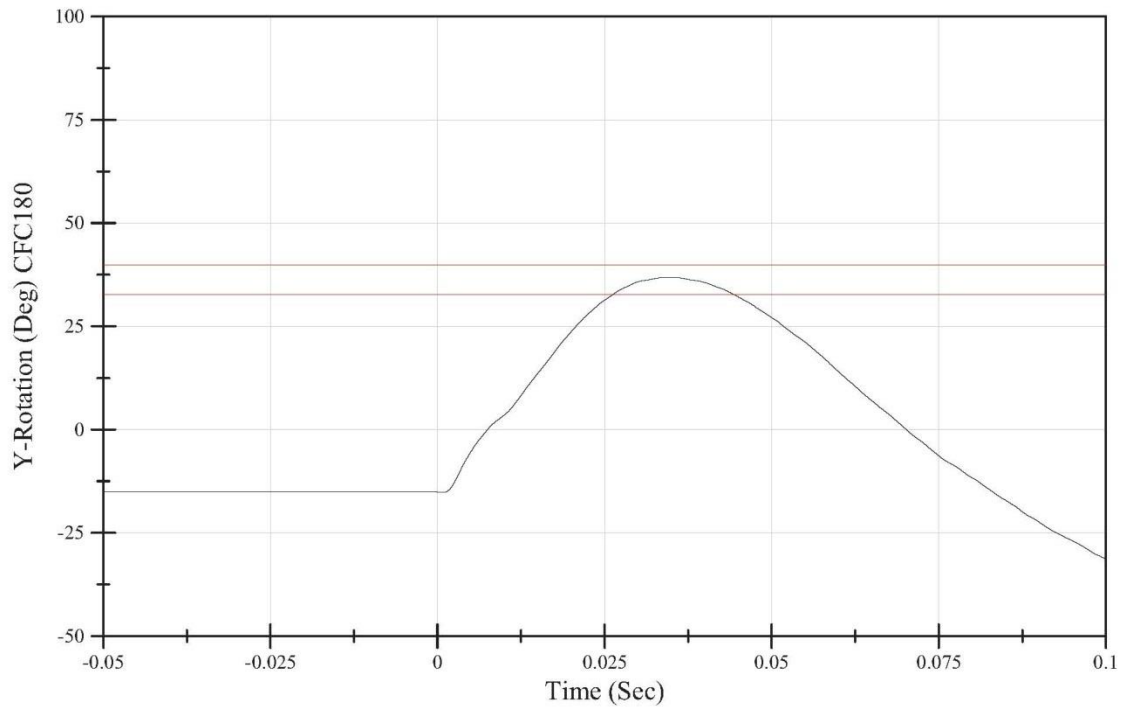
THOR Left Foot Dorsiflexion Certification
Ankle Y-Rotation
Serial Number: LX0019

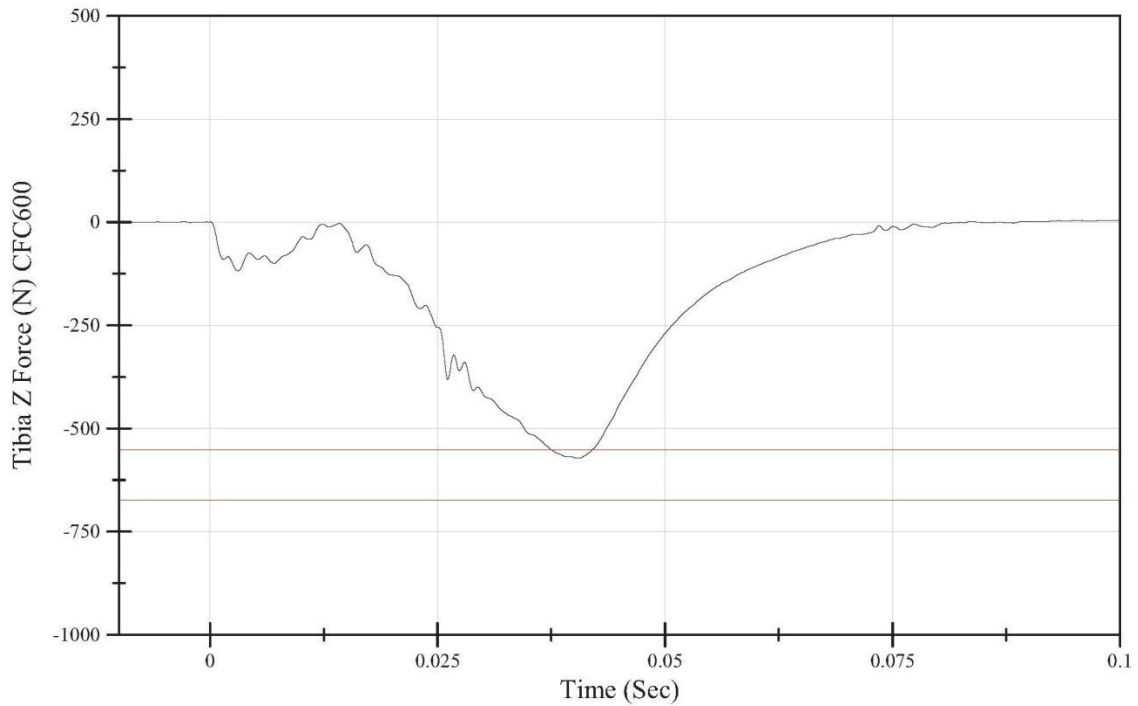
THOR Left Foot Eversion Certification
Tibia Load
Serial Number: LX0019

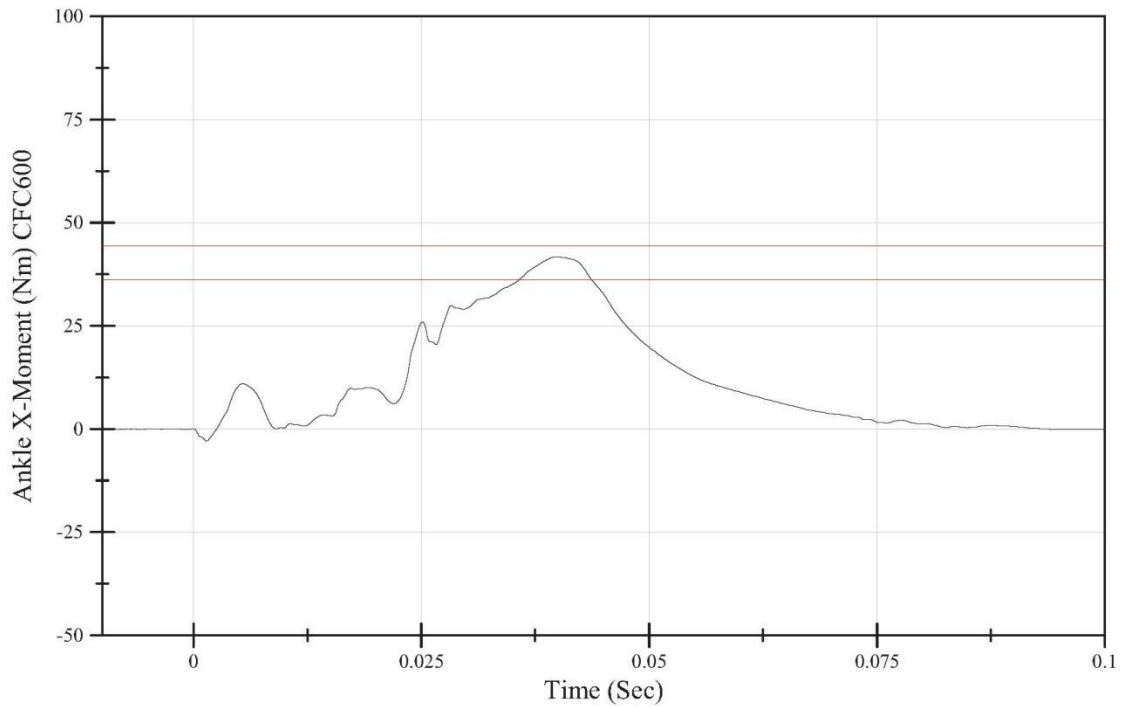
THOR Left Foot Eversion Certification
Ankle Moment
Serial Number: LX0019

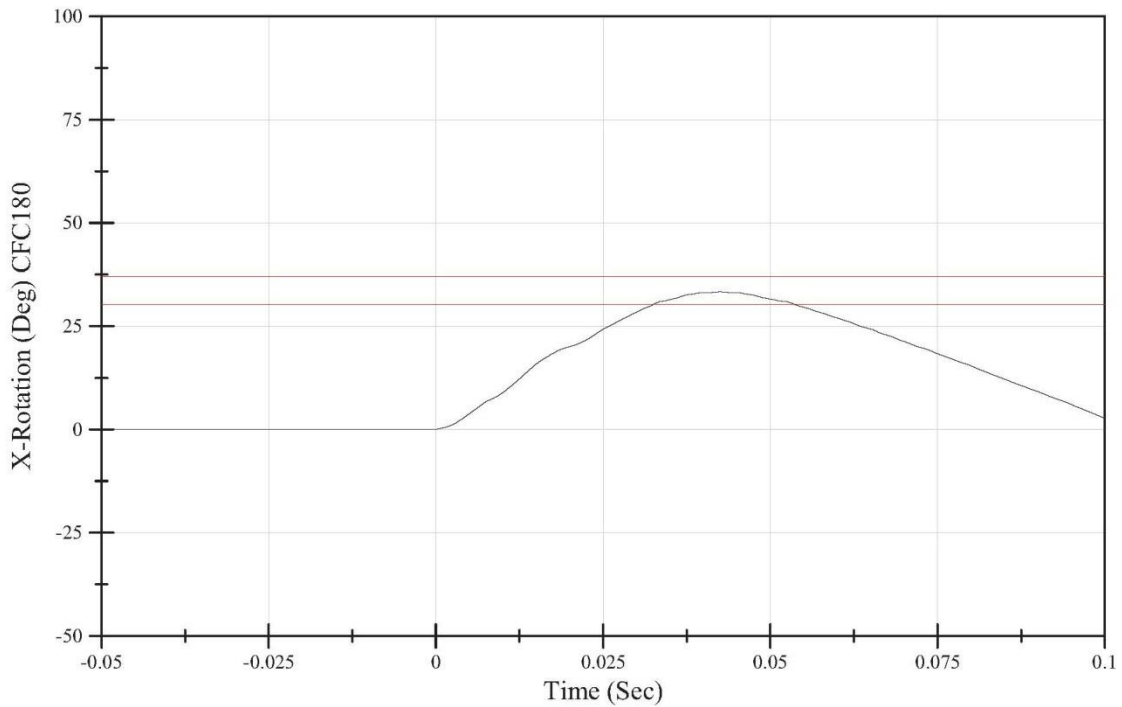
THOR Left Foot Eversion Certification
Ankle X-Rotation
Serial Number: LX0019

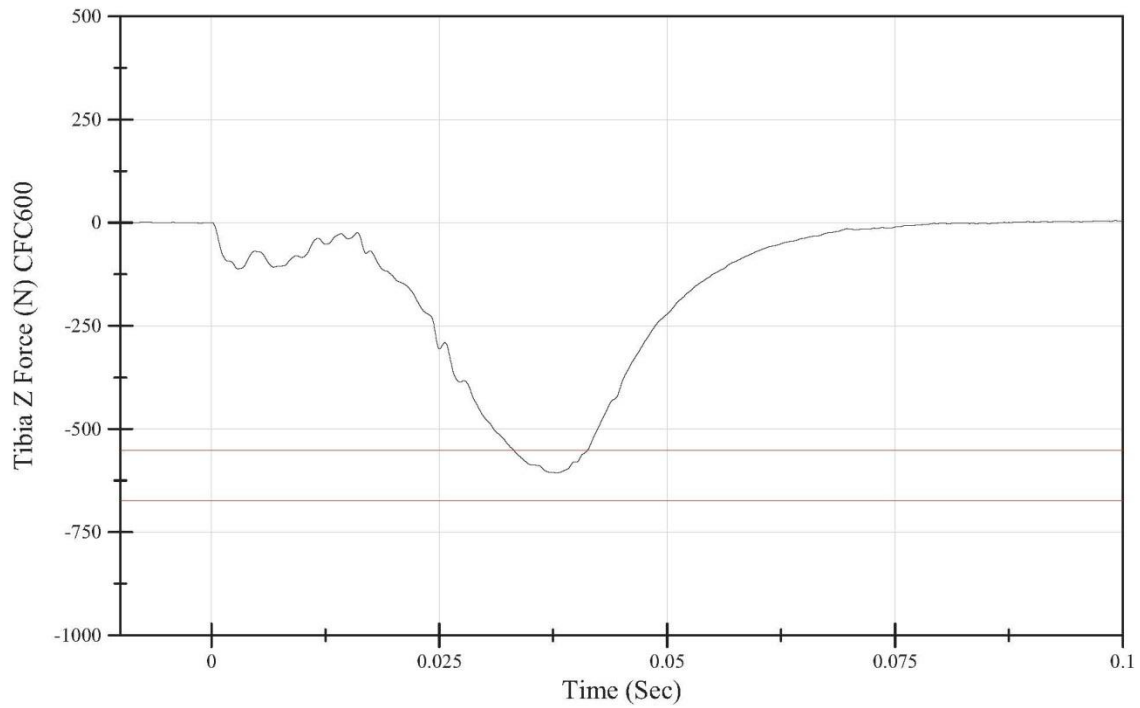
THOR Left Foot Inversion Certification
Tibia Load
Serial Number: LX0019
