REPORT NUMBER: R&D-CAL-13-001

**MOVING BARRIER TO VEHICLE CRASH TEST IN SUPPORT OF NHTSA'S
FRONTAL OBLIQUE OFFSET PROGRAM
RESEARCH MOVING DEFORMABLE BARRIER INTO LEFT FRONT OF A**

2013 DODGE DART

90.1KPH, 15 DEGREE ANGLE, 35% OVERLAP

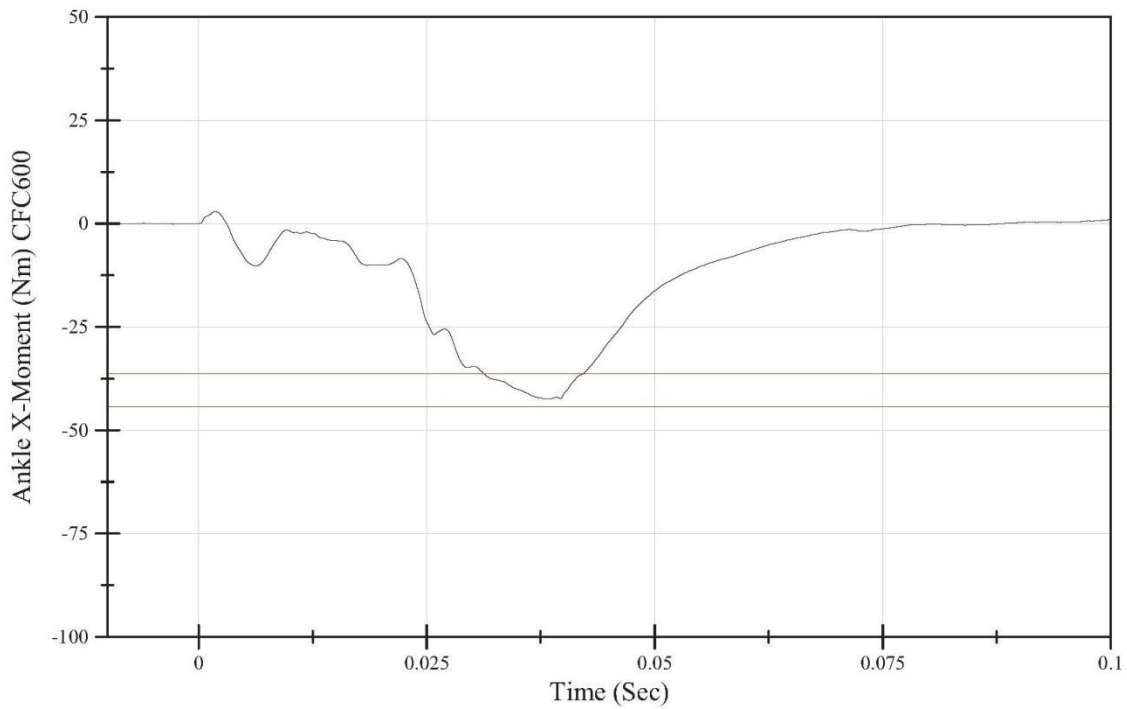
THOR Left Foot Inversion Certification
Ankle Moment
Serial Number: LX0019

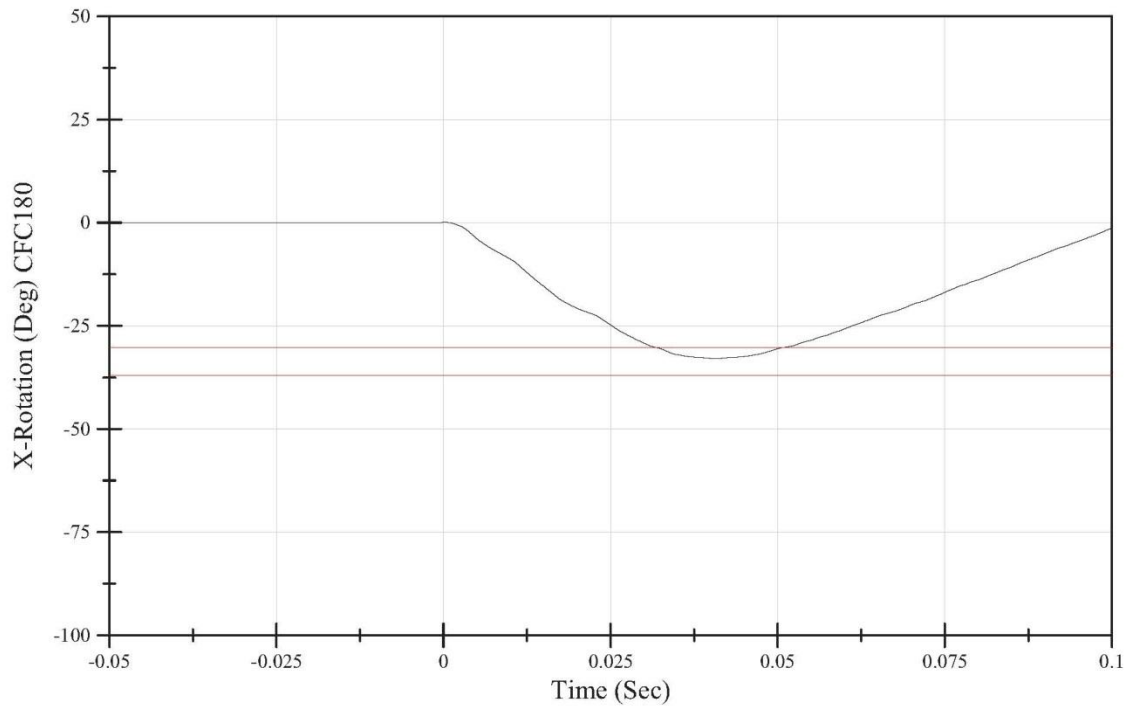
THOR Left Foot Inversion Certification
Ankle X-Rotation
Serial Number: LX0019

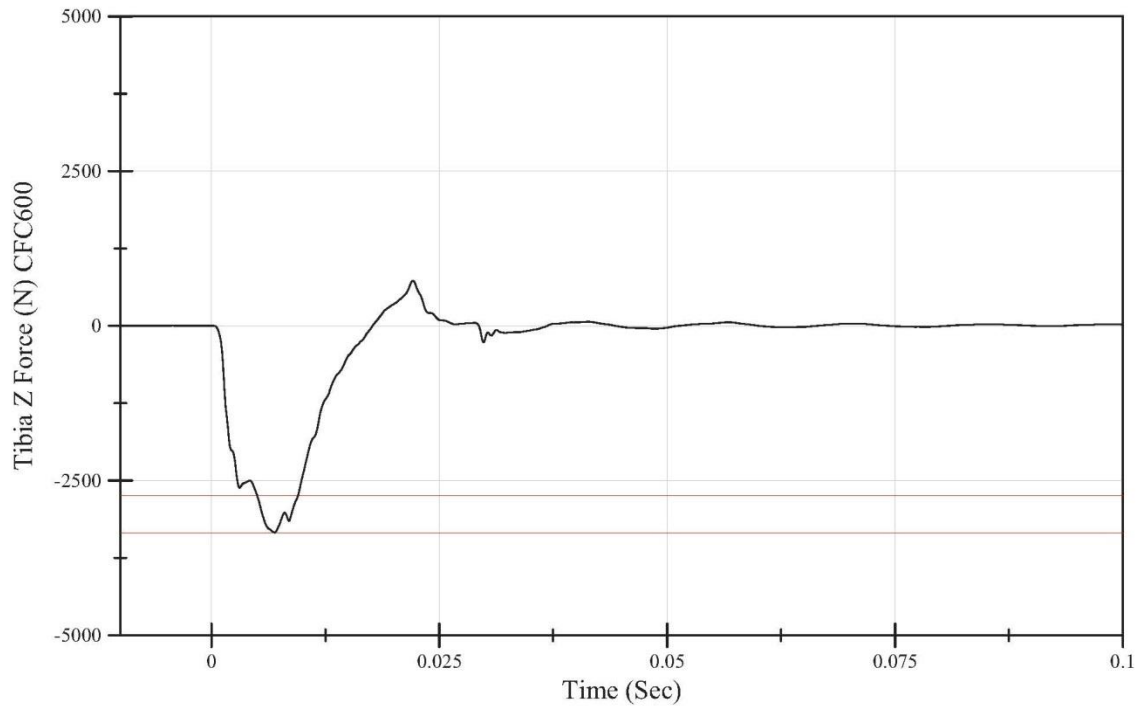
THOR Right Foot Heel Certification
Tibia Load
Serial Number: LX0018

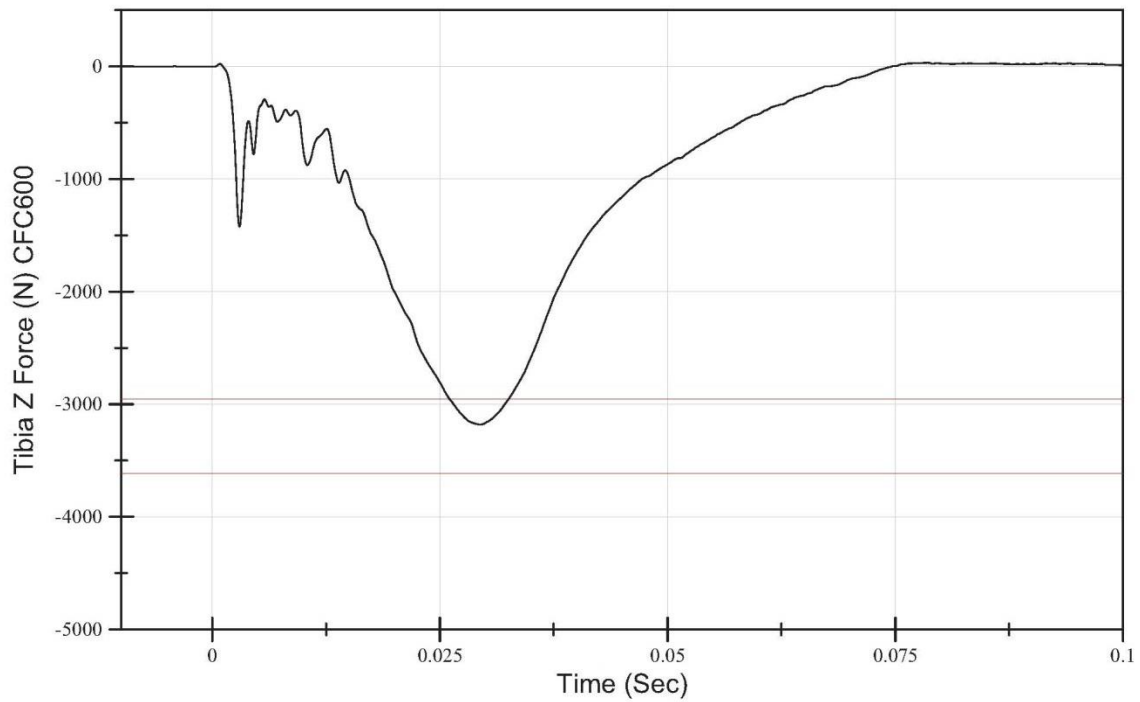
THOR Right Foot Dorsiflexion Certification
Tibia Load
Serial Number: LX0018

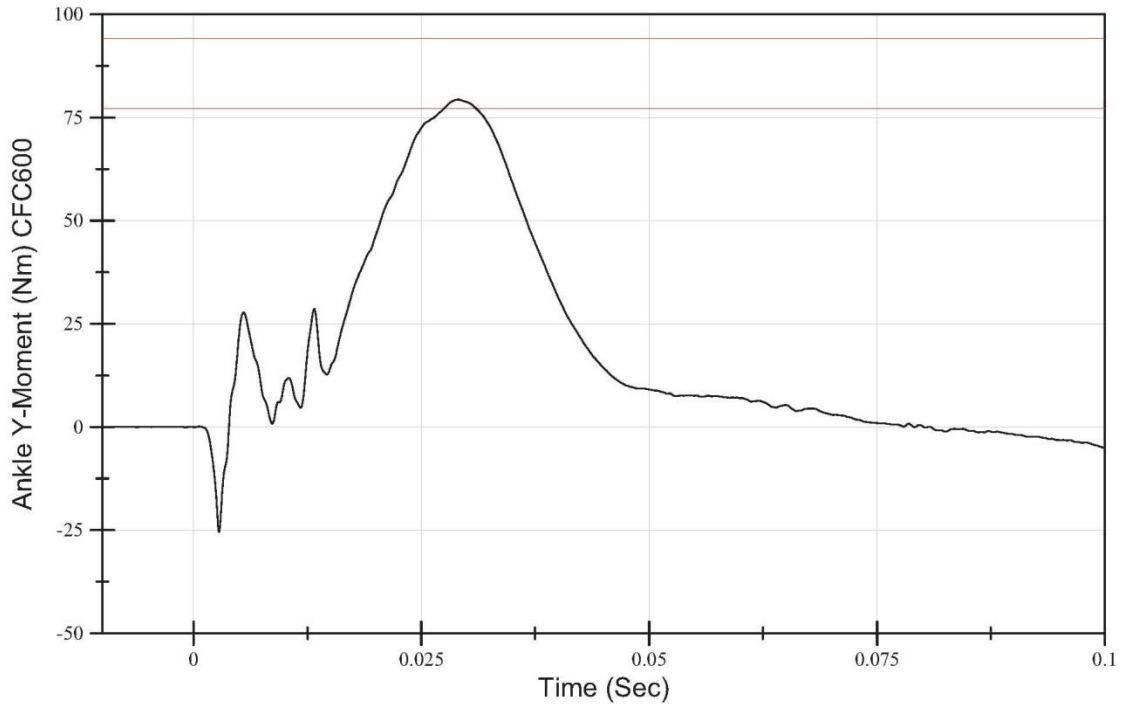
THOR Right Foot Dorsiflexion Certification
Ankle Y-Moment
Serial Number: LX0018

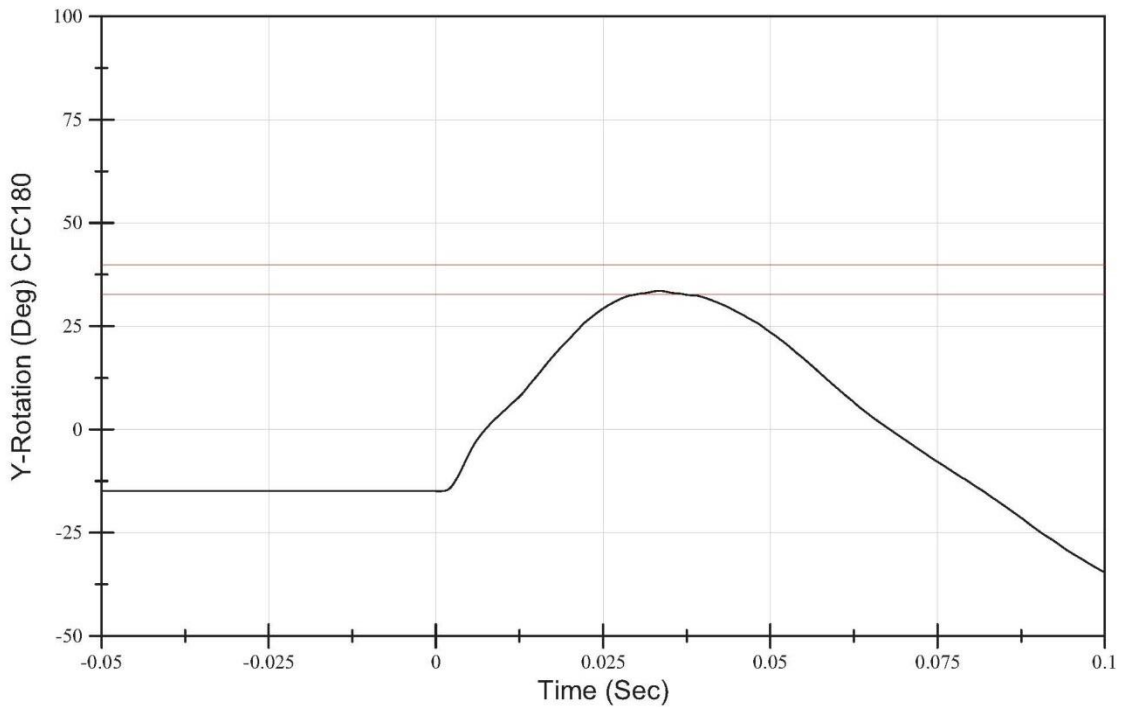
THOR Right Foot Dorsiflexion Certification
Ankle Y-Rotation
Serial Number: LX0018

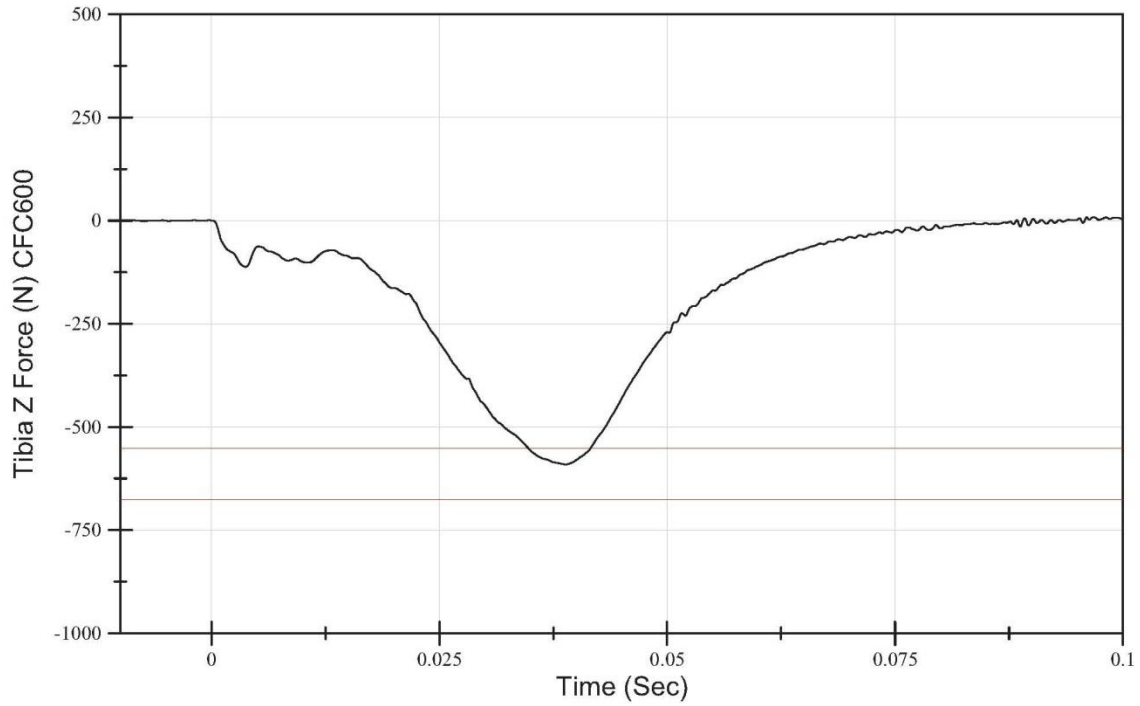
THOR Right Foot Eversion Certification
Tibia Load
Serial Number: LX0018

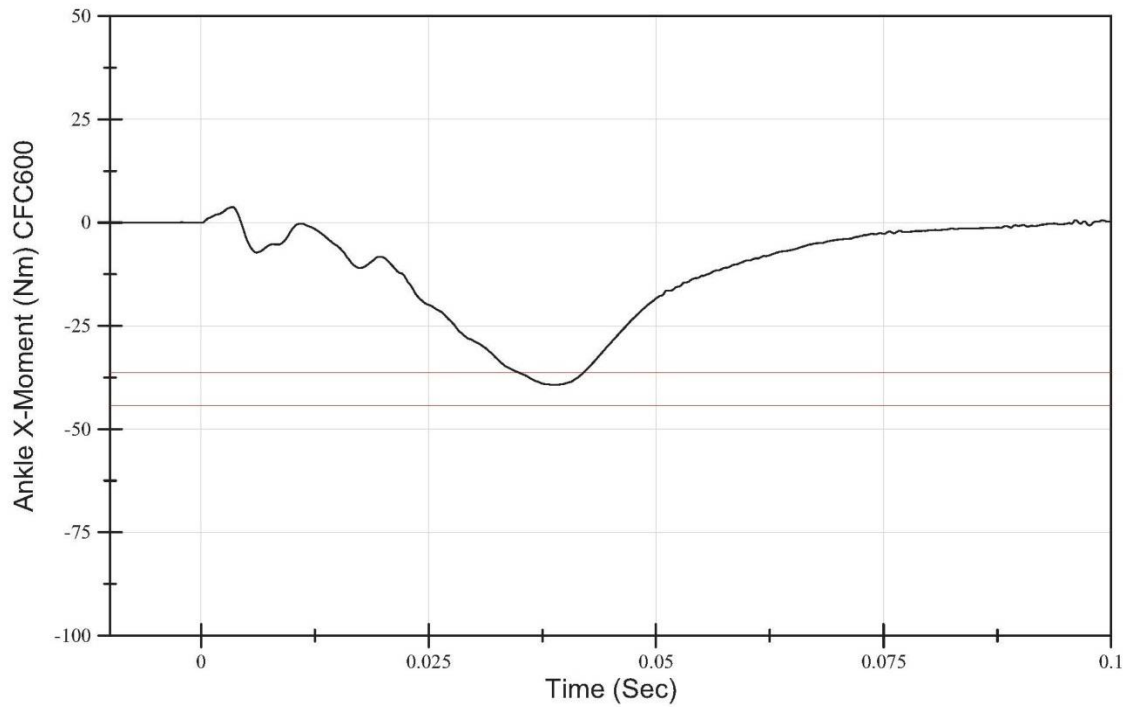
THOR Right Foot Eversion Certification
Ankle Moment
Serial Number: LX0018

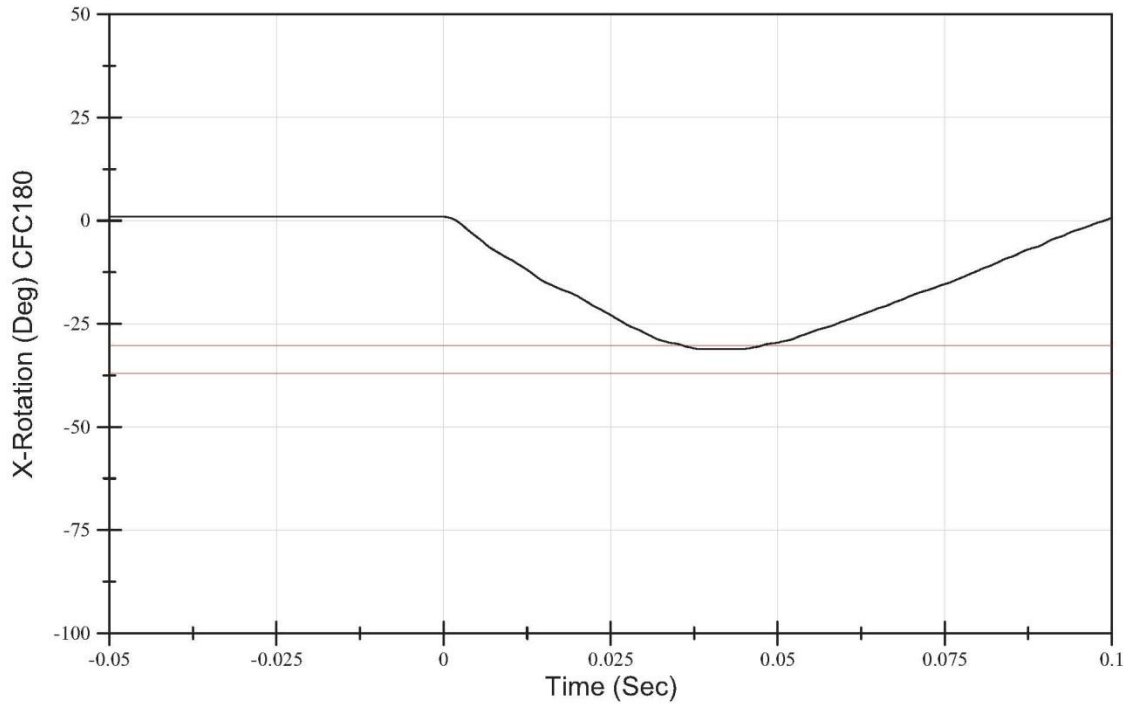
THOR Right Foot Eversion Certification
Ankle X-Rotation
Serial Number: LX0018

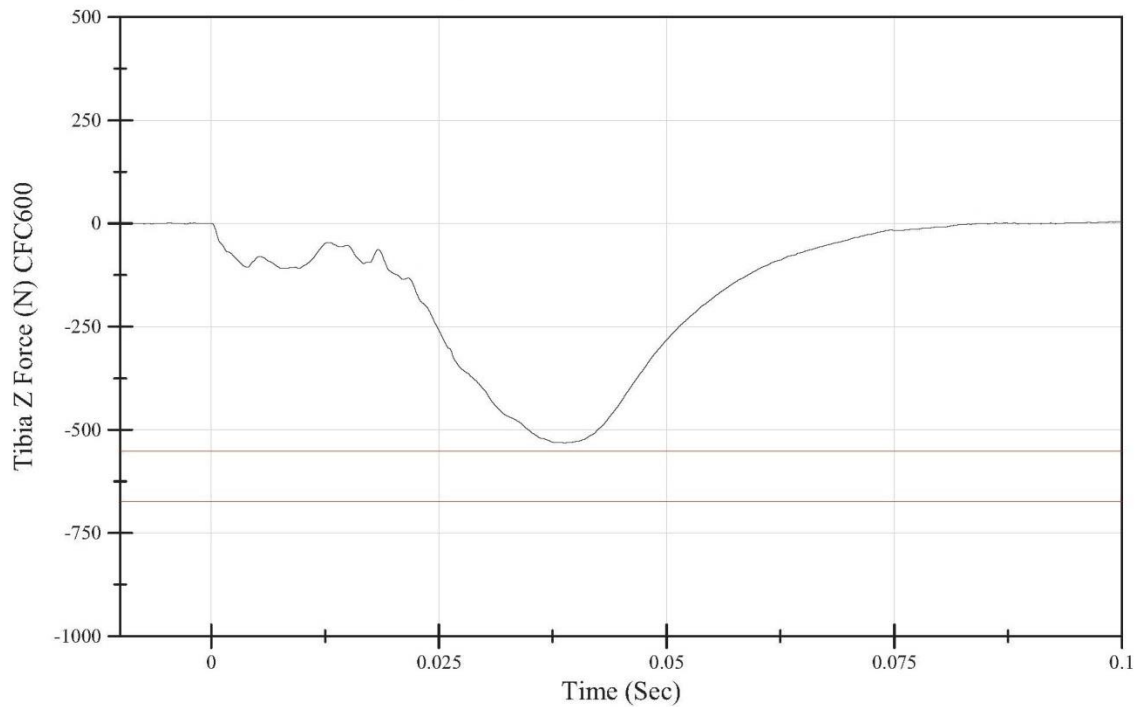
THOR Right Foot Inversion Certification
Tibia Load
Serial Number: LX0018

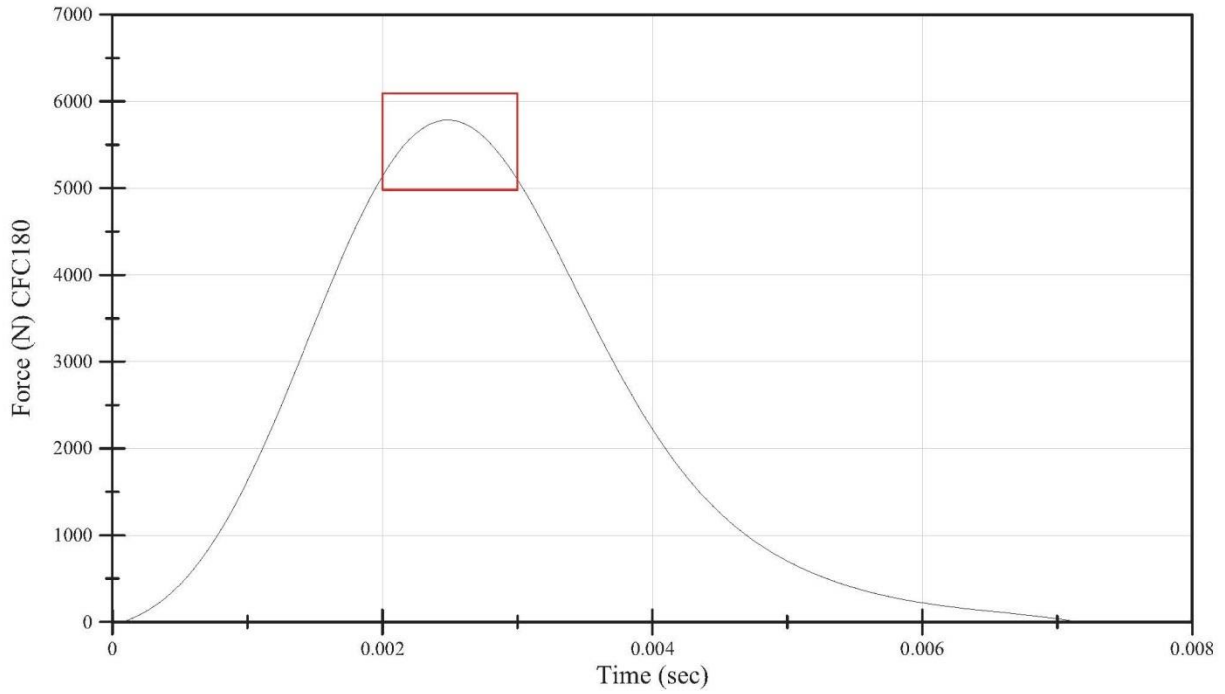
THOR Head Impact Certification
Probe Force
Serial Number: T015

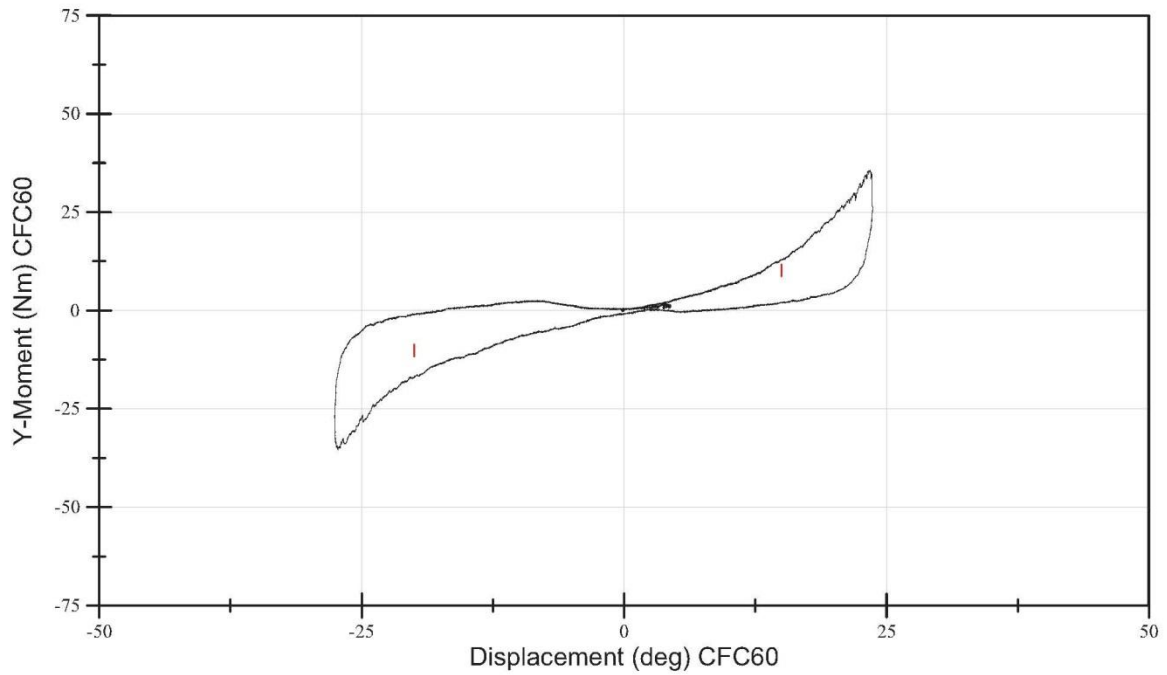
THOR Occipital Condyle Quasi-Static Certification
Displacement vs. Torque
Serial Number: T015

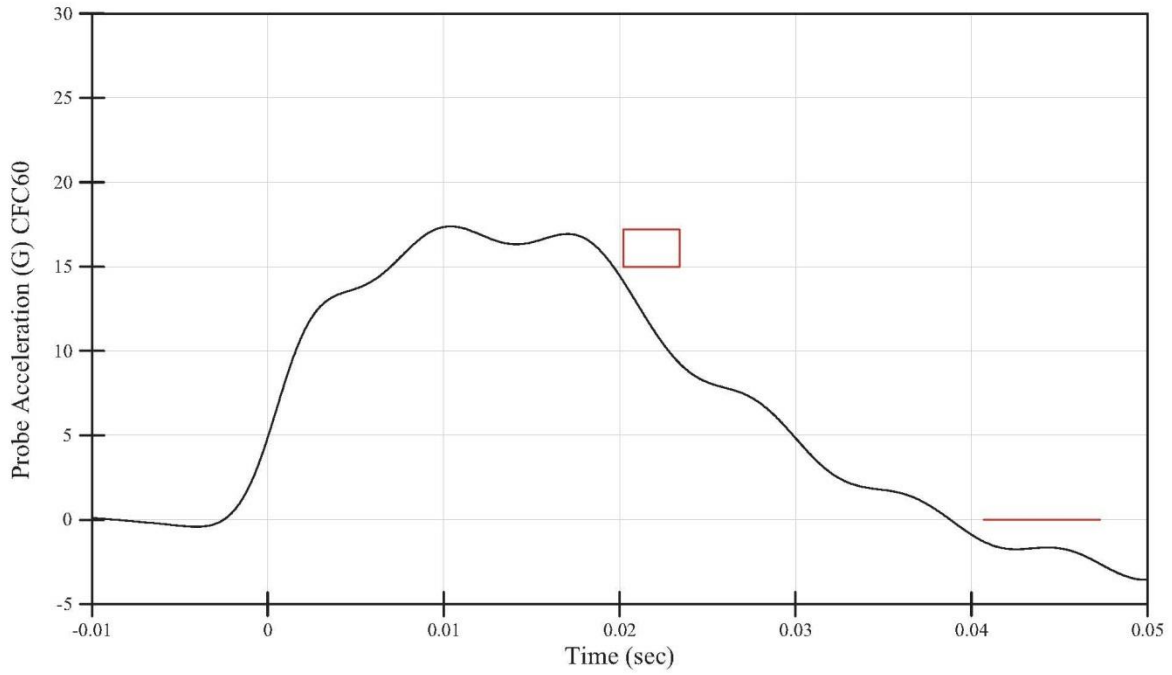
THOR Neck Left Lateral Flexion Certification
Probe Acceleration
Serial Number: T015

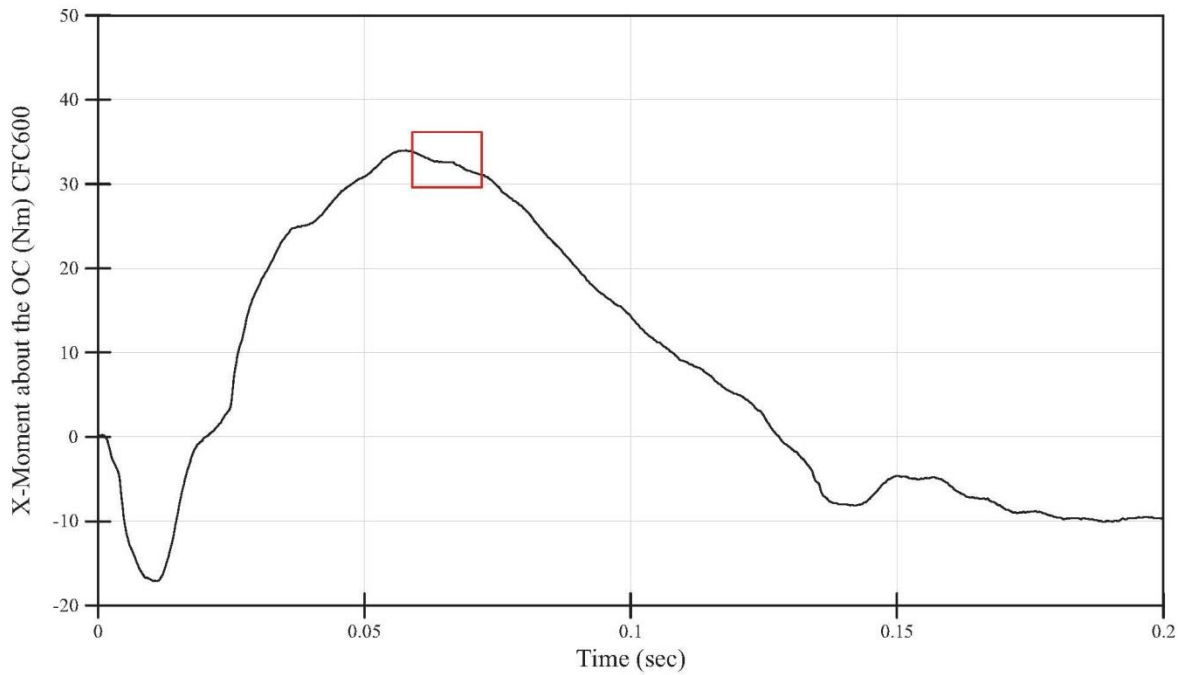
THOR Neck Left Lateral Flexion Certification
X-Moment
Serial Number: T015

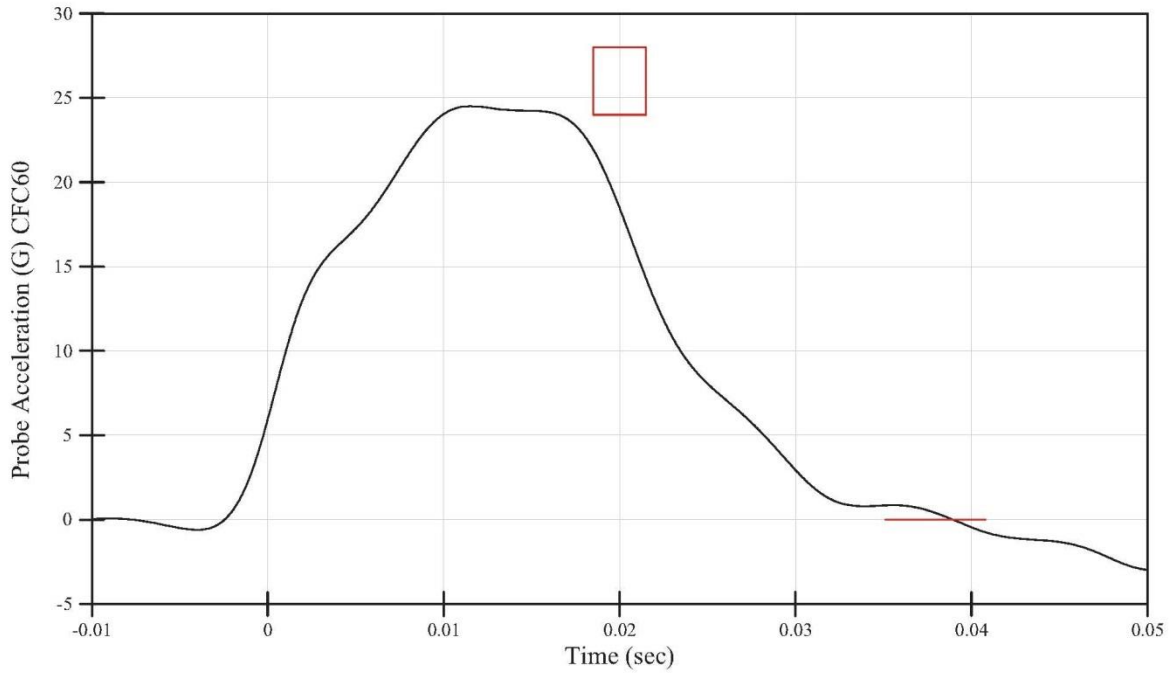
THOR Neck Flexion Certification
Probe Acceleration
Serial Number: T015

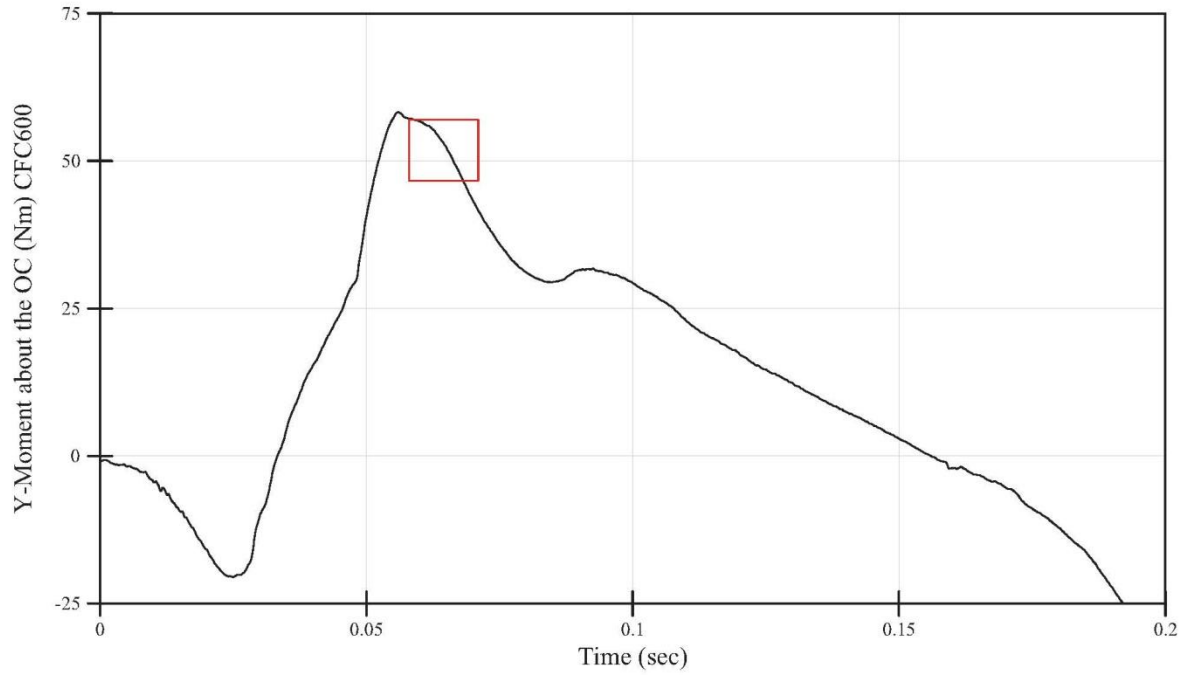
THOR Neck Flexion Certification
Y-Moment
Serial Number: T015

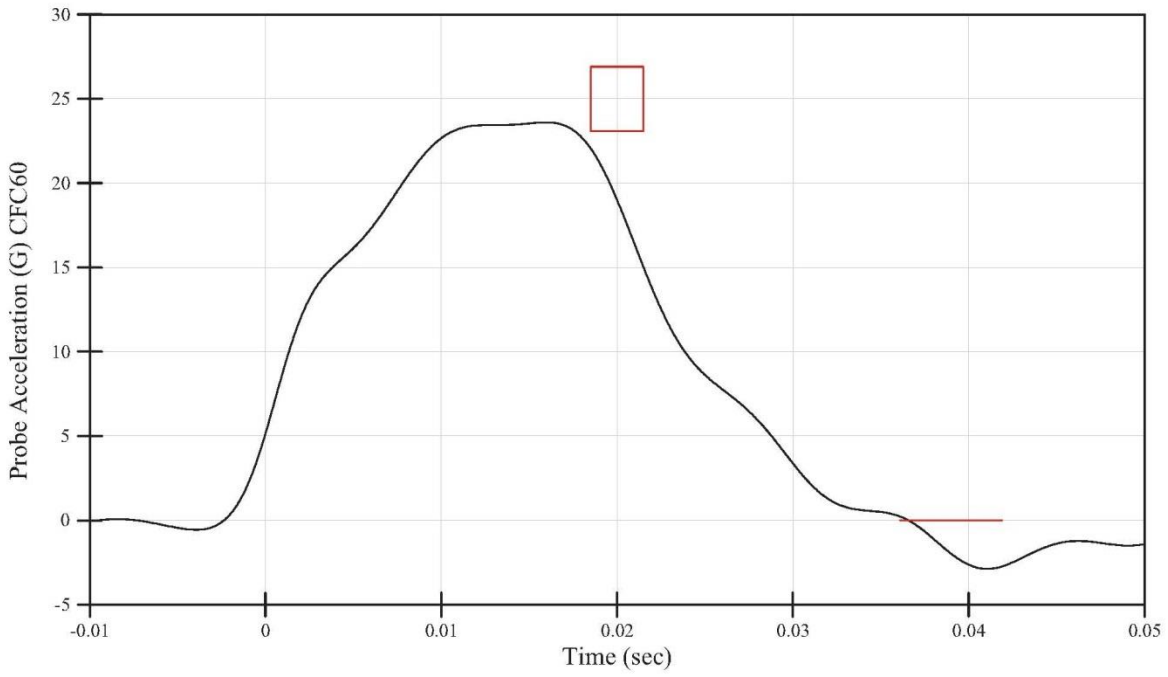
THOR Neck Extension Certification
Probe Acceleration
Serial Number: T015

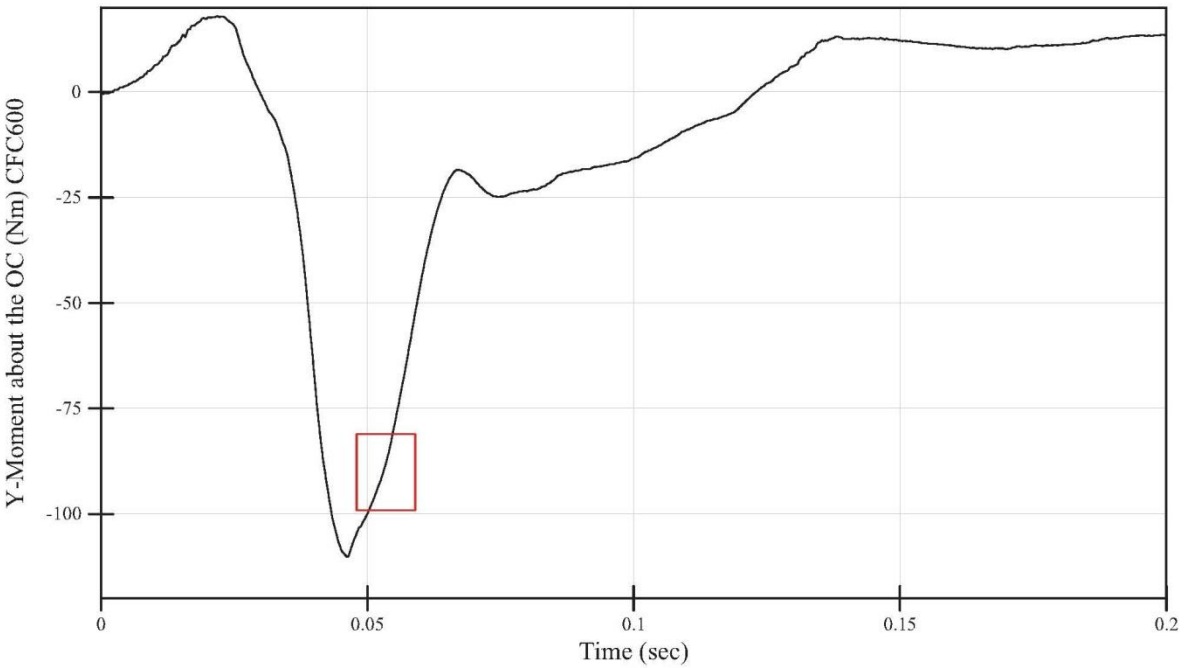
THOR Neck Extension Certification
Y-Moment
Serial Number: T015

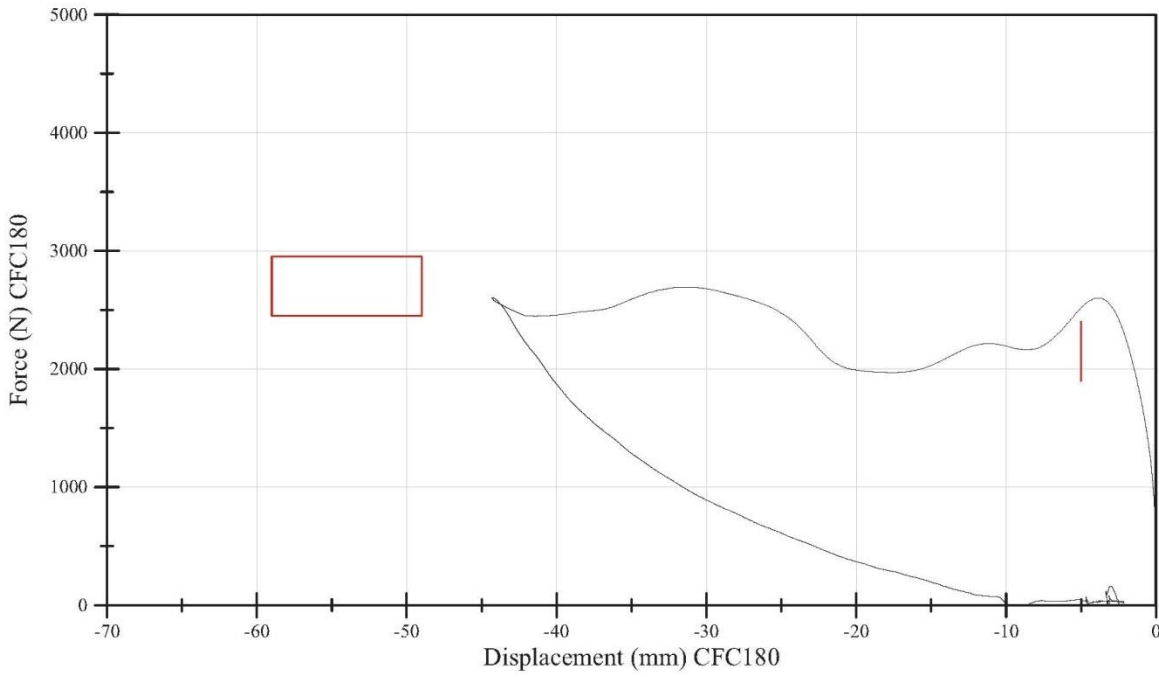
THOR Upper Thorax Certification
Thorax Displacement vs. Probe Force
Serial Number: T015

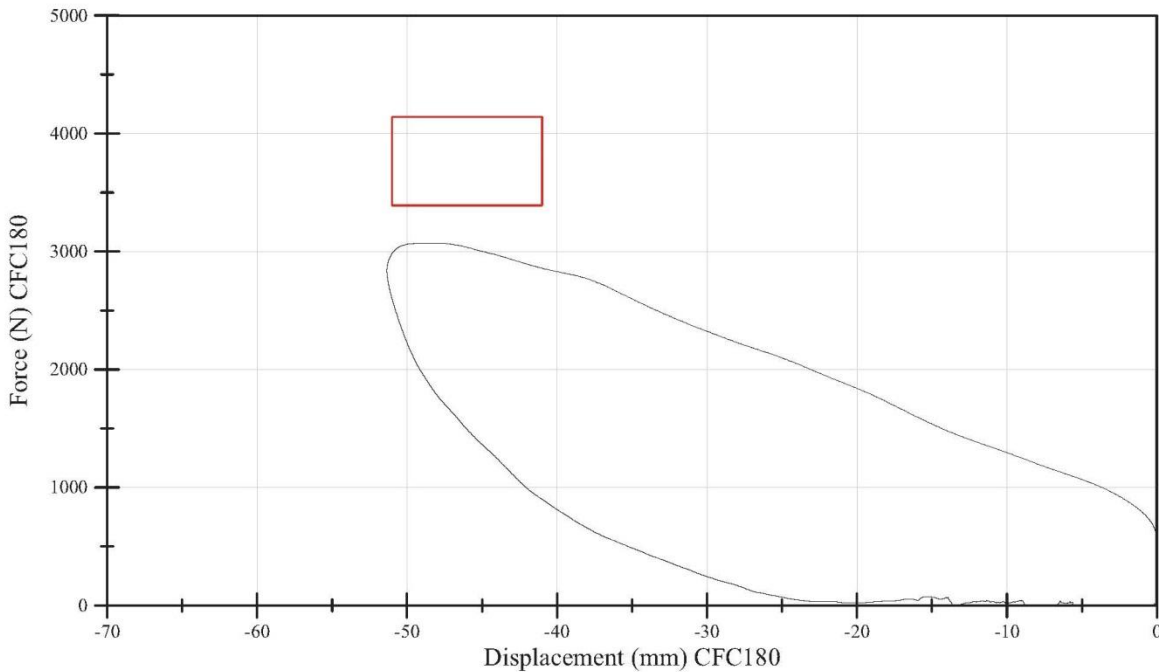
THOR Lower Left Oblique Thorax Certification
Thorax Displacement vs. Probe Force
Serial Number: T015

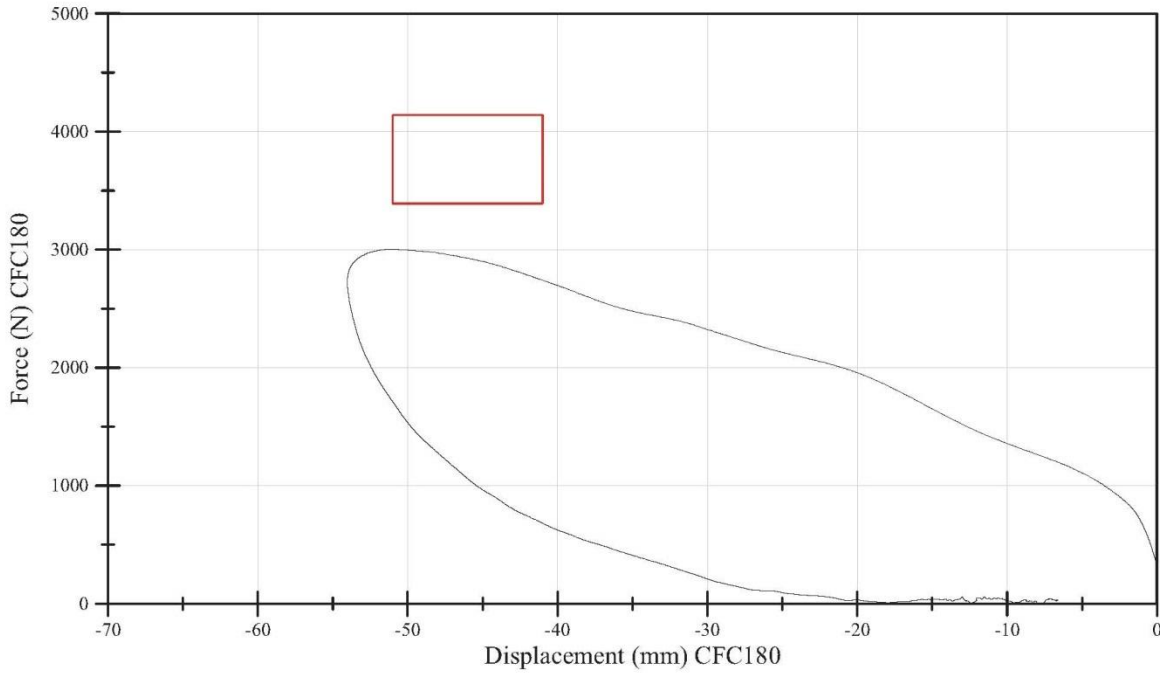
THOR Lower Right Oblique Thorax Certification
Thorax Displacement vs. Probe Force
Serial Number: T015

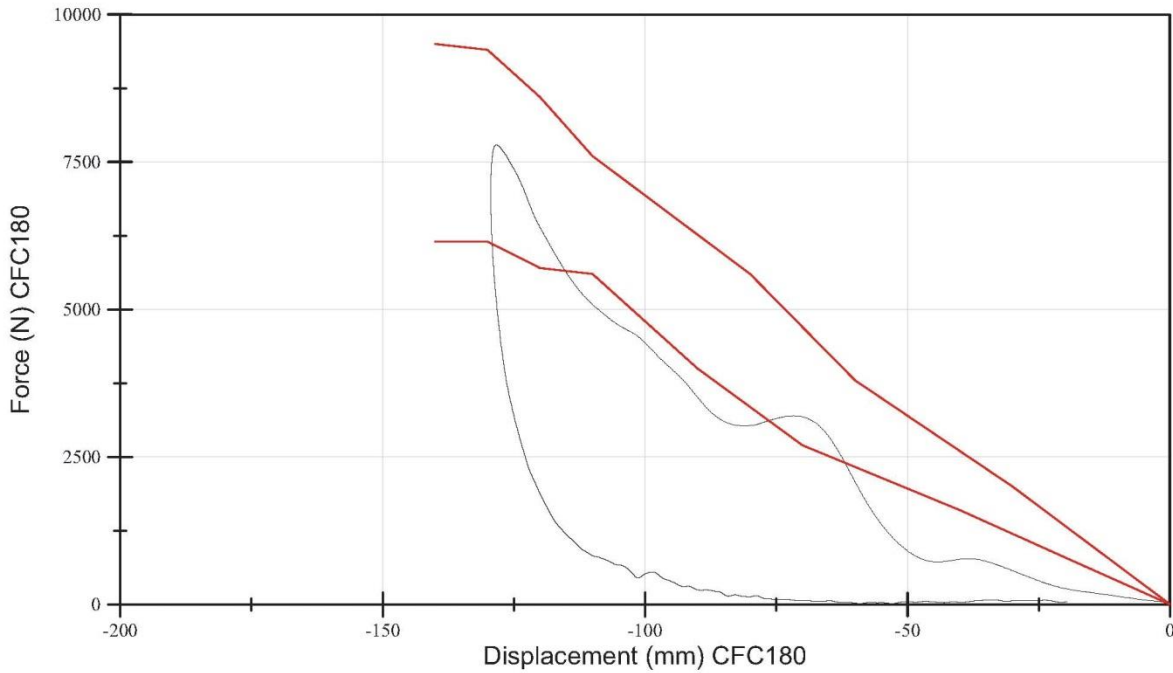
THOR Upper Abdomen Certification
Abdomen Displacement vs. Probe Force
Serial Number: T015

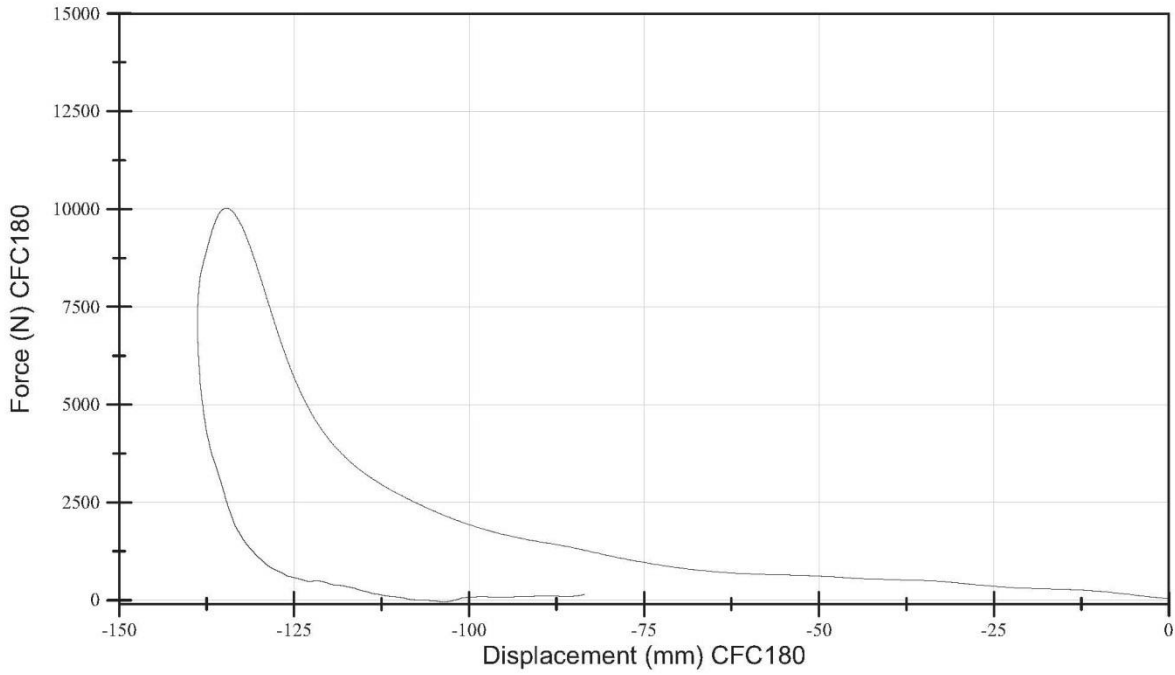
THOR Lower Abdomen Certification
Lower Abdomen Deflection (via PENXG and T12XG) vs. Probe Force
Serial Number: 015

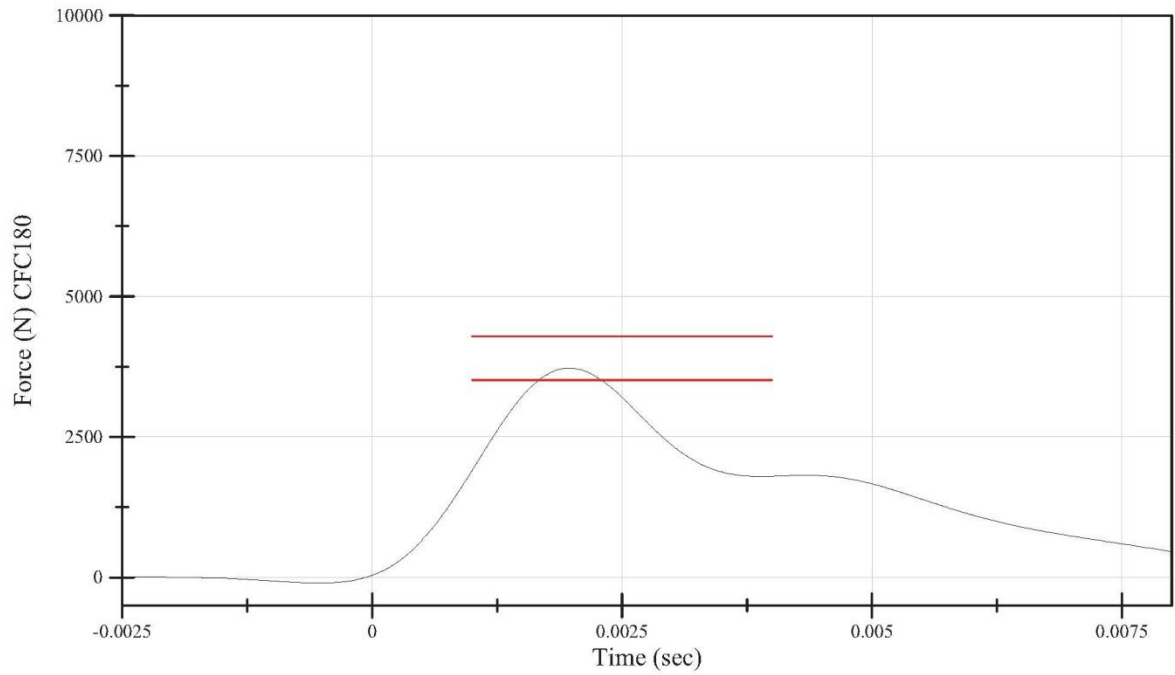
THOR Left Femur Certification
Probe Force
Serial Number: T015

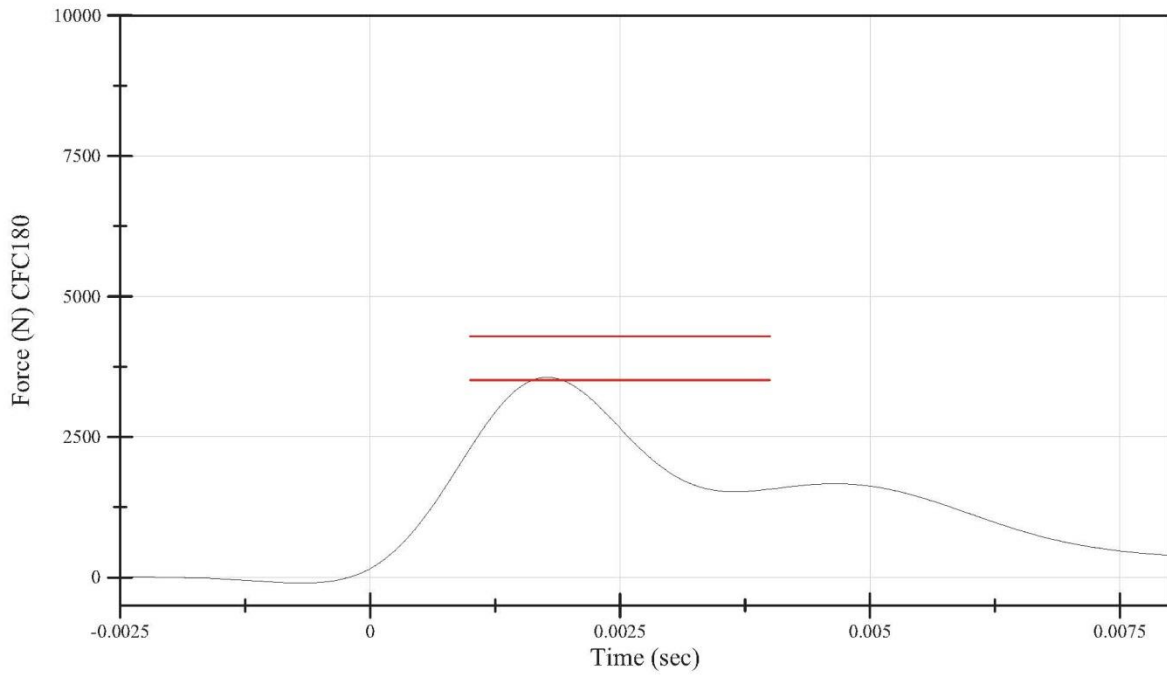
THOR Right Femur Certification
Probe Force
Serial Number: T015

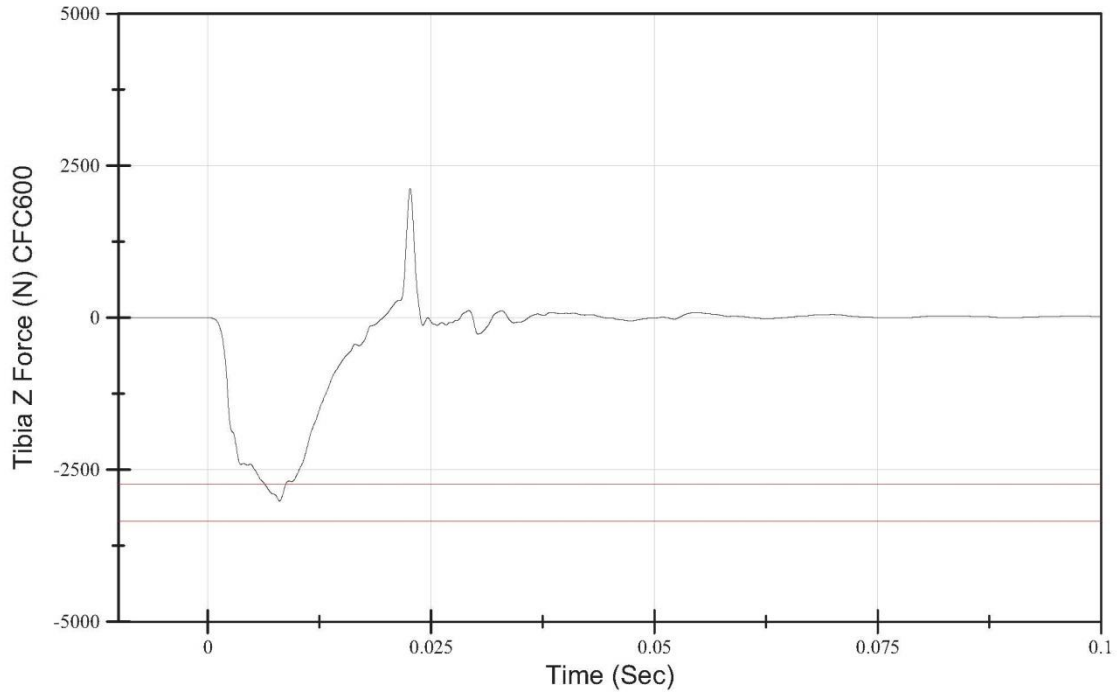
THOR Left Foot Heel Certification
Tibia Load
Serial Number: LX0039

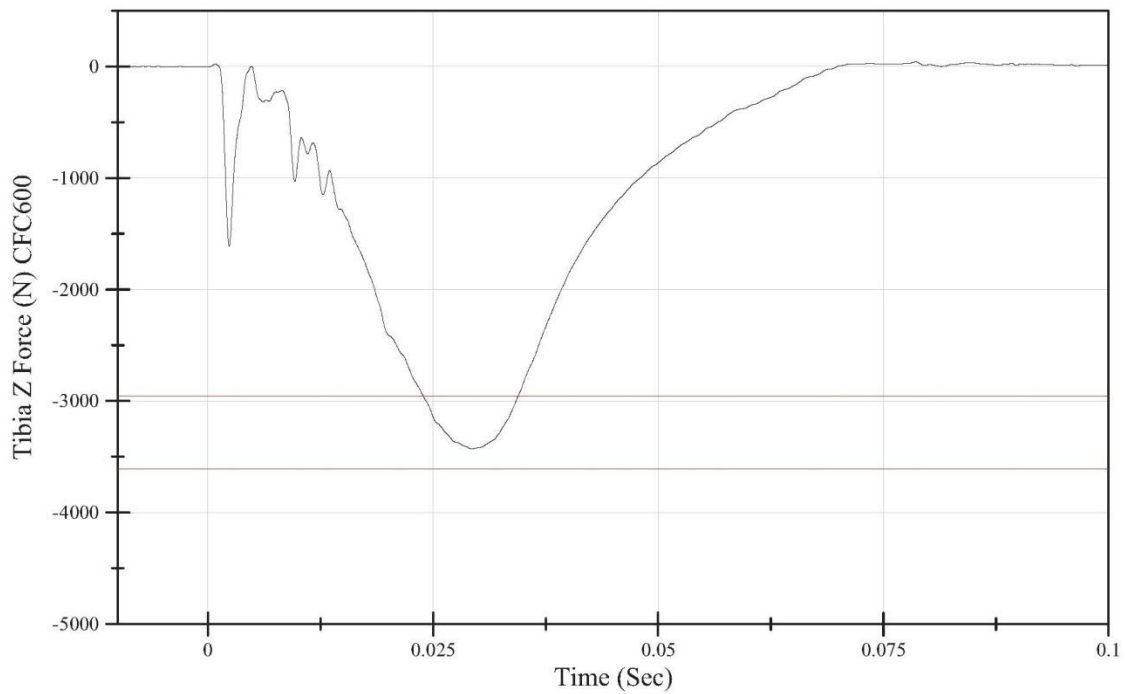
THOR Left Foot Dorsiflexion Certification
Tibia Load
Serial Number: LX0039

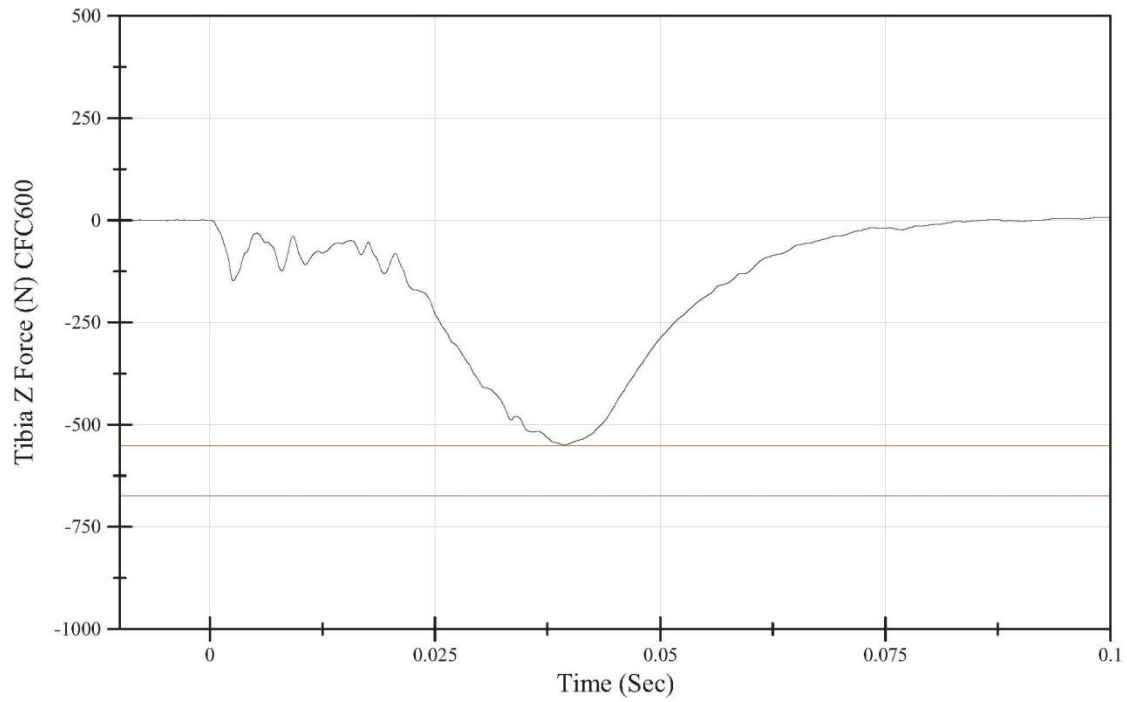
THOR Left Foot Eversion Certification
Tibia Load
Serial Number: LX0039
