REPORT NUMBER: R&D-CAL-13-001

**MOVING BARRIER TO VEHICLE CRASH TEST IN SUPPORT OF NHTSA'S
FRONTAL OBLIQUE OFFSET PROGRAM
RESEARCH MOVING DEFORMABLE BARRIER INTO LEFT FRONT OF A**

2013 DODGE DART

90.1KPH, 15 DEGREE ANGLE, 35% OVERLAP

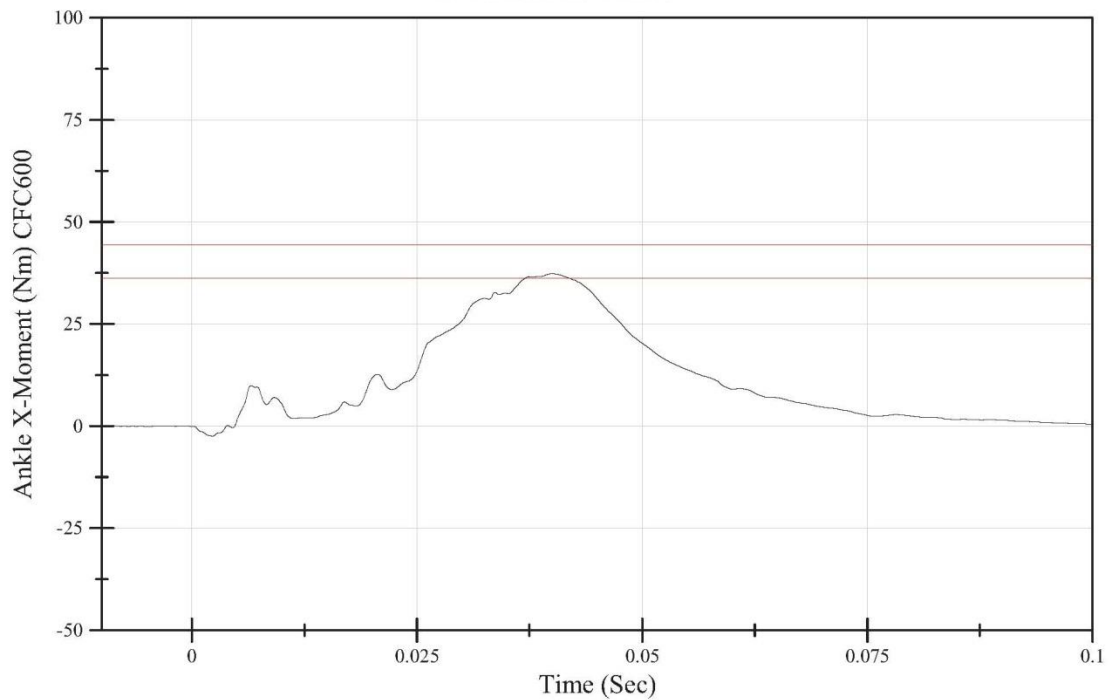
THOR Left Foot Eversion Certification
Ankle Moment
Serial Number: LX0039

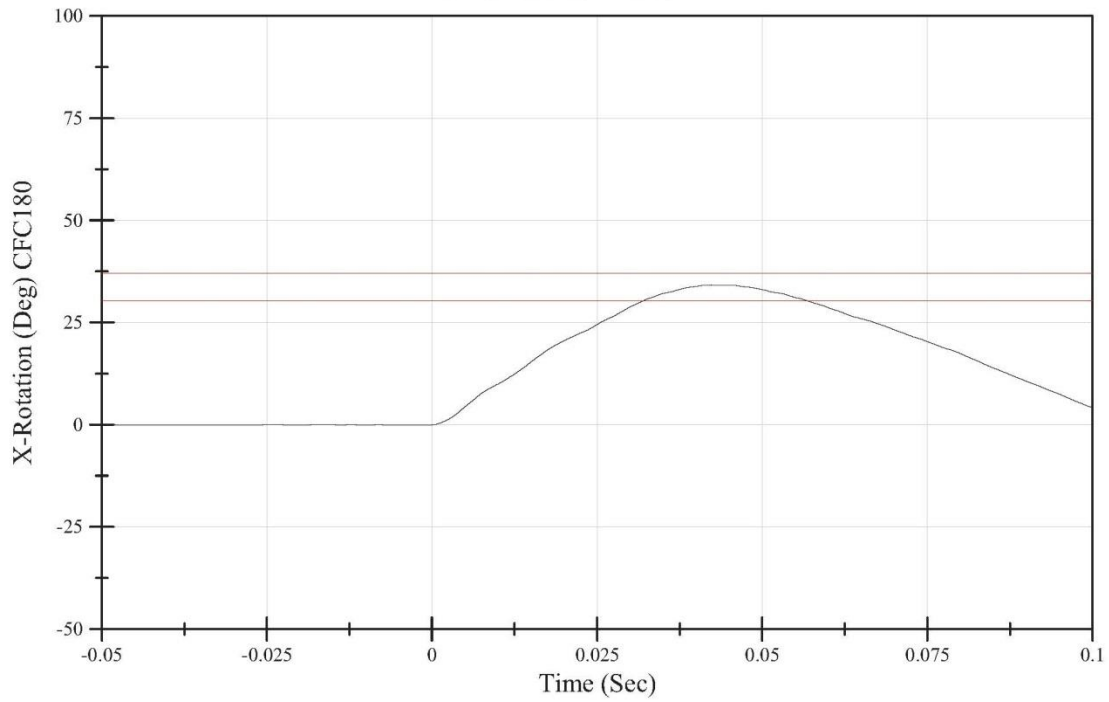
THOR Left Foot Eversion Certification
Ankle X-Rotation
Serial Number: LX0039

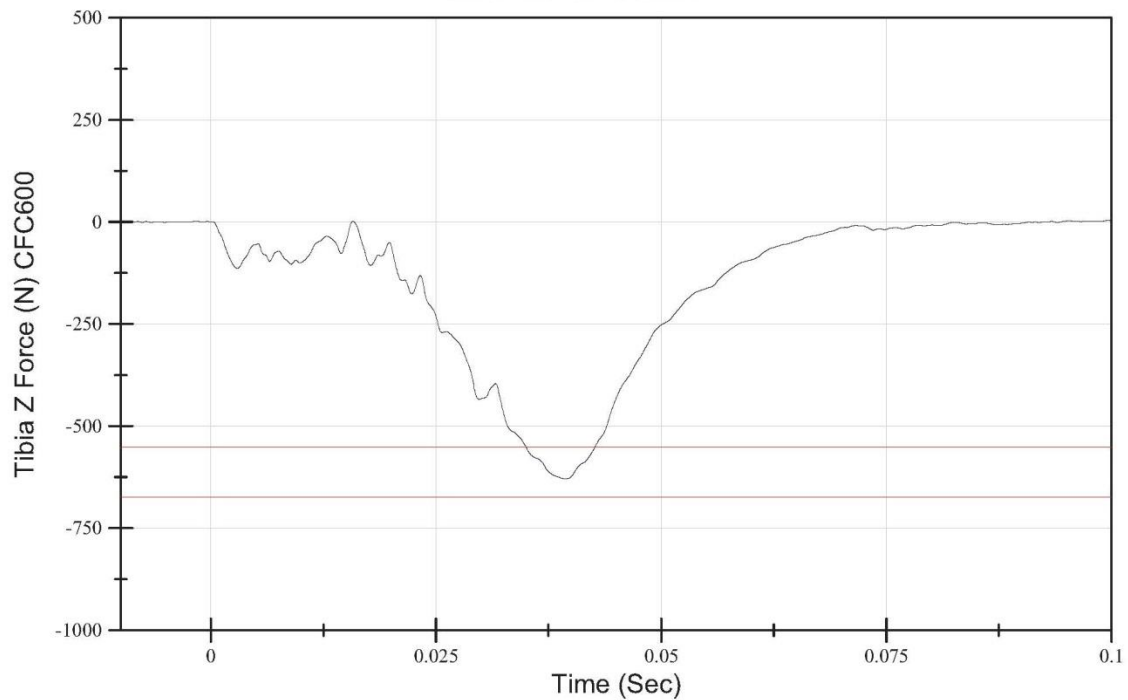
THOR Left Foot Inversion Certification
Tibia Load
Serial Number: LX0039

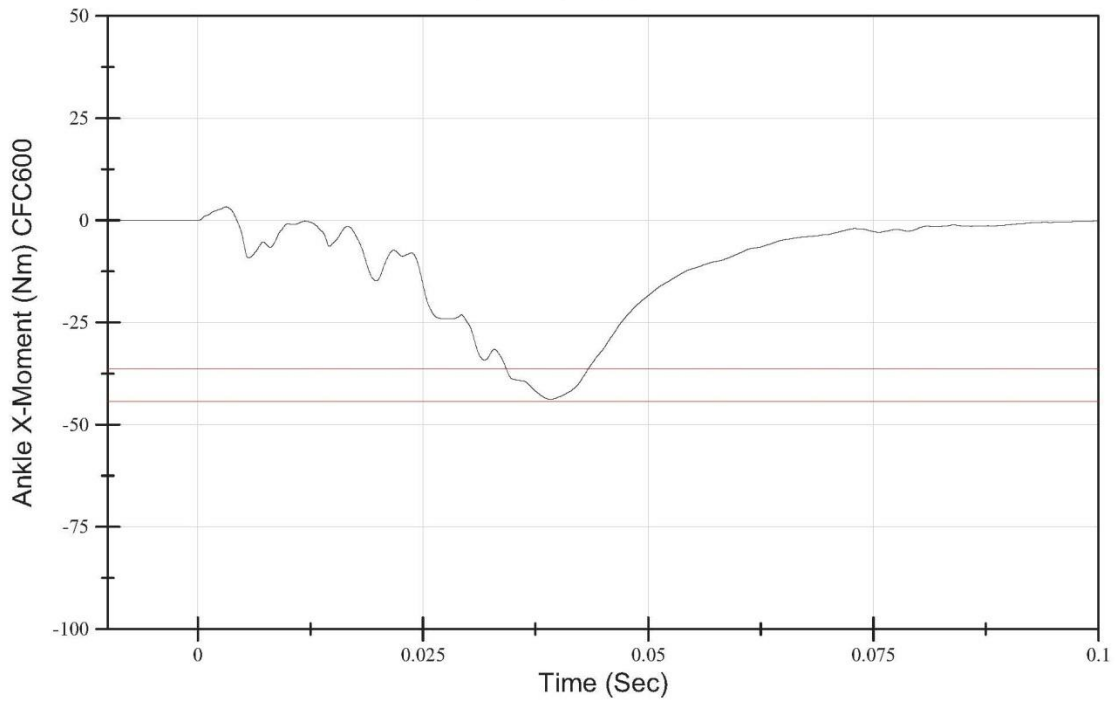
THOR Left Foot Inversion Certification
Ankle Moment
Serial Number: LX0039

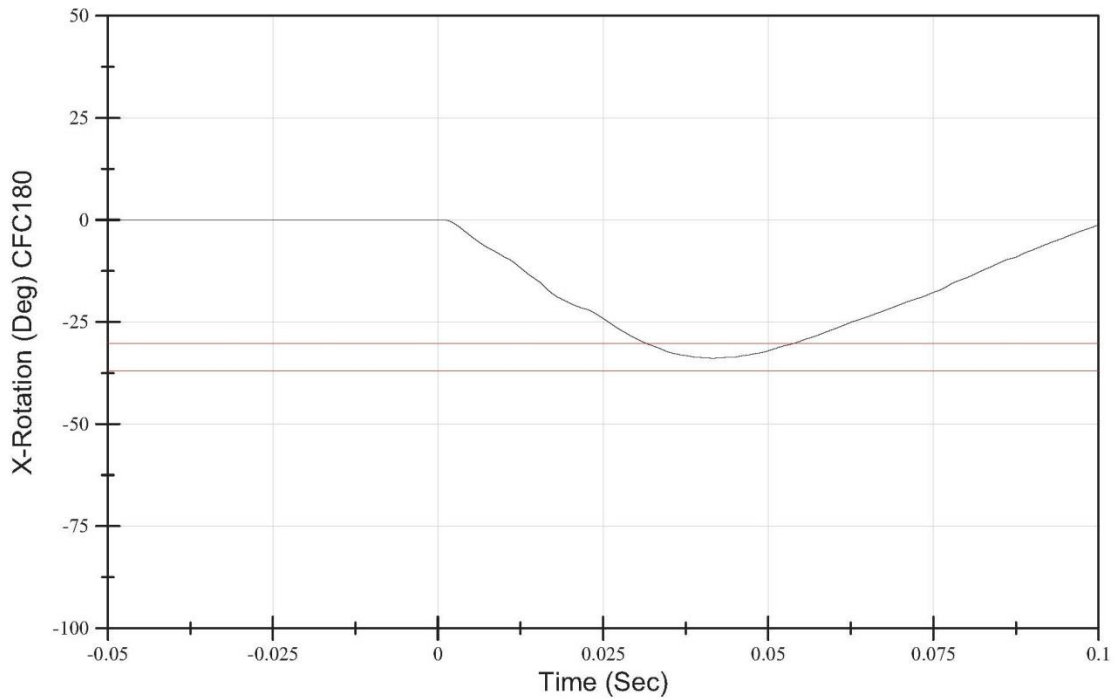
THOR Left Foot Inversion Certification
Ankle X-Rotation
Serial Number: LX0039

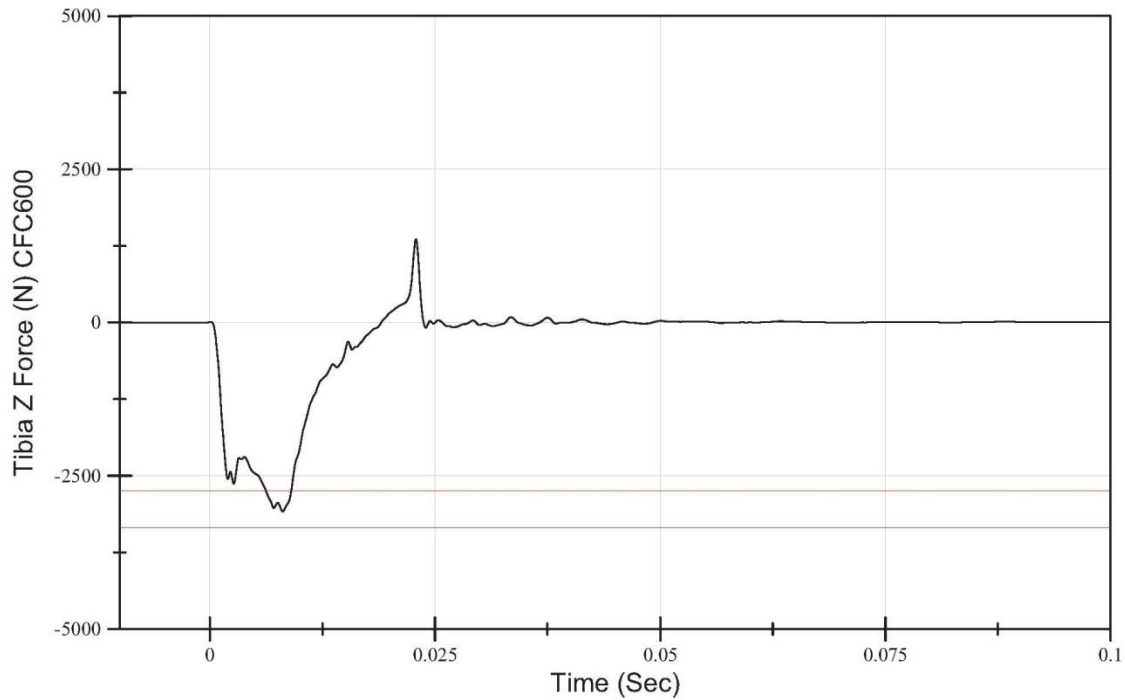
THOR Right Foot Heel Certification
Tibia Load
Serial Number: LX0038

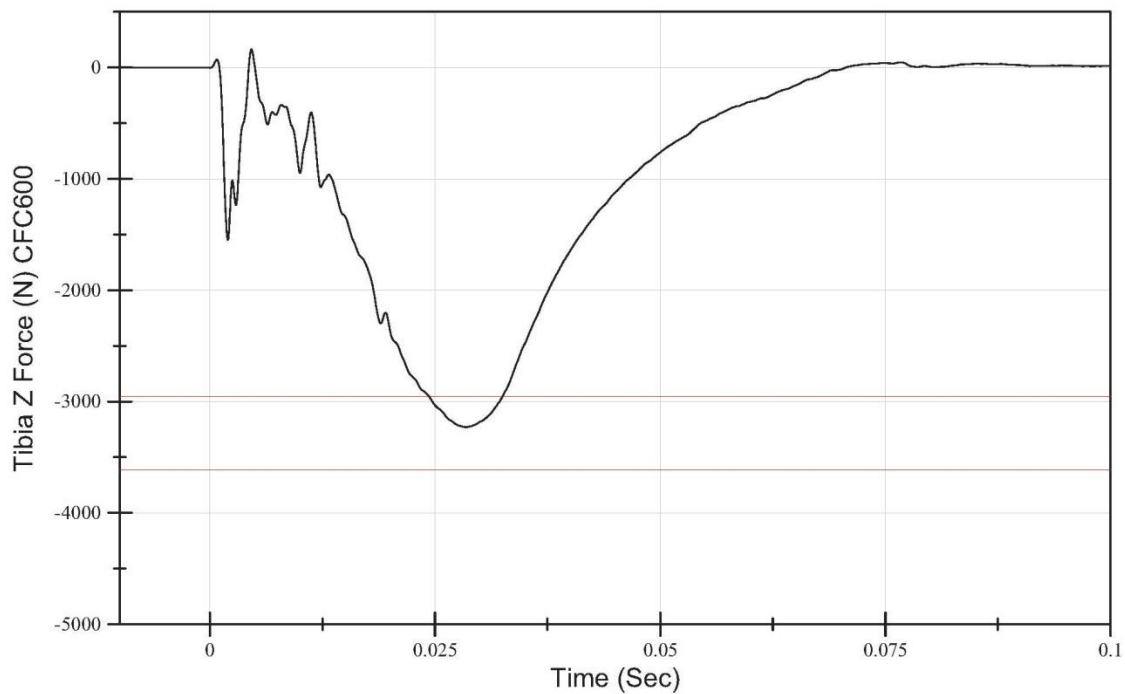
THOR Right Foot Dorsiflexion Certification
Tibia Load
Serial Number: LX0038

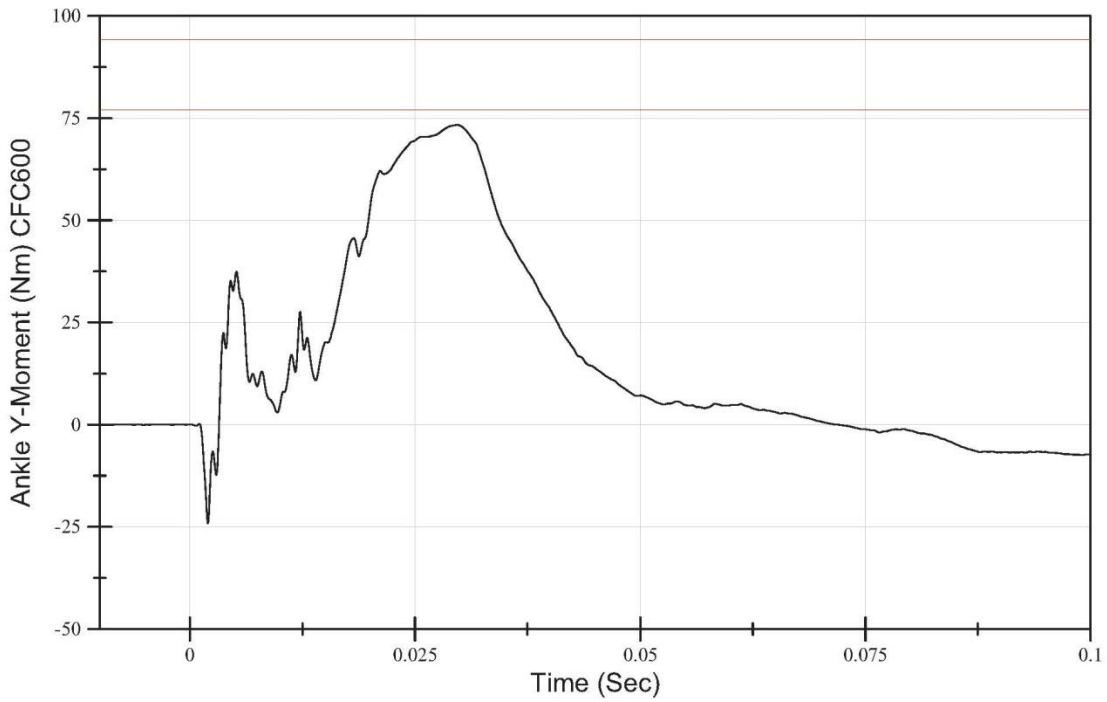
THOR Right Foot Dorsiflexion Certification
Ankle Y-Moment
Serial Number: LX0038

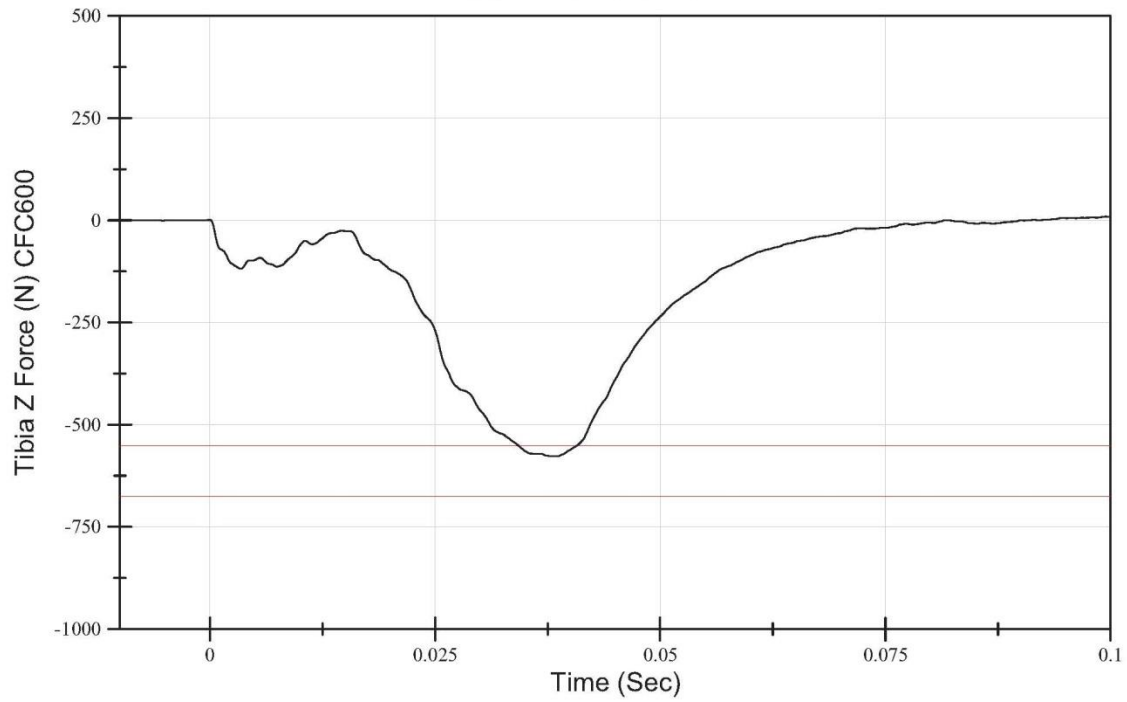
THOR Right Foot Eversion Certification
Tibia Load
Serial Number: LX0038

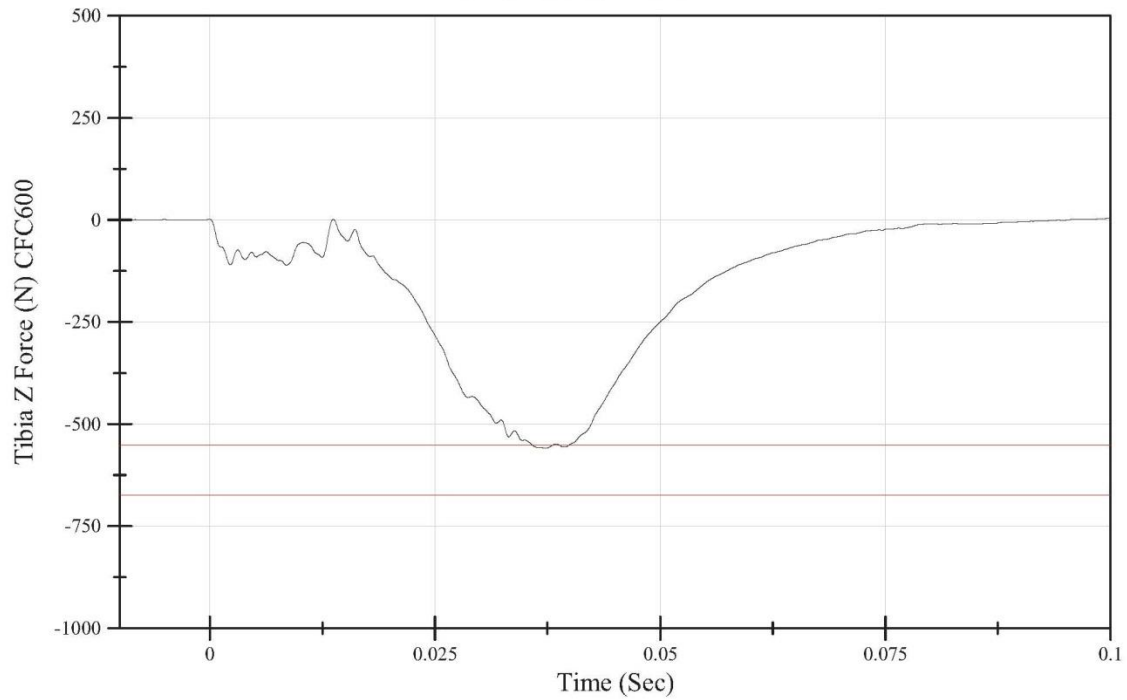
THOR Right Foot Inversion Certification
Tibia Load
Serial Number: LX0038

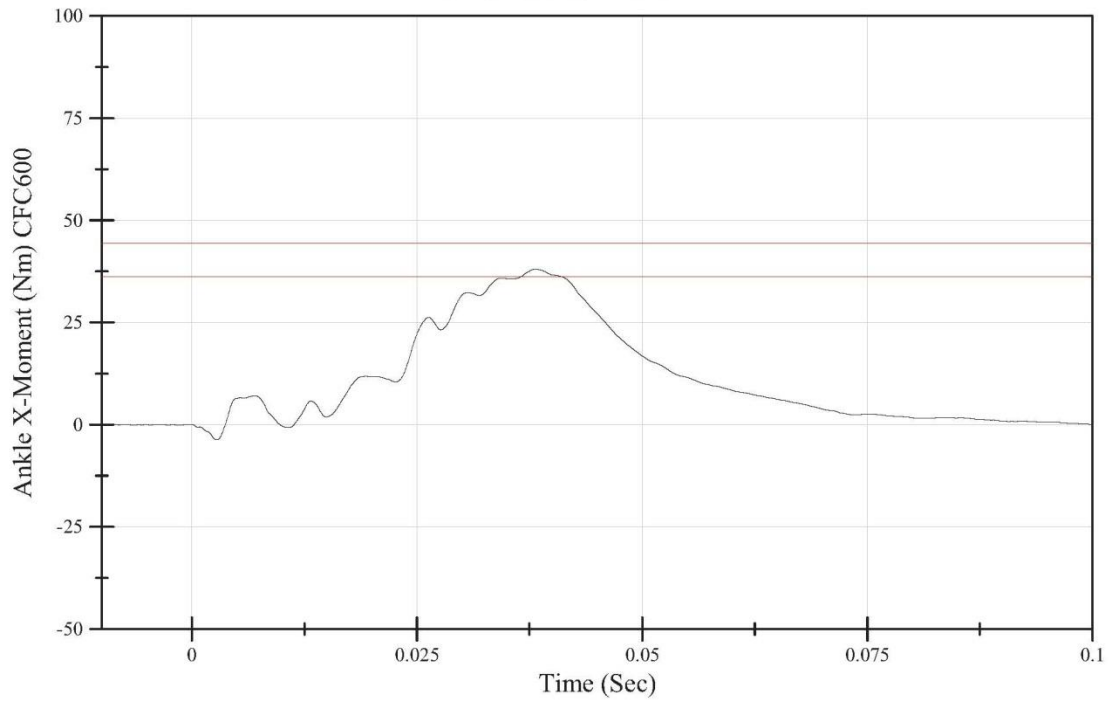
THOR Right Foot Inversion Certification
Ankle Moment
Serial Number: LX0038

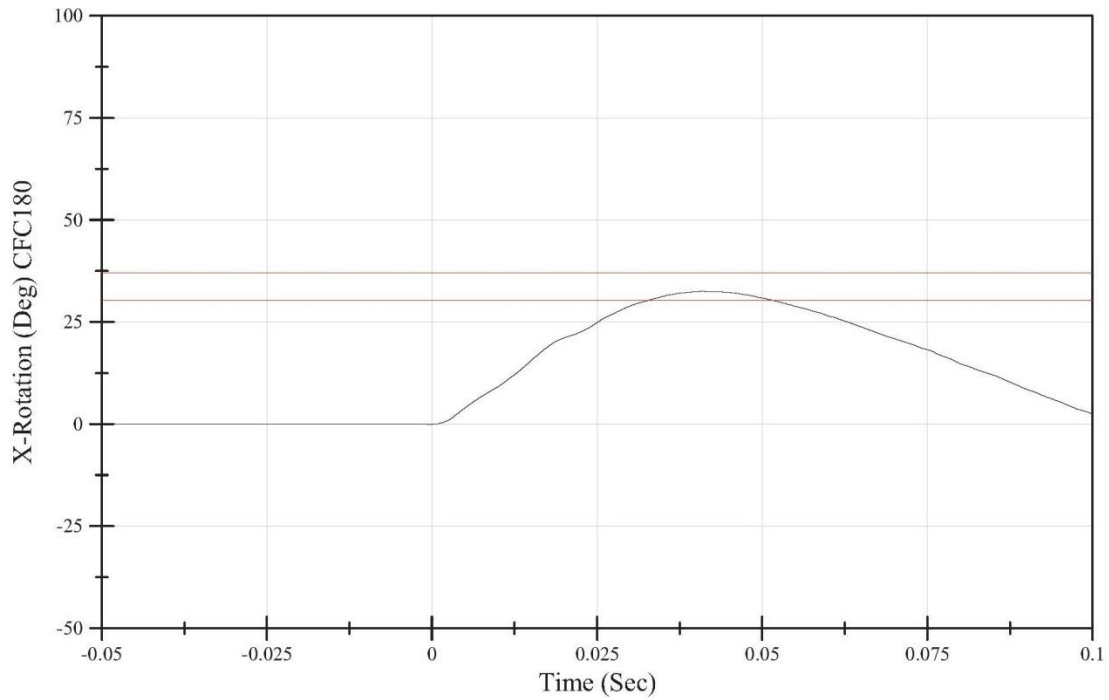
THOR Right Foot Inversion Certification
Ankle X-Rotation
Serial Number: LX0038

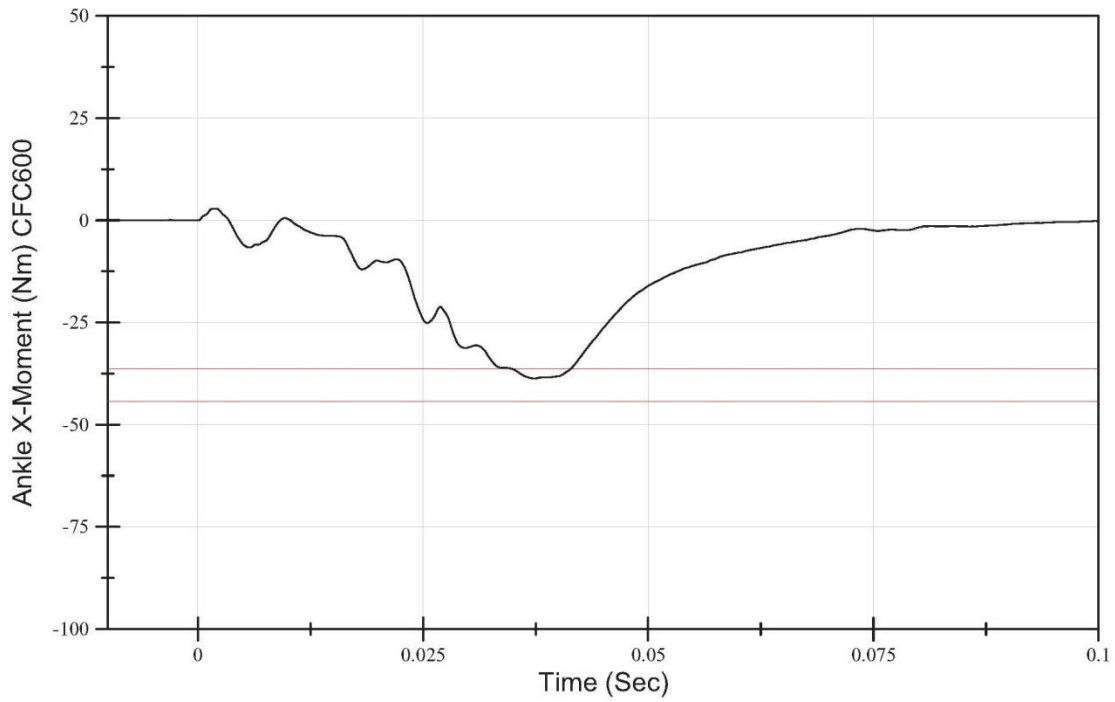
THOR Right Foot Eversion Certification
Ankle Moment
Serial Number: LX0038

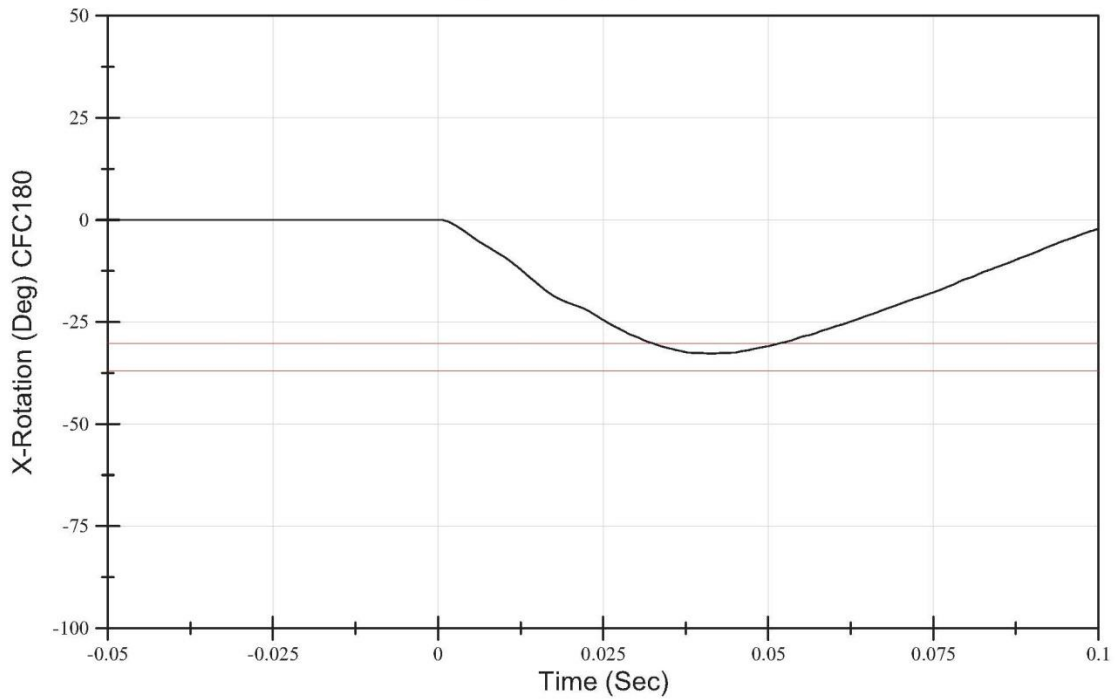
THOR Right Foot Eversion Certification
Ankle X-Rotation
Serial Number: LX0038
