**REPORT NUMBER: R&D-CAL-13-003**

**MOVING BARRIER TO VEHICLE CRASH TEST IN SUPPORT OF NHTSA'S  
FRONTAL OBLIQUE OFFSET PROGRAM  
RESEARCH MOVING DEFORMABLE BARRIER INTO LEFT FRONT OF A**

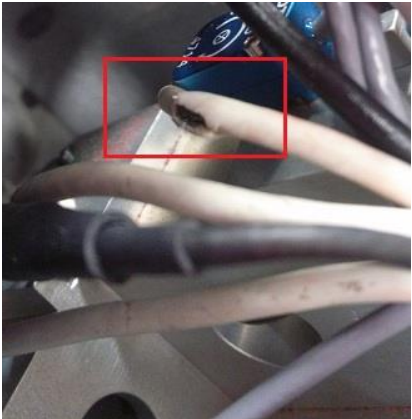
| HEAD | |
|---|---|
| OTHER | <p><b>Fraying of material for zipper at the back of the head</b></p> <p><b>Head CG Y Accelerometer wire damaged</b></p> |

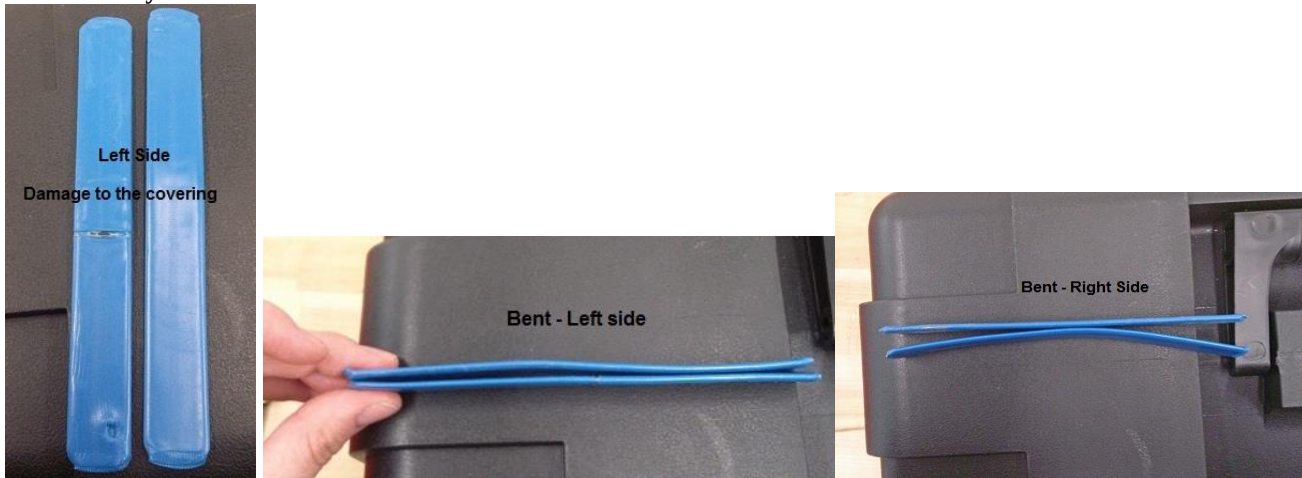
| JACKET | |
|---|---|
| Y / N | <p>Rib stiffeners show no sign of permanent deformation</p> <p><b>One of the left rib stiffeners has damage to the outer coating that goes all the way around, also, the rib stiffeners were severely bent when we received 0015.</b></p> |

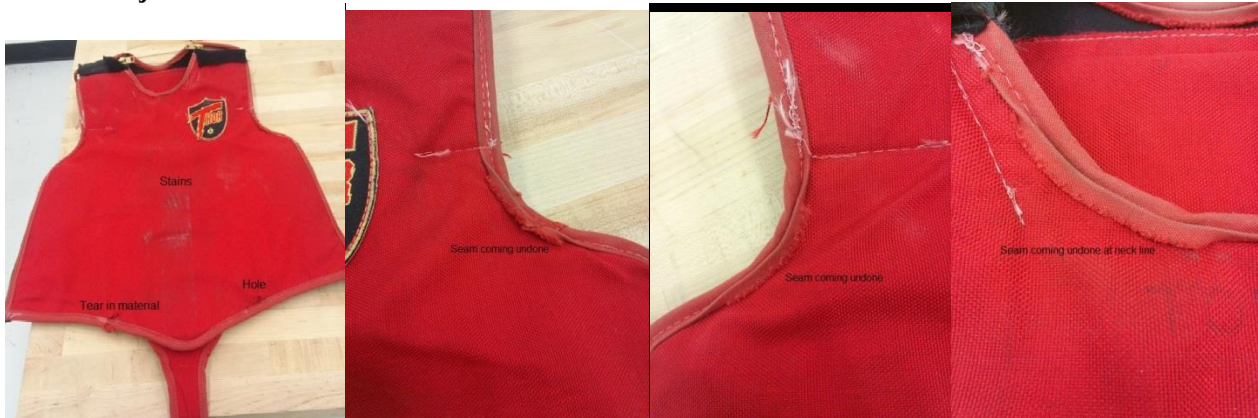
| JACKET | |
|---|---|
| Y / N | <p>No evidence of tears or holes in jacket fabric, Velcro, or zippers</p> <p><b>Many of the seams of the jacket are coming undone, and there is a hole on the bottom left side along with stains all over the jacket.</b></p> |

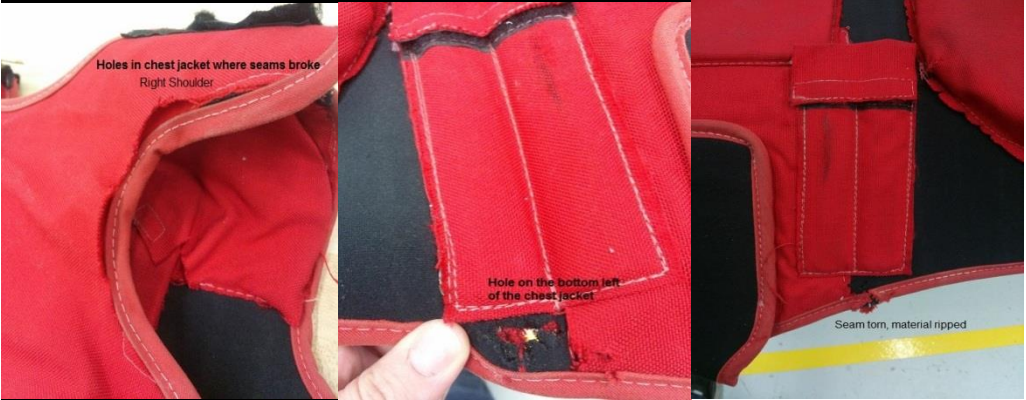
| OTHER | |

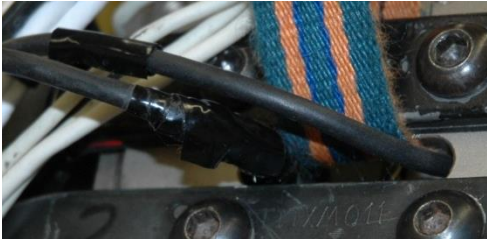
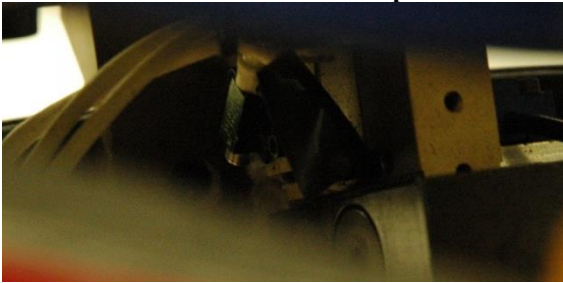
| THORAX | |
|---|---|
| OTHER | <br><b>Lower Neck LC Cable has been repaired where it passes through the upper rear spine box.</b><br><br><b>T6 X Accelerometer missing insulation at transducer. Electrical tape covers this.</b> |

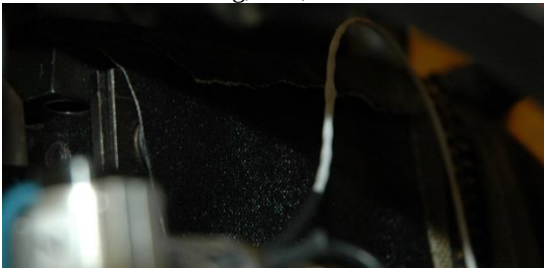
| THORAX | |
|---|---|
| Y / N | No evidence of tearing, cuts, or broken stitches in upper abdomen bag and zipper<br><br><b>Upper abdomen came held together with black tape</b> |

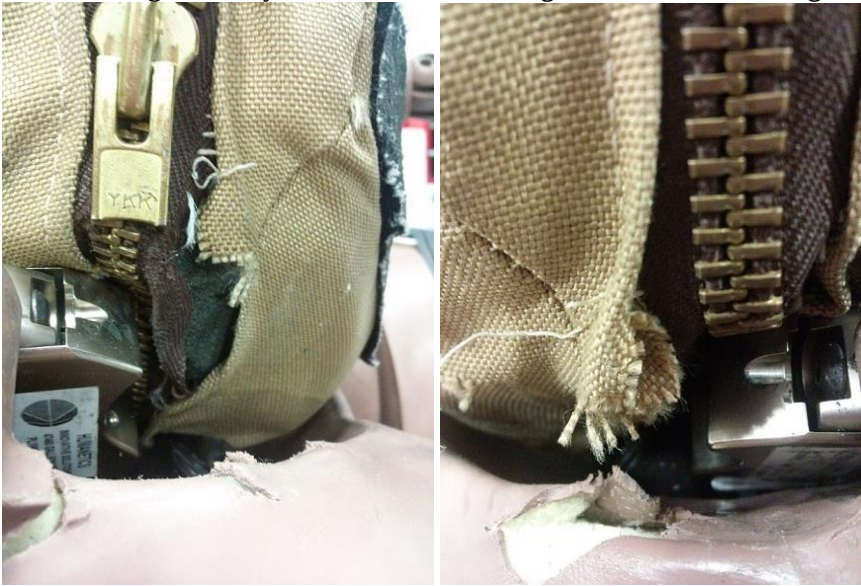
| Y / N | <p>No evidence of tearing, cuts, or broken stitches in lower abdomen bag and zipper</p> <p>Abdomen bag has many broken stitches forming, but no tears occurring.</p> <p><b>Both sides of the Abdomen Bag have torn where the stitches had broke</b></p> |

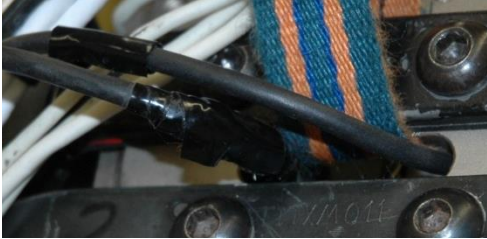
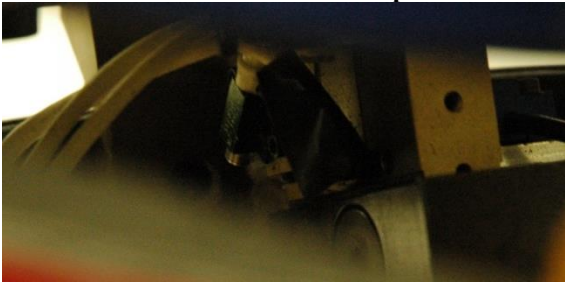
| THORAX | |
|---|---|
| OTHER | <p><b>Lower Neck LC Cable has been repaired where it passes through the upper rear spine box.</b></p> <p><b>T6 X Accelerometer missing insulation at transducer. Electrical tape covers this.</b></p> |

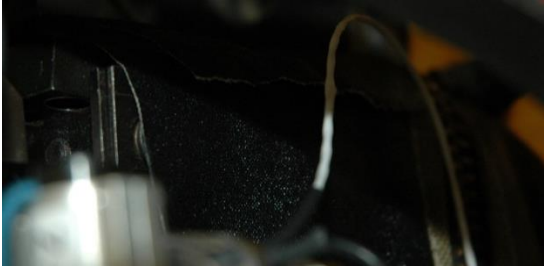
| ABDOMEN | |
|---|---|
| Y / N | <p>No evidence of tearing, cuts, or broken stitches in upper abdomen bag and zipper</p> <p><b>Upper abdomen came held together with black tape</b></p> |

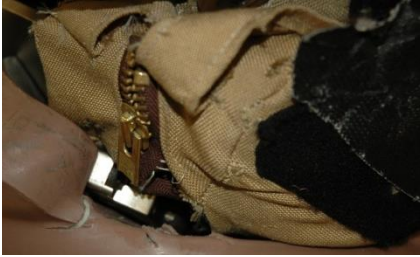
| ABDOMEN | |
|---|---|
| Y / N | <p>No evidence of tearing, cuts, or broken stitches in lower abdomen bag and zipper</p> <p><b>Abdomen bag has many broken stitches forming, but no tears occurring.</b></p> |

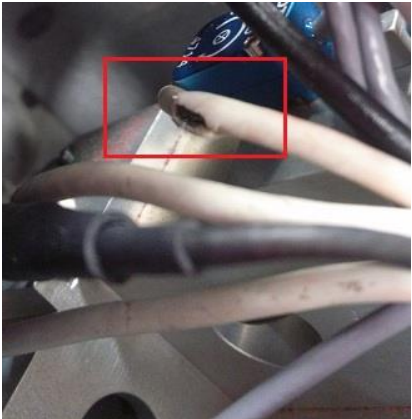
| HEAD | |
|---|---|
| OTHER | <p><b>Fraying of material for zipper at the back of the head</b></p> <p><b>Head CG Y Accelerometer wire damaged</b></p> |

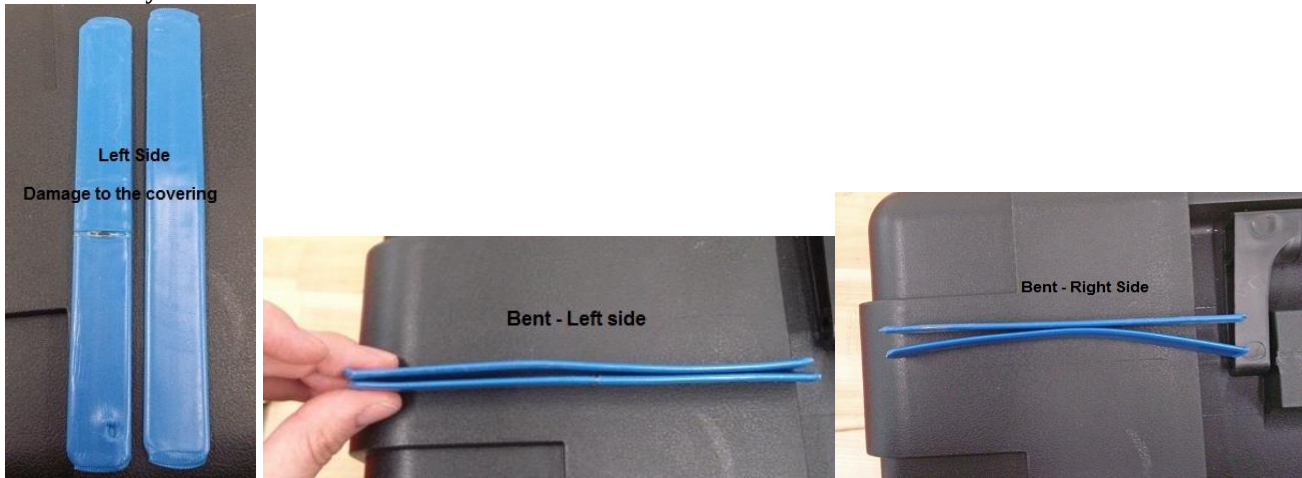
| JACKET | |
|---|---|
| Y / N | Rib stiffeners show no sign of permanent deformation<br><b>One of the left rib stiffeners has damage to the outer coating that goes all the way around, also, the rib stiffeners were severely bent when we received 0015.</b><br> |

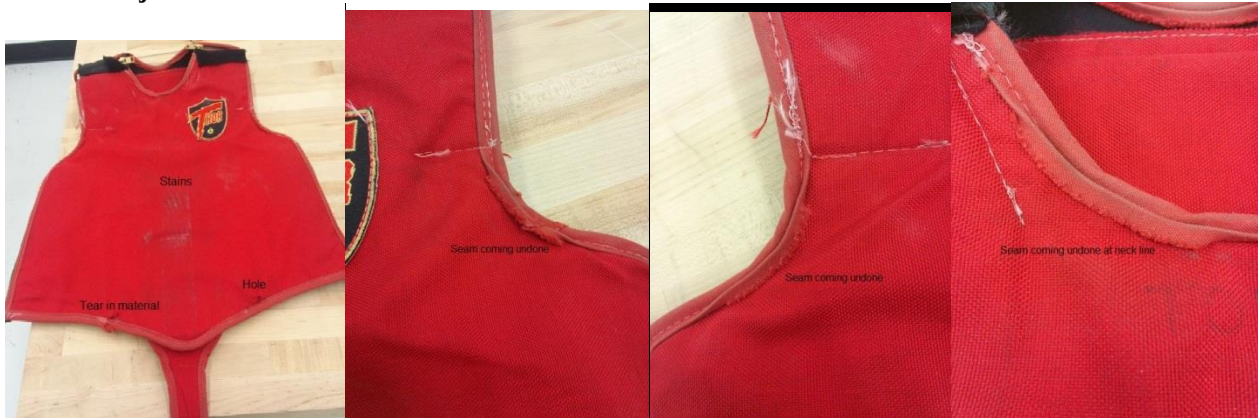
| JACKET | |
|---|---|
| Y / N | No evidence of tears or holes in jacket fabric, Velcro, or zippers<br><b>Many of the seams of the jacket are coming undone, and there is a hole on the bottom left side along with stains all over the jacket.</b><br> |
