**REPORT NUMBER: SINCAP-MGA-2014-043**

**NEW CAR ASSESSMENT PROGRAM (NCAP)  
Moving Deformable Barrier Side Impact Test**

**GENERAL MOTORS LLC  
2014 Chevrolet Malibu 1LS 4-Dr Sedan  
NHTSA No.: M20140110**

**MGA RESEARCH CORPORATION  
5000 Warren Road  
Burlington, WI 53105**

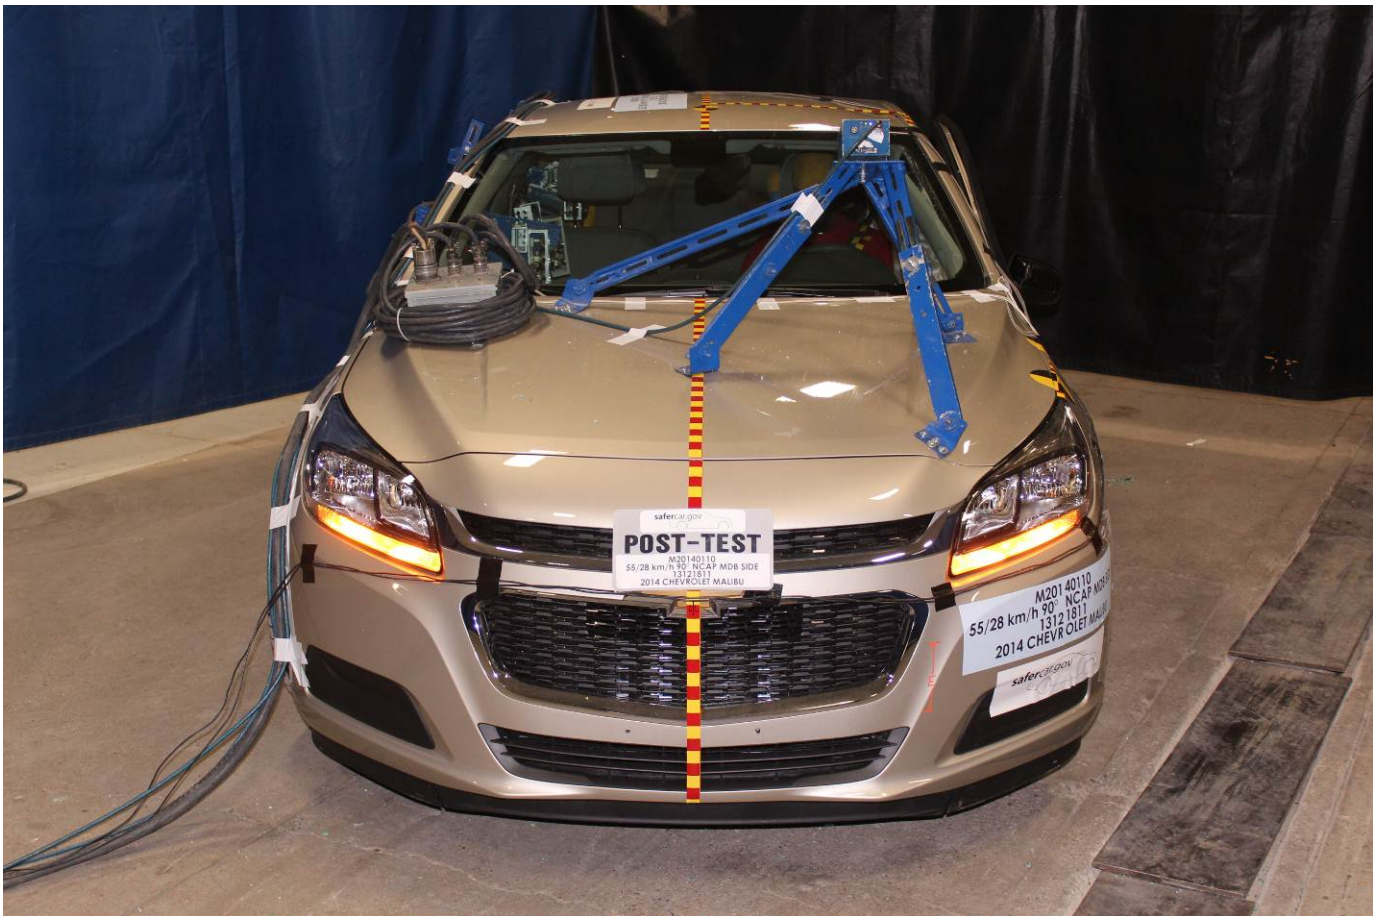
Post-Test Frontal View of Test Vehicle

Critical Areas of Performance	Observations and Conclusions
Pillar Performance	No Separation
Sill Separation	None
Windshield Damage	None
Side Window Damage	Left Front Window Broken
Other Notable Effects	None

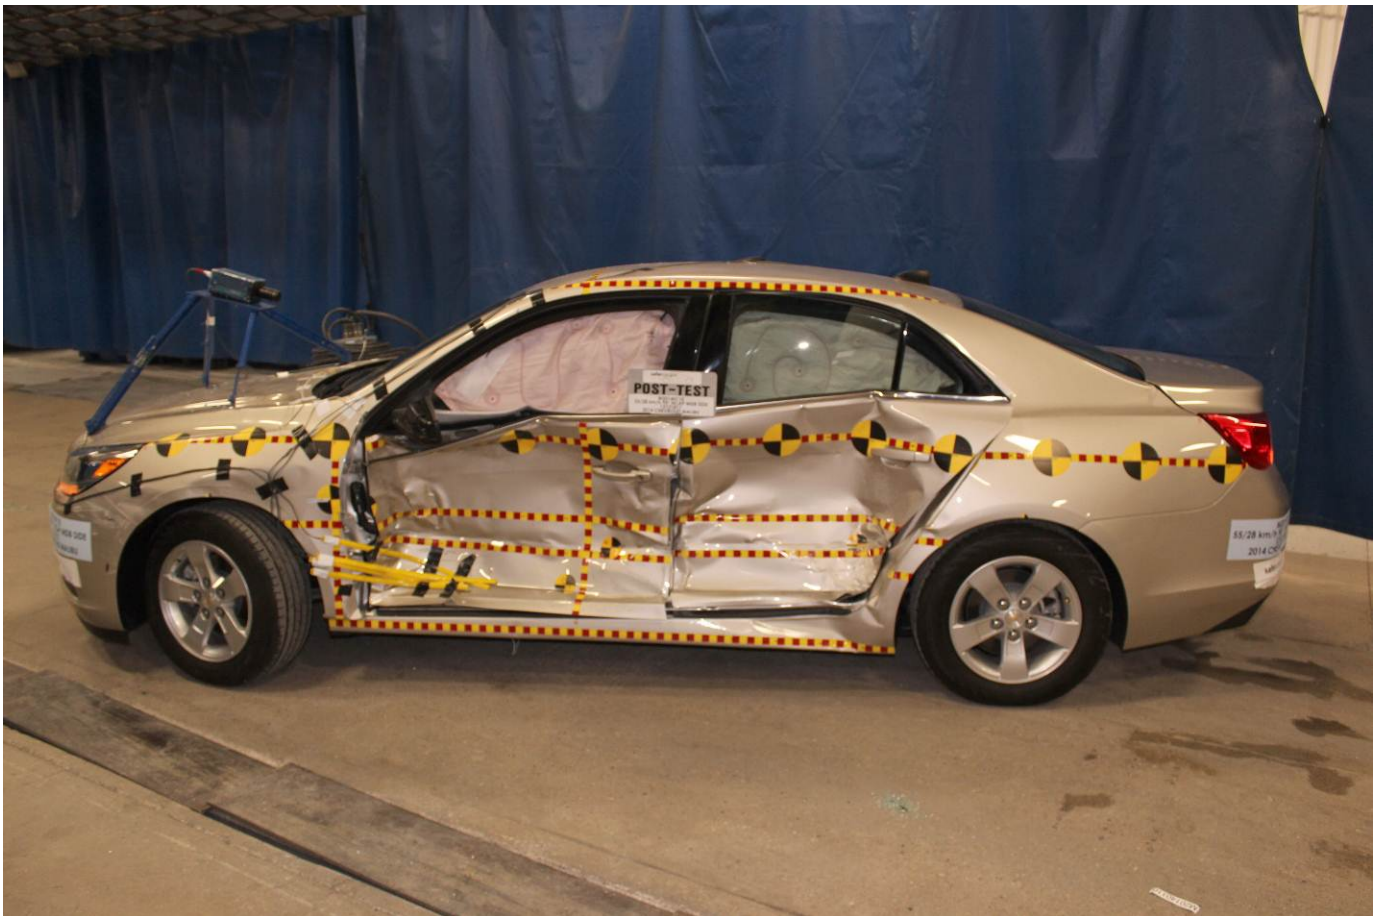
Post-Test Left Side View of Test Vehicle

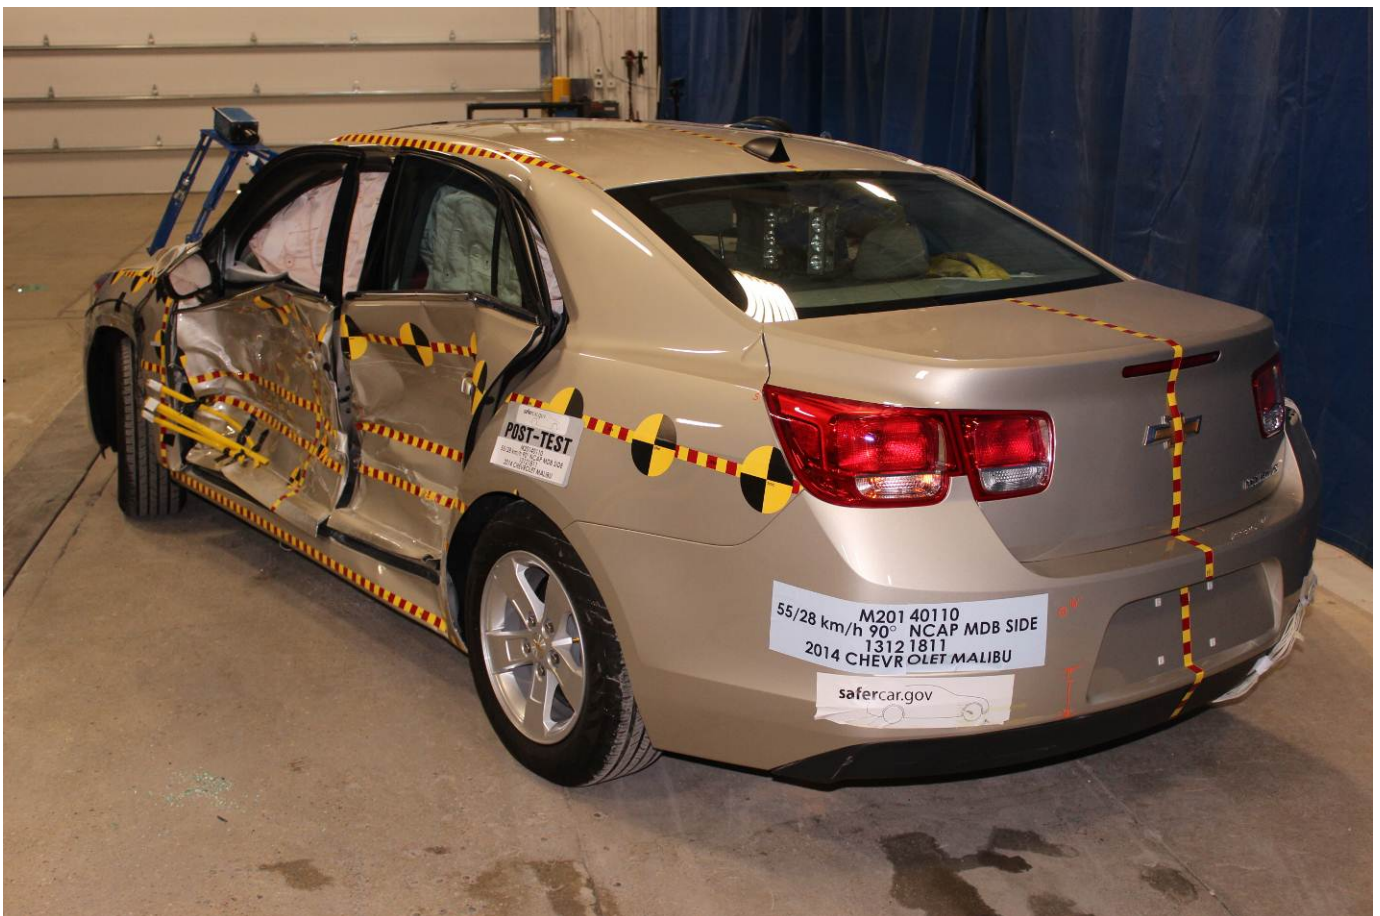
Post-Test Left Three-Quarter Rear View of Test Vehicle

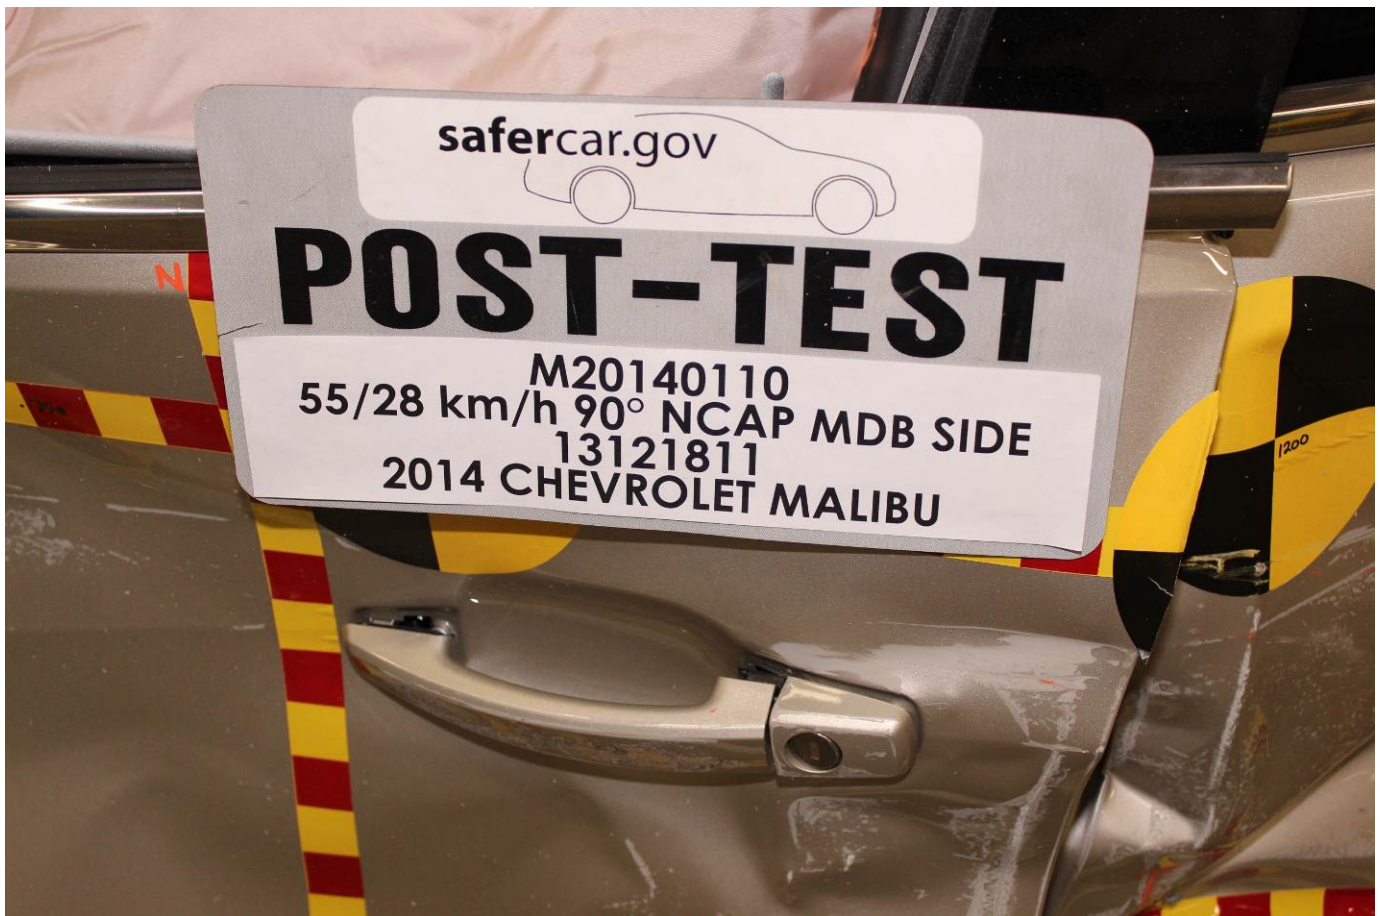
Post-Test Left Front Door Latch Close-Up

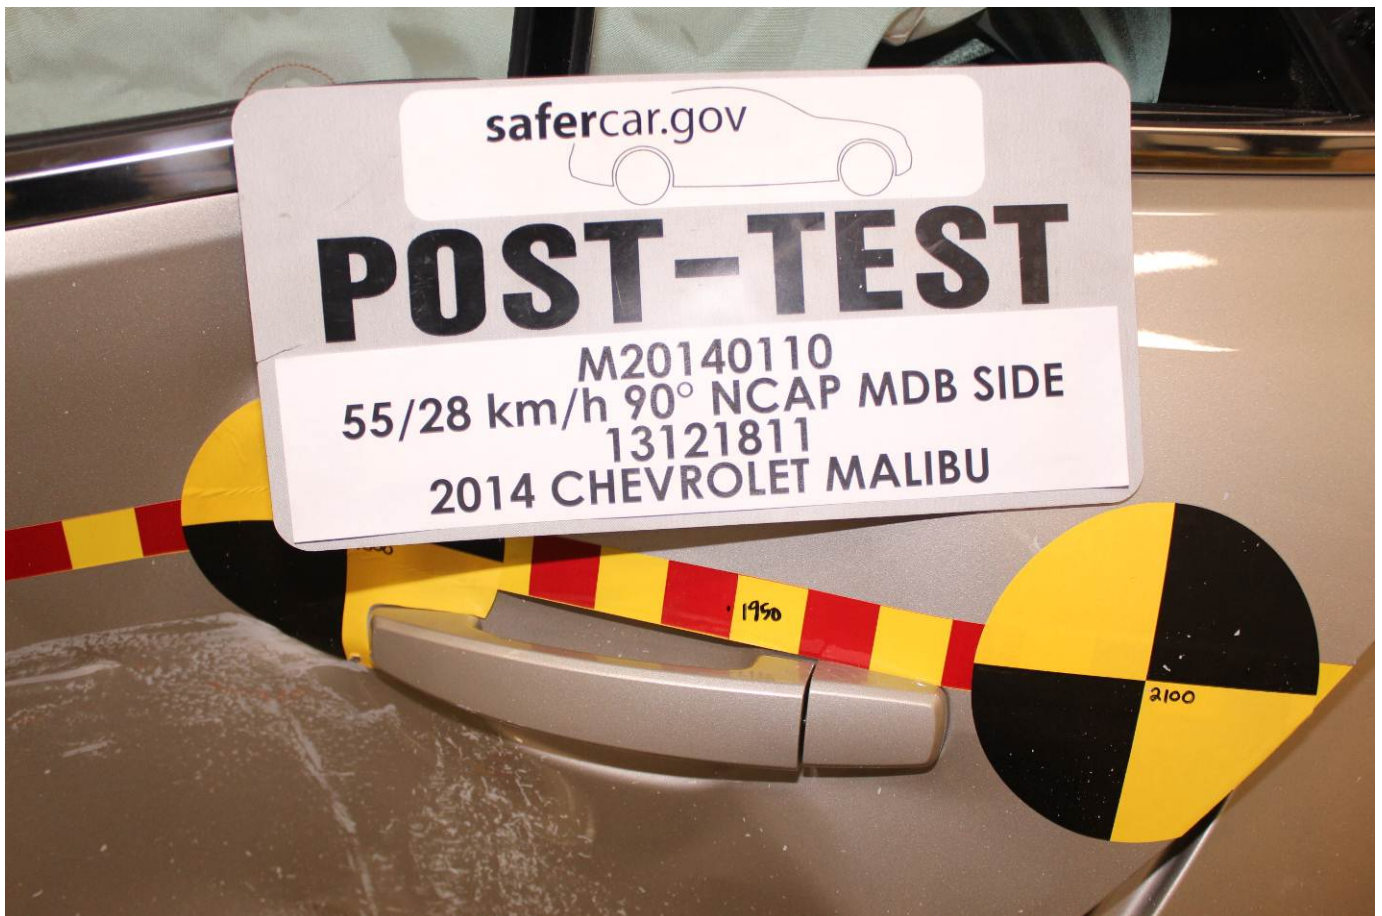
Post-Test Left Rear Door Latch Close-Up

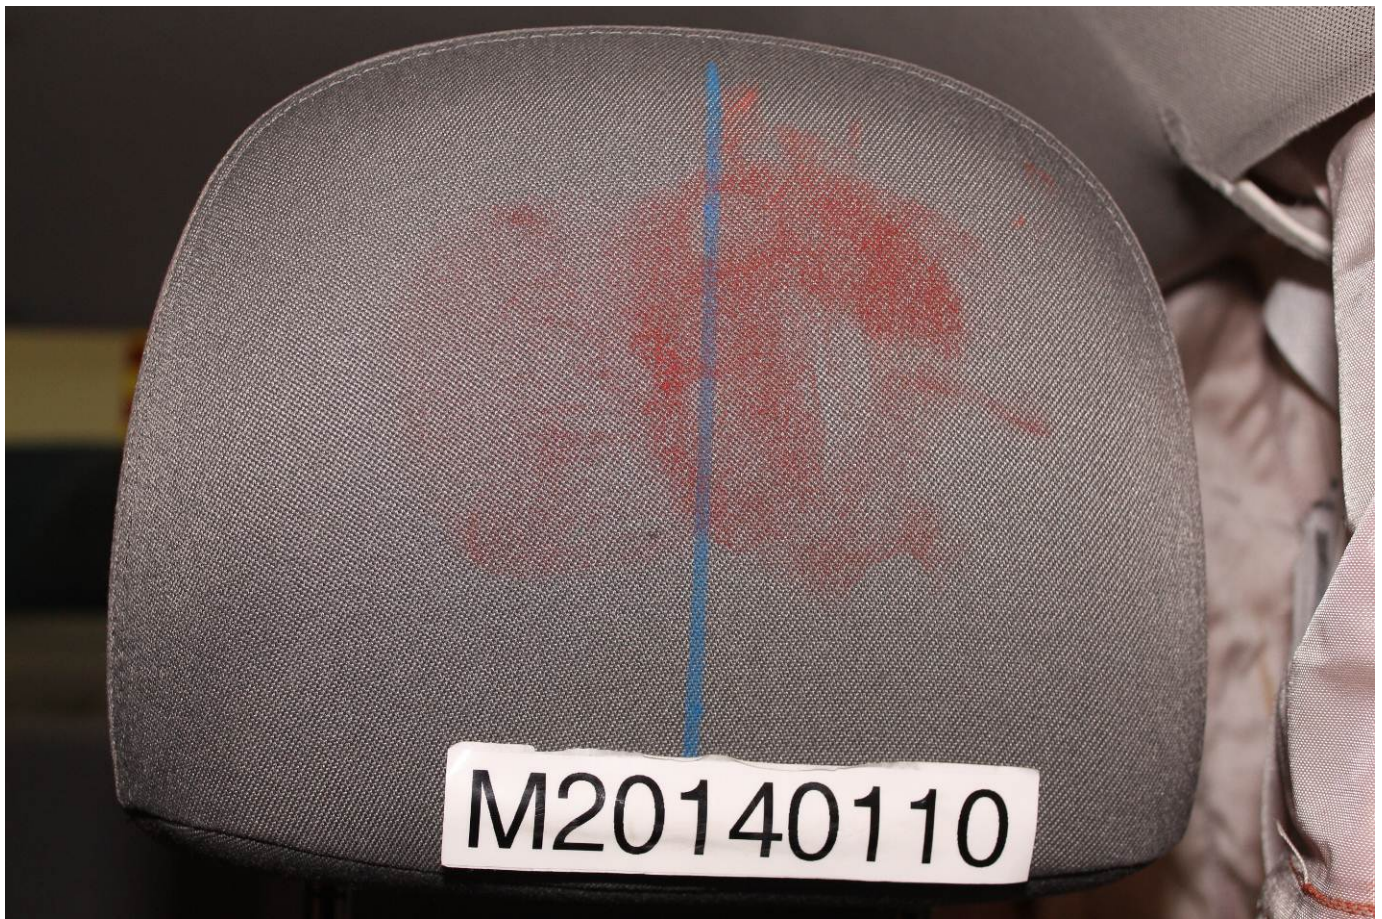
Post-Test Driver Dummy Close-up Head Contact with Vehicle Interior View

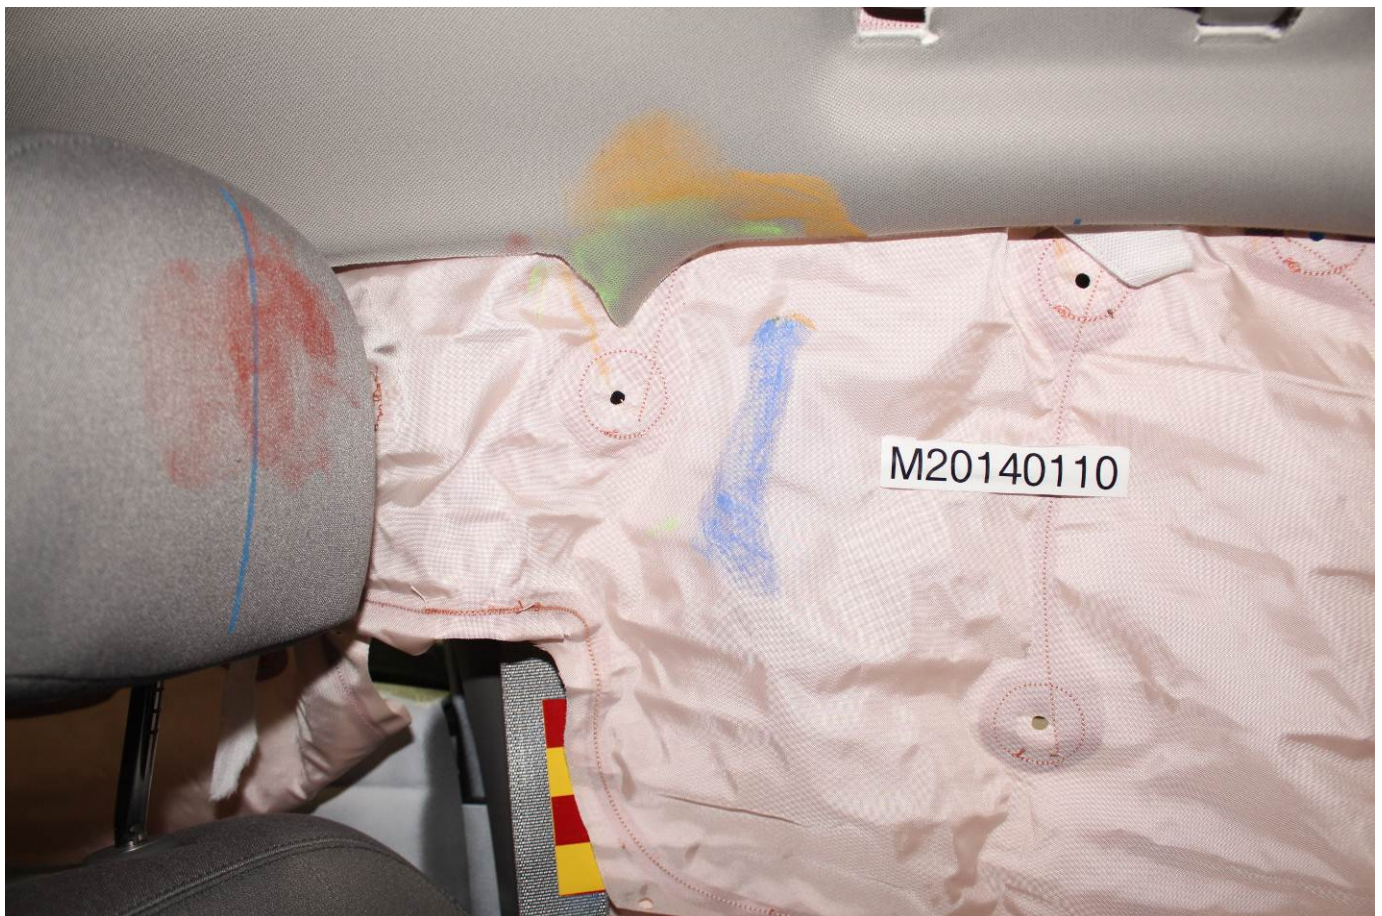
Post-Test Driver Dummy Close-up Head Contact with Side Airbag View

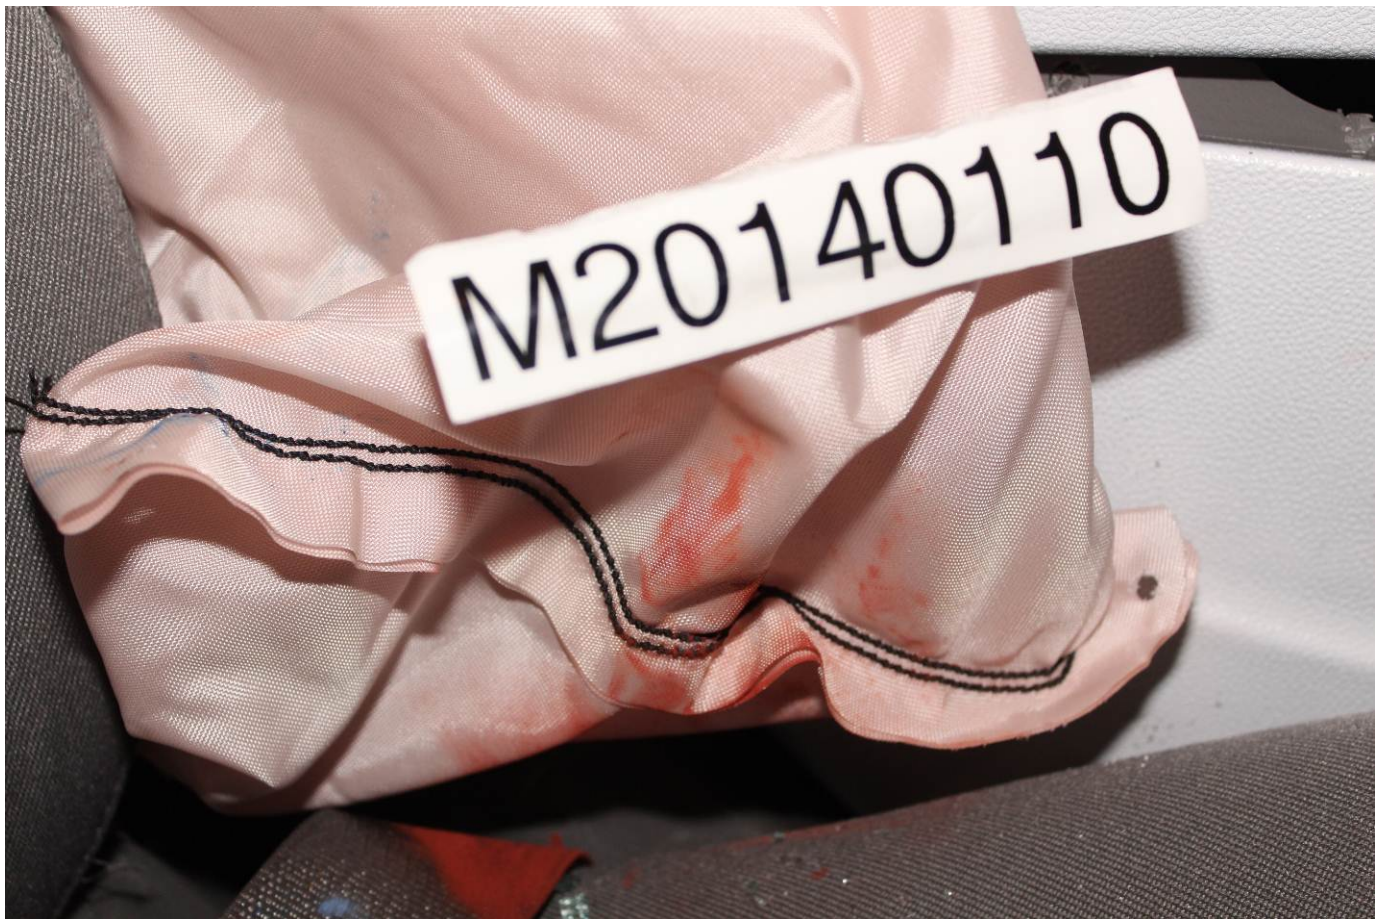
Post-Test Driver Dummy Close-up Pelvis Contact with Side Airbag View

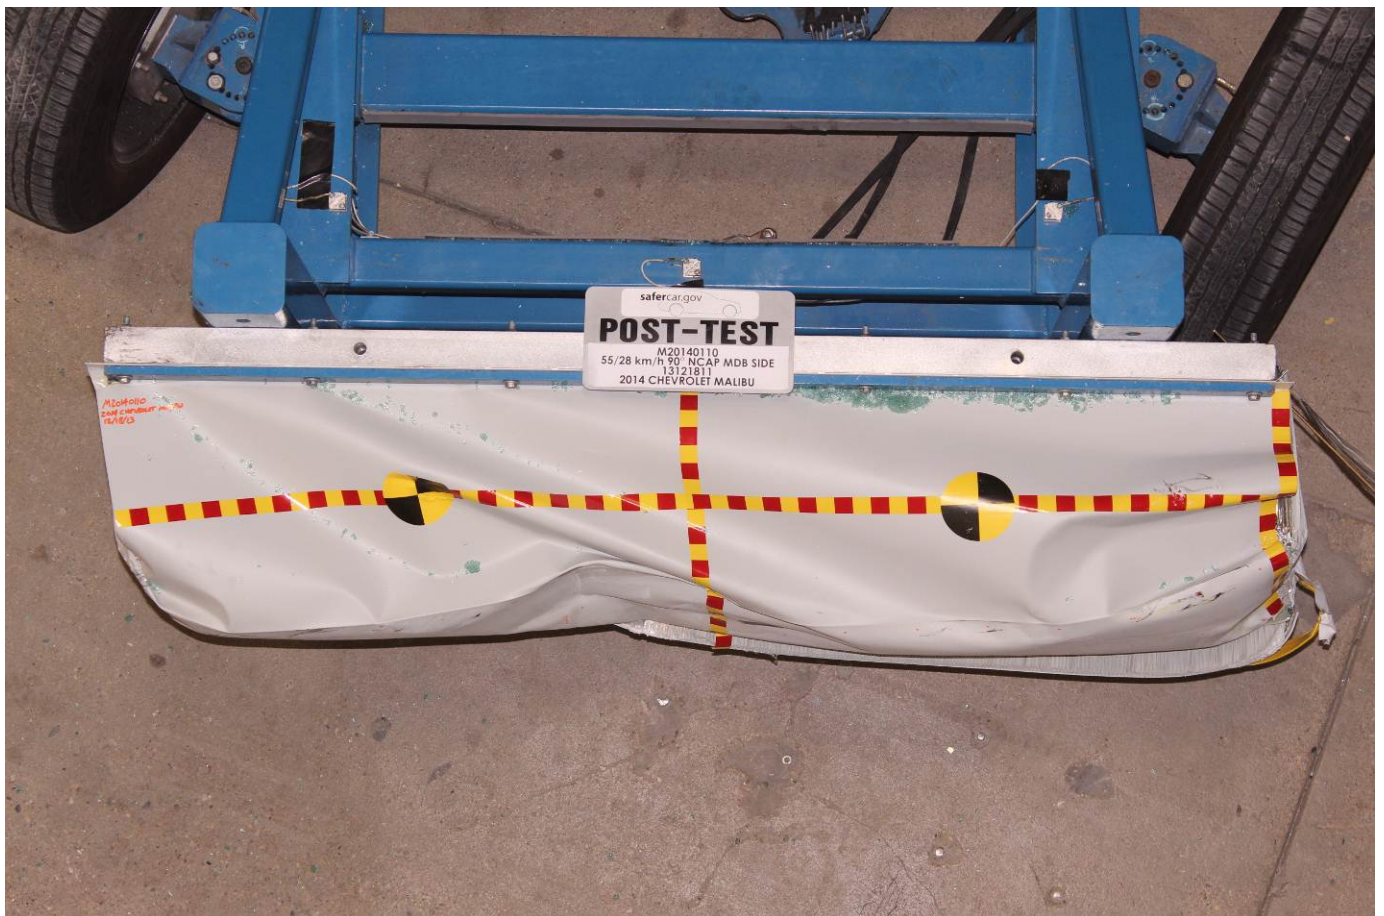
Post-Test Top View of MDB Impactor Face
