REPORT NUMBER: NCAP-CAL-14-004

**NEW CAR ASSESSMENT PROGRAM (NCAP)
FRONTAL BARRIER IMPACT TEST**

**Honda MFG. of Alabama, LLC
2014 Honda Odyssey
Mini Van**

FINAL REPORT

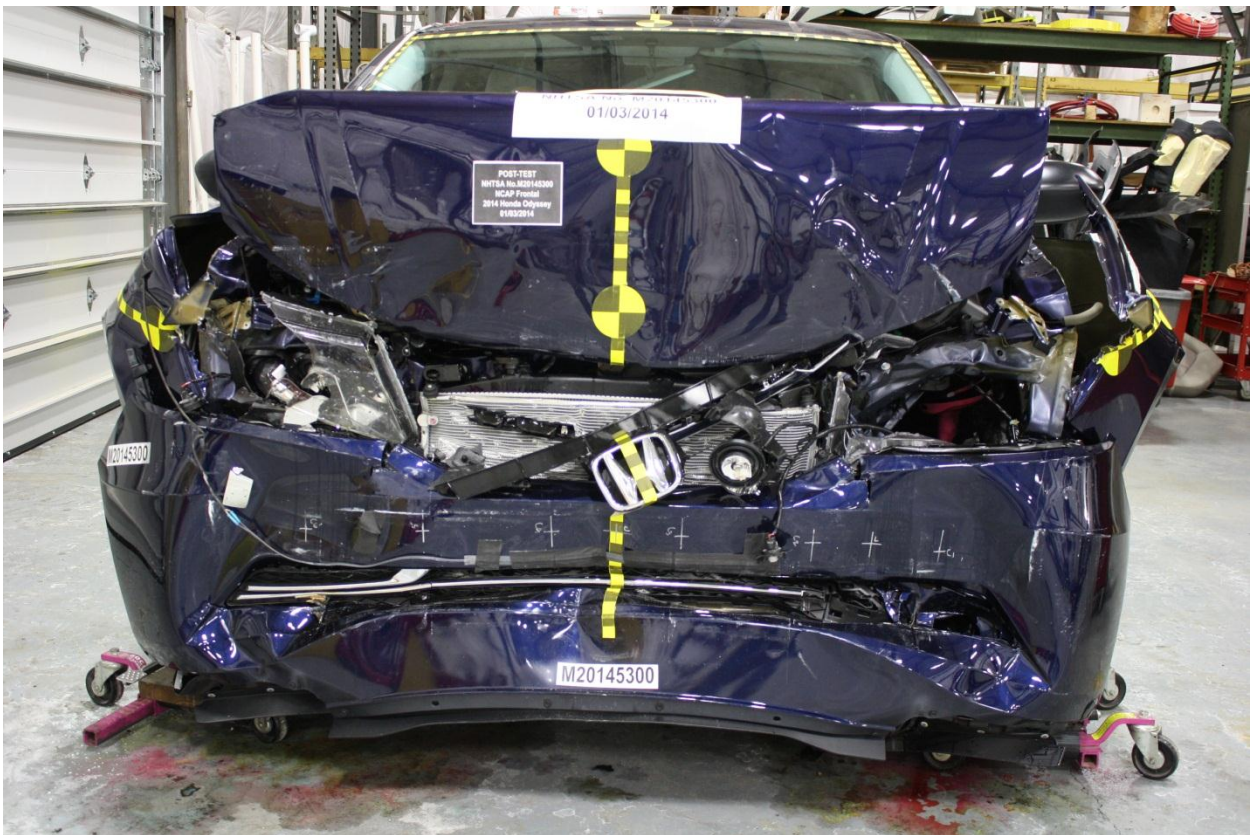
Figure A-8: Post-Test Front View of Test Vehicle

There was 100 percent windshield retention and no intrusion into the protected zone of the windshield during the event. There was a total of 0.0 grams of stoddard solvent leakage after the event and including all phases of the static rollover. The maximum static crush of the test vehicle was 561 mm at the centerline. During and after the impact event, the driver's and passenger's side door were closed and operational.

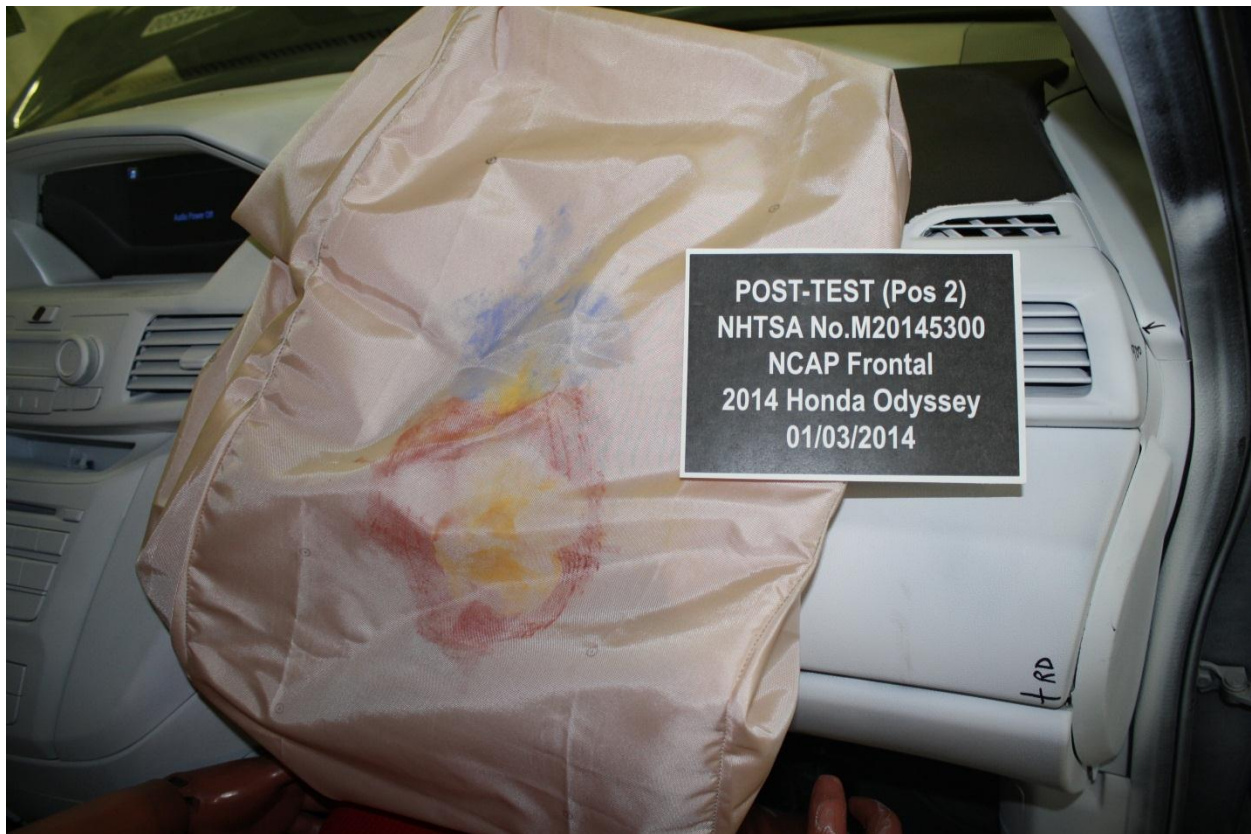
Figure A-67: Post-Test Passenger Dummy Contact With Airbag

The passenger's visible contact points were as follows: The passenger's head contacted the frontal airbag and then the head restraint. The upper torso contacted the frontal airbag. Both knees contacted the glove box.

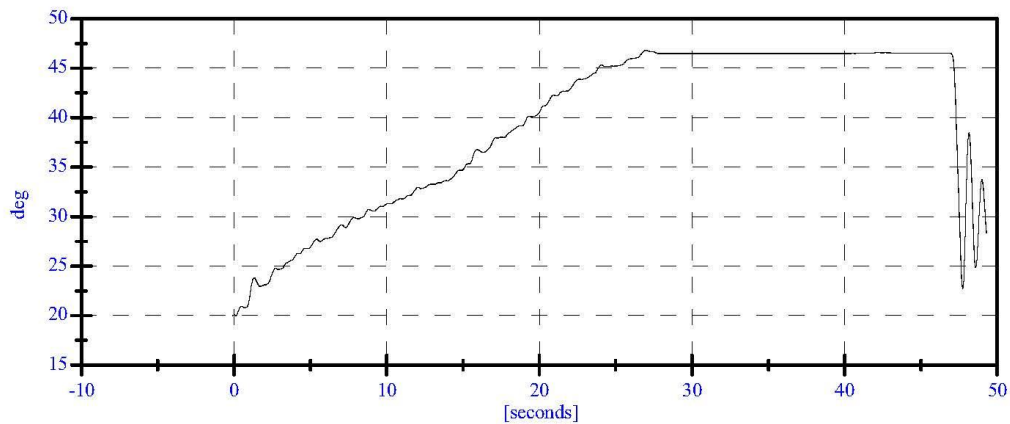
LUMBAR SPINE FLEXION TEST

<u>TEST PARAMETER</u>	<u>SPECIFICATION</u>	<u>TEST RESULTS</u>	<u>STATUS</u>
Lab Temperature:	18.9-25.6 C	21.8 C	Passed
Lab Humidity:	10-70 %	48.00 %	Passed
Initial Angle:	0.00-20.00 Deg	20.00 Deg	Passed
Force at 45 Deg	320.00-390.00 N	332.80 N	Passed
Return Angle	8 Deg Max from Initial	25.70 deg	Passed
