FINAL REPORT NUMBER: SPNCAP-TRC-14-005

**NEW CAR ASSESSMENT PROGRAM (NCAP)
SIDE IMPACT POLE TEST**

**Mazda Motor Corporation
2014 Mazda 6 I Sport 4-Door Sedan
NHTSA NUMBER: M20145401**

**PREPARED BY:
Transportation Research Center Inc.
10820 State Route 347
P. O. Box B-67
East Liberty, OH 43319**

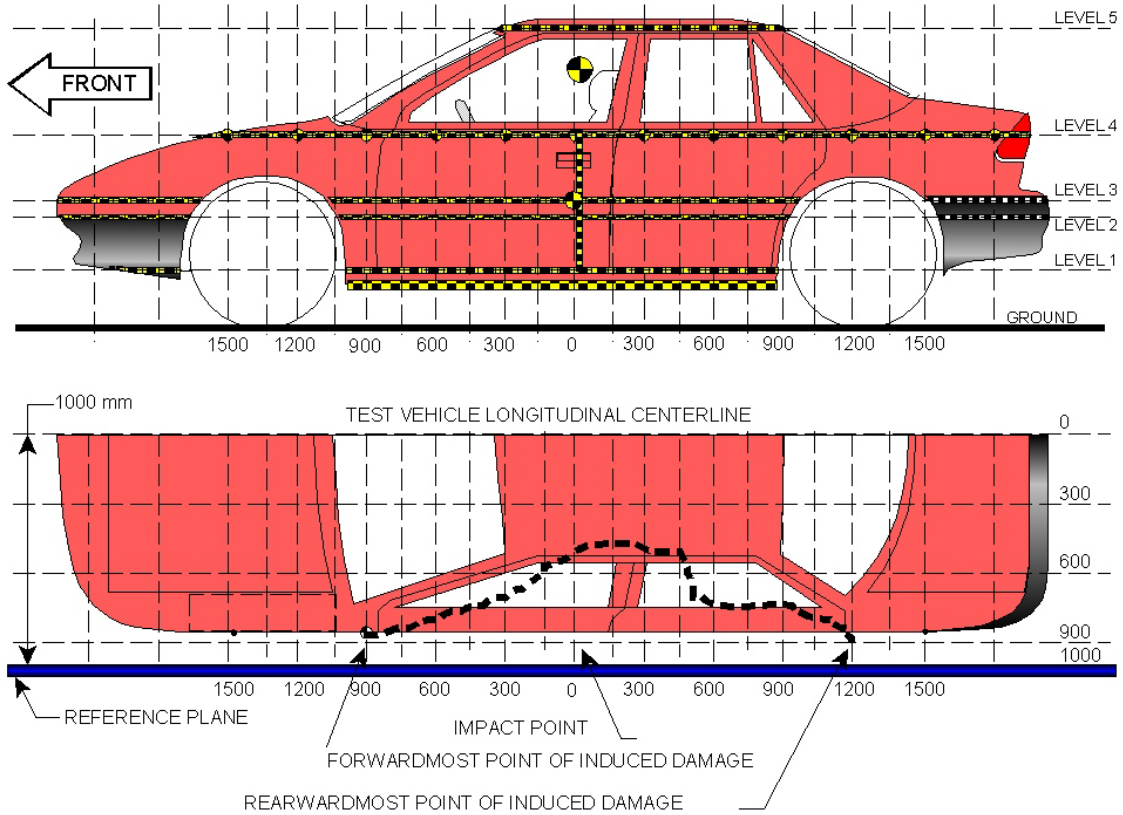
MAXIMUM EXTERIOR CRUSH MEASUREMENTS

NOTE: Pre-test measurements are taken when the vehicle is in the “As Tested” weight condition. Vehicle measurements forward of the vertical impact reference line are negative. The crush profile grid is established prior to the test based on an estimated impact point. The final distance from impact is determined after the final dummy positioning and the pole is aligned with the center of gravity of the dummy’s head.

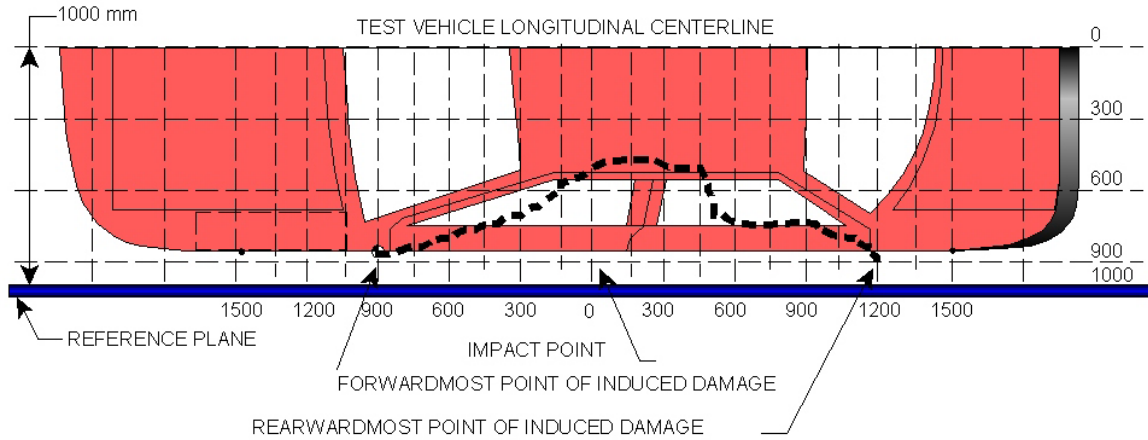
**DATA SHEET NO. 11
VEHICLE DAMAGE PROFILE DISTANCES**

VEHICLE DAMAGE PROFILE DISTANCES

DPD	Distance From Impact Point (mm)	Level	Post-Test (mm)	Pre-Test (mm)	Crush (mm)
1	-750	1	881	891	10
2	-150	3	556	908	352
3	300	2	785	891	106
4	750	2	861	904	43
5	1200	4	861	849	12
6	1650	4	845	846	1

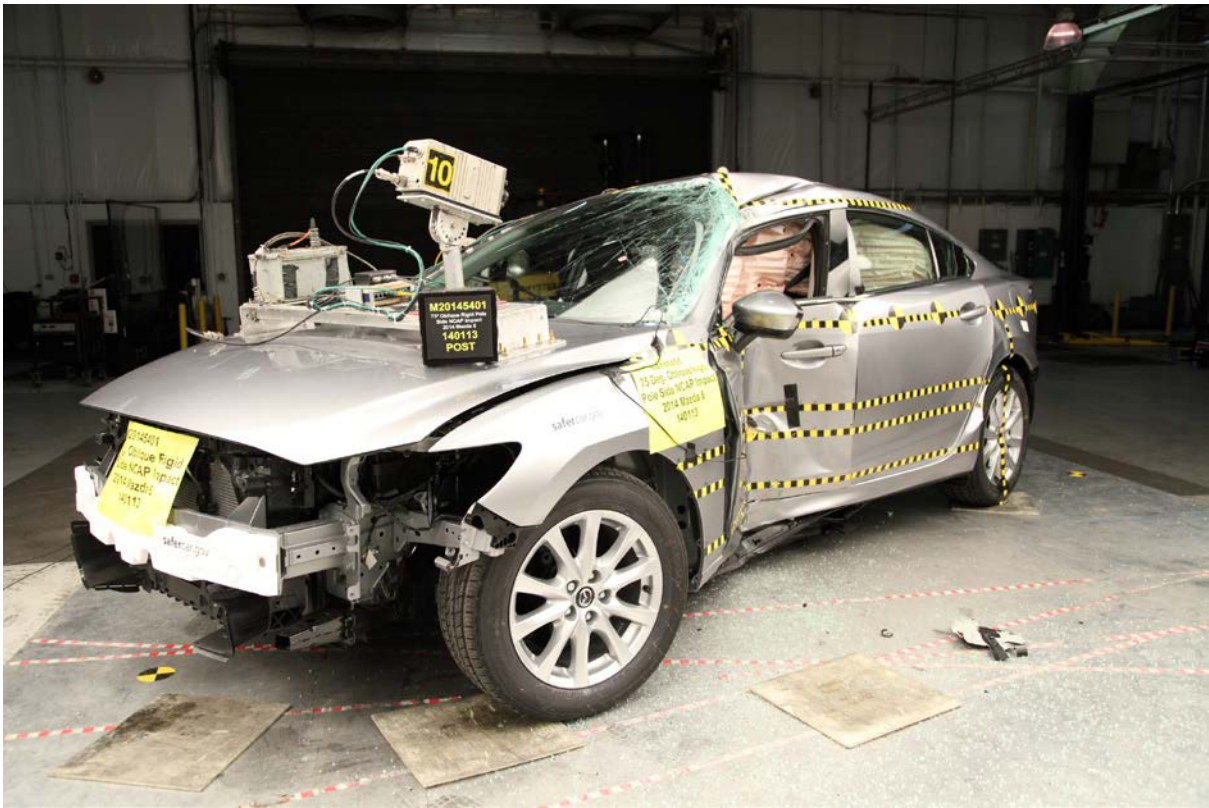
006 Post-Test Left Front 3-4 View of Test Vehicle

Critical Areas of Performance	Observations and Conclusions
Pillar Performance	Major deformation
Sill Separation	None Visible
Windshield Damage	Broken
Side Window Damage	Left Front Shattered; Left Rear Undamaged
Other Notable Effects	N/A
