**FINAL REPORT NUMBER: SPNCAP-TRC-14-004**

**NEW CAR ASSESSMENT PROGRAM (NCAP)  
SIDE IMPACT POLE TEST**

**Ford Motor Company  
2014 Ford Fiesta 4-Door Sedan  
NHTSA NUMBER: M20140200**

**PREPARED BY:  
Transportation Research Center Inc.  
10820 State Route 347  
P. O. Box B-67  
East Liberty, OH 43319**

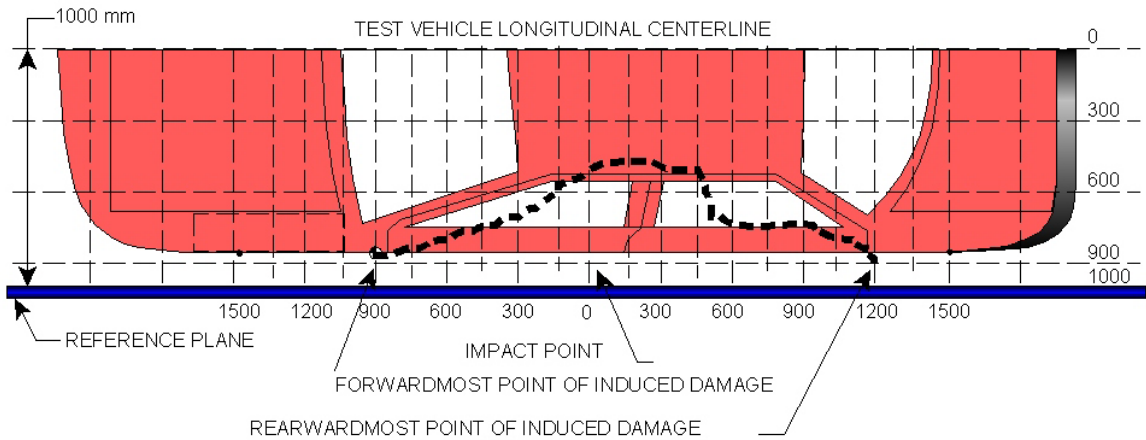
**DATA SHEET NO. 11**  
**VEHICLE DAMAGE PROFILE DISTANCES**

DPD	Distance From Impact Point (mm)	Level	Post-Test (mm)	Pre-Test (mm)	Crush (mm)
1	-600	2	793	836	43
2	-150	3	545	845	300
3	300	3	721	844	123
4	750	3	792	831	39
5	1200	3	840	847	7
6	1500	4	774	776	2

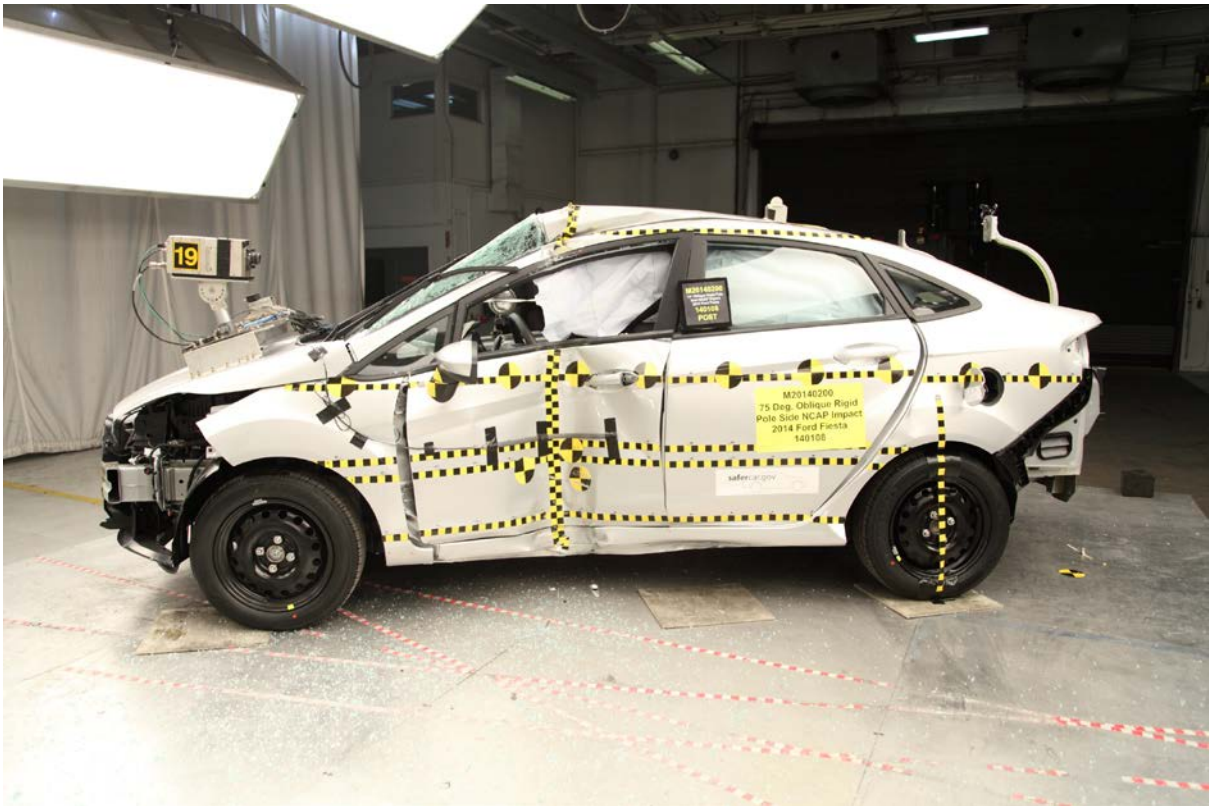
**008** Post-Test Left Side View of Test Vehicle

Critical Areas of Performance	Observations and Conclusions
Pillar Performance	Major deformation
Sill Separation	None
Windshield Damage	Broken
Side Window Damage	Shattered
Other Notable Effects	None

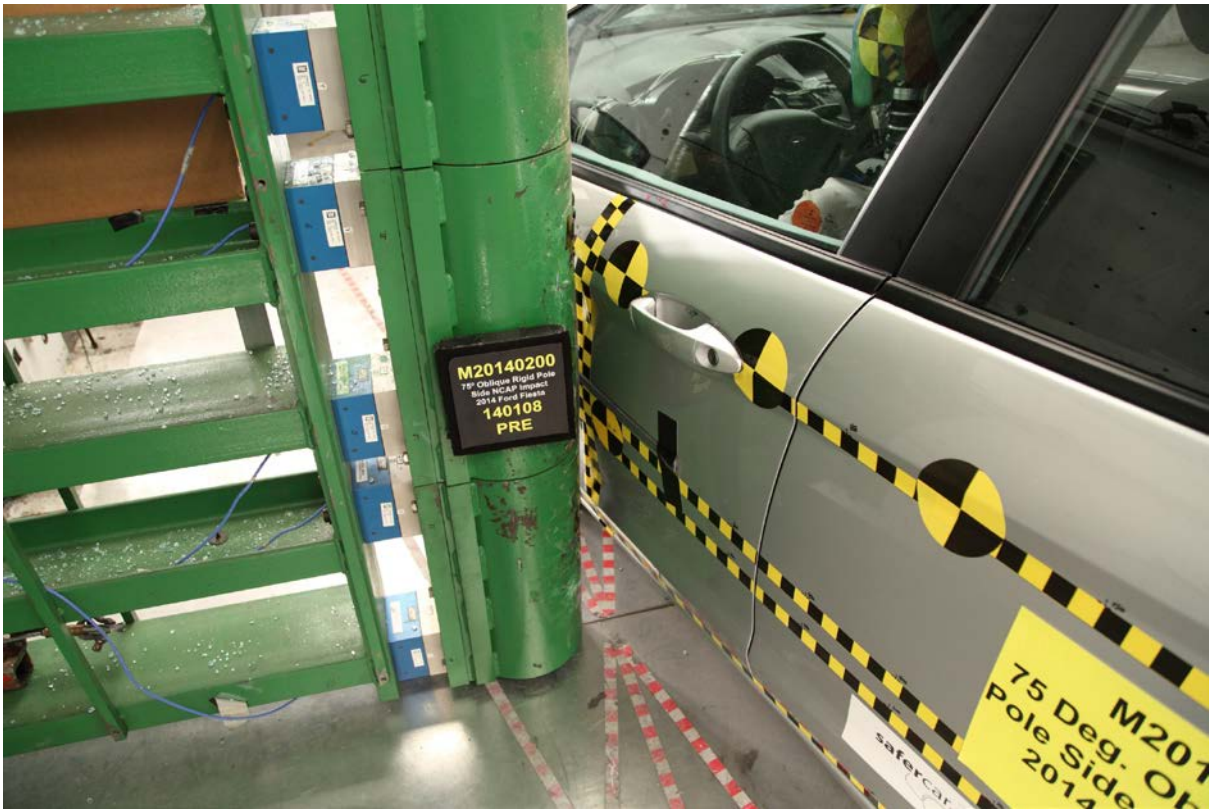
**017** Pre-Test Left Side View of Pole Positioned Against Side of Vehicle

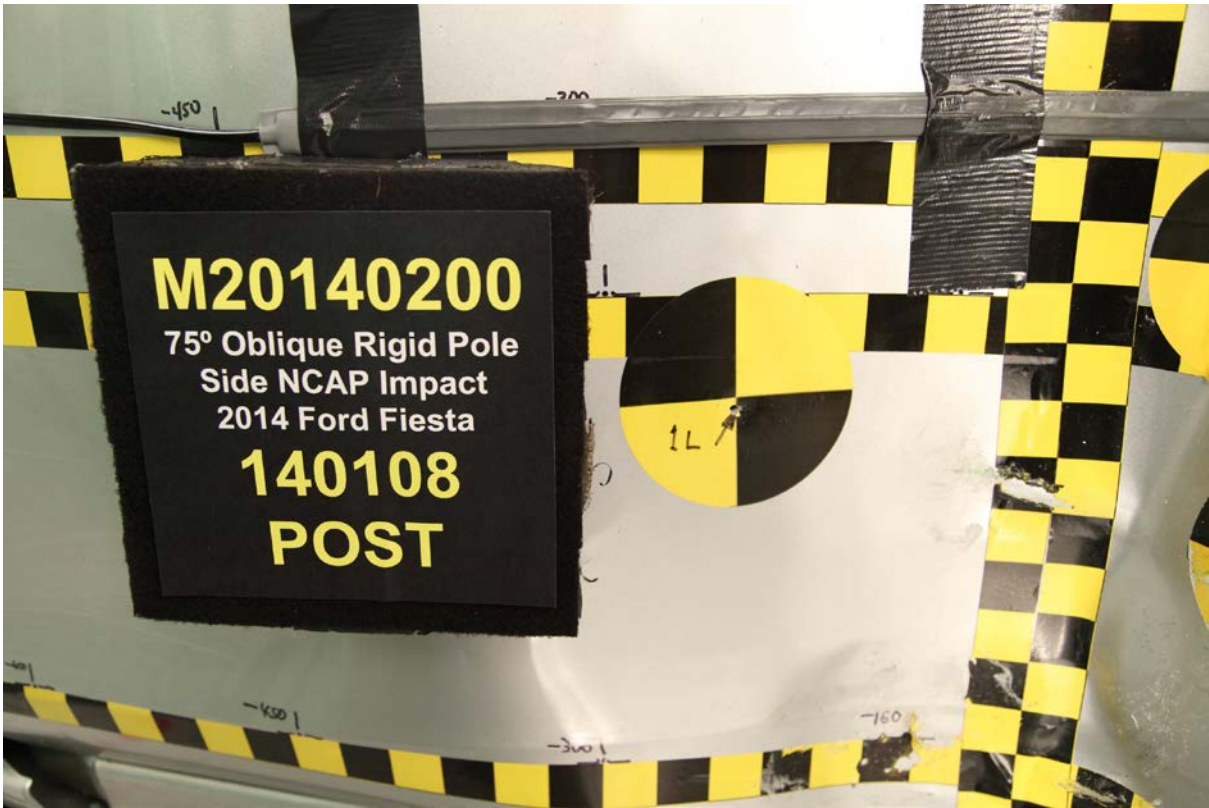
020 Post-Test Close-Up View of Impact Point Target Showing Impact Location

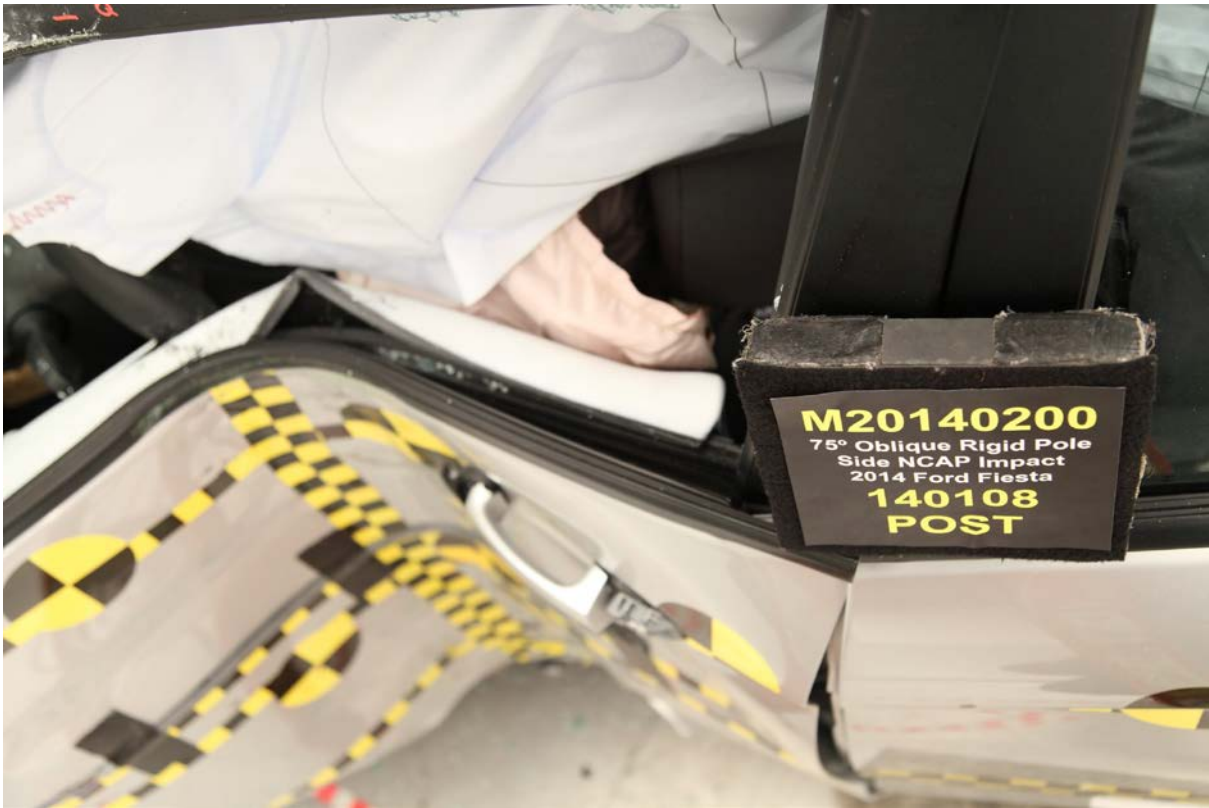
**041** Post-Test Dummy and Door Clearance View

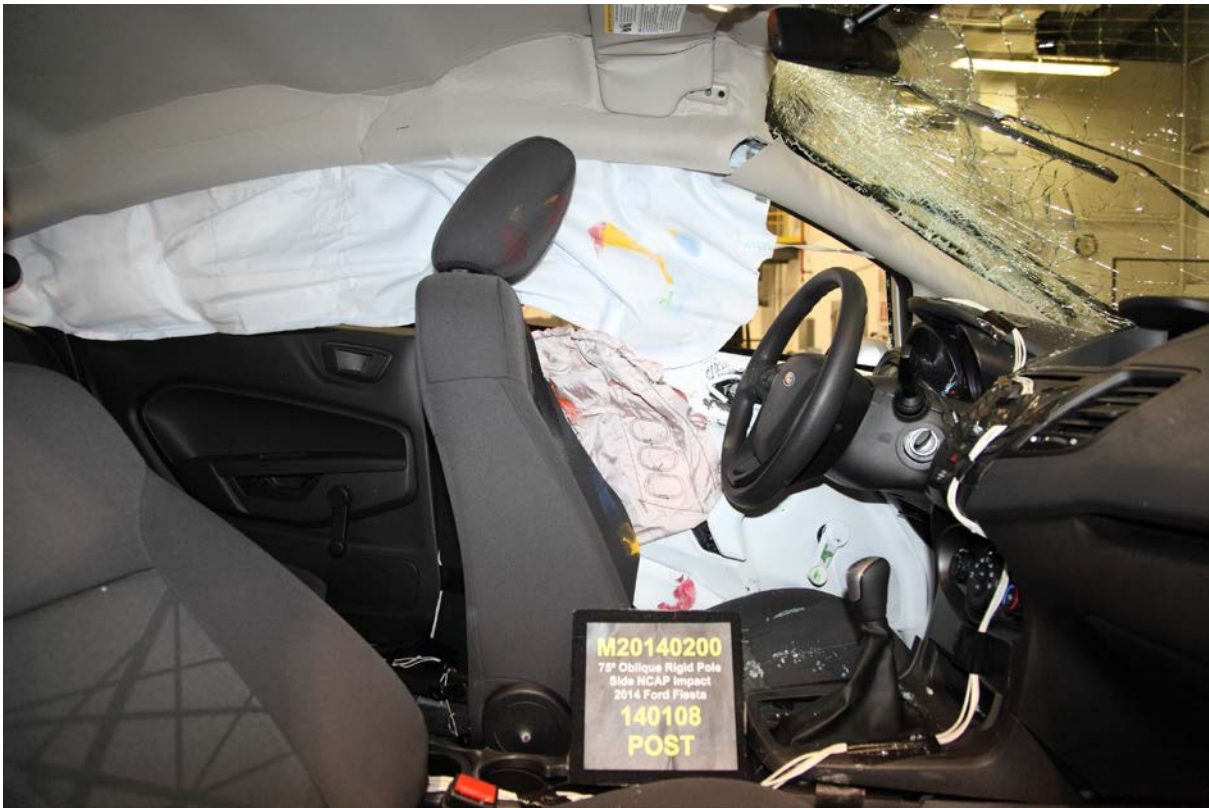
**045** Post-Test Inner Driver Door Panel View Showing Dummy Contact Location

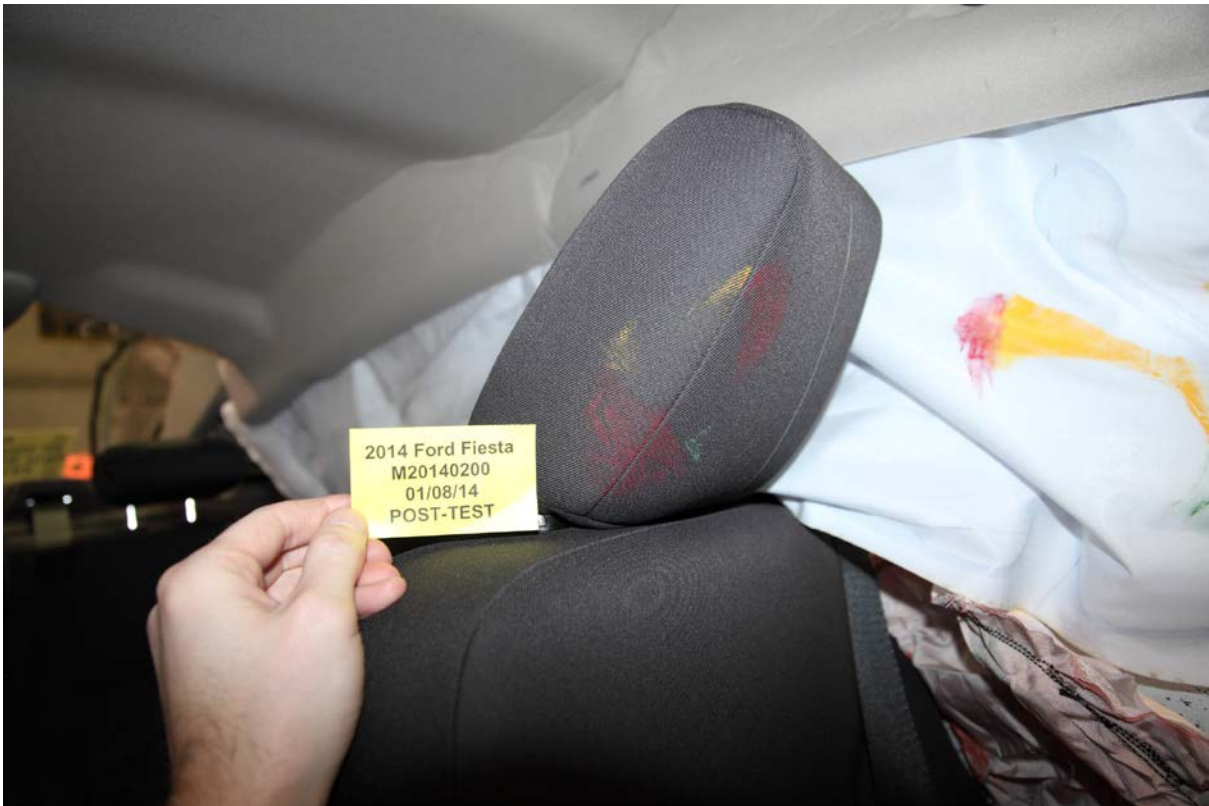
**046** Post-Test Dummy Close-Up Head Contact with Vehicle View

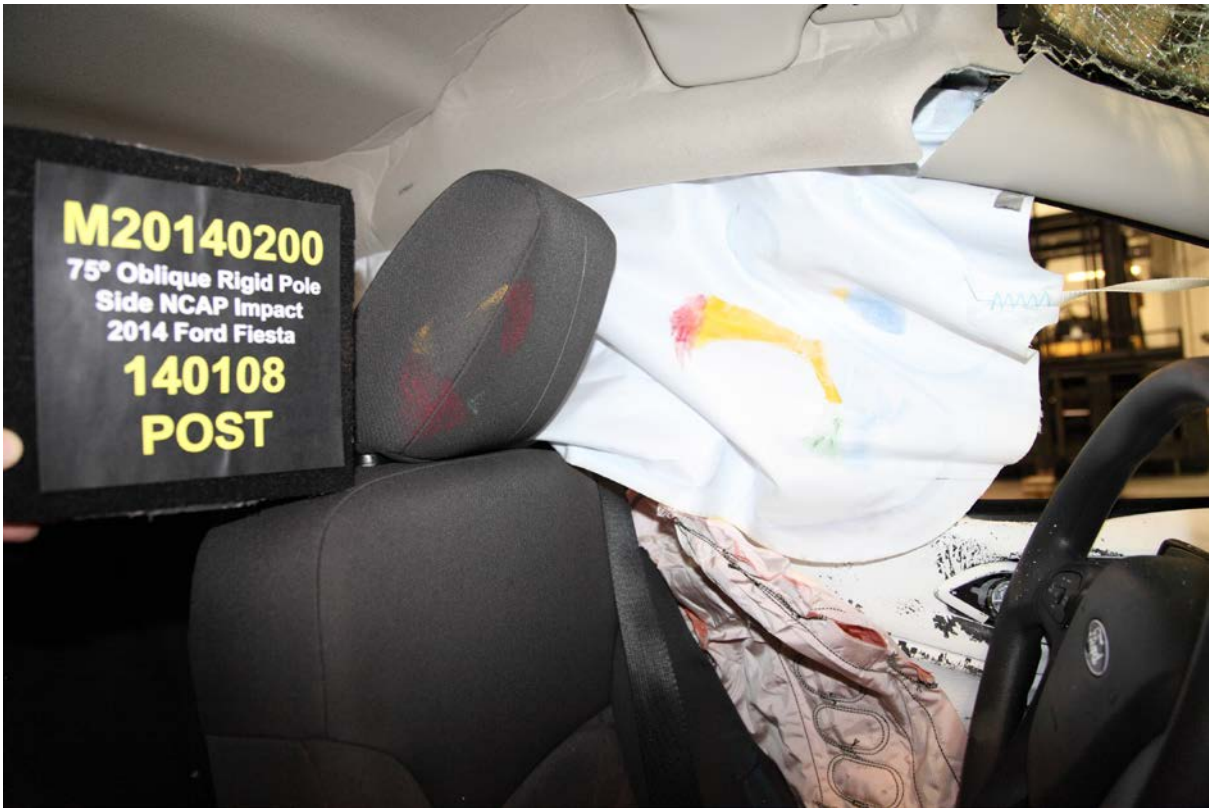
**047** Post-Test Dummy Close-Up Head Contact with Side Airbag View

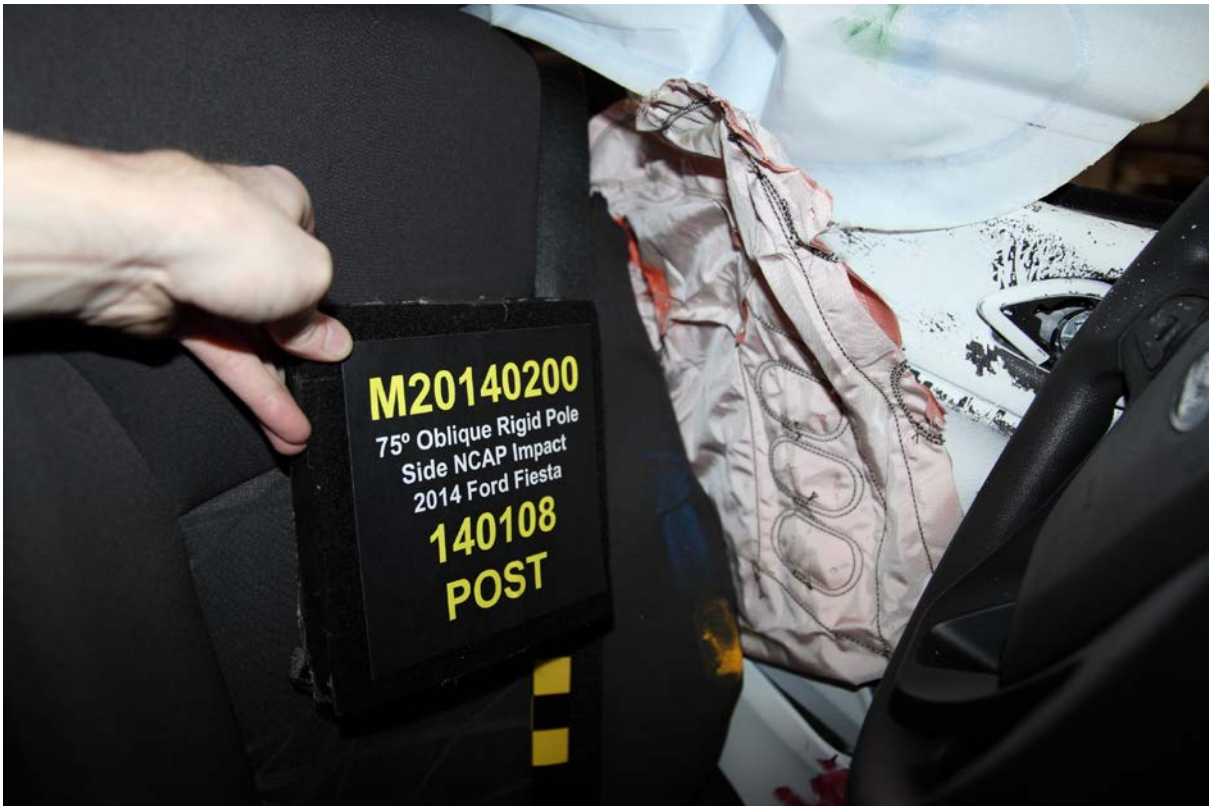
**048** Post-Test Dummy Close-Up Torso Contact with Vehicle Interior View

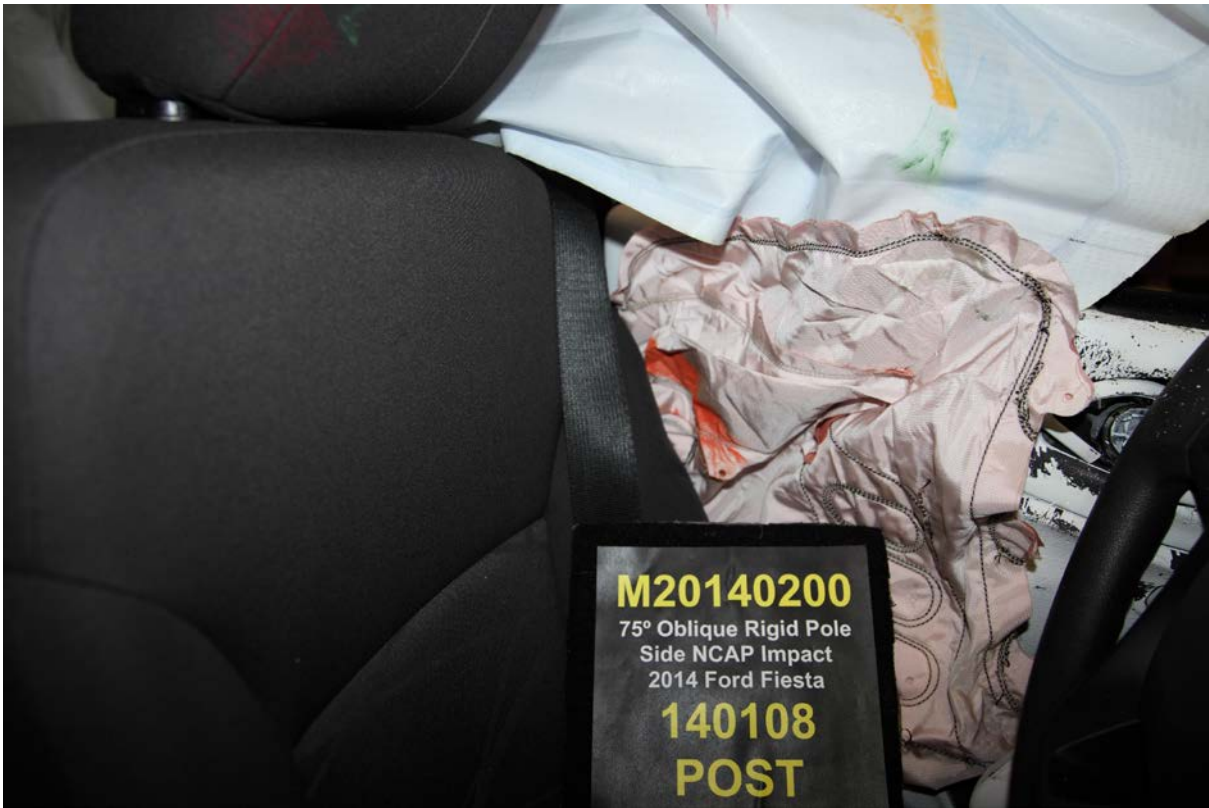
**049** Post-Test Dummy Close-Up Torso Contact with Side Airbag View

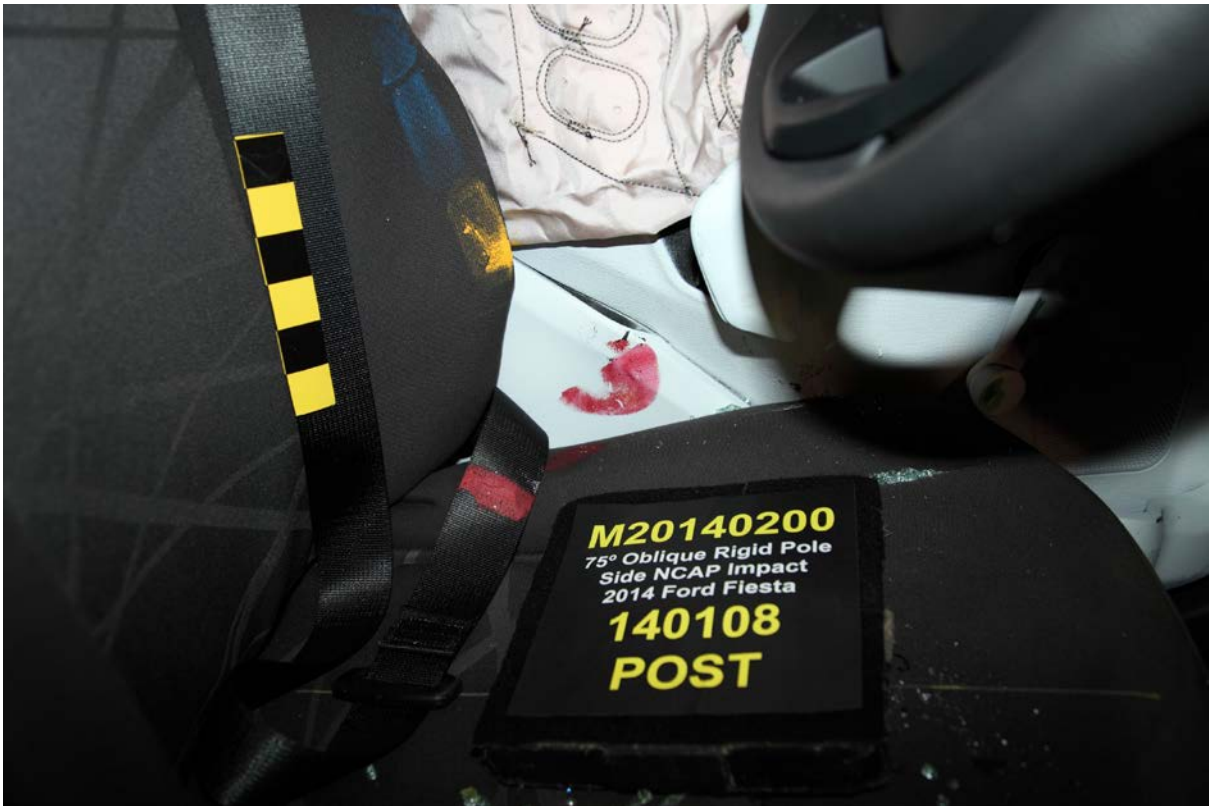
**050** Post-Test Dummy Close-Up Pelvis Contact with Vehicle Interior View

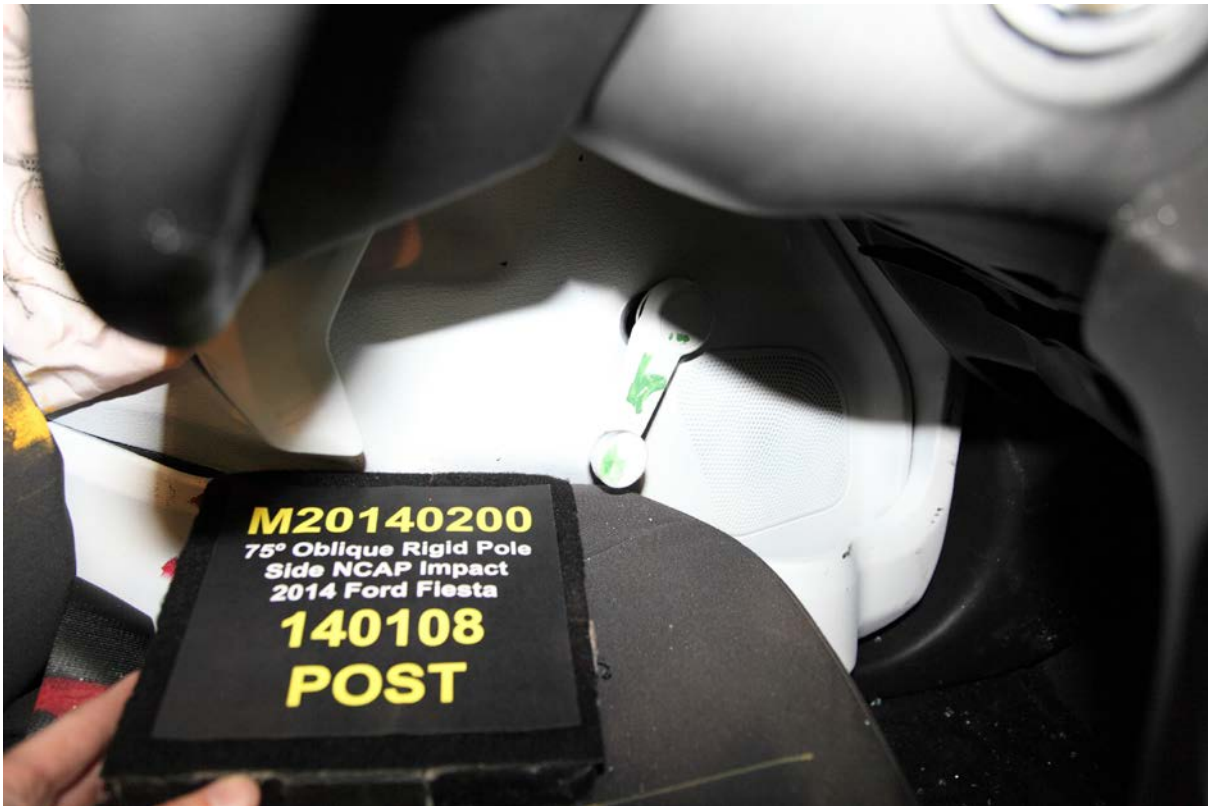
**052** Post-Test Dummy Close-Up Knee Contact with Vehicle Interior View

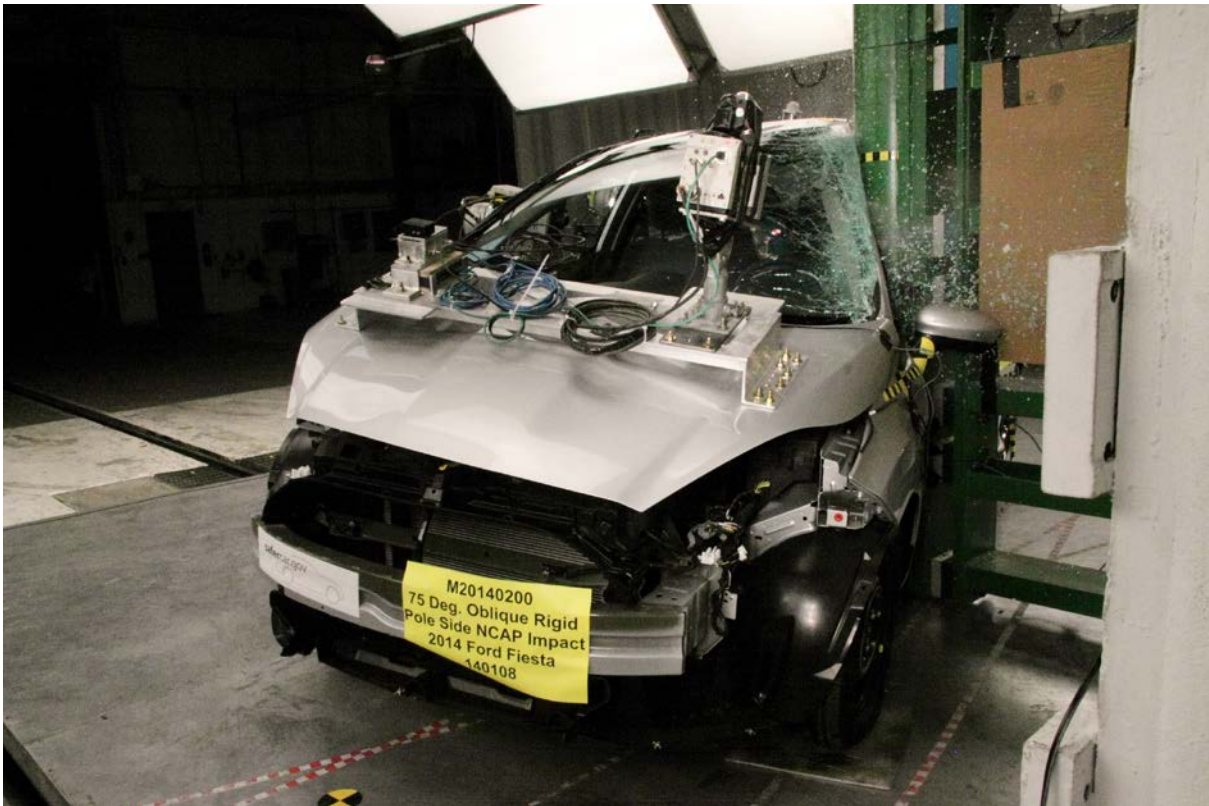
**068** Impact Event
