**REPORT NUMBER: TWG-MGA-2014-003**

**SIDE AIRBAG OUT-OF-POSITION INJURY  
TECHNICAL WORKING GROUP**

**TOYOTA MOTOR CORPORATION  
2014 Lexus IS250 AWD 4-Dr Sedan  
NHTSA No.: M20145100TWG2**

**FINAL REPORT**

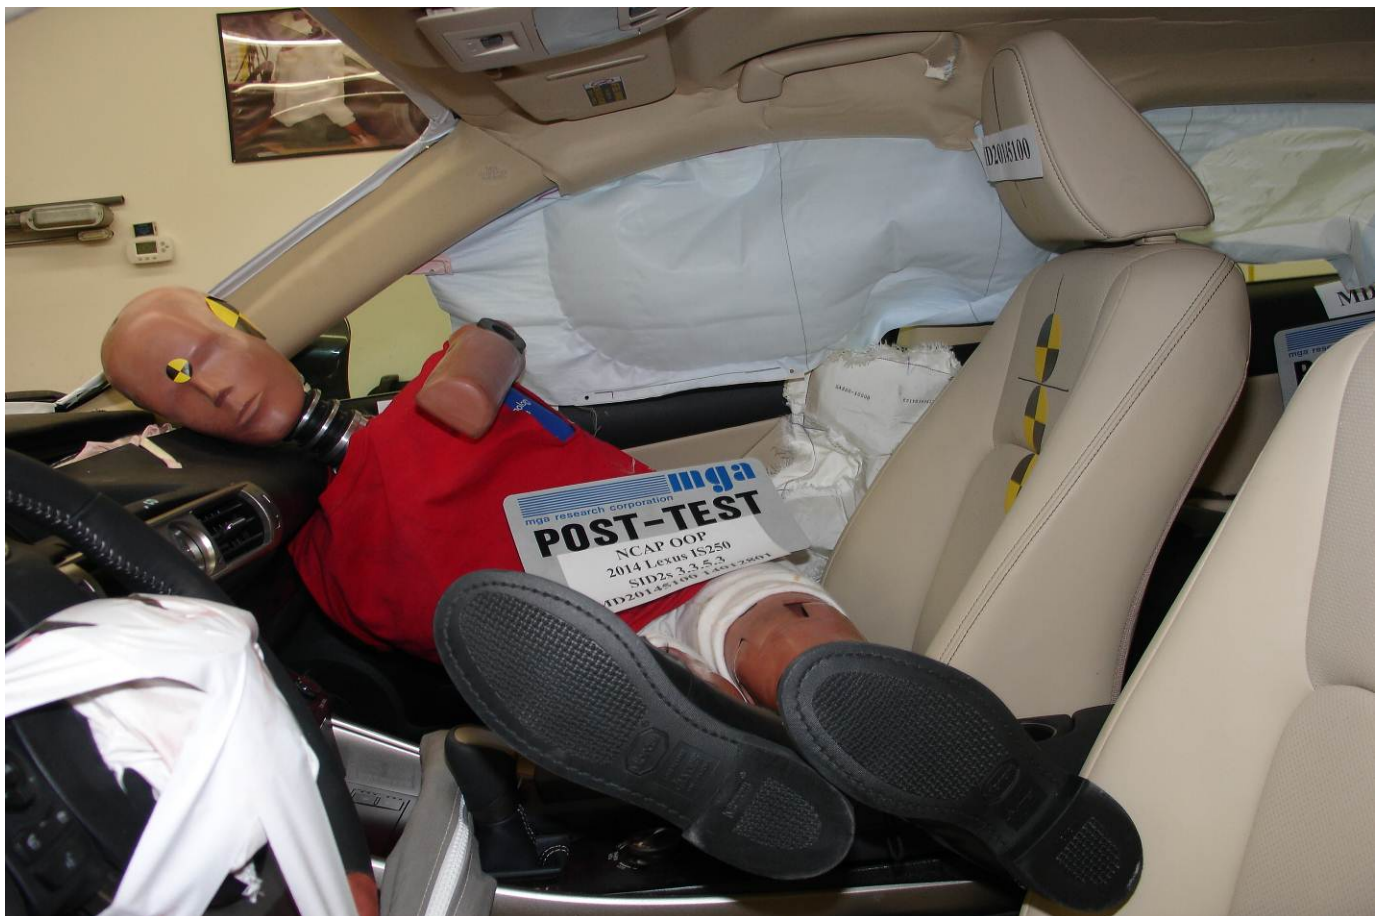
Post-Test SID-IIs Dummy Left Side View

- Curtain airbag to top and back of head
- Torso bag to left torso and left pelvis

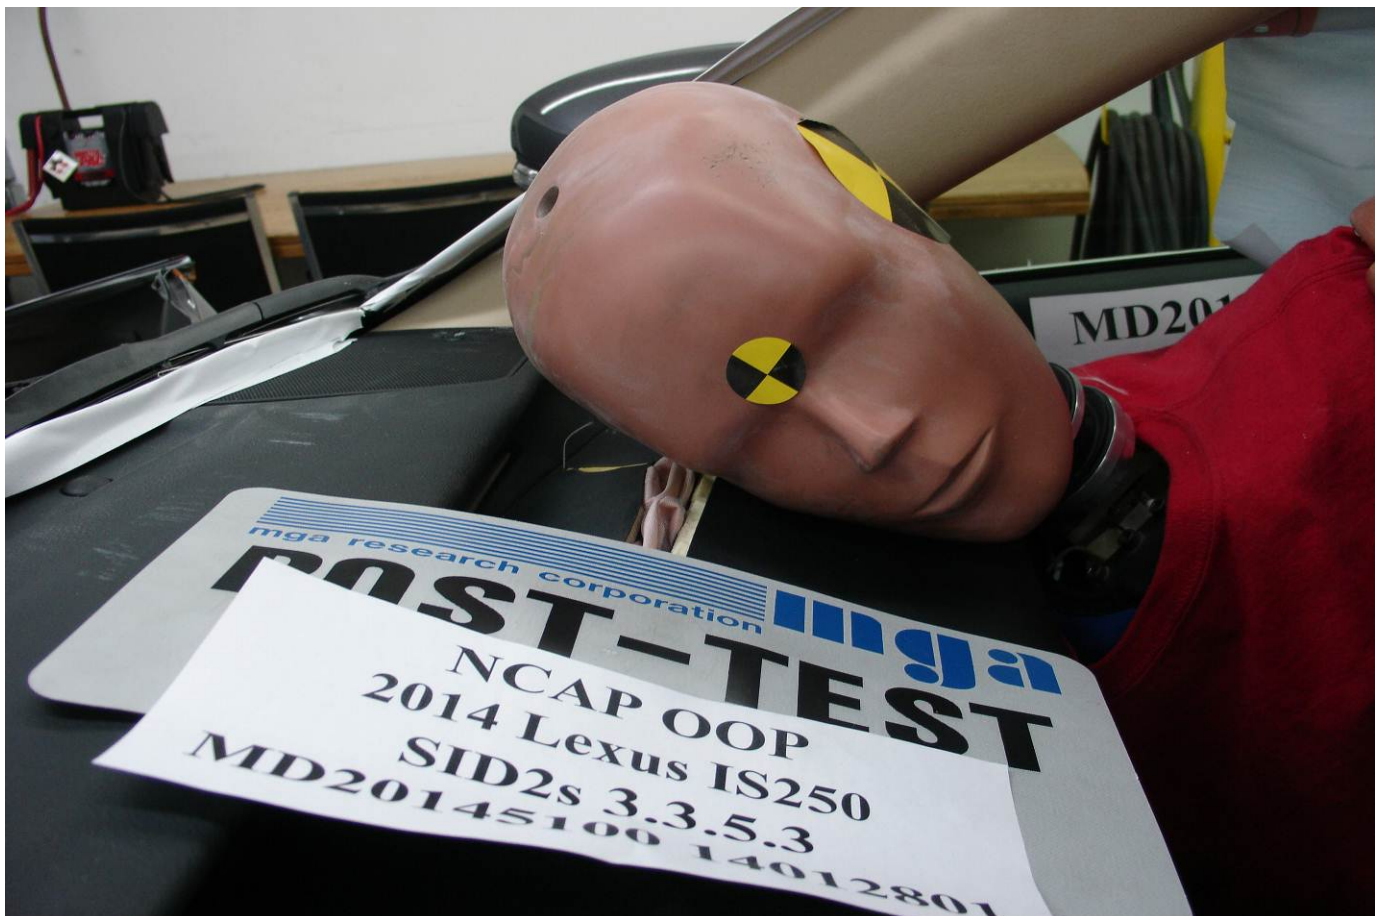
Post-Test SID-IIs Dummy Left Side Closeup View

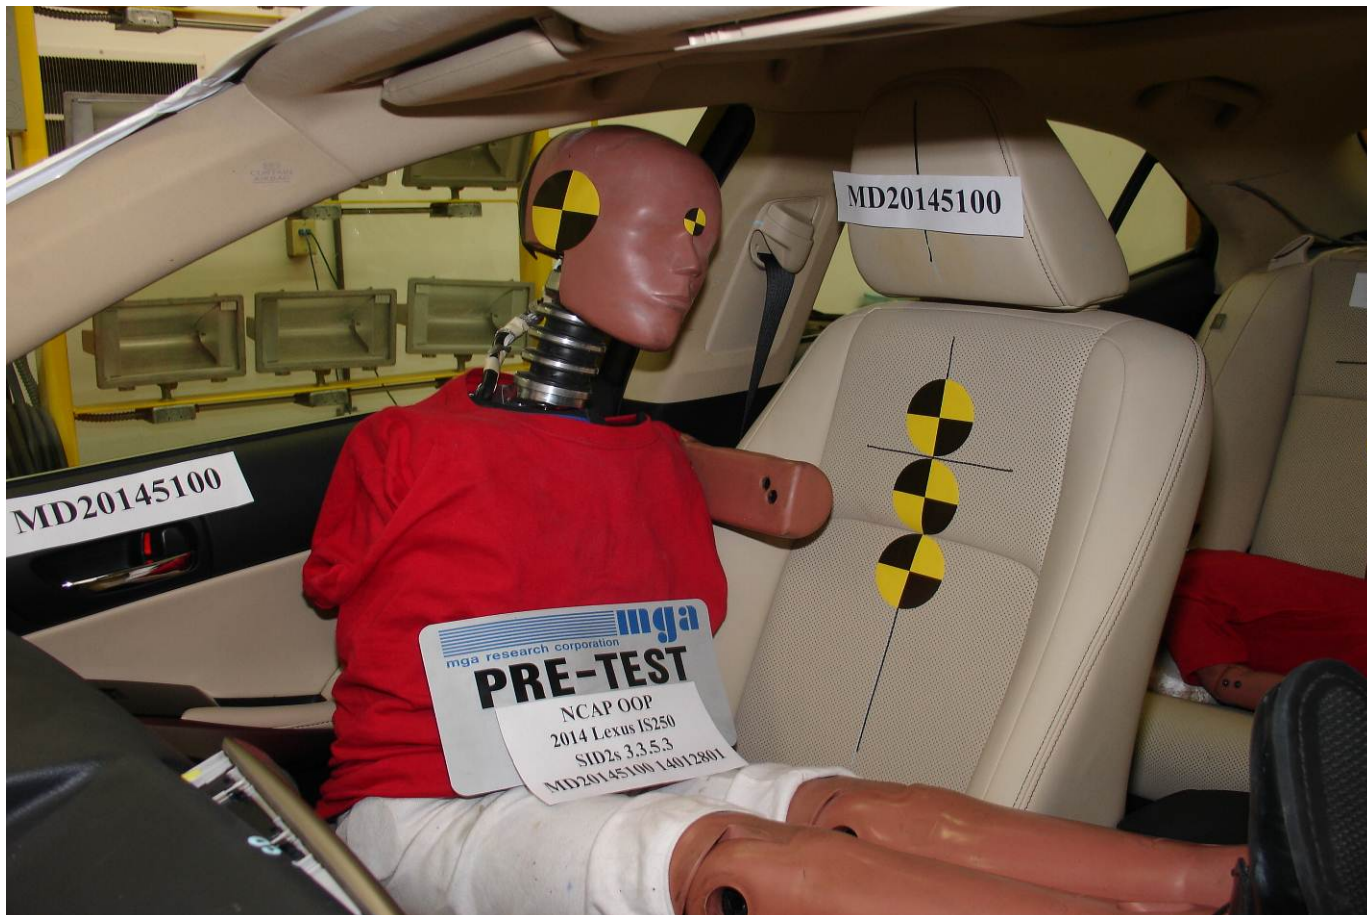
Pre-Test SID-IIs Dummy Left ¾ Front View

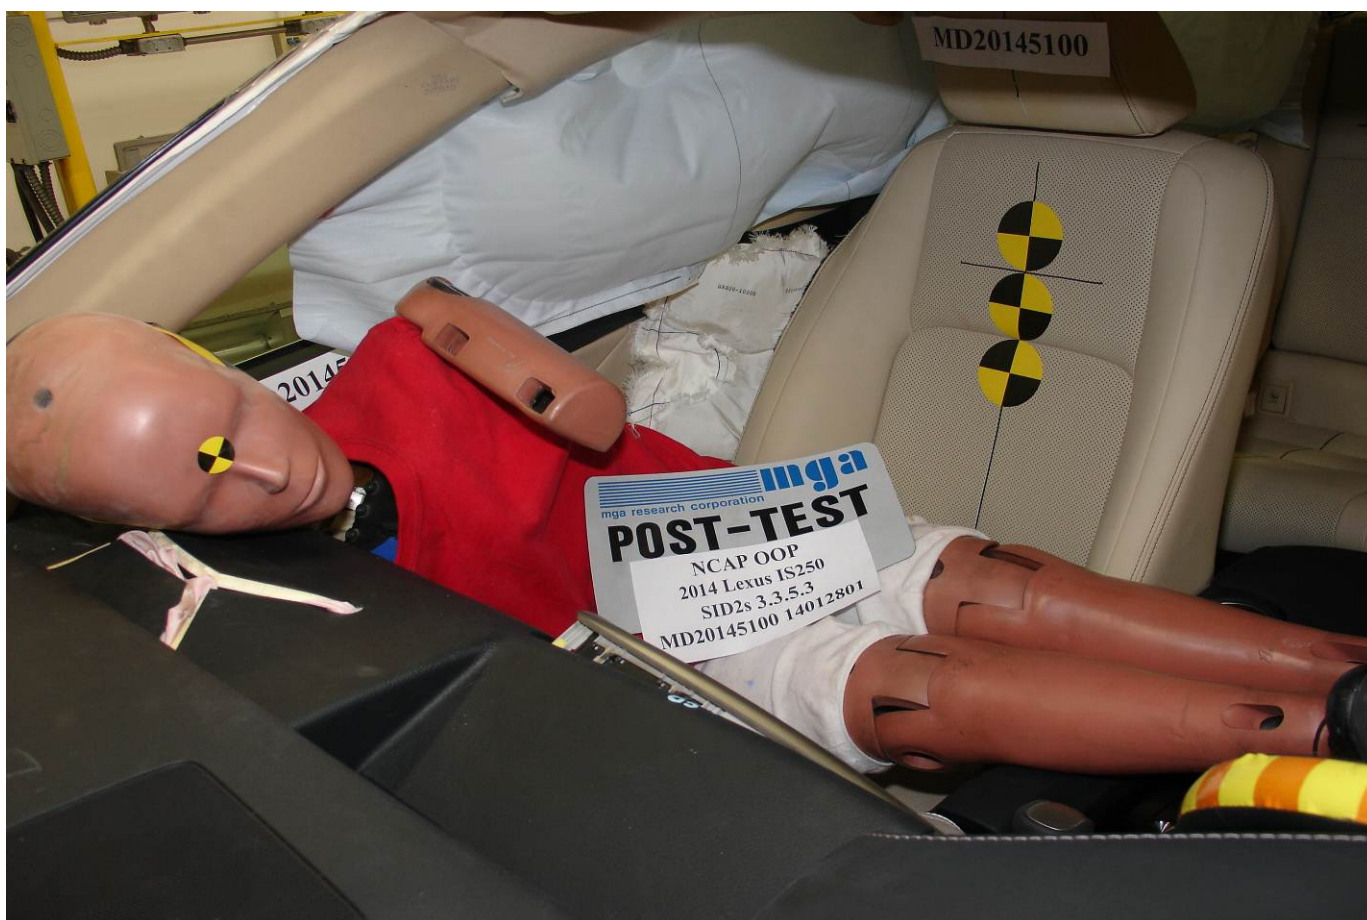
Post-Test SID-IIs Dummy Left ¾ Front View

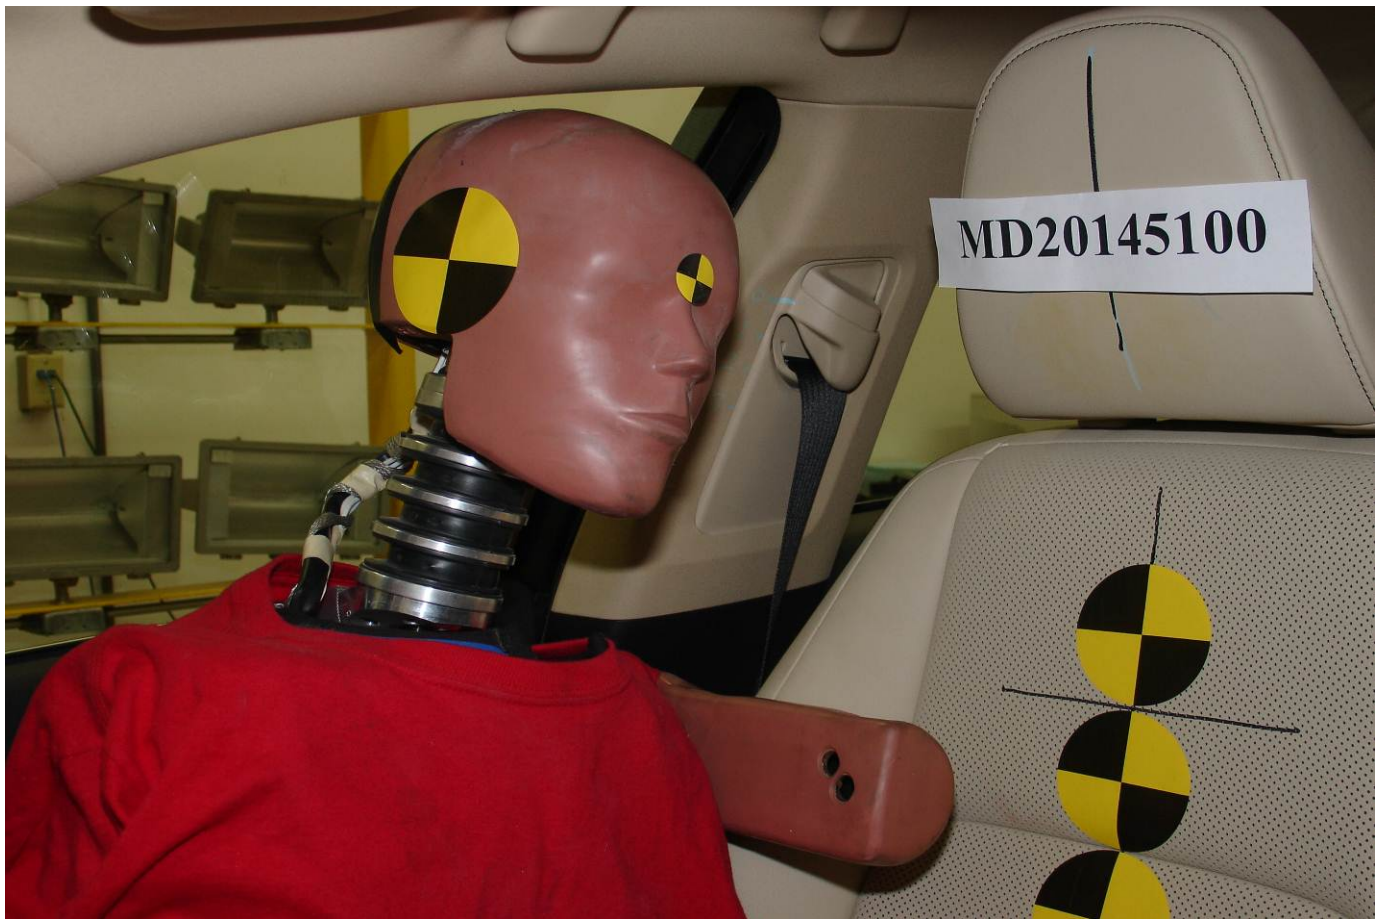
Pre-Test SID-IIs Dummy Left ¾ Front Closeup View

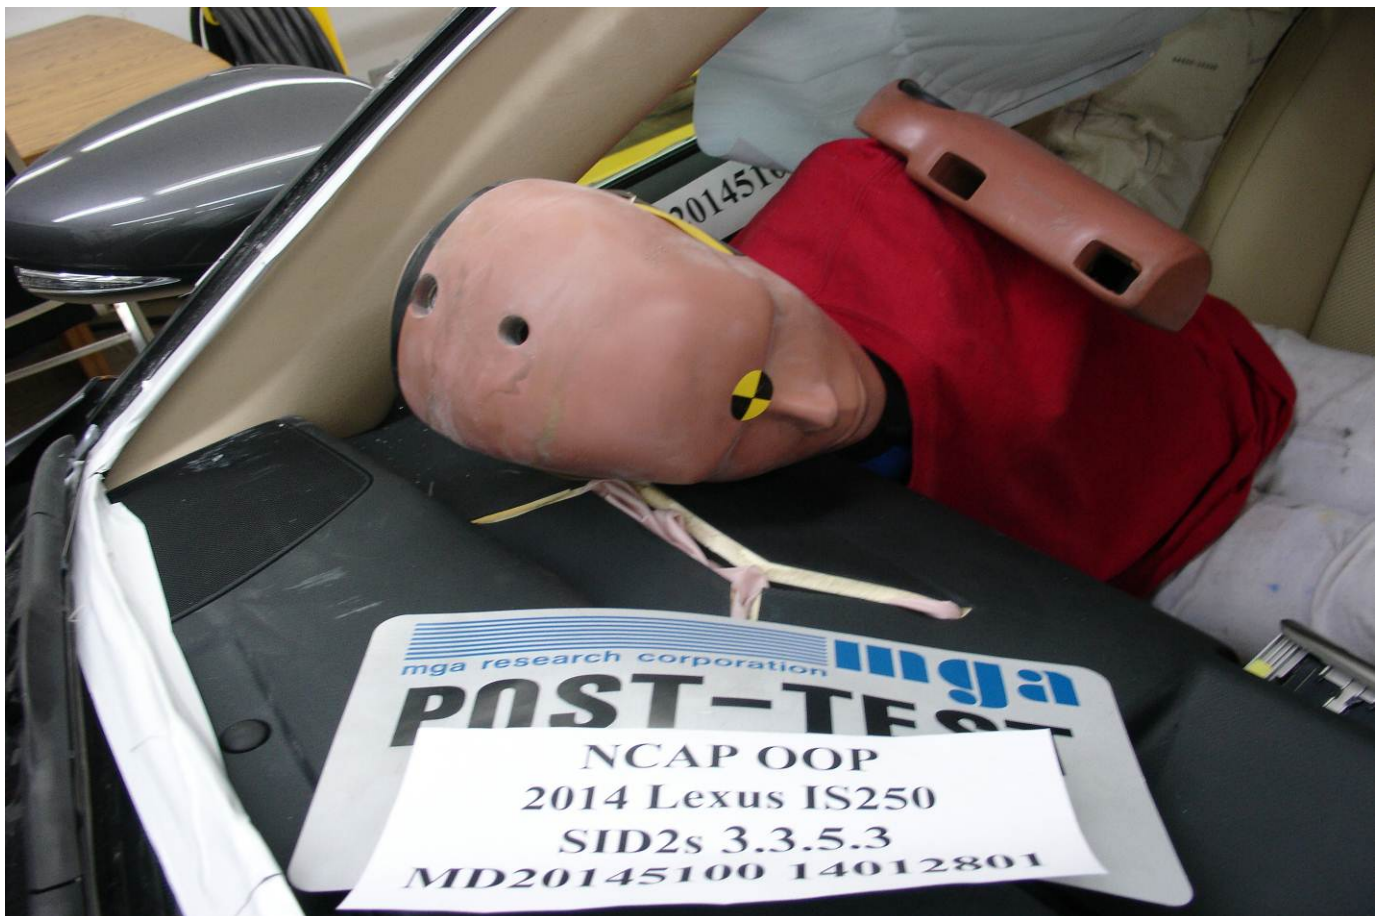
Post-Test SID-IIs Dummy Left ¾ Front Closeup View

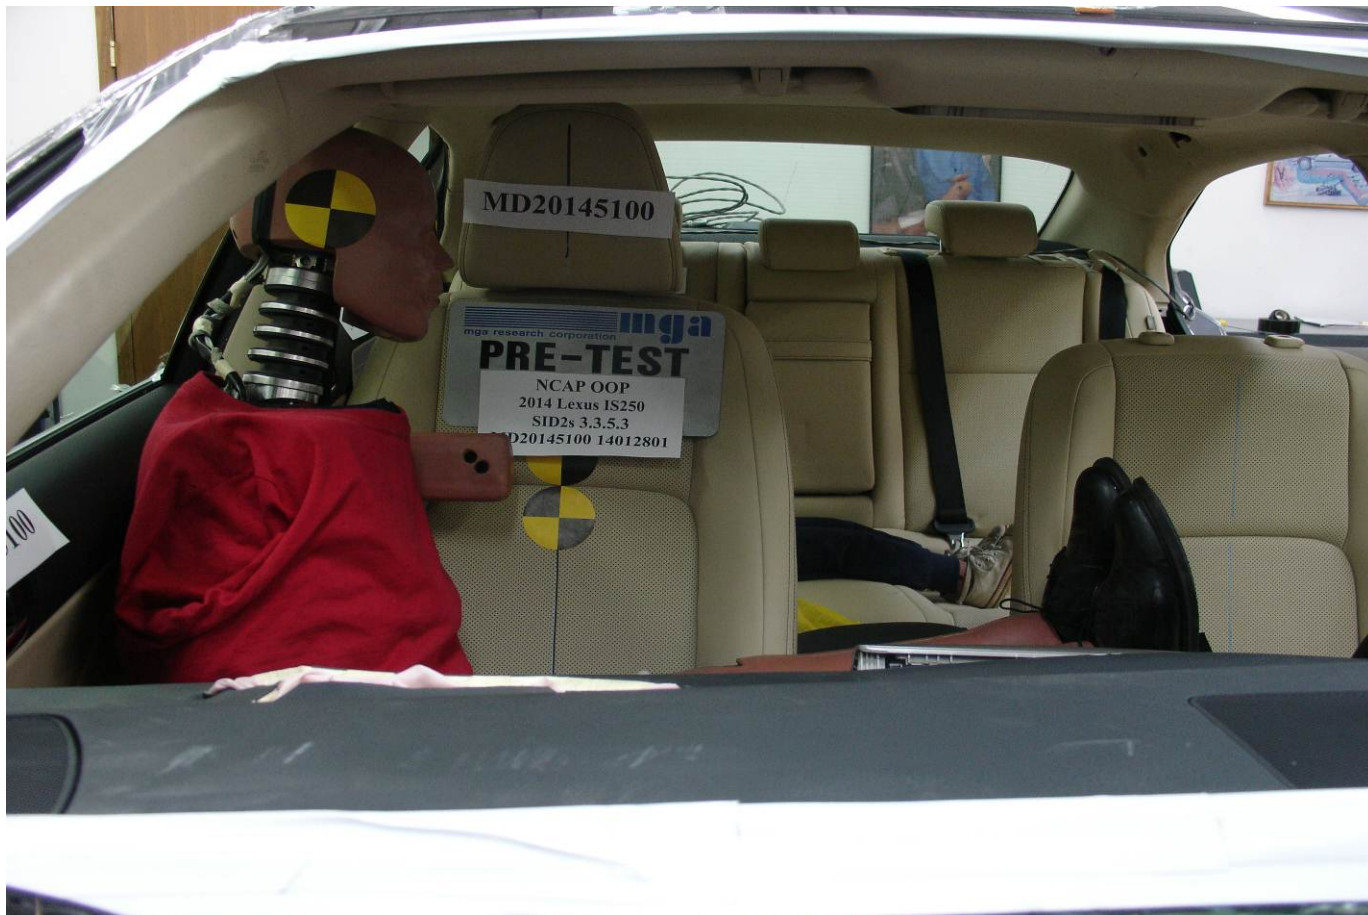
Pre-Test SID-IIs Dummy Front View

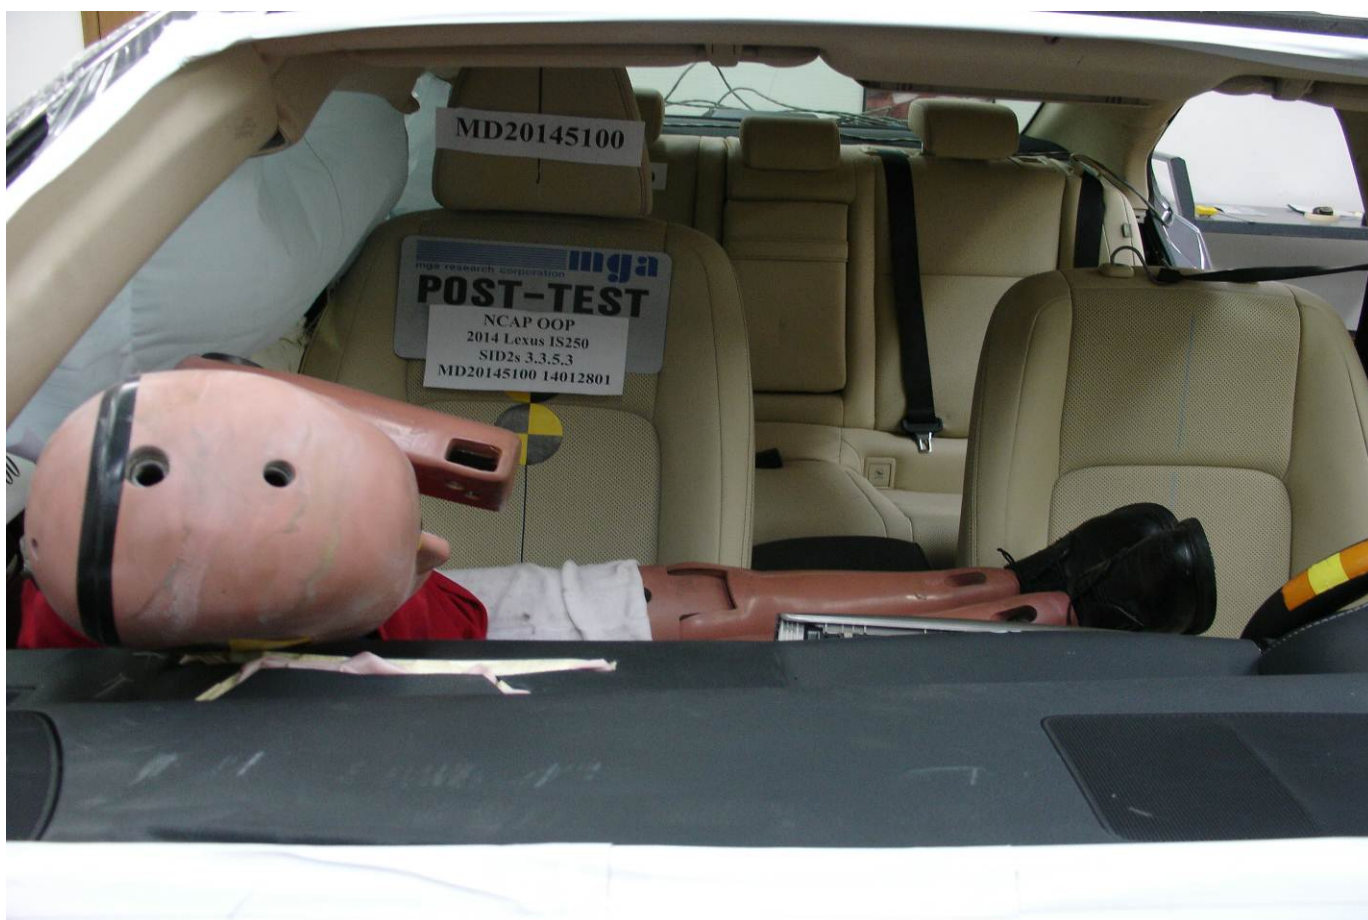
Post-Test SID-IIs Dummy Front View

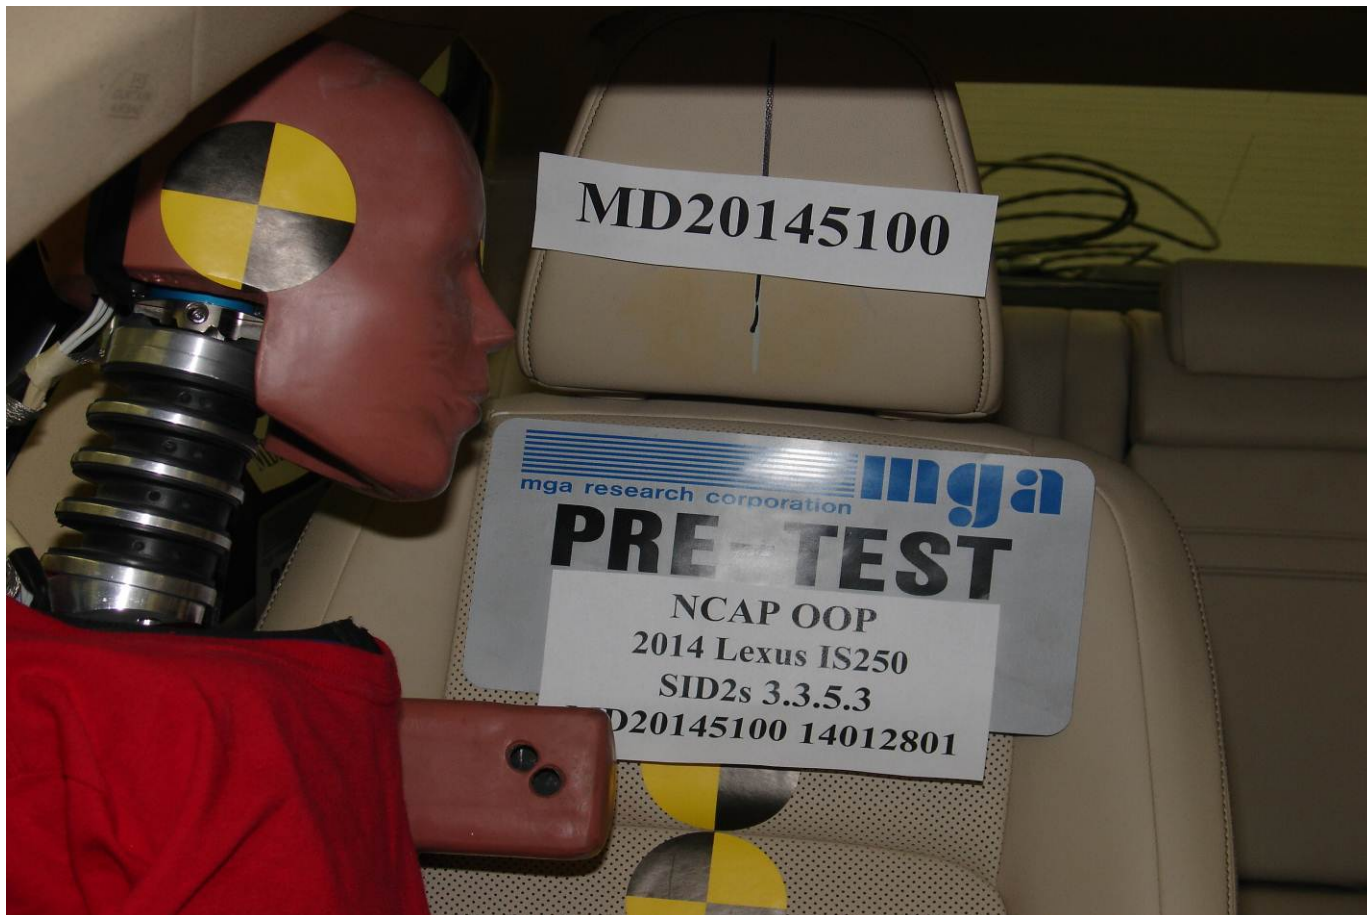
Pre-Test SID-IIs Dummy Front Closeup View

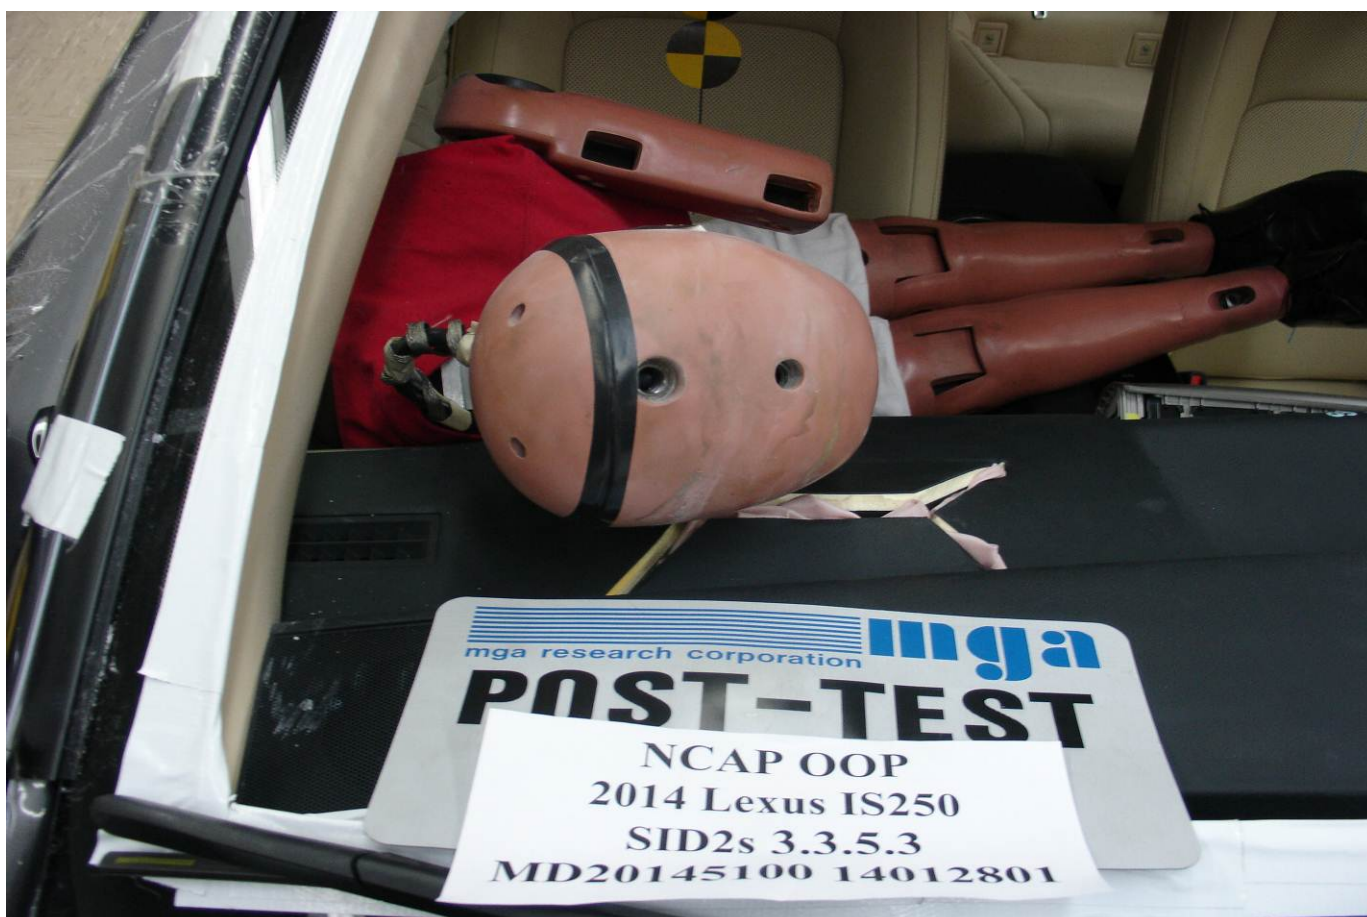
Post-Test SID-IIs Dummy Front Closeup View

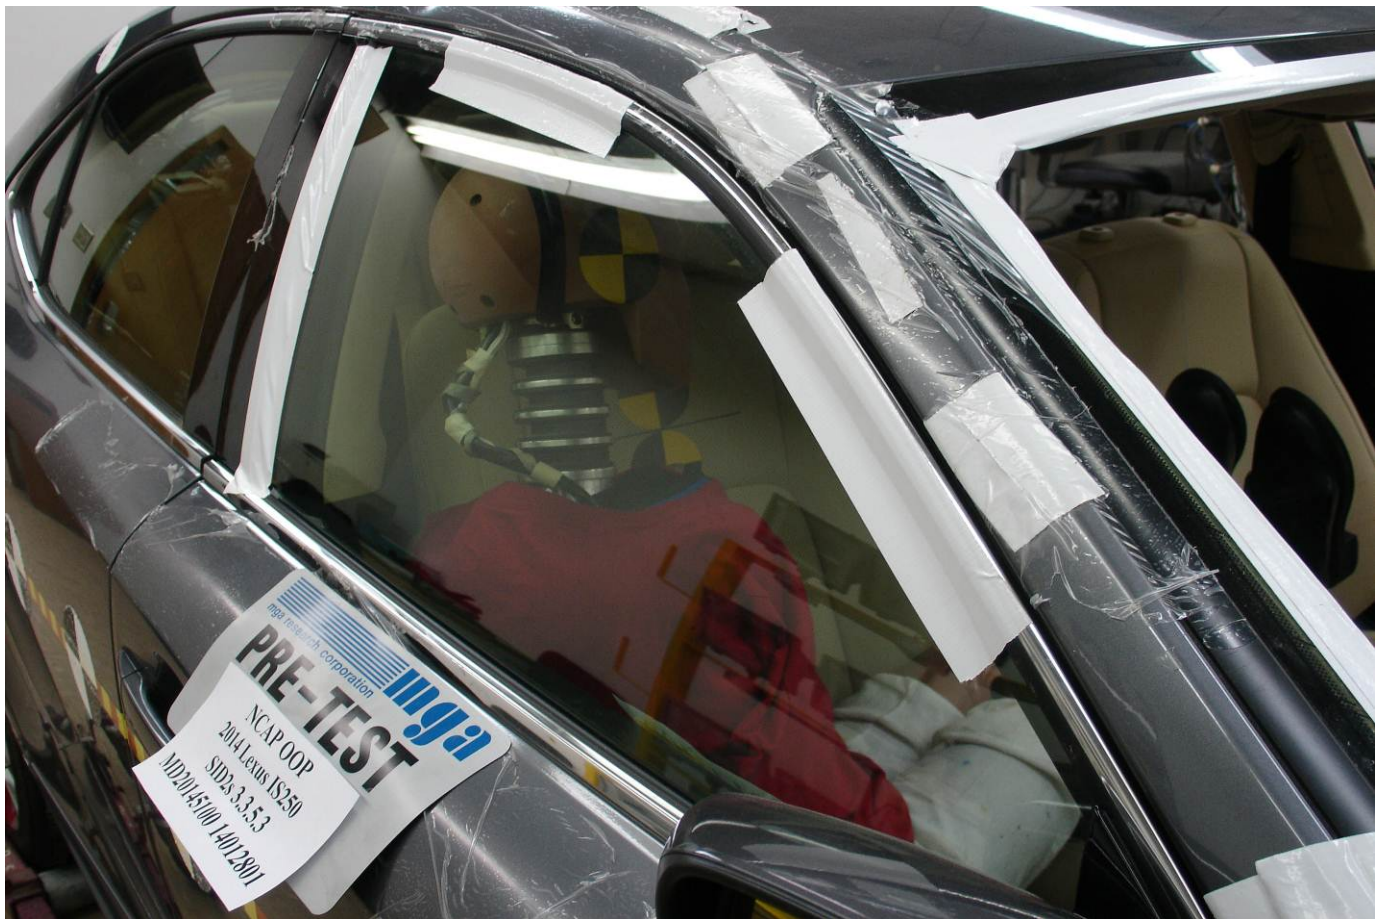
Pre-Test SID-IIs Dummy Right ¾ Front View

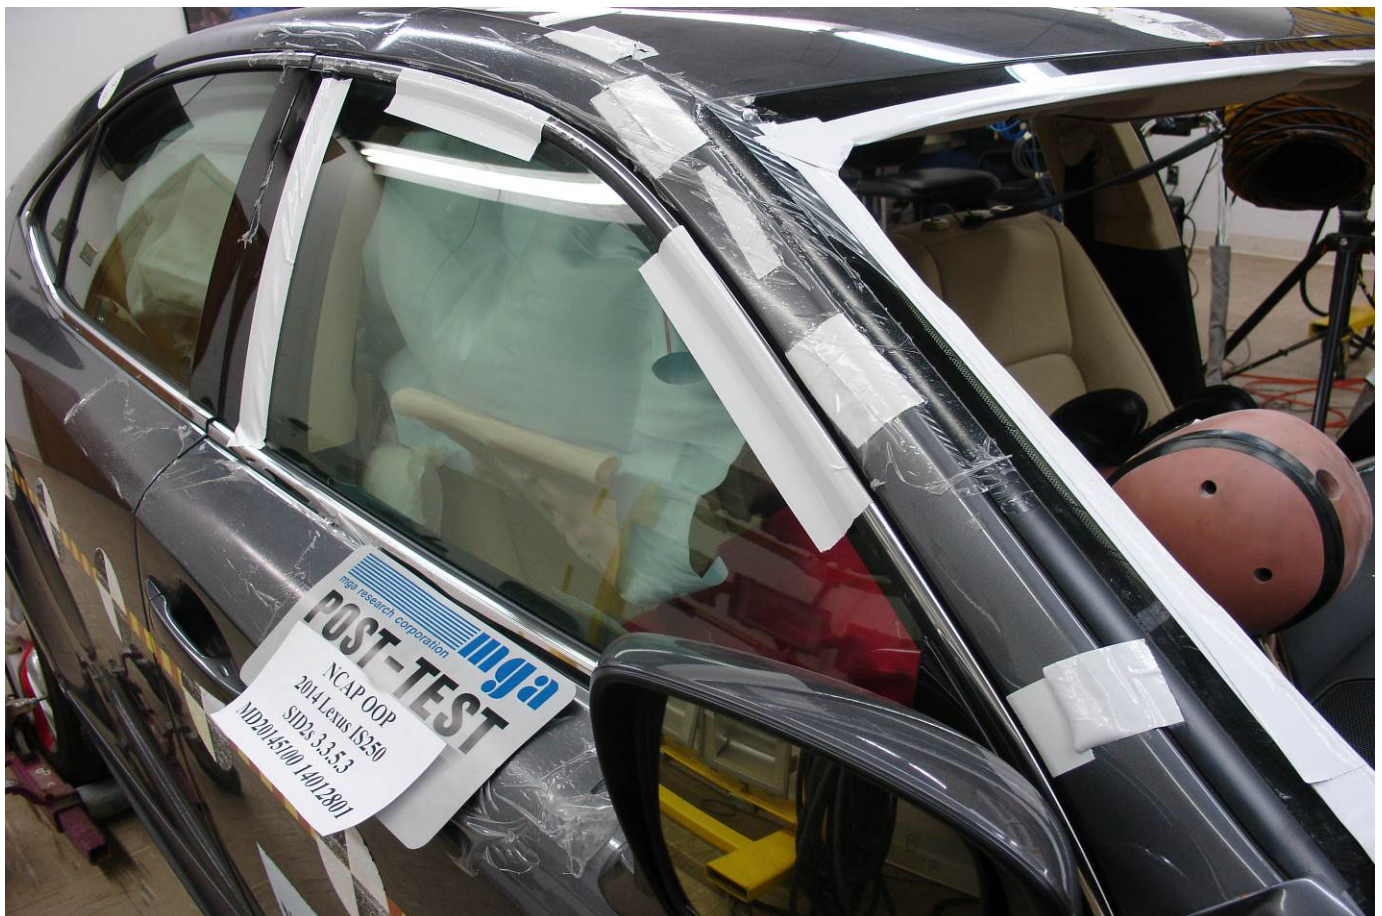
Post-Test SID-IIs Dummy Right ¾ Front View

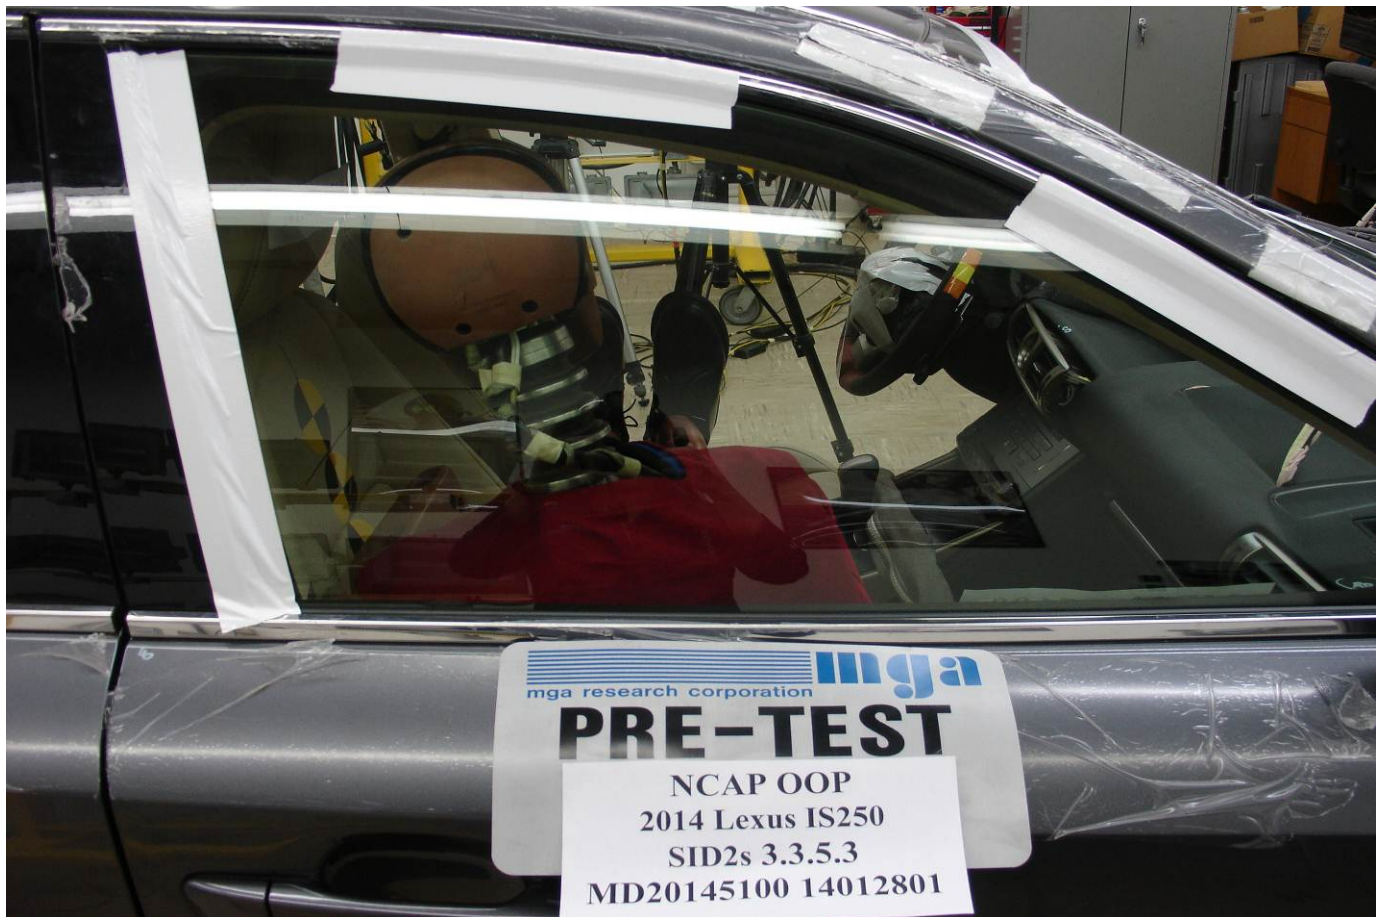
Pre-Test SID-IIs Dummy Right Side View

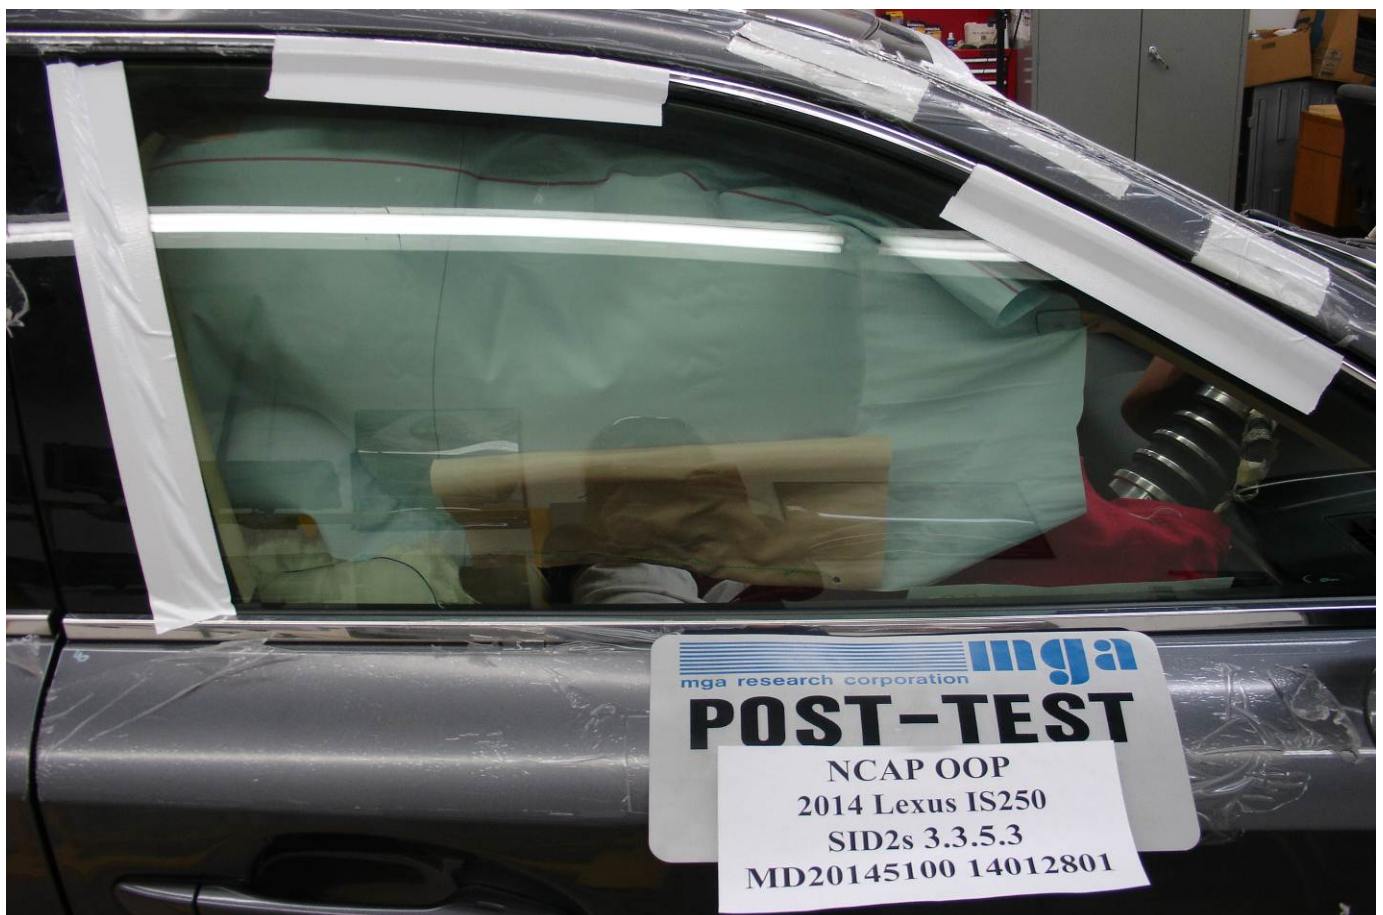
Post-Test SID-IIs Dummy Right Side View

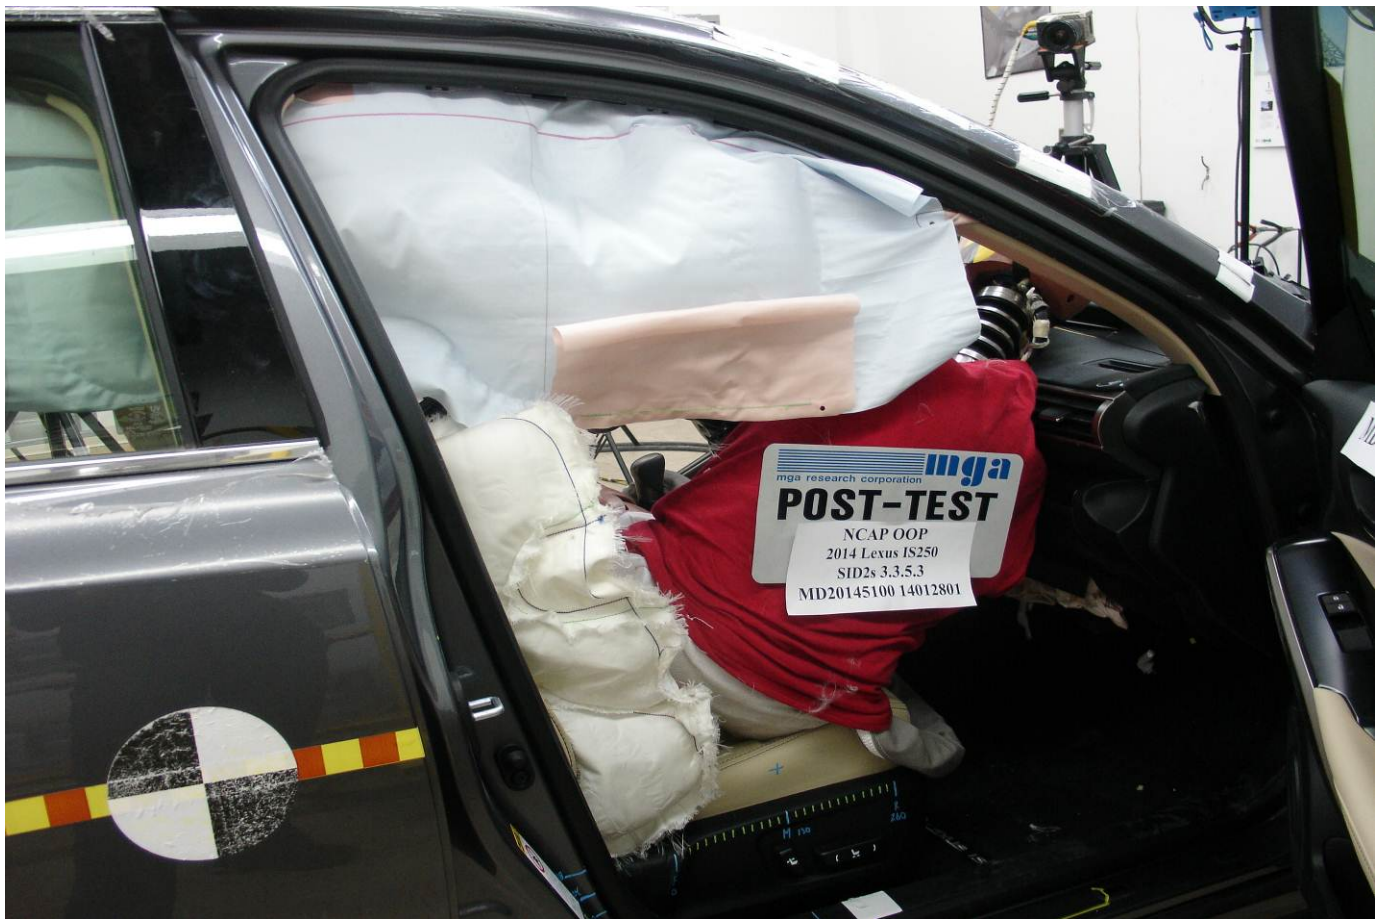
Post-Test SID-II's Dummy Right Side View (Door Open)

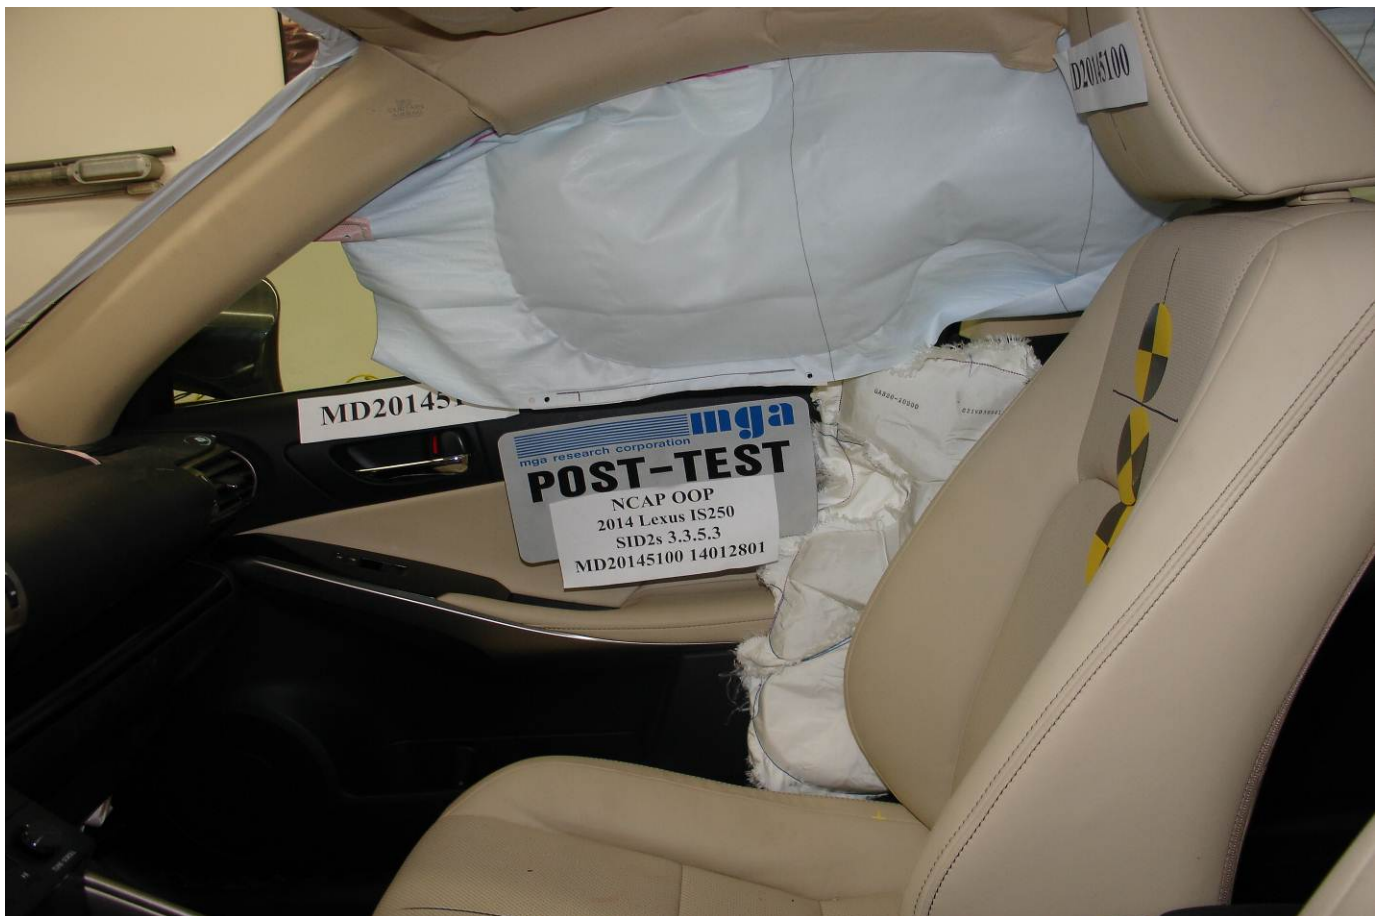
Post-Test Curtain Airbag Left Side View

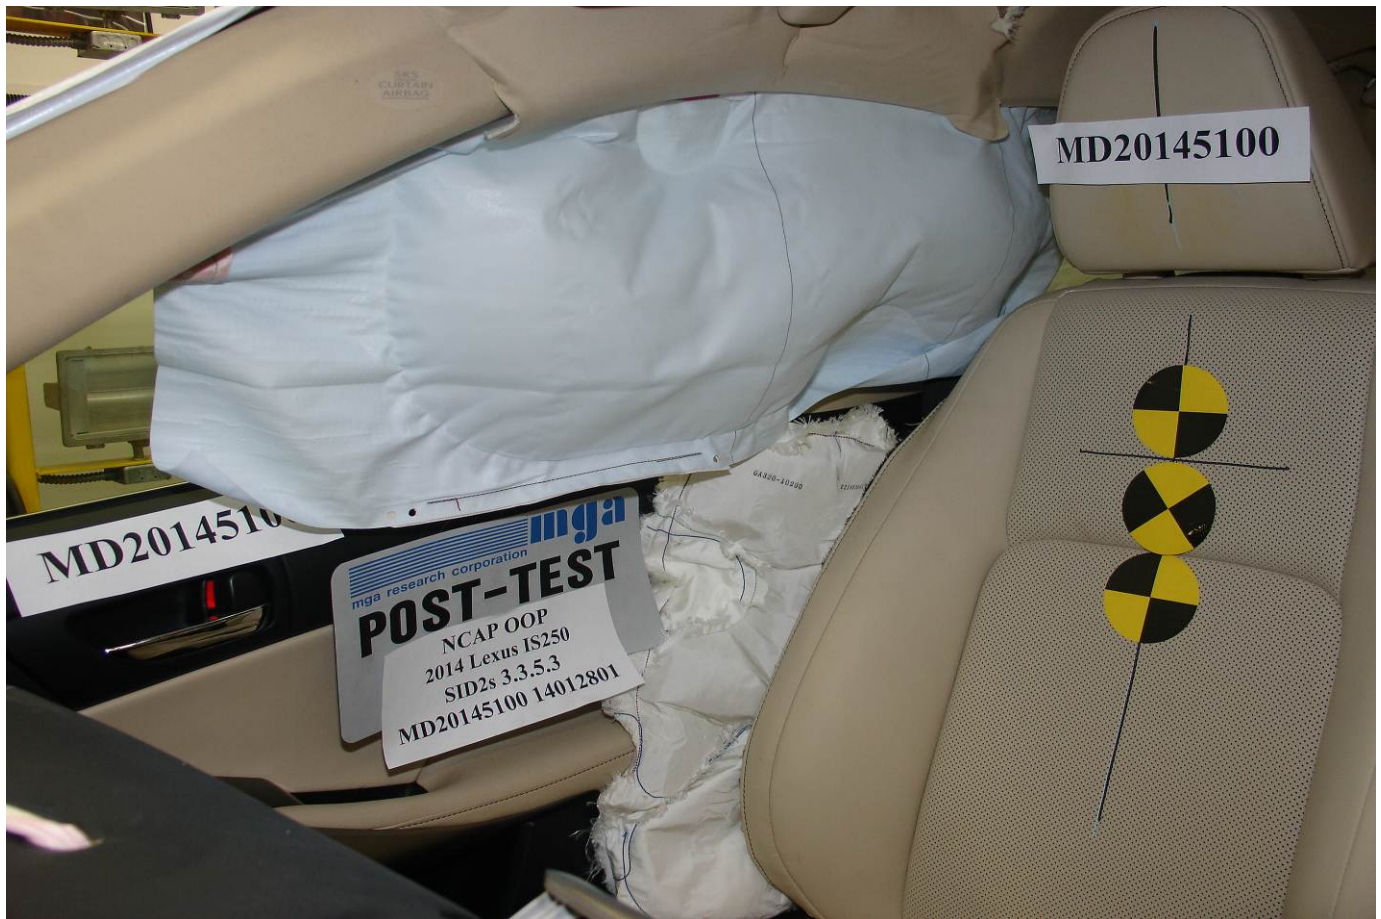
Post-Test Curtain Airbag Left 3/4 Front View

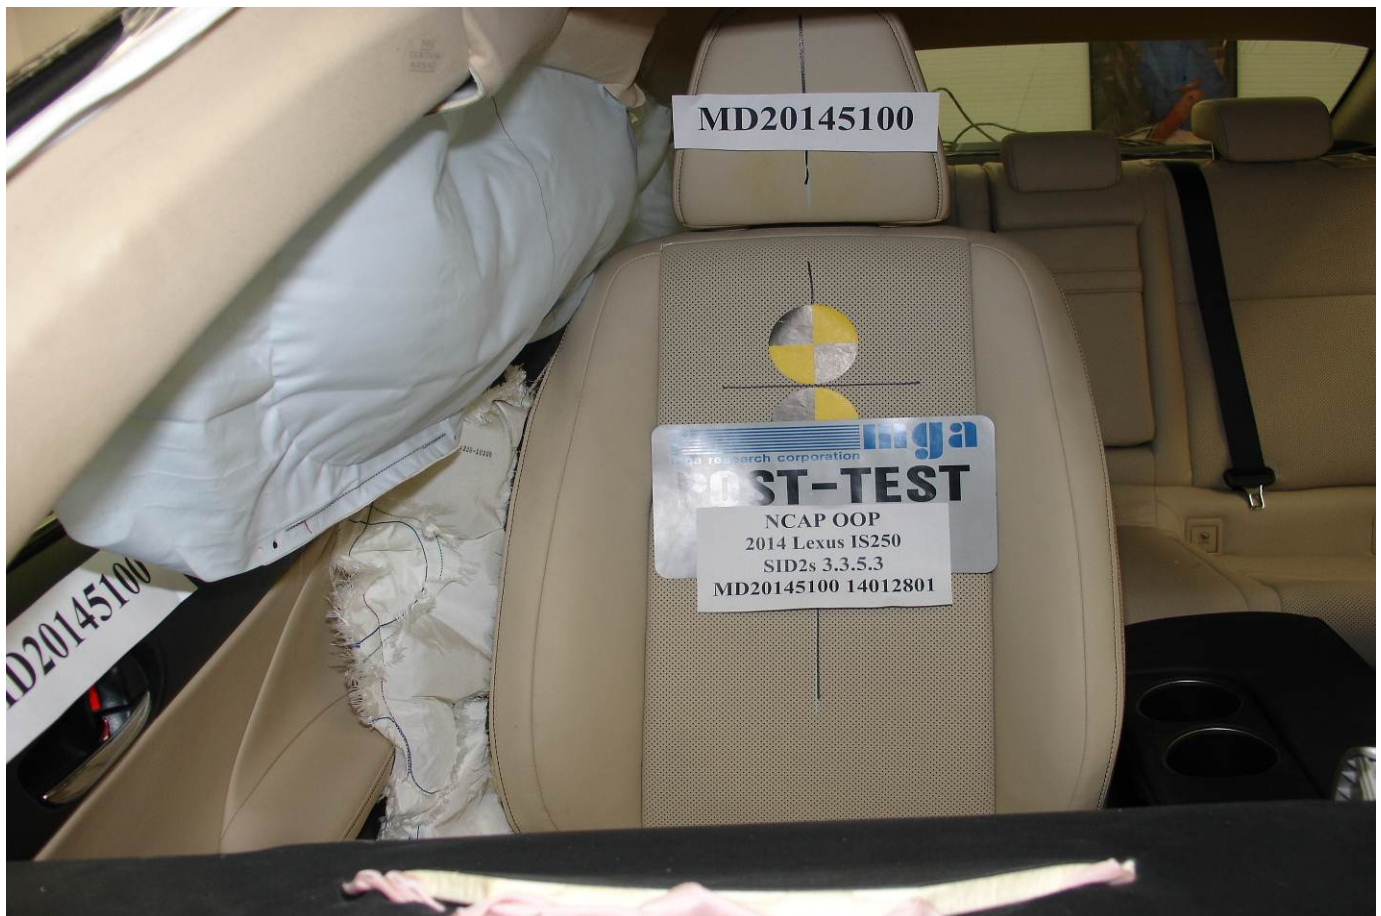
Post-Test Curtain Airbag Front View
