**REPORT NUMBER: TWG-MGA-2014-003**

**SIDE AIRBAG OUT-OF-POSITION INJURY  
TECHNICAL WORKING GROUP**

**TOYOTA MOTOR CORPORATION  
2014 Lexus IS250 AWD 4-Dr Sedan  
NHTSA No.: M20145100TWG2**

**FINAL REPORT**

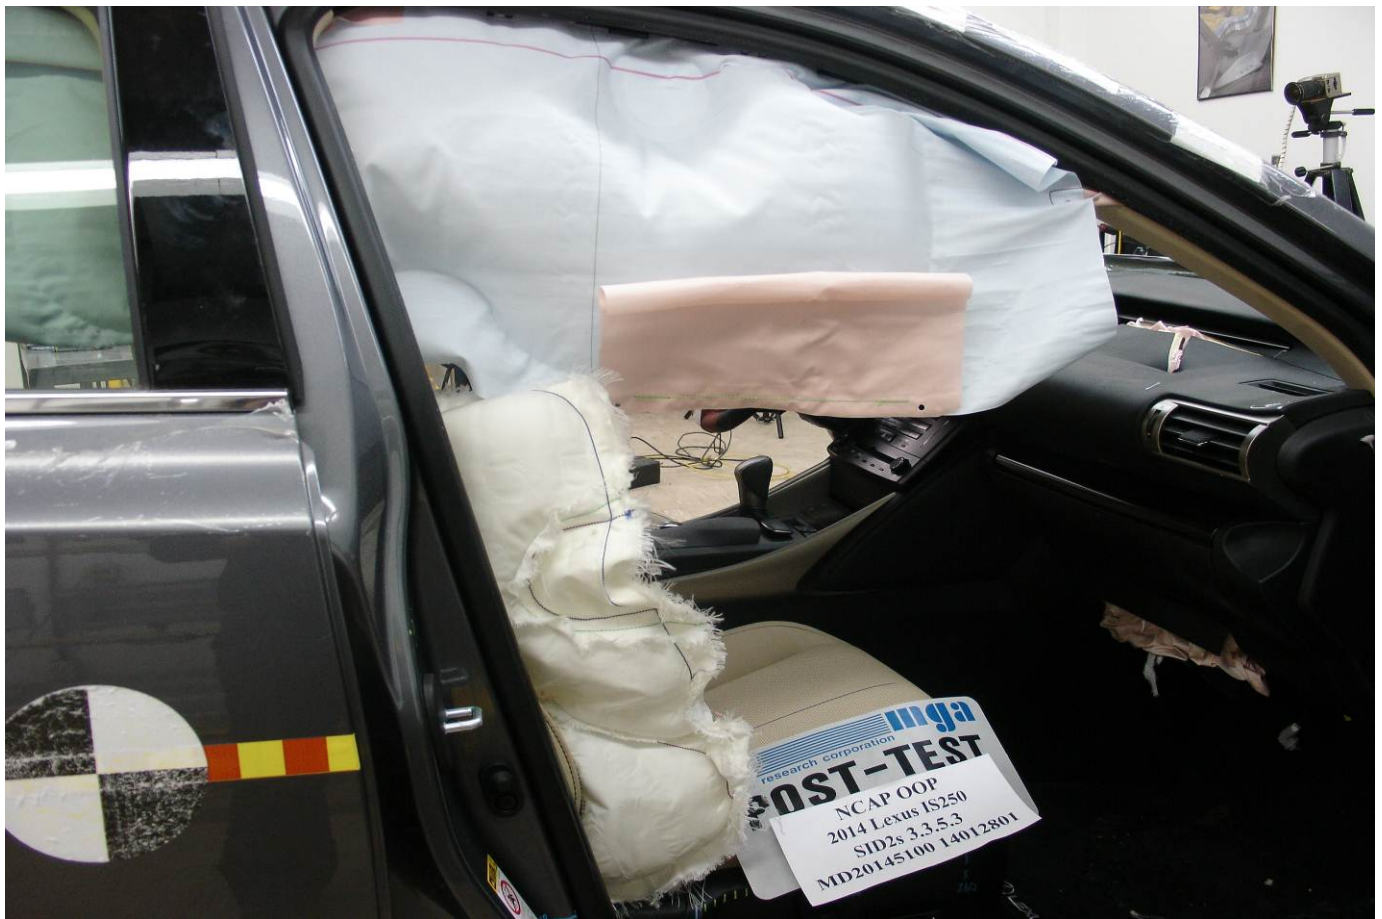
Post-Test Curtain Airbag Right Side View (Door Open)

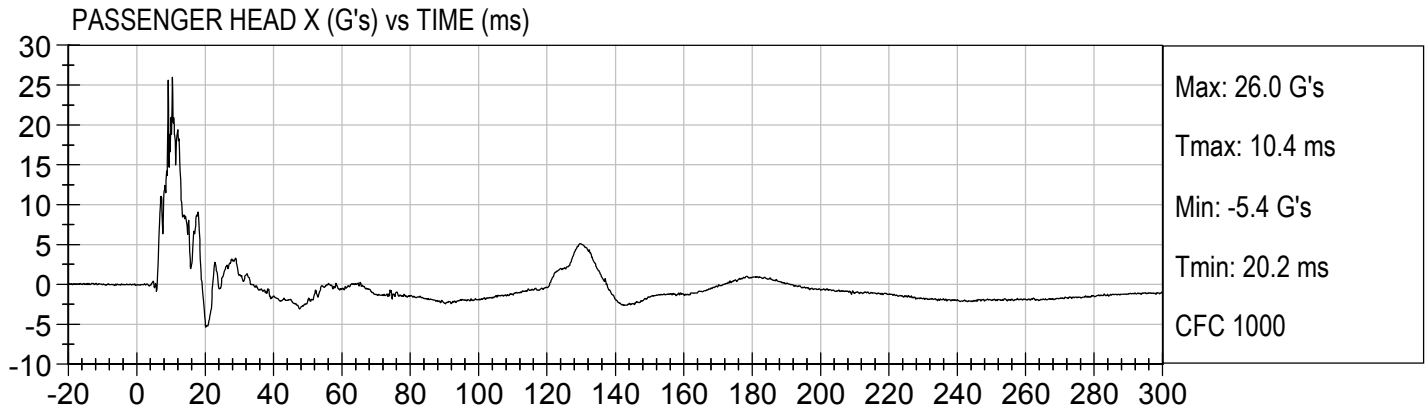
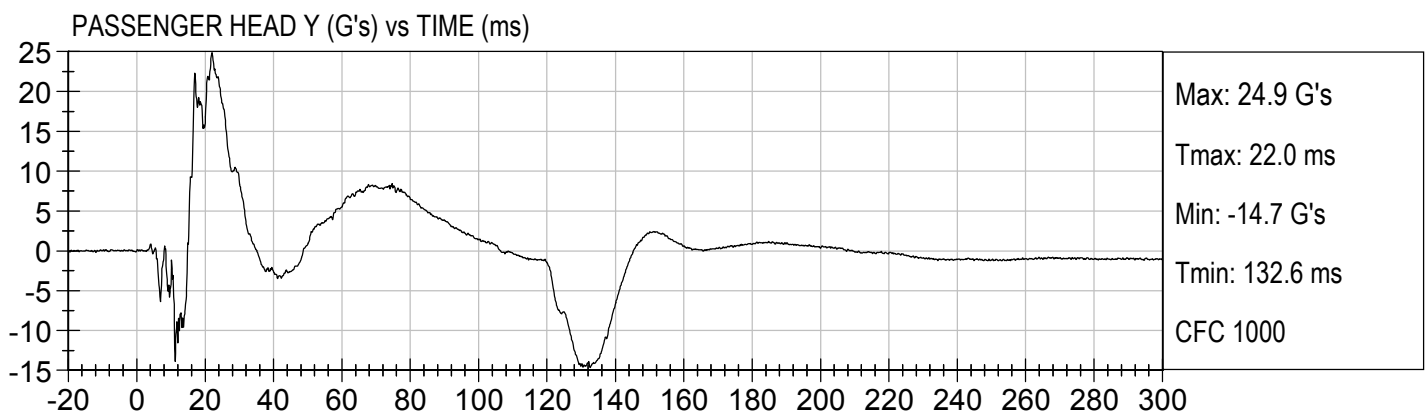
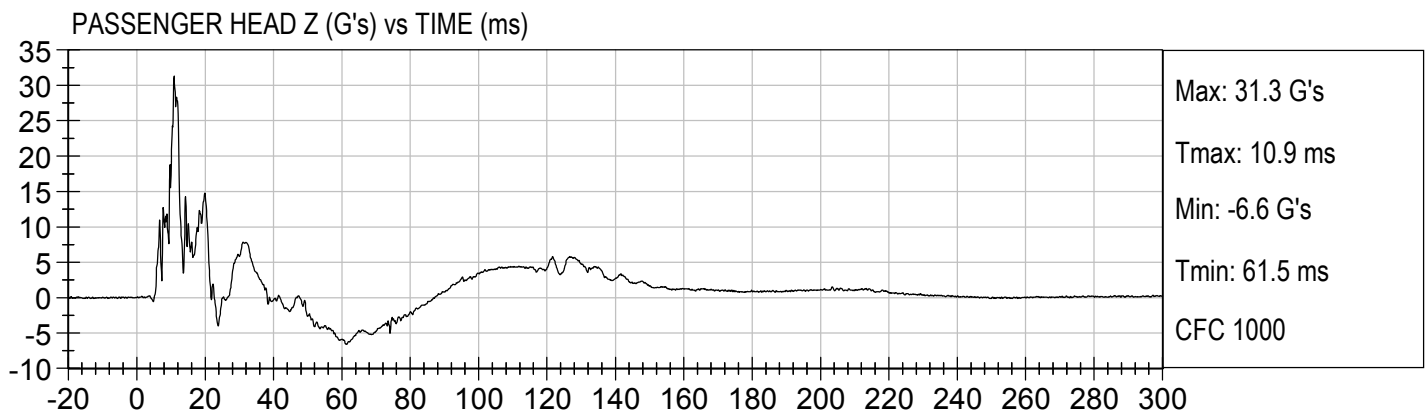
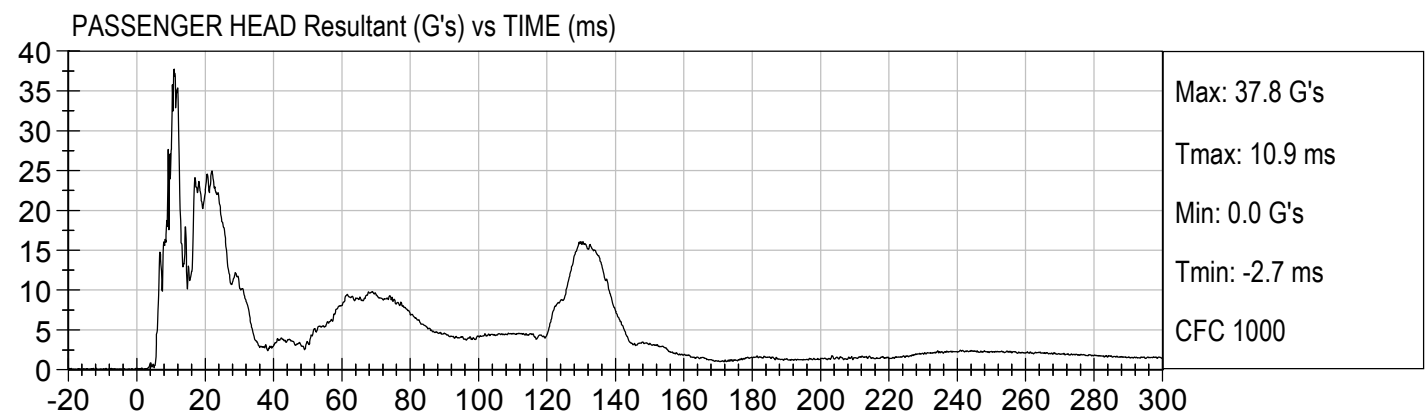
| | | <u>Page No.</u> |
|---|---|---|
| Figure No. 1. | Passenger Head X Acceleration vs. Time | 23 |
| Figure No. 2. | Passenger Head Y Acceleration vs. Time | 23 |
| Figure No. 3. | Passenger Head Z Acceleration vs. Time | 23 |
| Figure No. 4. | Passenger Head Resultant Acceleration vs. Time | 23 |

| | | MAXIMUM VALUE | | | |
|---|---|---|---|---|---|
| Head X | g | 26.0 | 10.4 | -5.4 | 20.2 |
| Head Y | g | 24.9 | 22.0 | -14.7 | 132.6 |
| Head Z | g | 31.3 | 10.9 | -6.6 | 61.5 |
| Head Resultant | g | 37.8 | 10.9 | | |

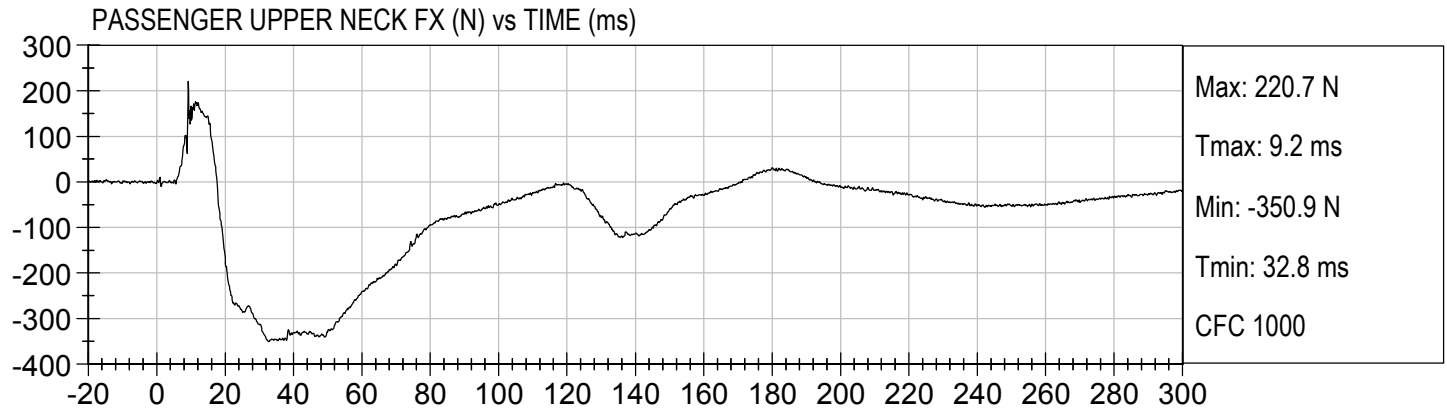
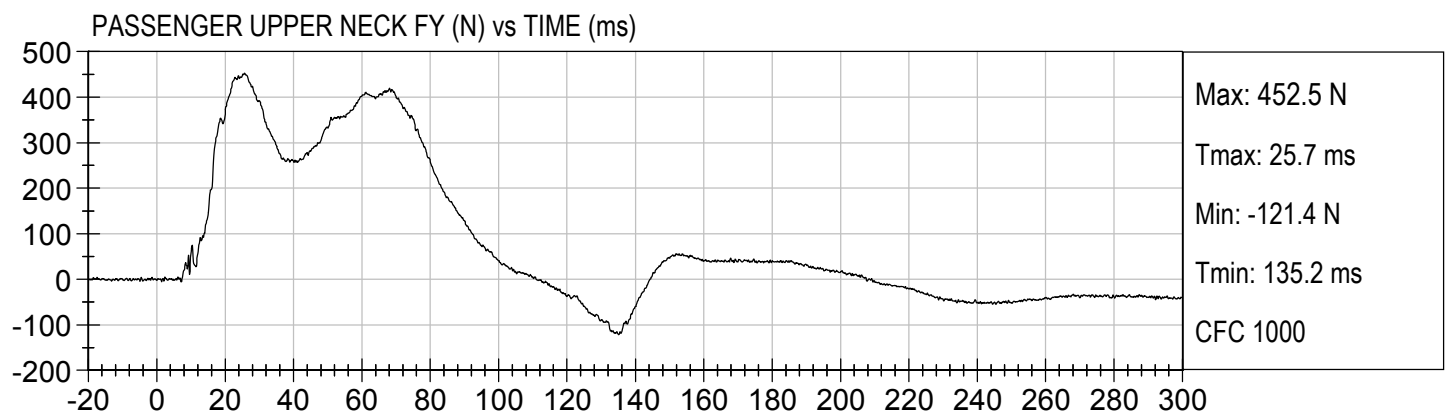
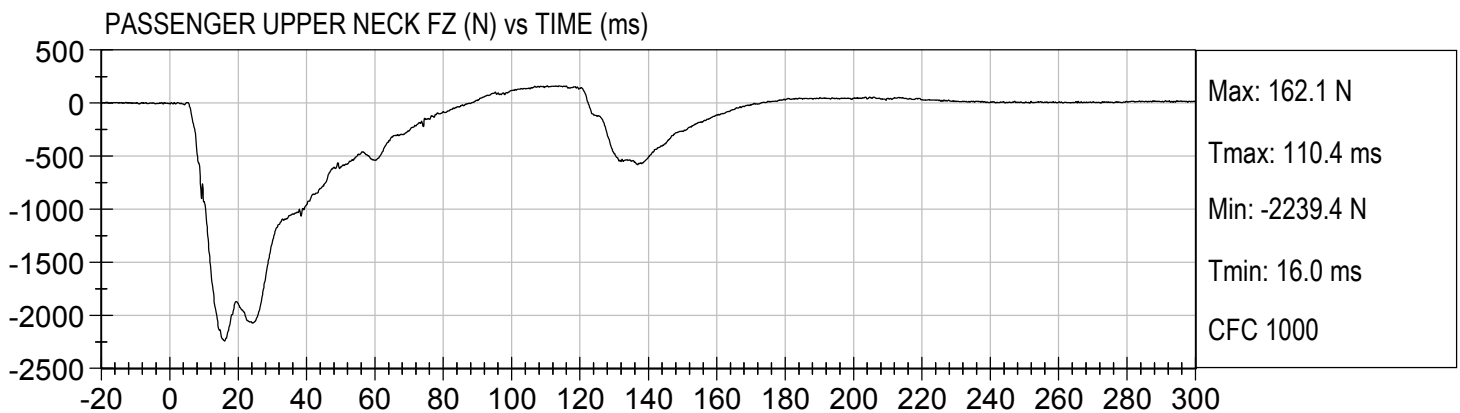
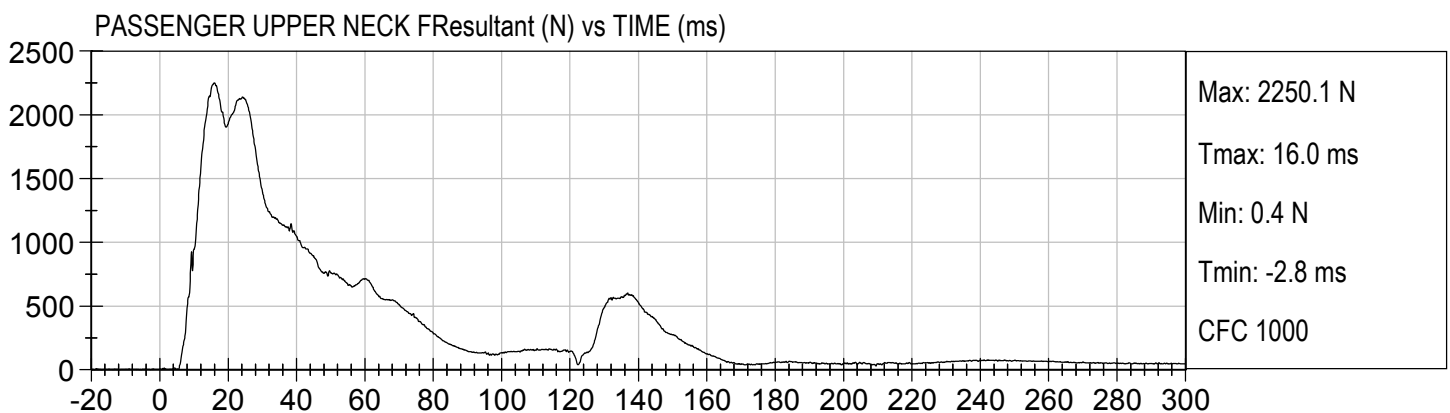
| | | <u>Page No.</u> |
|---|---|---|
| Figure No. 5. | Passenger Upper Neck X Force vs. Time | 24 |
| Figure No. 6. | Passenger Upper Neck Y Force vs. Time | 24 |
| Figure No. 7. | Passenger Upper Neck Z Force vs. Time | 24 |
| Figure No. 8. | Passenger Upper Neck Resultant Force vs. Time | 24 |

| | | MAXIMUM VALUE | | | |
|---|---|---|---|---|---|
| Upper Neck Fx | N | 220.7 | 9.2 | -350.9 | 32.8 |
| Upper Neck Fy | N | 452.5 | 25.7 | -121.4 | 135.2 |
| Upper Neck Fz | N | 162.1 | 110.4 | -2239.4 | 16.0 |
| Upper Neck F Resultant | N | 2250.1 | 16.0 | | |

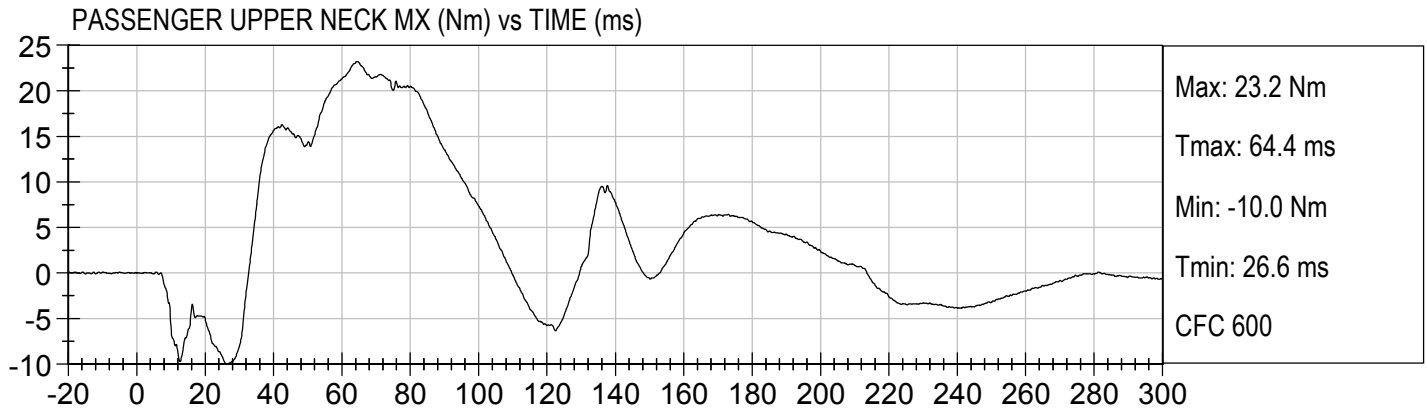
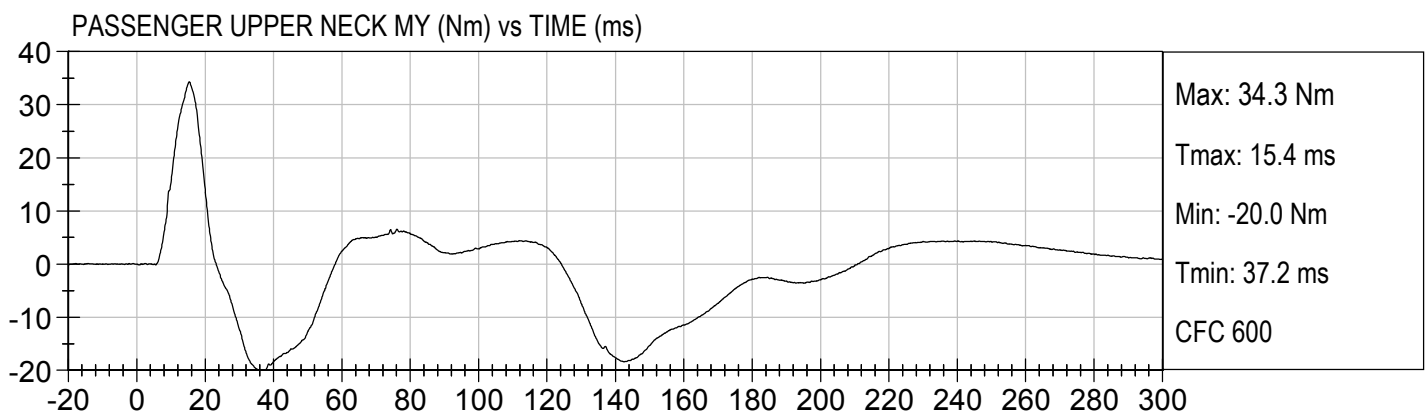
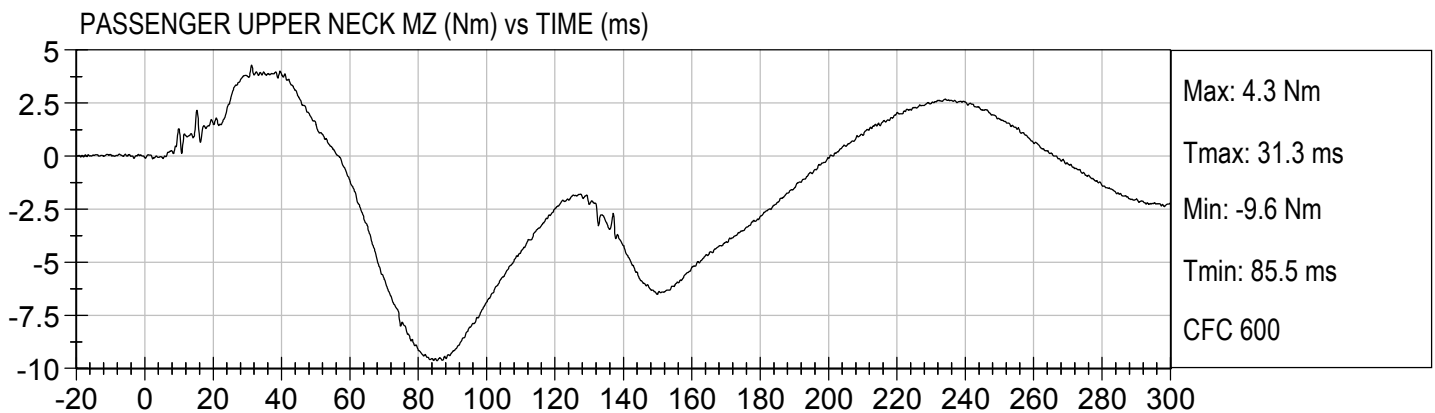
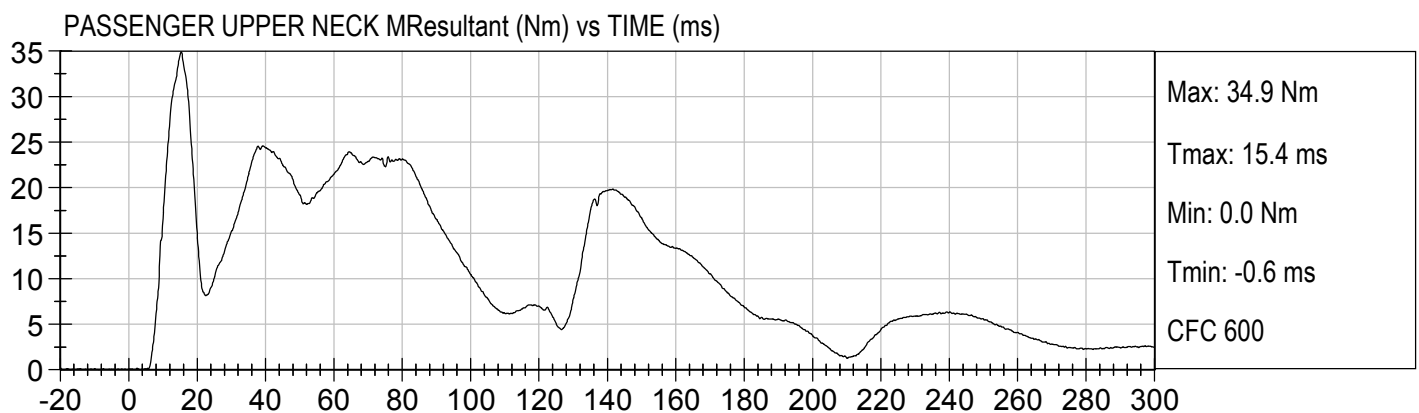
| | | <u>Page No.</u> |
|---|---|---|
| Figure No. 9. | Passenger Upper Neck X Moment vs. Time | 25 |
| Figure No. 10. | Passenger Upper Neck Y Moment vs. Time | 25 |
| Figure No. 11. | Passenger Upper Neck Z Moment vs. Time | 25 |
| Figure No. 12. | Passenger Upper Neck Resultant Moment vs. Time | 25 |

| | | MAXIMUM VALUE | | | |
|---|---|---|---|---|---|
| Upper Neck Mx | Nm | 23.2 | 64.4 | -10.0 | 26.6 |
| Upper Neck My | Nm | 34.3 | 15.4 | -20.0 | 37.2 |
| Upper Neck Mz | Nm | 4.3 | 31.3 | -9.6 | 85.5 |
| Upper Neck M Resultant | Nm | 34.9 | 15.4 | | |

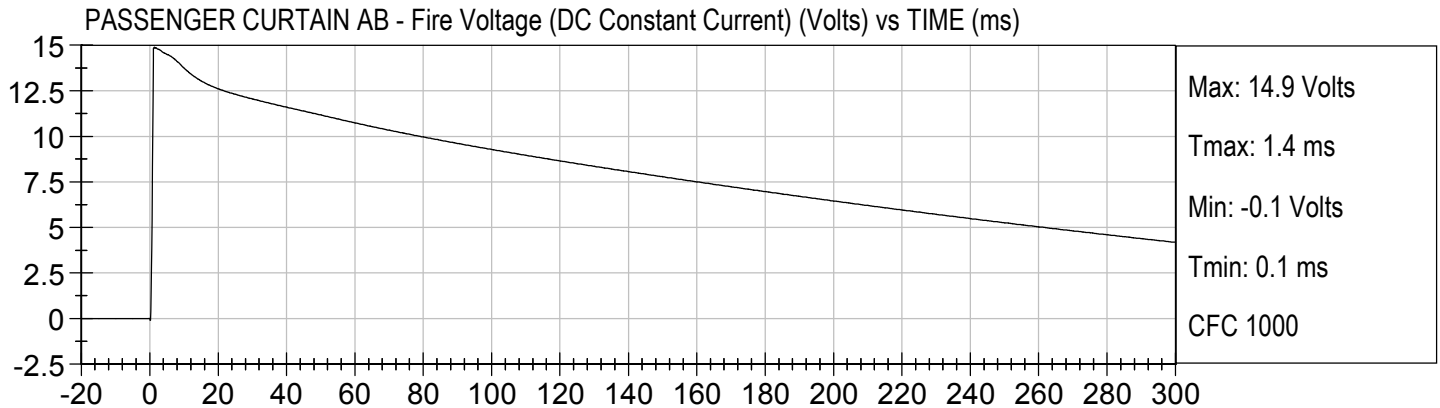
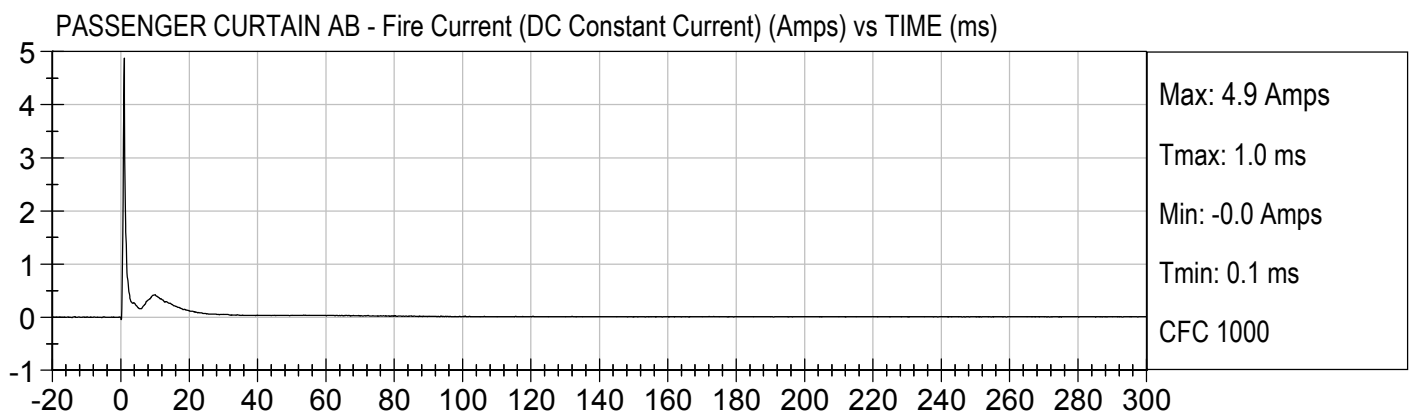
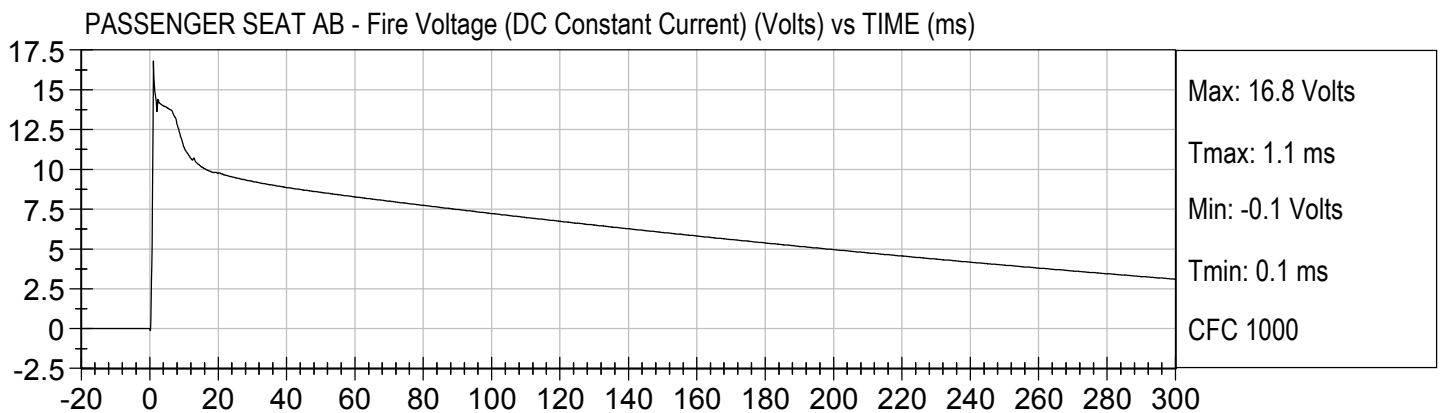
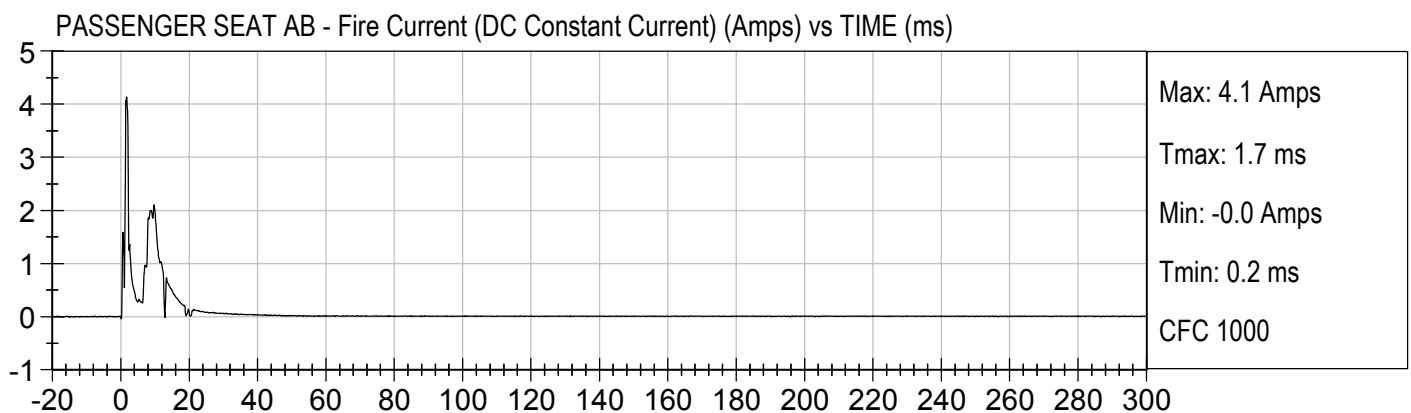
| | | <u>Page No.</u> |
|---|---|---|
| Figure No. 13. | Passenger Curtain Airbag – Fire Voltage vs. Time | 26 |
| Figure No. 14. | Passenger Curtain Airbag – Fire Current vs. Time | 26 |
| Figure No. 15. | Passenger Seat Airbag – Fire Voltage vs. Time | 26 |
| Figure No. 16. | Passenger Seat Airbag – Fire Current vs. Time | 26 |
