**REPORT NUMBER: TWG-MGA-2014-003A**

**SIDE AIRBAG OUT-OF-POSITION INJURY  
TECHNICAL WORKING GROUP**

**TOYOTA MOTOR CORPORATION  
2014 Lexus IS250 AWD 4-Dr Sedan  
NHTSA No.: M20145100TWG3**

**FINAL REPORT**

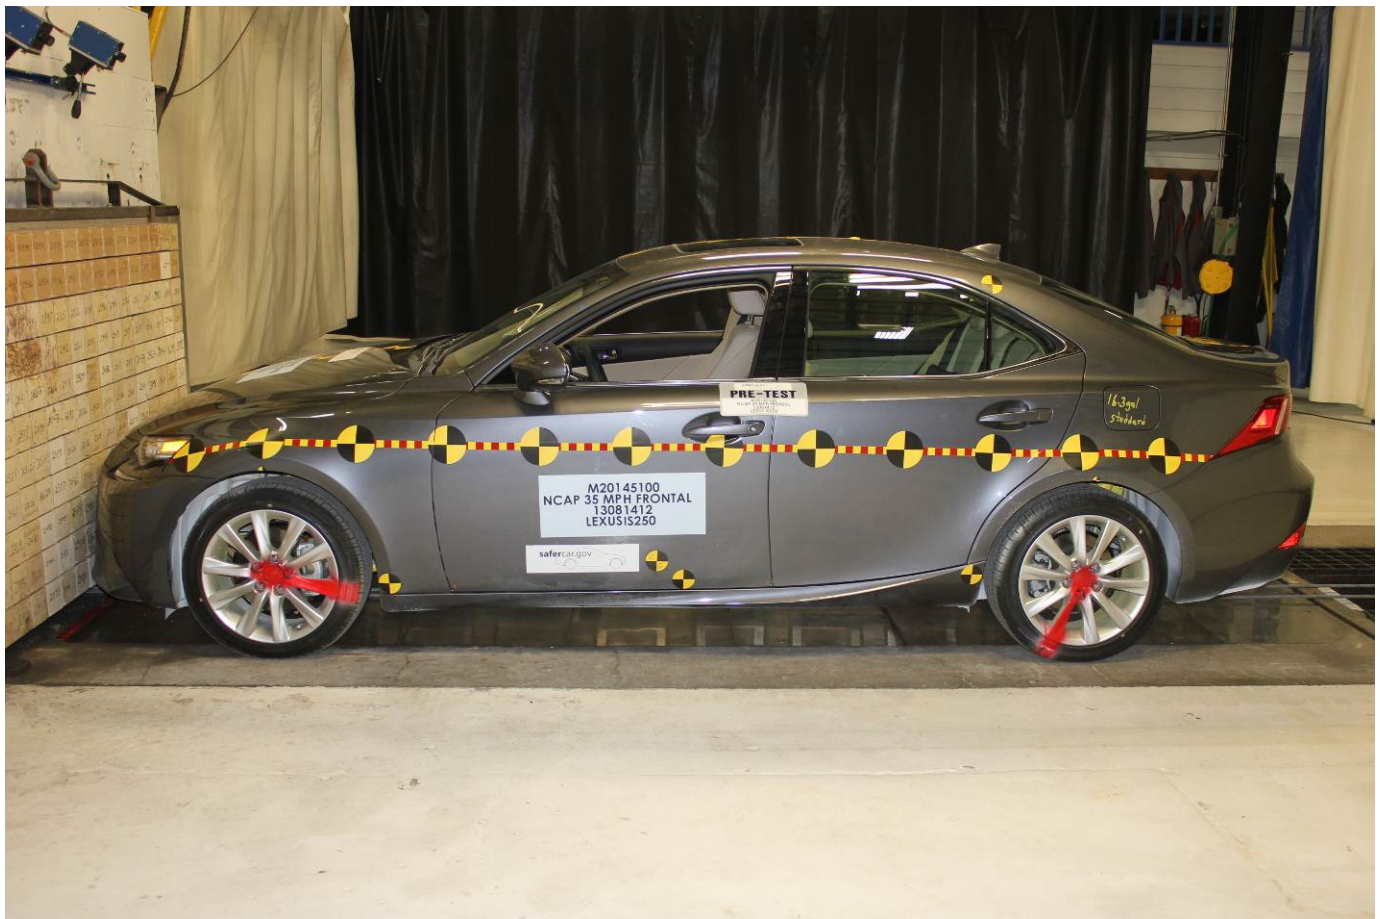
Pre-Test Vehicle Left Side View

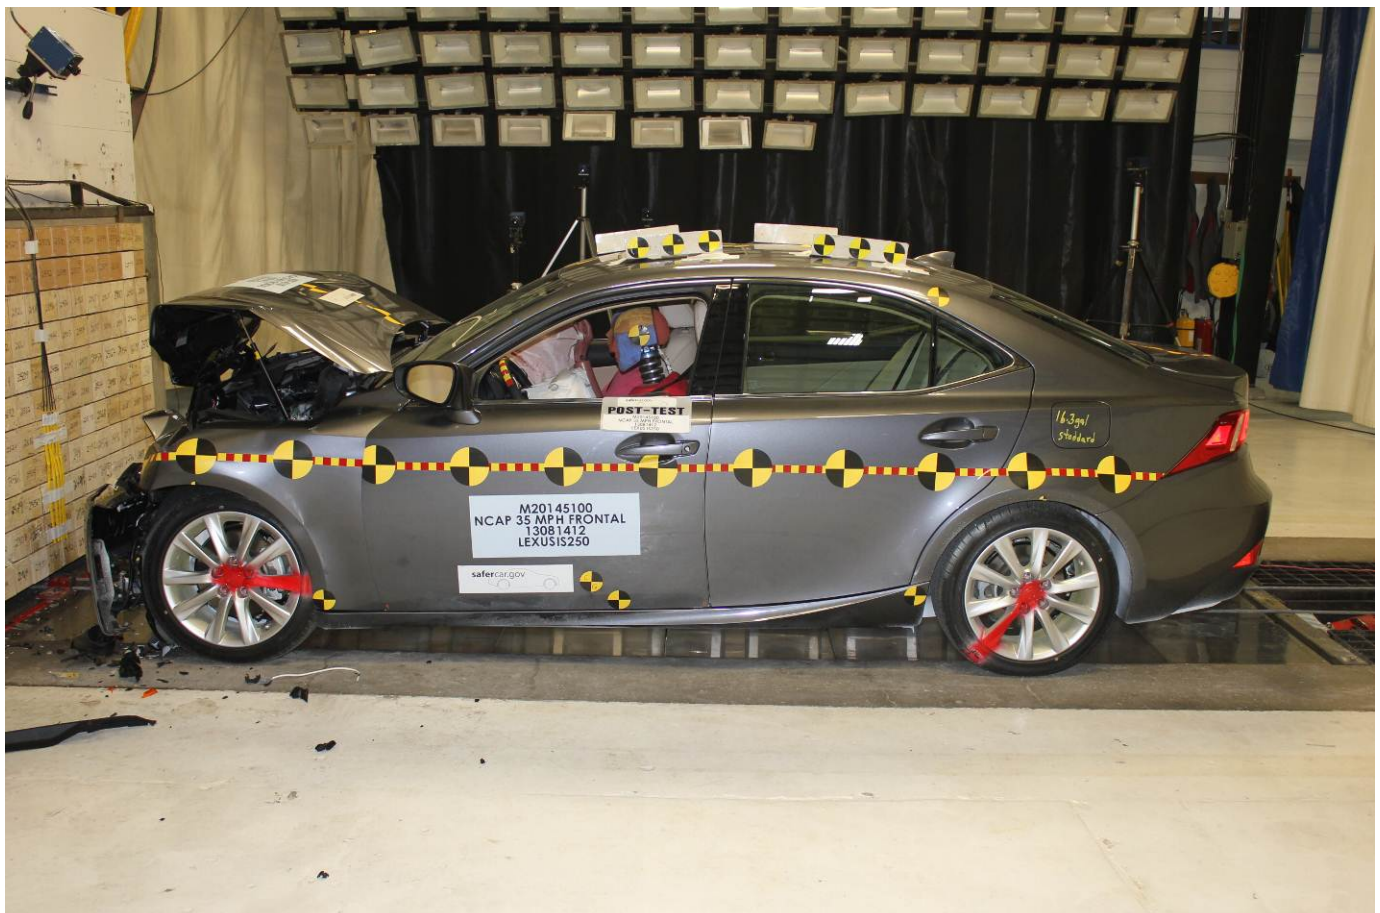
Post-Test Vehicle Left Side View

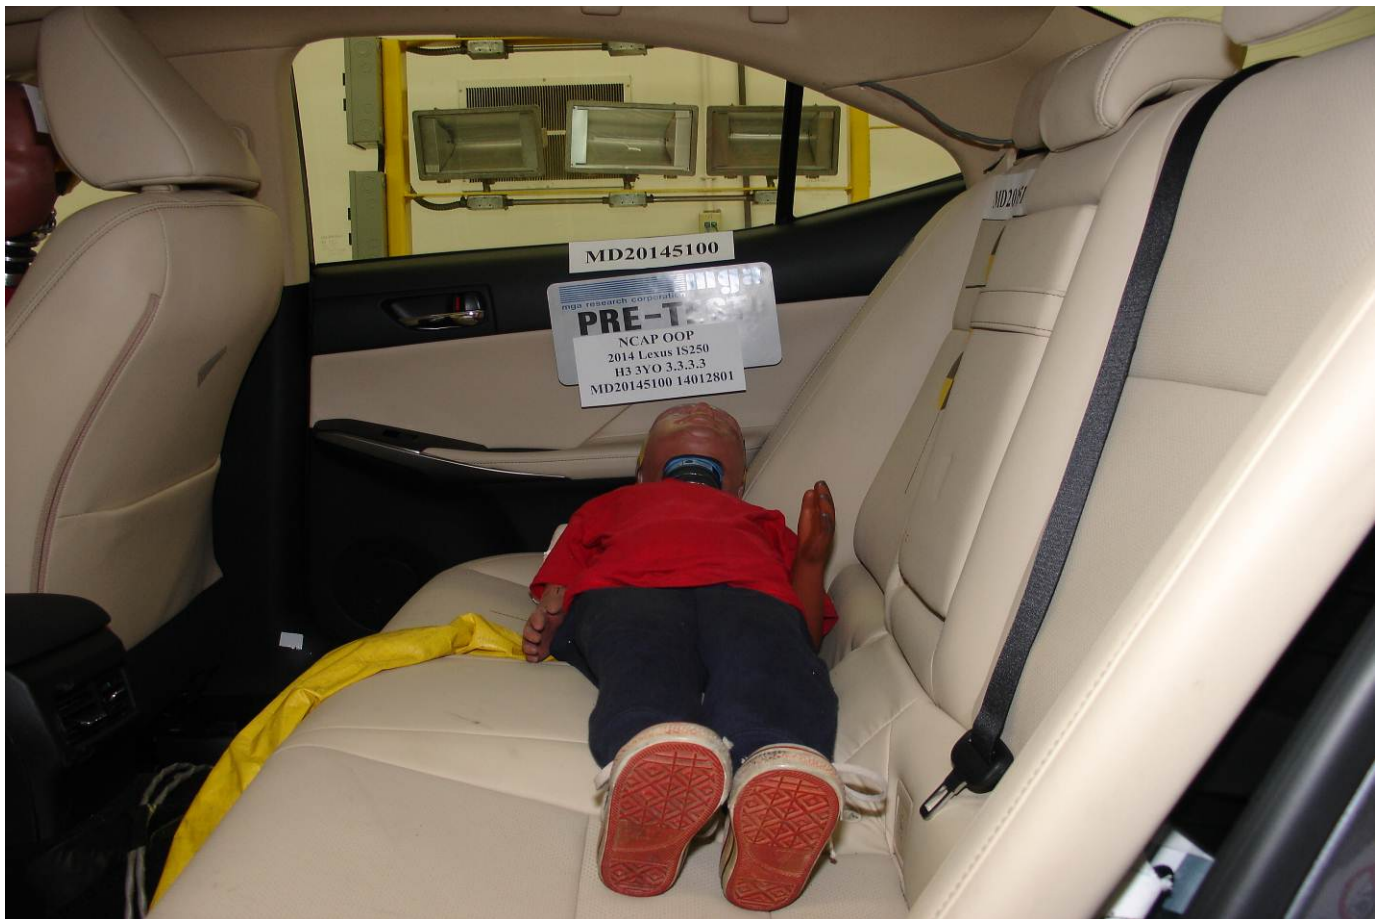
Pre-Test 3-Year-Old Child Dummy Left Side View

The Hybrid III 3-Year-Old child dummy was placed in the right rear passenger seat lying on its back with its arms at its sides so that its rearmost arm contacts the seatback. While bending the dummy at the waist, the dummy was slid outboard until the CG of the head was aligned with the vertical centerline of the airbag module and the head touching the armrest. A wedge-shaped foam block was used to support the dummy's back so that the head remained in a neutral position and does not exert a significant downward force on the armrest. The dummy's arm closest to the front edge of the seat was adjusted so that it was parallel to the torso and was rested on the foam block with the fingertips just touching the seat cushion. The rearmost upper arm was adjusted to an orientation 45 degrees to the upper arm.

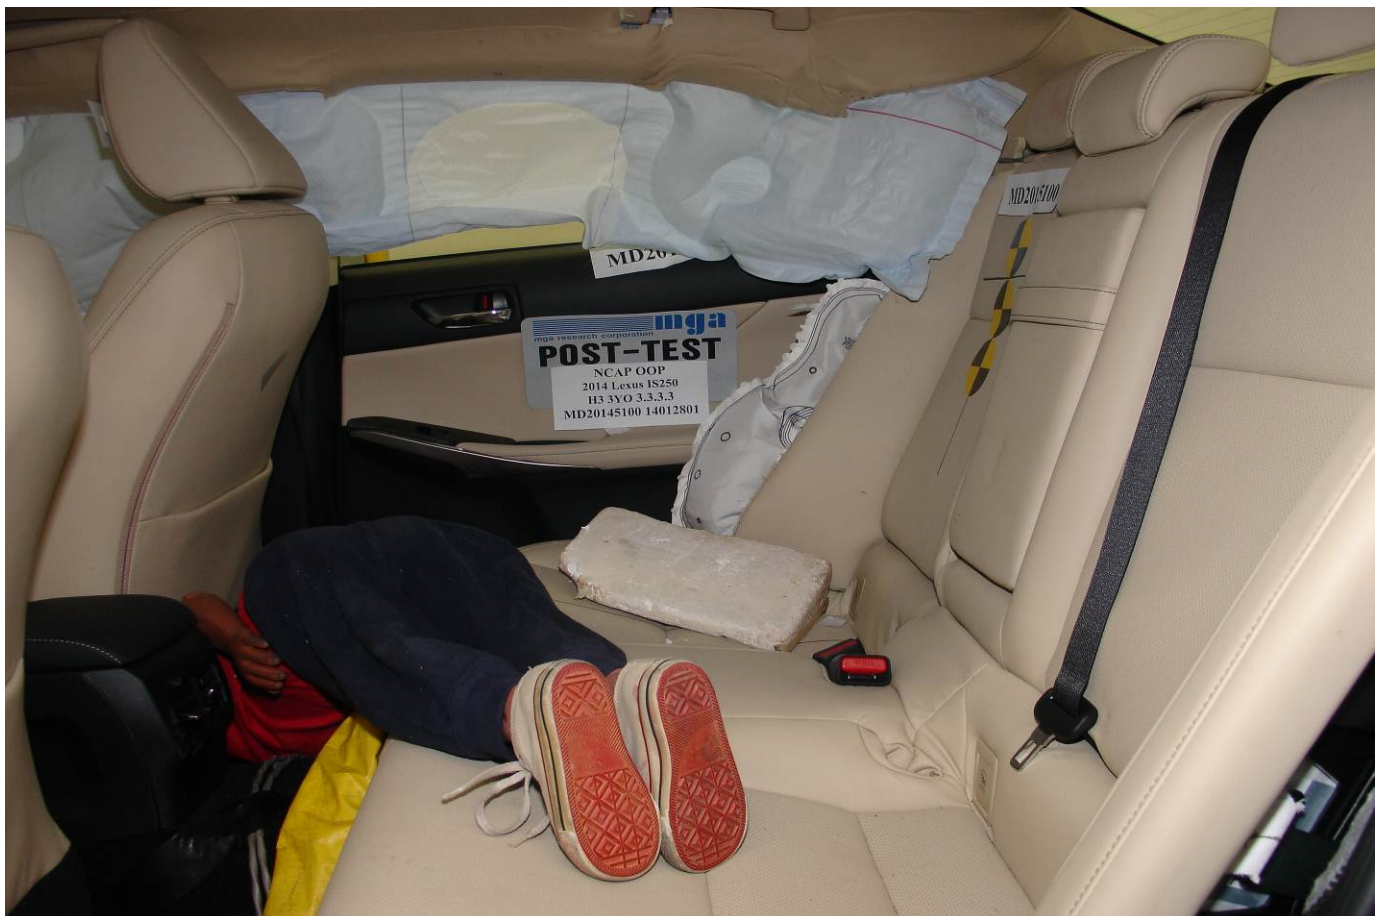
Post-Test 3-Year-Old Child Dummy Left Side View

- Torso airbag to back and left side of head

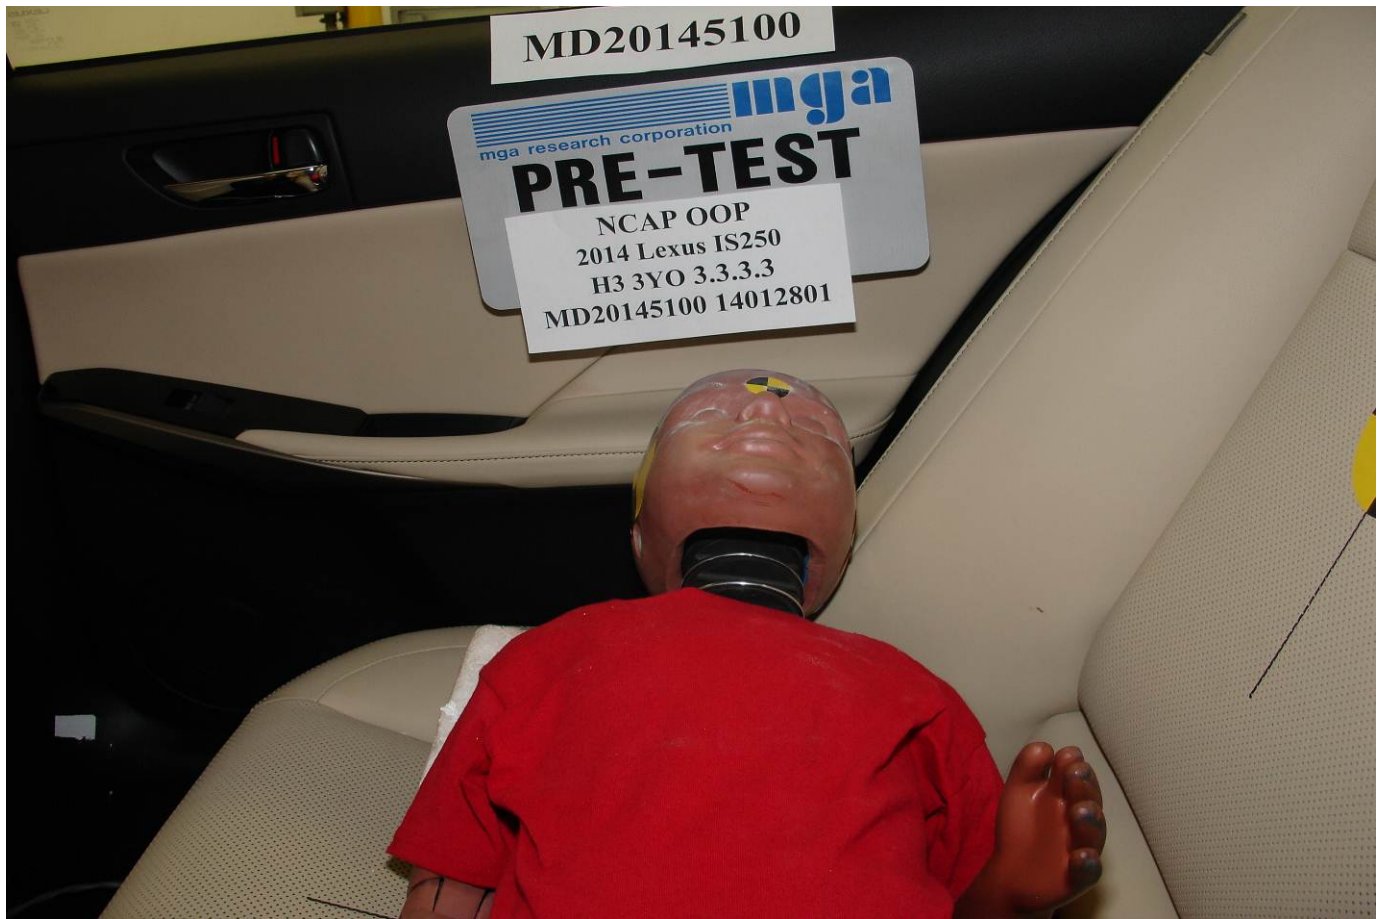
Pre-Test 3-Year-Old Child Dummy Left Side Closeup View

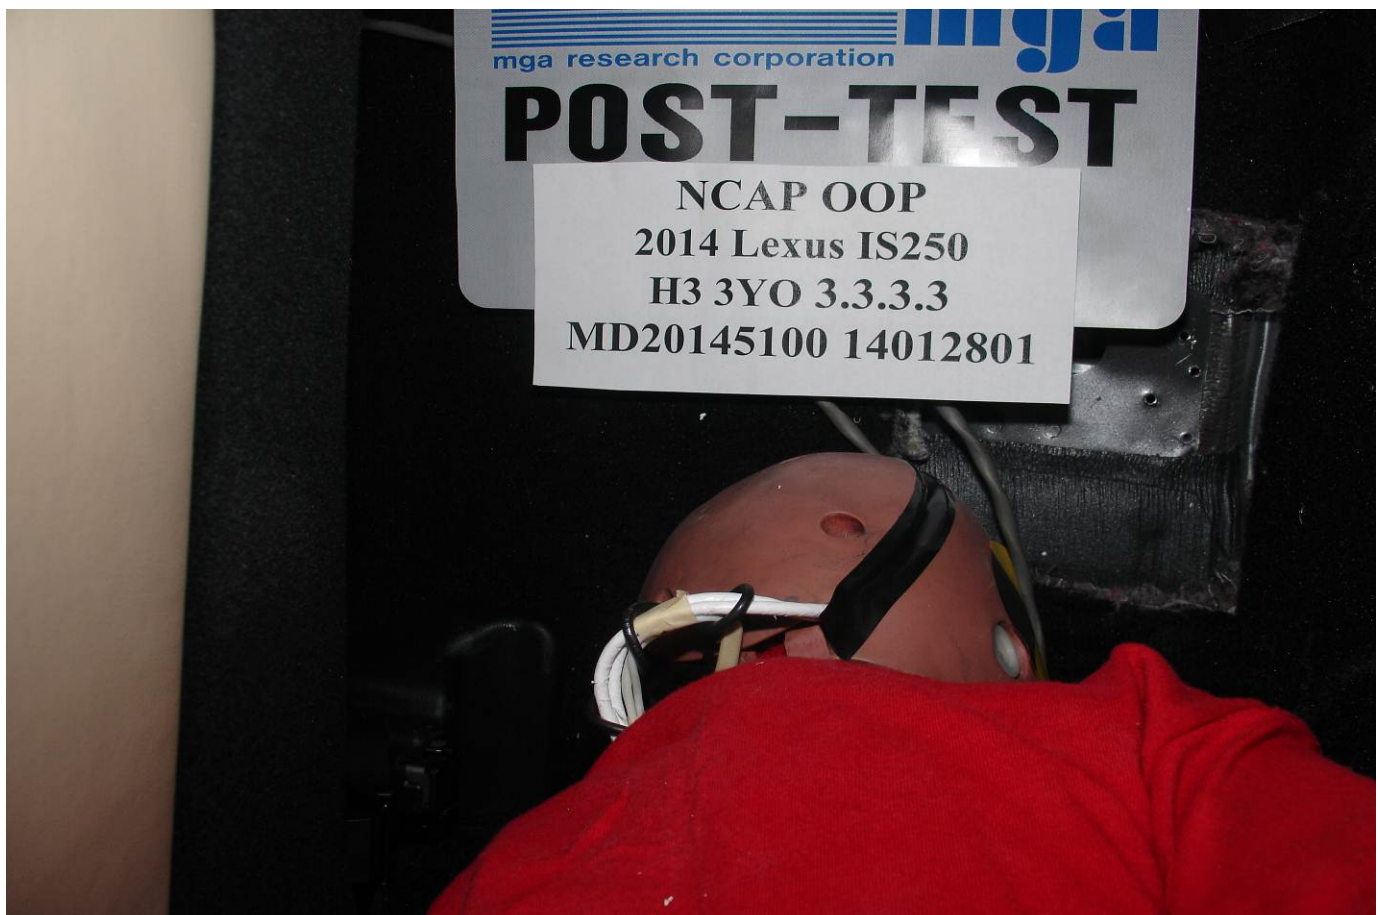
Post-Test 3-Year-Old Child Dummy Left Side Closeup View

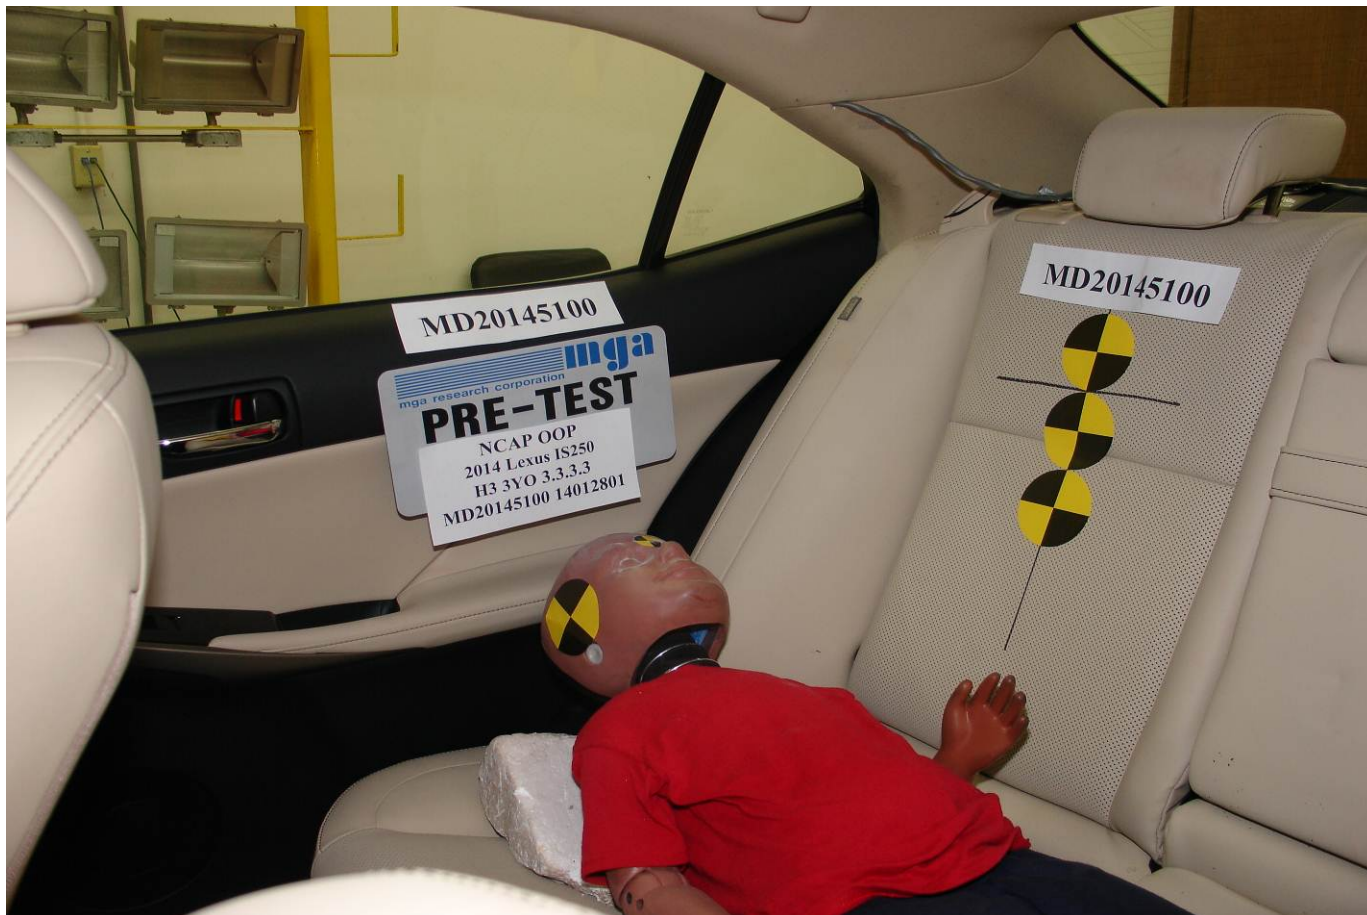
Pre-Test 3-Year-Old Child Dummy Left 3/4 Front View

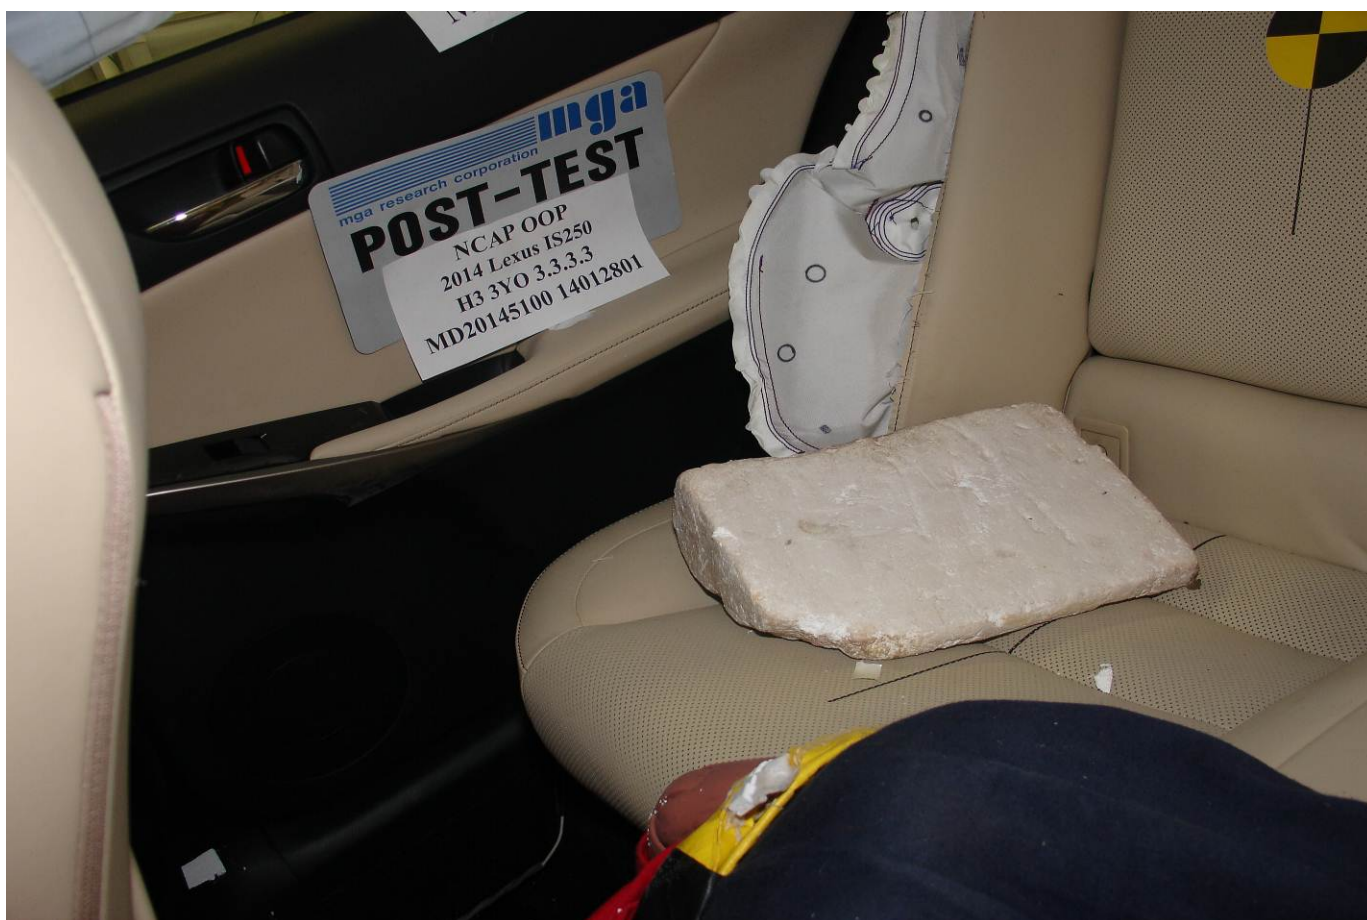
Post-Test 3-Year-Old Child Dummy Left 3/4 Front View

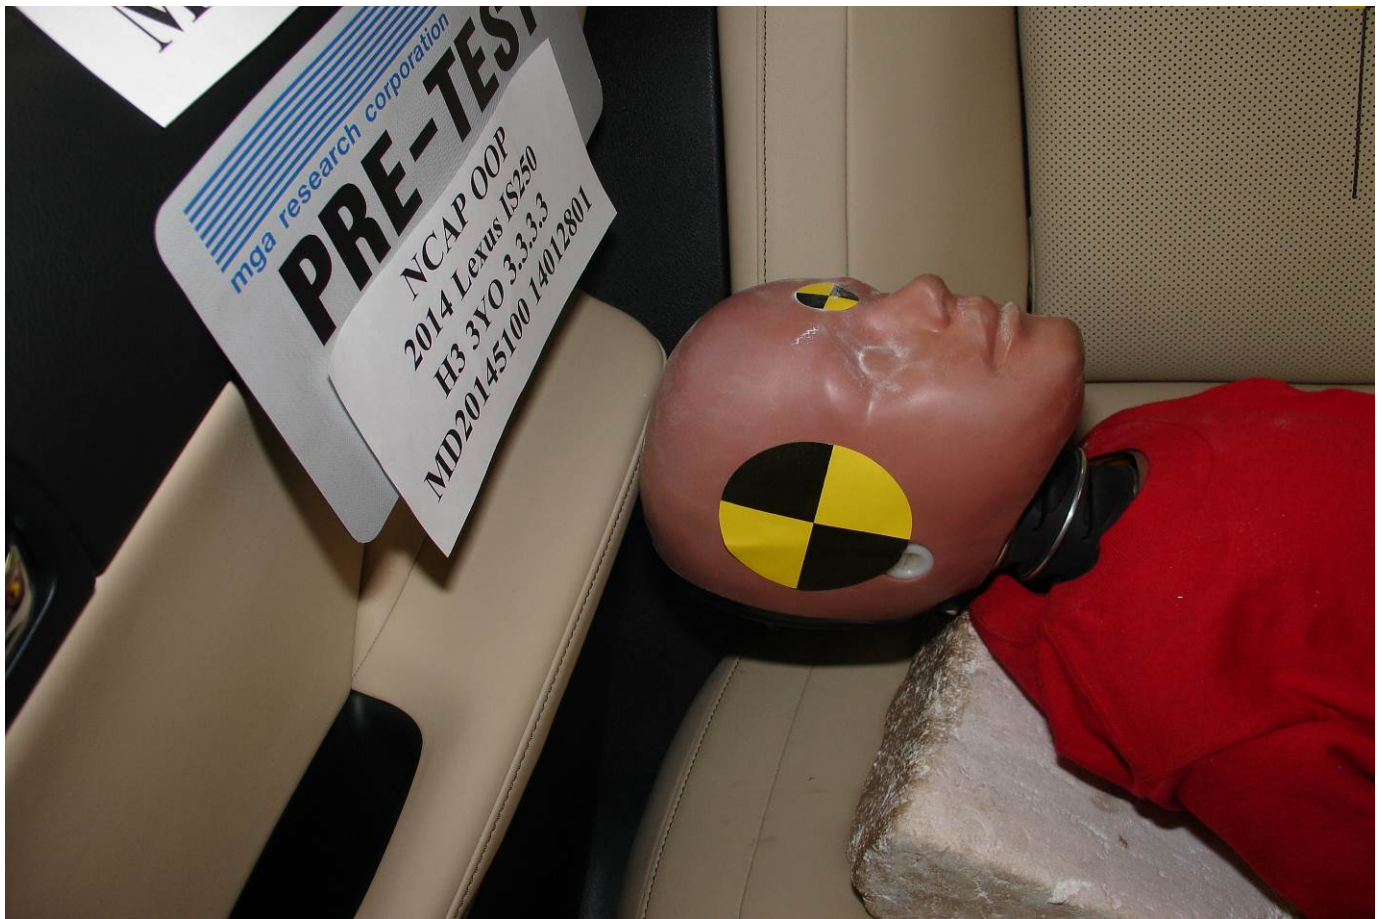
Pre-Test 3-Year-Old Child Dummy Front View

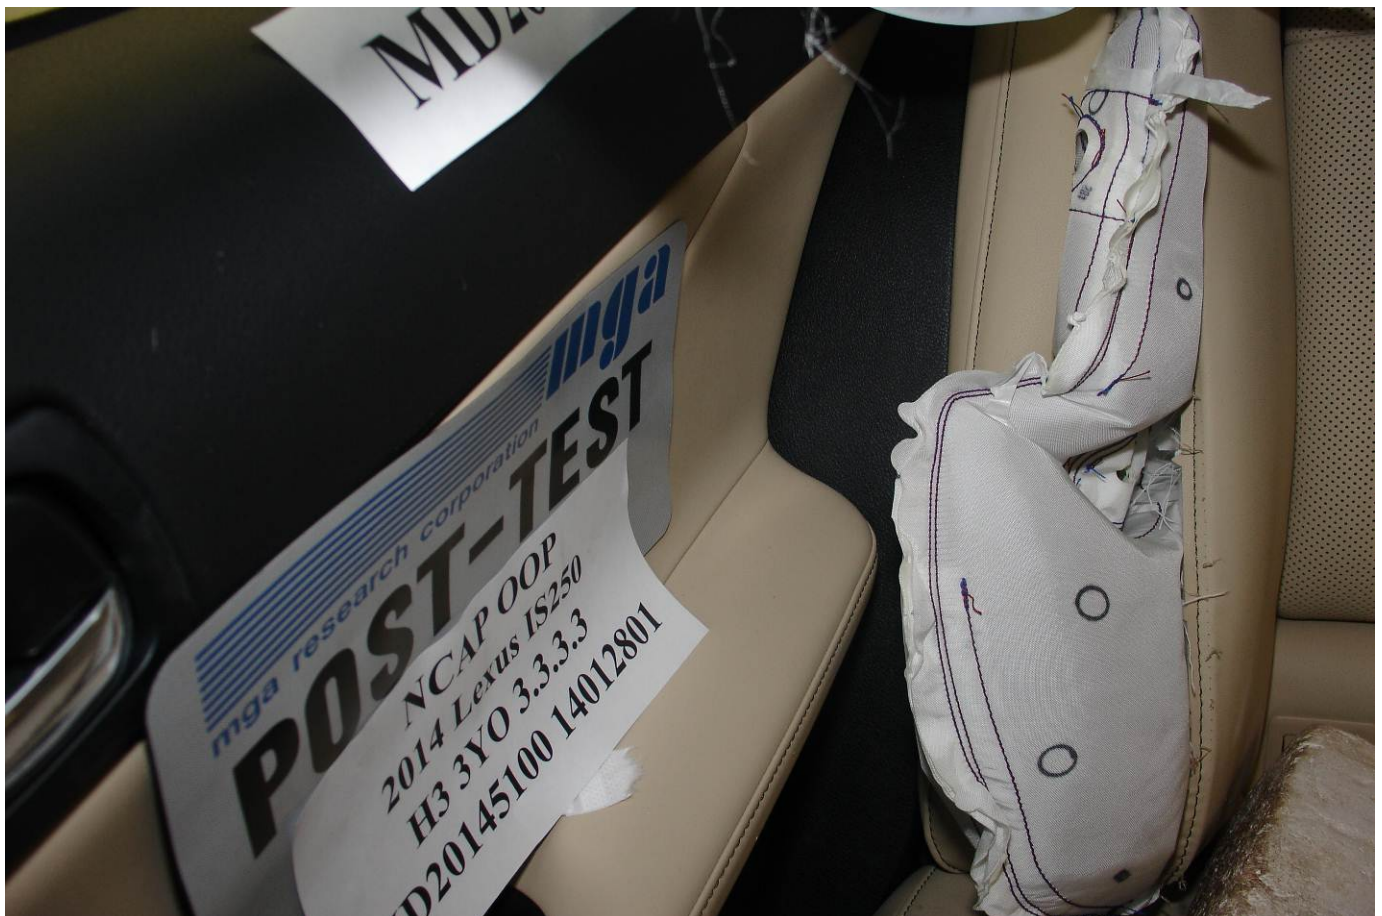
Post-Test 3-Year-Old Child Dummy Front View

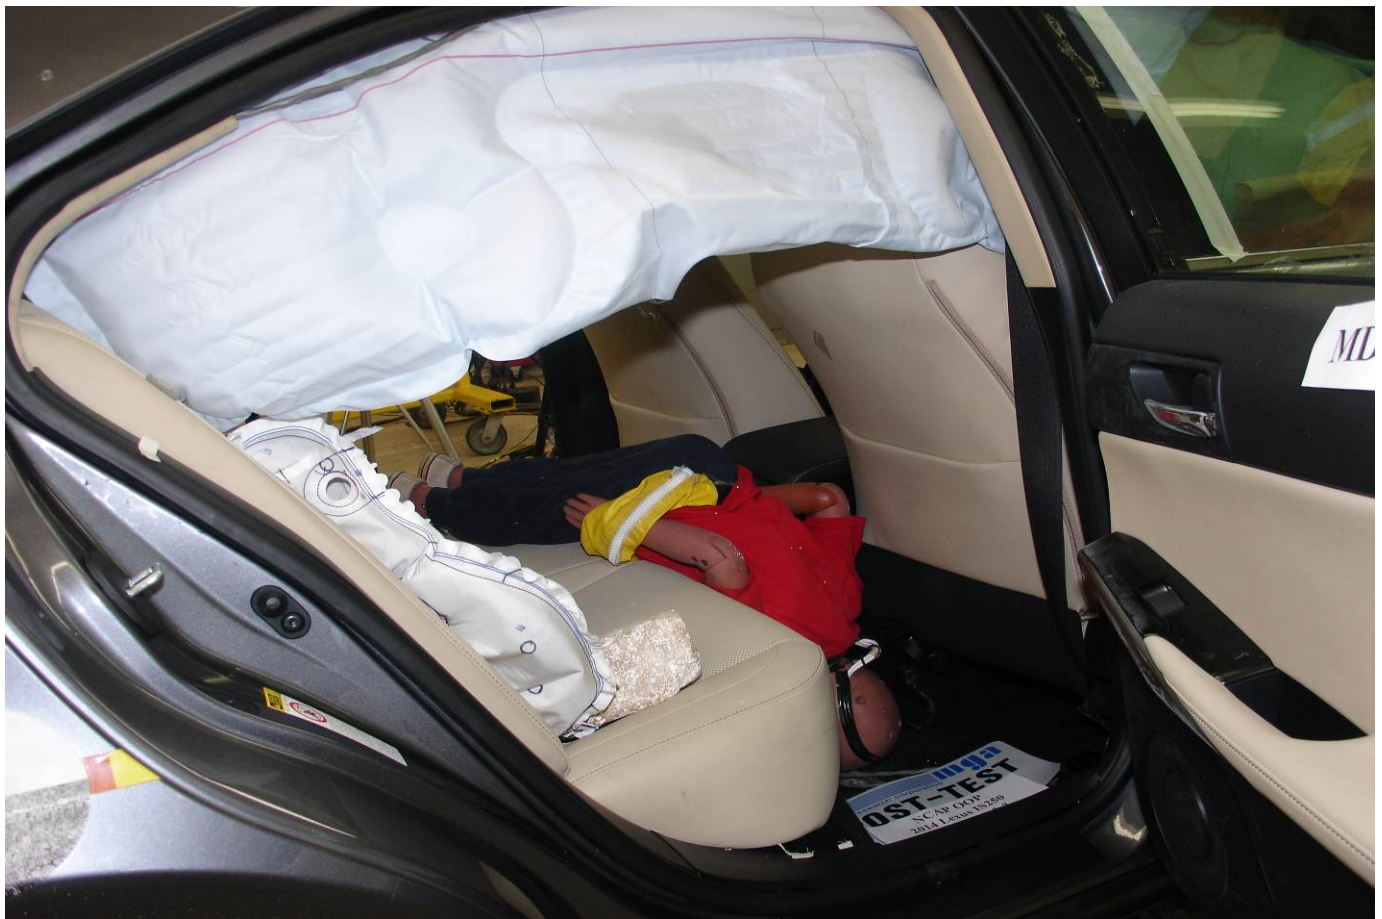
Post-Test 3-Year-Old Child Dummy Right Side View (Door Open)

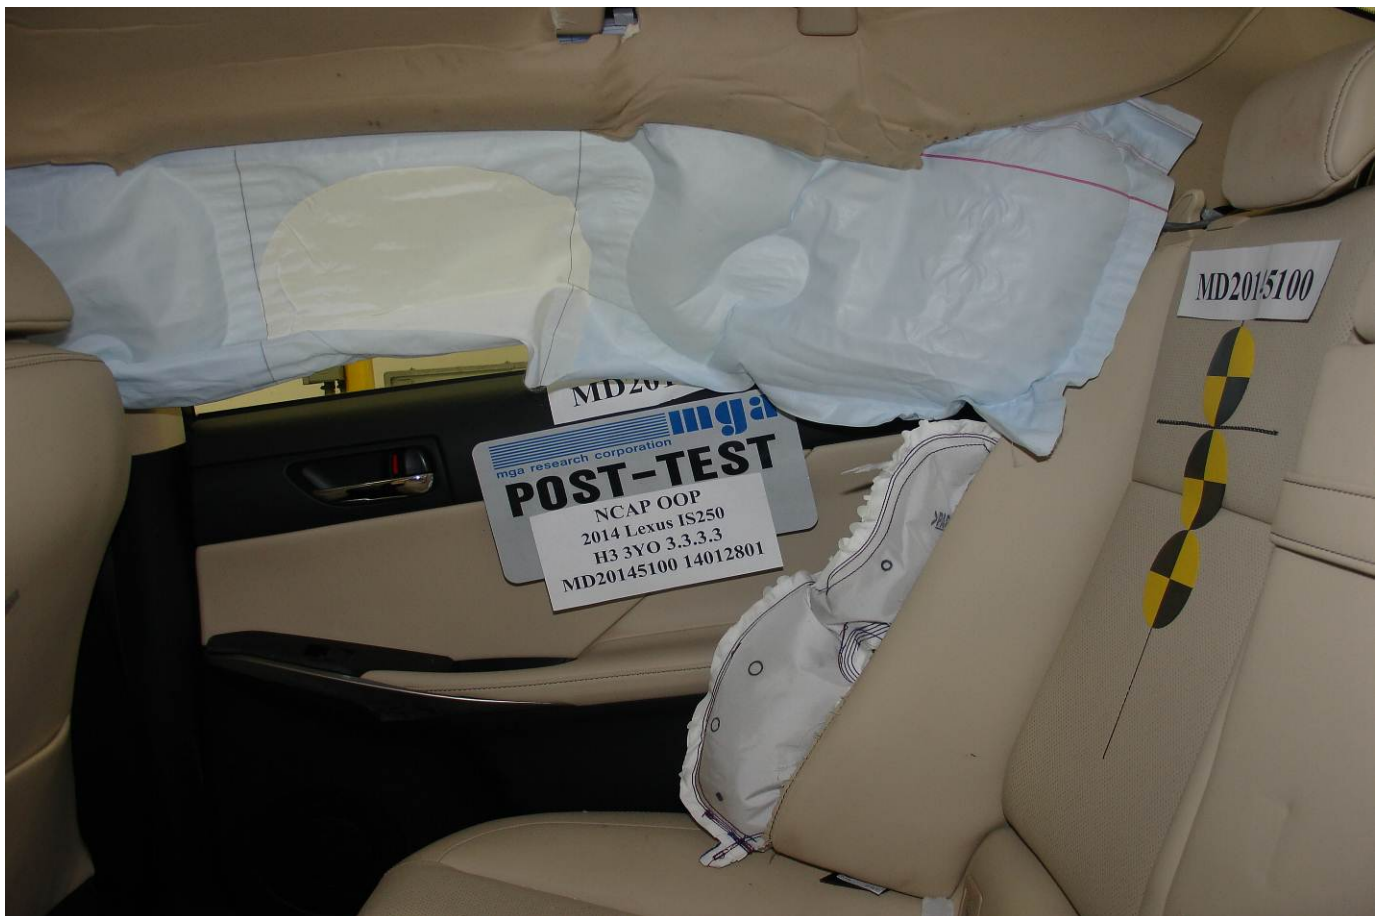
Post-Test Curtain Airbag Left Side View

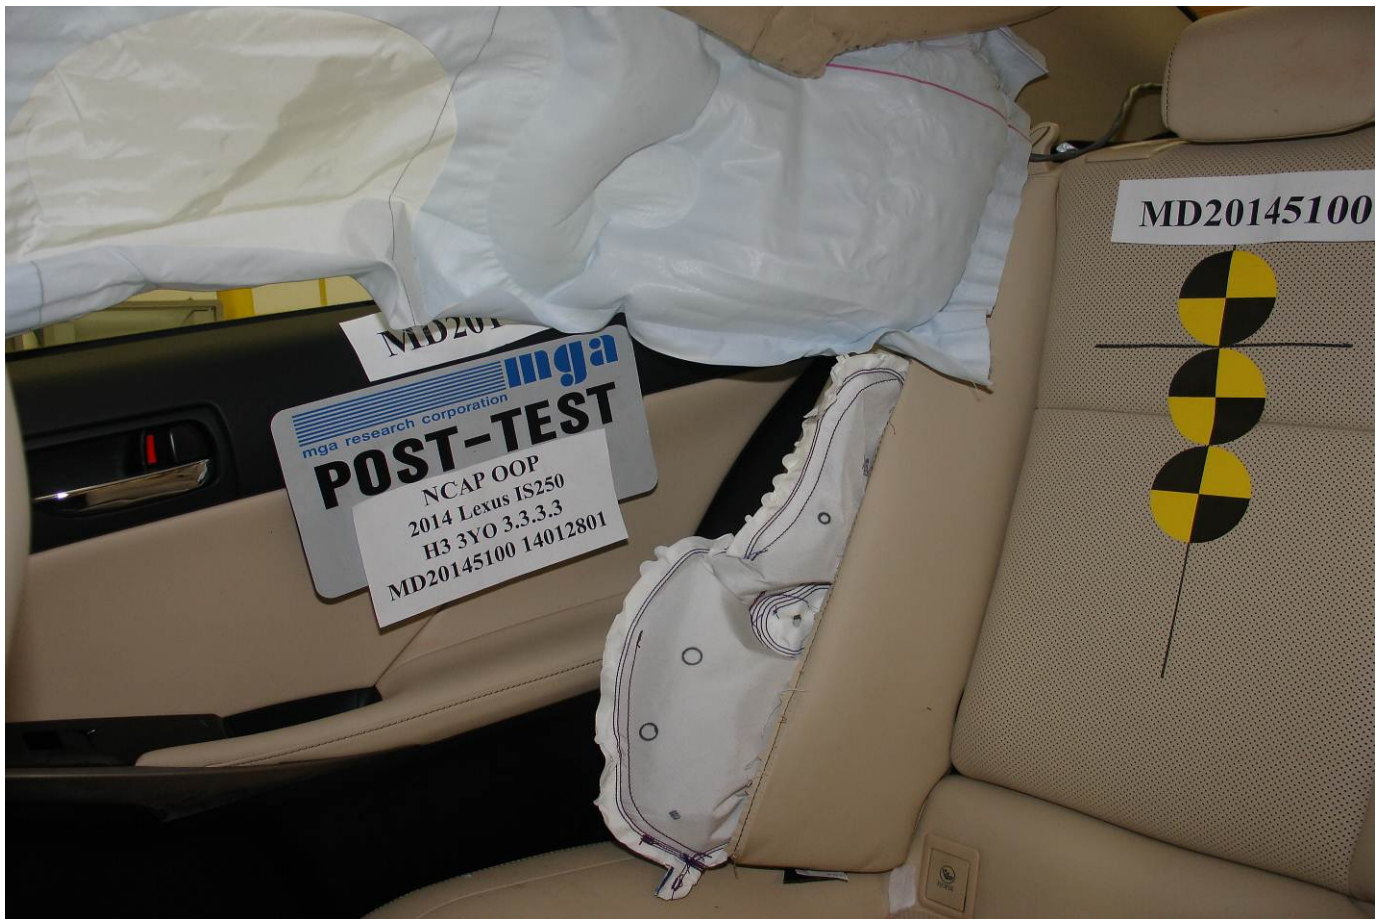
Post-Test Curtain Airbag Left 3/4 Front View

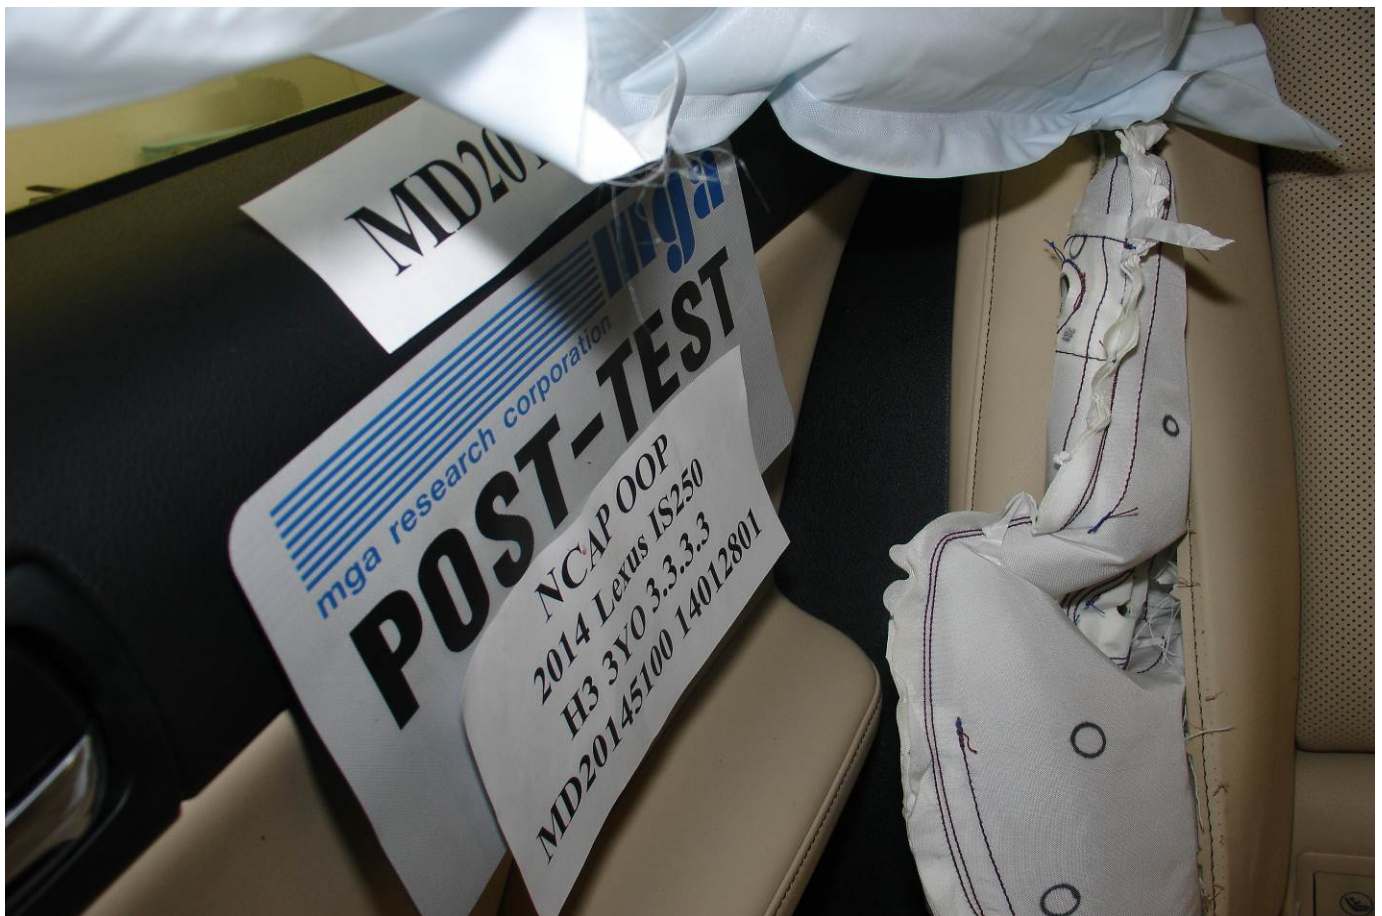
Post-Test Curtain Airbag Front View

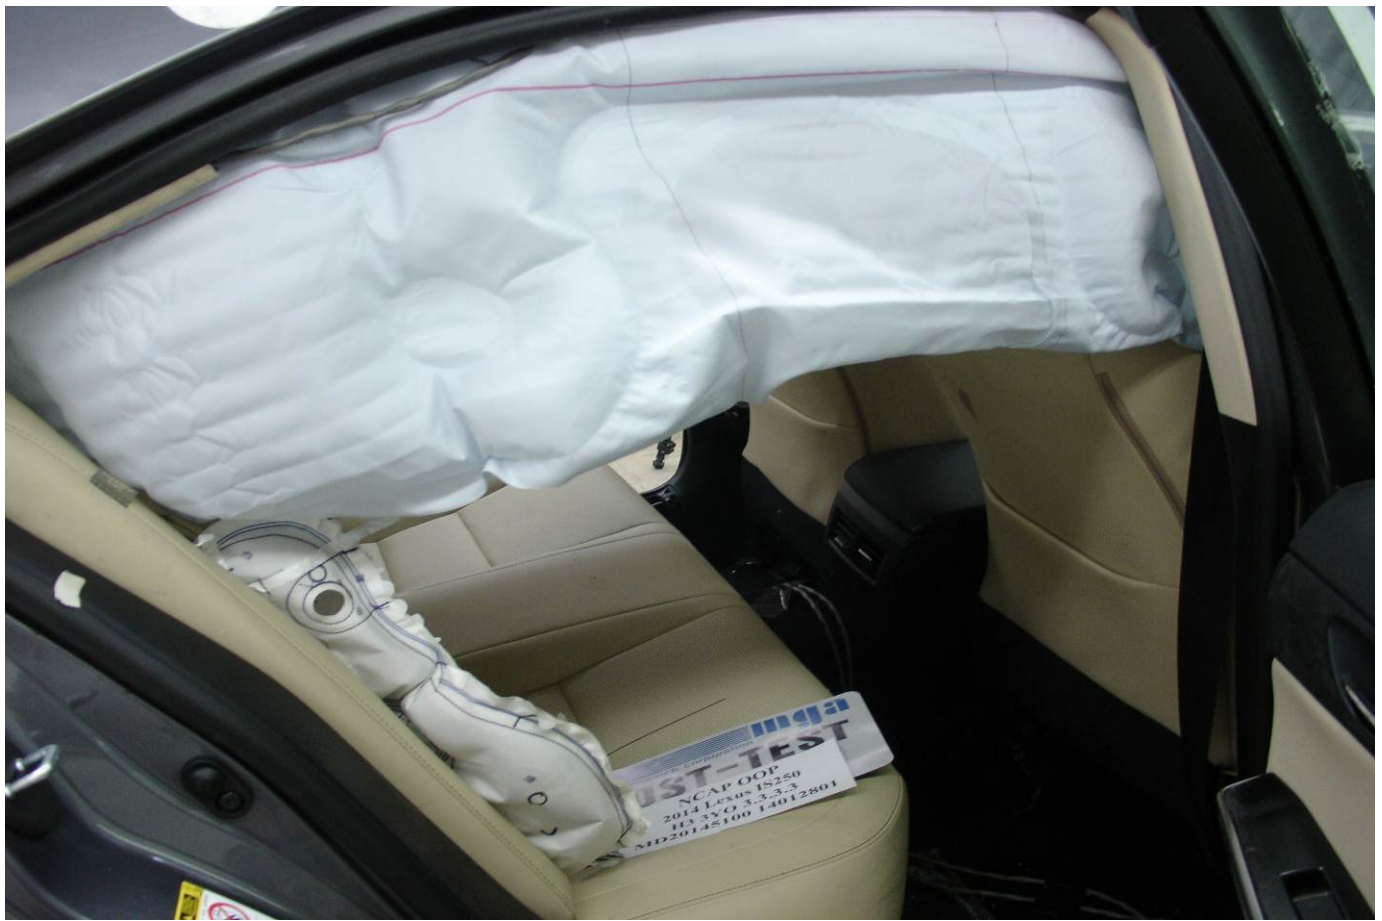
Post-Test Curtain Airbag Right Side View (Door Open)

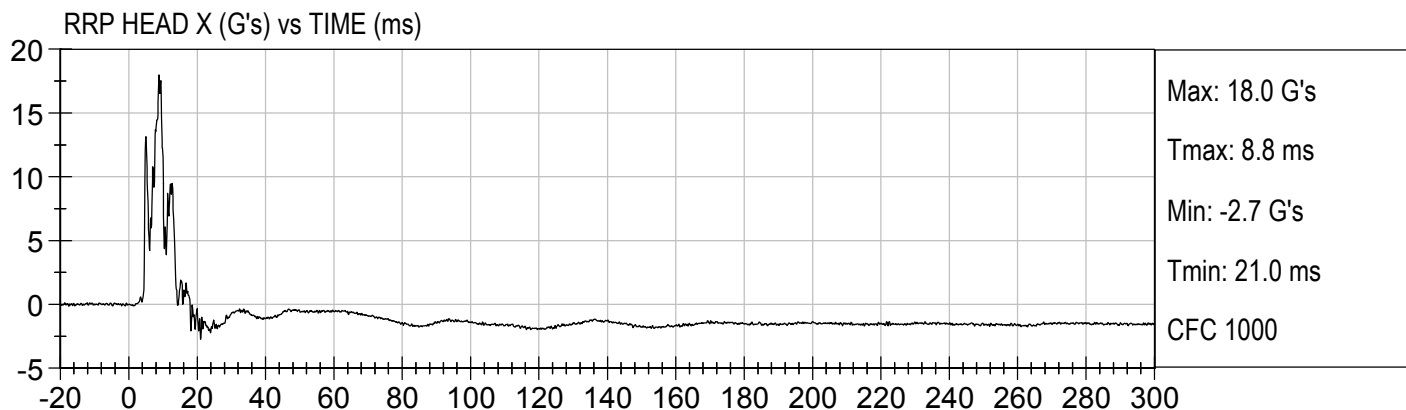
| | <u>Page No.</u> |
|---|---|
| Figure No. 1. RRP Head X Acceleration vs. Time | 19 |

| | | MAXIMUM VALUE | | | |
|---|---|---|---|---|---|
| Head X | g | 18.0 | 8.8 | -2.7 | 21.0 |

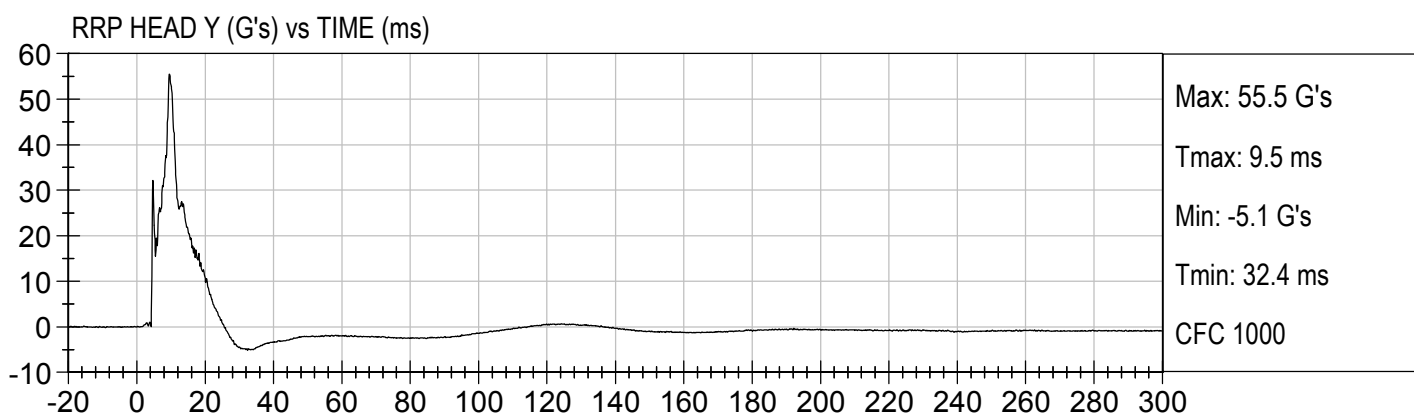
| | <u>Page No.</u> |
|---|---|
| Figure No. 2. RRP Head Y Acceleration vs. Time | 19 |

| | | MAXIMUM VALUE | | | |
|---|---|---|---|---|---|
| Head Y | g | 55.5 | 9.5 | -5.1 | 32.4 |

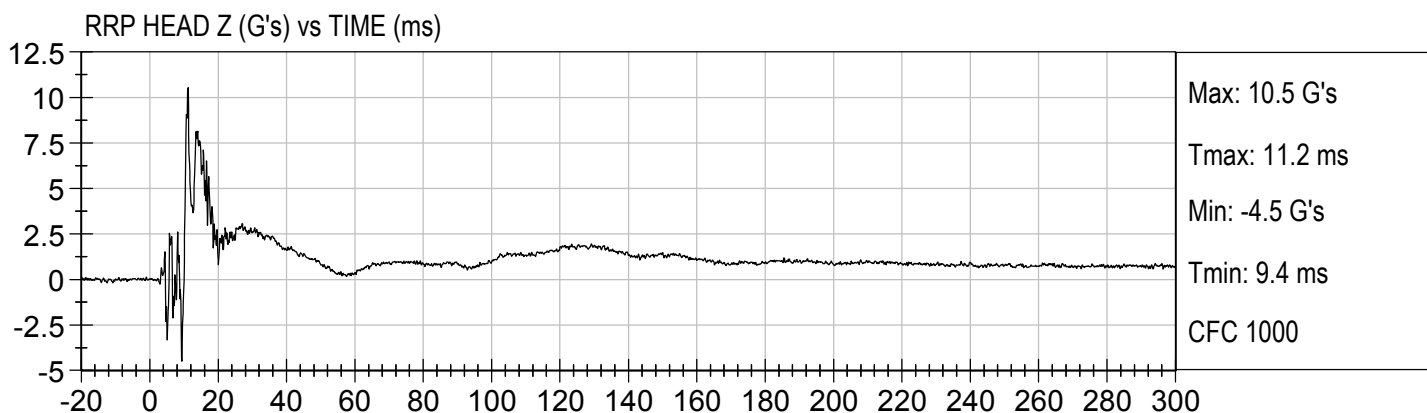
| | <u>Page No.</u> |
|---|---|
| Figure No. 3. RRP Head Z Acceleration vs. Time | 19 |

| | | MAXIMUM VALUE | | | |
|---|---|---|---|---|---|
| Head Z | g | 10.5 | 11.2 | -4.5 | 9.4 |

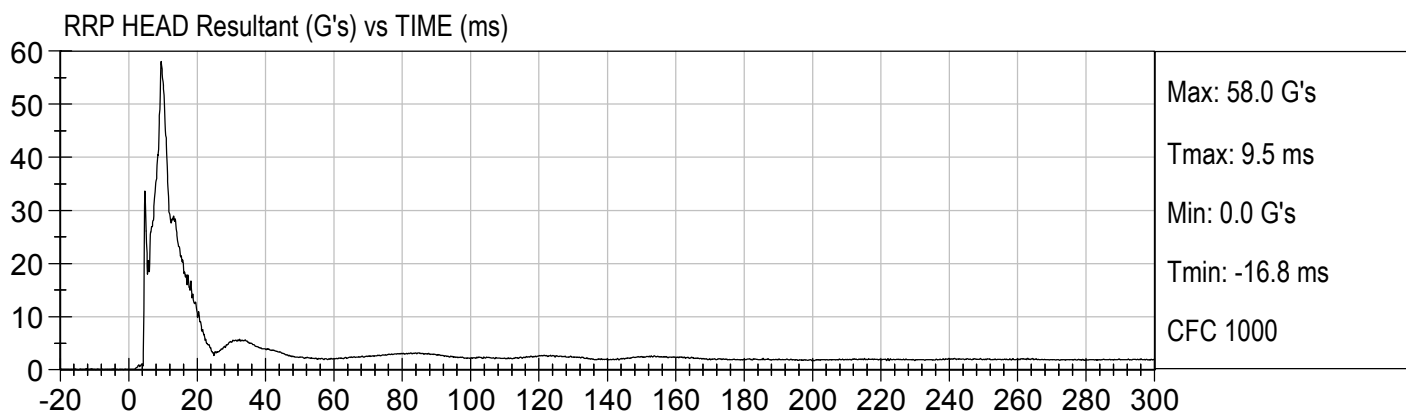
| | <u>Page No.</u> |
|---|---|
| Figure No. 4. RRP Head Resultant Acceleration vs. Time | 19 |

| | | MAXIMUM VALUE | | | |
|---|---|---|---|---|---|
| Head Resultant | g | 58.0 | 9.5 | | |

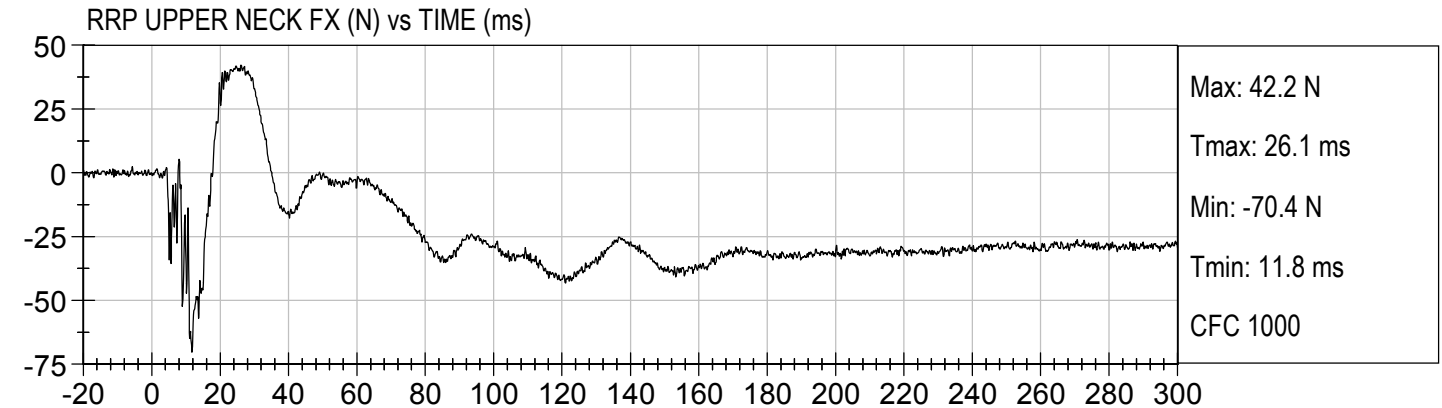
| | <u>Page No.</u> |
|---|---|
| Figure No. 5. RRP Upper Neck X Force vs. Time | 20 |

| | | MAXIMUM VALUE | | | |
|---|---|---|---|---|---|
| Upper Neck Fx | N | 42.2 | 26.1 | -70.4 | 11.8 |

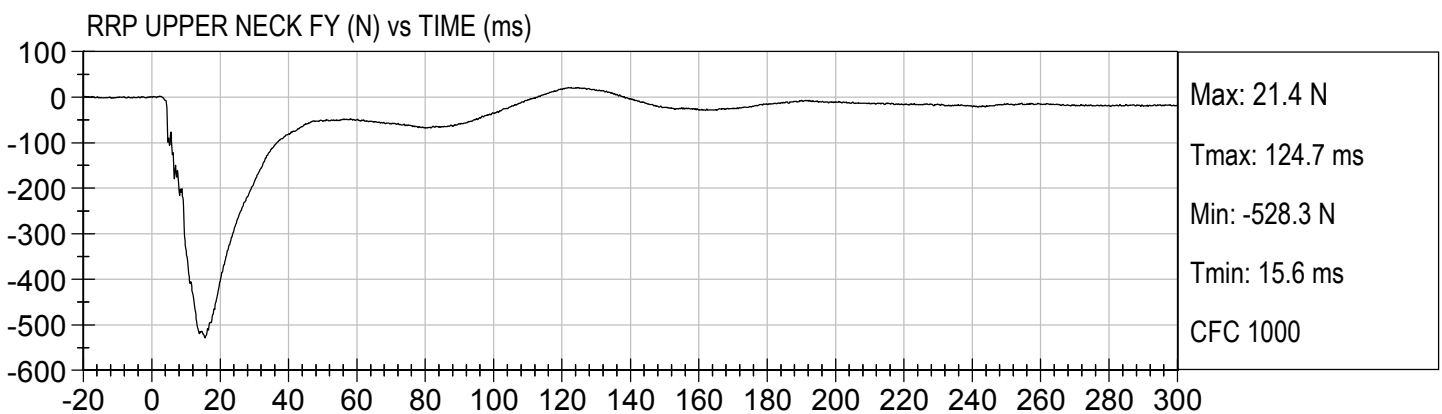
| | <u>Page No.</u> |
|---|---|
| Figure No. 6. RRP Upper Neck Y Force vs. Time | 20 |

| | | MAXIMUM VALUE | | | |
|---|---|---|---|---|---|
| Upper Neck Fy | N | 21.4 | 124.7 | -528.3 | 15.6 |
