**REPORT NUMBER: TWG-MGA-2014-003A**

**SIDE AIRBAG OUT-OF-POSITION INJURY  
TECHNICAL WORKING GROUP**

**TOYOTA MOTOR CORPORATION  
2014 Lexus IS250 AWD 4-Dr Sedan  
NHTSA No.: M20145100TWG3**

**FINAL REPORT**

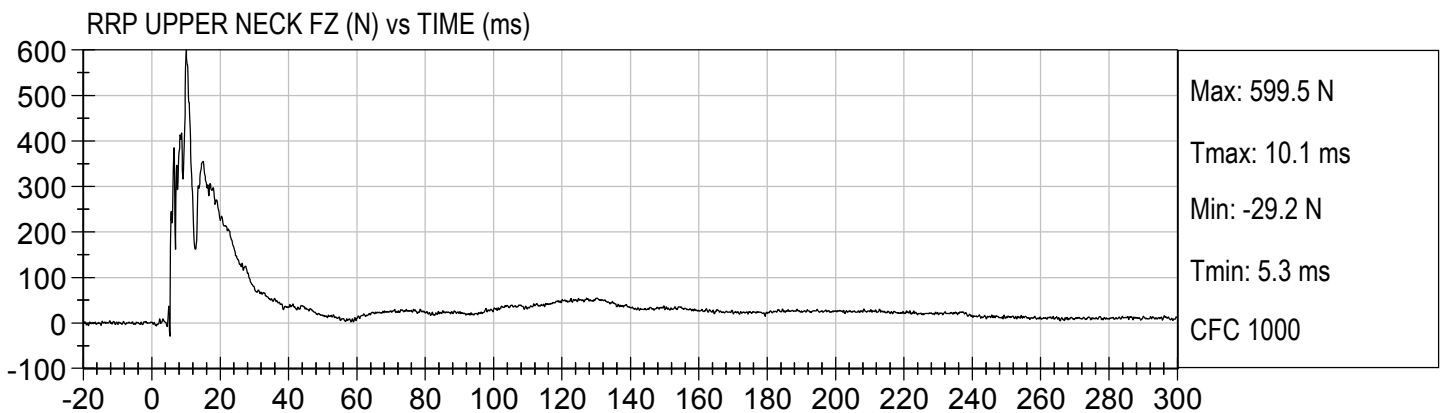
| | <u>Page No.</u> |
|---|---|
| Figure No. 7. RRP Upper Neck Z Force vs. Time | 20 |

| | | MAXIMUM VALUE | | | |
|---|---|---|---|---|---|
| Upper Neck Fz | N | 599.5 | 10.1 | -29.2 | 5.3 |

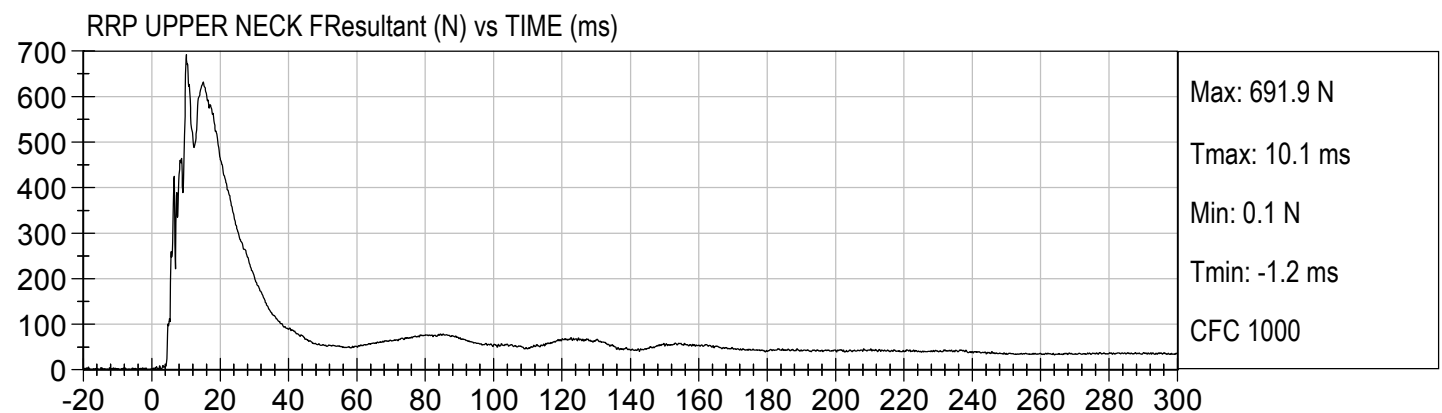
| | <u>Page No.</u> |
|---|---|
| Figure No. 8. RRP Upper Neck Resultant Force vs. Time | 20 |

| | | MAXIMUM VALUE | | | |
|---|---|---|---|---|---|
| Upper Neck F Resultant | N | 691.9 | 10.1 | | |

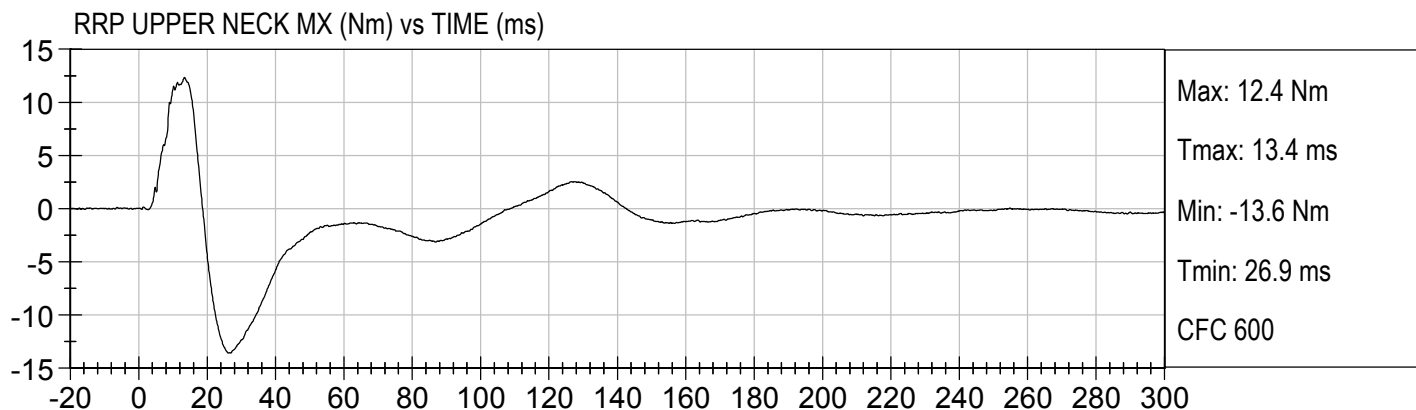
| | <u>Page No.</u> |
|---|---|
| Figure No. 9. RRP Upper Neck X Moment vs. Time | 21 |

| | | MAXIMUM VALUE | | | |
|---|---|---|---|---|---|
| Upper Neck Mx | Nm | 12.4 | 13.4 | -13.6 | 26.9 |

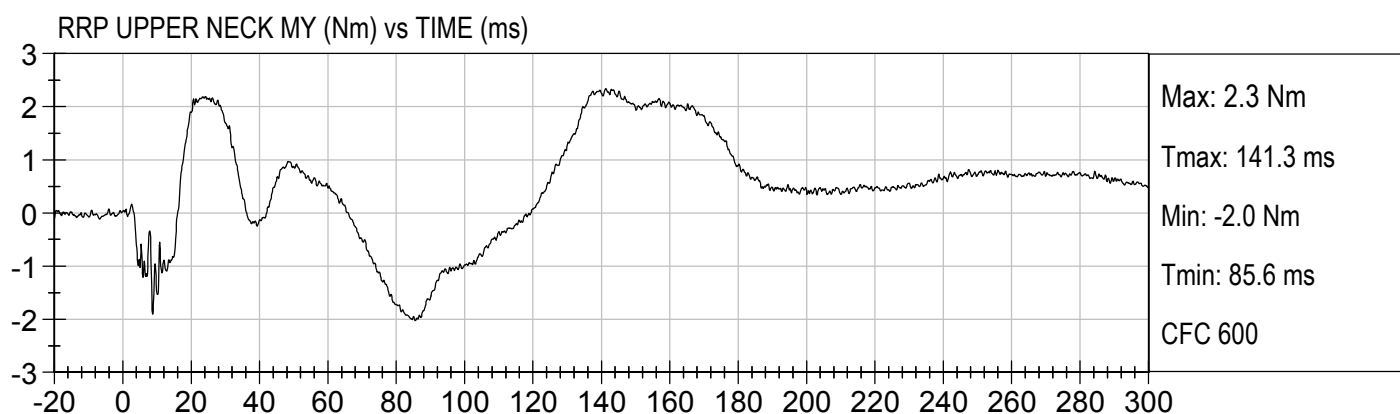
| | <u>Page No.</u> |
|---|---|
| Figure No. 10. RRP Upper Neck Y Moment vs. Time | 21 |

| | | MAXIMUM VALUE | | | |
|---|---|---|---|---|---|
| Upper Neck My | Nm | 2.3 | 141.3 | -2.0 | 85.6 |

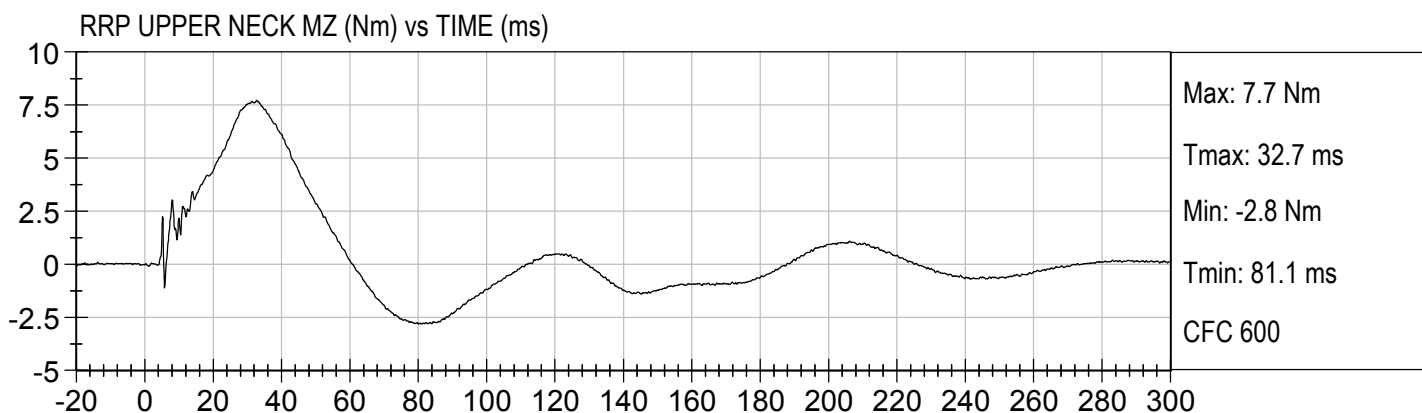
| | <u>Page No.</u> |
|---|---|
| Figure No. 11. RRP Upper Neck Z Moment vs. Time | 21 |

| | | MAXIMUM VALUE | | | |
|---|---|---|---|---|---|
| Upper Neck Mz | Nm | 7.7 | 32.7 | -2.8 | 81.1 |

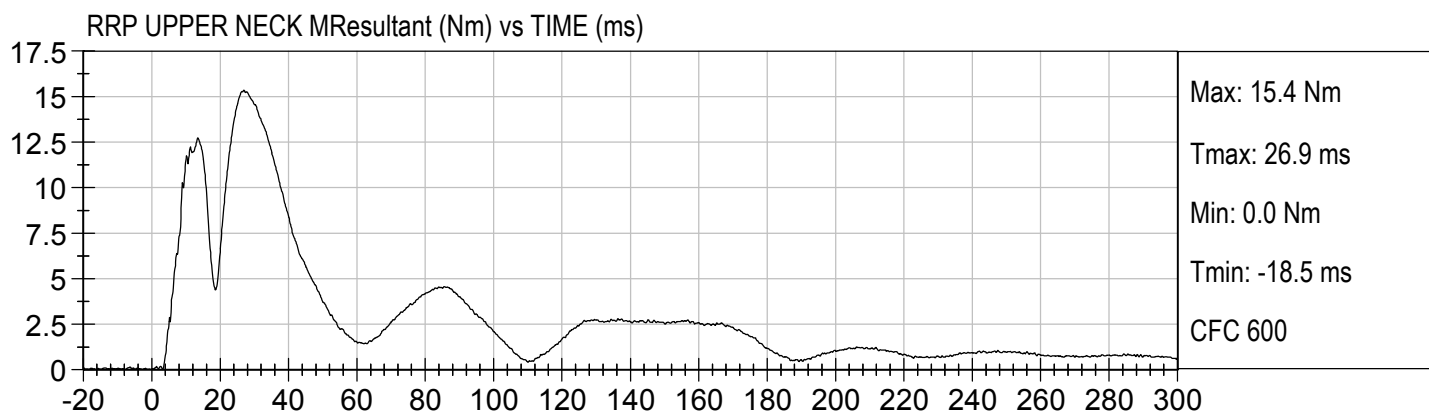
| | <u>Page No.</u> |
|---|---|
| Figure No. 12. RRP Upper Neck Resultant Moment vs. Time | 21 |

| | | MAXIMUM VALUE | | | |
|---|---|---|---|---|---|
| Upper Neck M Resultant | Nm | 15.4 | 26.9 | | |

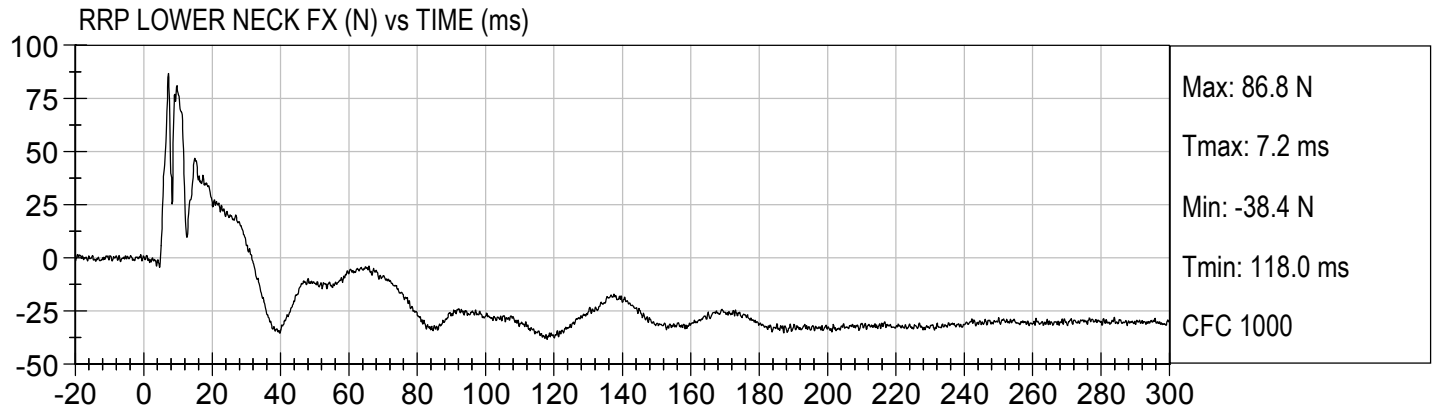
| | <u>Page No.</u> |
|---|---|
| Figure No. 13. RRP Lower Neck X Force vs. Time | 22 |

| | | MAXIMUM VALUE | | | |
|---|---|---|---|---|---|
| Lower Neck Fx | N | 86.8 | 7.2 | -38.4 | 118.0 |

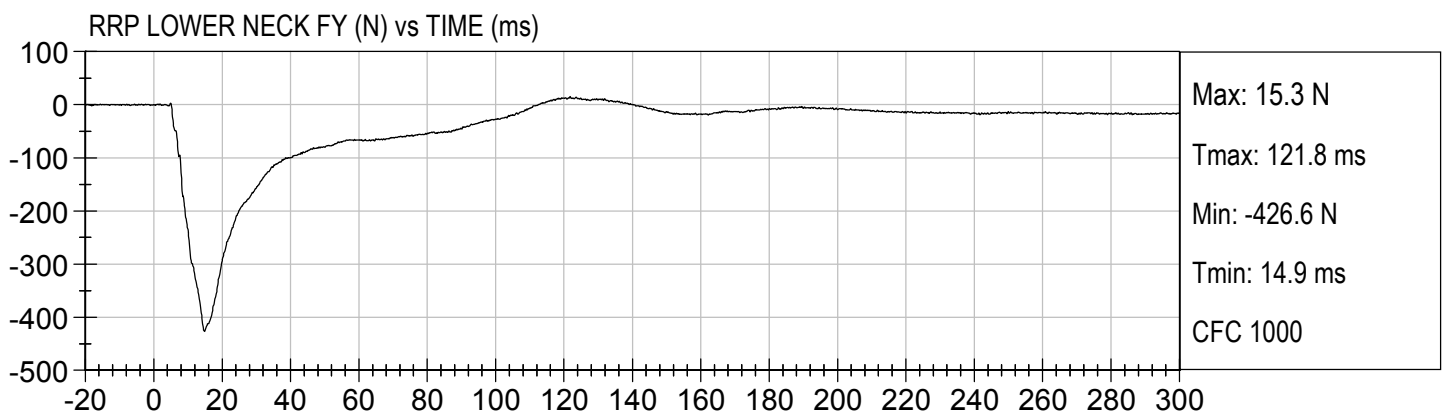
| | <u>Page No.</u> |
|---|---|
| Figure No. 14. RRP Lower Neck Y Force vs. Time | 22 |

| | | MAXIMUM VALUE | | | |
|---|---|---|---|---|---|
| Lower Neck Fy | N | 15.3 | 121.8 | -426.6 | 14.9 |

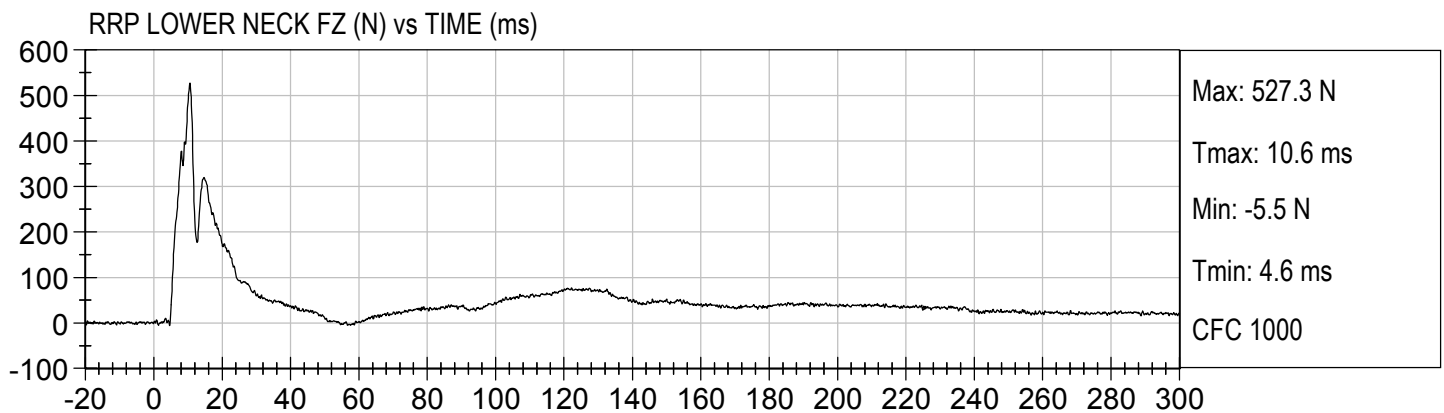
| | <u>Page No.</u> |
|---|---|
| Figure No. 15. RRP Lower Neck Z Force vs. Time | 22 |

| | | MAXIMUM VALUE | | | |
|---|---|---|---|---|---|
| Lower Neck Fz | N | 527.3 | 10.6 | -5.5 | 4.6 |

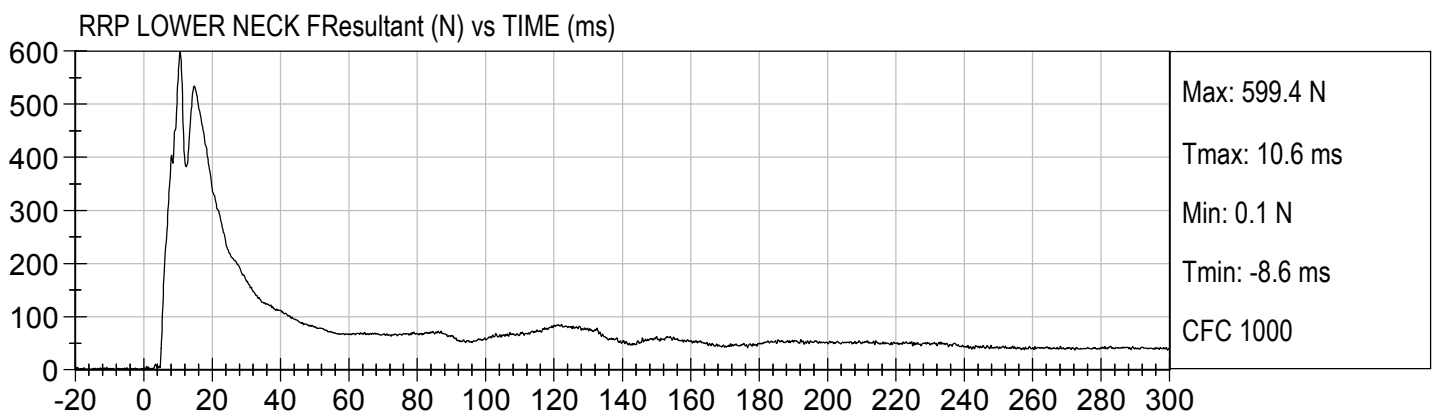
| | <u>Page No.</u> |
|---|---|
| Figure No. 16. RRP Lower Neck Resultant Force vs. Time | 22 |

| | | MAXIMUM VALUE | | | |
|---|---|---|---|---|---|
| Lower Neck F Resultant | N | 599.4 | 10.6 | | |

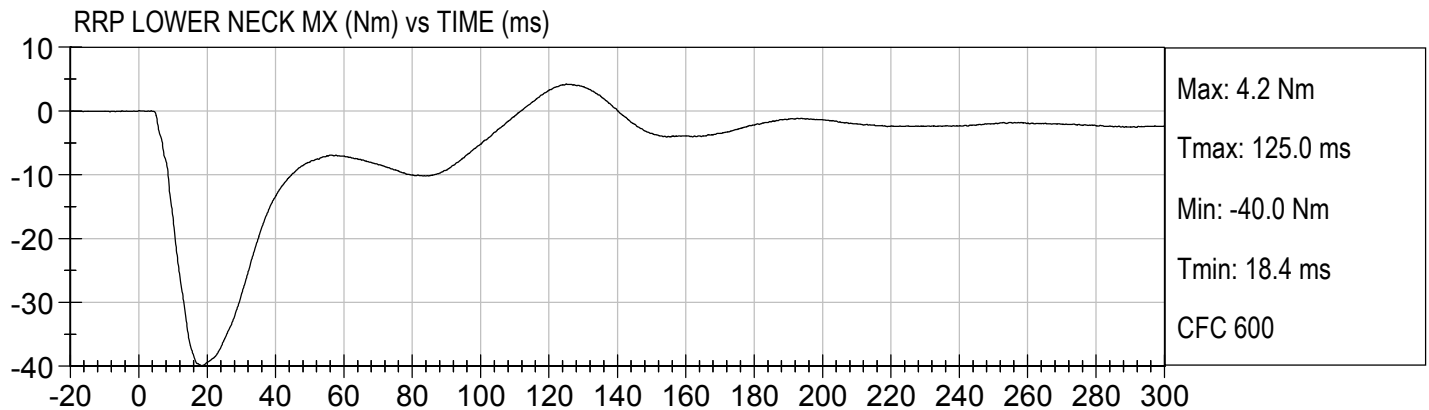
| | <u>Page No.</u> |
|---|---|
| Figure No. 17. RRP Lower Neck X Moment vs. Time | 23 |

| | | MAXIMUM VALUE | | | |
|---|---|---|---|---|---|
| Lower Neck Mx | Nm | 4.2 | 125.0 | -40.0 | 18.4 |

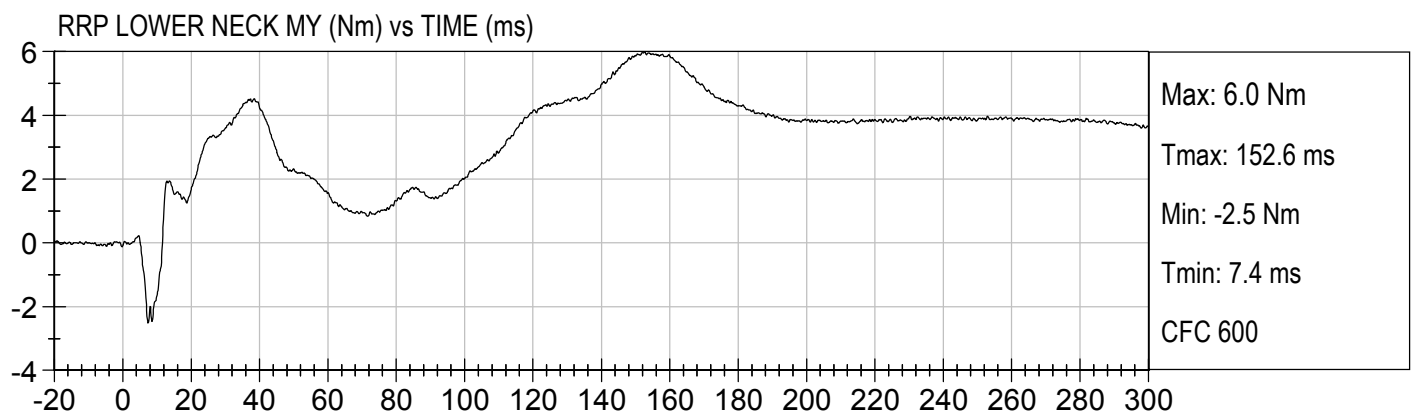
| | <u>Page No.</u> |
|---|---|
| Figure No. 18. RRP Lower Neck Y Moment vs. Time | 23 |

| | | MAXIMUM VALUE | | | |
|---|---|---|---|---|---|
| Lower Neck My | Nm | 6.0 | 152.6 | -2.5 | 7.4 |

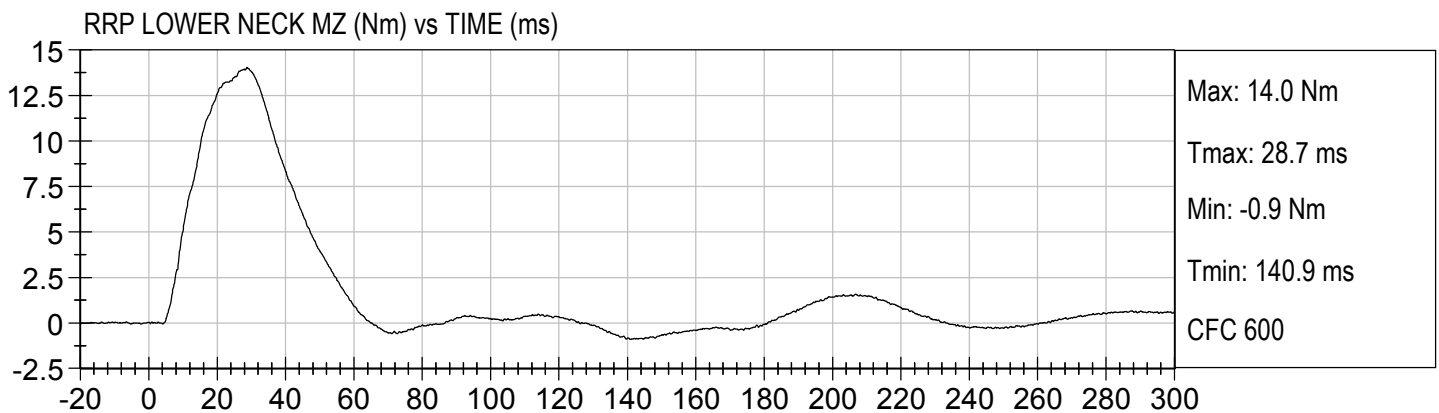
| | <u>Page No.</u> |
|---|---|
| Figure No. 19. RRP Lower Neck Z Moment vs. Time | 23 |

| | | MAXIMUM VALUE | | | |
|---|---|---|---|---|---|
| Lower Neck Mz | Nm | 14.0 | 28.7 | -0.9 | 140.9 |

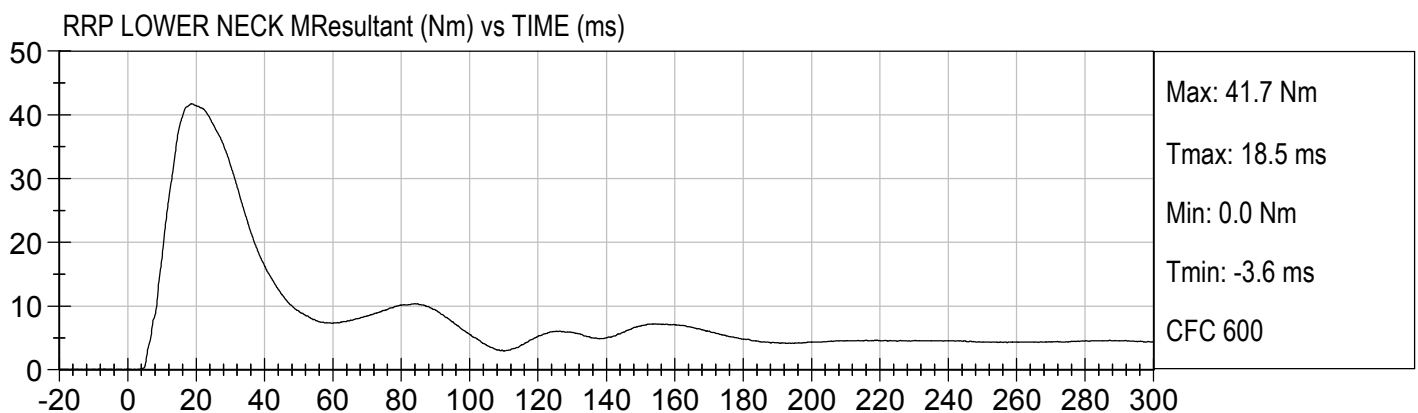
| | <u>Page No.</u> |
|---|---|
| Figure No. 20. RRP Lower Neck Resultant Moment vs. Time | 23 |

| | | MAXIMUM VALUE | | | |
|---|---|---|---|---|---|
| Lower Neck M Resultant | Nm | 41.7 | 18.5 | | |

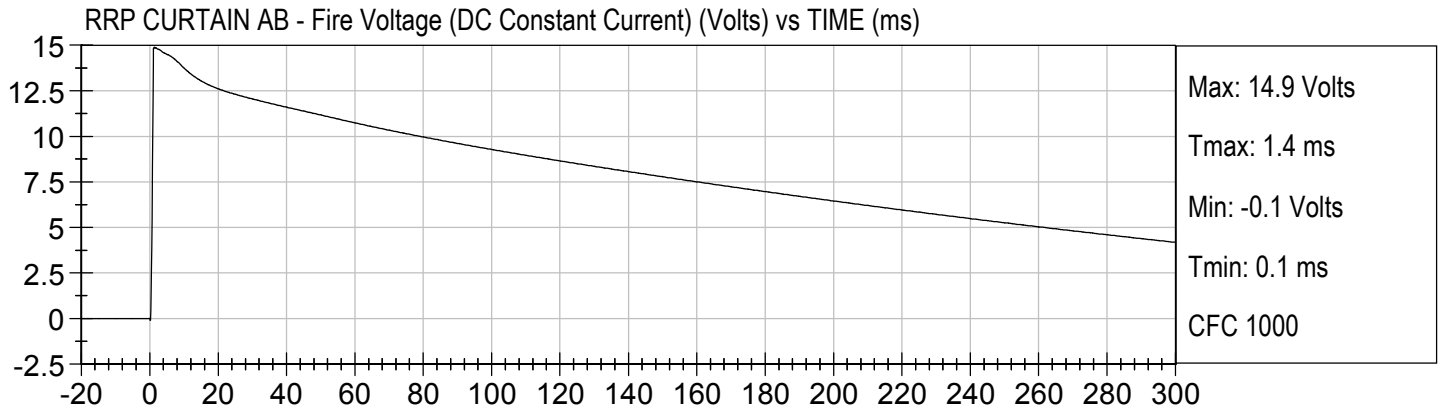
| | <u>Page No.</u> |
|---|---|
| Figure No. 21. RRP Curtain Airbag – Fire Voltage vs. Time | 24 |

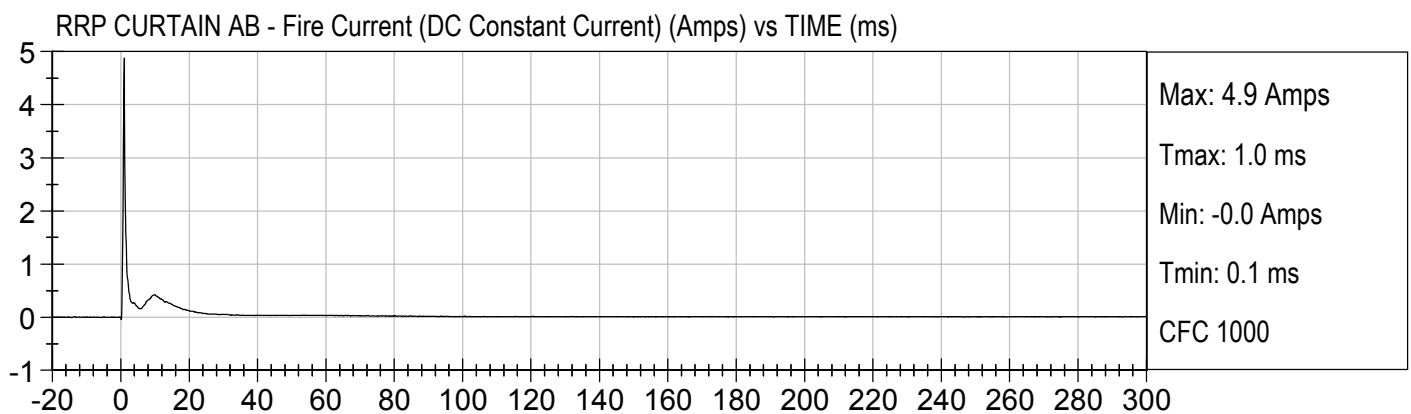
| | <u>Page No.</u> |
|---|---|
| Figure No. 22. RRP Curtain Airbag – Fire Current vs. Time | 24 |

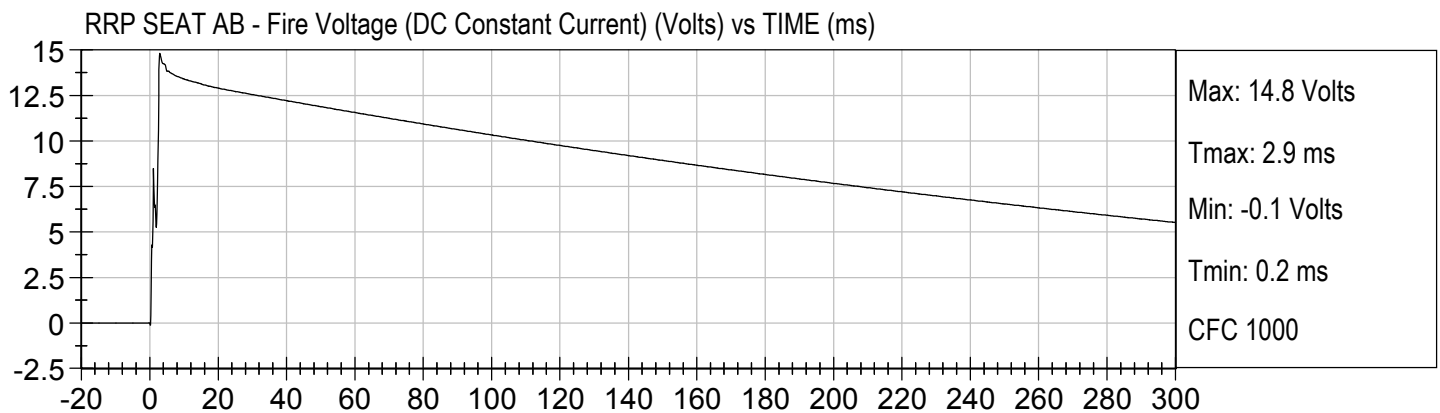
| | <u>Page No.</u> |
|---|---|
| Figure No. 23. RRP Seat Airbag – Fire Voltage vs. Time | 24 |

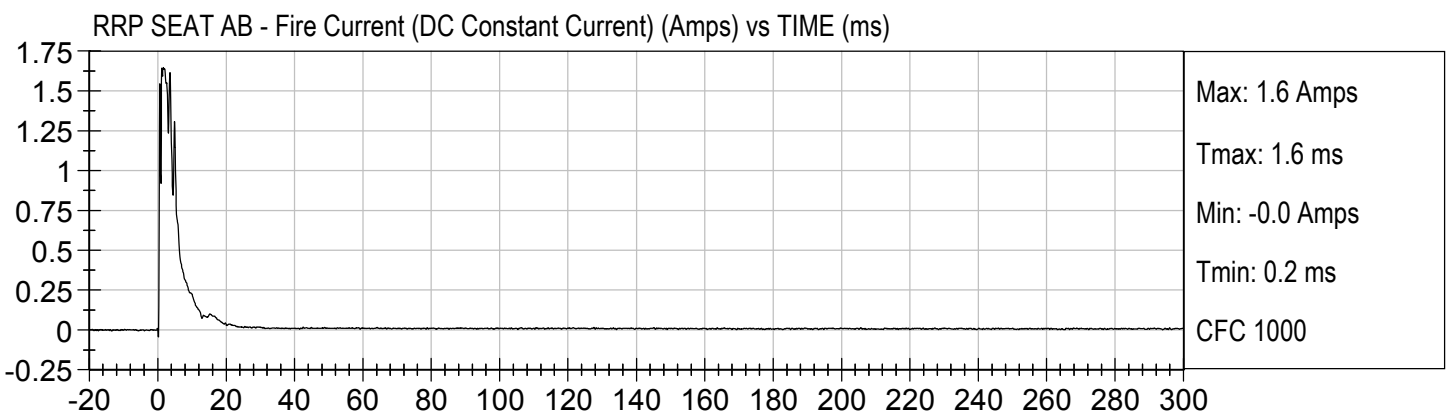
| | <u>Page No.</u> |
|---|---|
| Figure No. 24. RRP Seat Airbag – Fire Current vs. Time | 24 |
