REPORT NUMBER: NCAP-MGA-2014-046

**NEW CAR ASSESSMENT PROGRAM (NCAP)
Frontal Barrier Impact Test**

**AUDI AG
2014 Audi A6 AWD 4-Dr Sedan
NHTSA No.: O20145802**

**MGA RESEARCH CORPORATION
5000 Warren Road
Burlington, WI 53105**

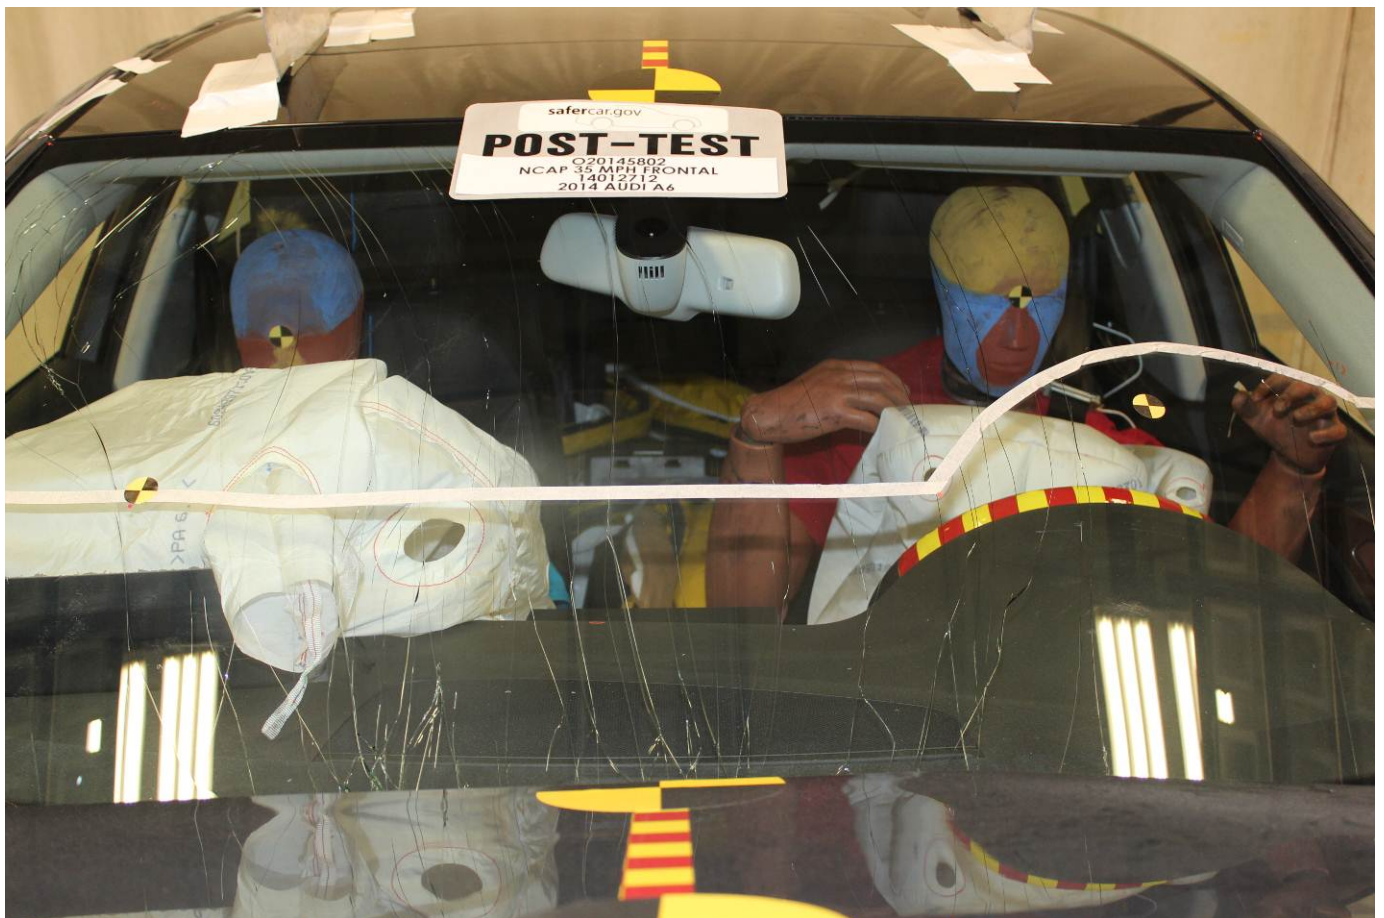
Post-Test Windshield View

There was 100 percent windshield retention and no intrusion into the protected zone of the windshield during the event. There was no Stoddard Solvent leakage after the event or during any phase of the static rollover.

Critical Areas of Performance	Observations and Conclusions
Windshield Damage	Cracked
Window Damage	None
Other Notable Effects	None

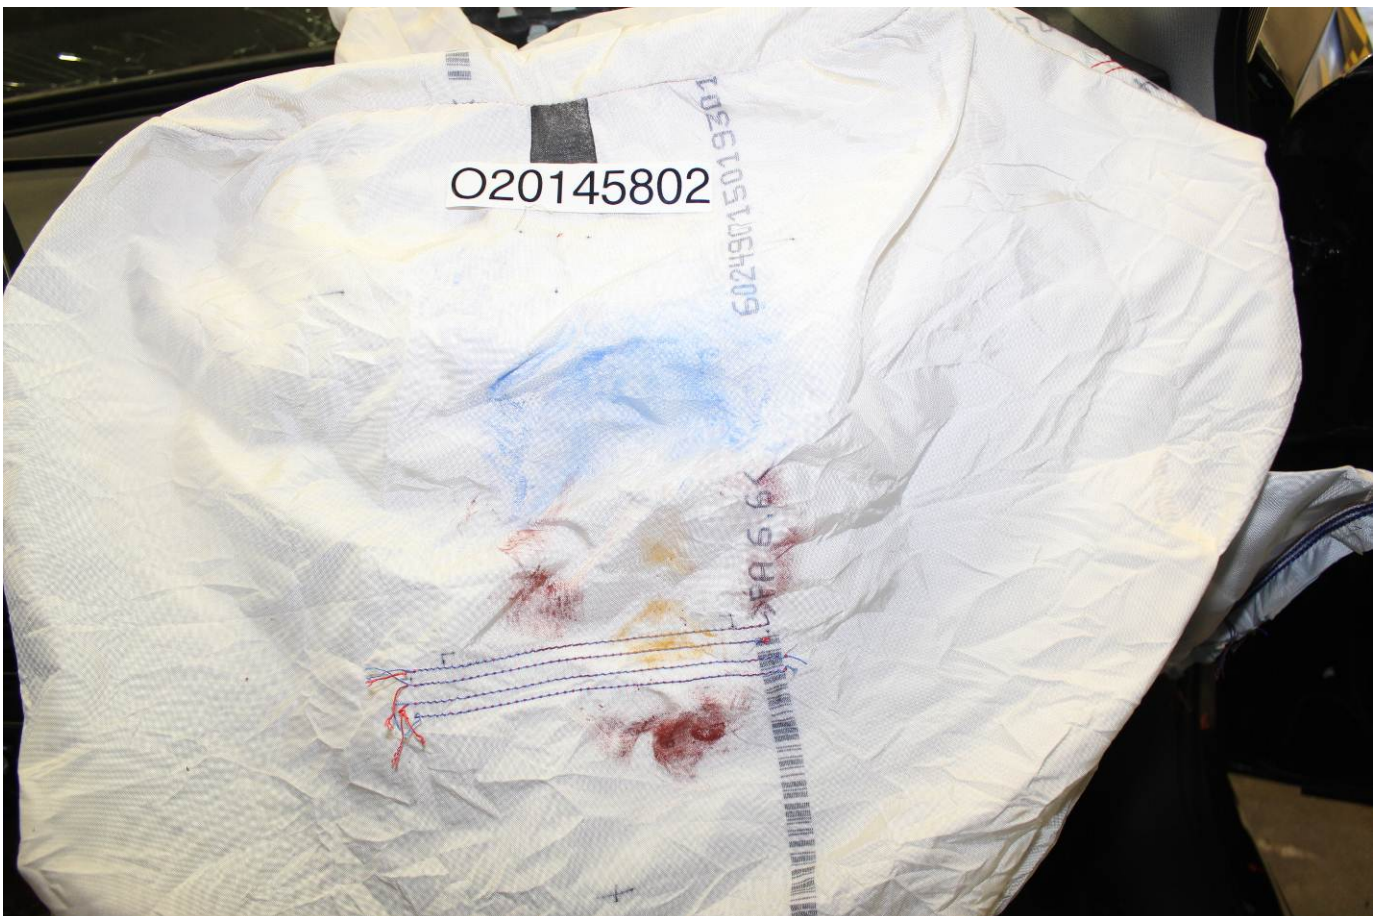
Post-Test Driver Dummy Contact with Airbag

The driver's visible contact points were as follows: The driver's head and chest contacted the airbag. The driver's head also contacted the headrest. The driver's knees contacted the knee airbag. The passenger's visible contact points were as follows: The passenger's head and chest contacted the airbag. The passenger's head also contacted the headrest. The passenger's knees contacted the knee airbag.

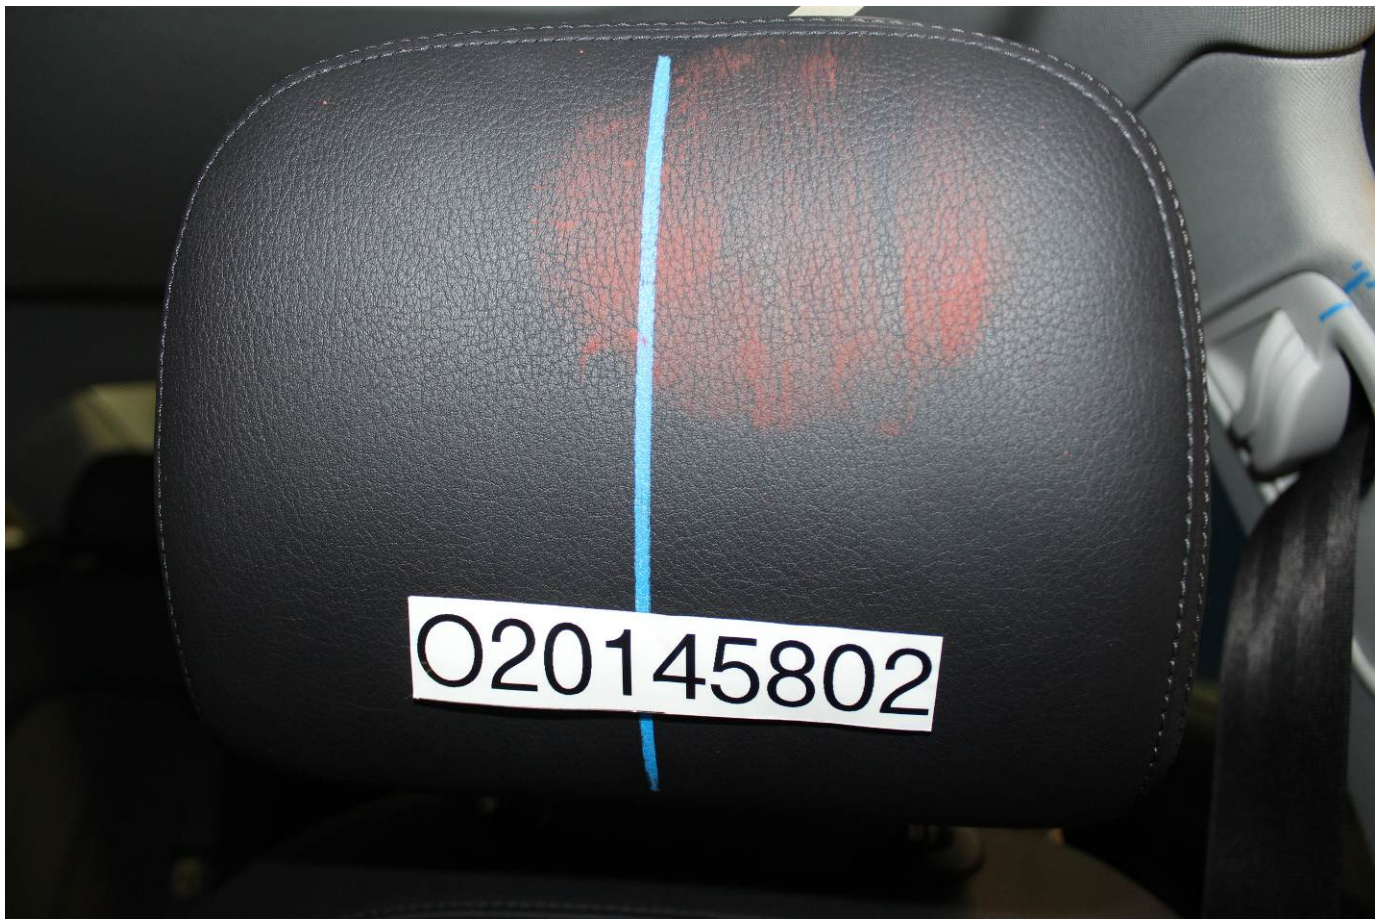
Post-Test Driver Dummy Contact with Headrest

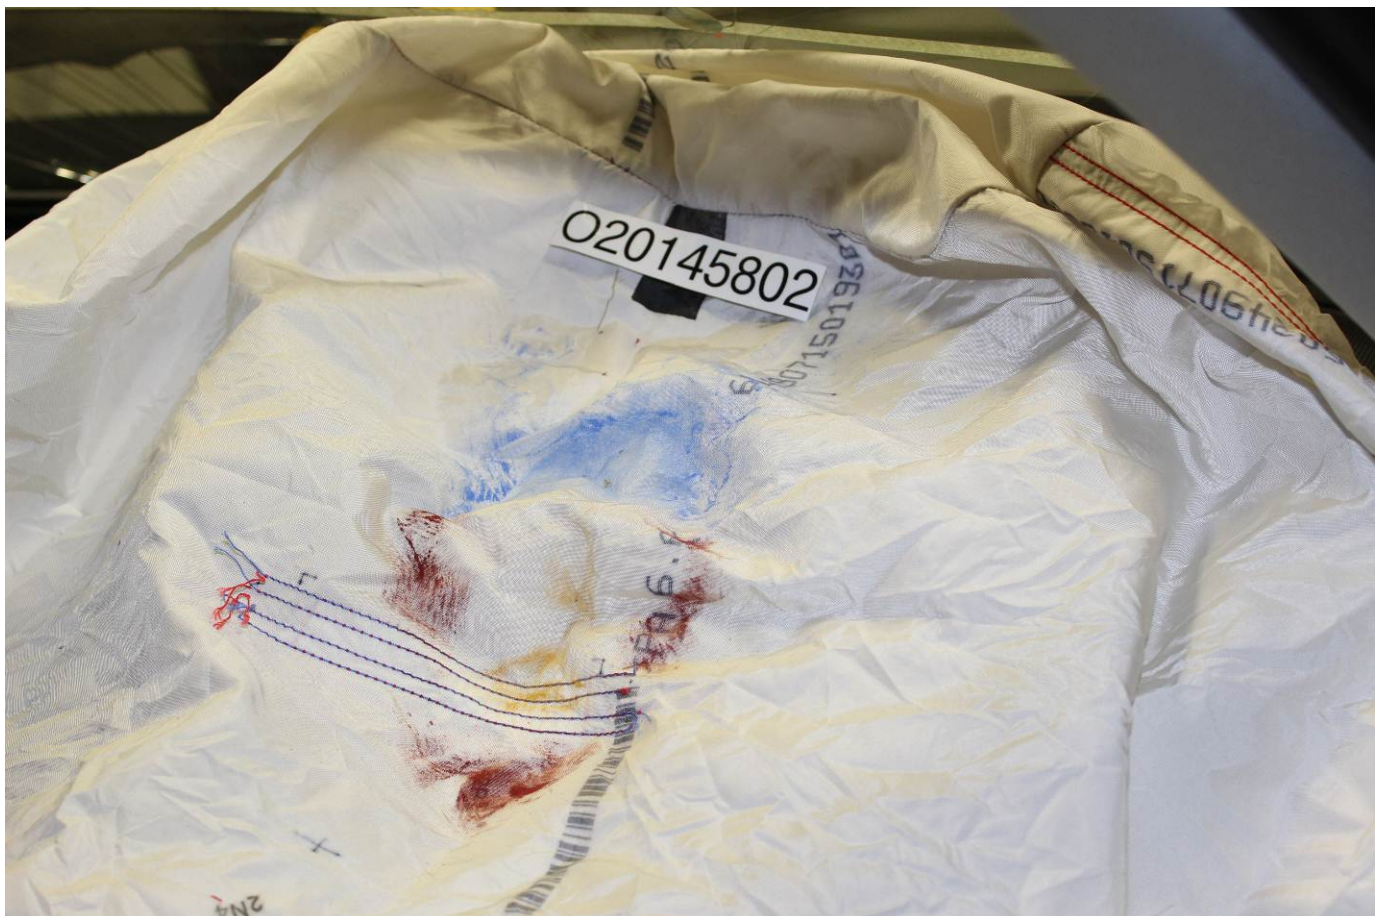
Post-Test Passenger Dummy Contact with Airbag

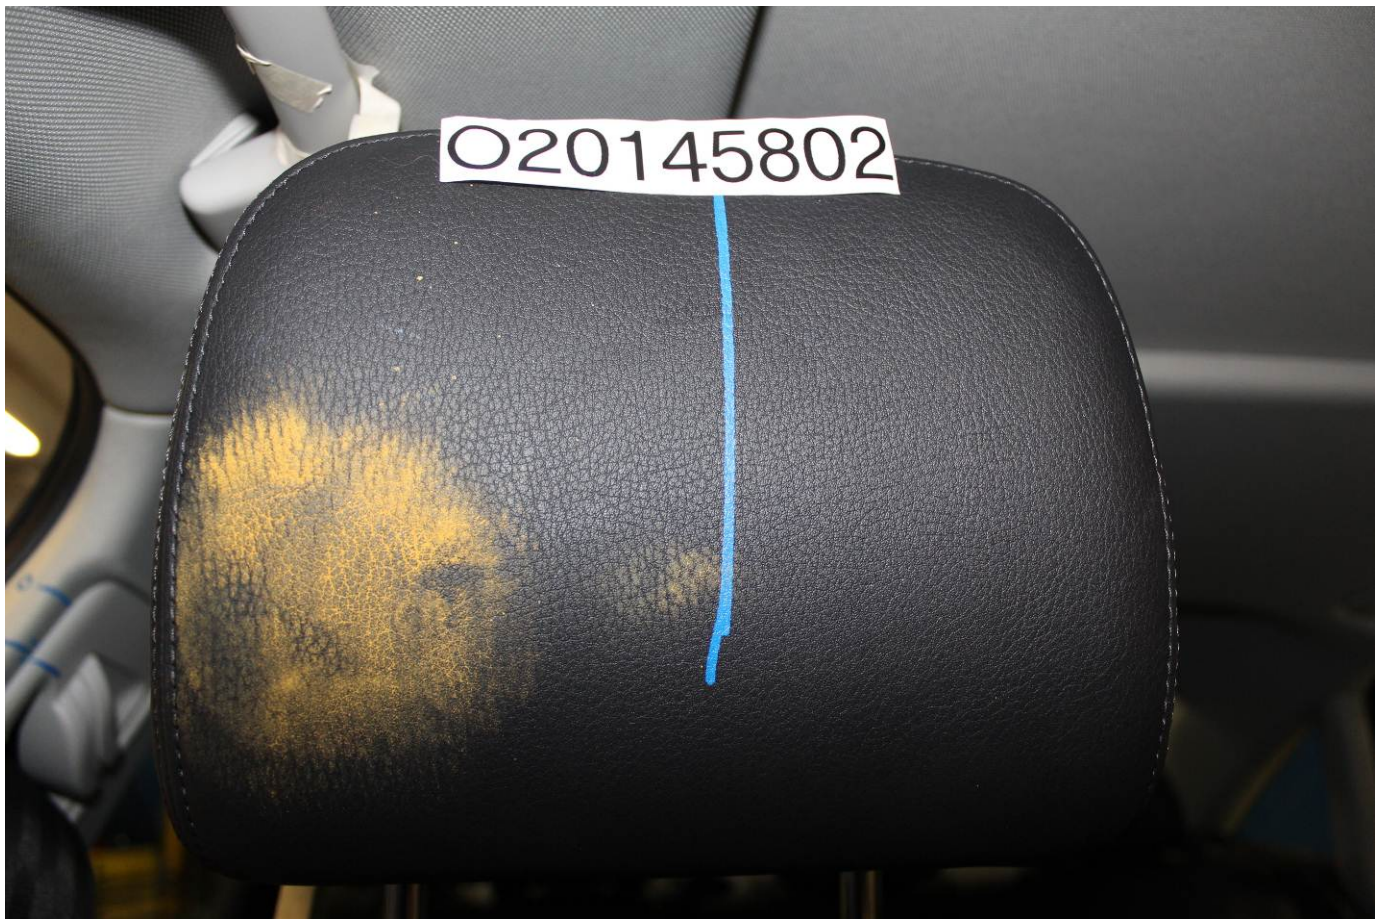
Post-Test Passenger Dummy Contact with Headrest

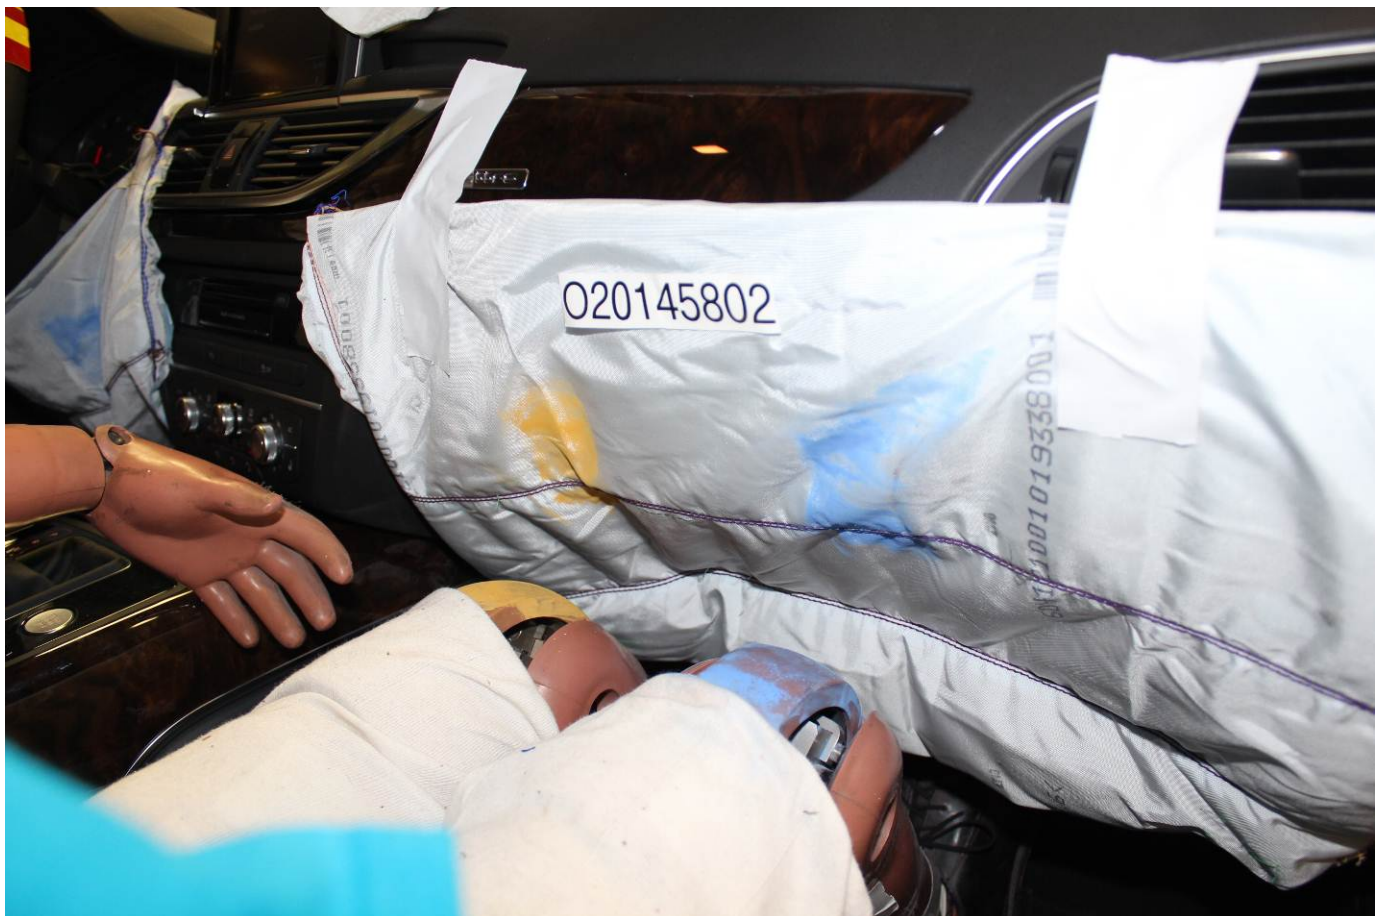
Post-Test Passenger Dummy Contact with Knee Airbag

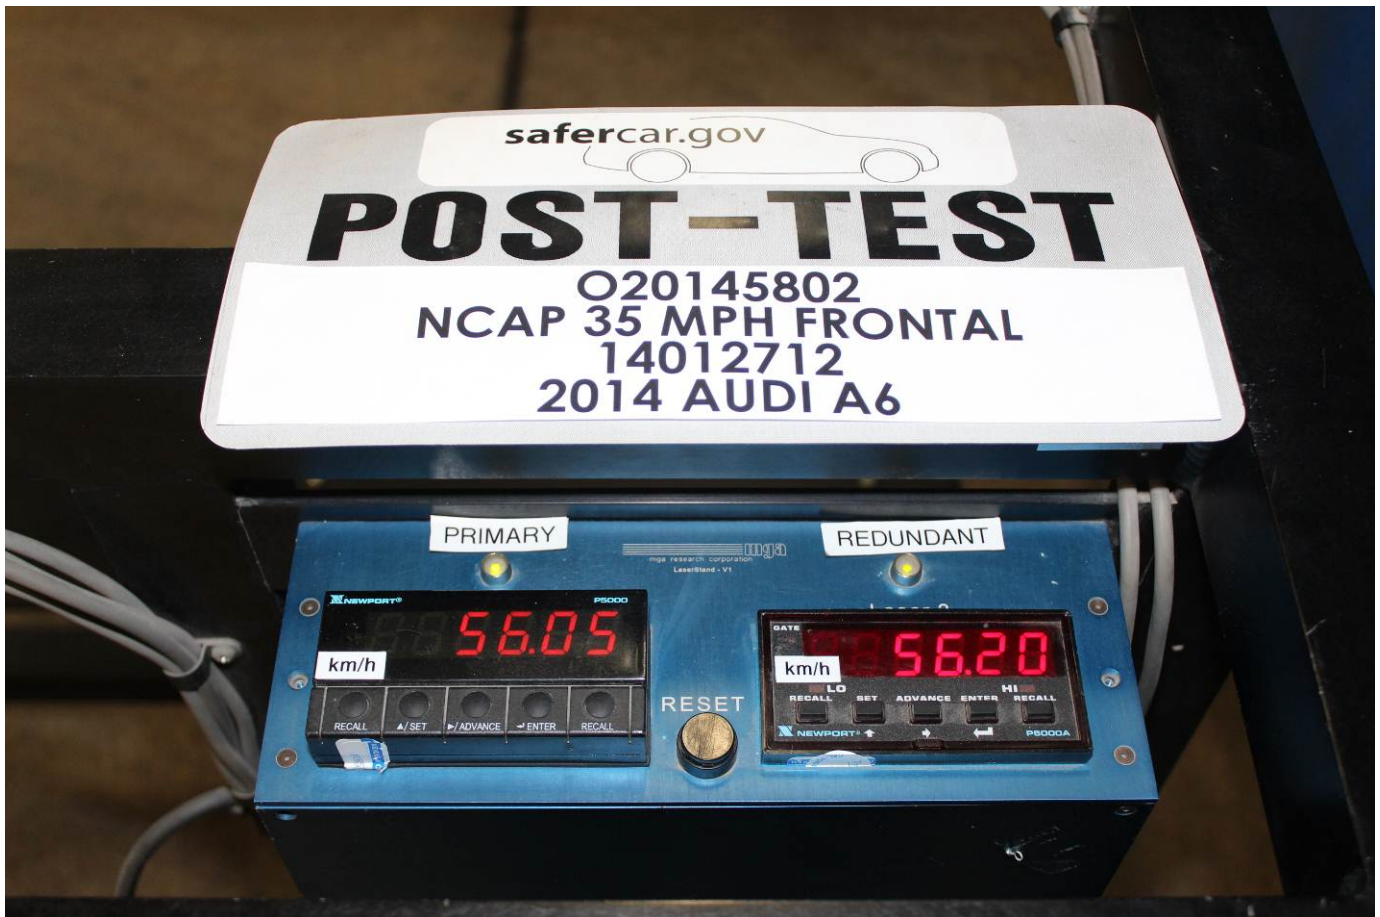
Post-Test Speed Trap Read-Out

A load cell barrier consisting of 176 load cells was impacted by a 2014 Audi A6 AWD 4-Dr Sedan at a velocity of 56.1 km/h. The test was performed at MGA Research Corporation on January 27, 2014. Pre-test and post-test photographs of the vehicle and dummies can be found in Appendix A.

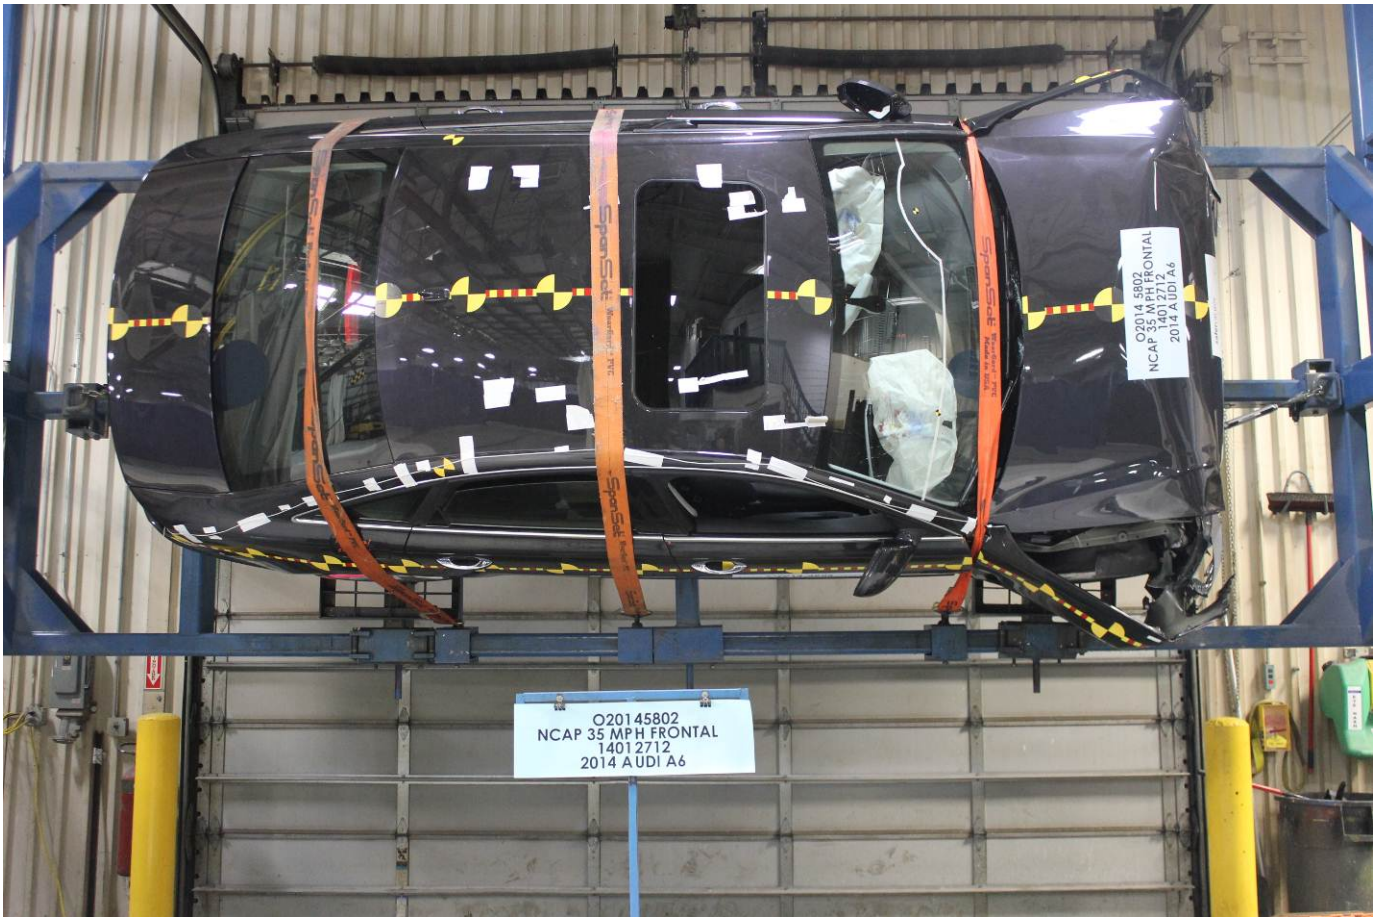
Vehicle at 90 Degrees on Static Rollover Device

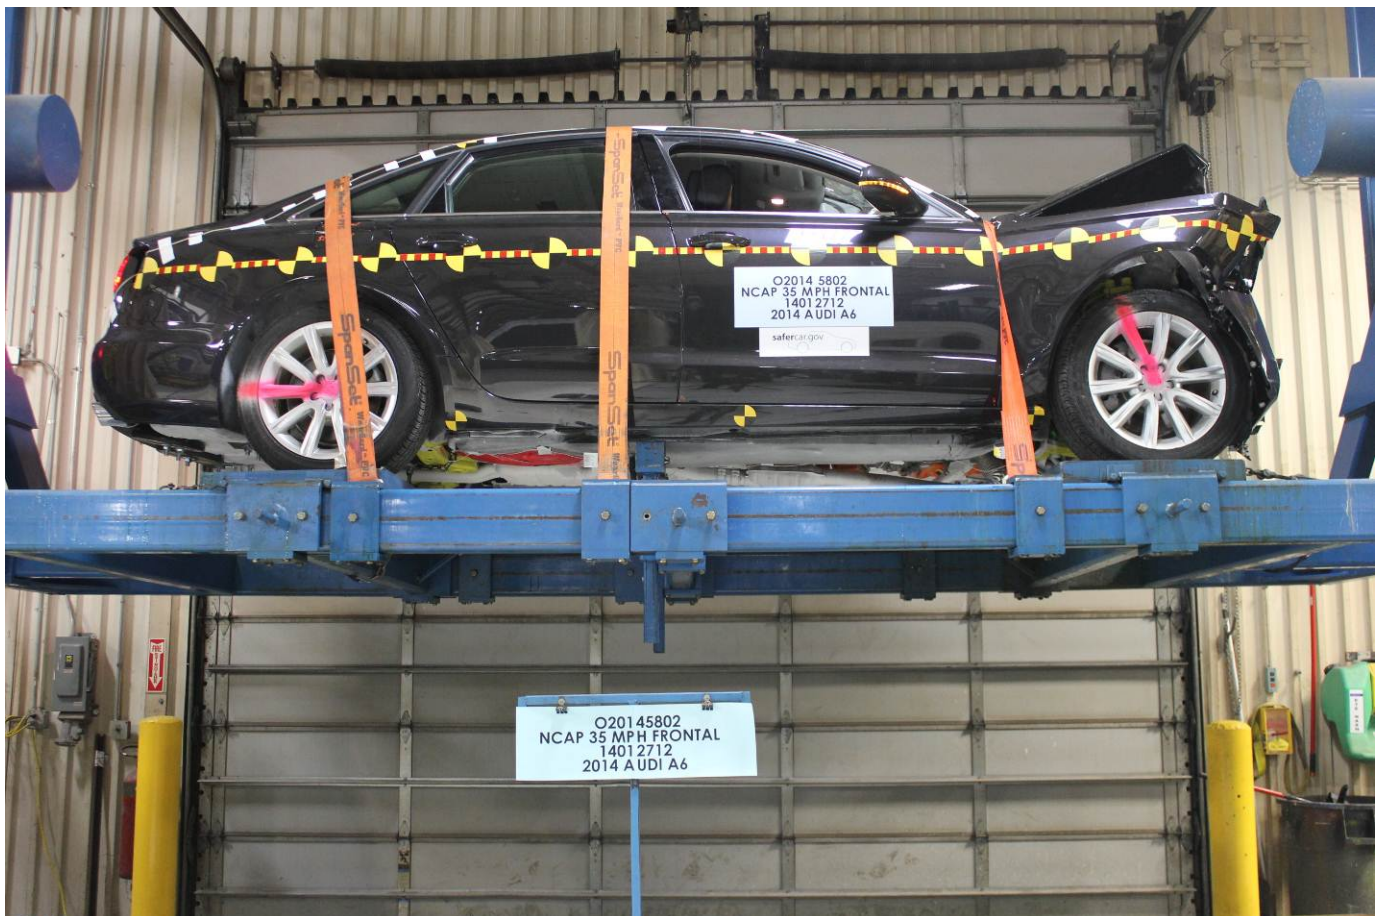
Vehicle at 360 Degrees on Static Rollover Device
