**REPORT NUMBER: SPNCAP-MCW-14-013**

**NEW CAR ASSESSMENT PROGRAM (SPNCAP)  
SIDE IMPACT POLE TEST**

**MINITUBISHI MOTORS CORPORATION  
2014 MITSUBISHI OUTLANDER 5-DOOR MPV  
NHTSA NUMBER: M20145601**

**FINAL REPORT**

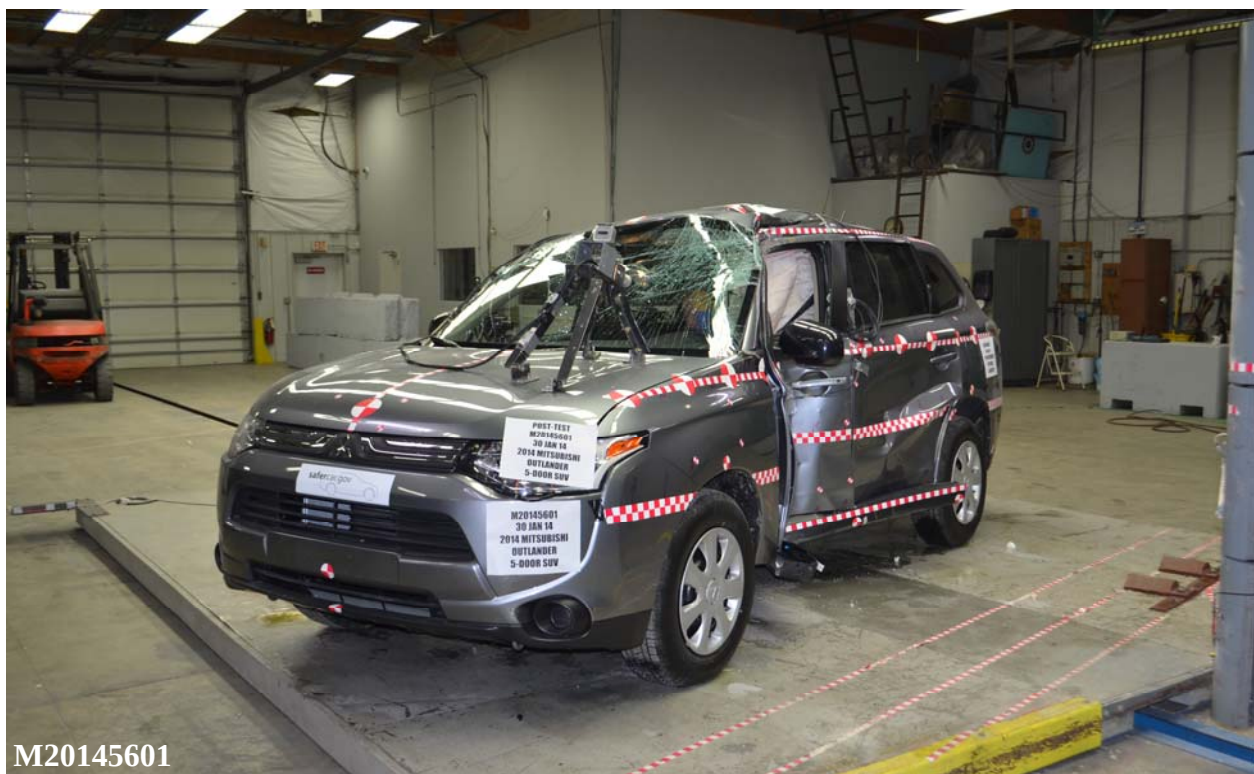
Figure 006: Post-Test Left Front 3-4 View of Test Vehicle

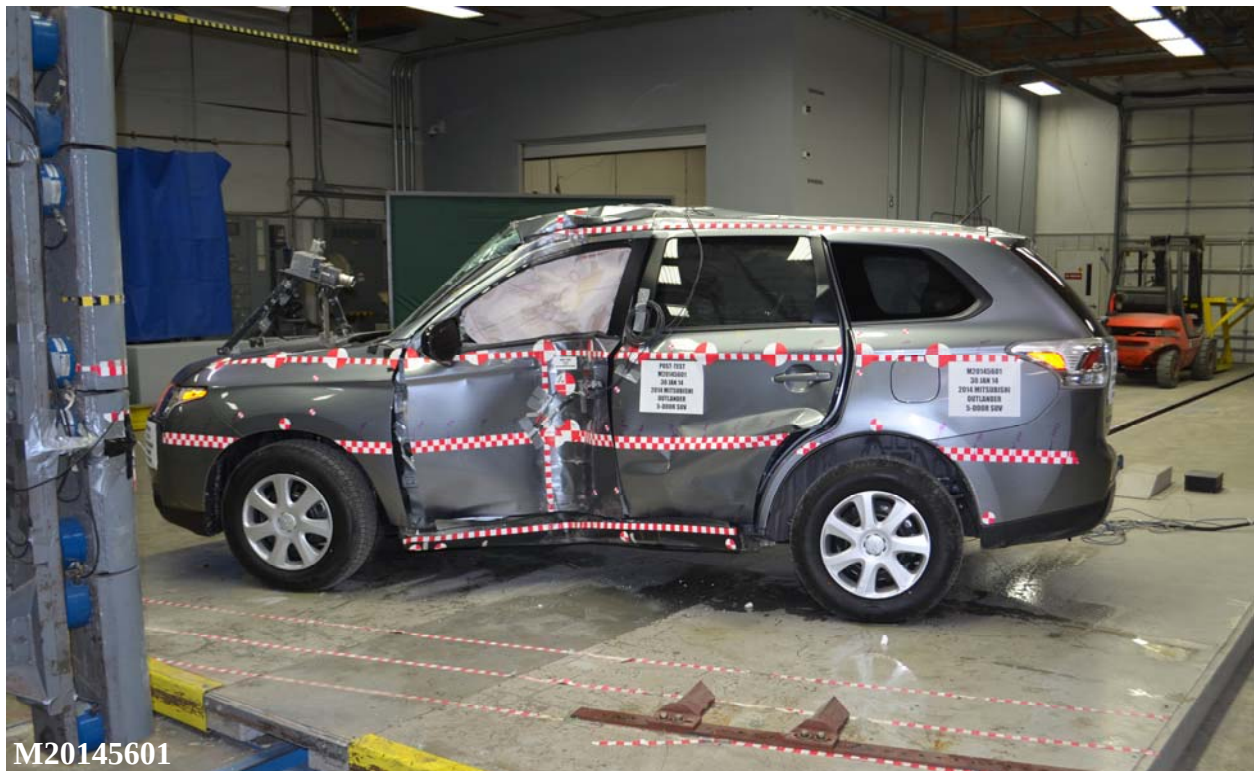
Figure 008: Post-Test Left Side View of Test Vehicle

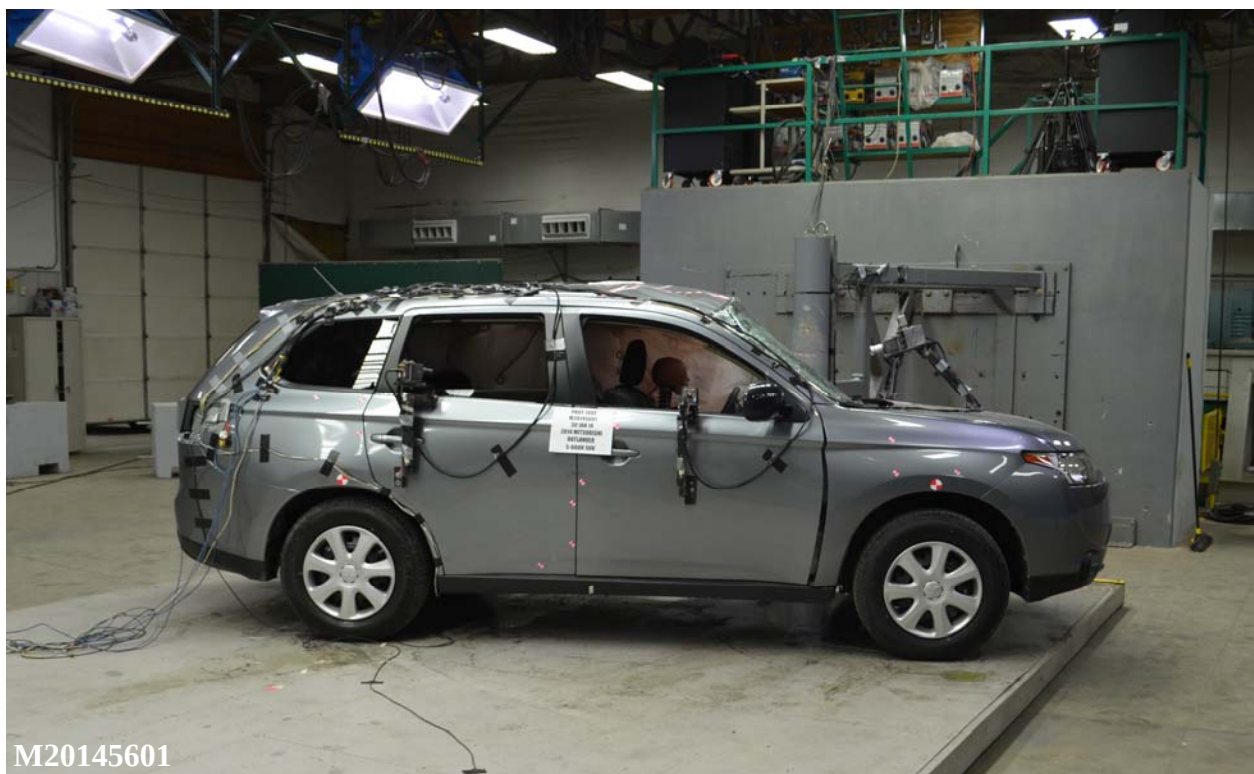
Figure 014: Post-Test Right Side View of Test Vehicle

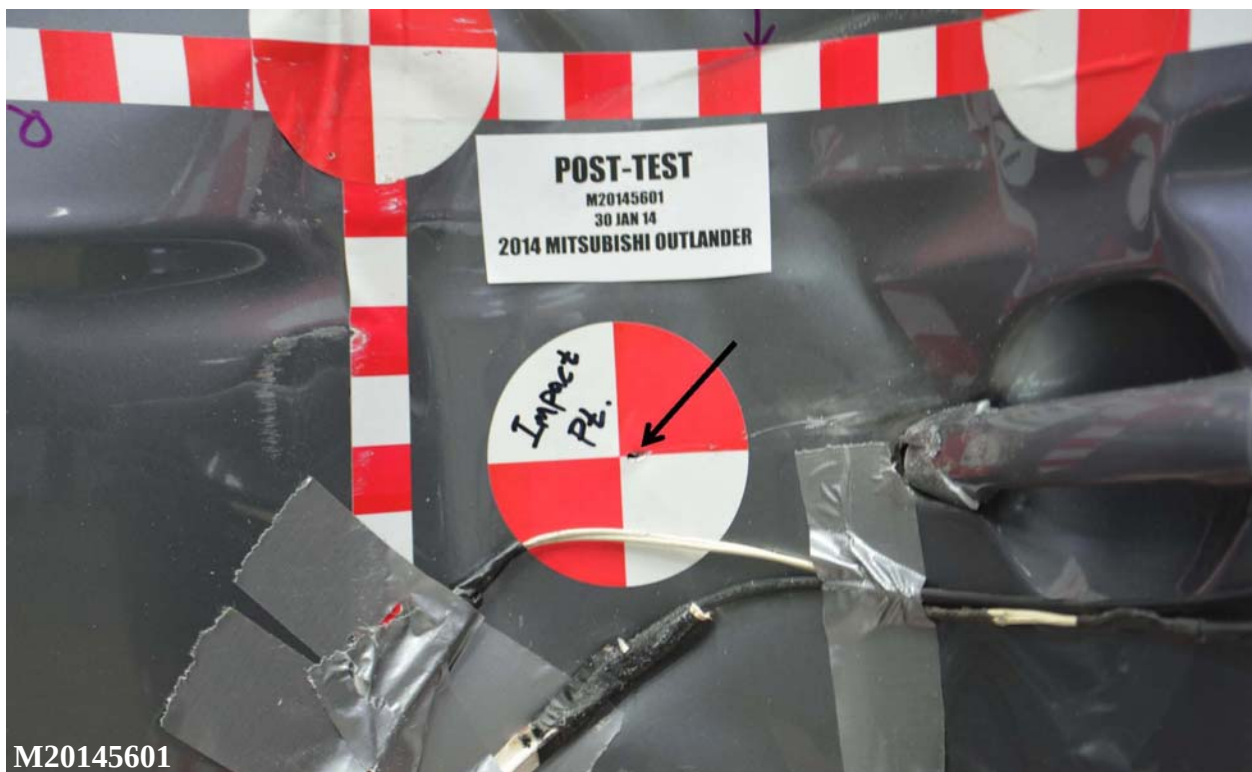
Figure 020: Post-Test Close-Up View of Impact Point Target Showing Impact Location

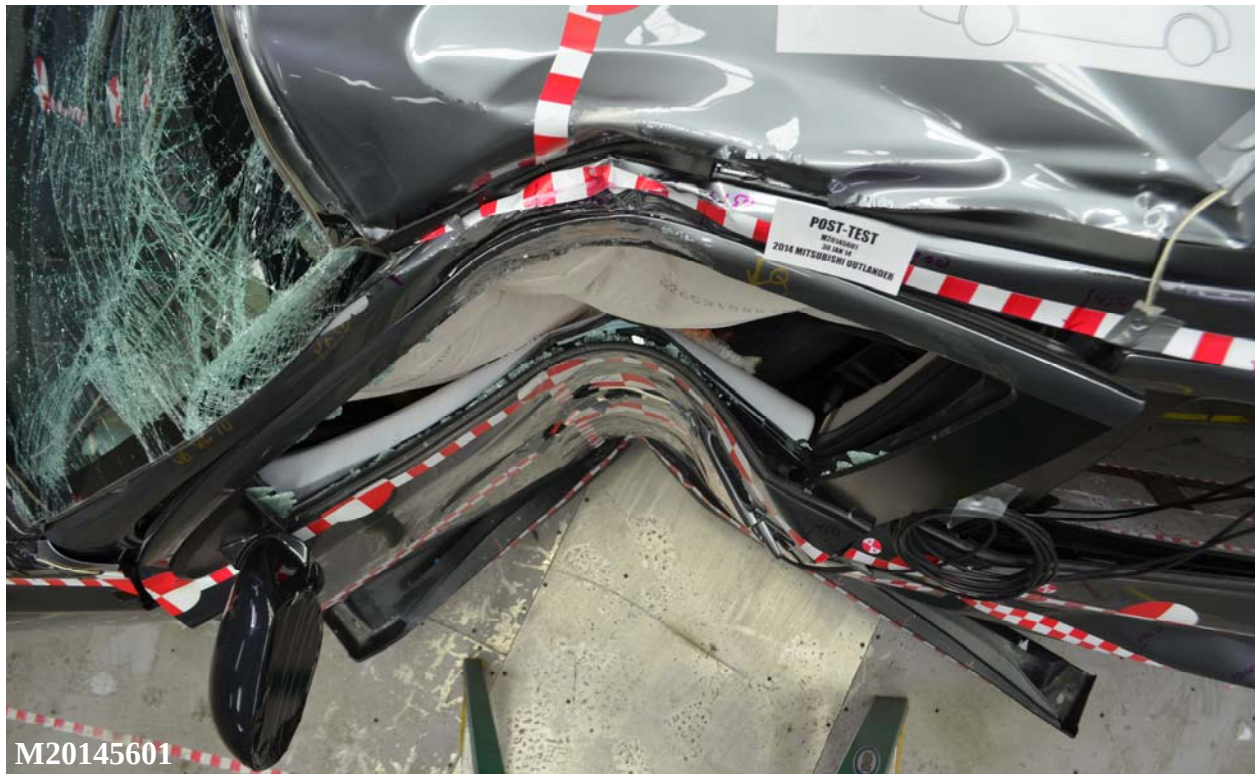
Figure 041: Post-Test Dummy and Door Clearance View

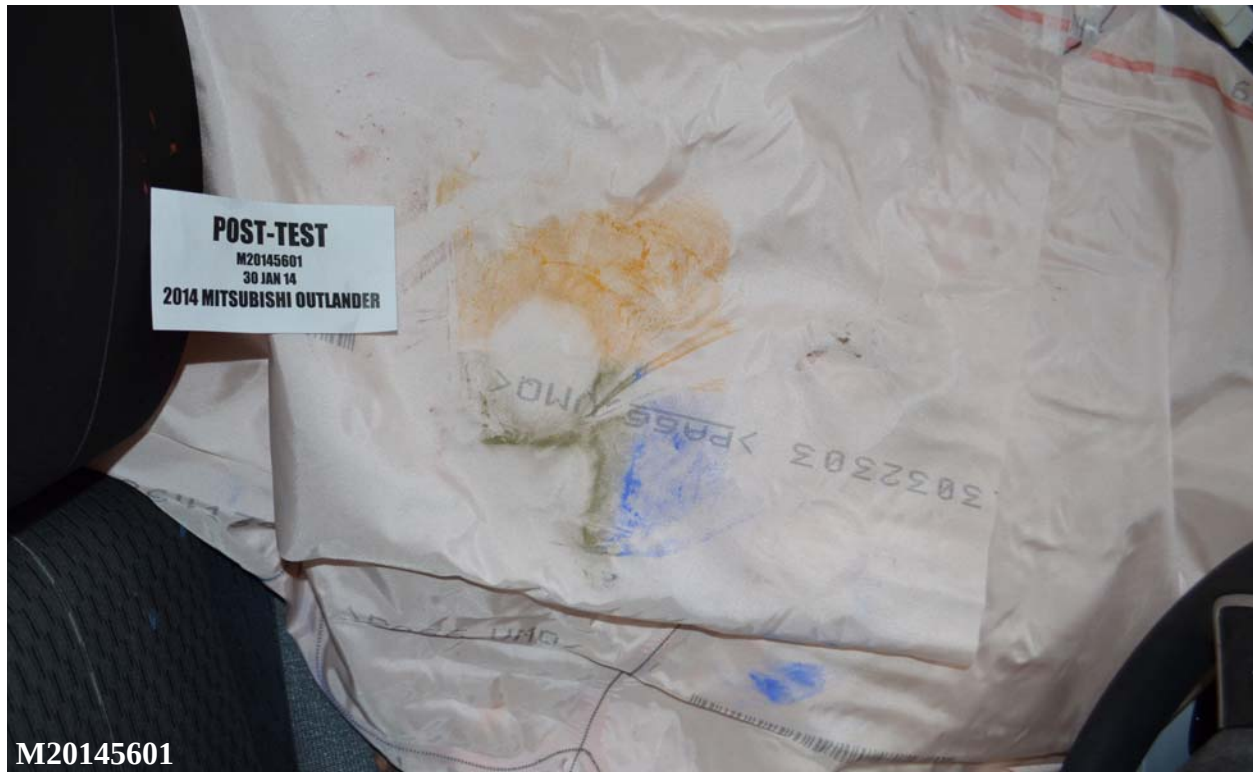
Figure 047: Post-Test Dummy Close-Up Head Contact with Side Air bag View

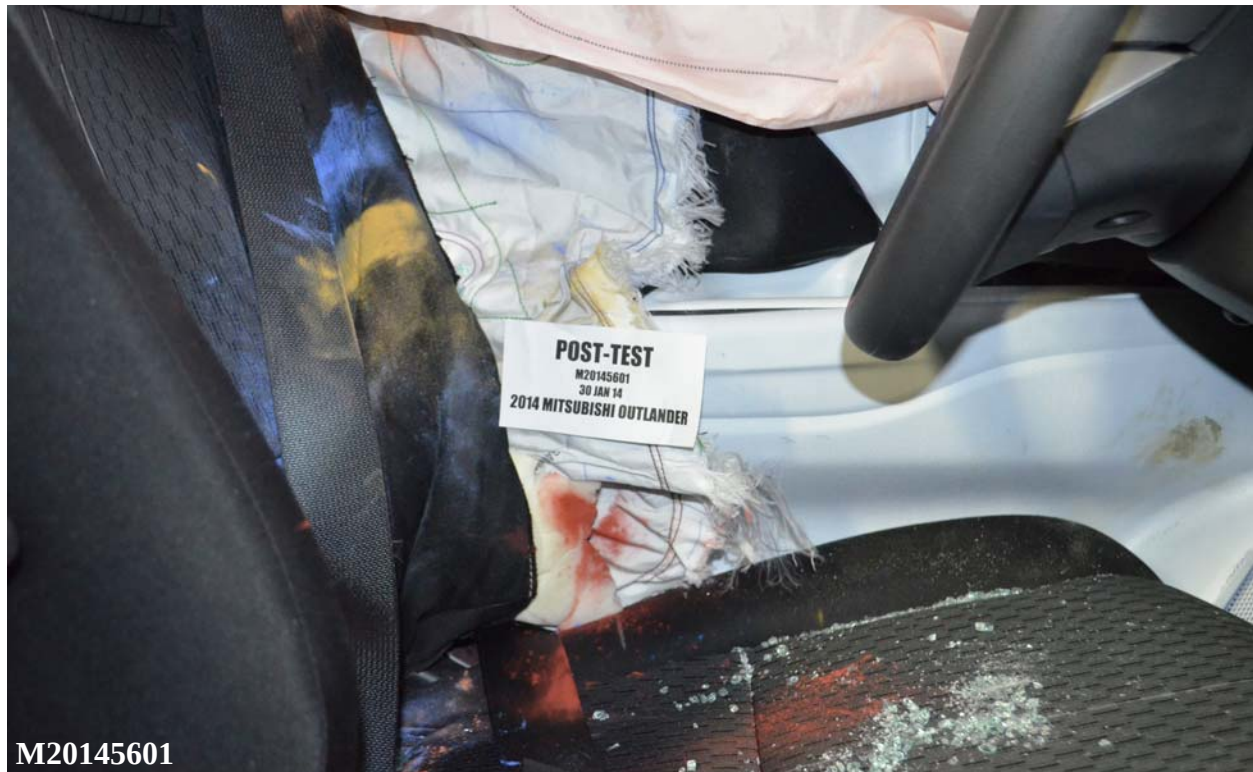
Figure 049: Post-Test Dummy Close-Up Torso Contact with Side Air bag View

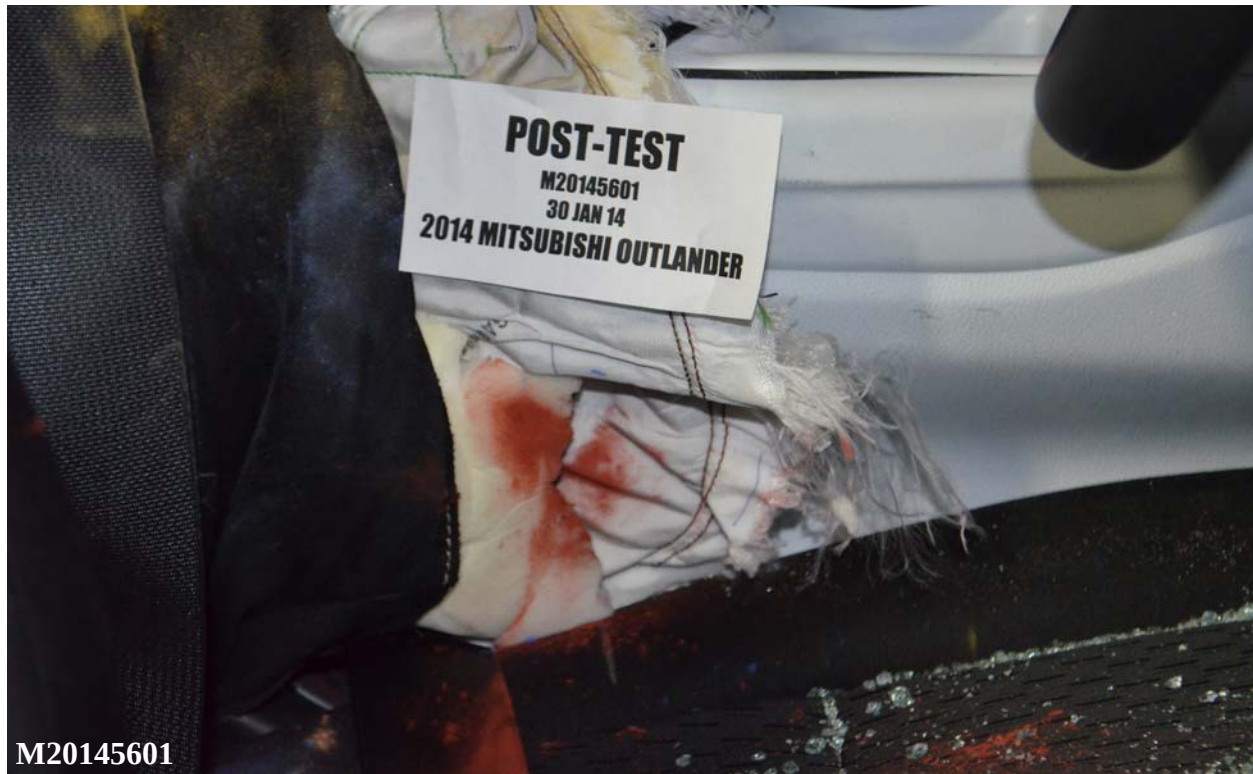
Figure 051: Post-Test Dummy Close-Up Pelvis Contact with Side Air bag View

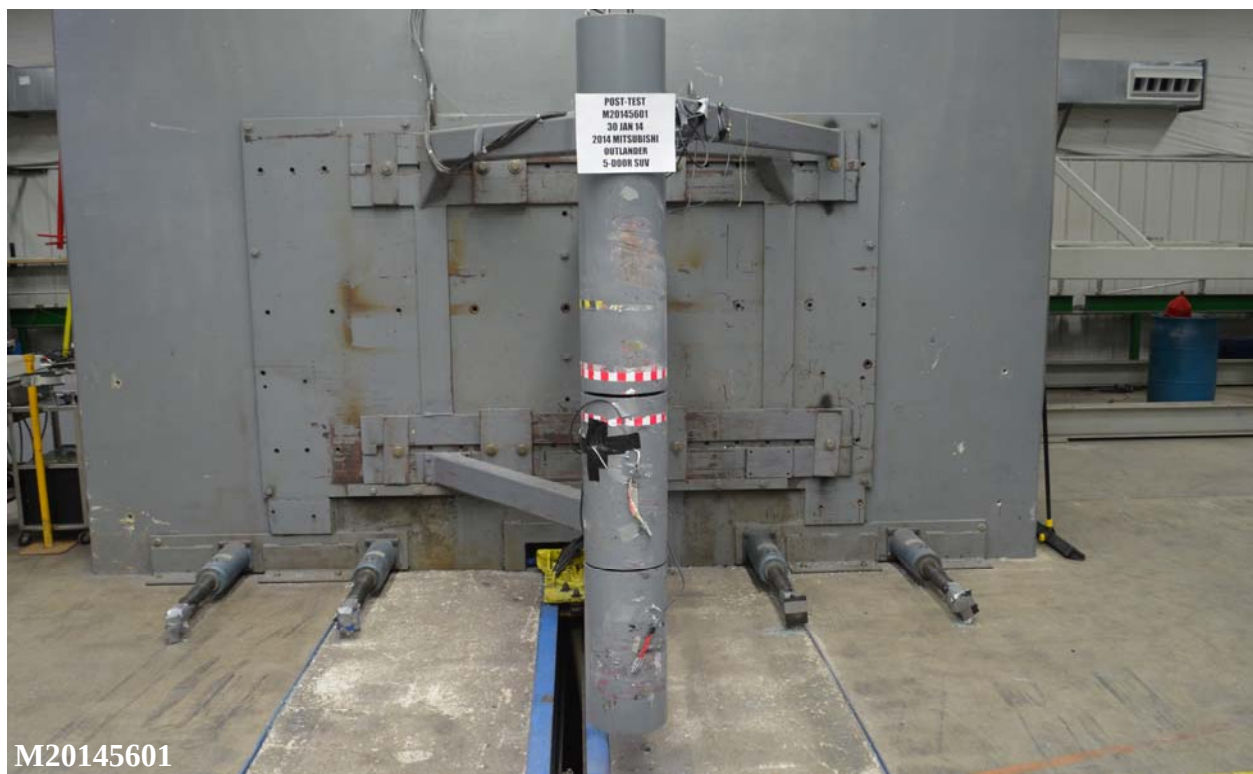
Figure 058: Post-Test Pole Barrier Front View

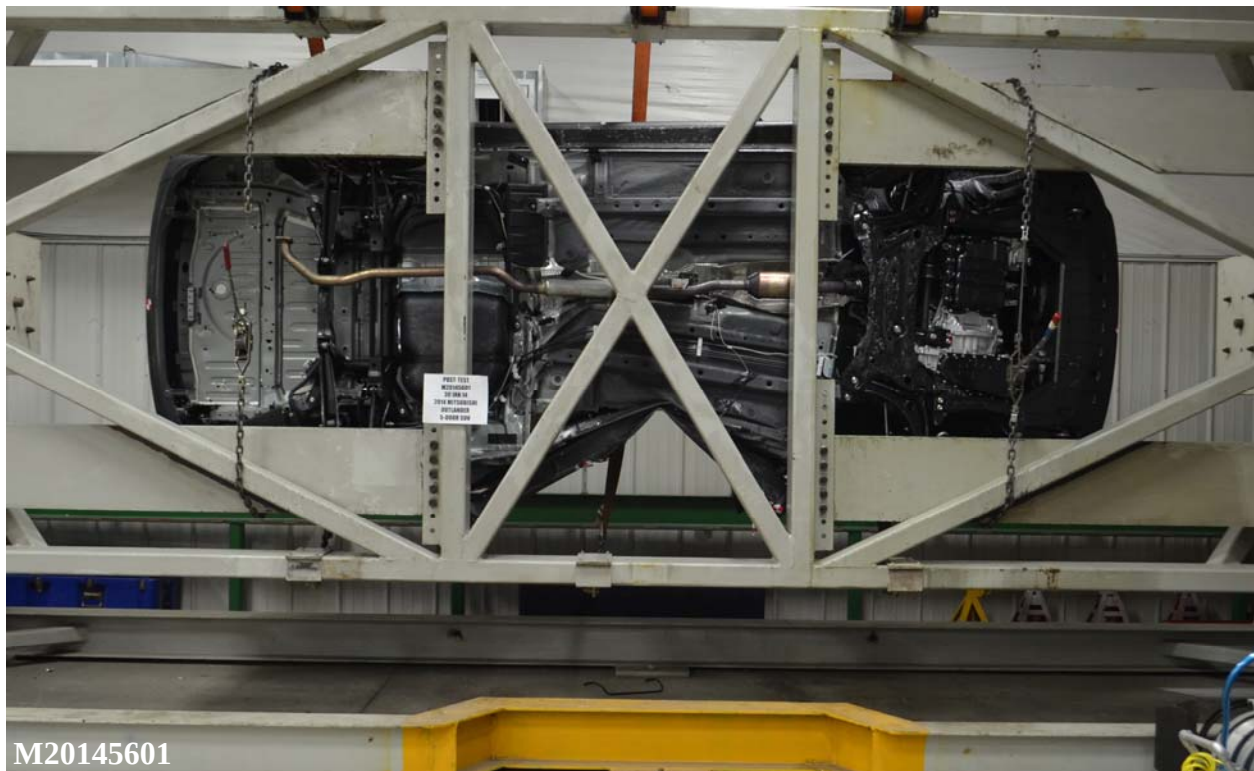
Figure 064: FMVSS No. 301 Static Rollover 90 Degrees

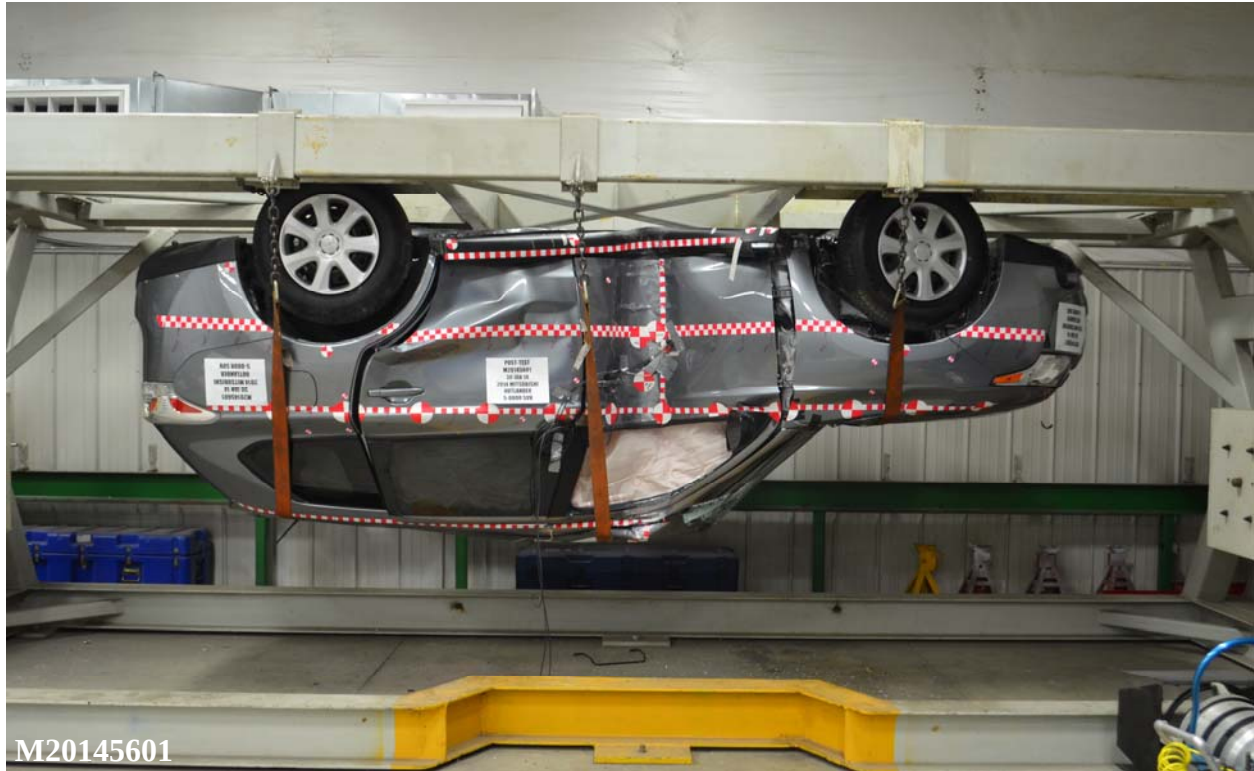
Figure 065: FMVSS No. 301 Static Rollover 180 Degrees

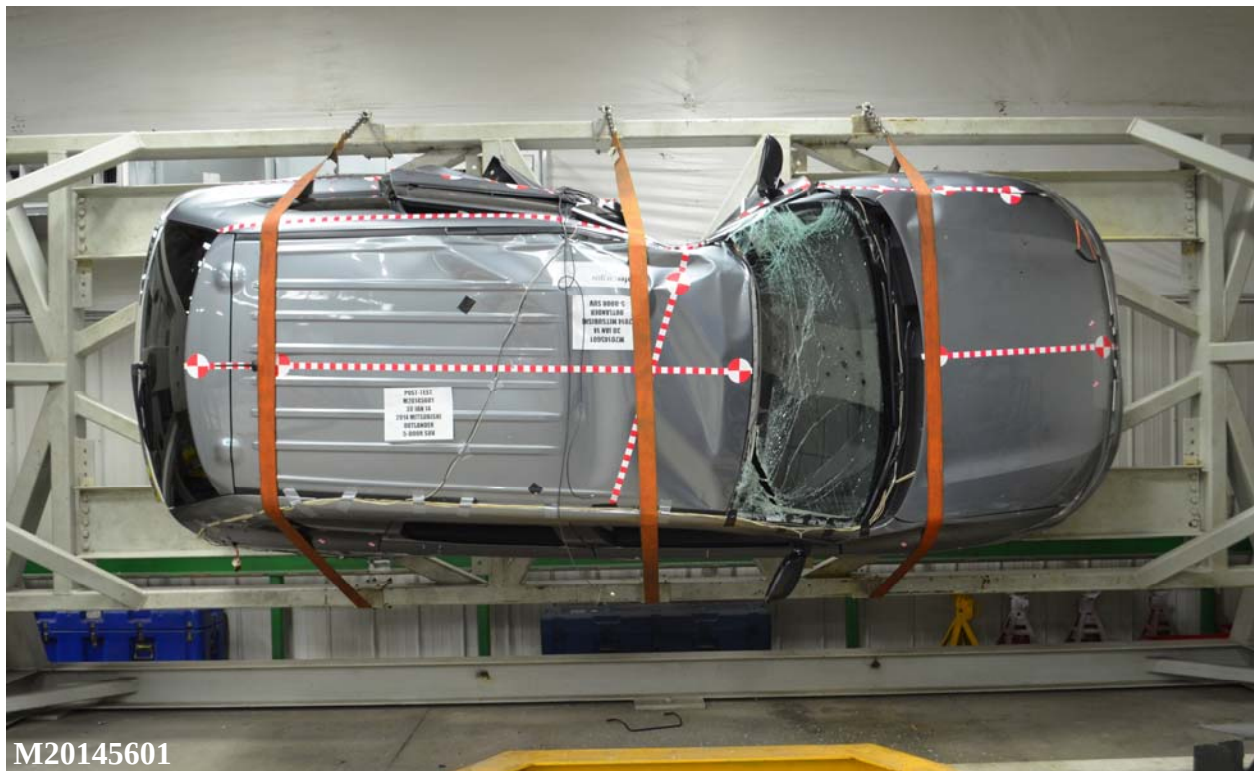
Figure 066: FMVSS No. 301 Static Rollover 270 Degrees
