**FINAL REPORT NUMBER: SPNCAP-TRC-14-008**

**NEW CAR ASSESSMENT PROGRAM (NCAP)  
SIDE IMPACT POLE TEST**

**Toyota Motor Manufacturing  
2014 Toyota Tundra 4X2 Double Cab  
NHTSA NUMBER: M20145119**

**PREPARED BY:  
Transportation Research Center Inc.  
10820 State Route 347  
P. O. Box B-67  
East Liberty, OH 43319**

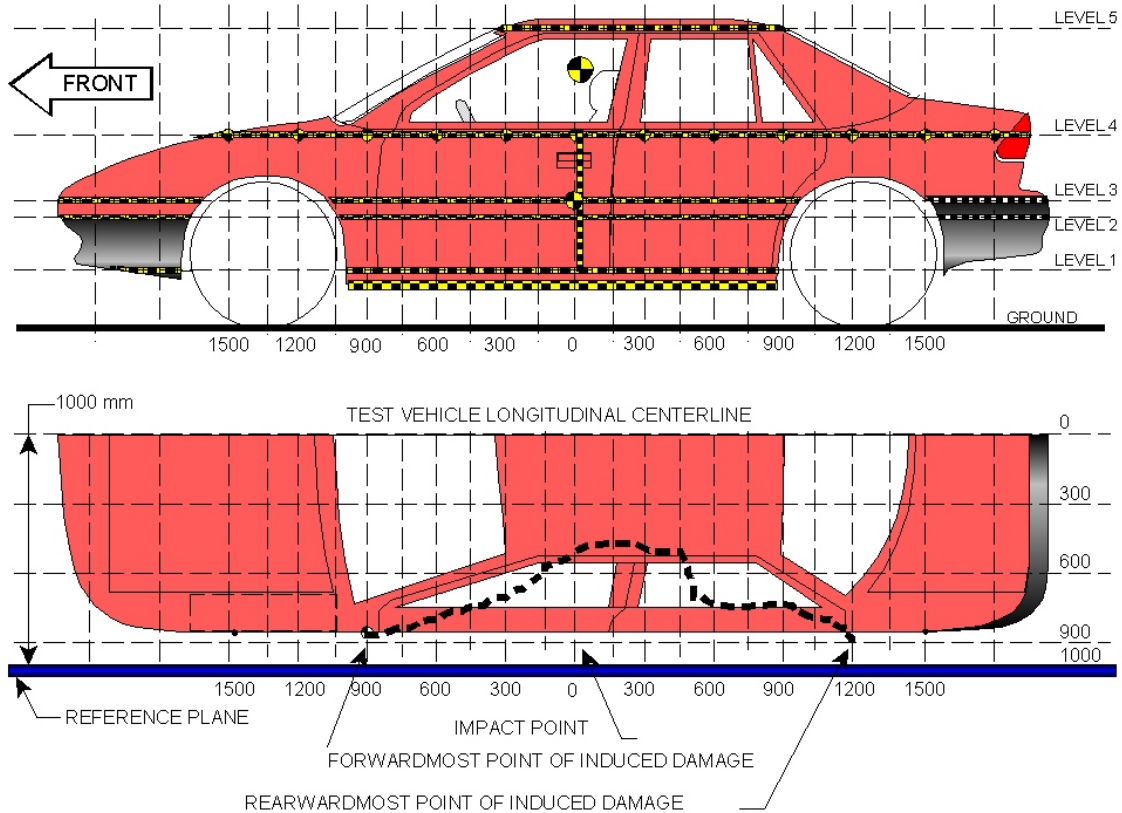
NOTE: All measurements are in millimeters (mm)

**MAXIMUM EXTERIOR CRUSH MEASUREMENTS**

**NOTE:** Pre-test measurements are taken when the vehicle is in the “As Tested” weight condition. Vehicle measurements forward of the vertical impact reference line are negative. The crush profile grid is established prior to the test based on an estimated impact point. The final distance from impact is determined after the final dummy positioning and the pole is aligned with the center of gravity of the dummy’s head.

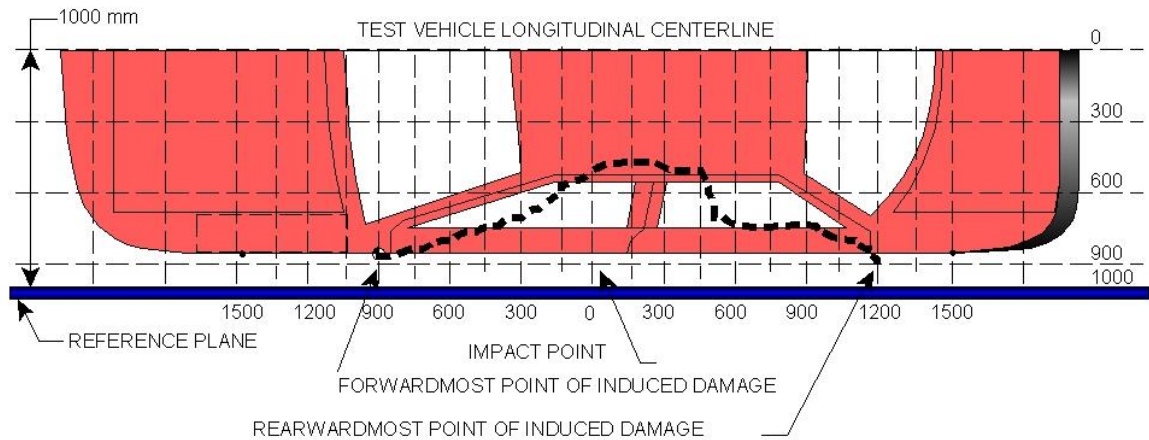
**VEHICLE DAMAGE PROFILE DISTANCES**

| DPD | Distance From Impact Point (mm) | Level | Post-Test (mm) | Pre-Test (mm) | Crush (mm) |

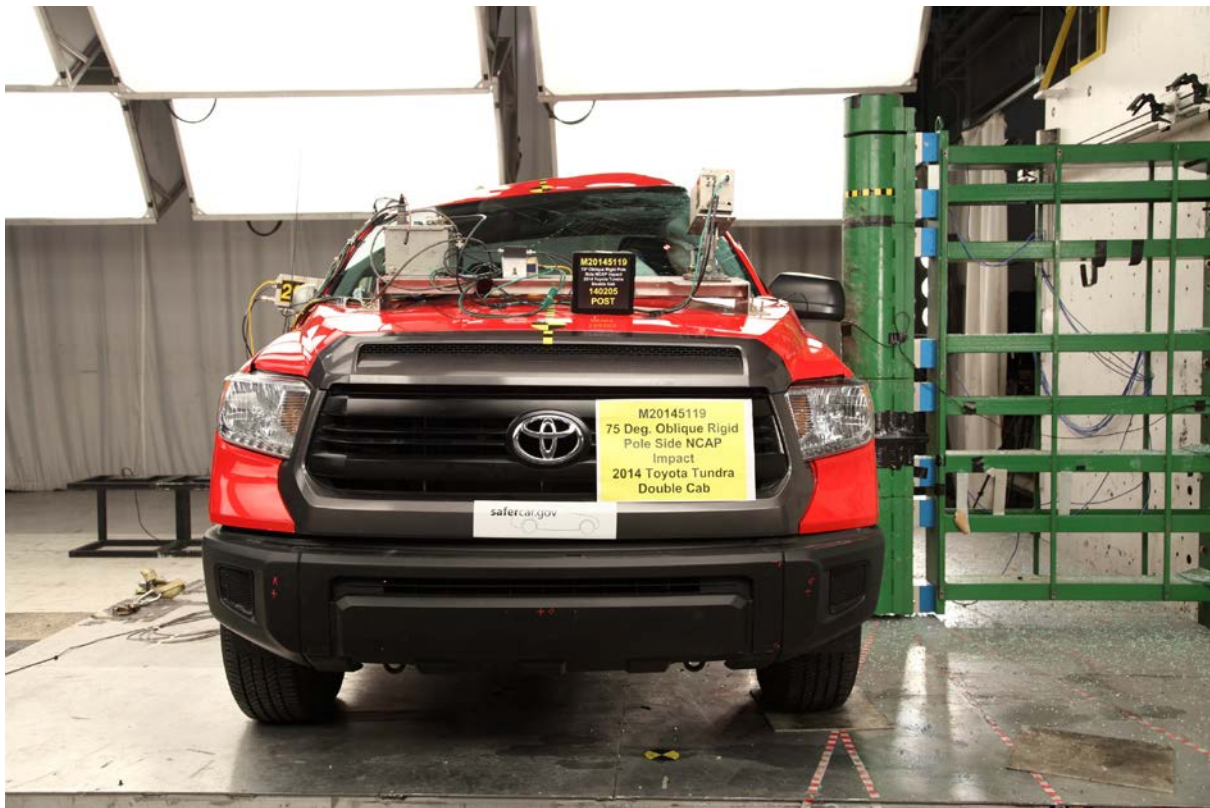
**004** Post-Test Frontal View of Test Vehicle

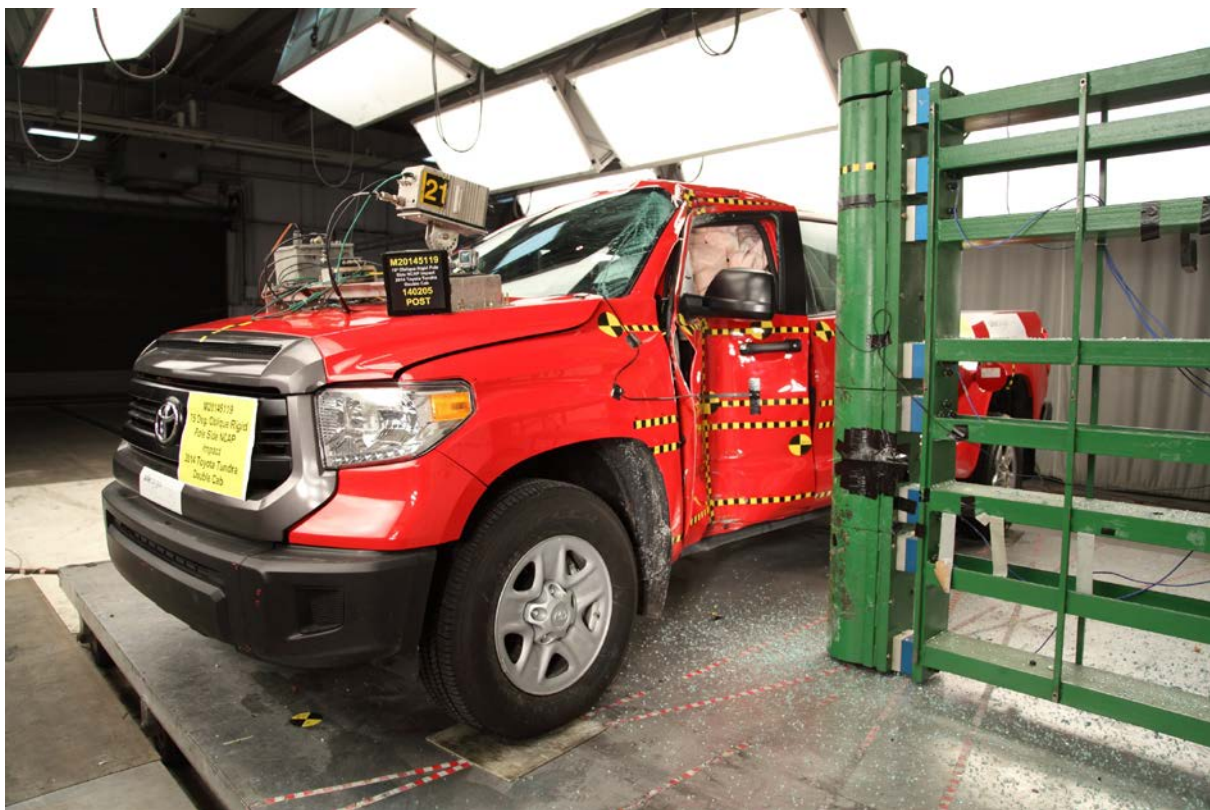
**006** Post-Test Left Front 3-4 View of Test Vehicle

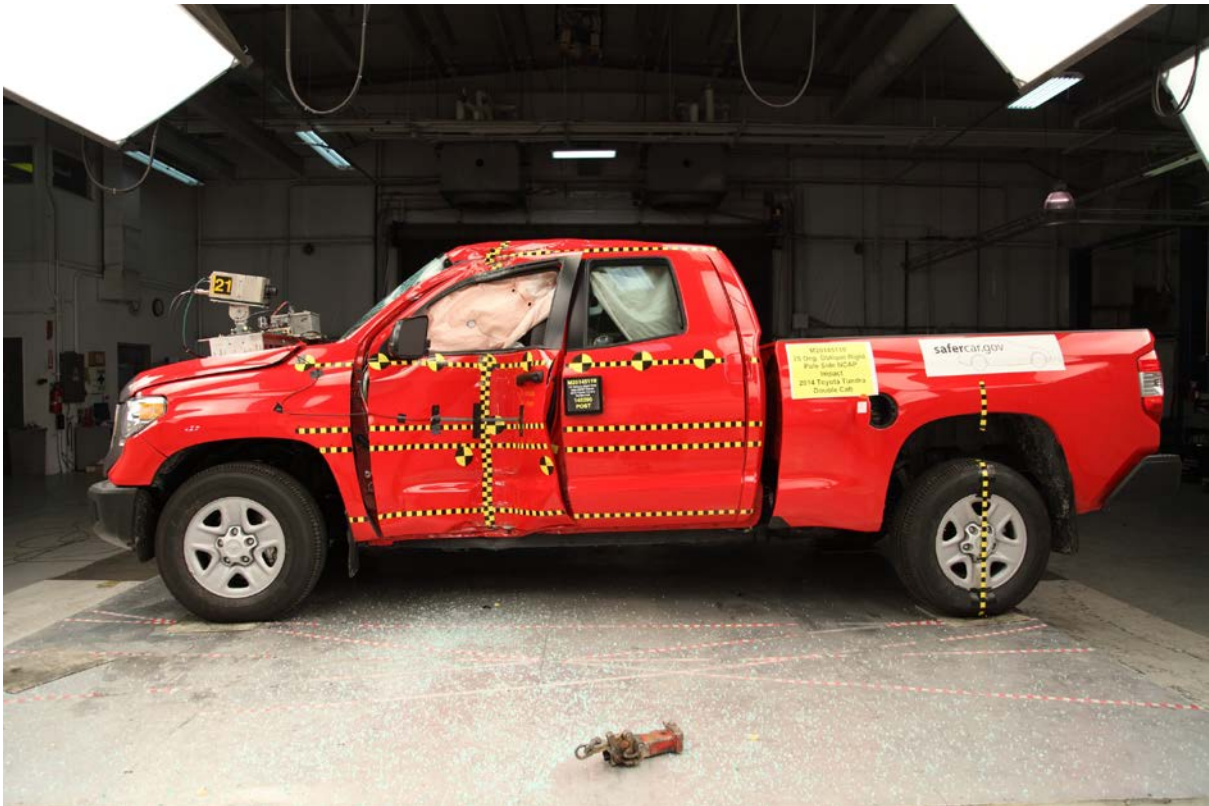
**008** Post-Test Left Side View of Test Vehicle

| Critical Areas of Performance | Observations and Conclusions |
|---|---|
| Side Window Damage | Left Front Shattered; Left Rear Undamaged |

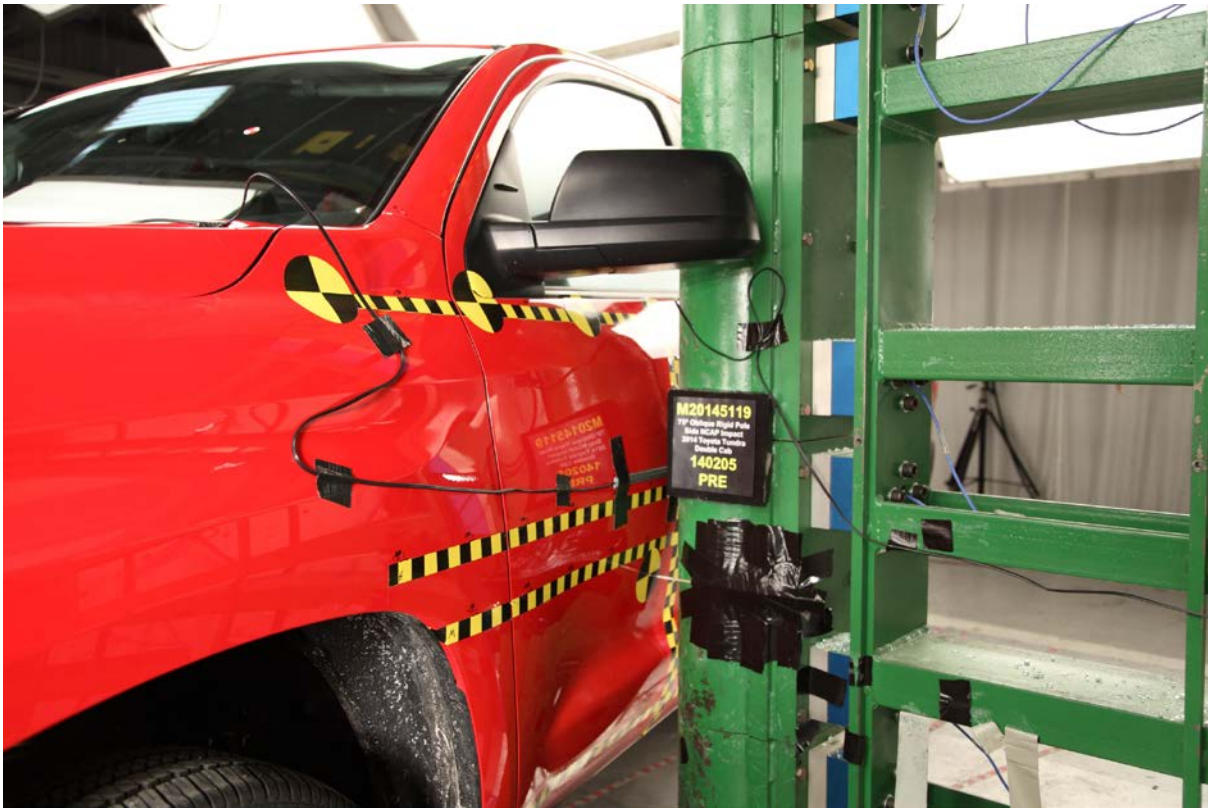
**017** Pre-Test Left Side View of Pole Positioned Against Side of Vehicle

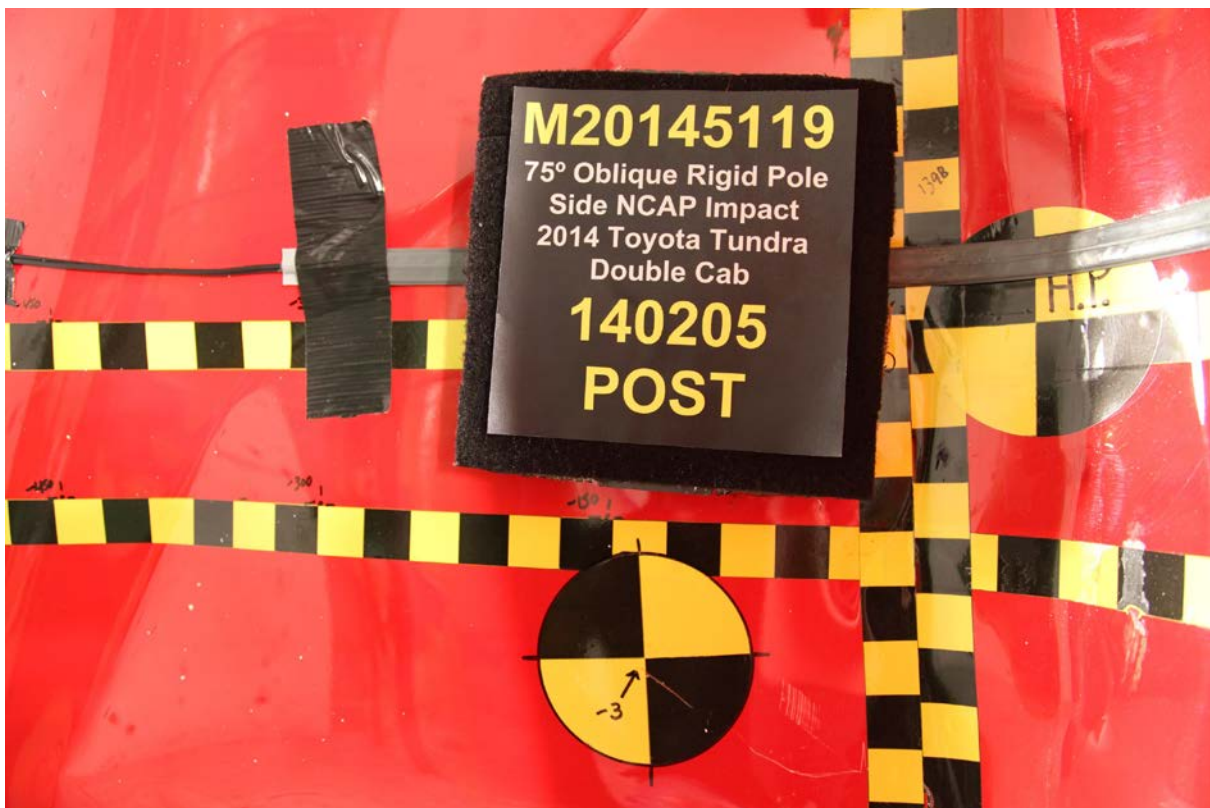
**020** Post-Test Close-Up View of Impact Point Target Showing Impact Location

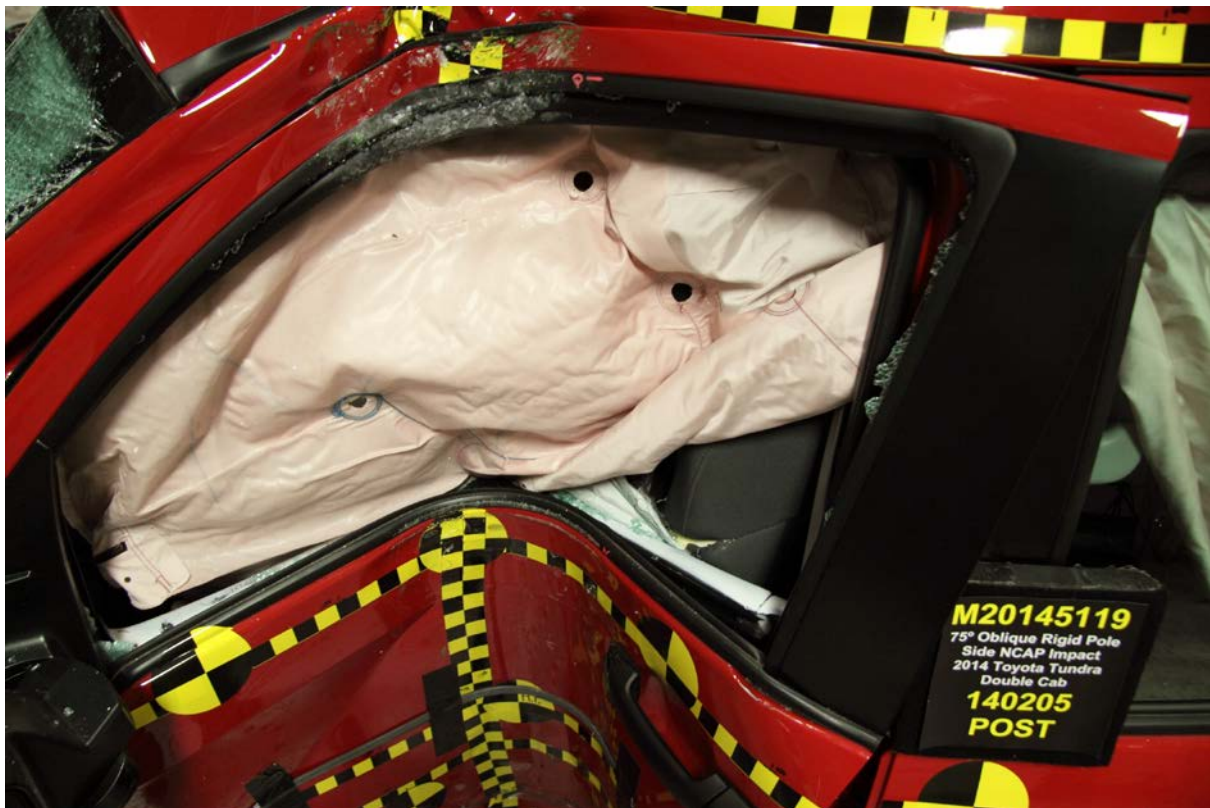
**041** Post-Test Dummy and Door Clearance View

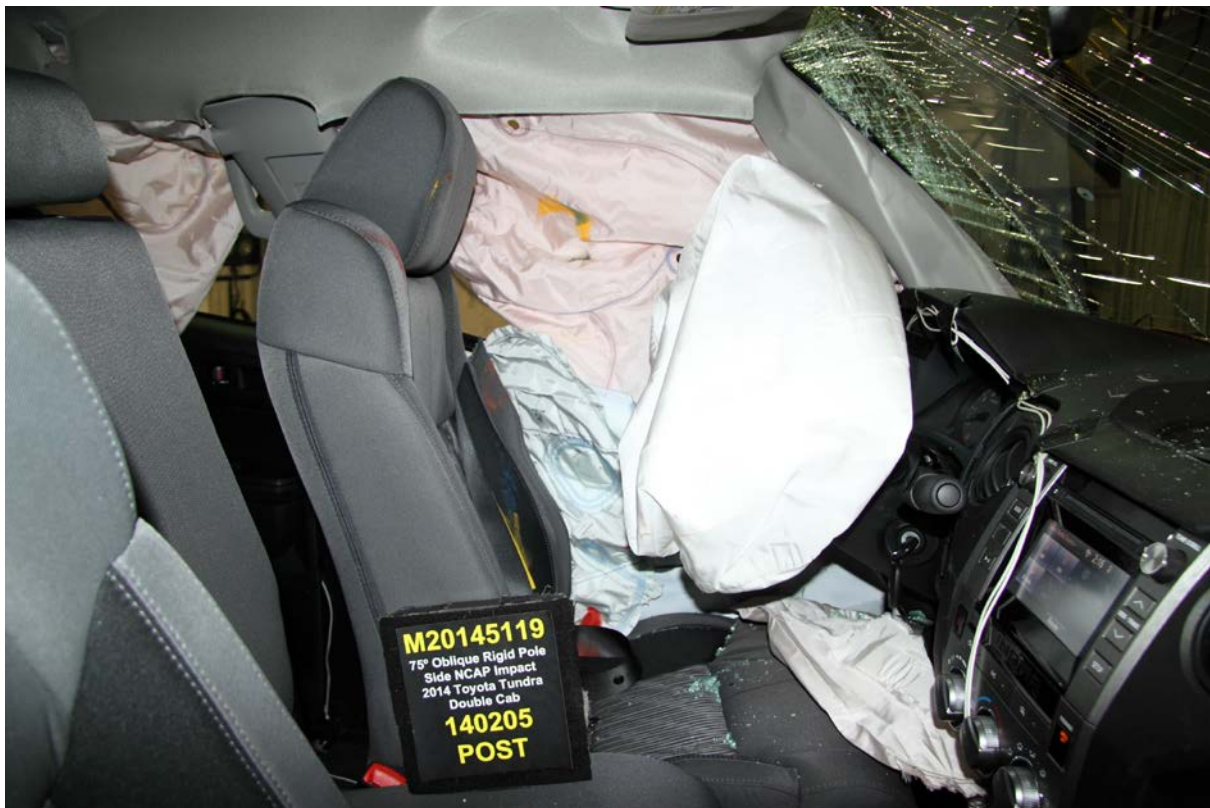
**045** Post-Test Inner Driver Door Panel View Showing Dummy Contact Location

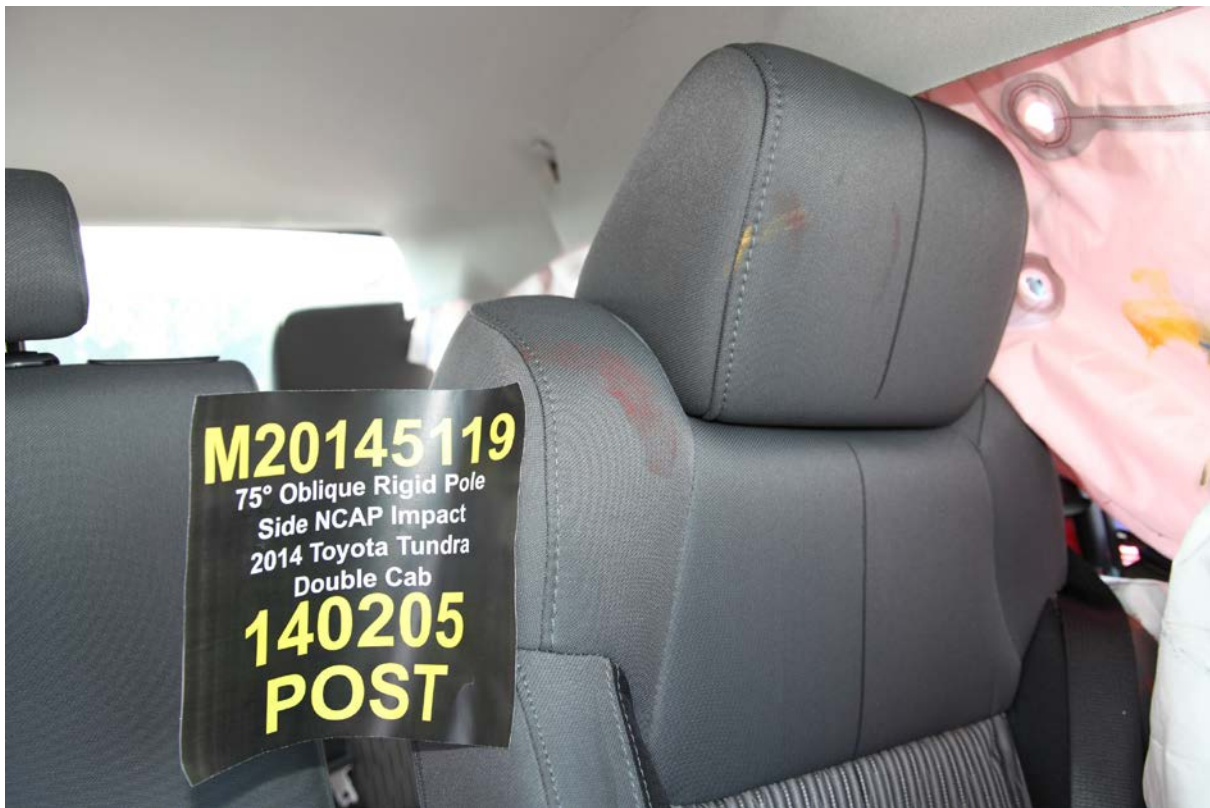
**046** Post-Test Dummy Close-Up Head Contact with Vehicle View

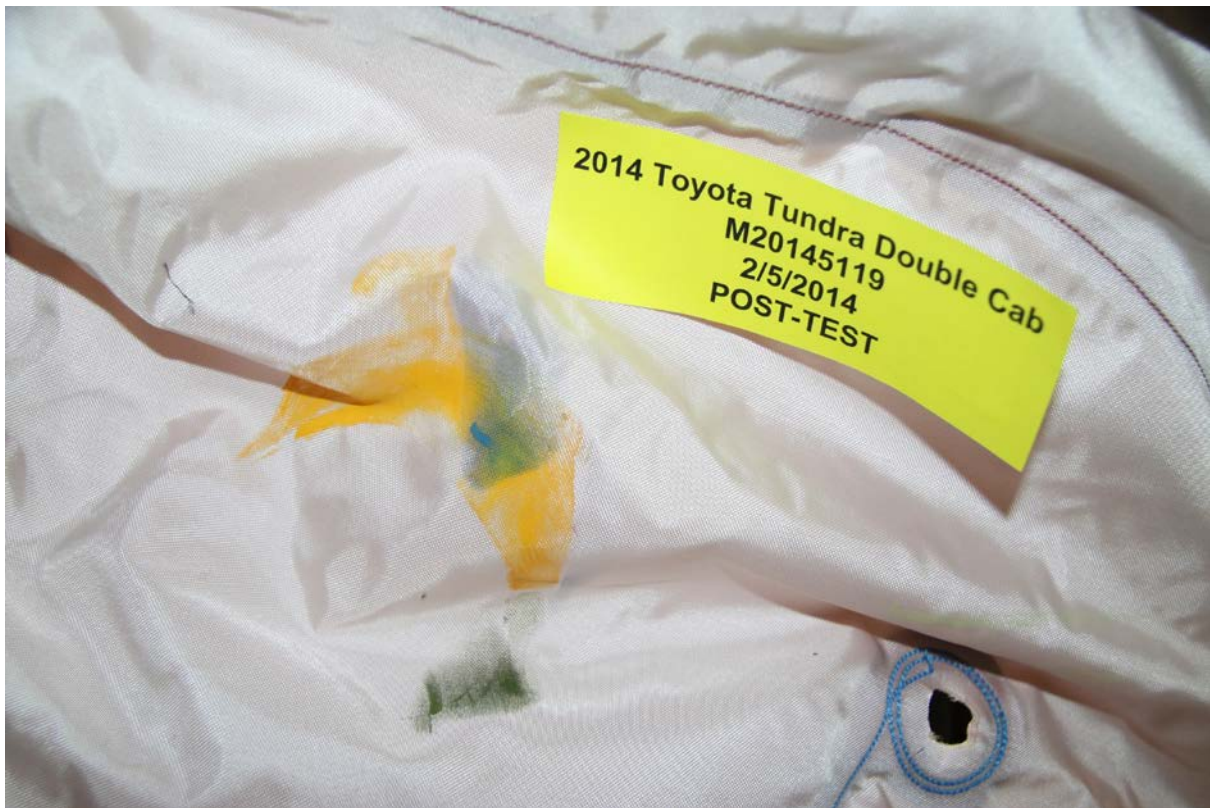
**047** Post-Test Dummy Close-Up Head Contact with Side Airbag View

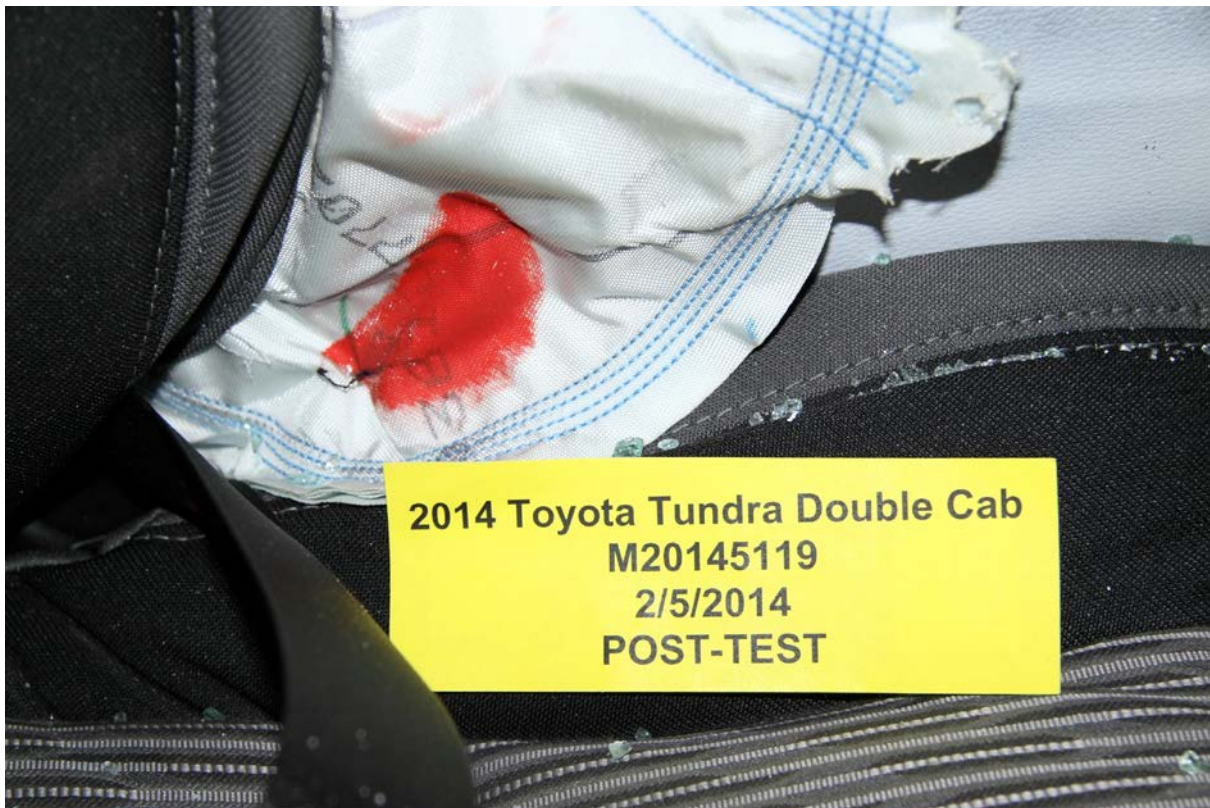
**051** Post-Test Dummy Close-Up Pelvis Contact with Side Airbag View

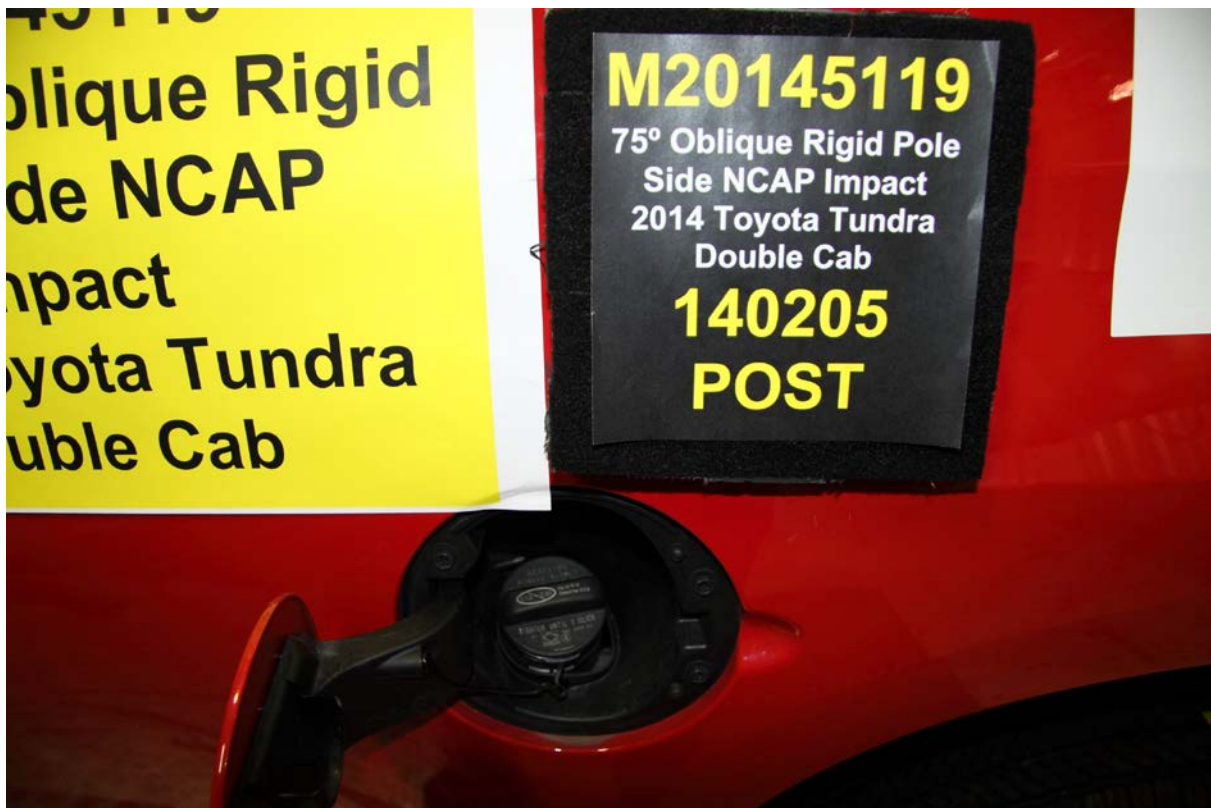
054 Post-Test View of Fuel Filler Cap or Fuel Filler Neck

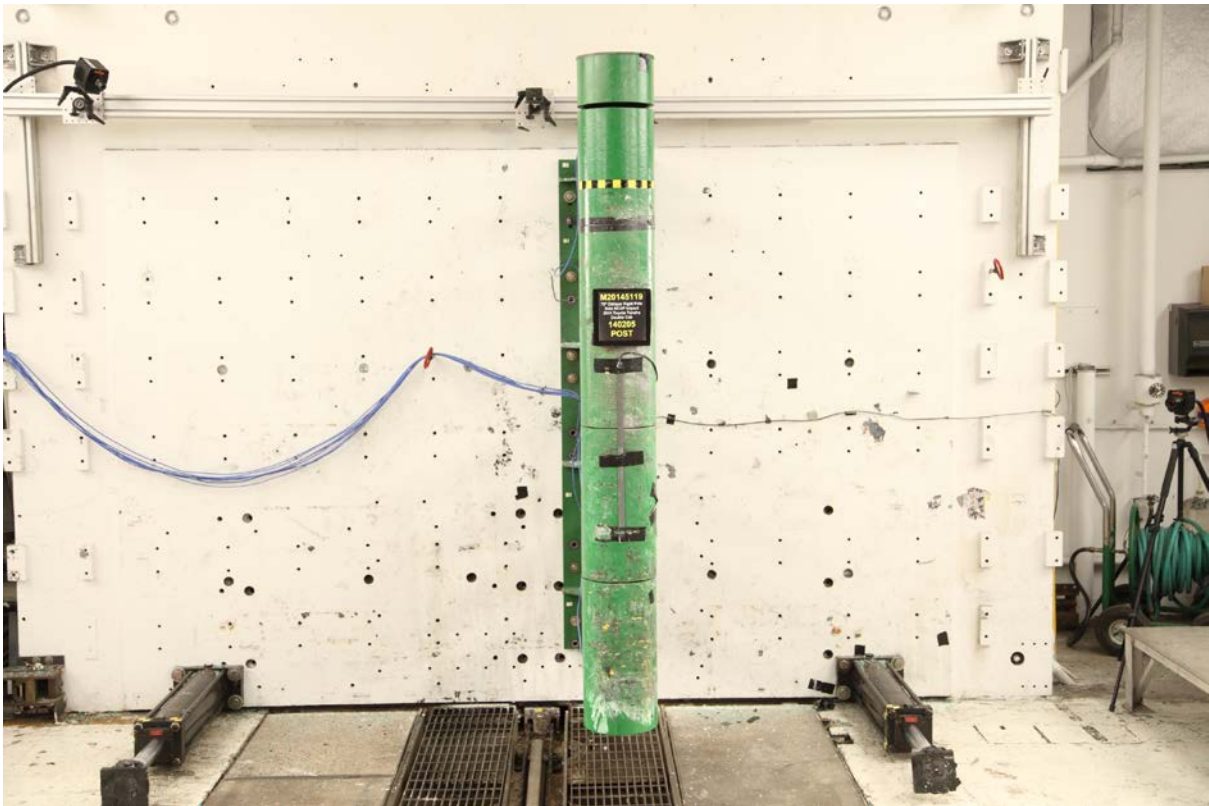
**058** Post-Test Pole Barrier Front View

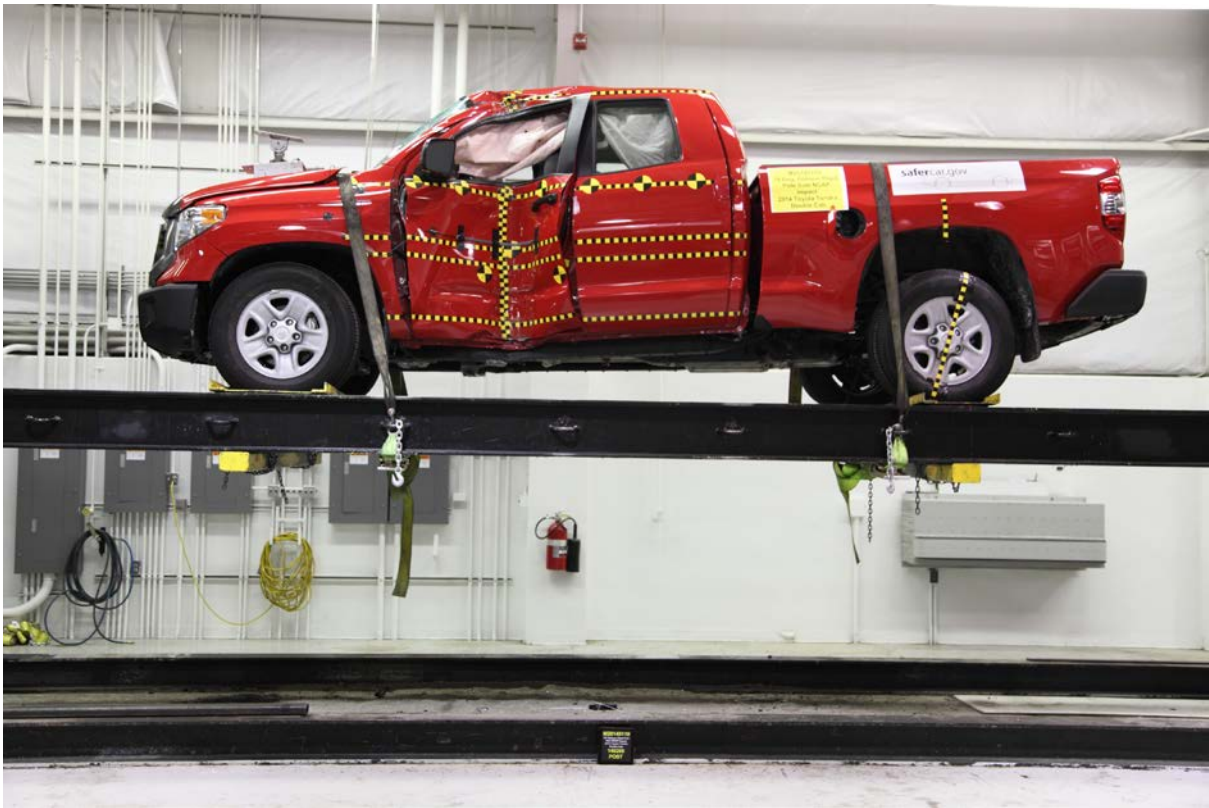
**063** FMVSS No. 301 Static Rollover 0 Degrees

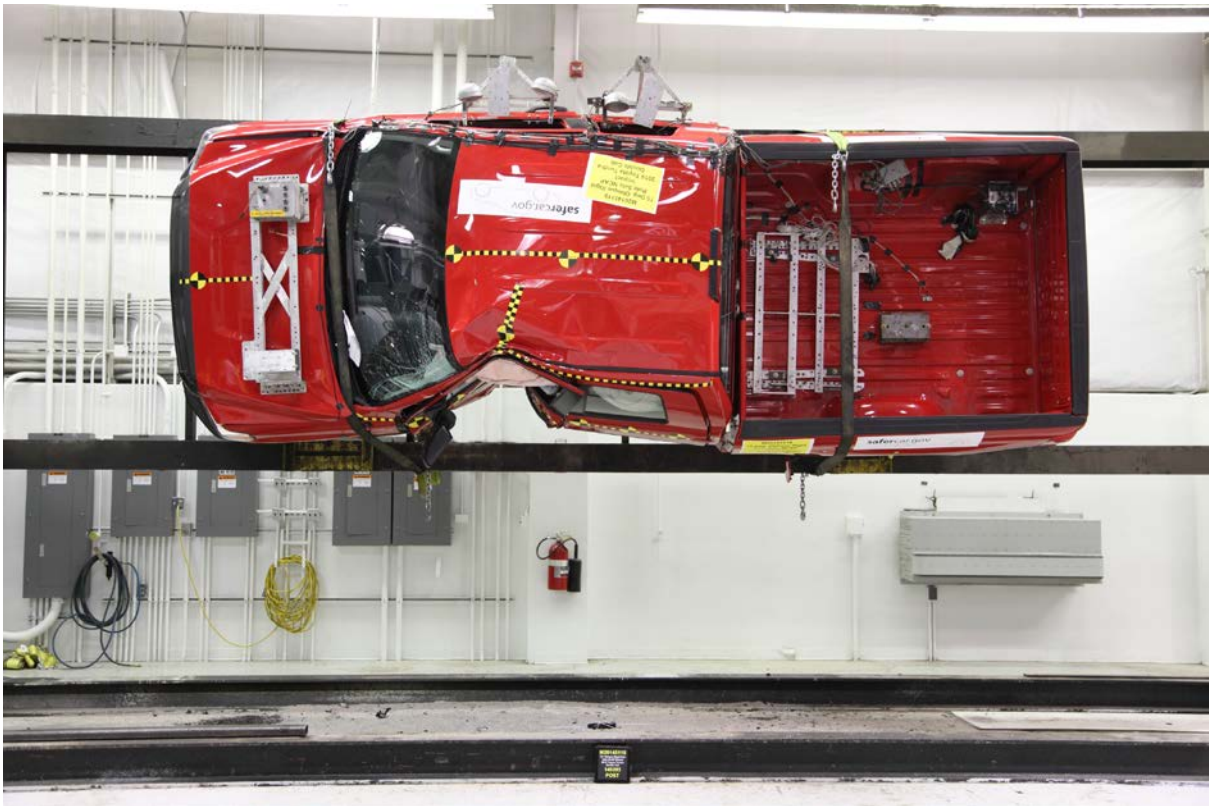
**064** FMVSS No. 301 Static Rollover 90 Degrees

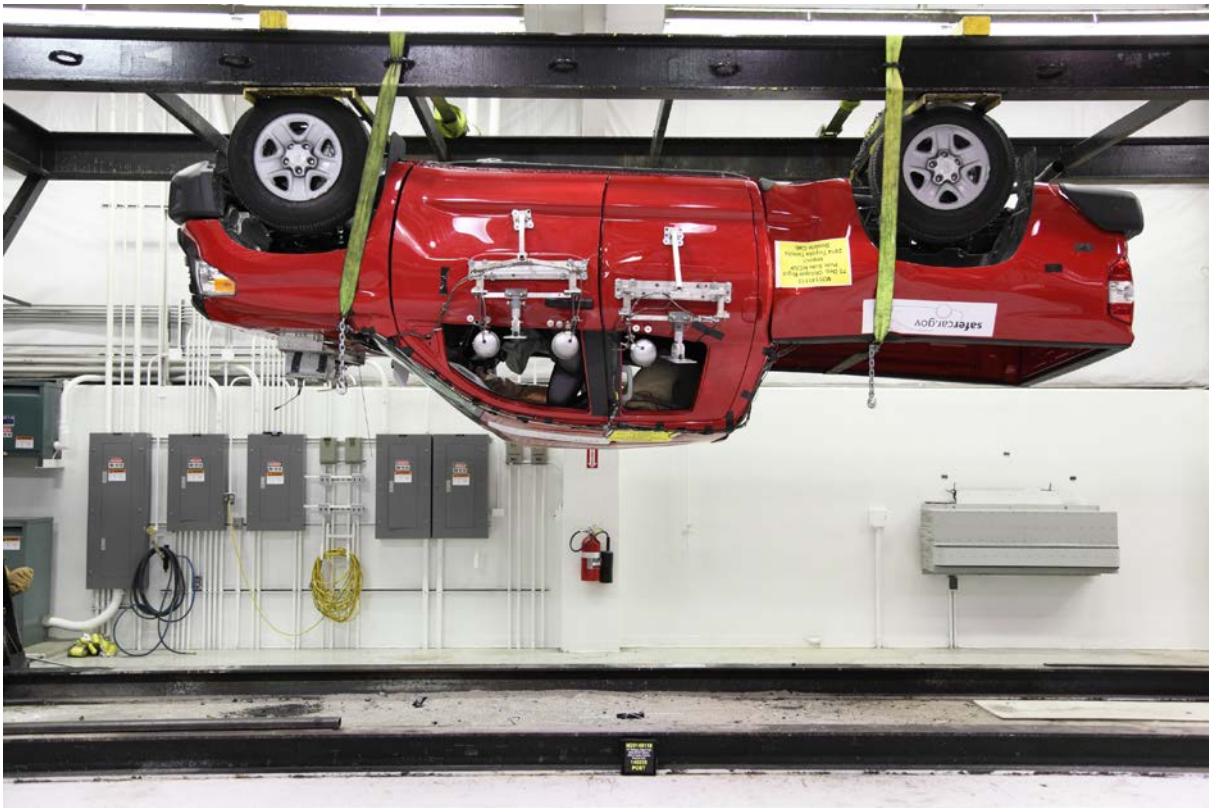
**065** FMVSS No. 301 Static Rollover 180 Degrees

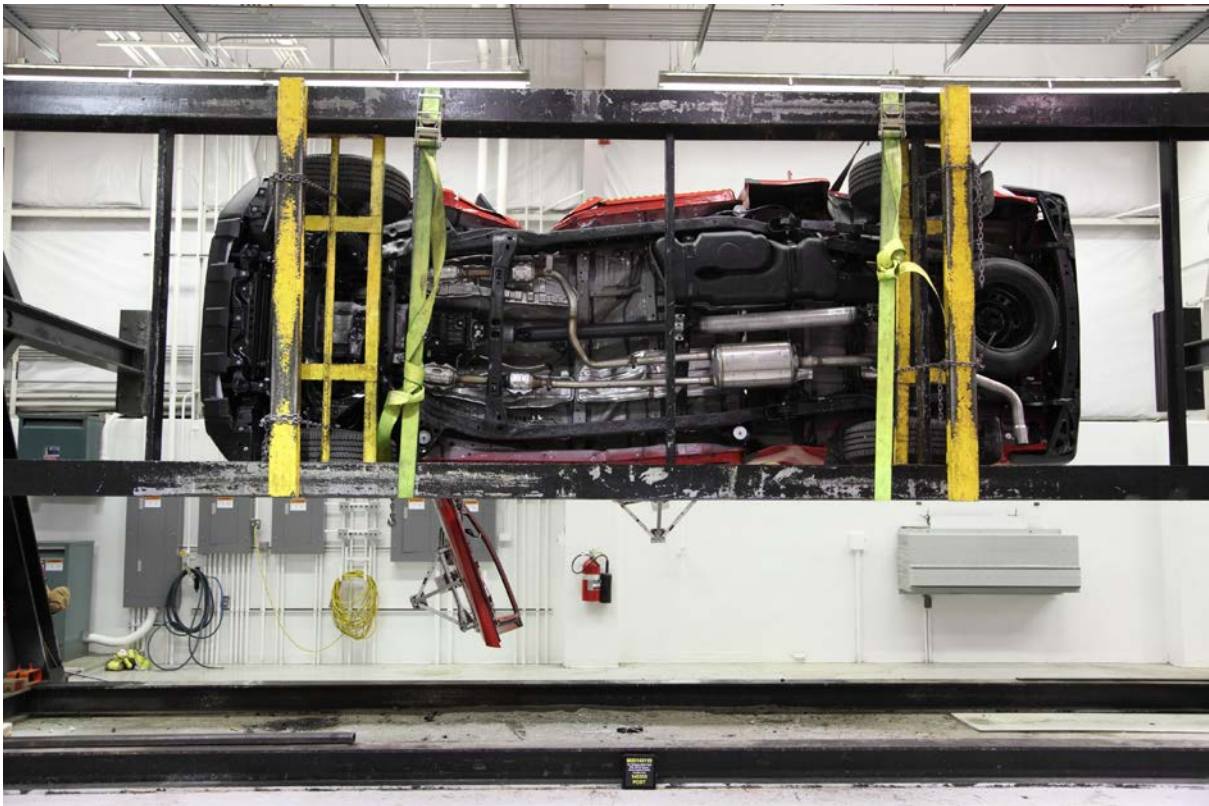
**066** FMVSS No. 301 Static Rollover 270 Degrees

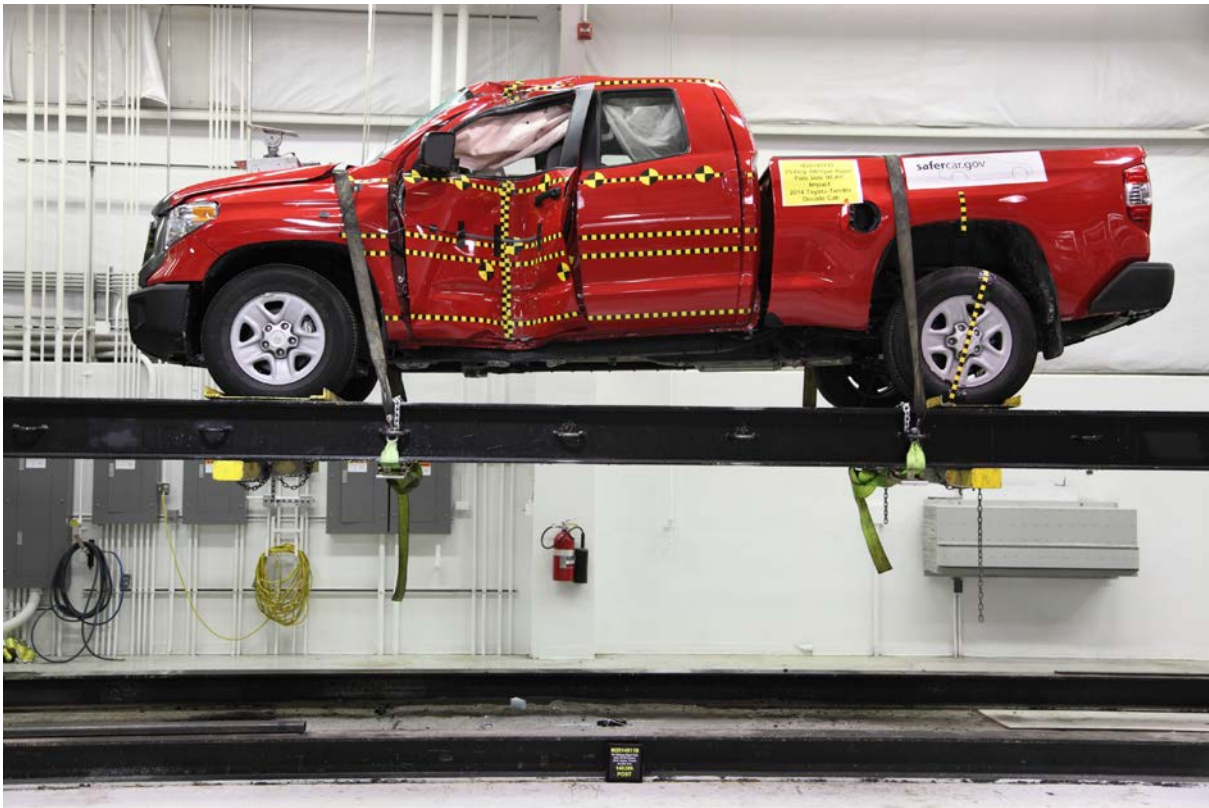
**067** FMVSS No. 301 Static Rollover 360 Degrees

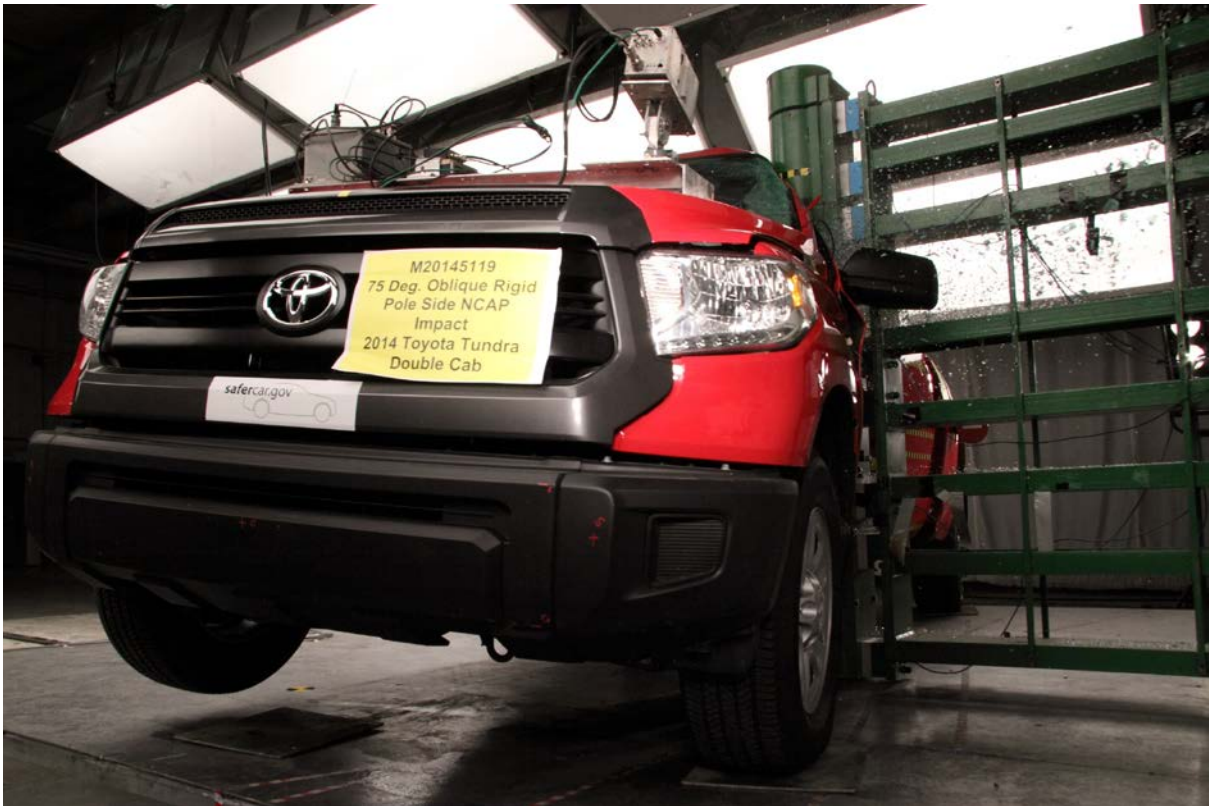
**068** Impact Event

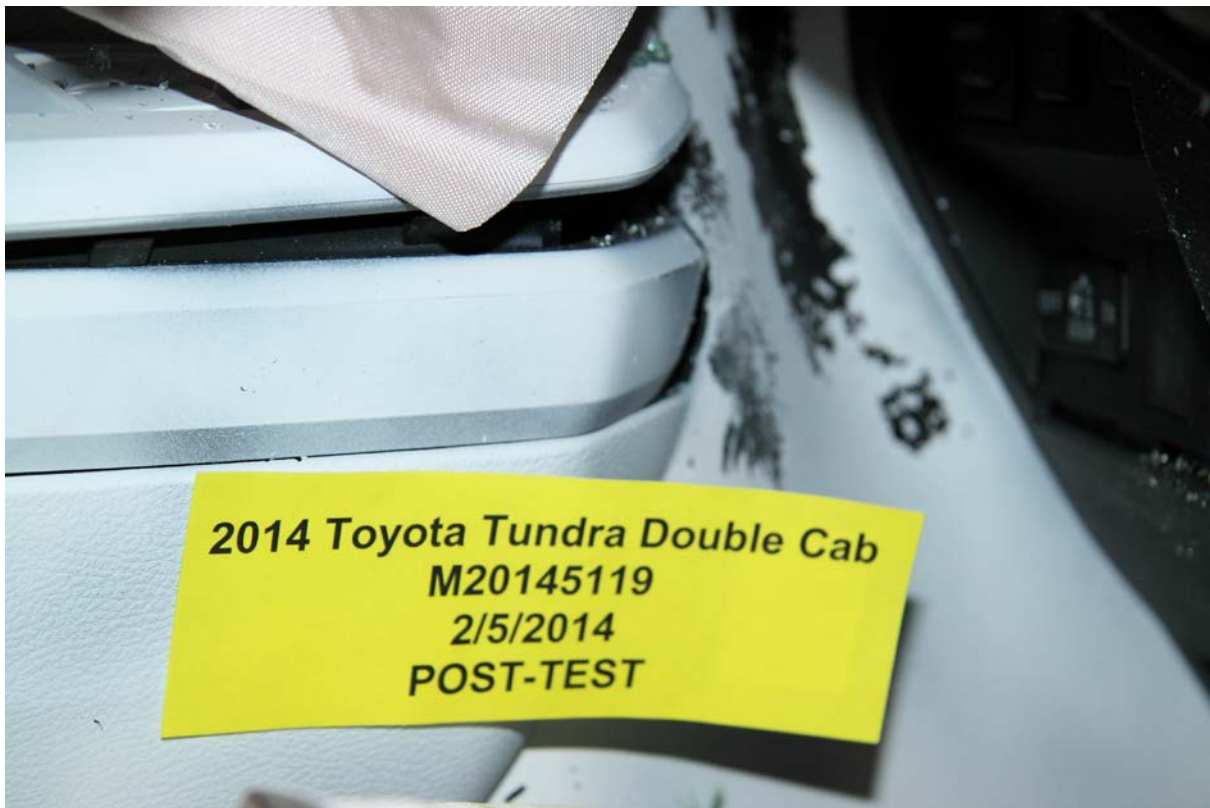
**071** Post-Test View of Shattered Vehicle Inner Door Panel
