**REPORT NUMBER: NCAP-MGA-2014-049**

**NEW CAR ASSESSMENT PROGRAM (NCAP)  
Frontal Barrier Impact Test**

**TOYOTA MOTOR MANUFACTURING, INDIANA, INC.  
2014 Toyota Highlander LE AWD 5-Dr SUV  
NHTSA No.: O20145105**

**FINAL REPORT**

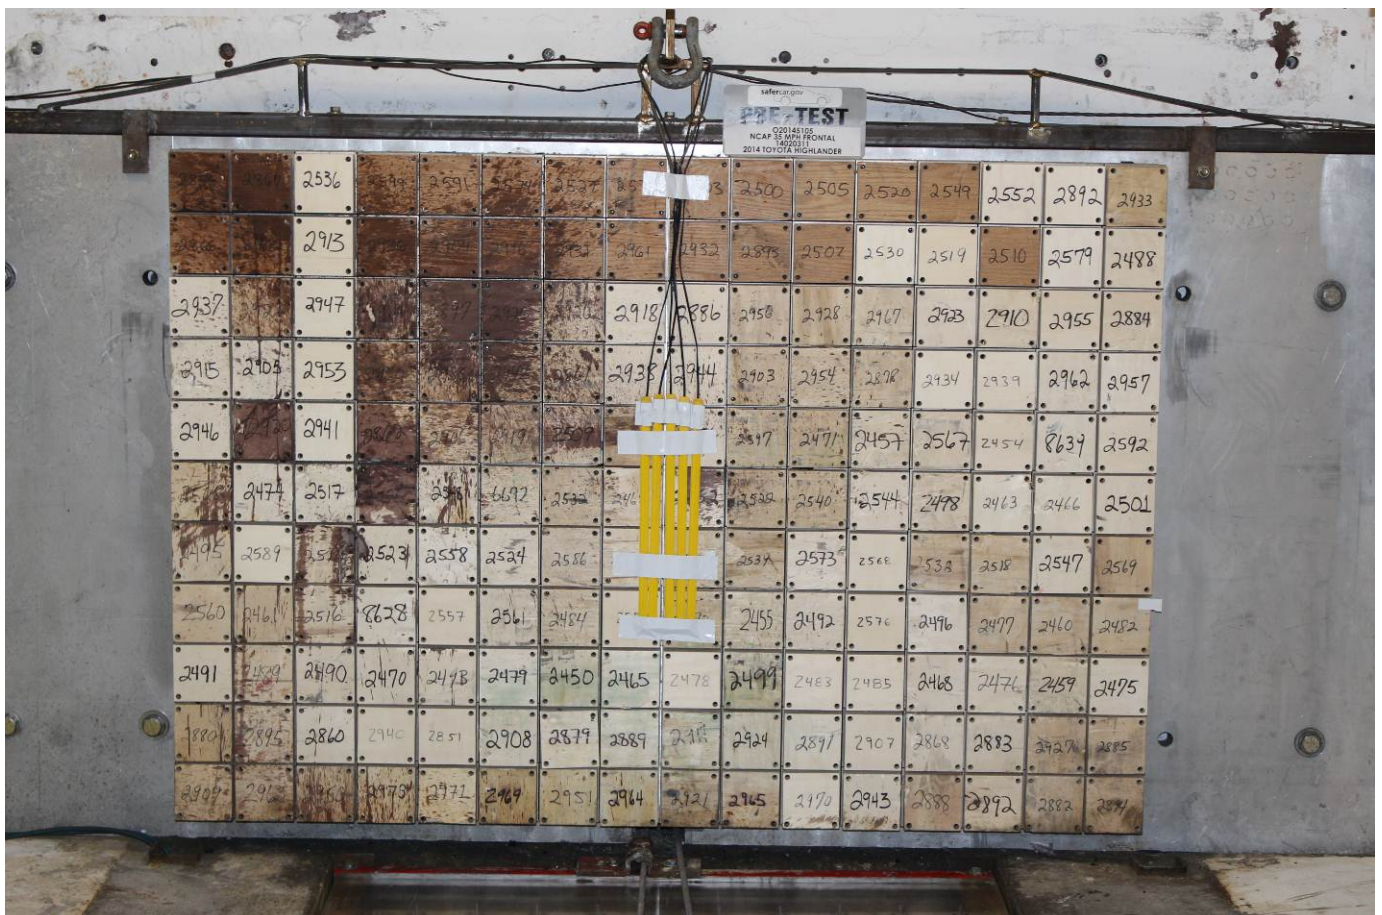
Load Cell Wall

A load cell barrier consisting of 176 load cells was impacted by a 2014 Toyota Highlander LE AWD 5-Dr SUV at a velocity of 56.4 km/h. The test was performed at MGA Research Corporation on February 3, 2014. Pre-test and post-test photographs of the vehicle and dummies can be found in Appendix A.

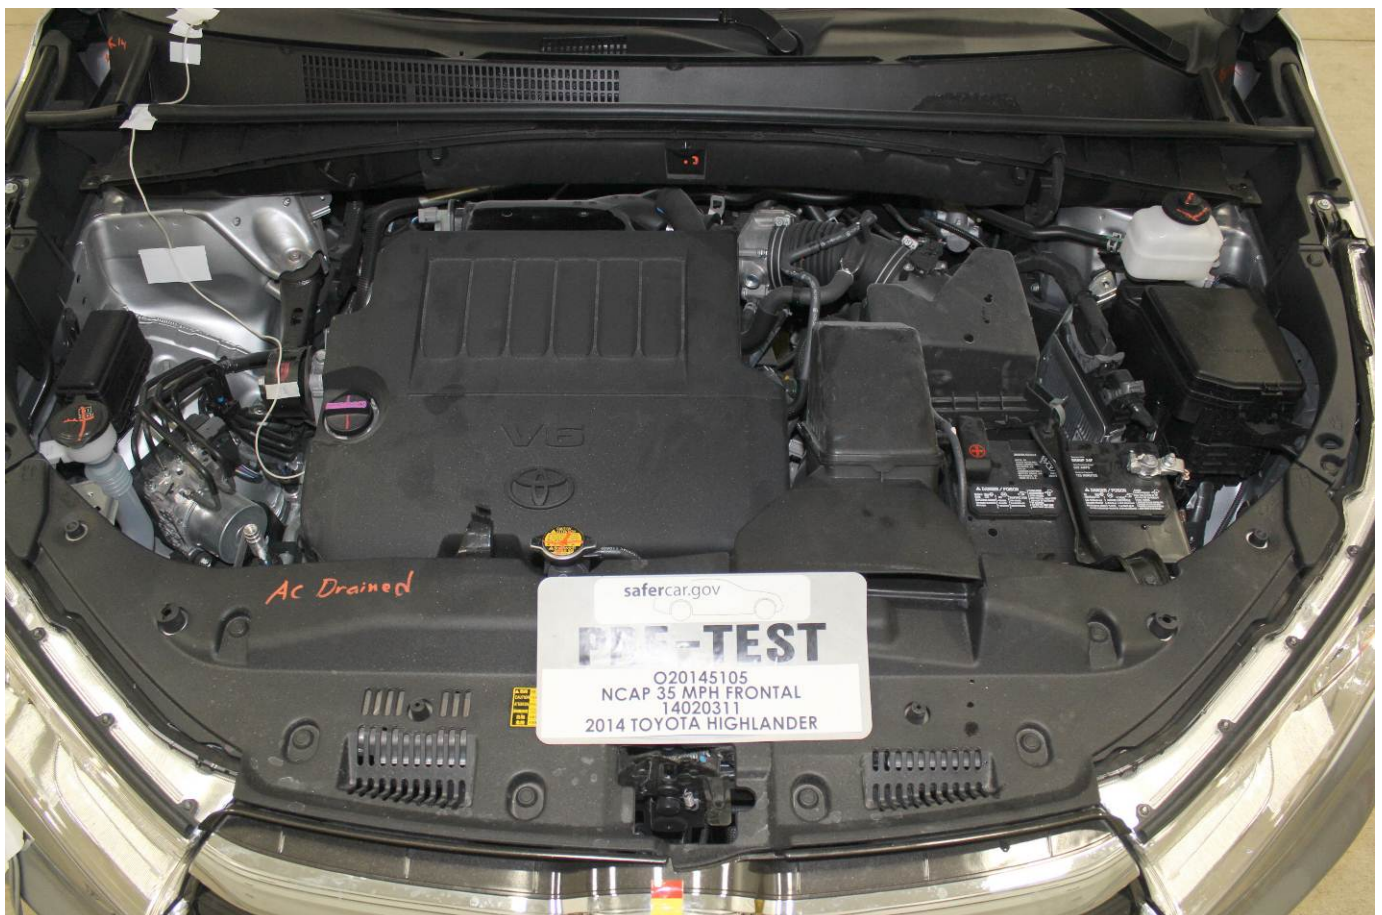
Post-Test Engine Compartment View

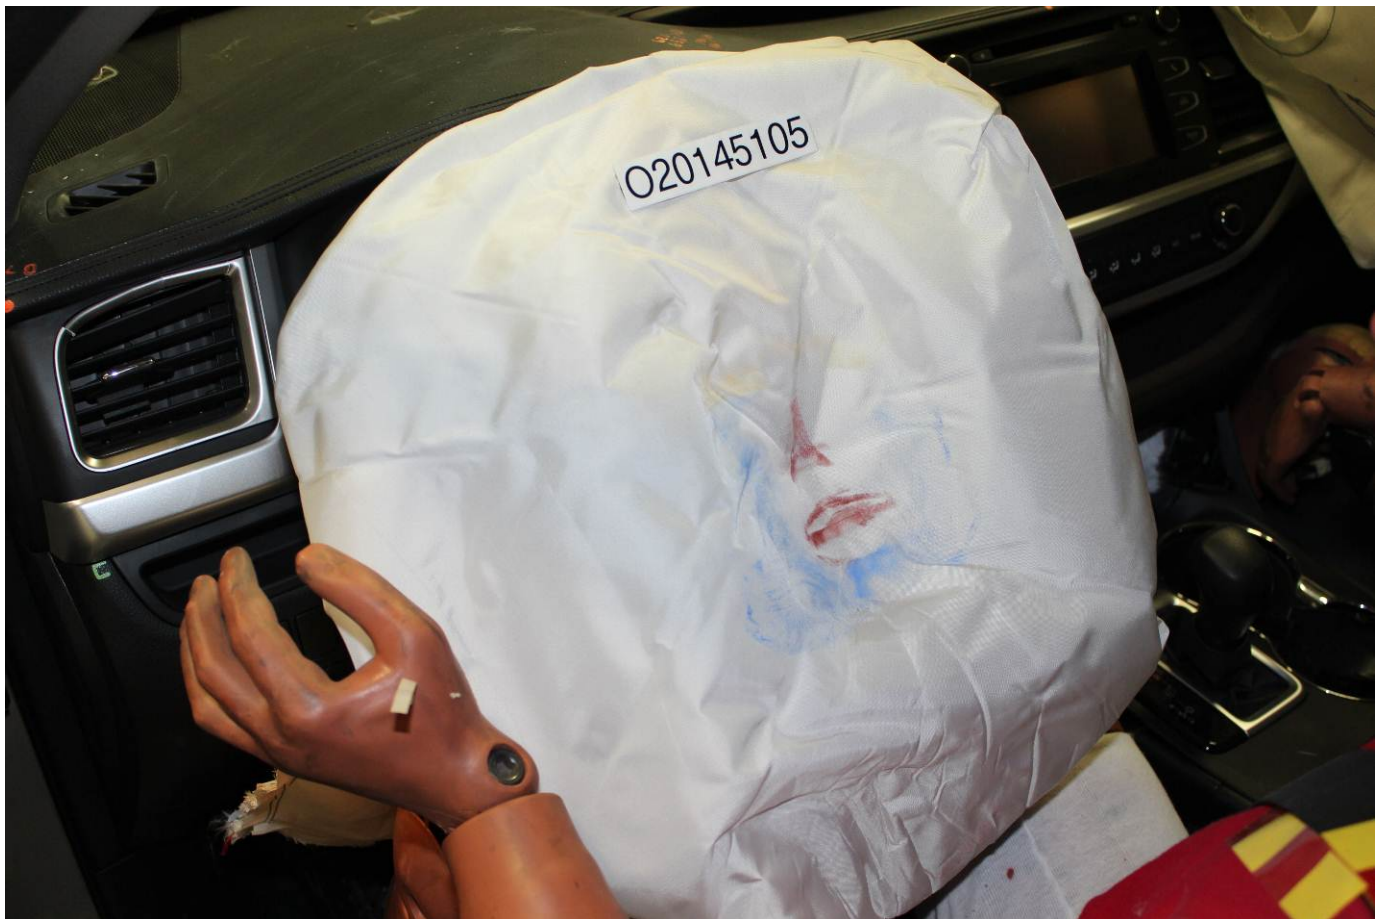
Post-Test Driver Dummy Contact with Airbag

The driver's visible contact points were as follows: The driver's head and chest contacted the airbag. The driver's head also contacted the headrest. The driver's knees contacted the knee airbag. The passenger's visible contact points were as follows: The passenger's head and chest contacted the airbag. The passenger's head also contacted the headrest. The passenger's knees contacted the glovebox.

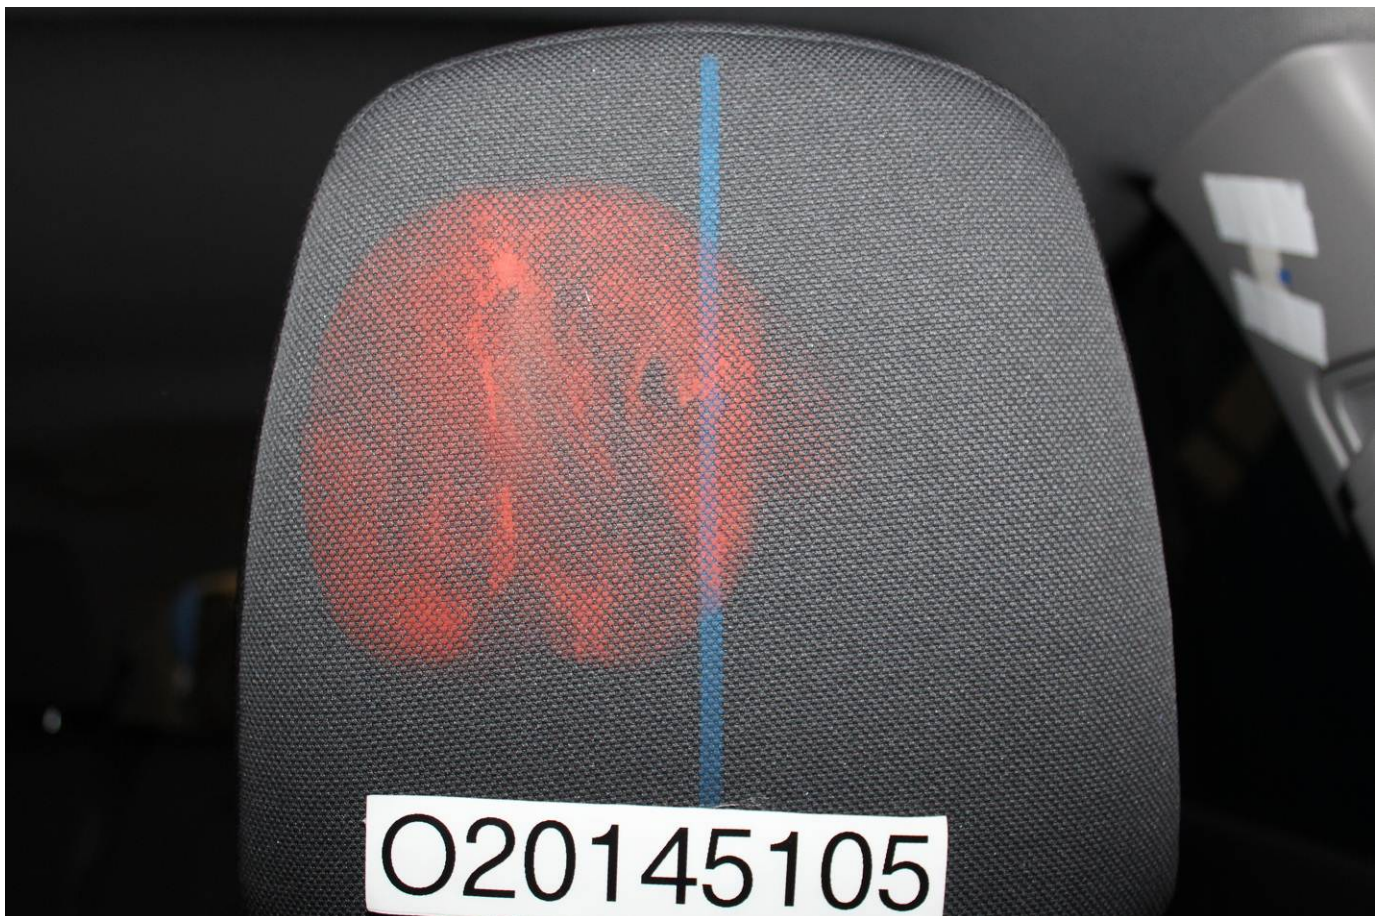
Post-Test Driver Dummy Contact with Headrest

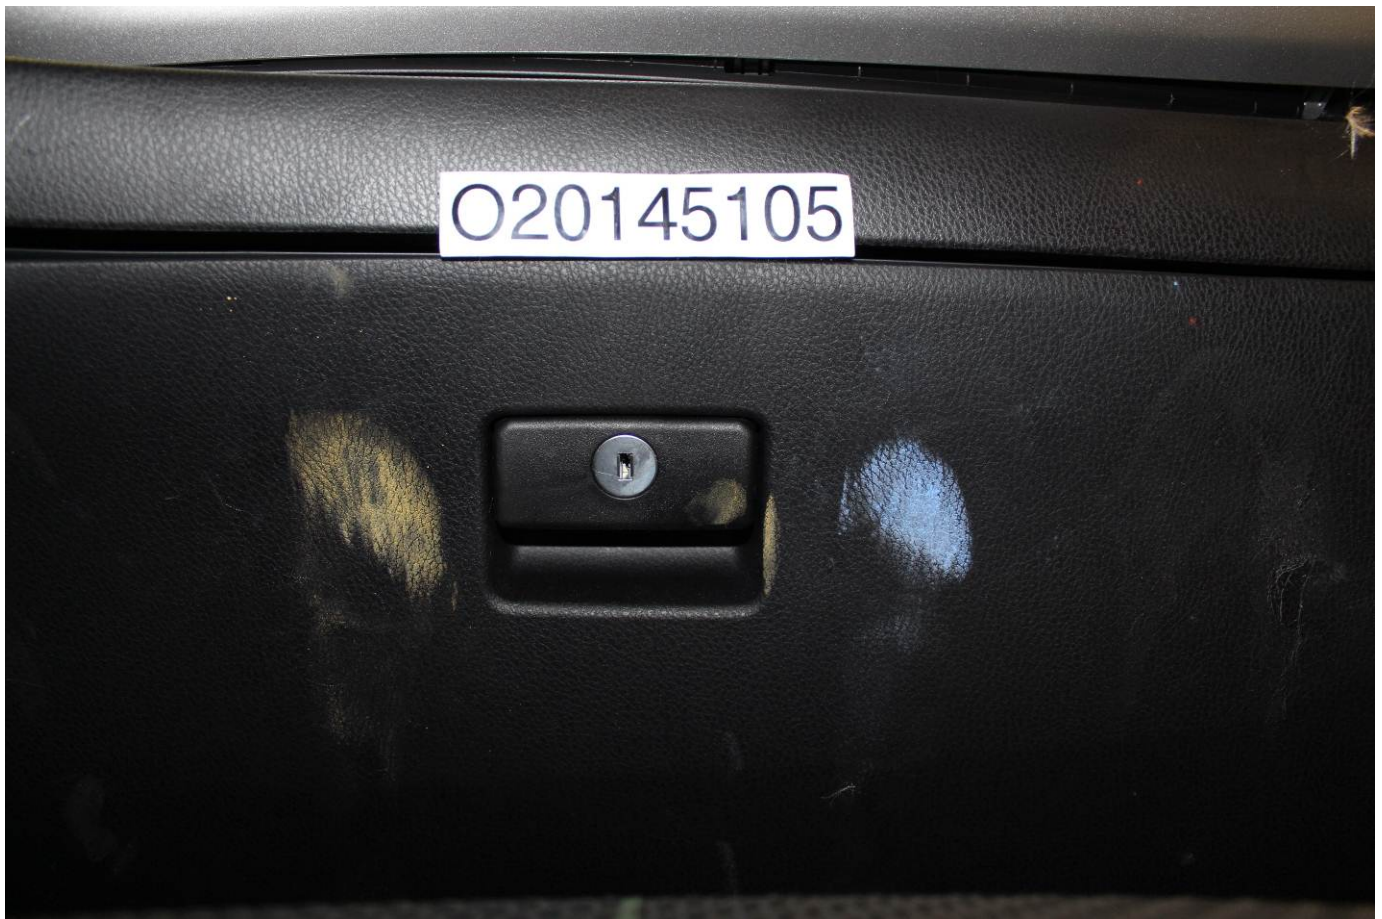
Post-Test Passenger Dummy Contact with Glovebox

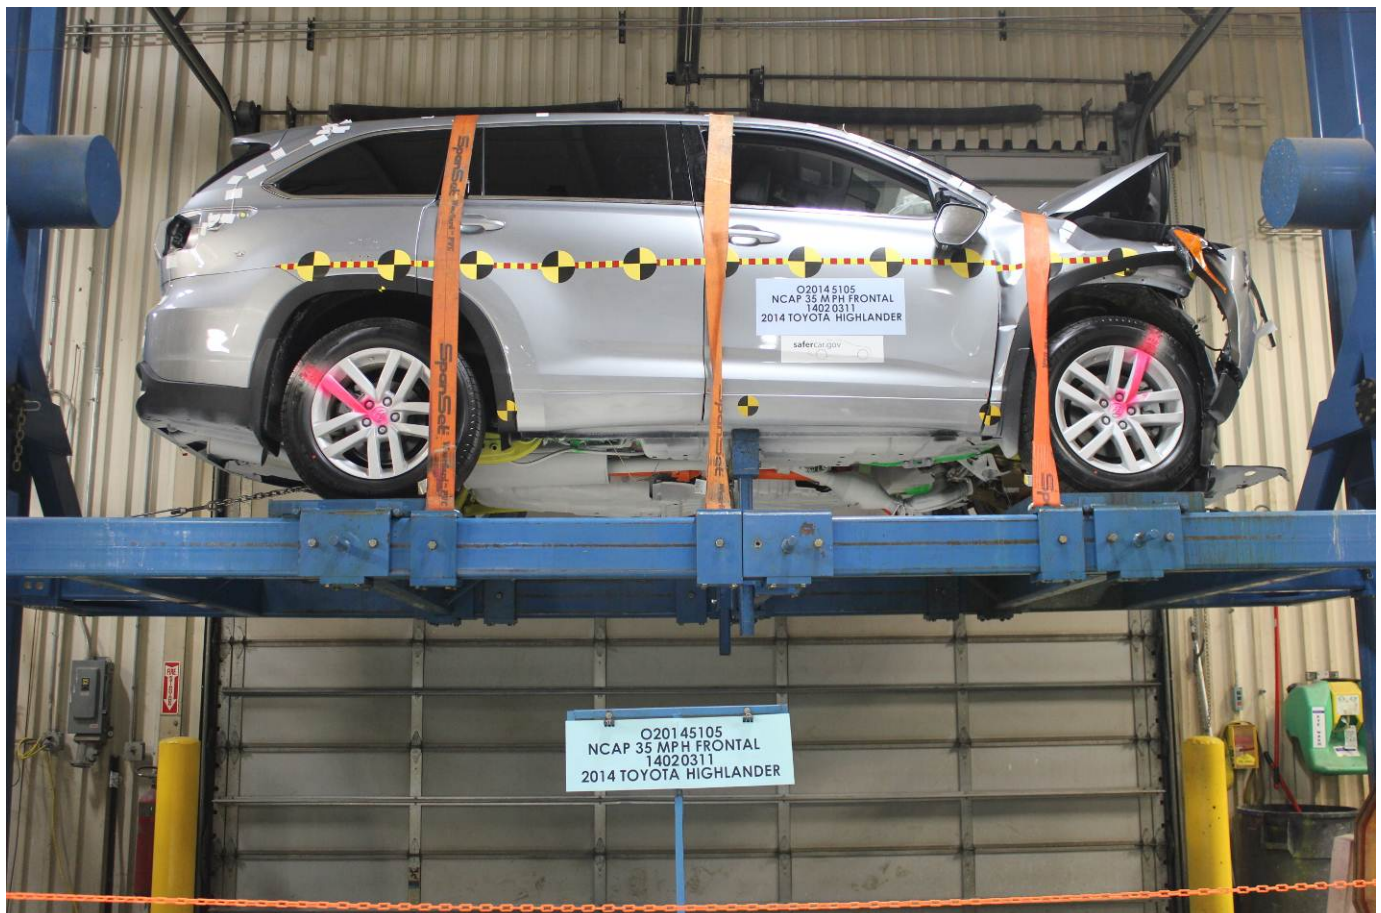
Vehicle at 0 Degree on Static Rollover Device

There was 100 percent windshield retention and no intrusion into the protected zone of the windshield during the event. There was no Stoddard Solvent leakage after the event or during any phase of the static rollover.

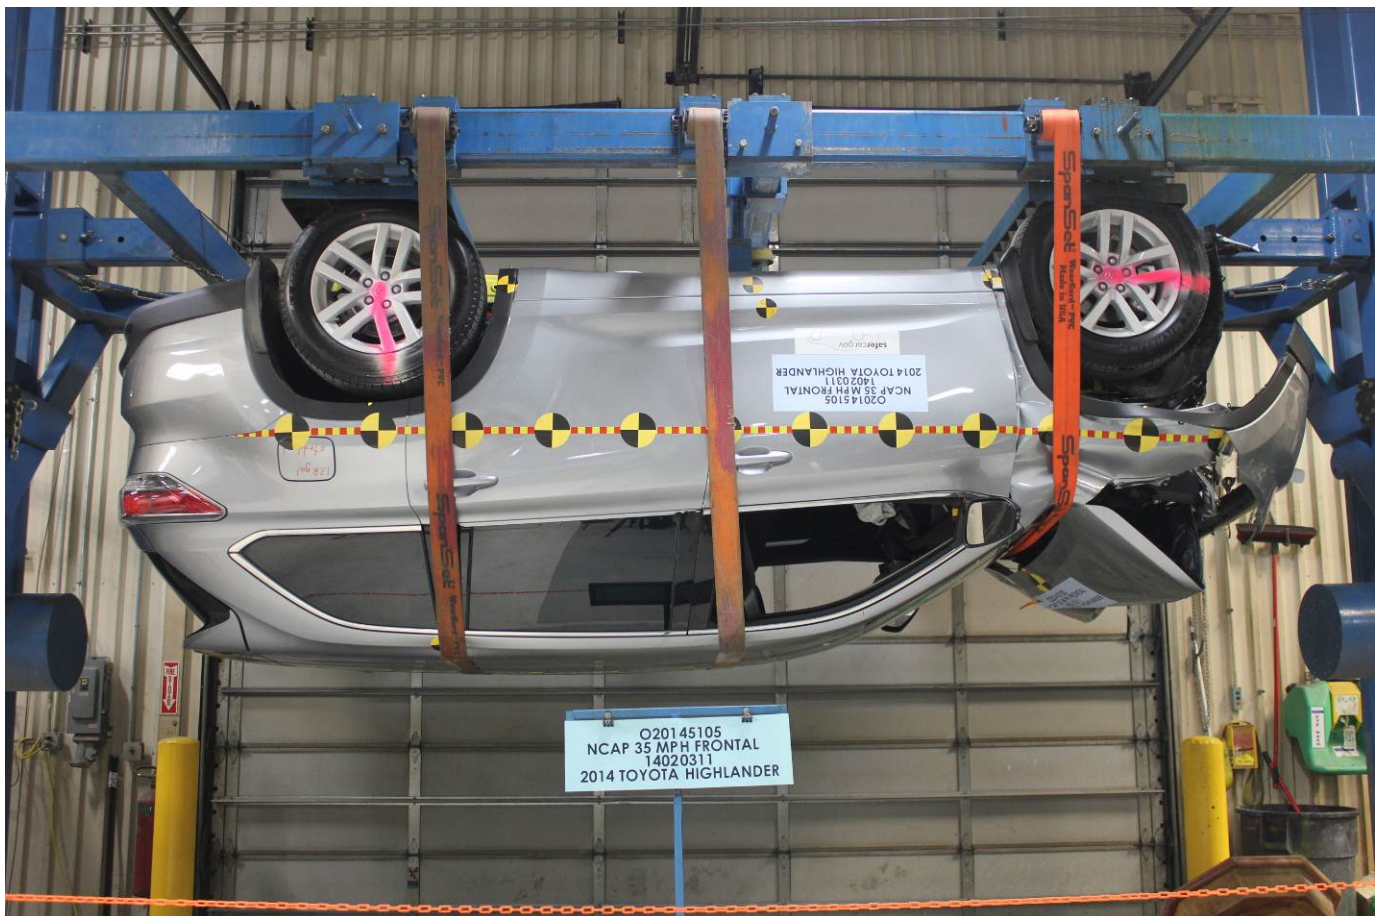
Vehicle at 180 Degrees on Static Rollover Device

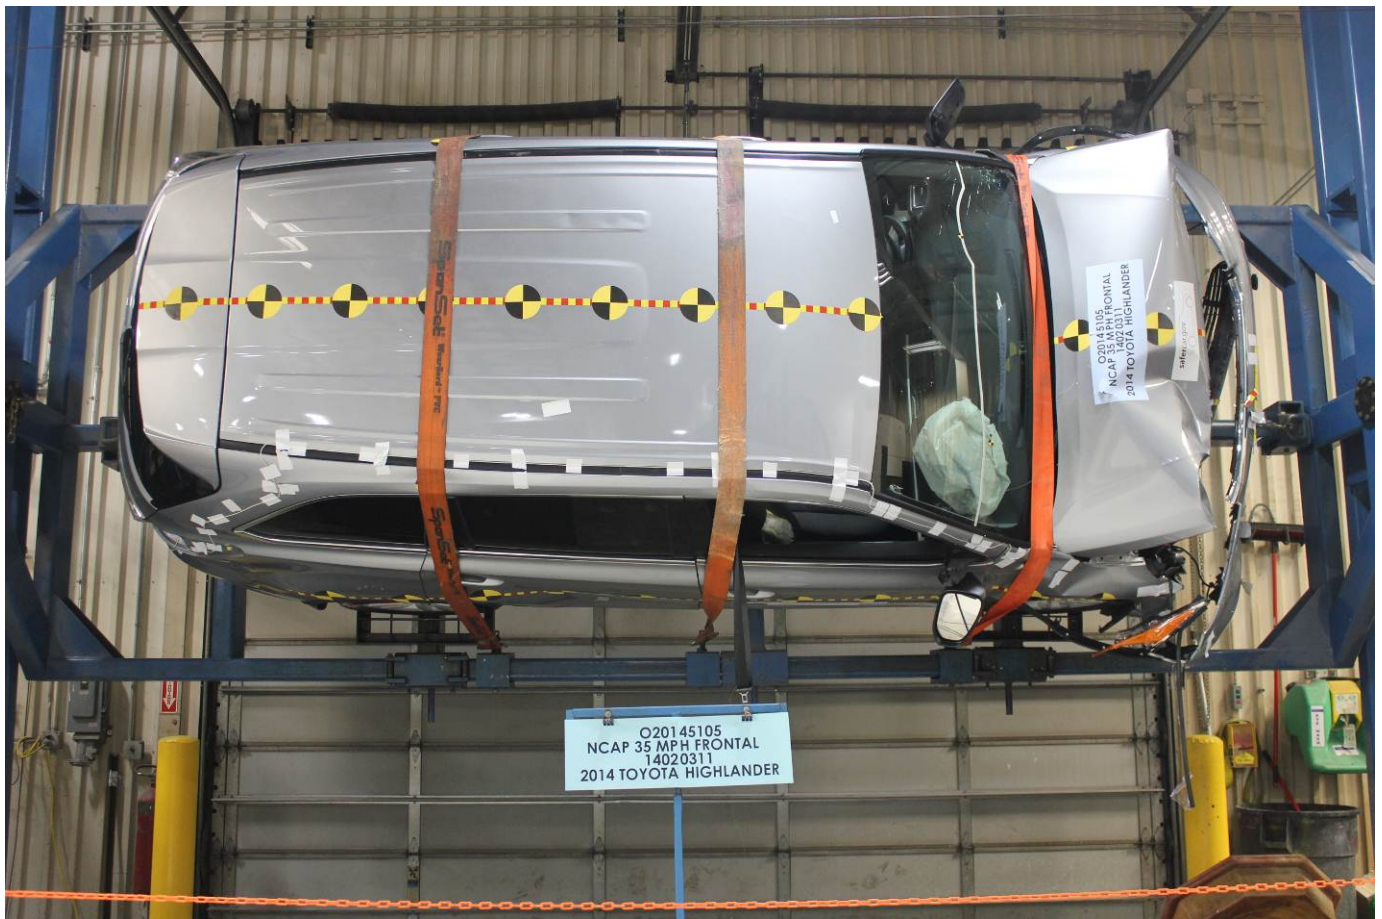
Vehicle at 270 Degrees on Static Rollover Device

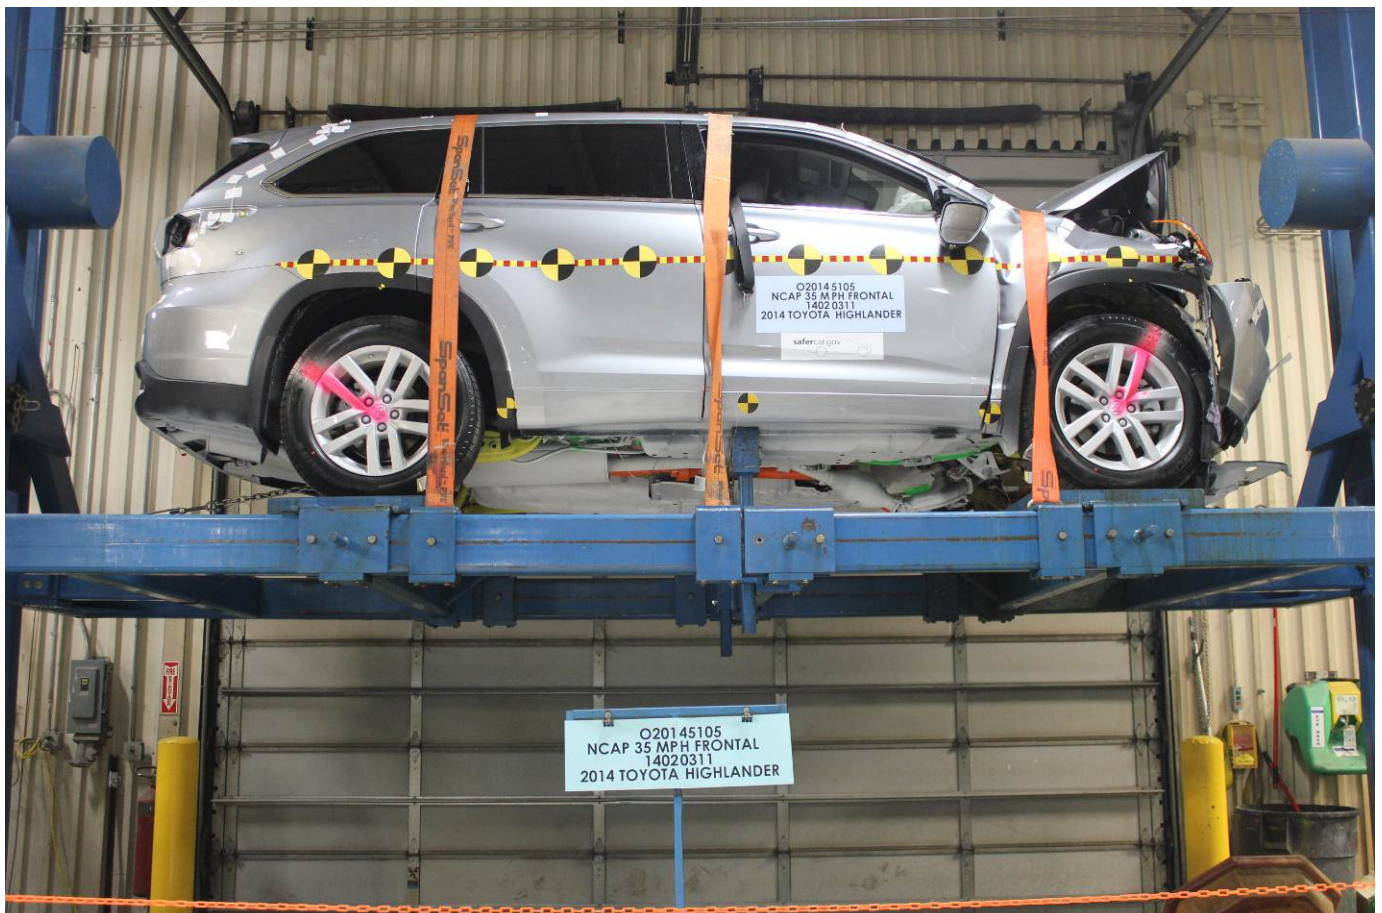
Vehicle at 360 Degrees on Static Rollover Device
