**REPORT NUMBER: SINCAP-MGA-2014-051**

**NEW CAR ASSESSMENT PROGRAM (NCAP)  
Moving Deformable Barrier Side Impact Test**

**TOYOTA MOTOR MANUFACTURING, INDIANA, INC.  
2014 Toyota Highlander LE 5-Dr SUV  
NHTSA No.: O20145107**

**MGA RESEARCH CORPORATION  
5000 Warren Road  
Burlington, WI 53105**

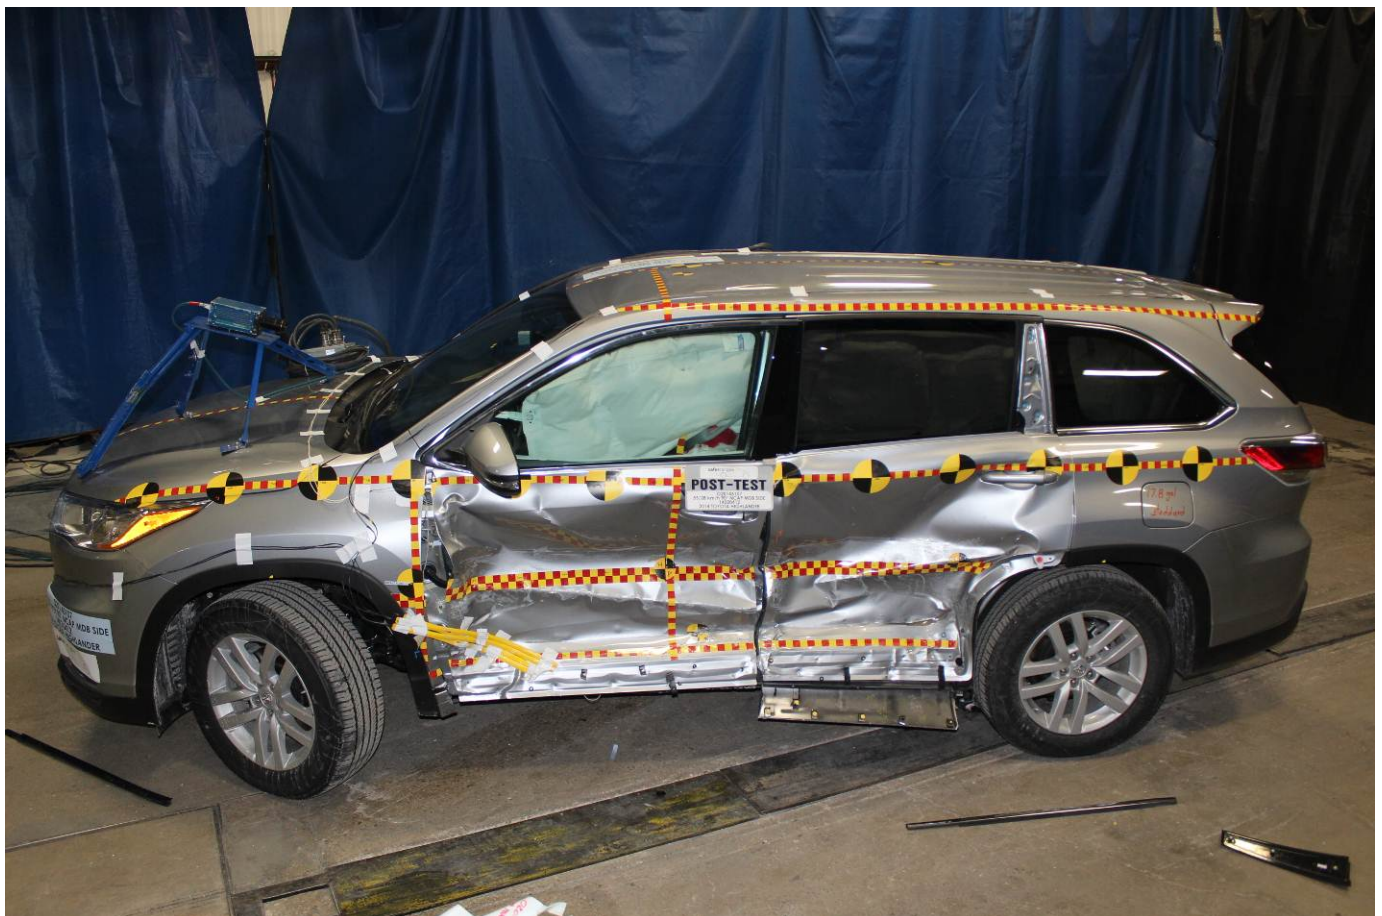
Post-Test Left Side View of Test Vehicle

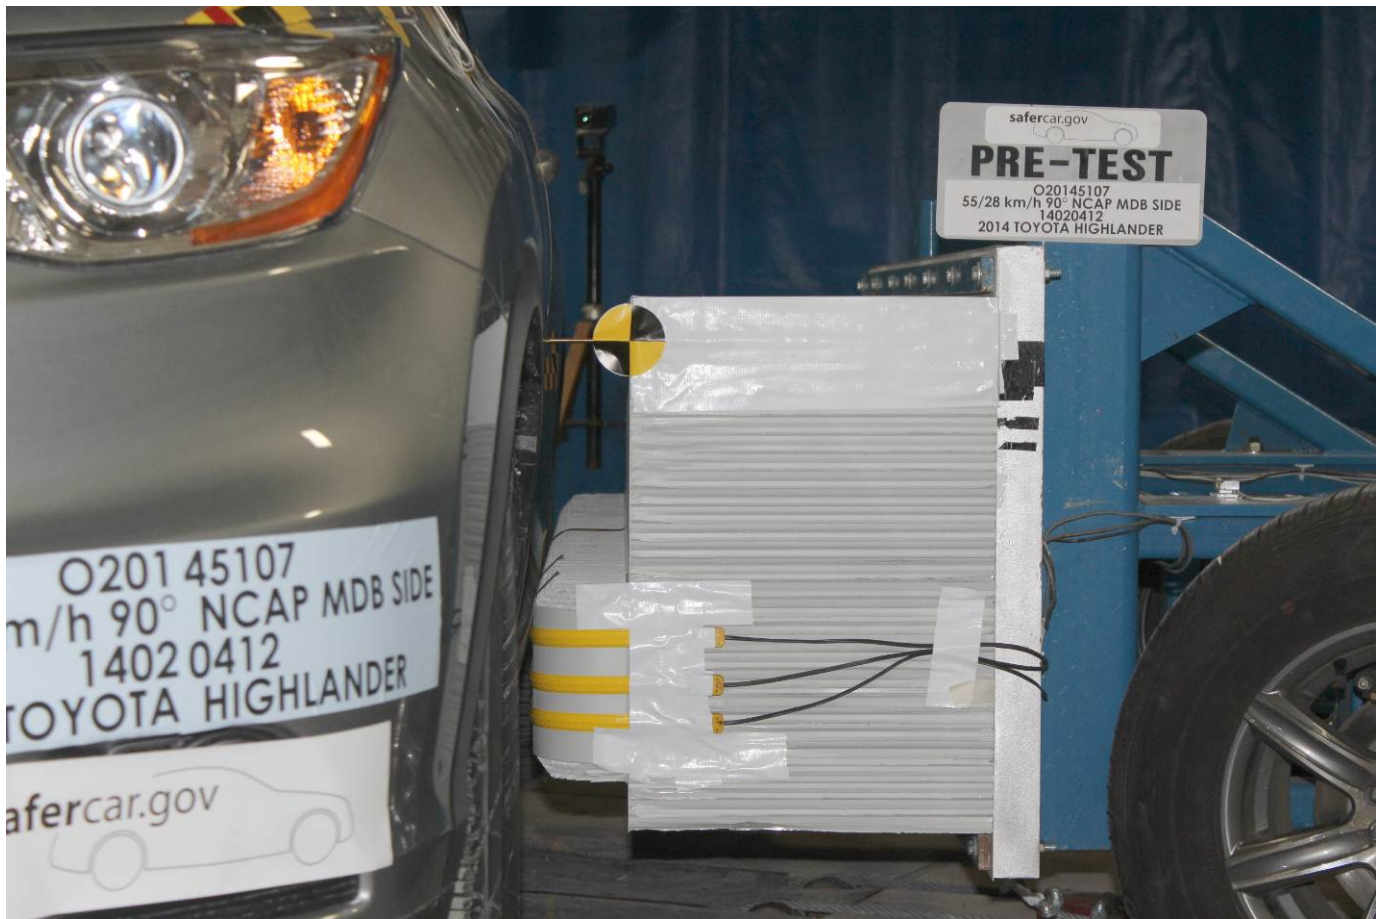
Pre-Test Left Side View of MDB Positioned Against Side of Test Vehicle

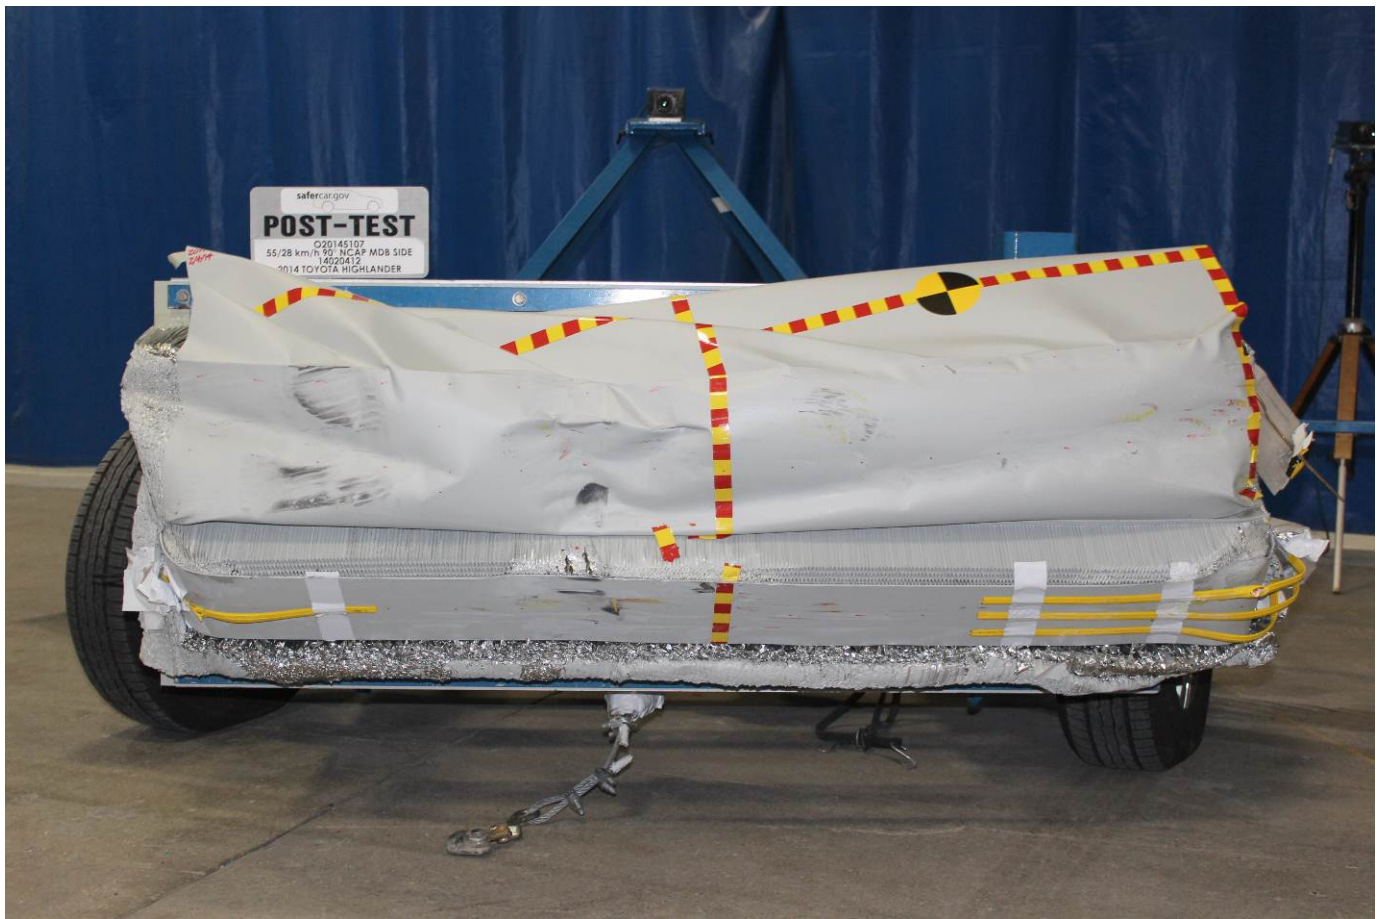
Post-Test Front View of MDB Impactor Face
