**REPORT NUMBER: NCAP305I-KAR-14-015**

**NEW CAR ASSESSMENT PROGRAM (NCAP)  
FMVSS NO. 305 INDICANT TEST**

**AUDI AG  
2014 AUDI Q5 HYBRID QUATTRO 5-DOOR MPV**

**FINAL REPORT**

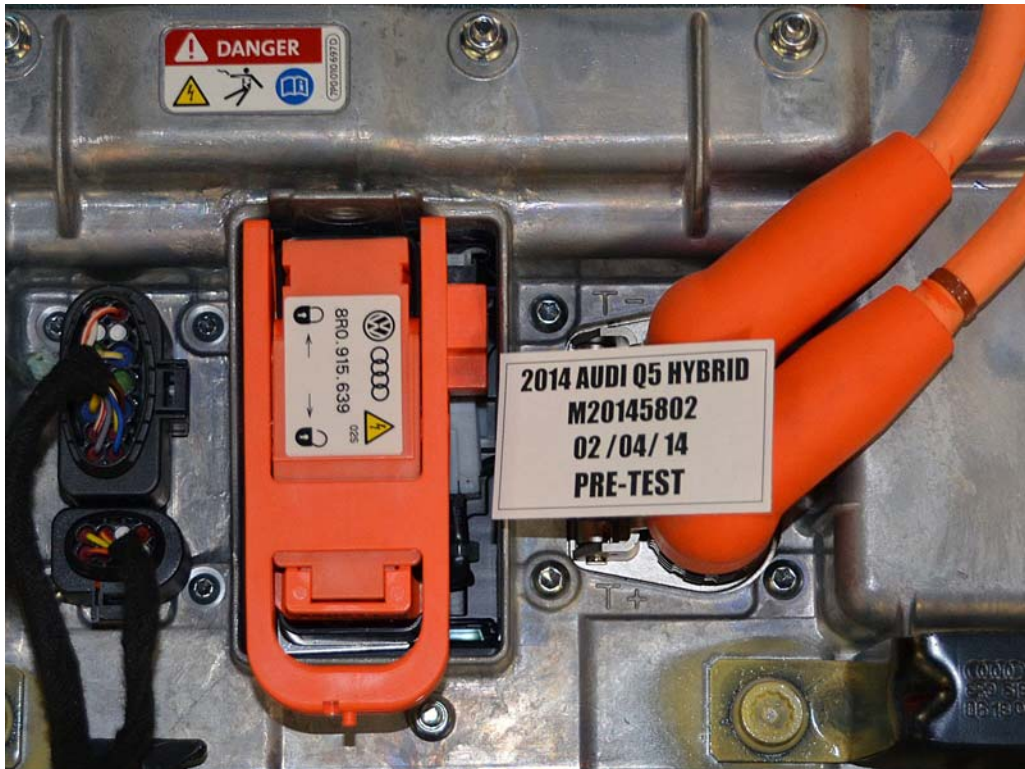
FIGURE 6. Manual High Voltage Service Disconnect in Place

The electrical propulsion system utilized one Lithium – Ion battery and a traction motor to propel the vehicle. The propulsion battery is located in the trunk area underneath the luggage compartment and is retained to the vehicle by nine (9) bolts. The positive and negative high voltage cables run from the battery to the motor located in the front engine compartment. The cables are routed underneath the vehicle on the passenger side. The battery’s service disconnect is located on the top rear side of the propulsion battery. A photograph of the location of the propulsion battery service disconnect is included in Figure 6 of Appendix A.

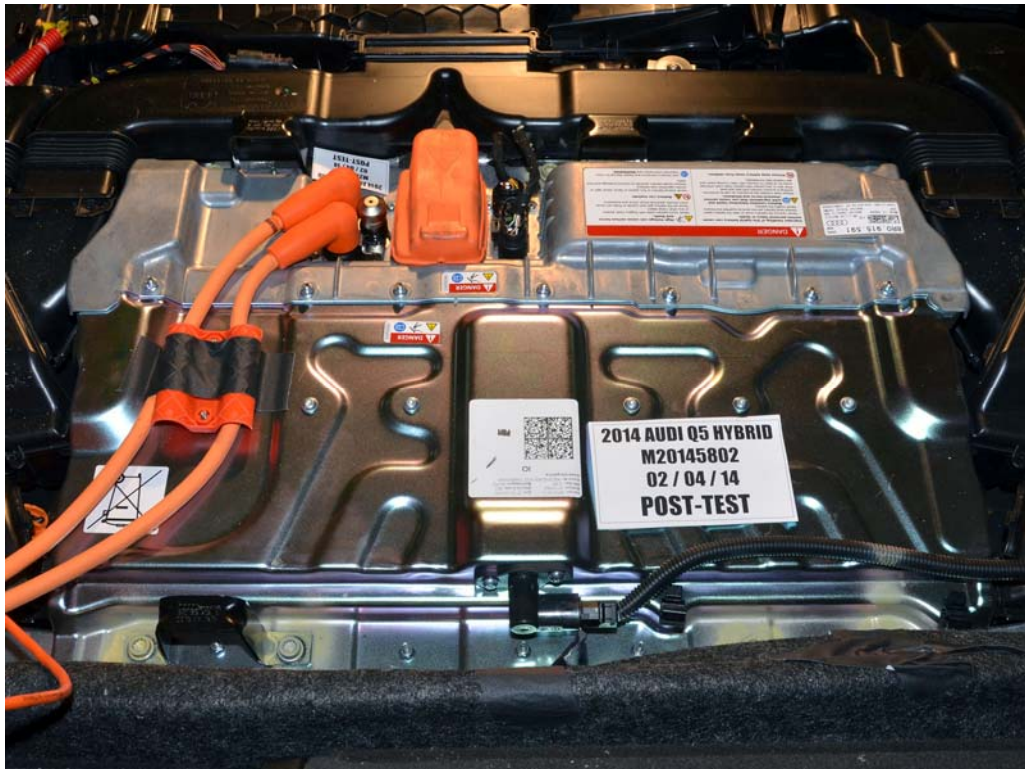
FIGURE 10. Post-Impact Front View of Propulsion Battery

Describe any movement: There was no movement of the propulsion battery.

Describe any intrusion: There was no intrusion of the propulsion battery into the occupant compartment.

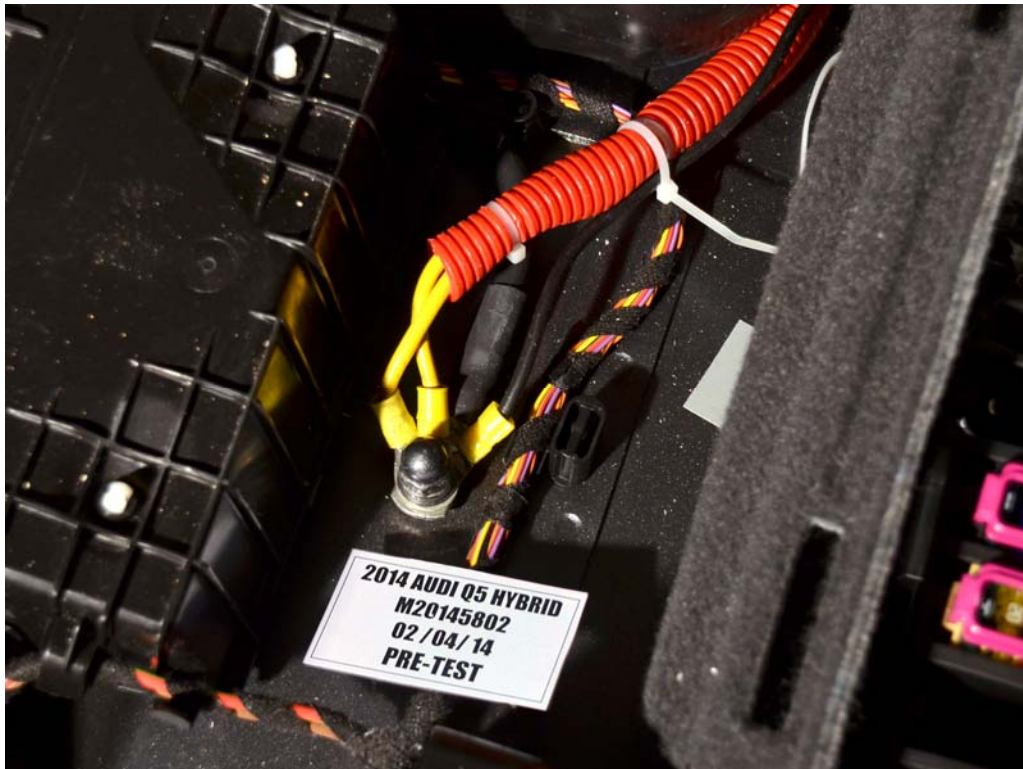
FIGURE 21. Pre-Impact View of Ground Lead Attached

The chassis ground used for the electrical isolation measurements was a pre-existing chassis ground point located on the right rear floor of the trunk compartment. A photograph of the location is included in Figure 21 of Appendix A.

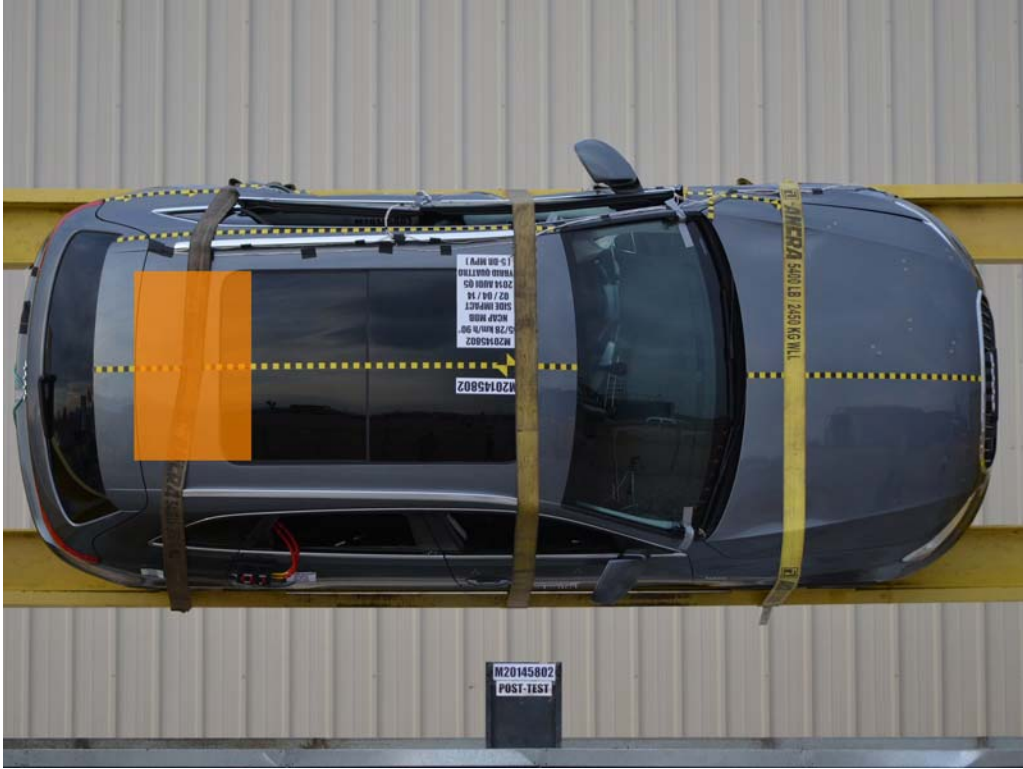
FIGURE 29. FMVSS No. 305 Static Rollover at 90°

Test Phase	Propulsion Battery Electrolyte Spillage (L)	Spillage Location
0° To 90°	0.0	N/A
90° To 180°	0.0	N/A
180° To 270°	0.0	N/A
270° To 360°	0.0	N/A

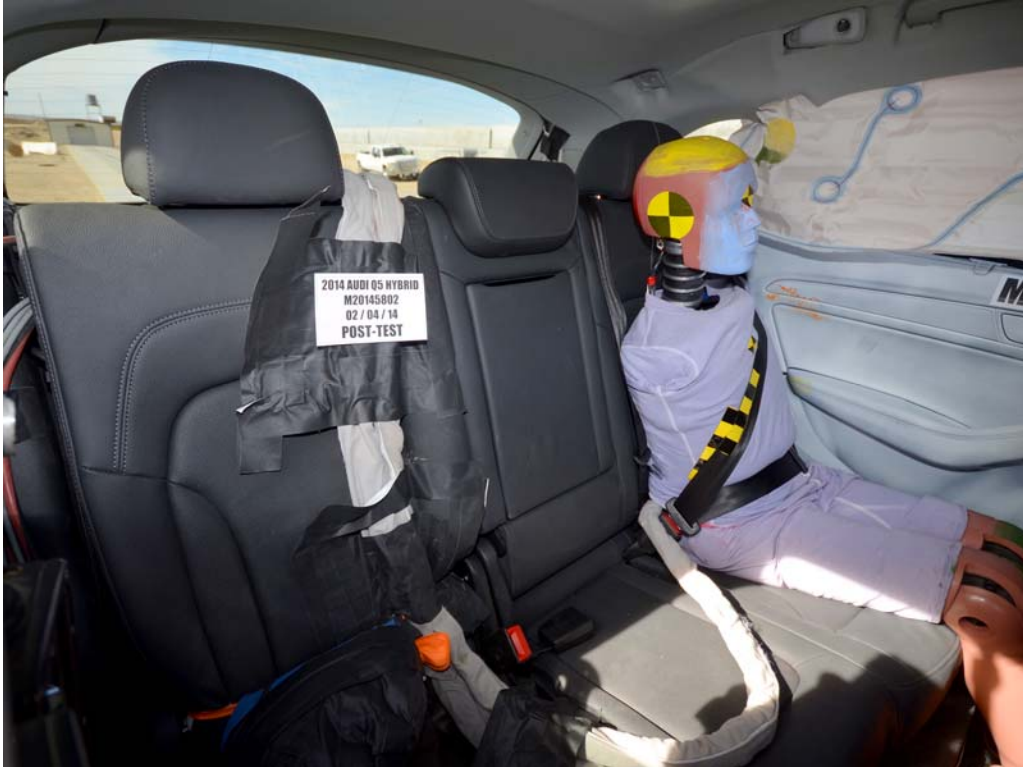
FIGURE 34. Post-Impact View of the Vehicle Passenger Compartment Adjacent to Propulsion Battery

Is there propulsion battery electrolyte spillage visible in the passenger compartment: No
