**REPORT NUMBER: NCAP-CAL-14-009**

**NEW CAR ASSESSMENT PROGRAM (NCAP)  
FRONTAL BARRIER IMPACT TEST**

**Toyota Motor Manufacturing, Kentucky, Inc.  
2014.5 Toyota Camry  
Four Door Sedan**

**FINAL REPORT**

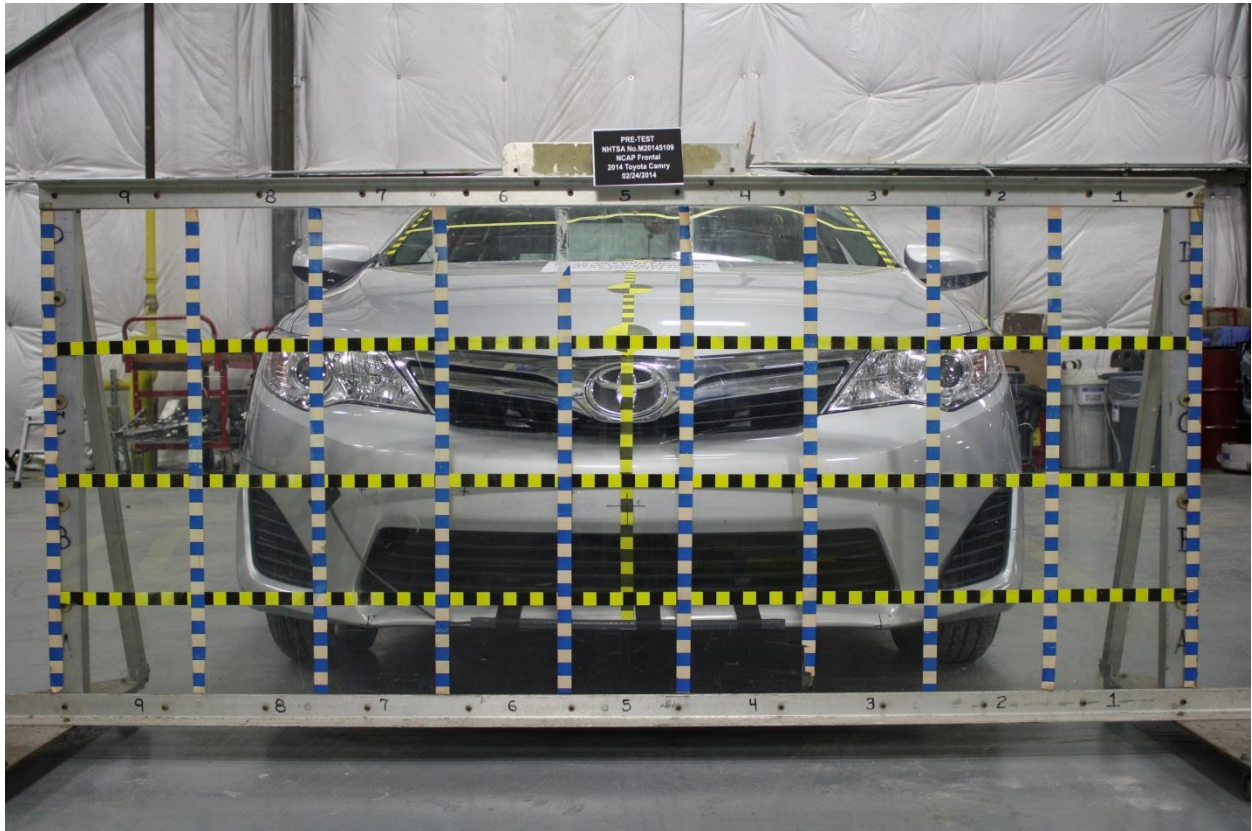
Figure A-1: Load Cell Location

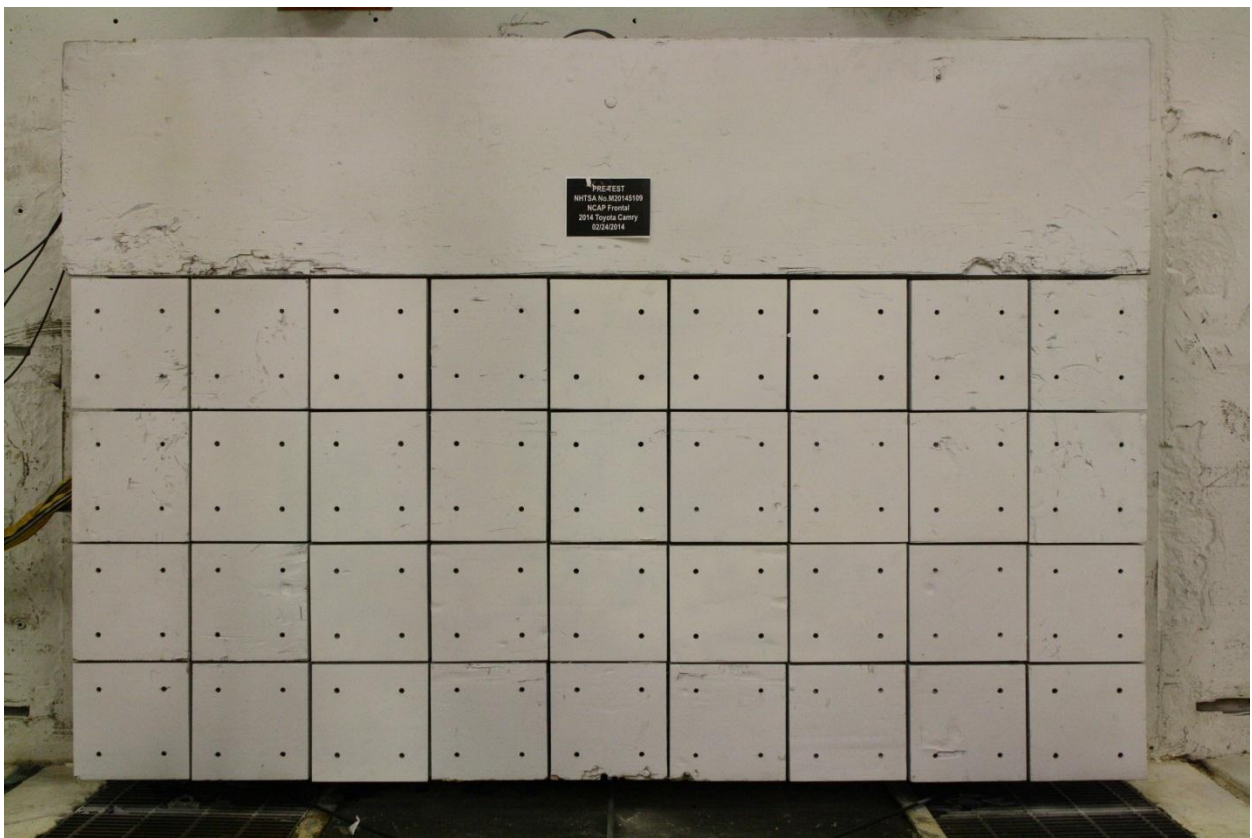
Figure A-2: Load Cell Wall

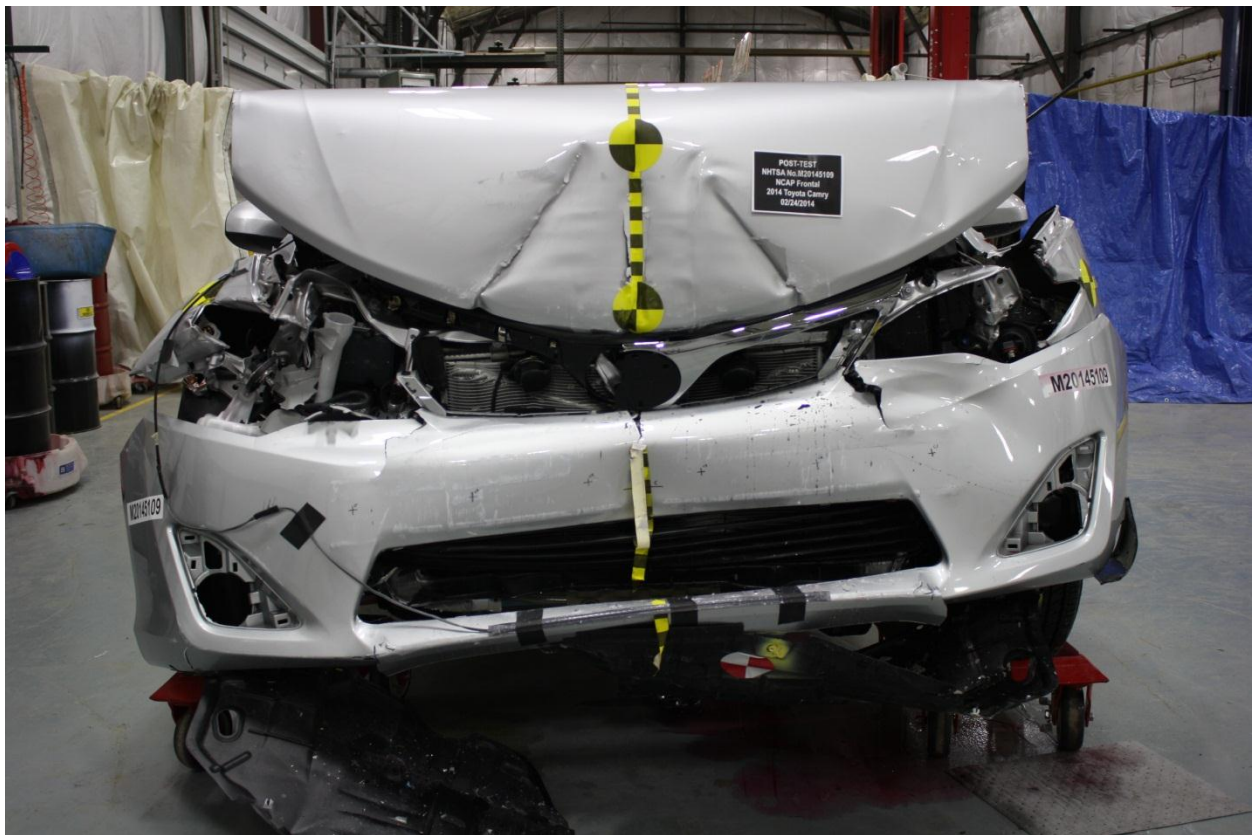
**Figure A-8: Post-Test Front View of Test Vehicle**

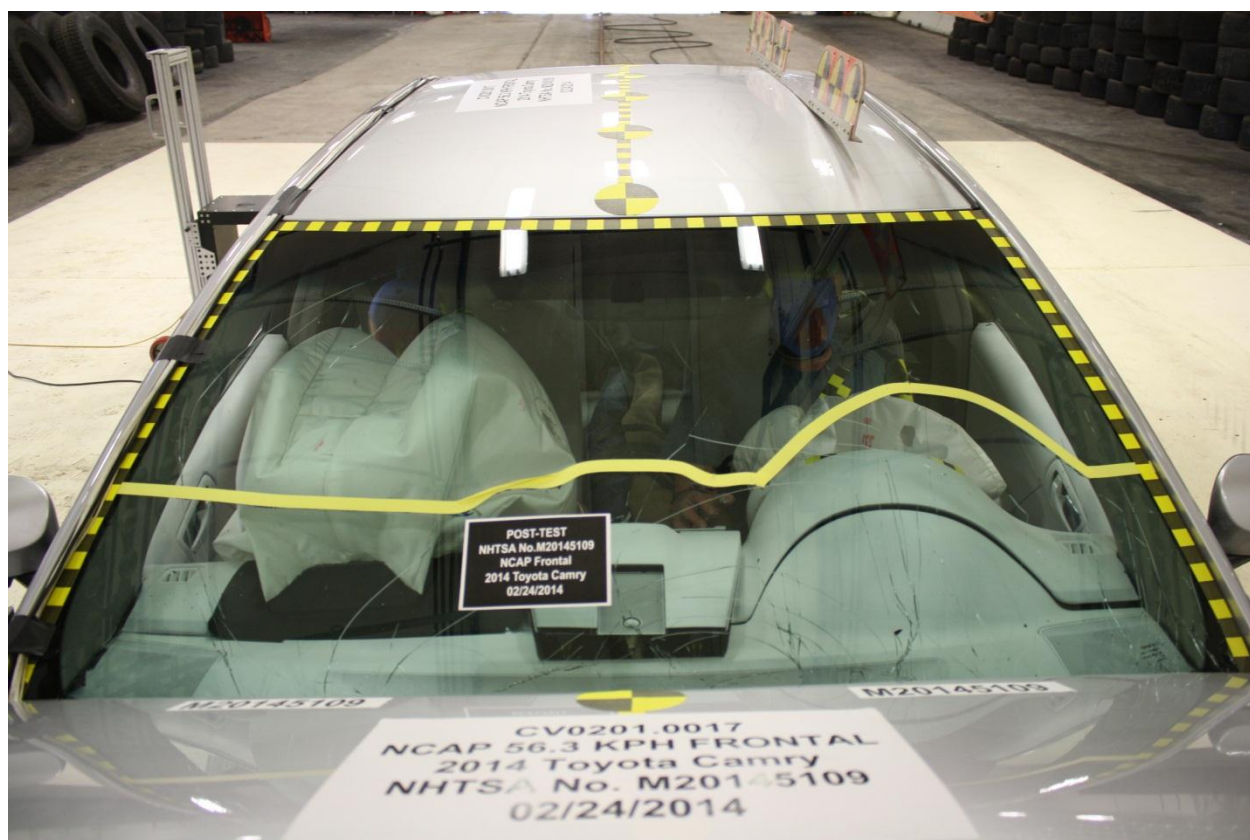
Figure A-18: Post-Test Windshield View

| Critical Areas of Performance | Observations and Conclusions |
|---|---|
| Windshield Damage | Minor cracks |

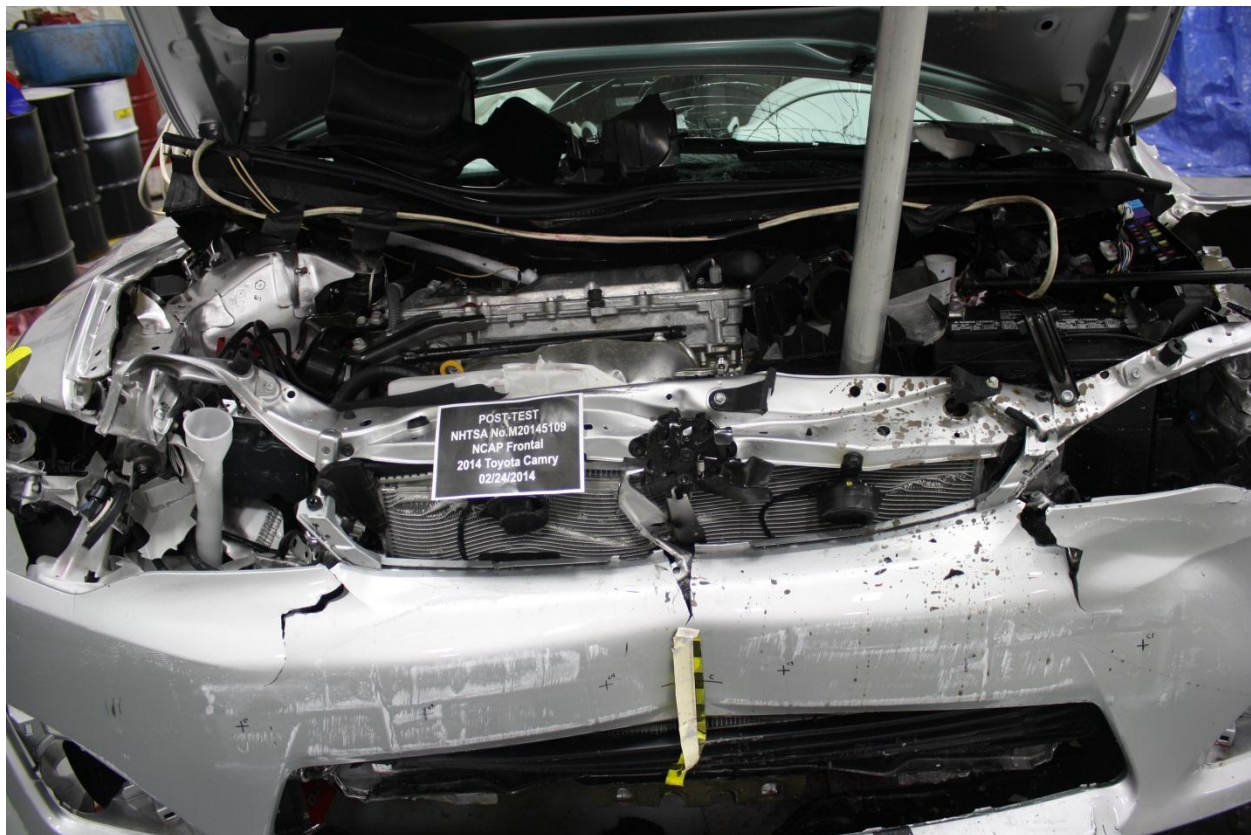
**Figure A-20: Post-Test Engine Compartment View**

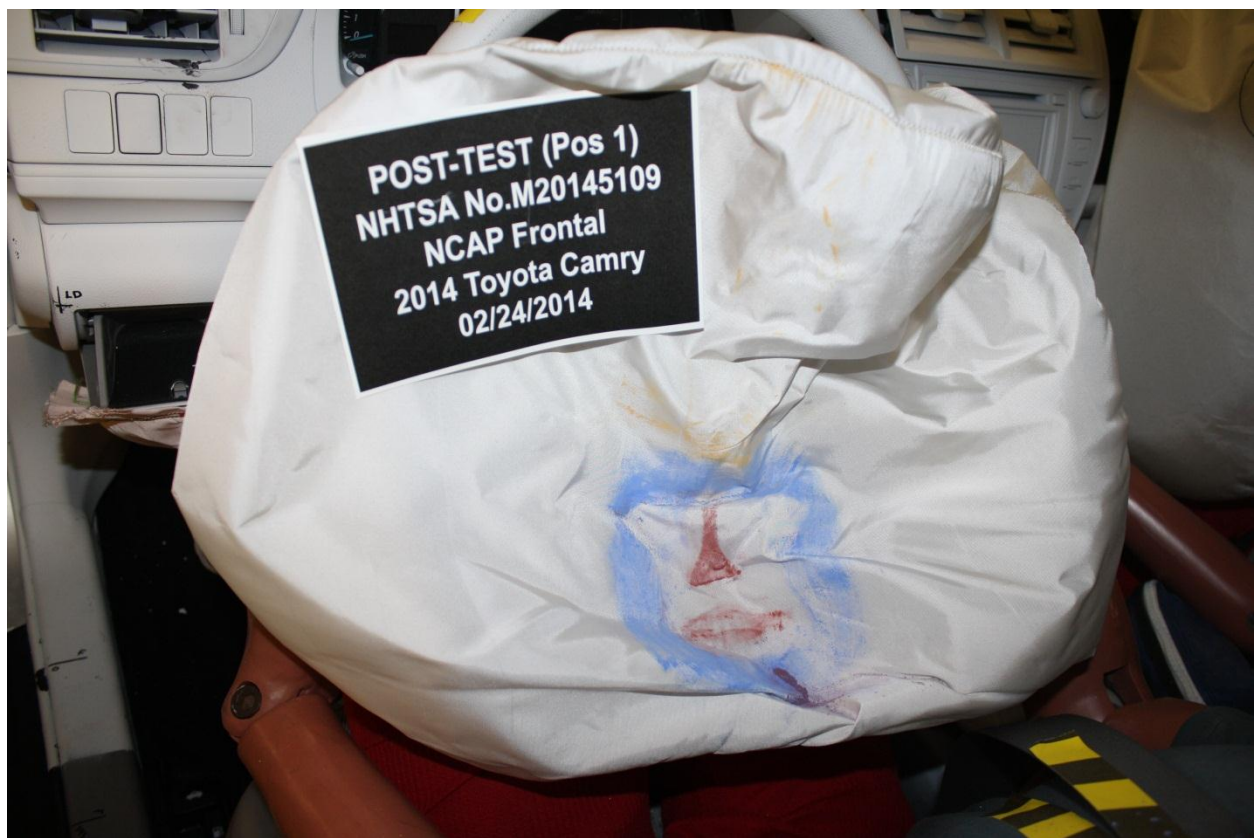
**Figure A-46: Post-Test Driver Dummy Contact With Airbag**

The driver's visible contact points were as follows: The driver's head contacted the frontal airbag and then the head restraint. The upper torso contacted the frontal airbag. Both knees contacted the knee airbag.

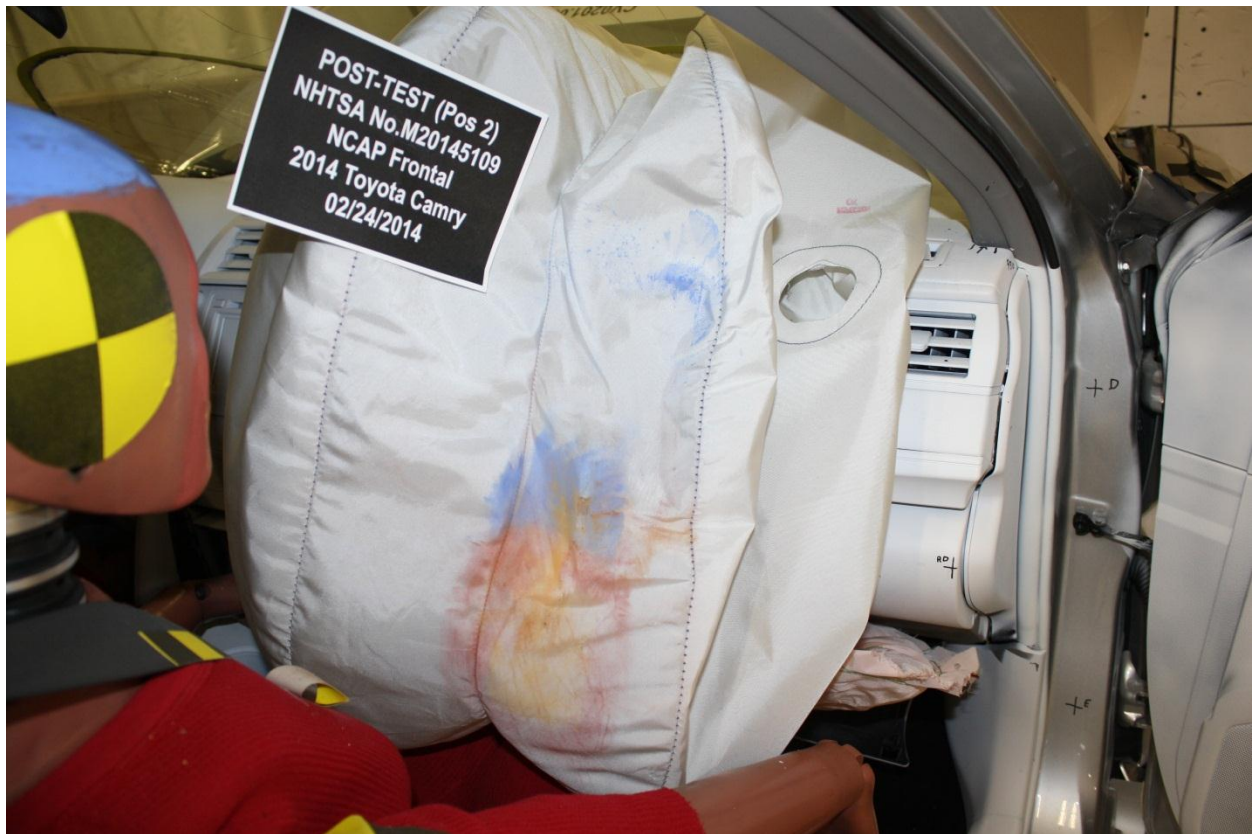
**Figure A-67: Post-Test Passenger Dummy Contact With Airbag**

The passenger's visible contact points were as follows: The passenger's head contacted the frontal airbag and then the head restraint. The upper torso contacted the frontal airbag. Both knees contacted the knee airbag.

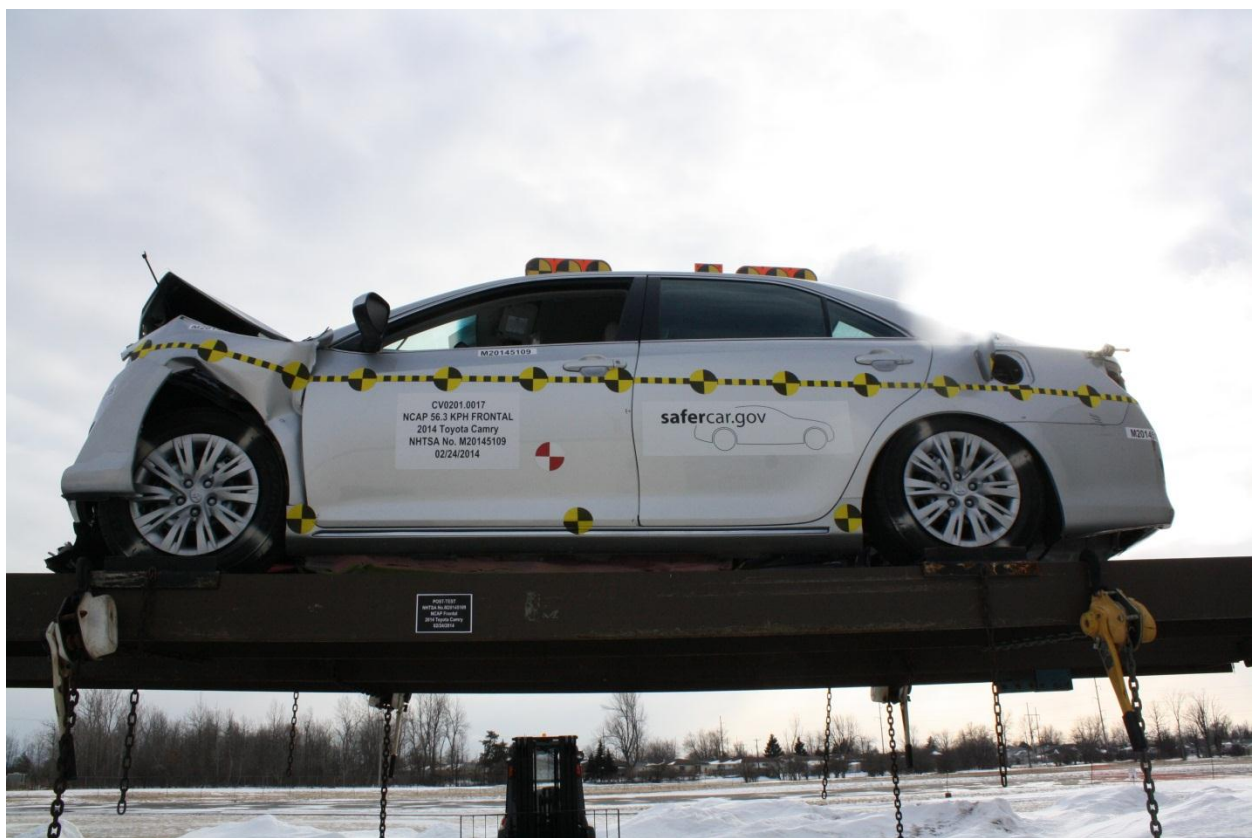
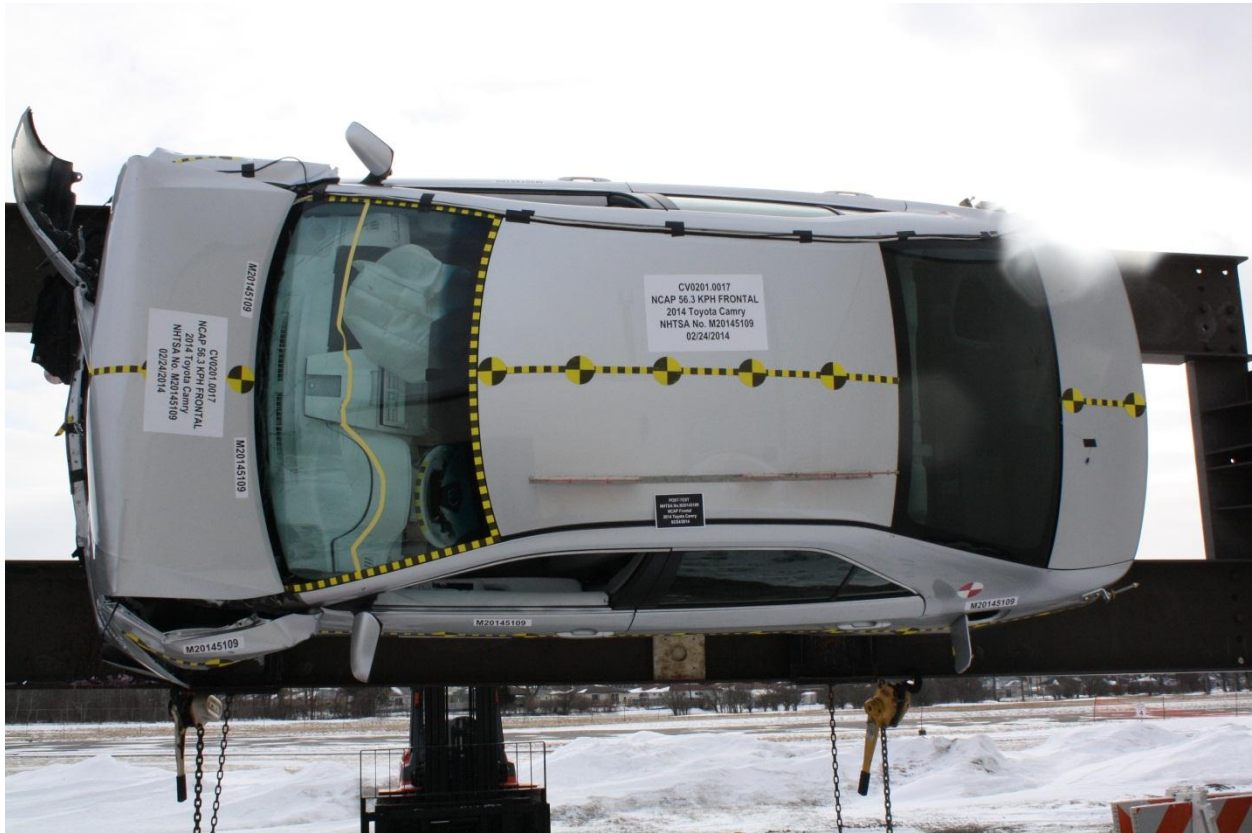
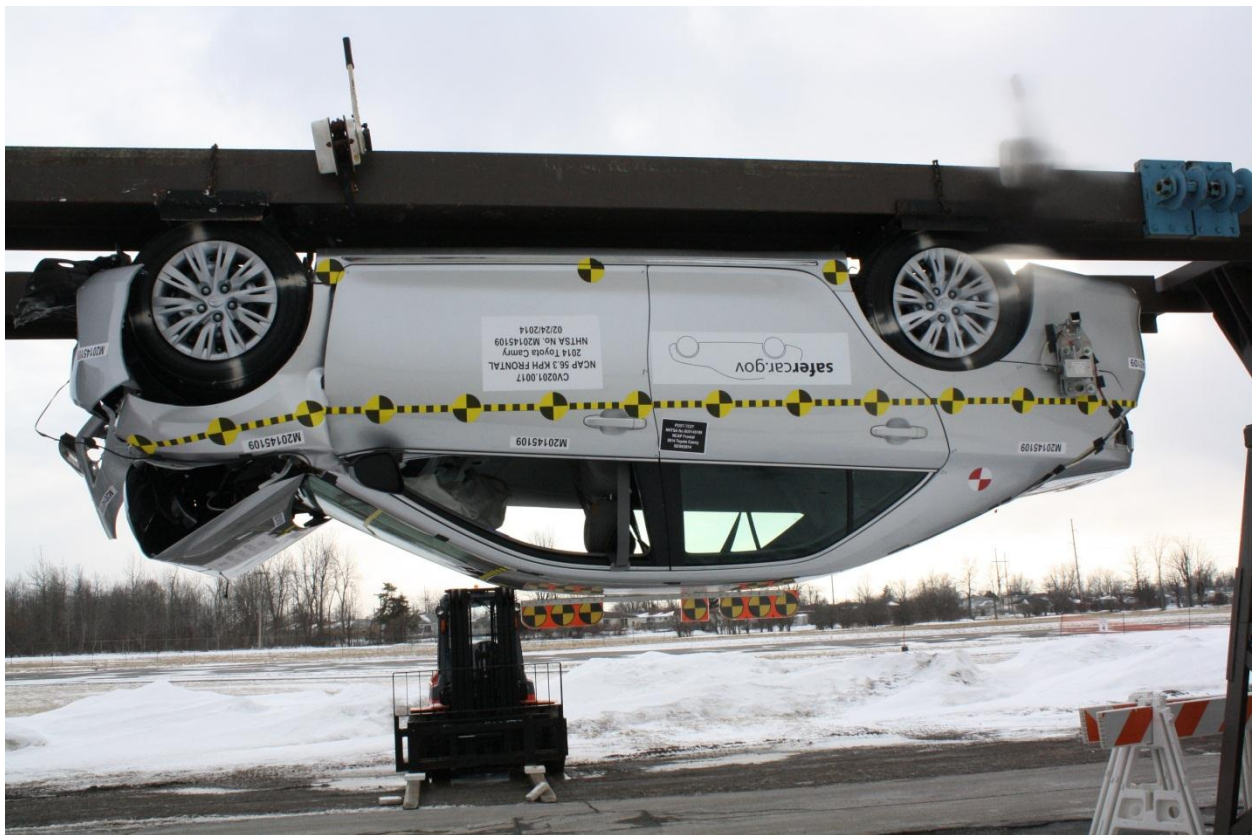
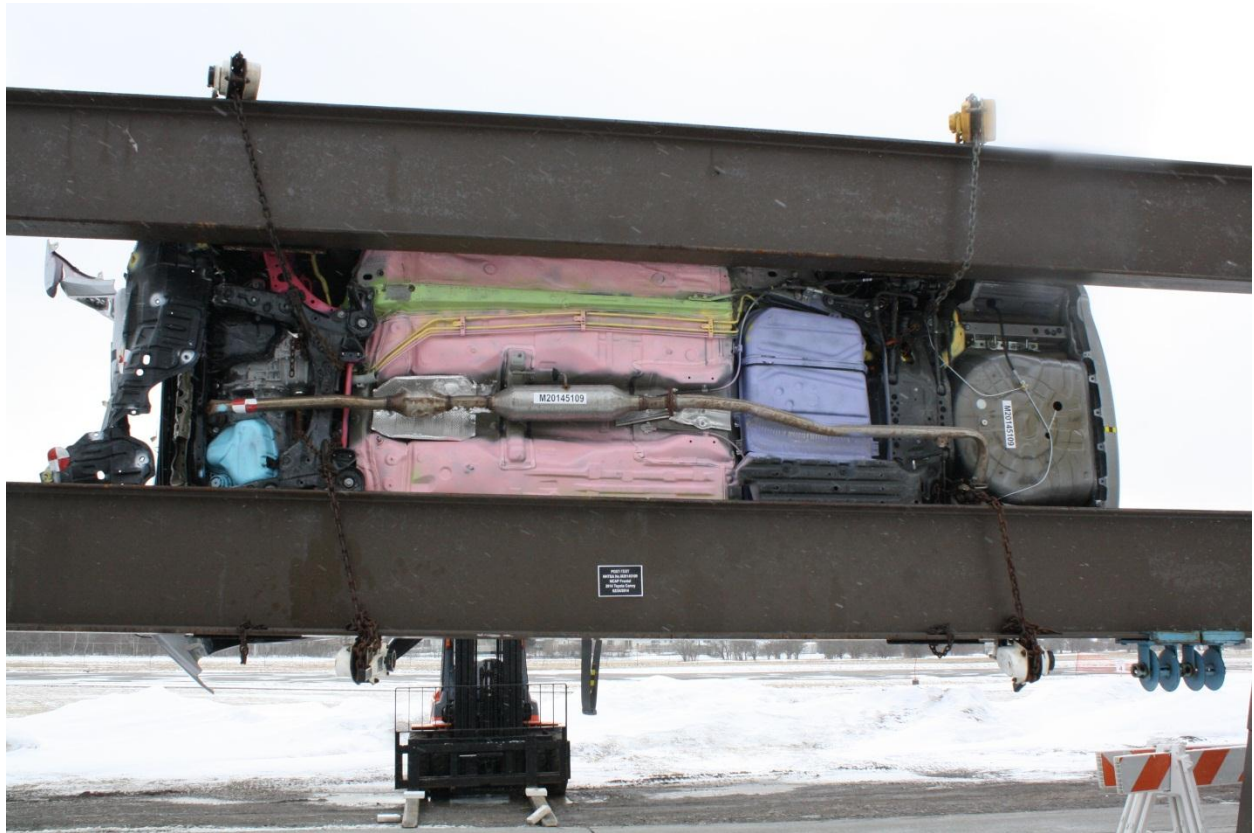
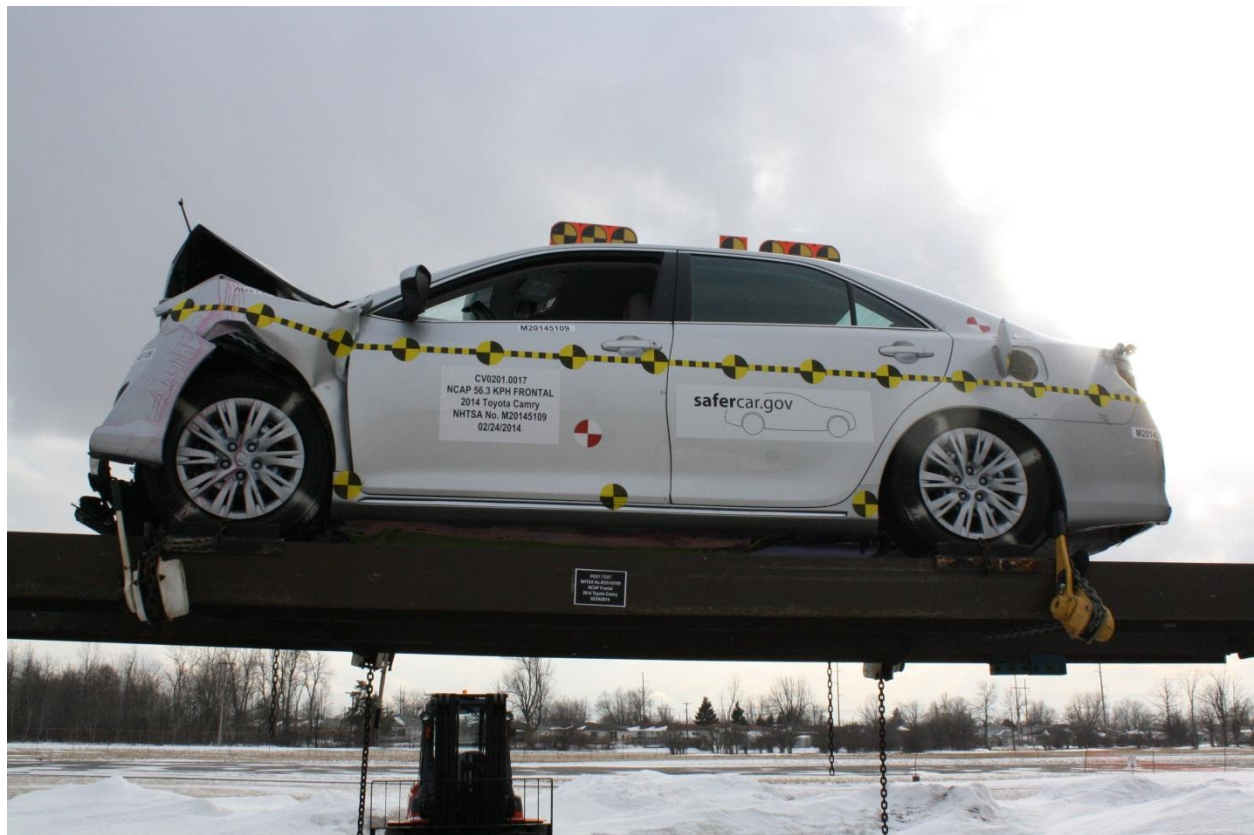
Figure A-72: Vehicle at 0° on Static Rollover Device

Figure A-73: Vehicle at 90° on Static Rollover Device

Figure A-74: Vehicle at 180° on Static Rollover Device

Figure A-75: Vehicle at 270° on Static Rollover Device

Figure A-76: Vehicle at 360° on Static Rollover Device

There was 100 percent windshield retention and no intrusion into the protected zone of the windshield during the event. There was a total of 0.0 grams of stoddard solvent leakage after the event and including all phases of the static rollover. The maximum static crush of the test vehicle was 554 mm at the centerline. During and after the impact event, the driver's and passenger's side door were closed and operational.

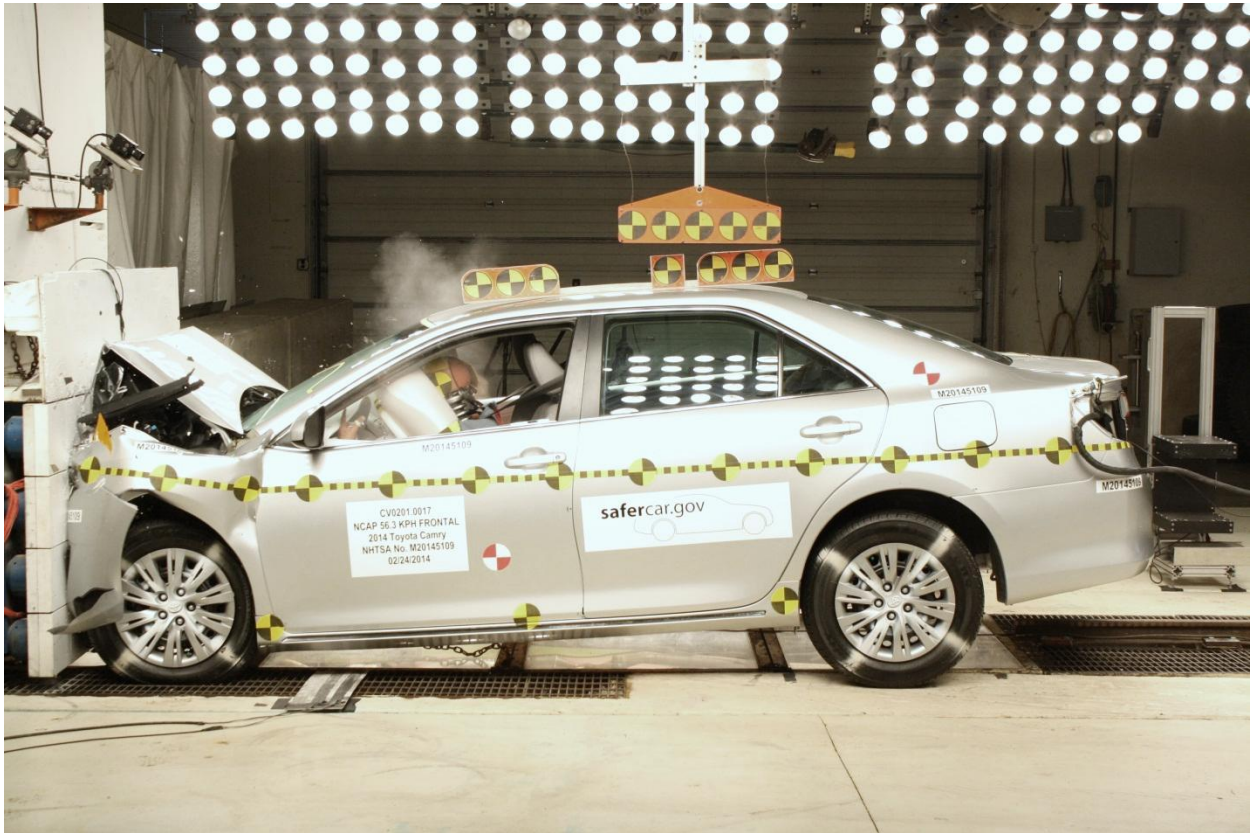
Figure A-77: 2014.5 Toyota Camry Frontal Impact Event

A load cell barrier consisting of 36 load cells was impacted by a 2014.5 Toyota Camry four door sedan at a velocity of 56.71 km/h. The test was performed at Calspan Corporation's Transportation Test Operations facility in Buffalo, New York on February 24, 2014. Pre- and post-test photographs of the vehicle and dummies to document the test can be found in Appendix A. One real-time camera and 14 high-speed cameras were used to document the frontal barrier impact event. Camera locations and other pertinent camera information can be found in Data Sheet 6 of this report.
