**Vehicle Research and Test Center  
1997 Plymouth Neon into  
Rear of a 2004 Jeep Liberty  
TRC Inc. Test Number: 130925**

**Prepared By:  
Transportation Research Center Inc.  
10820 State Route 347  
East Liberty, OH 43319**

**Final Report  
September – October 2013**

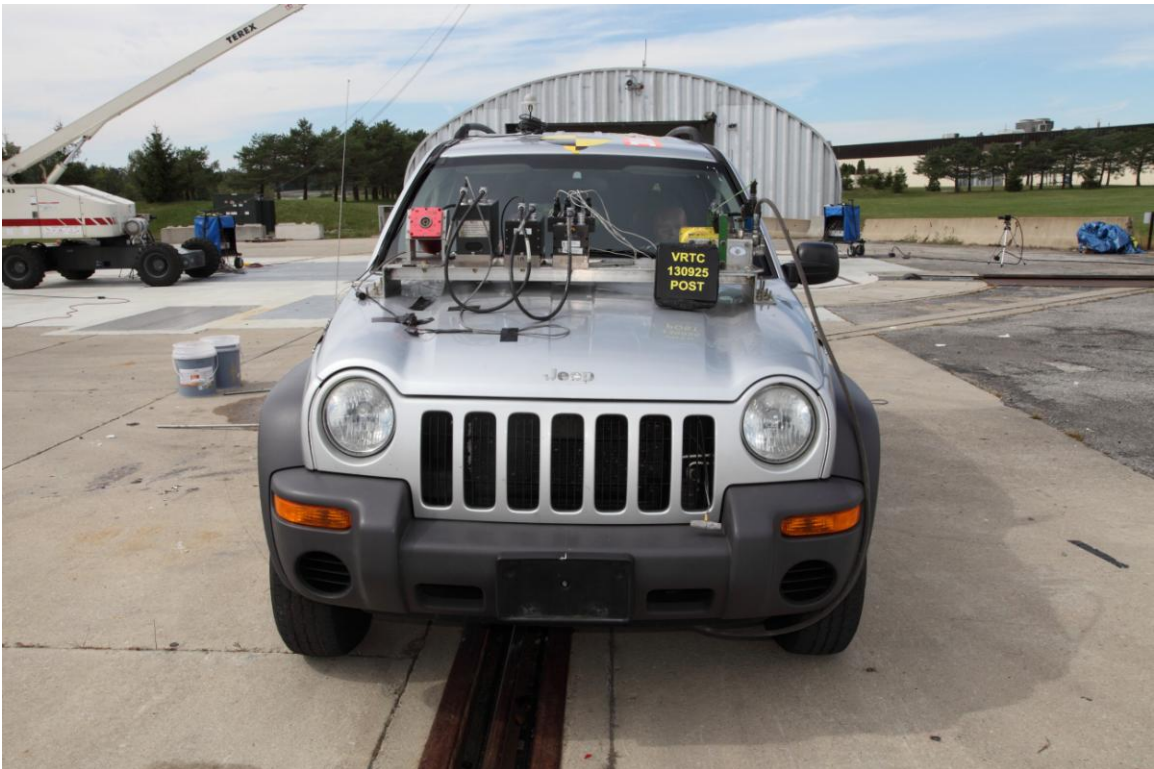
**Figure A-2 Post-Test Target Vehicle Frontal View**

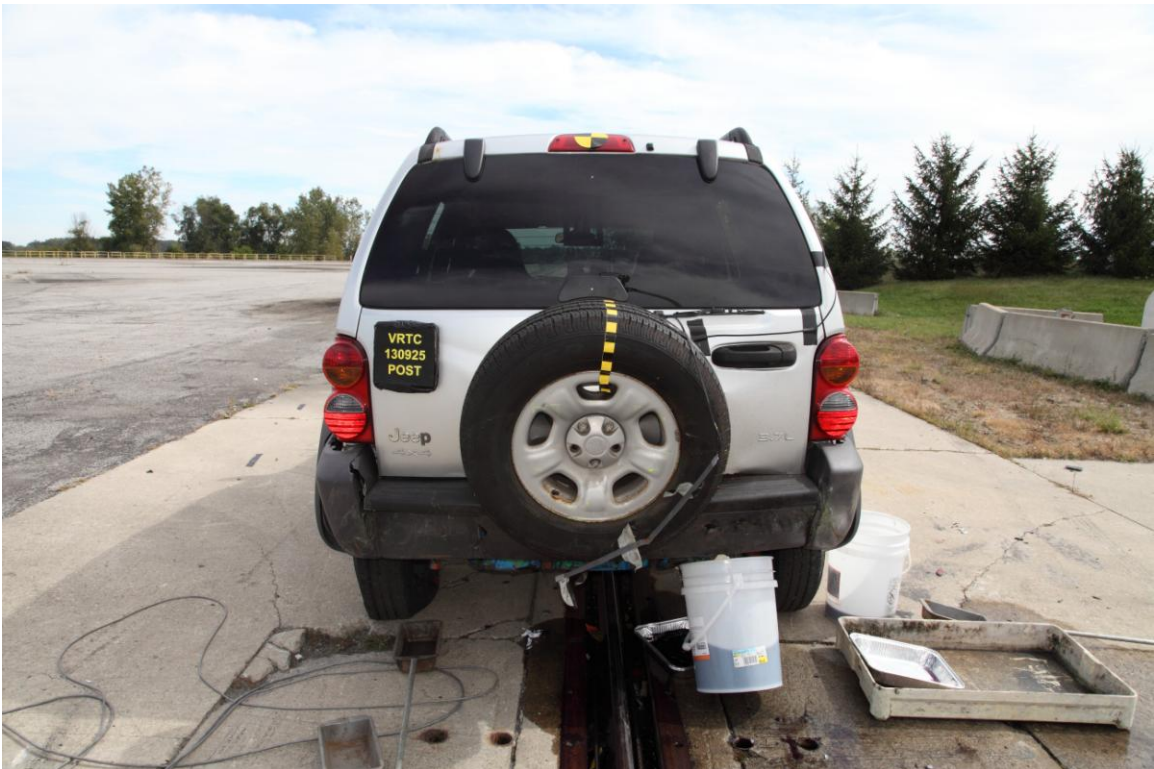
**Figure A-8 Post-Test Target Vehicle Rear View**

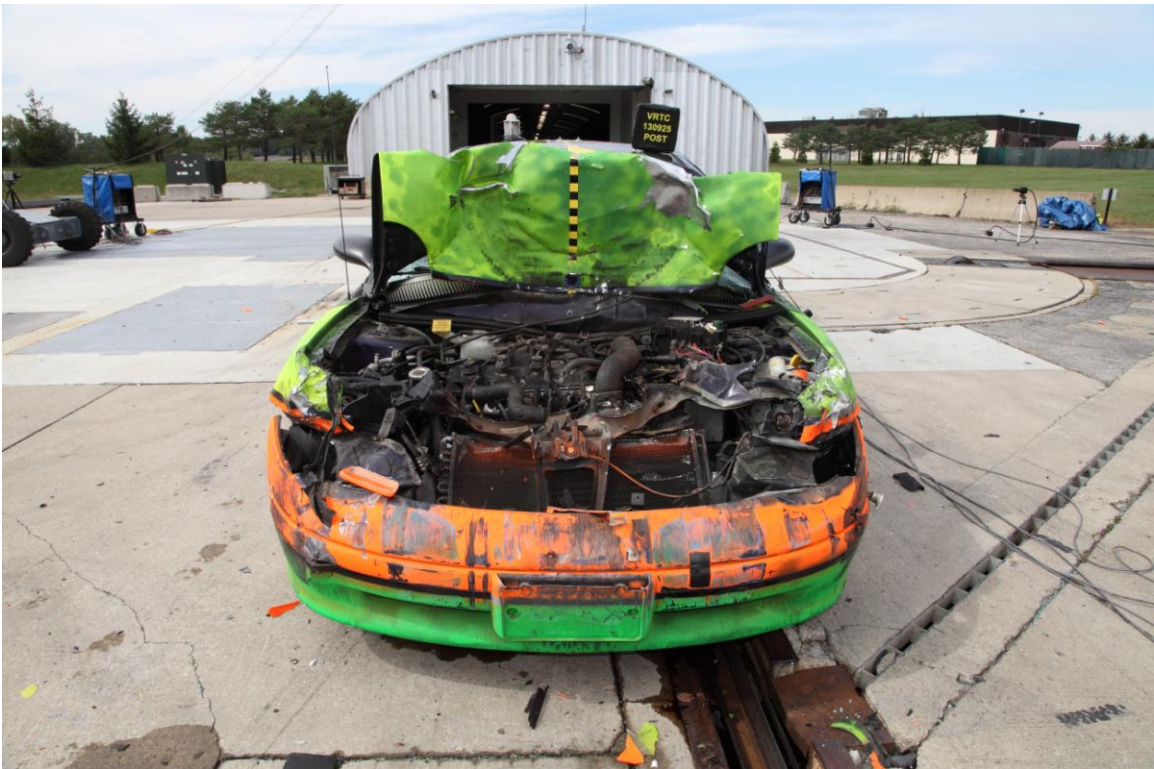
**Figure A-29 Post-Test Bullet Vehicle Frontal View**

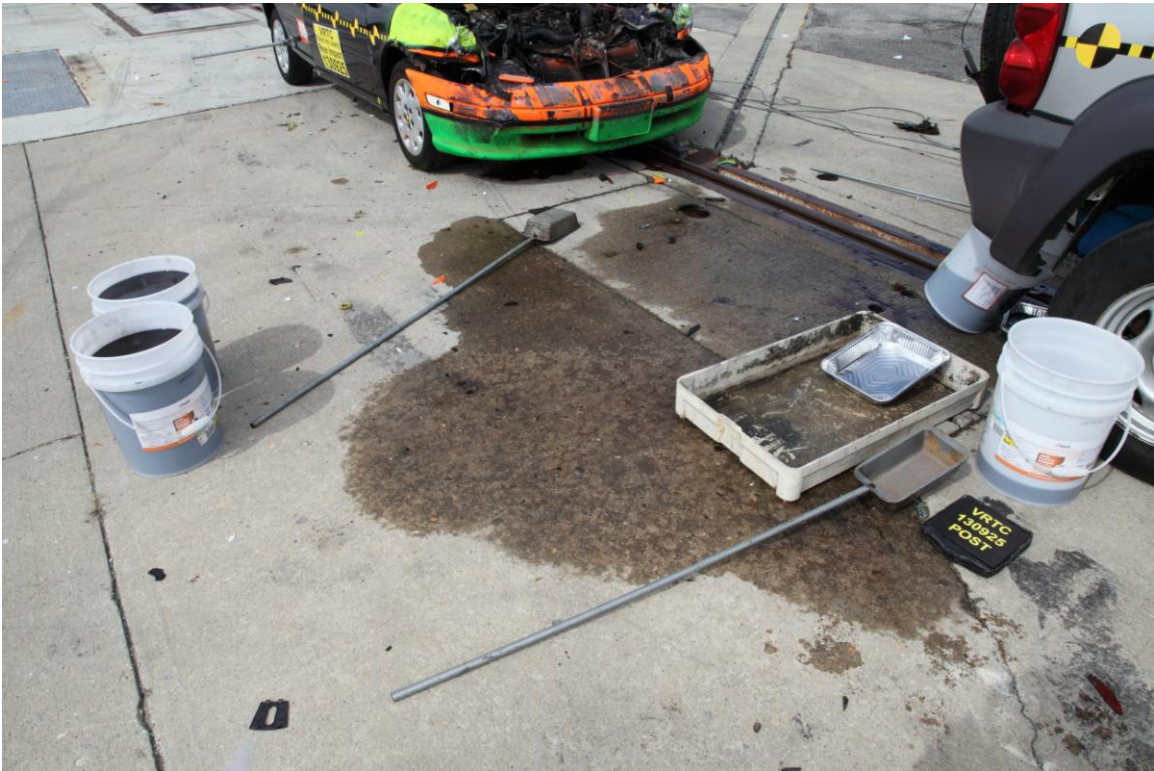
**Figure A-58 Post-Test Fuel System Fluid Spillage – View 2**

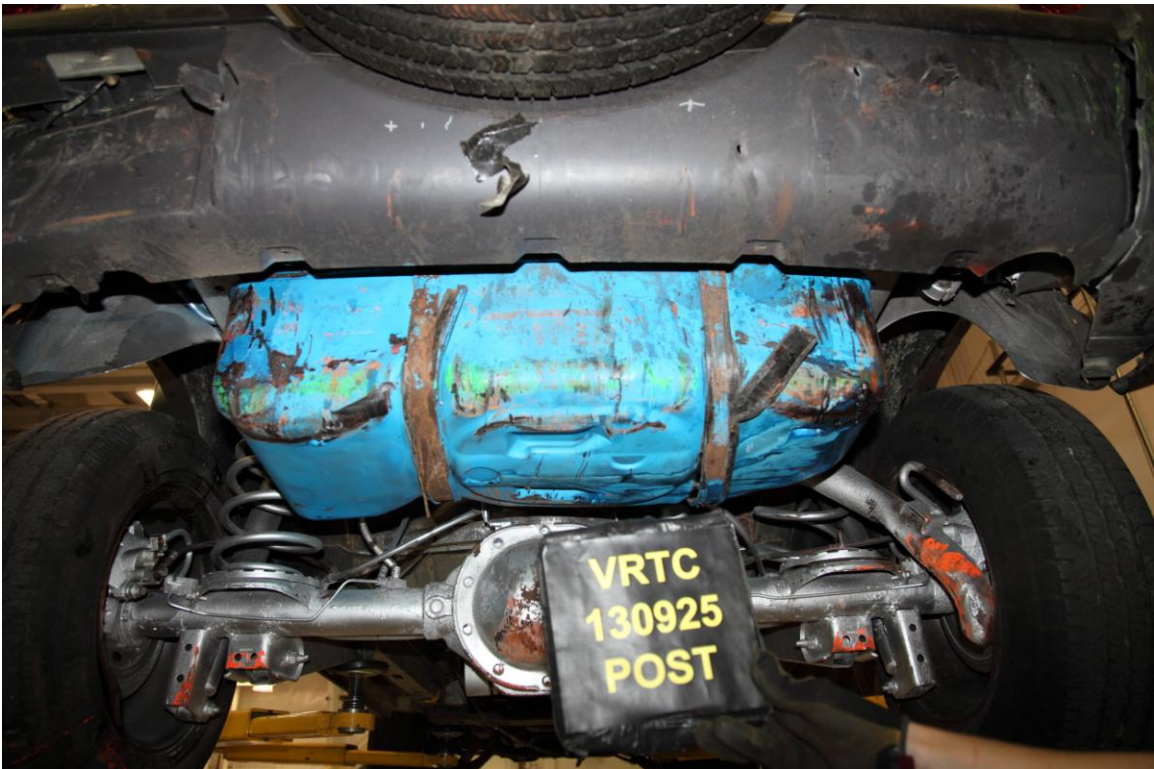
**Figure A-59 Post-Test Target Vehicle Damaged Area Close-up View**

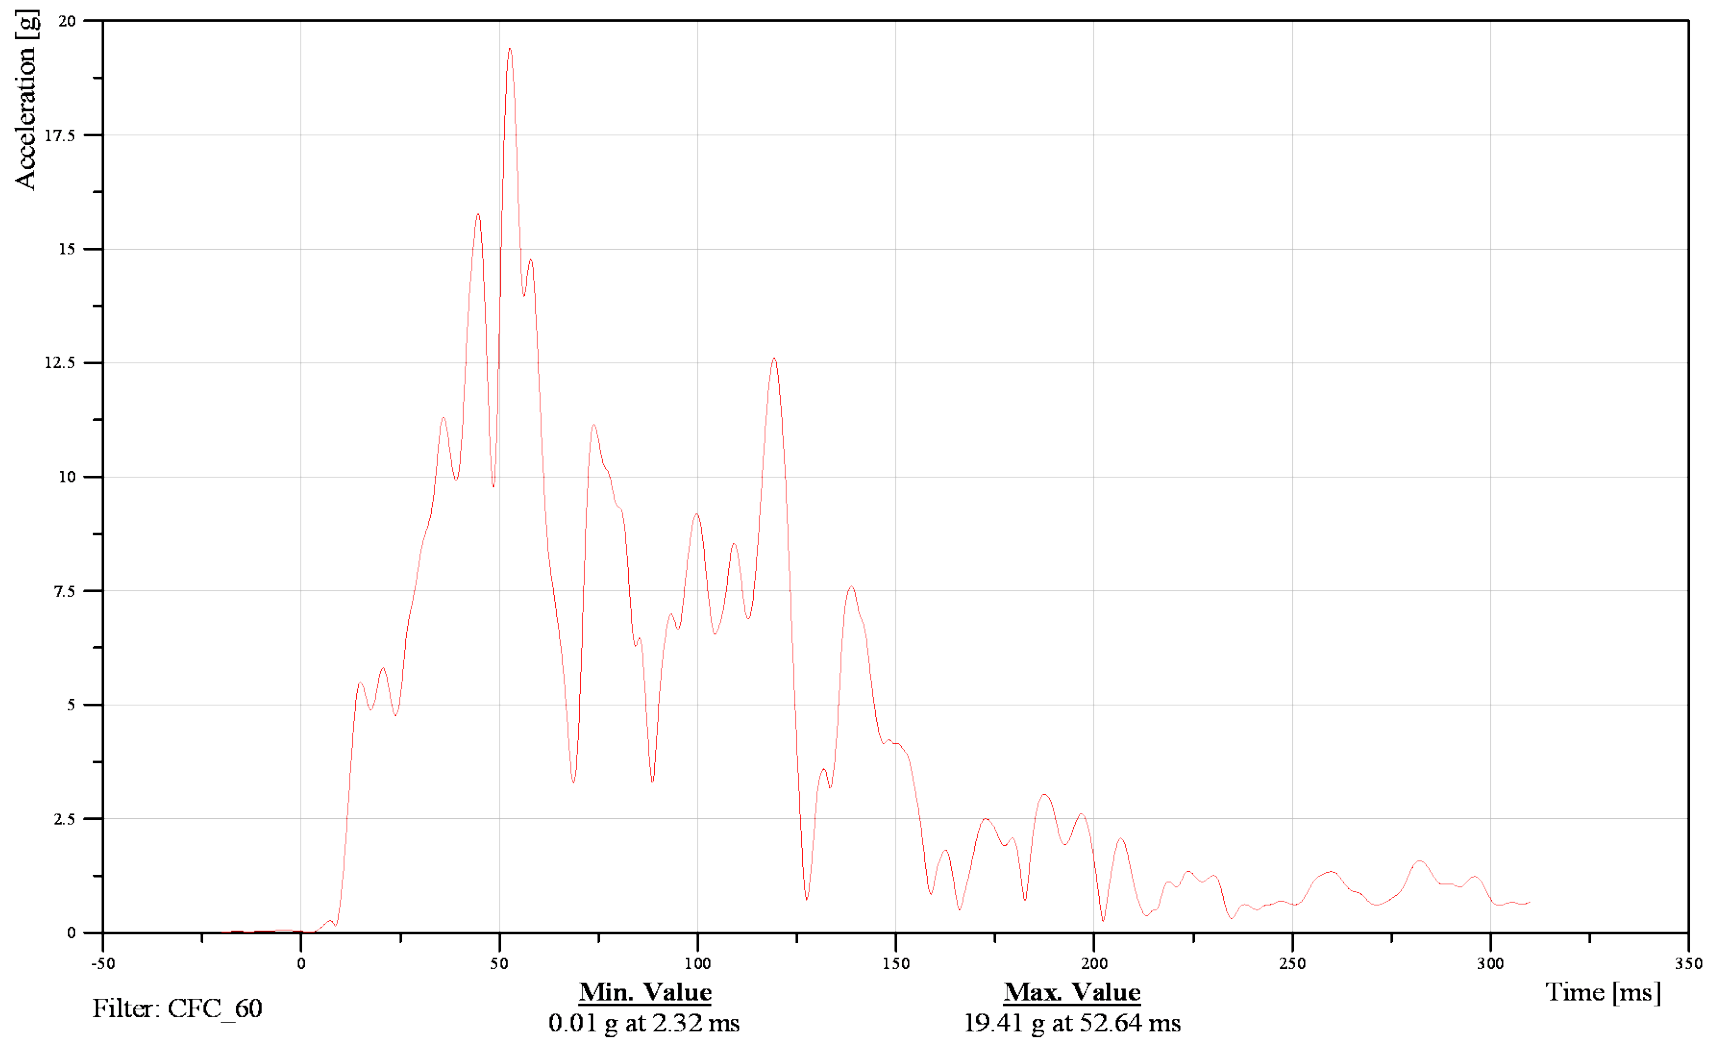
1997 Neon into Rear of 2004 Jeep Liberty  
Target Vehicle CG Redundant Acceleration Resultant
