**Vehicle Research and Test Center
1997 Plymouth Neon into
Rear of a 2004 Jeep Liberty
TRC Inc. Test Number: 131024**

**Prepared By:
Transportation Research Center Inc.
10820 State Route 347
East Liberty, OH 43319**

**Final Report
October - November 2013**

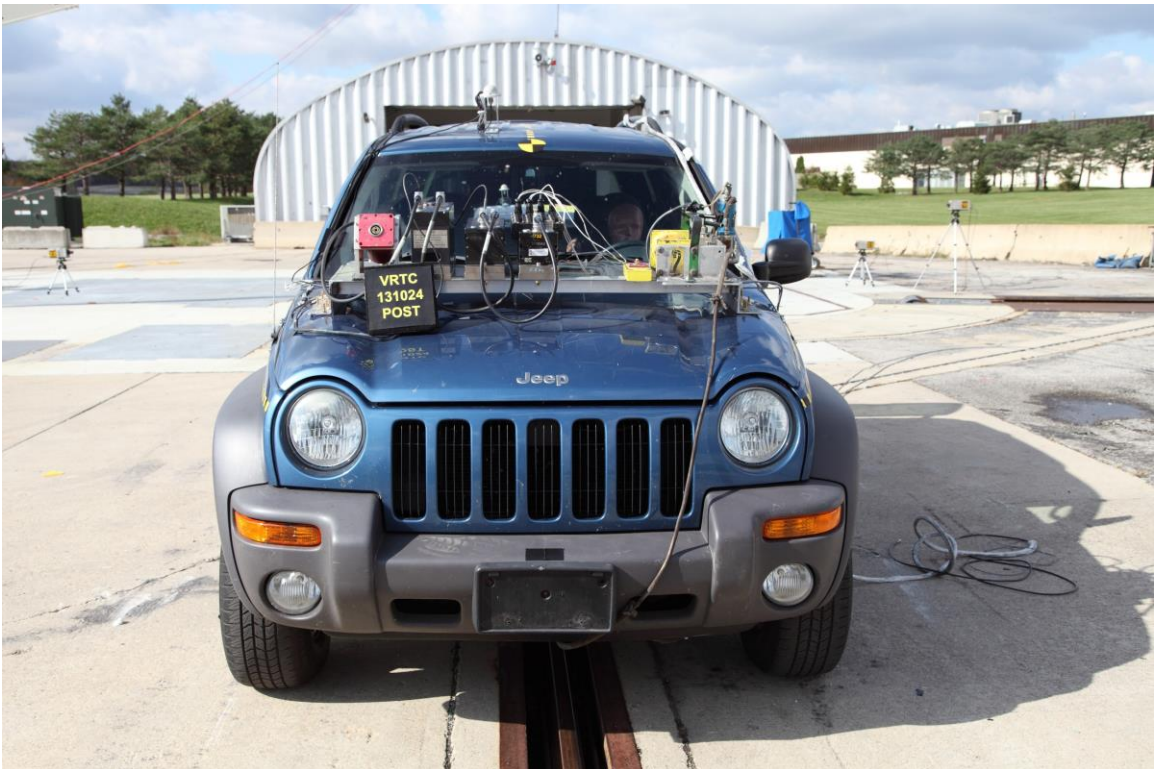
Figure A-2 Post-Test Target Vehicle Frontal View

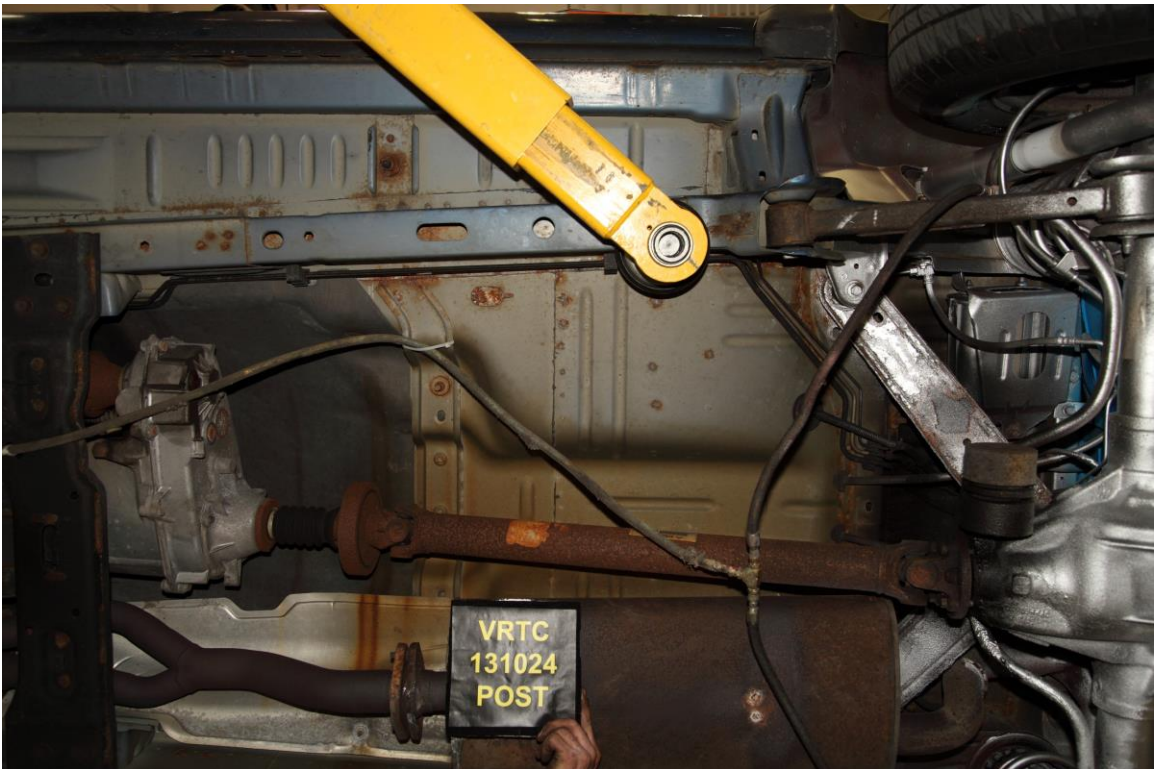
Figure A-24 Post-Test Target Vehicle Fuel Line Close-up View

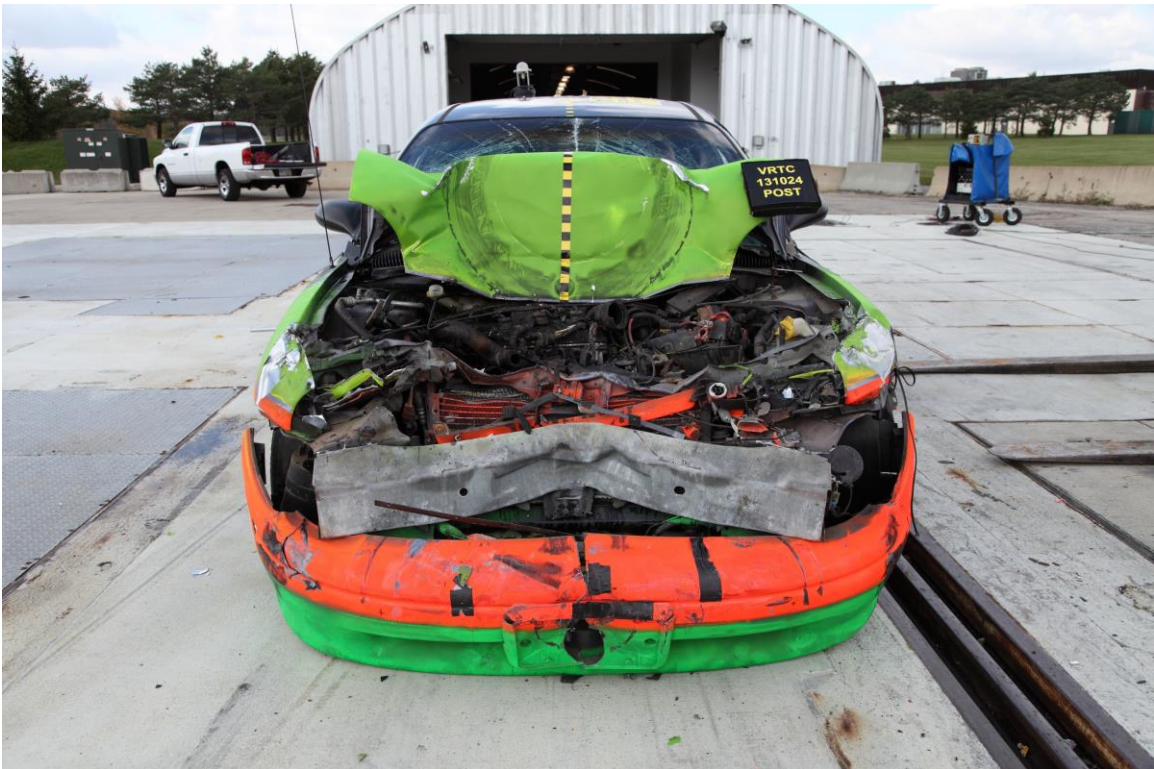
Figure A-33 Post-Test Bullet Vehicle Frontal View

Pre-test	Post-test	Crush
L	1524 mm		
C1	4145	N/A ¹	N/A ¹
C2	4305	N/A ¹	N/A ¹
C3	4373	N/A ¹	N/A ¹
CL	4373	N/A ¹	N/A ¹
C4	4365	N/A ¹	N/A ¹
C5	4305	N/A ¹	N/A ¹
C6	4164	N/A ¹	N/A ¹
