**Vehicle Research and Test Center  
1993 Cadillac DeVille into  
Rear of a 1998 Jeep Cherokee  
TRC Inc. Test Number: 131031**

**Prepared By:  
Transportation Research Center Inc.  
10820 State Route 347  
East Liberty, OH 43319**

**Final Report  
October - December 2013**

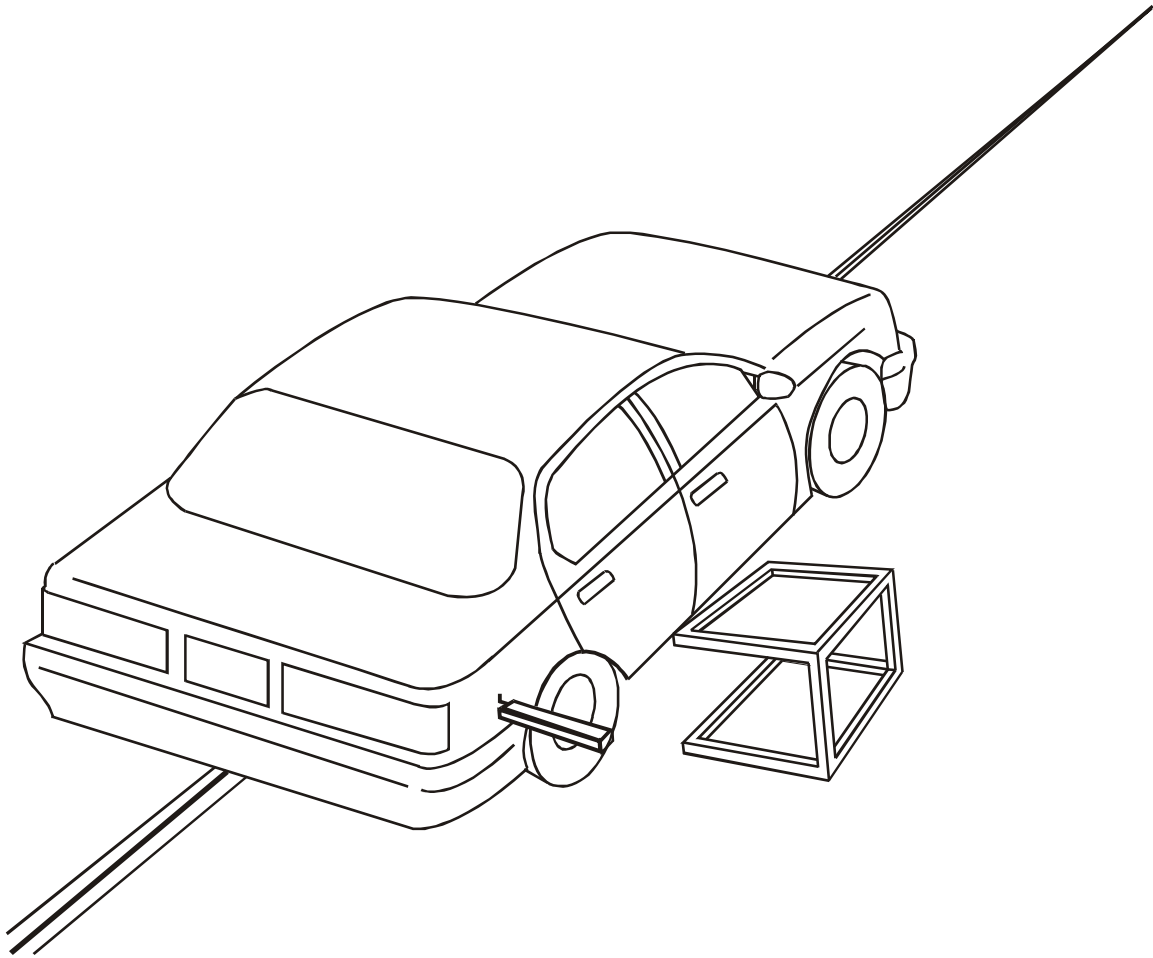
Figure 1 Impact Velocity Measurement System

The vane clears the final emitter/receiver pair approximately 50 millimeters before impact.

The emitter/receiver pairs have 610-millimeter spacing.
