**Vehicle Research and Test Center  
1993 Cadillac DeVille into  
Rear of a 1996 Jeep GC-ZJ  
TRC Inc. Test Number: 131107**

**Prepared By:  
Transportation Research Center Inc.  
10820 State Route 347  
East Liberty, OH 43319**

**Final Report  
November 2013 – January 2014**

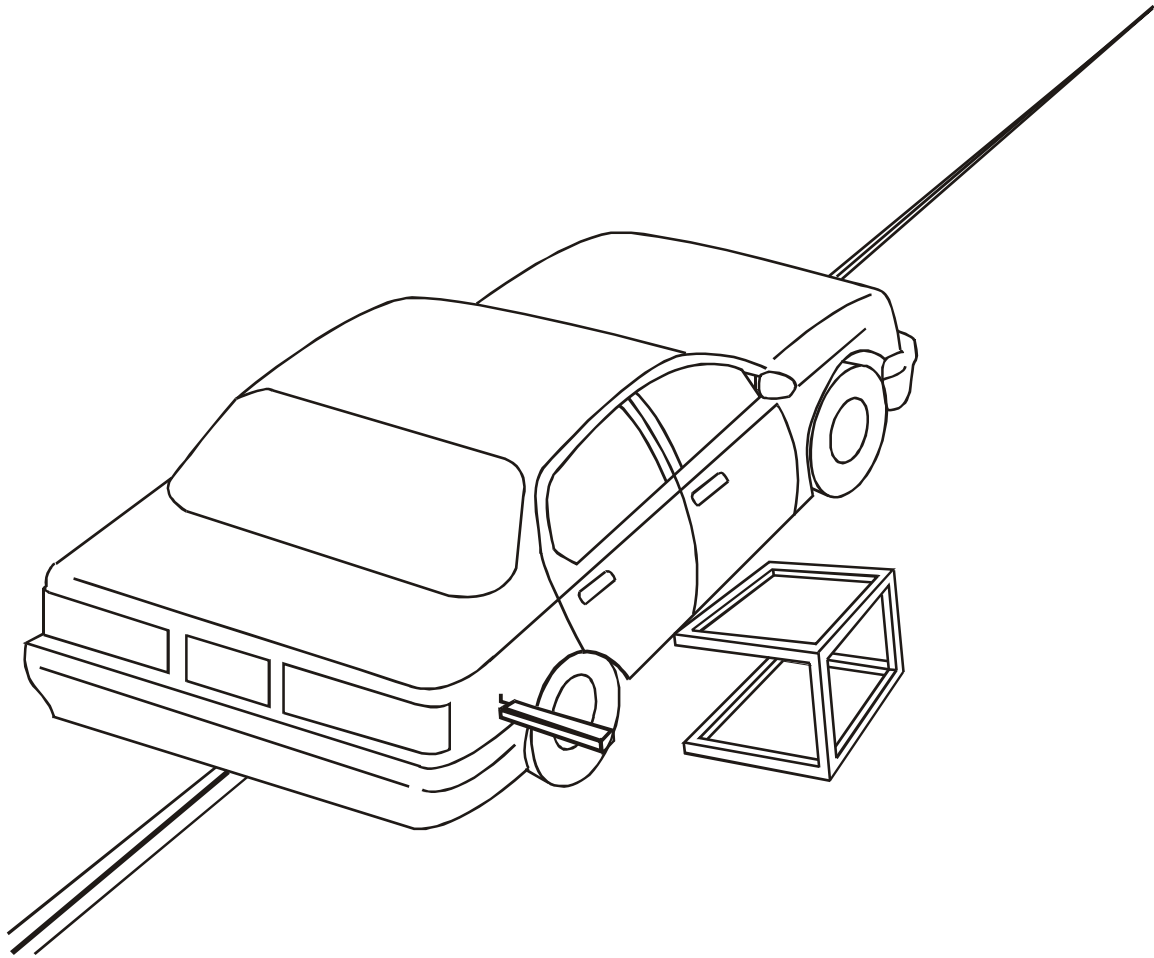
Figure 1 Impact Velocity Measurement System

The vane clears the final emitter/receiver pair approximately 50 millimeters before impact.

The emitter/receiver pairs have 610-millimeter spacing.

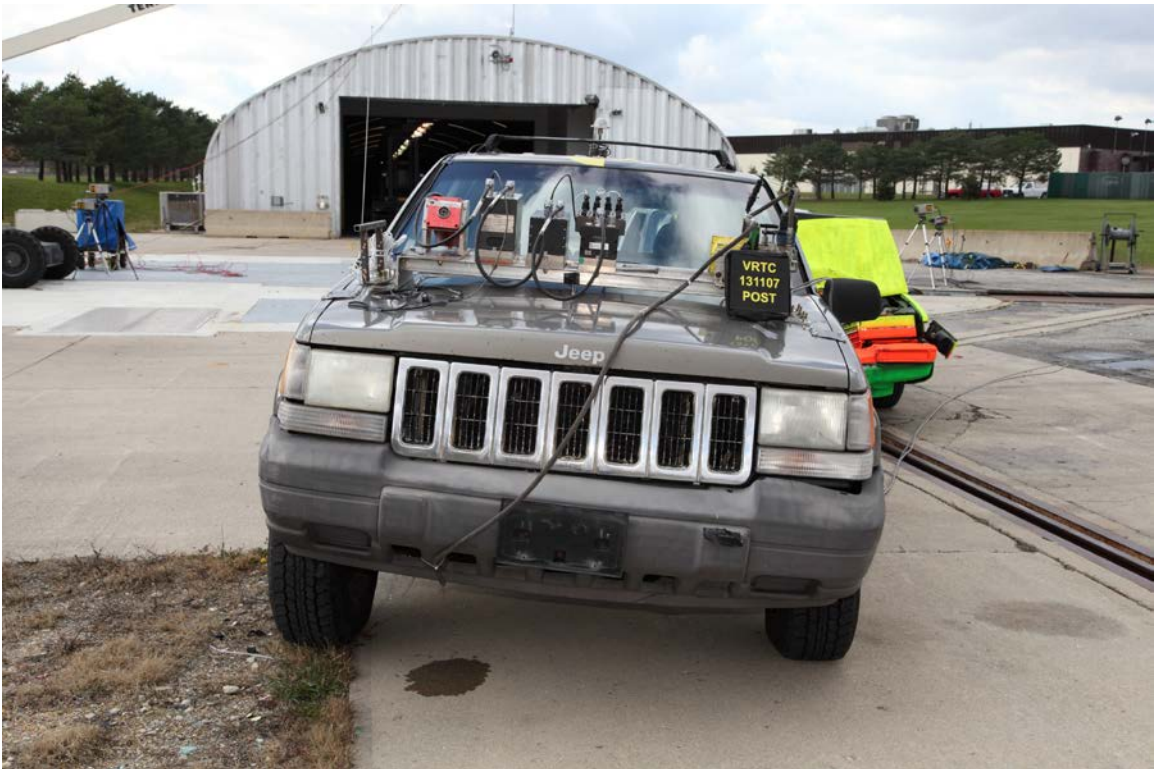
**Figure A-2 Post-Test Target Vehicle Frontal View**

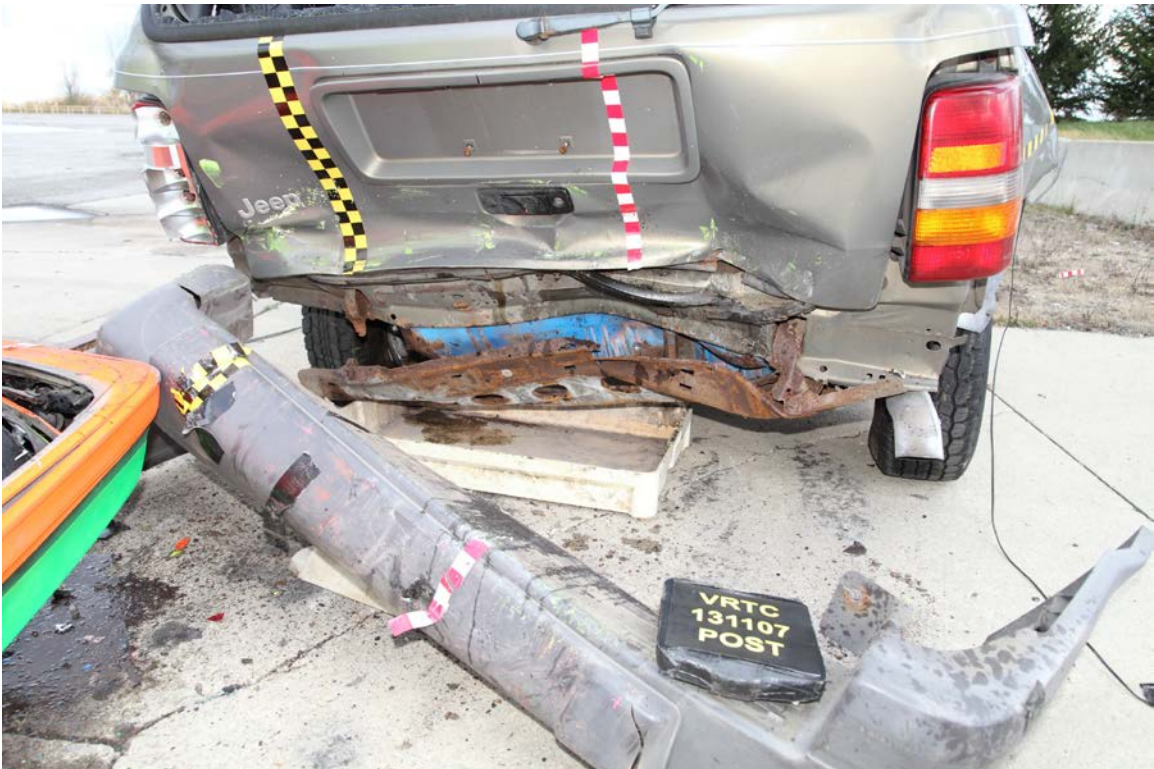
**Figure A-8 Post-Test Target Vehicle Rear View**

Pre-test	Post-test	Crush
L	1524		
C1	4430	3903	527
C2	4500	3987	513
C3	4475	4018	457
CL	4475	4031	444
C4	4477	4056	421
C5	4495	4126	369
C6	4430	4200	230

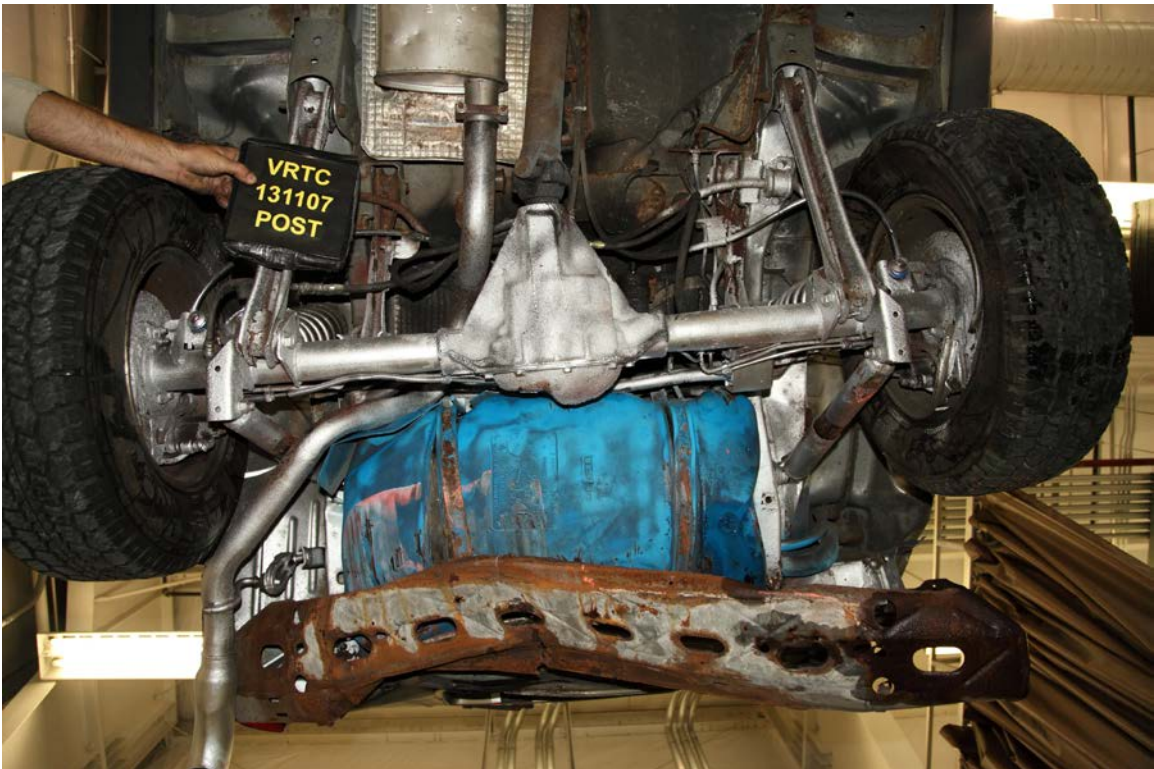
**Figure A-16 Post-Test Target Vehicle Rear Underbody View**

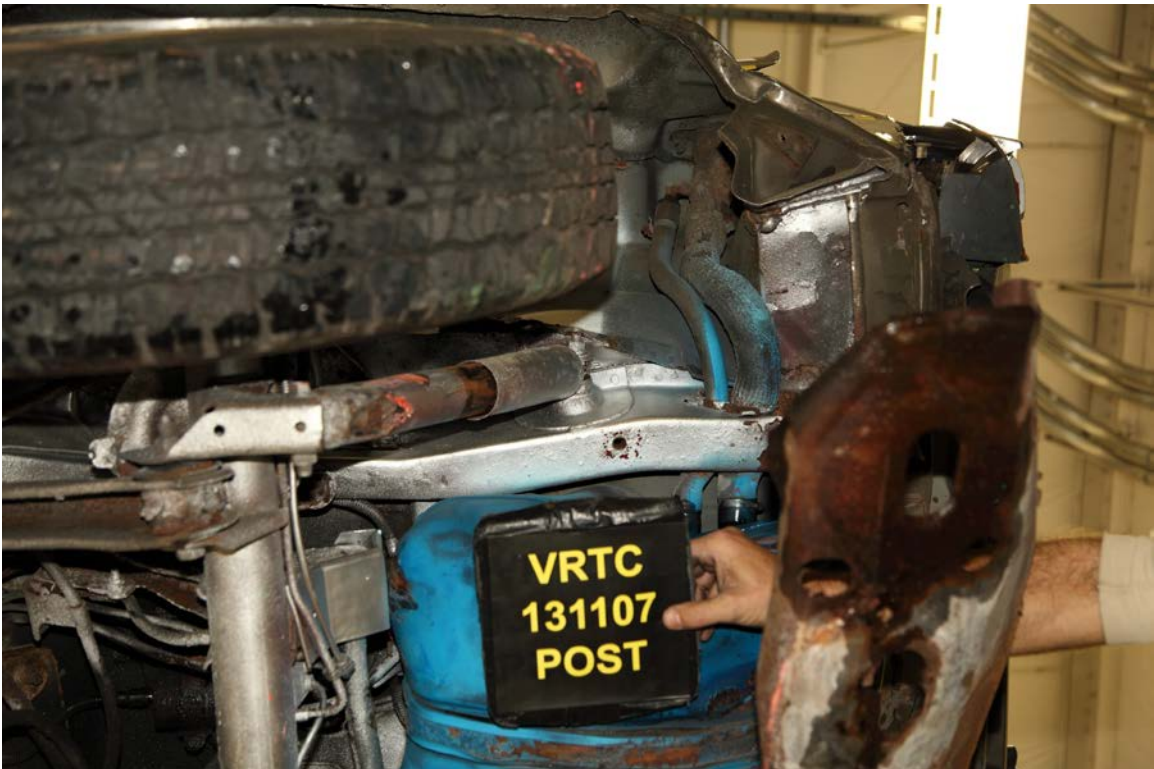
**Figure A-24 Post-Test Target Vehicle Fuel Filler Close-up View**

Fuel system fluid spillage location(s): Fuel filler neck tank connection.

<sup>1</sup> Rollover cancelled due to fuel filler neck disconnecting from fuel tank during the impact event.

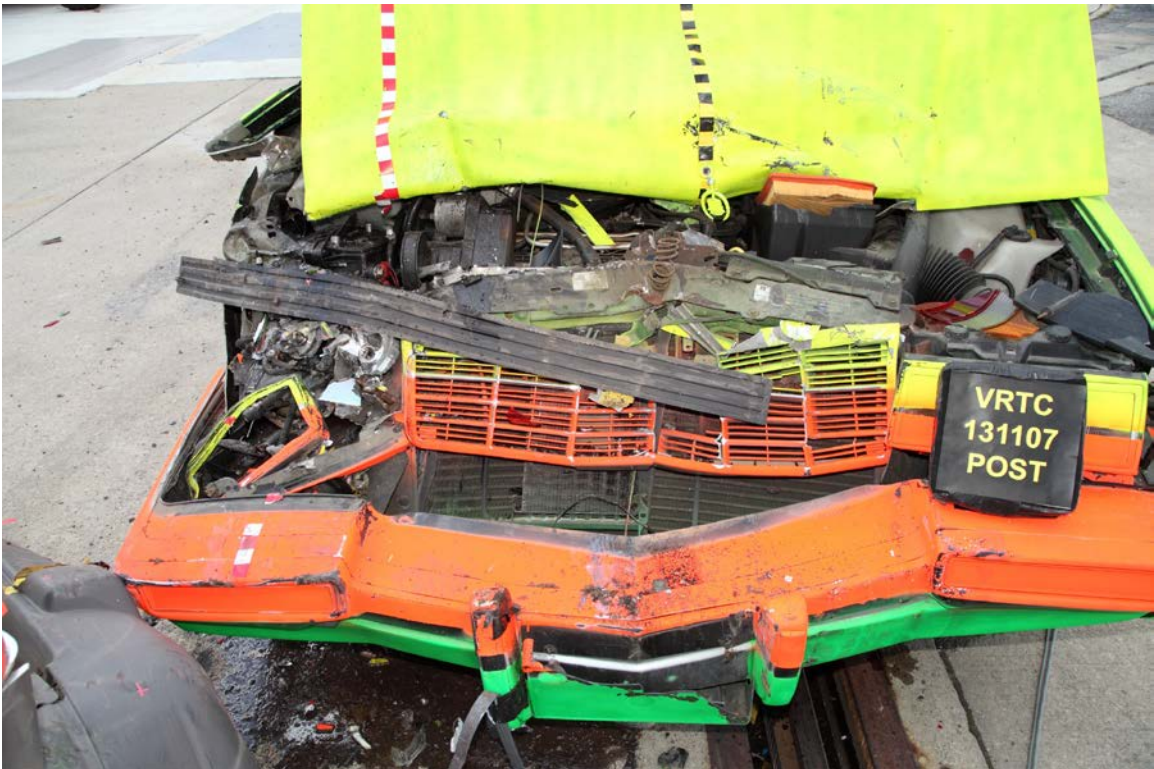
**Figure A-29 Post-Test Bullet Vehicle Frontal View**

Pre-test	Post-test	Crush
$L$	1524		
$C1$	5118	5106	12
$C2$	5138	5083	55
$C3$	5208	5168	40
$CL$	5208	5168	40
$C4$	5208	5178	30
$C5$	5138	5088	50
$C6$	5128	5099	29
