**Vehicle Research and Test Center  
1993 Cadillac DeVille into  
Rear of a 1996 Jeep Grand Cherokee Limited  
TRC Inc. Test Number: 131121**

**Prepared By:  
Transportation Research Center Inc.  
10820 State Route 347  
East Liberty, OH 43319**

**Final Report  
November 2013 – January 2014**

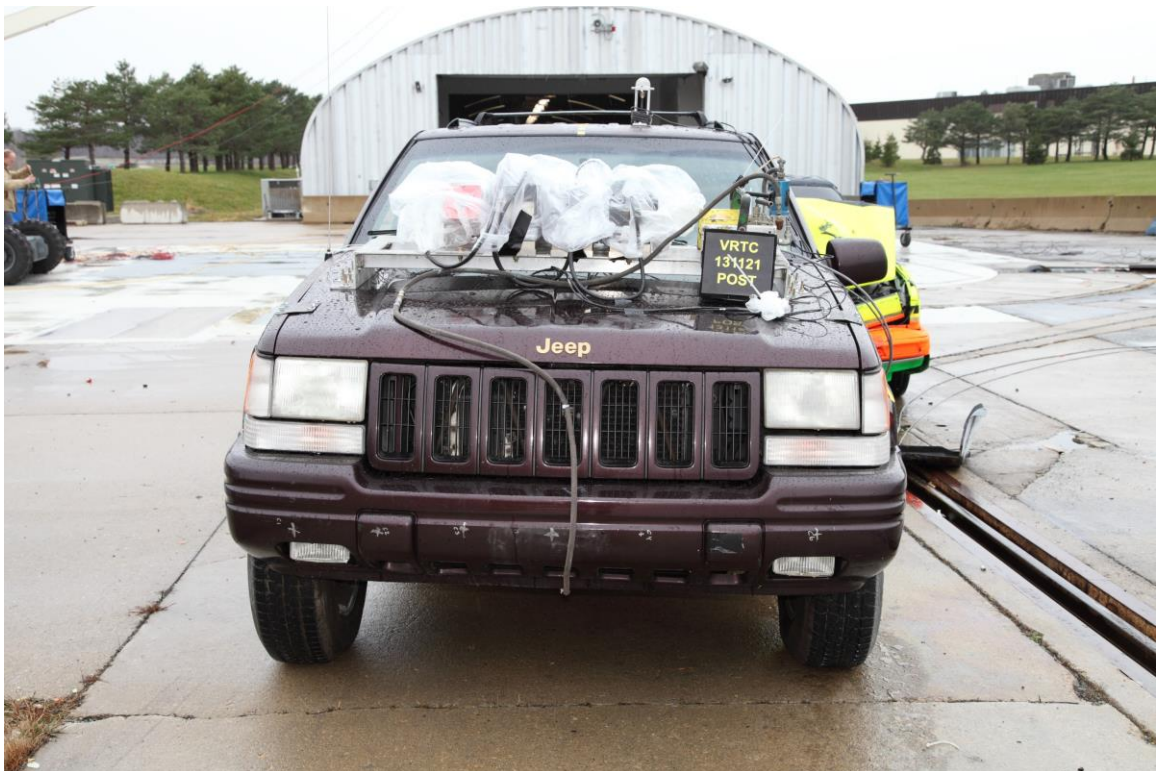
**Figure A-2 Post-Test Target Vehicle Frontal View**

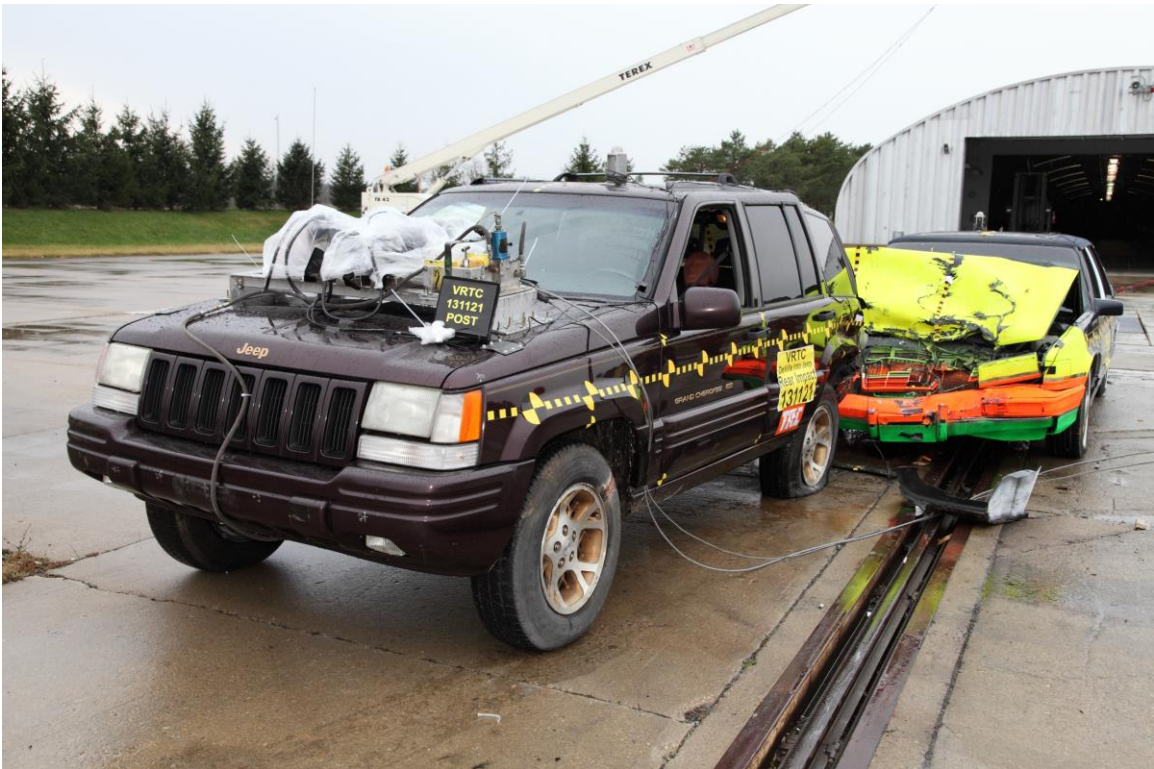
**Figure A-4 Post-Test Target Vehicle Left Front 3/4 View**

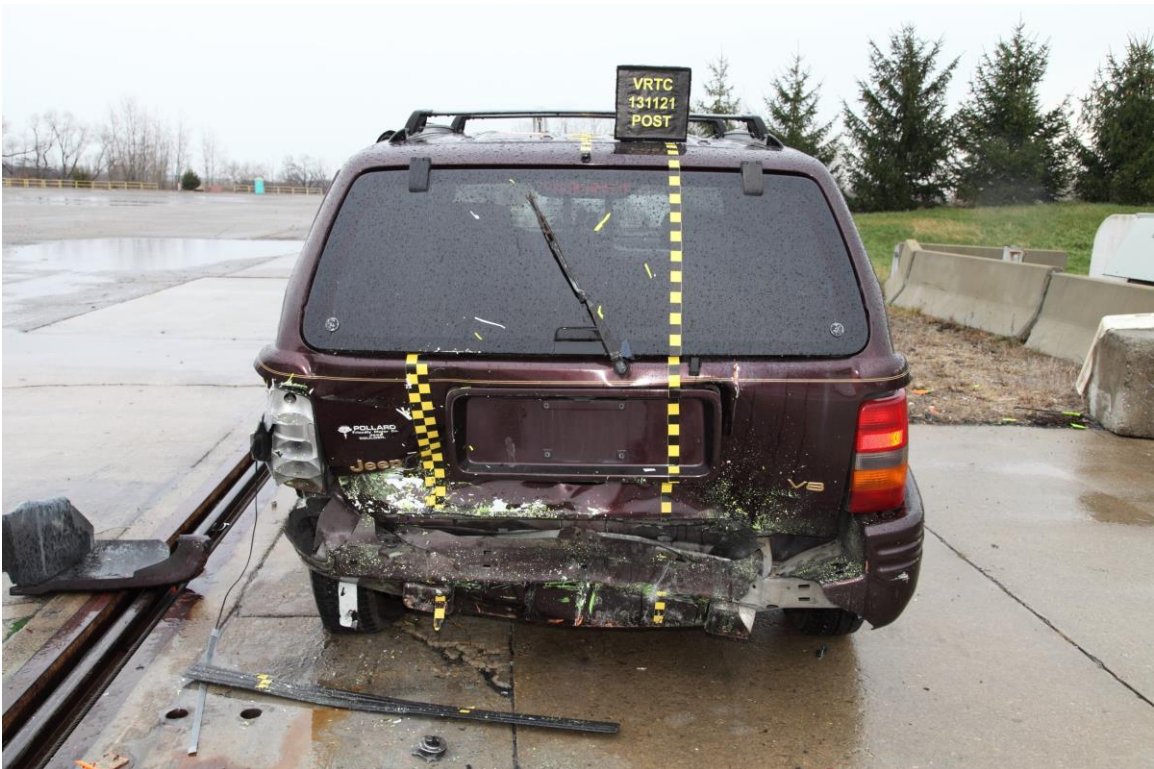
**Figure A-8 Post-Test Target Vehicle Rear View**

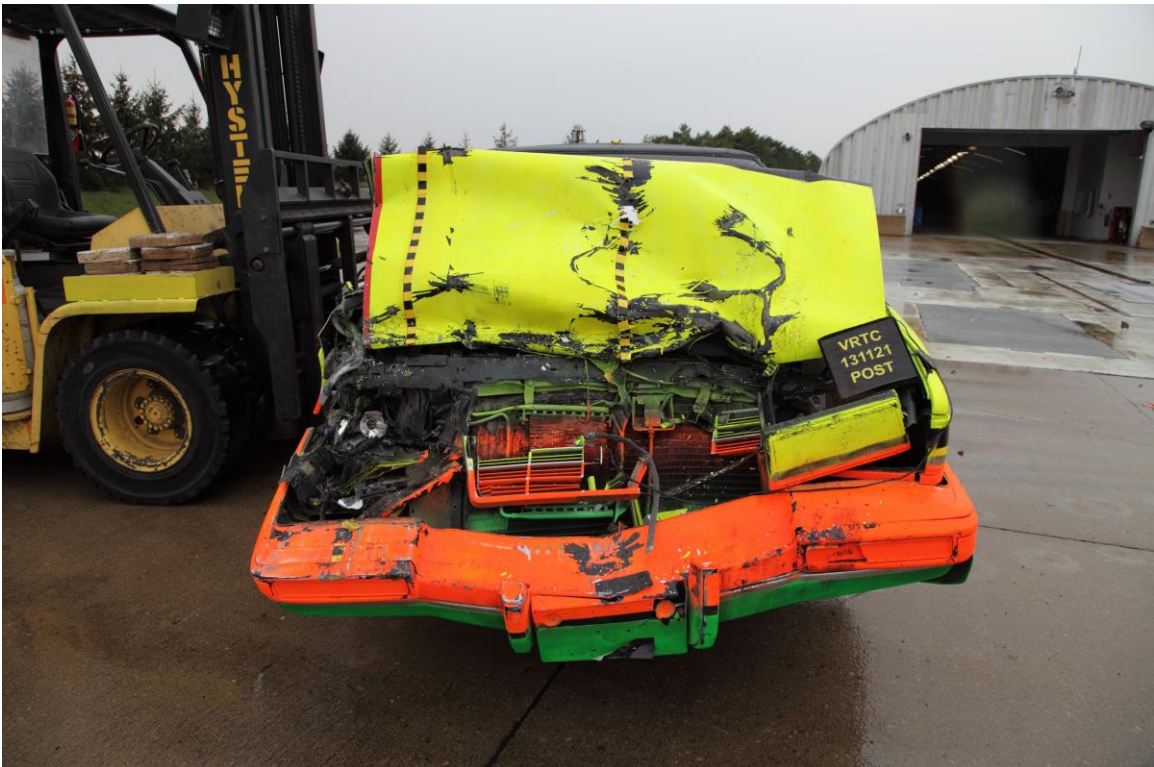
**Figure A-29 Post-Test Bullet Vehicle Frontal View**

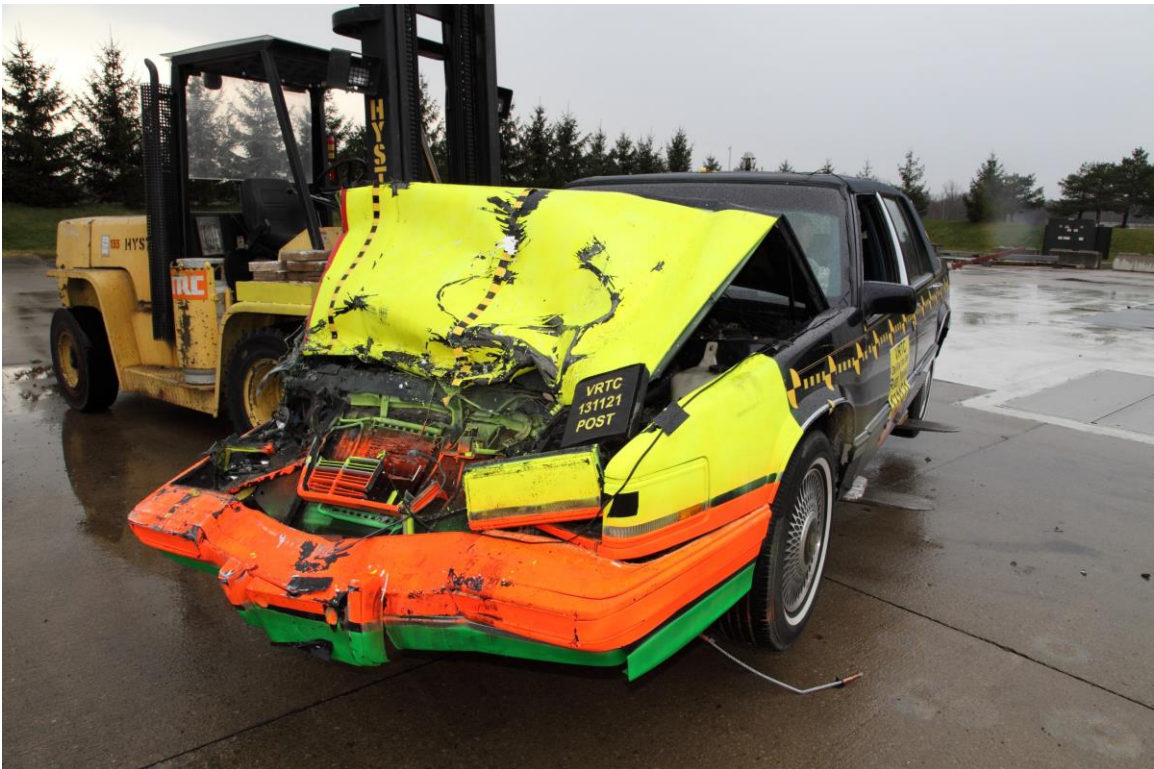
**Figure A-31 Post-Test Bullet Vehicle Left Front 3/4 View**

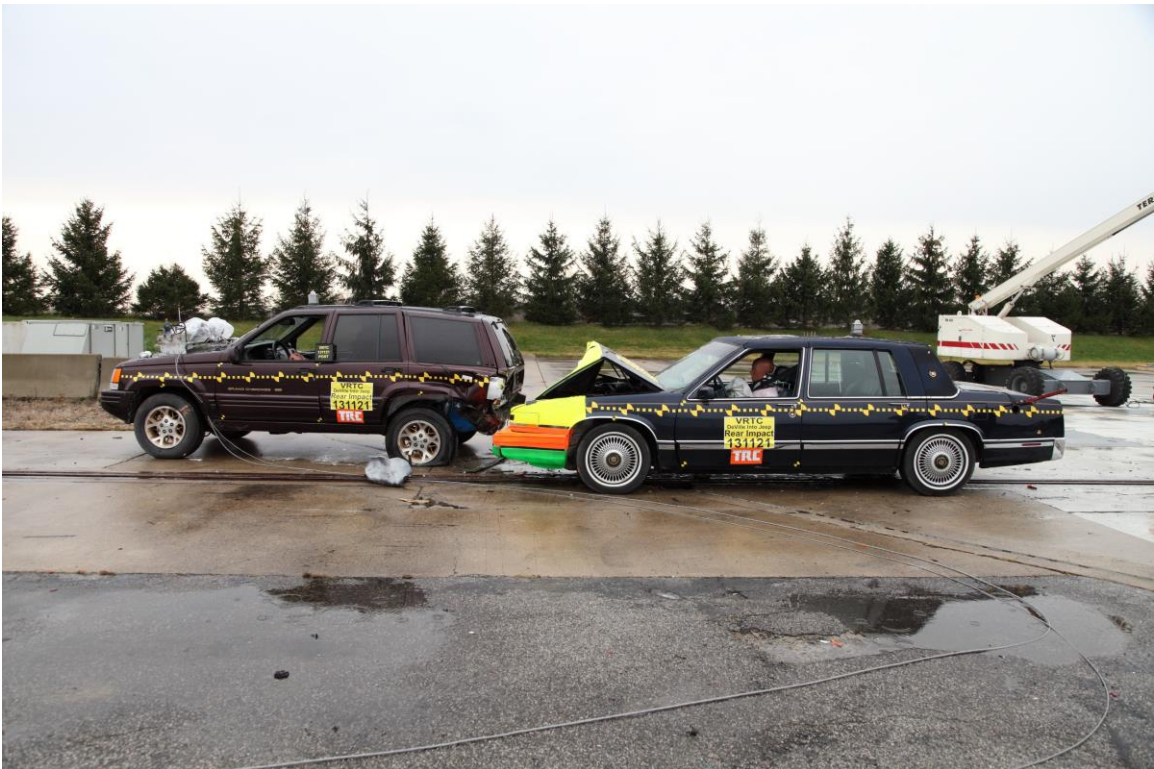
**Figure A-53 Post-Test Bullet and Target Vehicles Overall Left Side View**

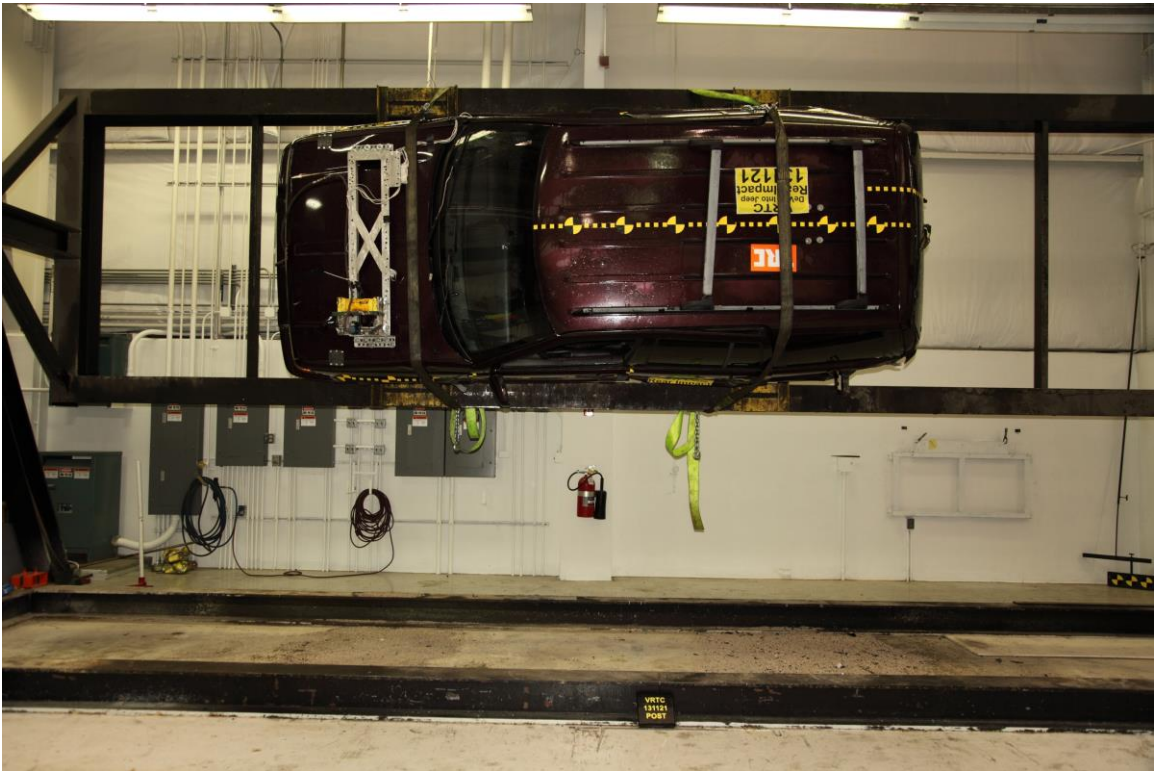
**Figure A-59 Target Vehicle at 90° on Static Rollover Device**

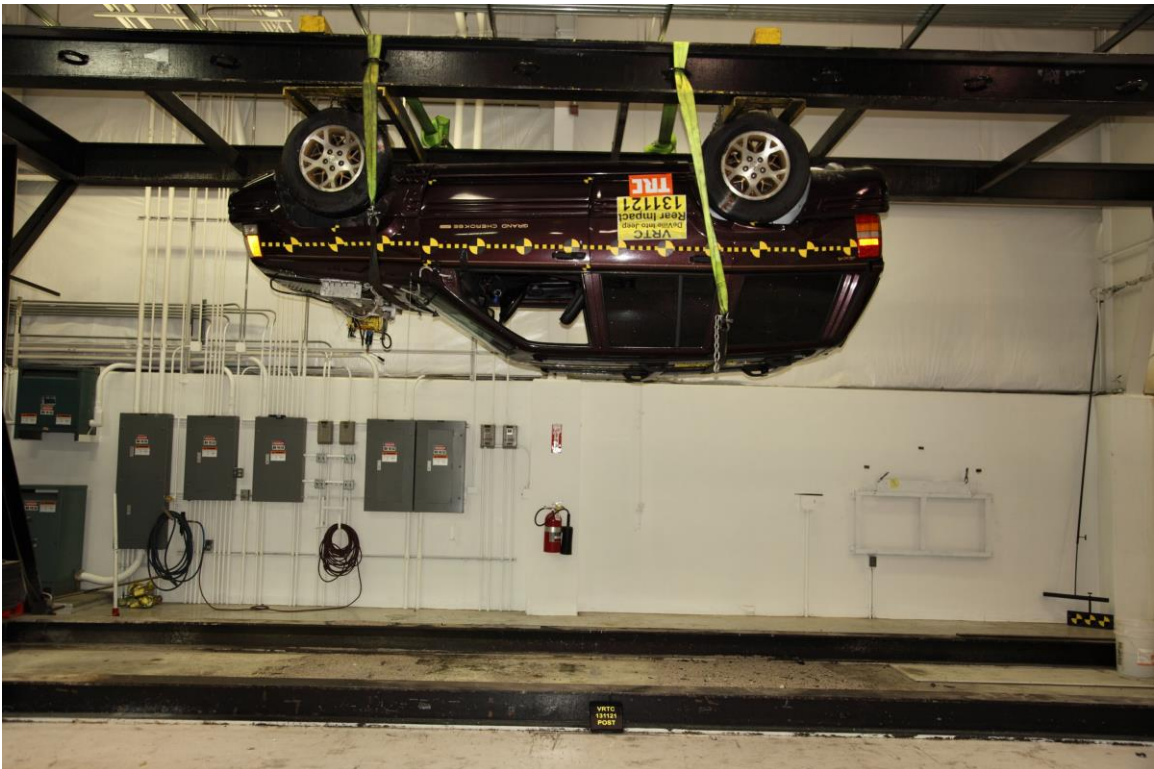
**Figure A-60 Target Vehicle at 180° on Static Rollover Device**

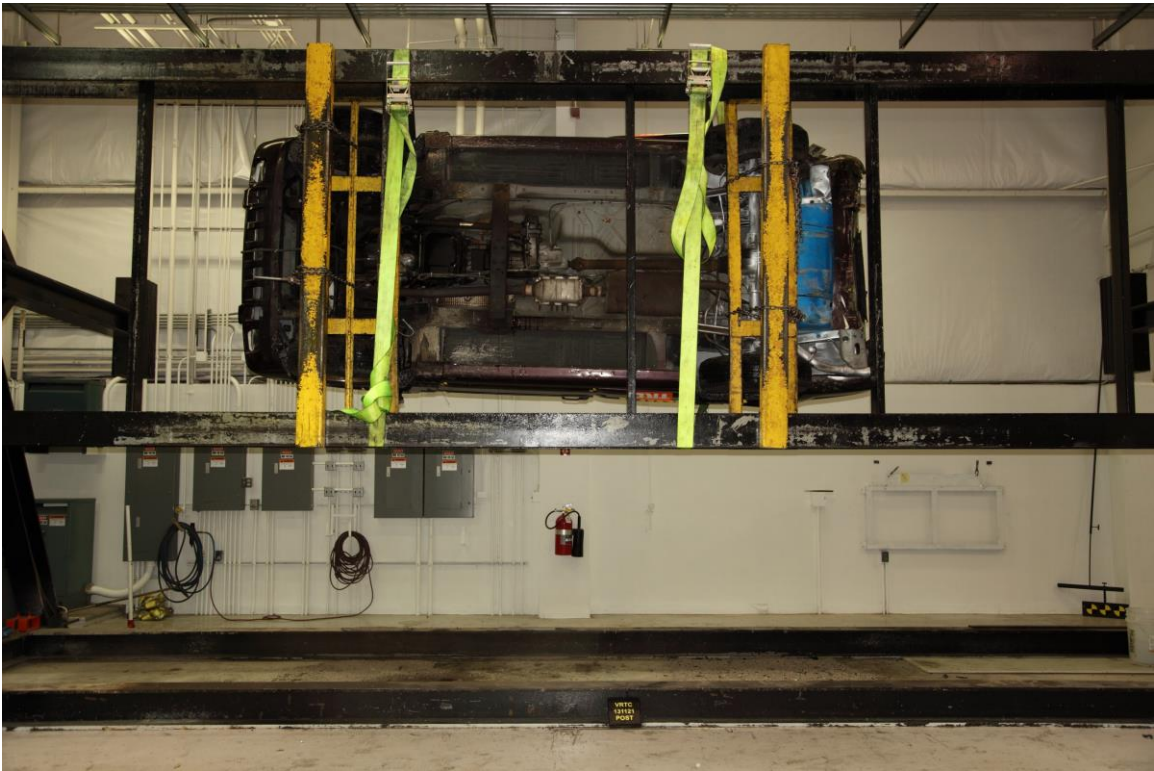
**Figure A-61 Target Vehicle at 270° on Static Rollover Device**
