**Vehicle Research and Test Center
1993 Cadillac DeVille into
Rear of a 1996 Jeep Grand Cherokee Laredo
TRC Inc. Test Number: 131127**

**Prepared By:
Transportation Research Center Inc.
10820 State Route 347
East Liberty, OH 43319**

**Final Report
November - December 2013**

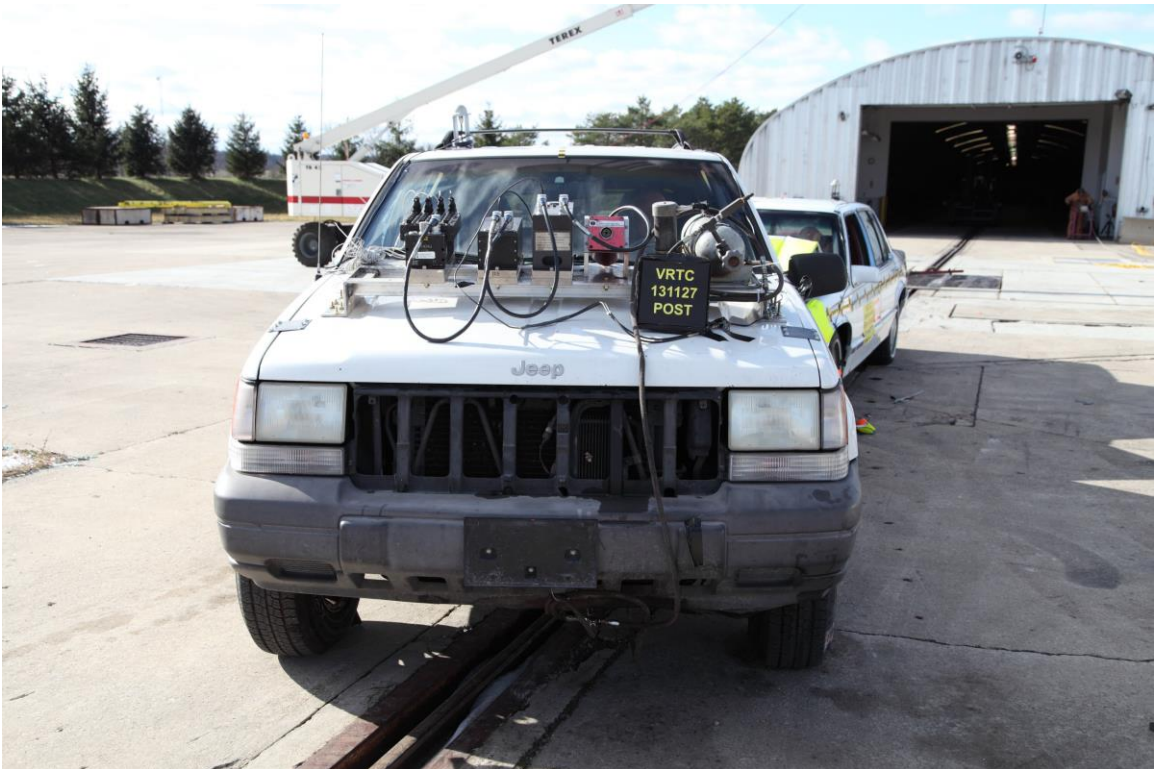
Figure A-2 Post-Test Target Vehicle Frontal View

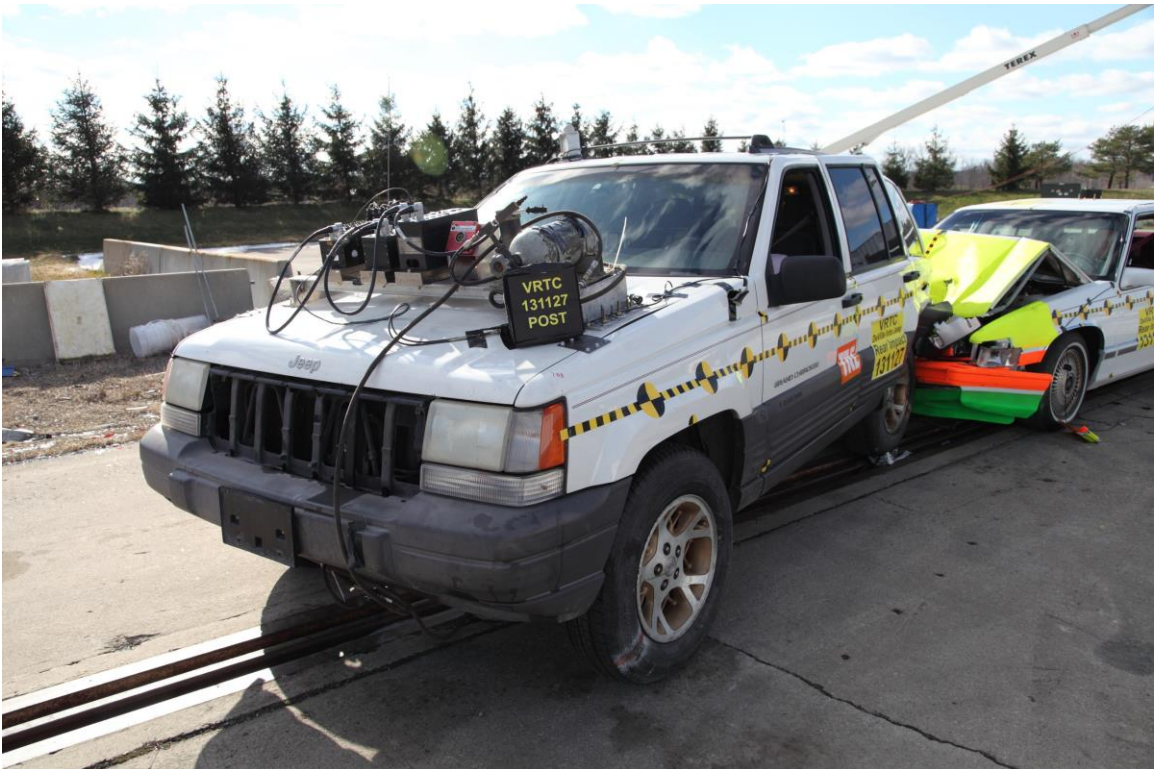
Figure A-4 Post-Test Target Vehicle Left Front 3/4 View

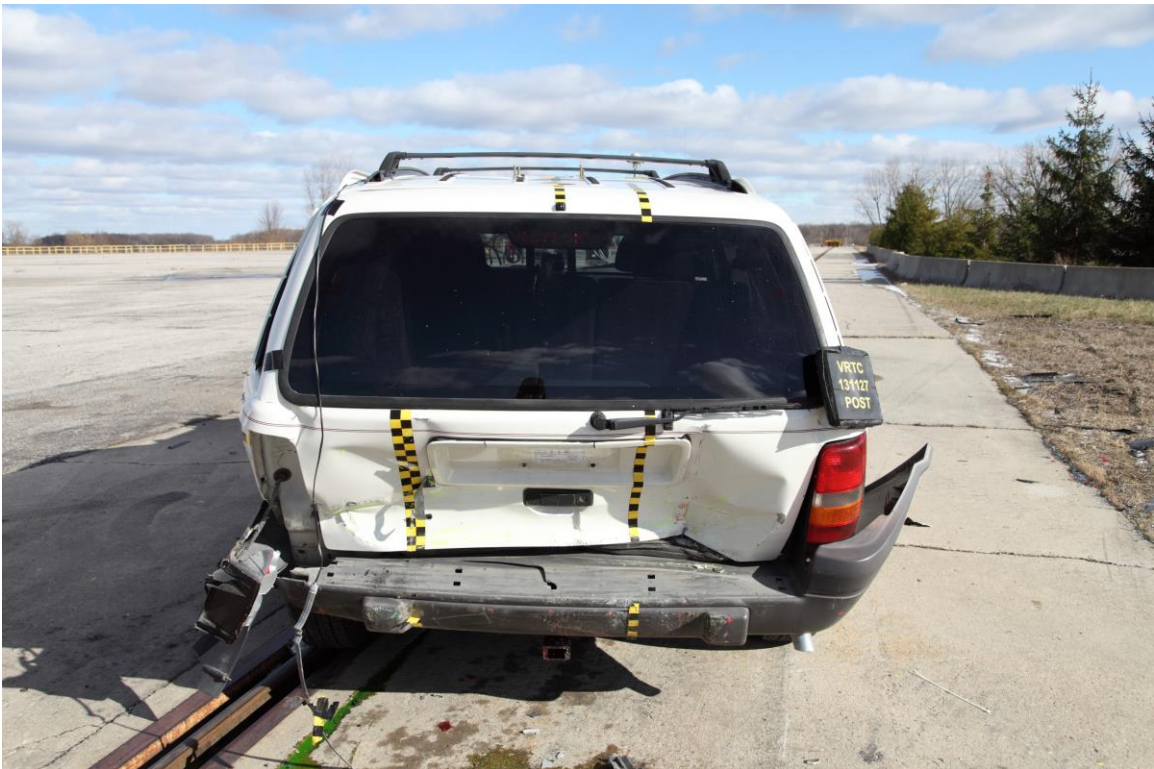
Figure A-8 Post-Test Target Vehicle Rear View

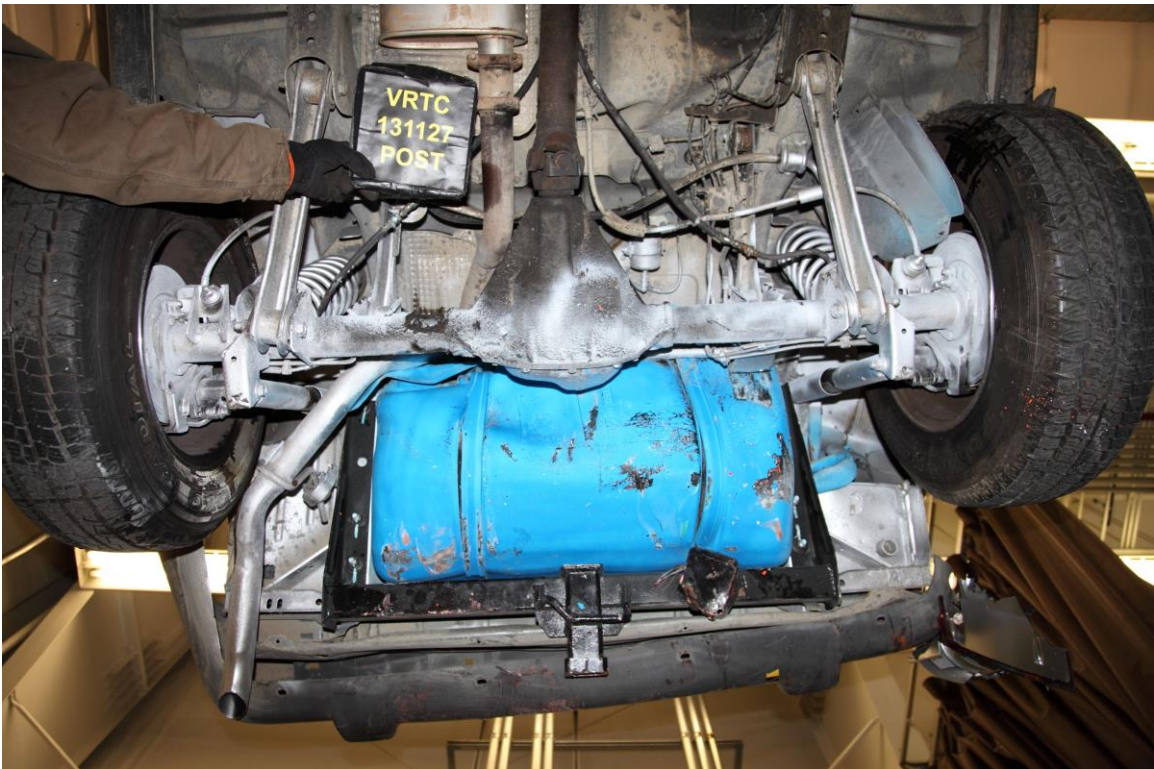
Figure A-16 Post-Test Target Vehicle Rear Underbody View

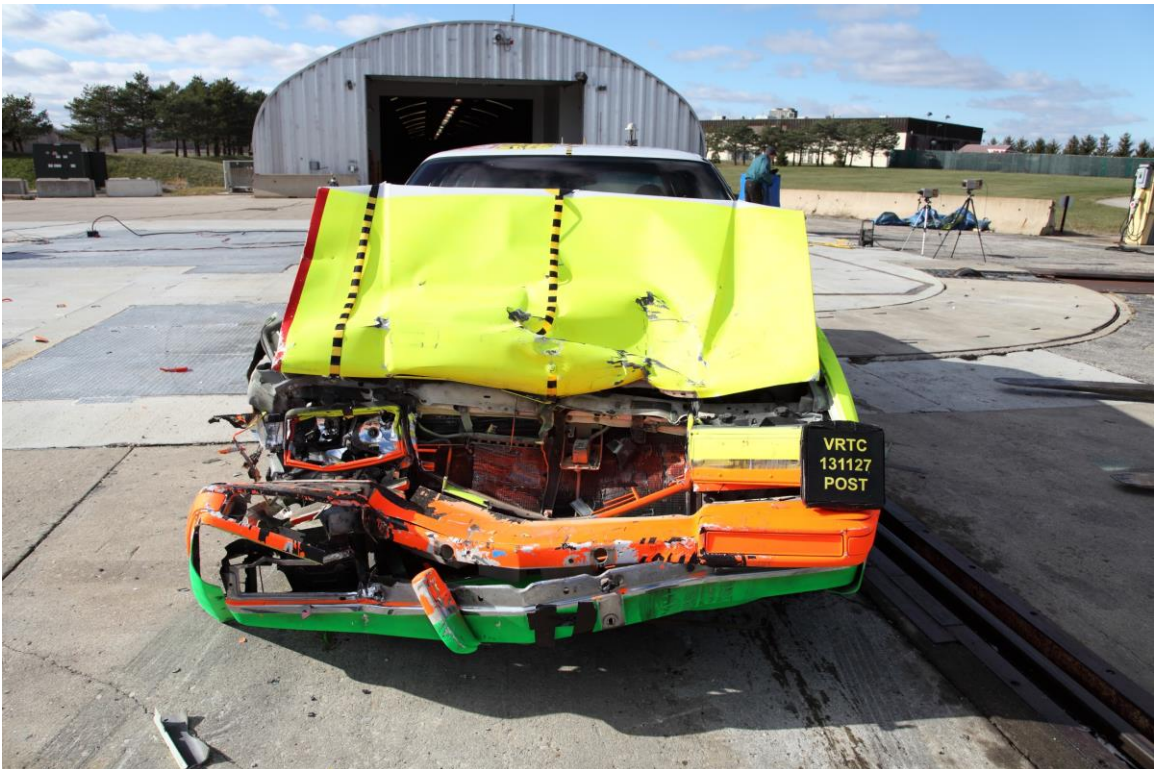
Figure A-29 Post-Test Bullet Vehicle Frontal View

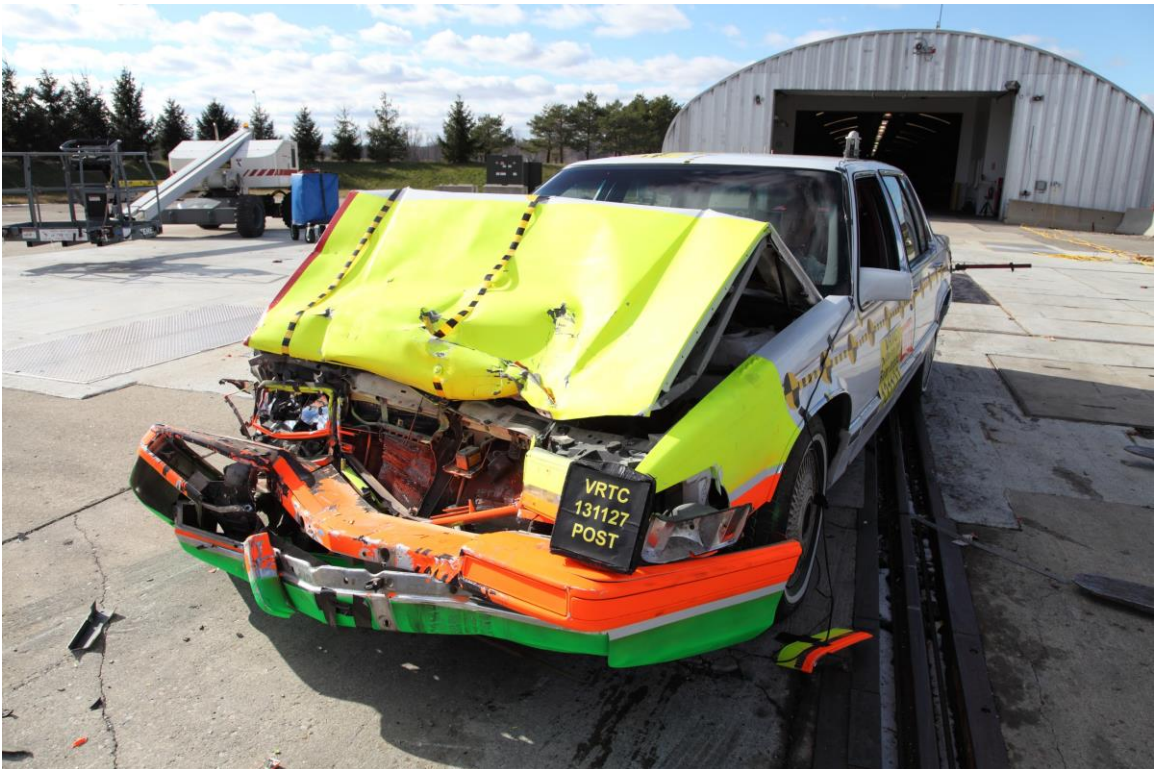
Figure A-31 Post-Test Bullet Vehicle Left Front 3/4 View

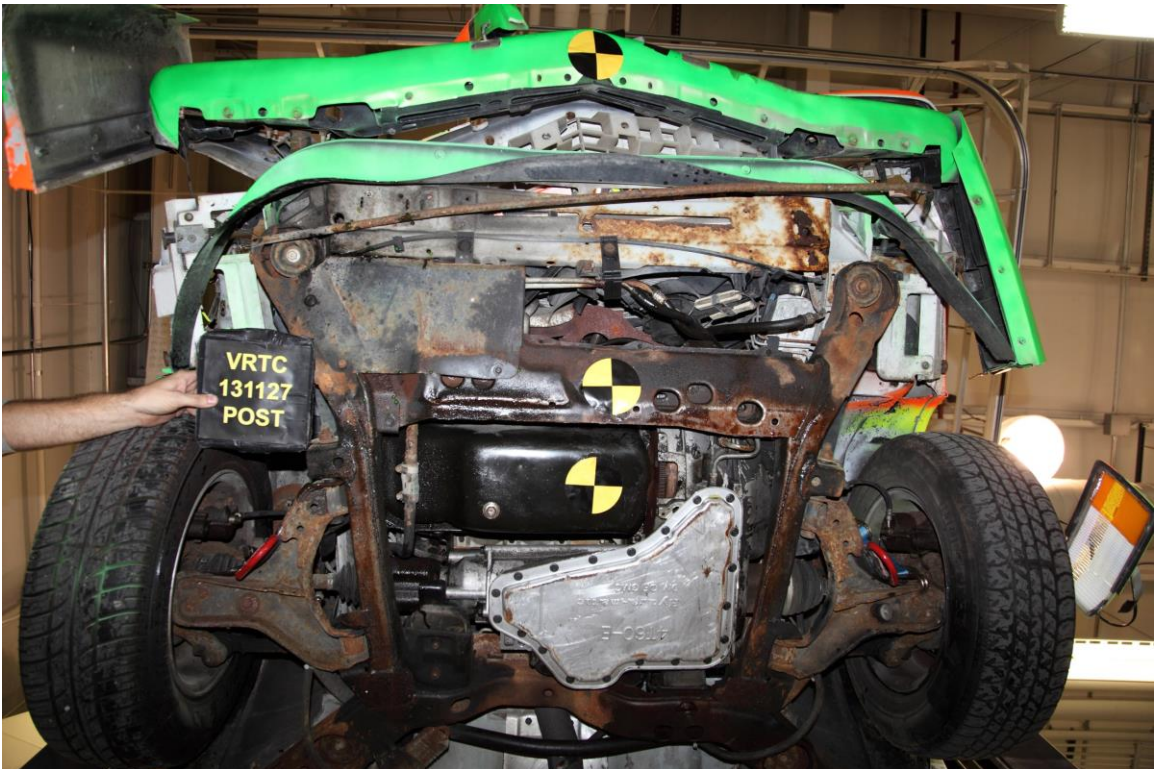
Figure A-41 Post-Test Bullet Vehicle Front Underbody View

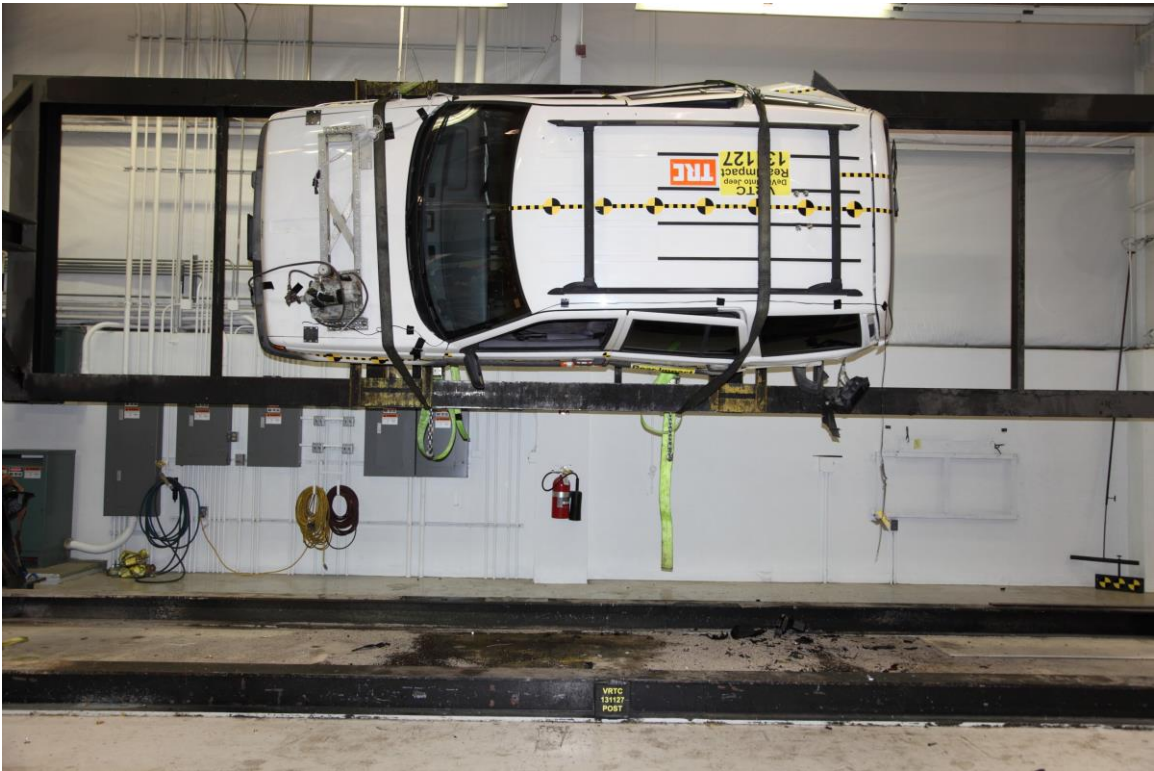
Figure A-59 Target Vehicle at 90° on Static Rollover Device

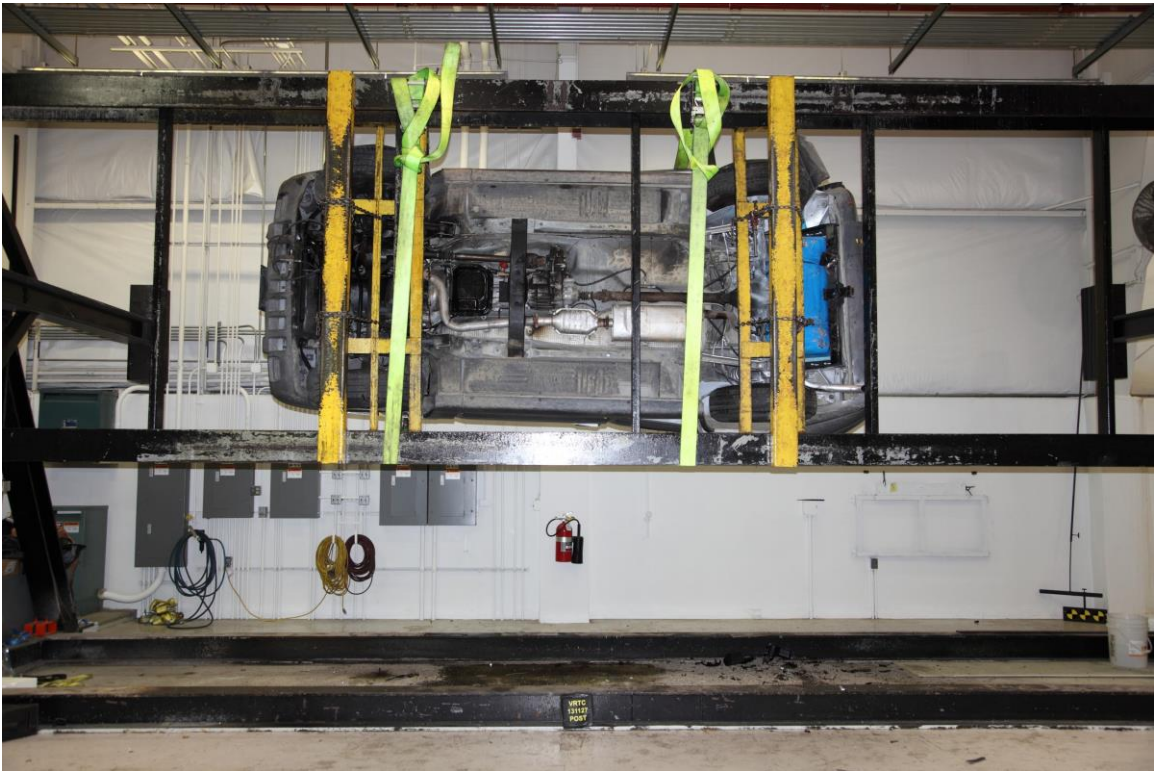
Figure A-61 Target Vehicle at 270° on Static Rollover Device
