**Vehicle Research and Test Center  
1993 Cadillac DeVille into  
Rear of a 1996 Jeep Grand Cherokee Limited  
TRC Inc. Test Number: 131204**

**Prepared By:  
Transportation Research Center Inc.  
10820 State Route 347  
East Liberty, OH 43319**

**Final Report  
December 2013**

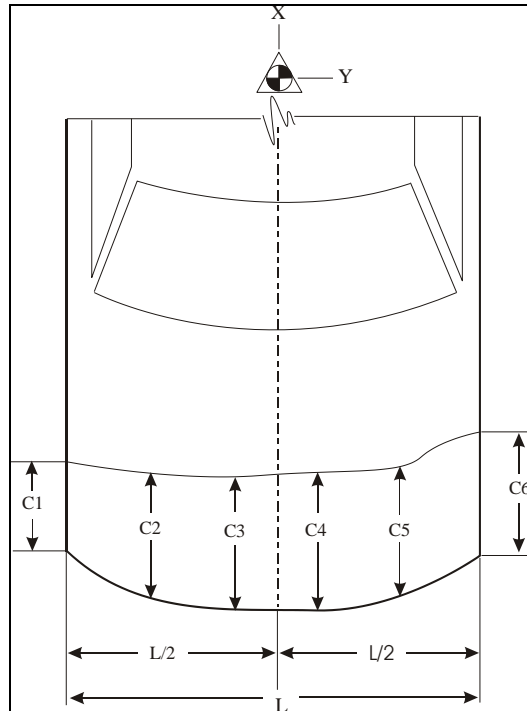
Figure 2 Target Vehicle Crush

Notes: L is pre-test length of contact surface.  
 C1 through C6 are spaced equally apart.  
 CL is vehicle centerline.

Pre-test	Post-test	Crush
L	1524	N/A	N/A
C1	4423	4065	358
C2	4483	4105	378
C3	4468	4155	313
CL	4468	4180	288
C4	4468	4195	273
C5	4485	4232	253
C6	4428	4227	201

X13	Front Surface of Vehicle to Bottom of " A " Post on Left Side	1448	--- <sup>1</sup>	--- <sup>1</sup>
X14	Front Surface of Vehicle to Firewall-Right Side	1068	1080	-12
X15	Front Surface of Vehicle to Firewall-Left Side	1108	1120	-12
X16	Rear Surface of Vehicle to Steering Wheel Center	1909	1930	-21
X17	Center of Steering Column to " A " Post	292	--- <sup>1</sup>	--- <sup>1</sup>
X18	Center of Steering Column to Headliner	435	450	-15
X19	Front Surface of Vehicle to Right Side of Rear Bumper	4428	4227	201
X20	Front Surface of Vehicle to Left Side of Rear Bumper	4423	4065	358
X21	Length of Engine Block	700	700	0

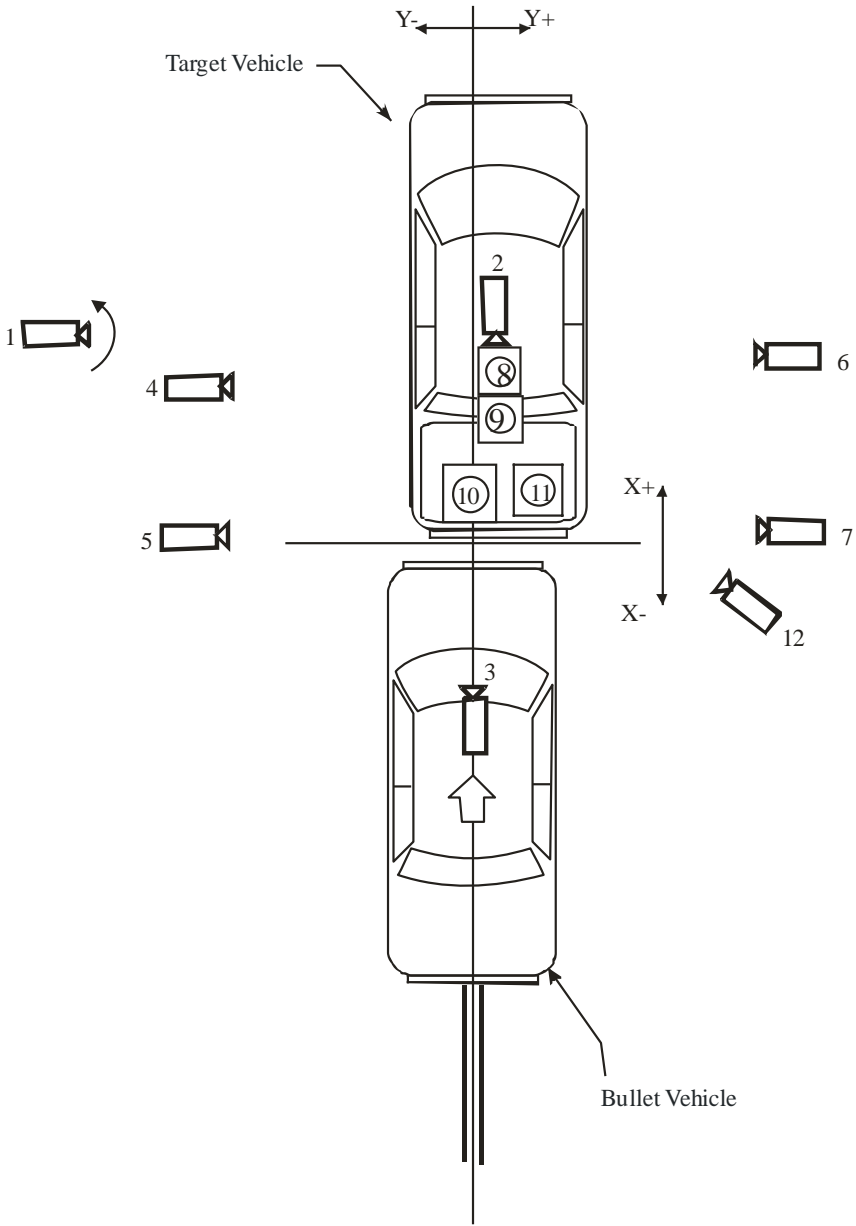
Figure 5 Camera Positions

Camera Number	Location	Location, mm			Angle (deg.)	Lens (mm)	Speed (fps)
		X	Y	Z			
1	Realtime Panning	N/A	N/A	N/A	N/A	Zoom	30
2	Realtime onboard target vehicle	N/A	N/A	N/A	N/A	Zoom	30
3	Realtime onboard bullet vehicle	N/A	N/A	N/A	N/A	Zoom	30
4	Left side target vehicle	1265	-6147	-1336	-1.5°	8.5	1000
5	Left side impact	0	-6325	-858	-1.1°	16	1000
6	Right side target vehicle	1490	6706	-1280	-3.4°	8.5	1000
7	Right side impact	460	6584	-964	0.1°	16	1000
8	Overhead	1040	710	-5334	N/A	8.5	1000
9	Pit wide	931	110	2907	85.3°	16	1000
10	Pit medium	575	210	2699	88.1°	25	N/A <sup>1</sup>
11	Pit tight	471	-50	2990	89.1°	75	N/A <sup>1</sup>
12	Right ground level tight impact	-2038	3353	-65	10.2°	50	N/A <sup>1</sup>

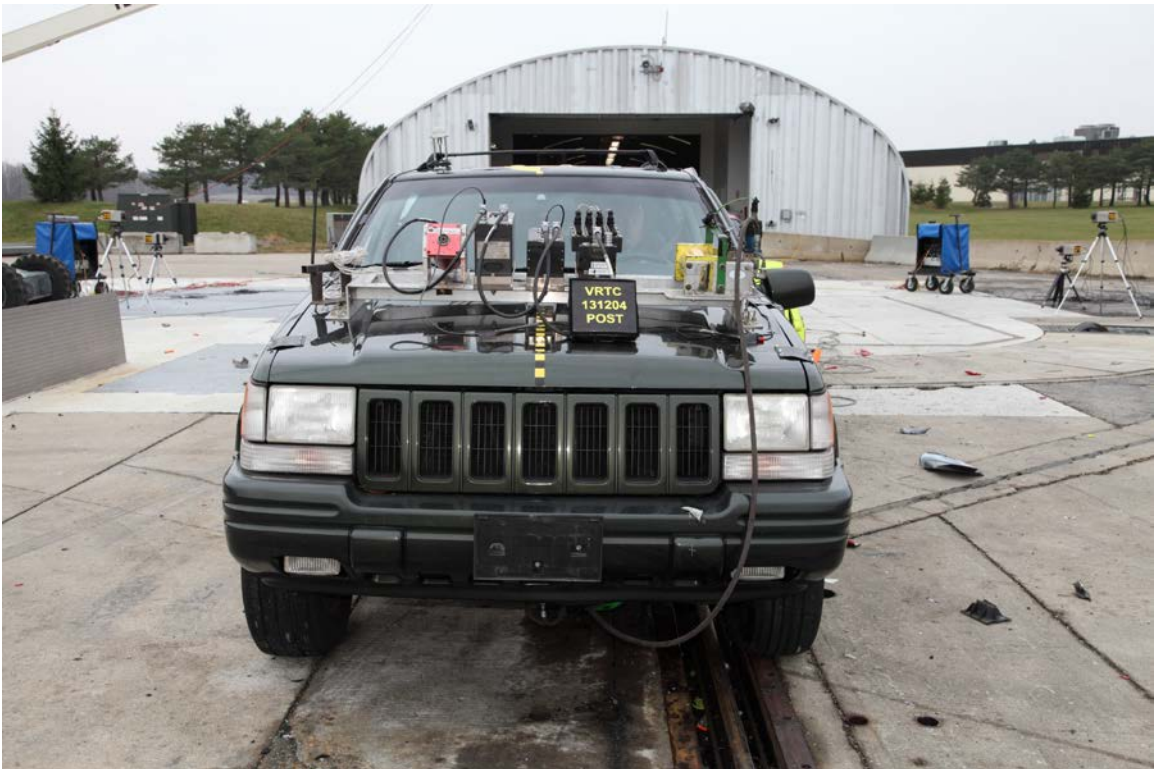
**Figure A-2 Post-Test Target Vehicle Frontal View**

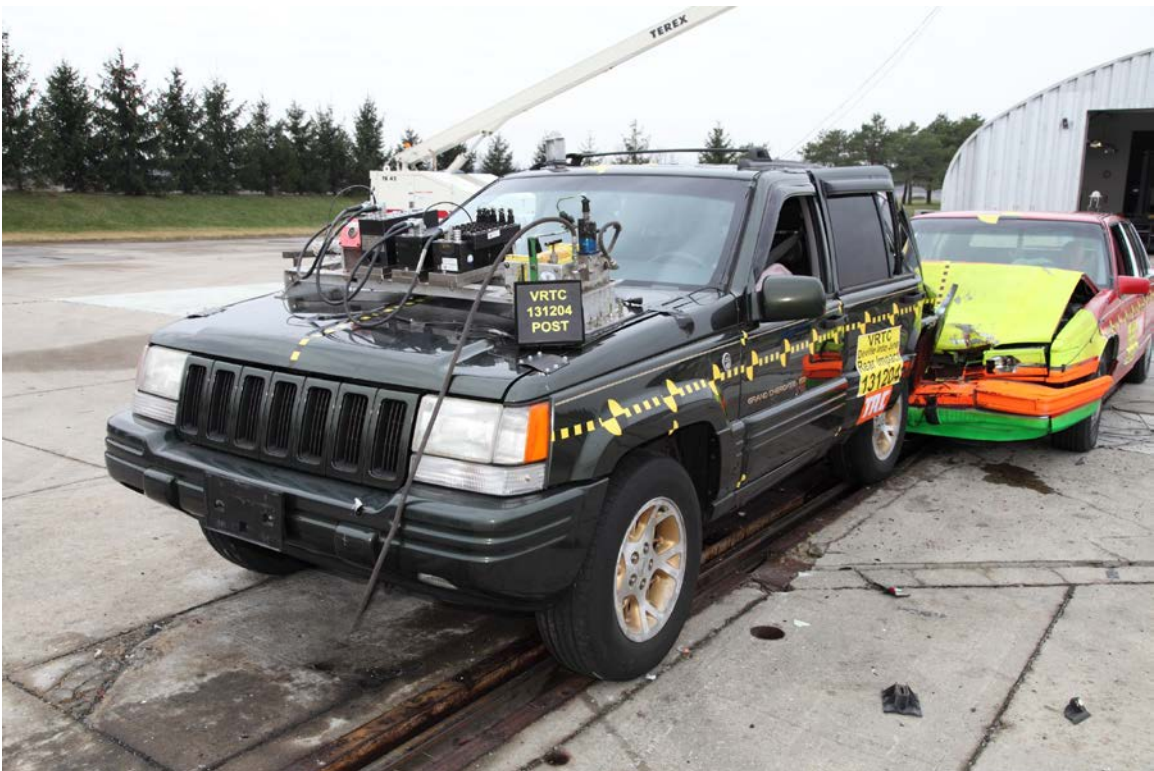
**Figure A-4 Post-Test Target Vehicle Left Front 3/4 View**

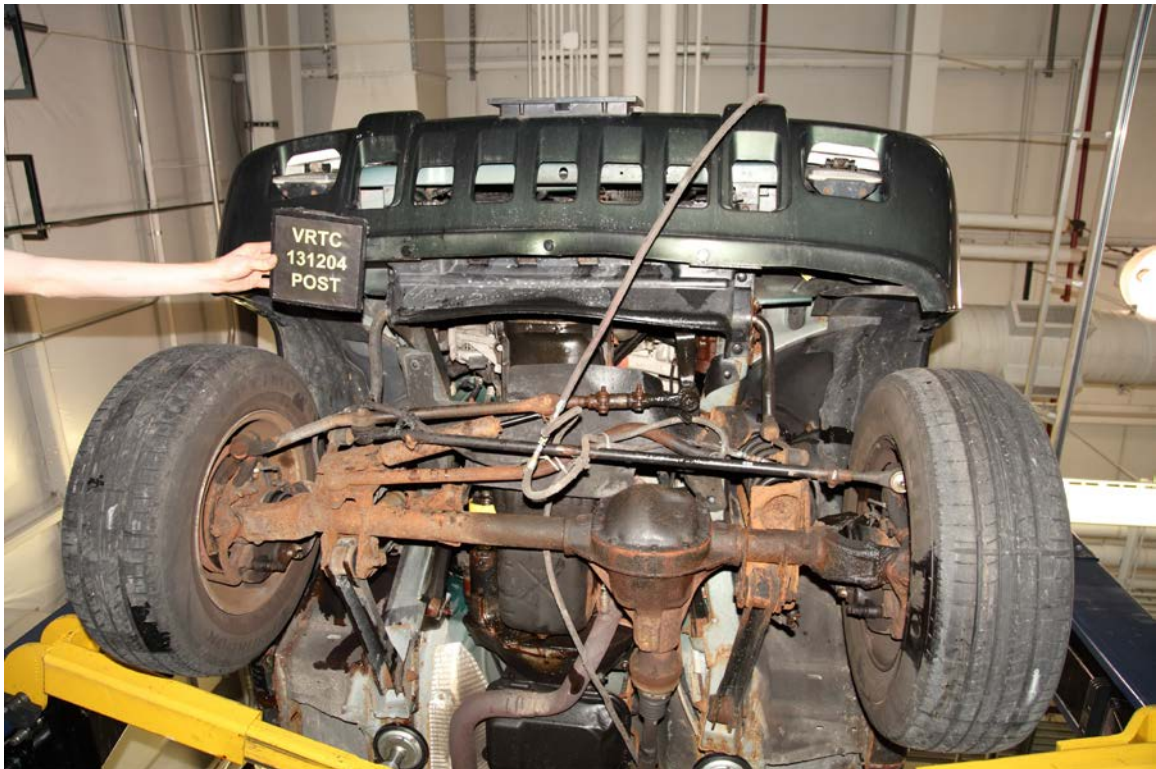
**Figure A-14 Post-Test Target Vehicle Front Underbody View**

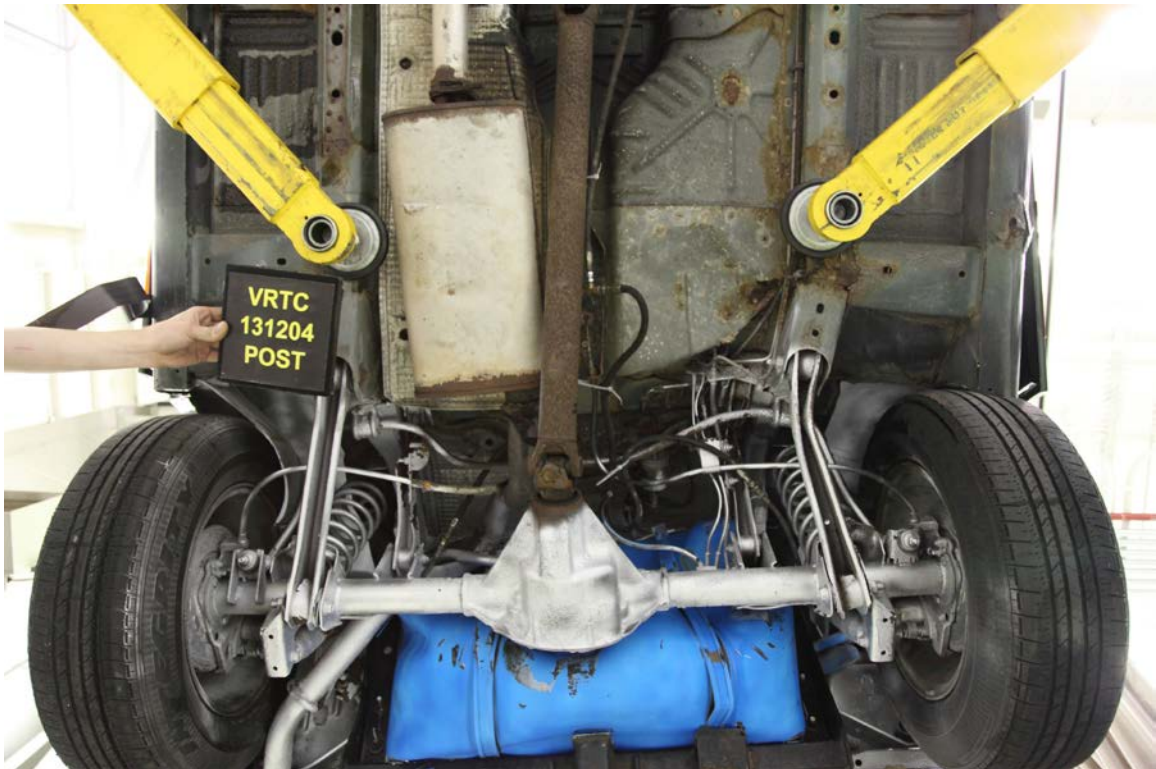
**Figure A-16 Post-Test Target Vehicle Rear Underbody View**

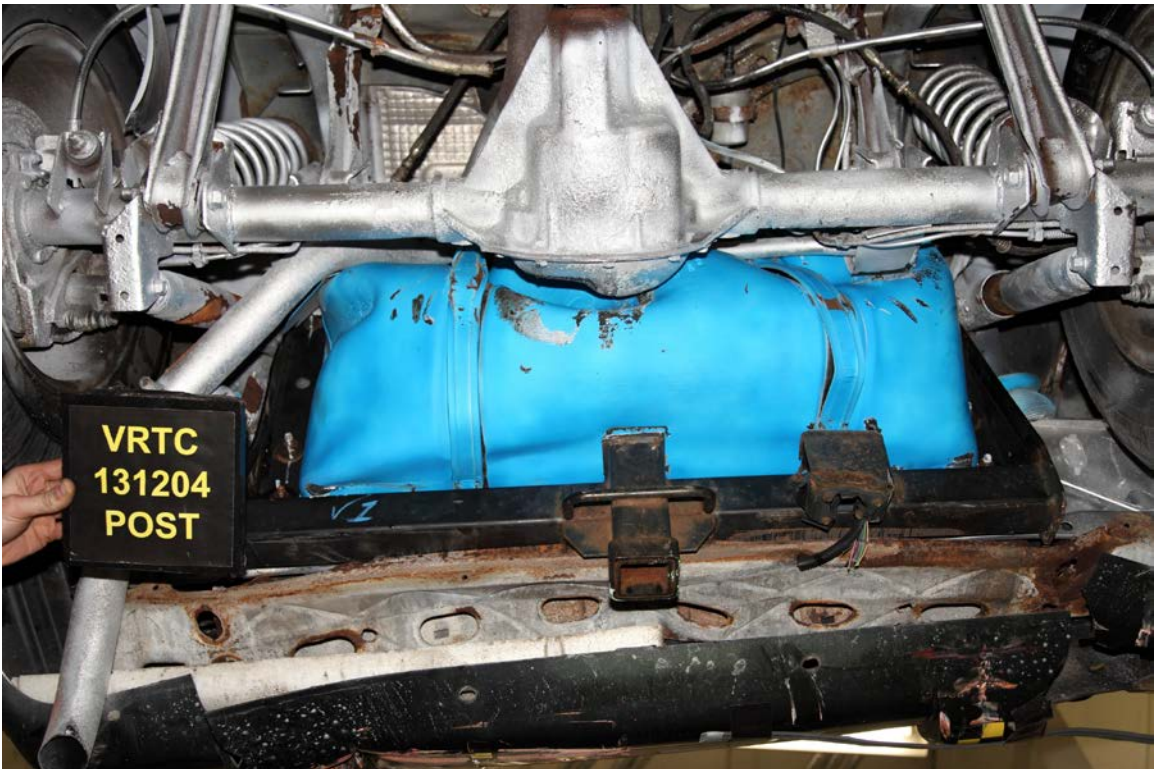
Figure A-20 Post-Test Target Vehicle Fuel Tank Close-up View

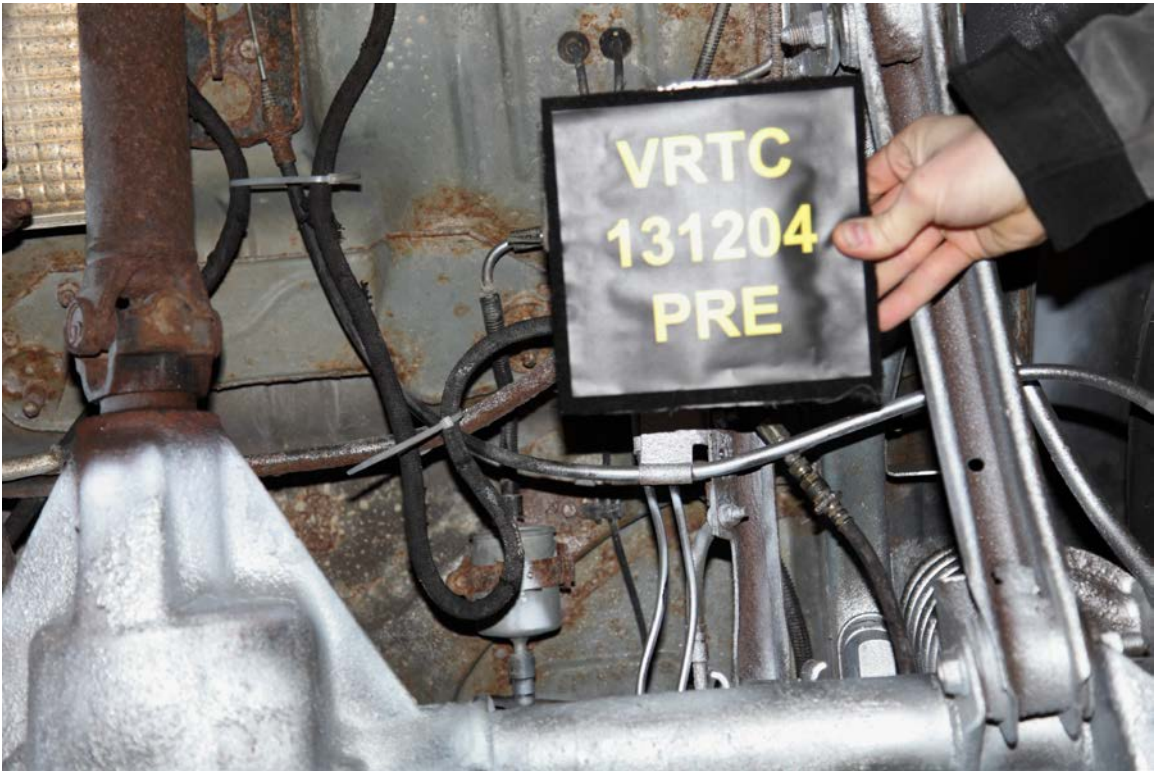
**Figure A-21 Pre-Test Target Vehicle Fuel Line Close-up View**

Vehicle year/make/ model/body style:	1996/Jeep/Grand Cherokee Limited/MPV
Actual test volume:	68.5 liters
Test fluid type:	Stoddard
Specific gravity:	0.764
Kinematic viscosity:	0.99 centistoke
Test fluid color:	Purple
Type of fuel pump:	Electric
Did electric fuel pump operate with ignition switch "on" and the engine not operating.	Yes
Details of fuel system:	The fuel tank is located behind the rear axle. The fuel filler neck enters the top left side of the fuel tank. The fuel filler cap is located on the left rear quarter panel. The fuel lines run along the inside of the left frame rail.

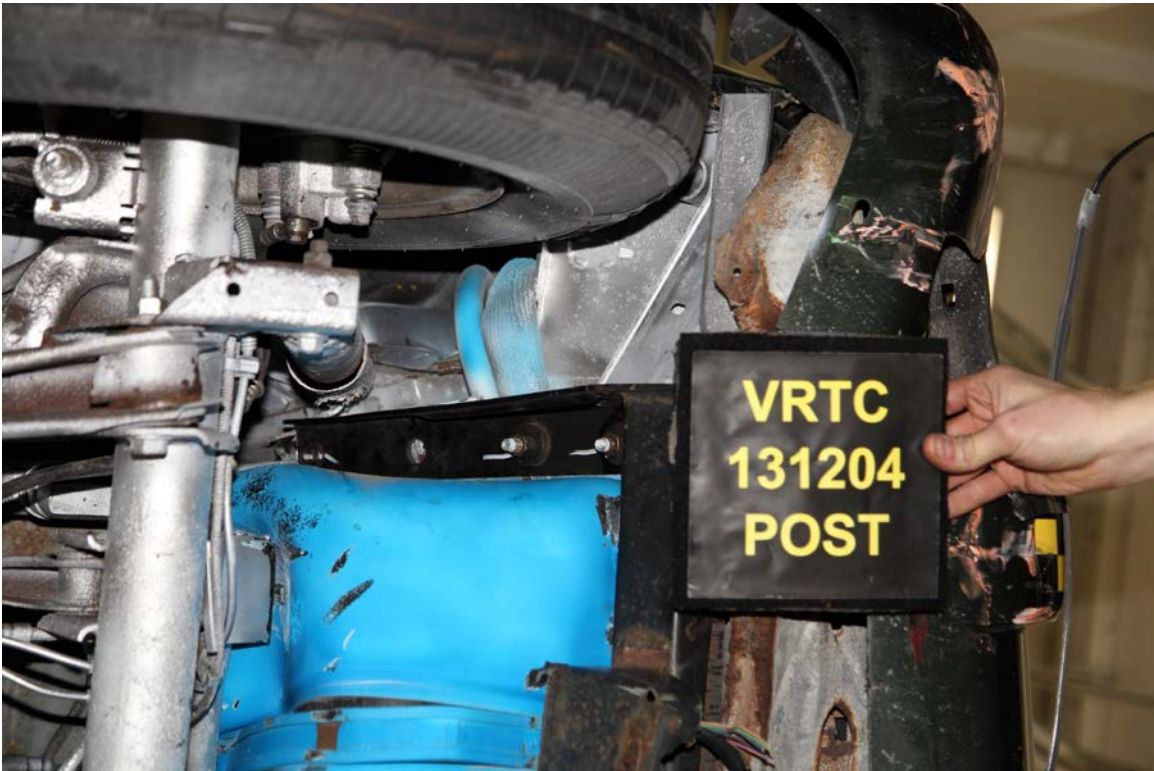
**Figure A-23 Post-Test Target Vehicle Fuel Filler Close-up – View 1**

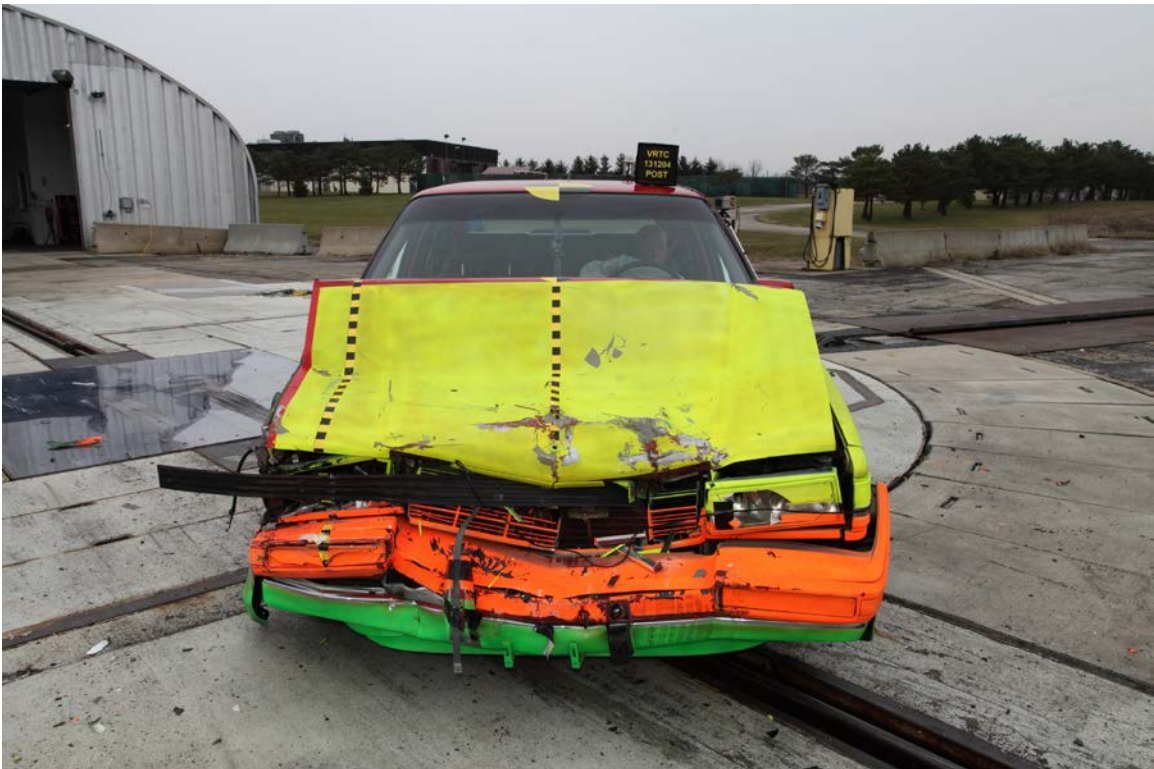
**Figure A-29 Post-Test Bullet Vehicle Frontal View**

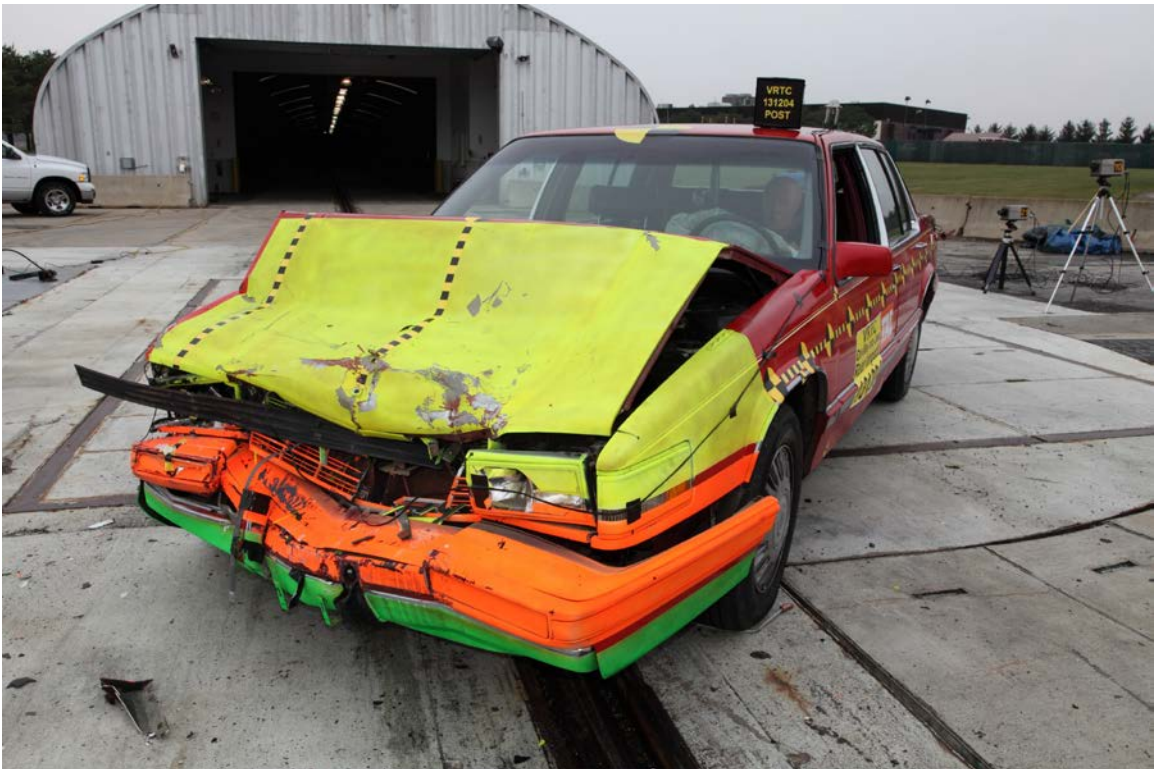
Figure A-31 Post-Test Bullet Vehicle Left Front 3/4 View

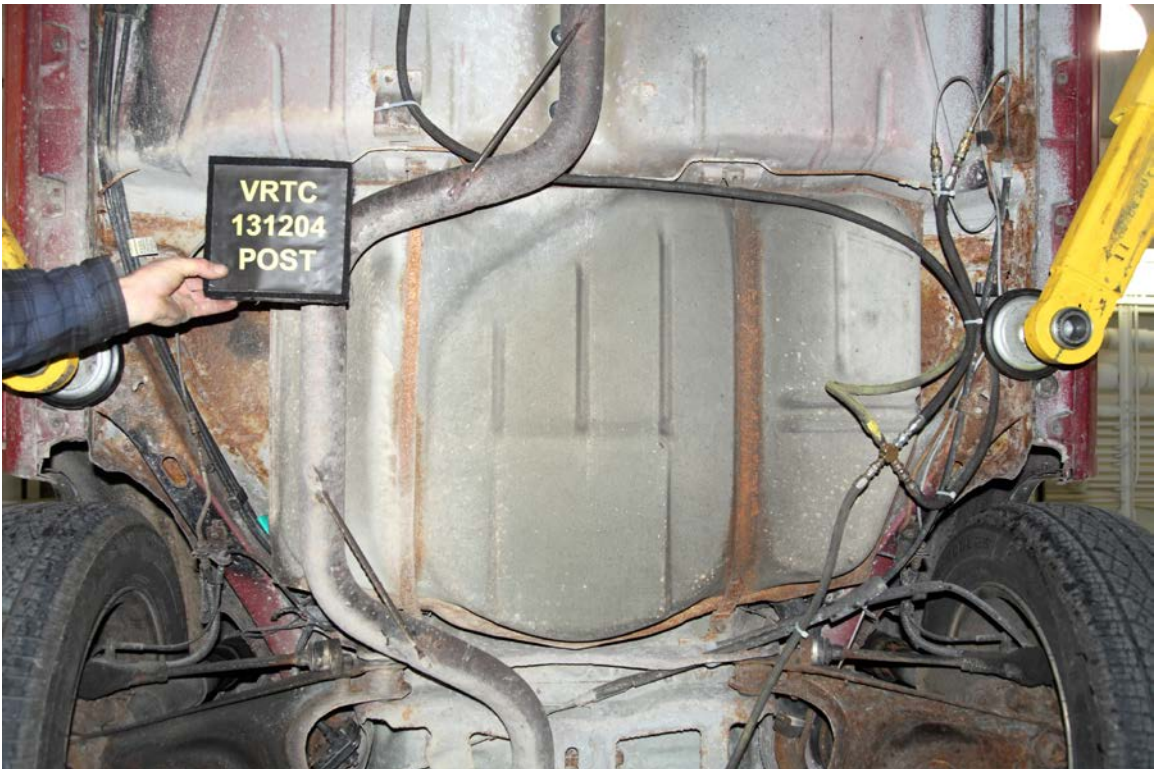
**Figure A-45 Post-Test Bullet Vehicle Fuel Tank View**

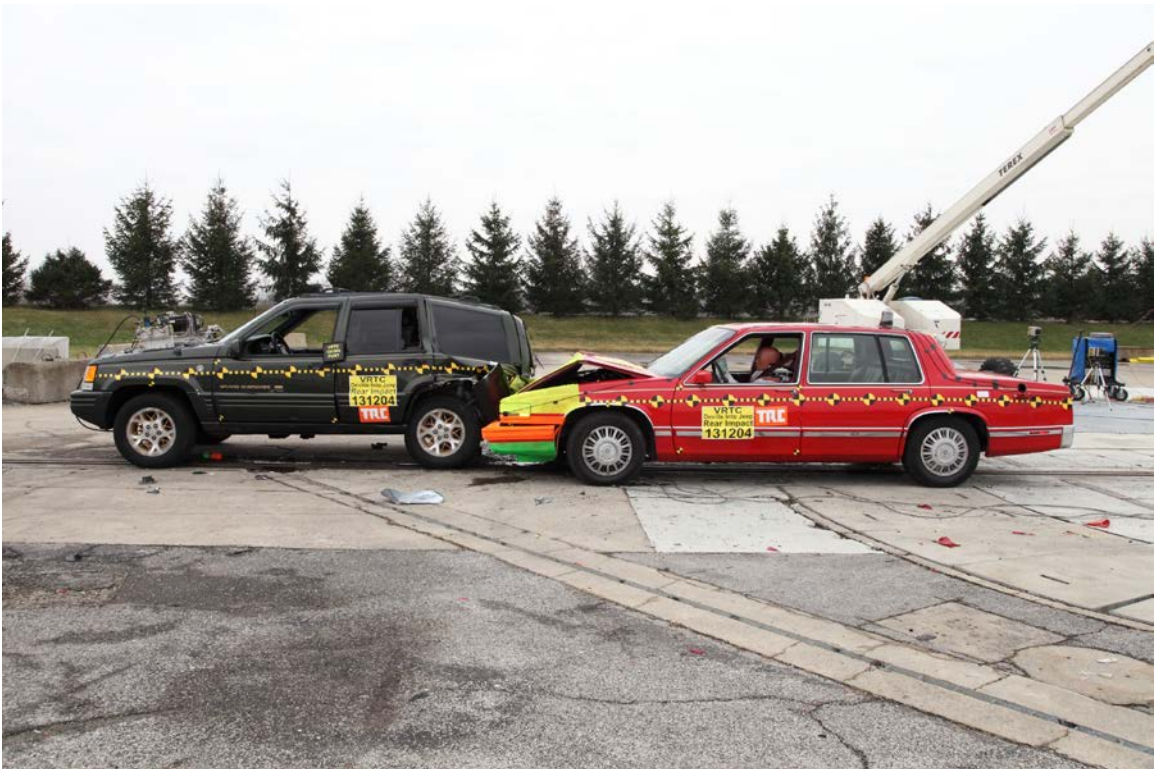
**Figure A-53 Post-Test Bullet and Target Vehicles Overall Left Side View**

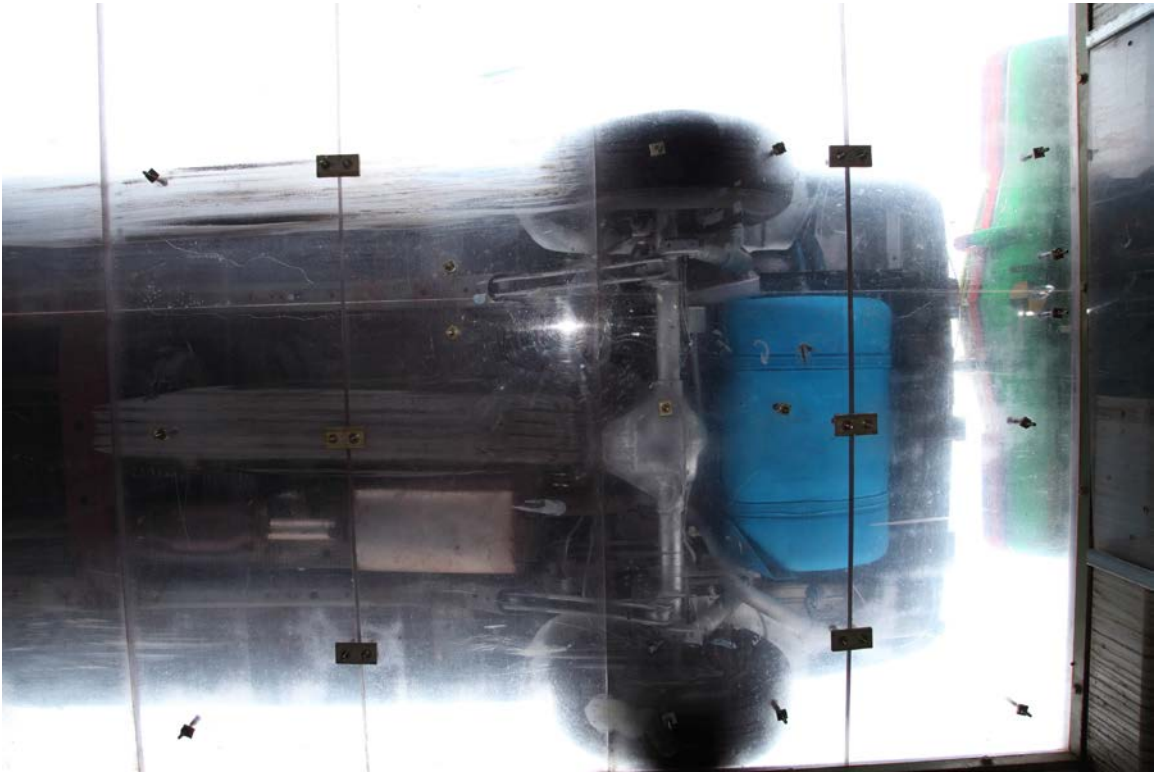
**Figure A-58 Pre-Test Impact Alignment – Bullet and Target Vehicles Pit View**
