**Vehicle Research and Test Center
2008 Ford F150 into
Rear of a 2004 Jeep Liberty
TRC Inc. Test Number: 131212**

**Prepared By:
Transportation Research Center Inc.
10820 State Route 347
East Liberty, OH 43319**

**Final Report
December 2013 – January 2014**

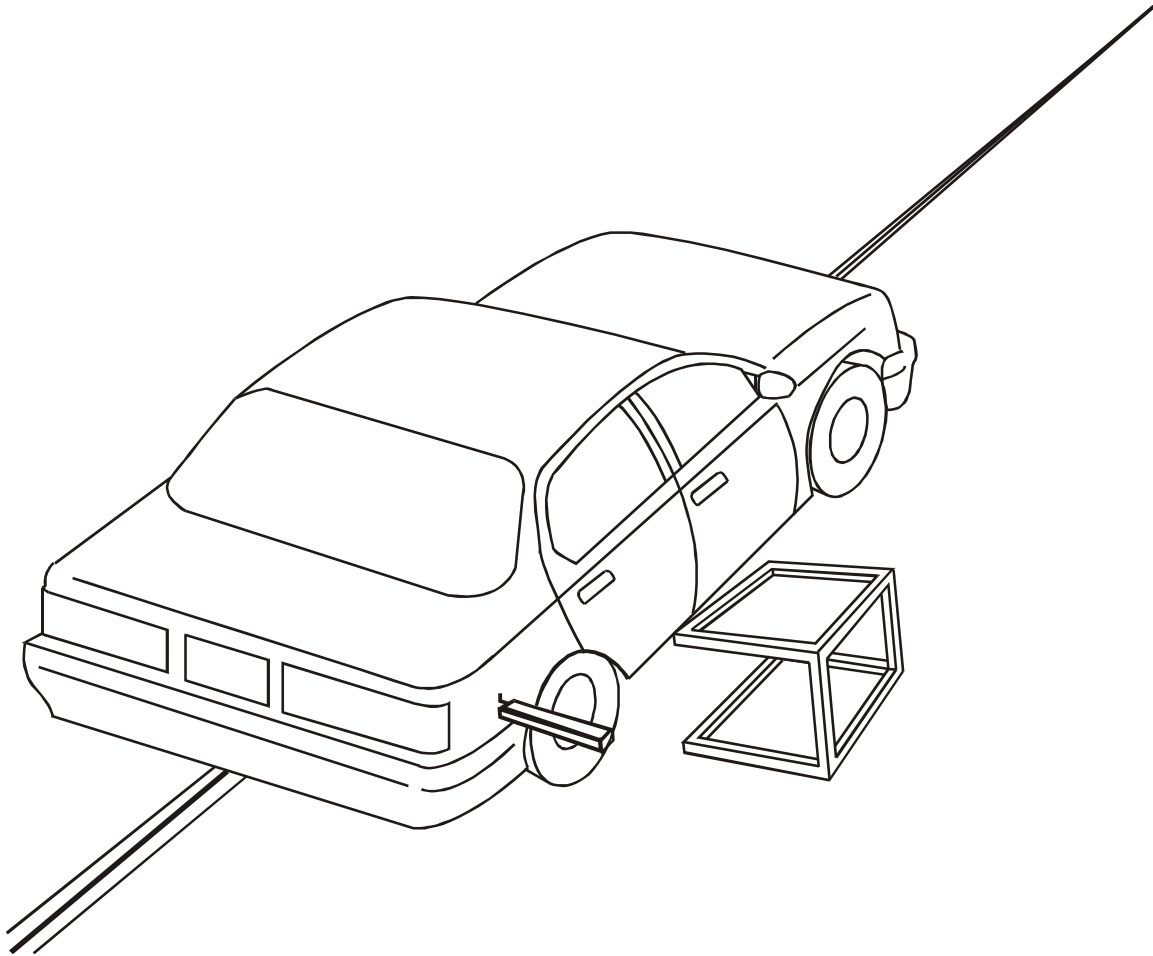
Figure 1 Impact Velocity Measurement System

The vane clears the final emitter/receiver pair approximately 50 millimeters before impact.

The emitter/receiver pairs have 610-millimeter spacing.

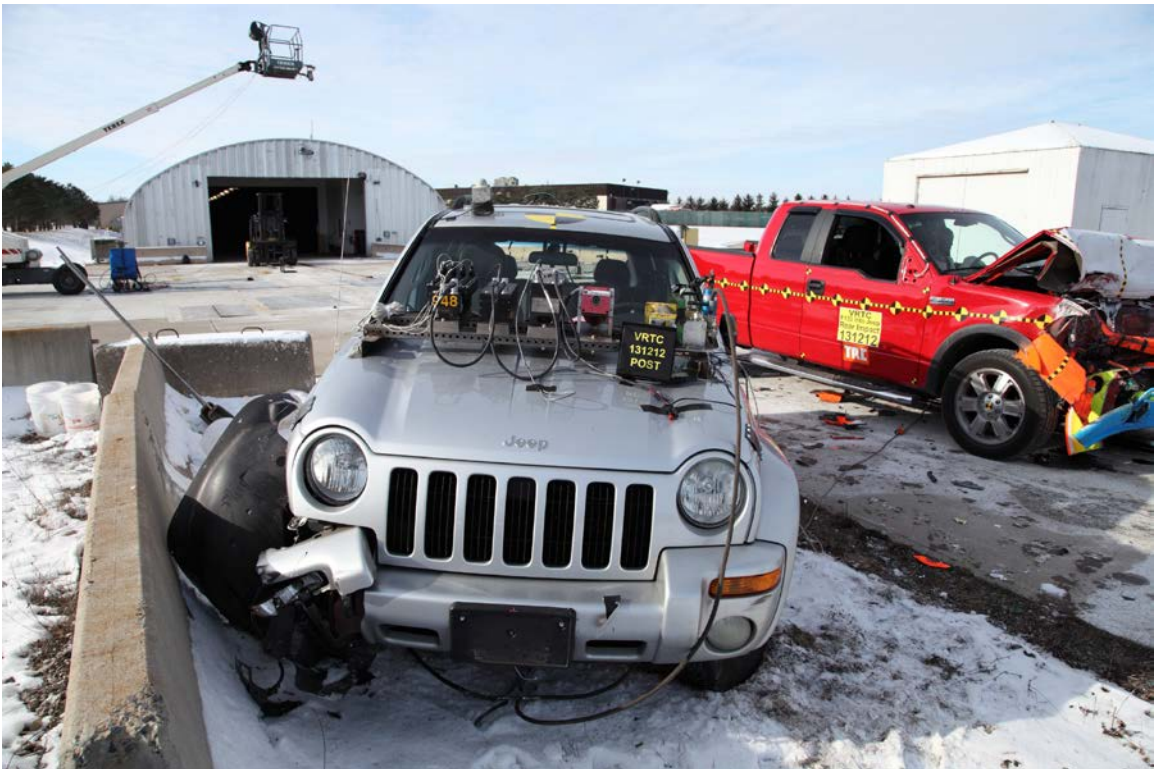
Figure A-2 Post-Test Target Vehicle Frontal View

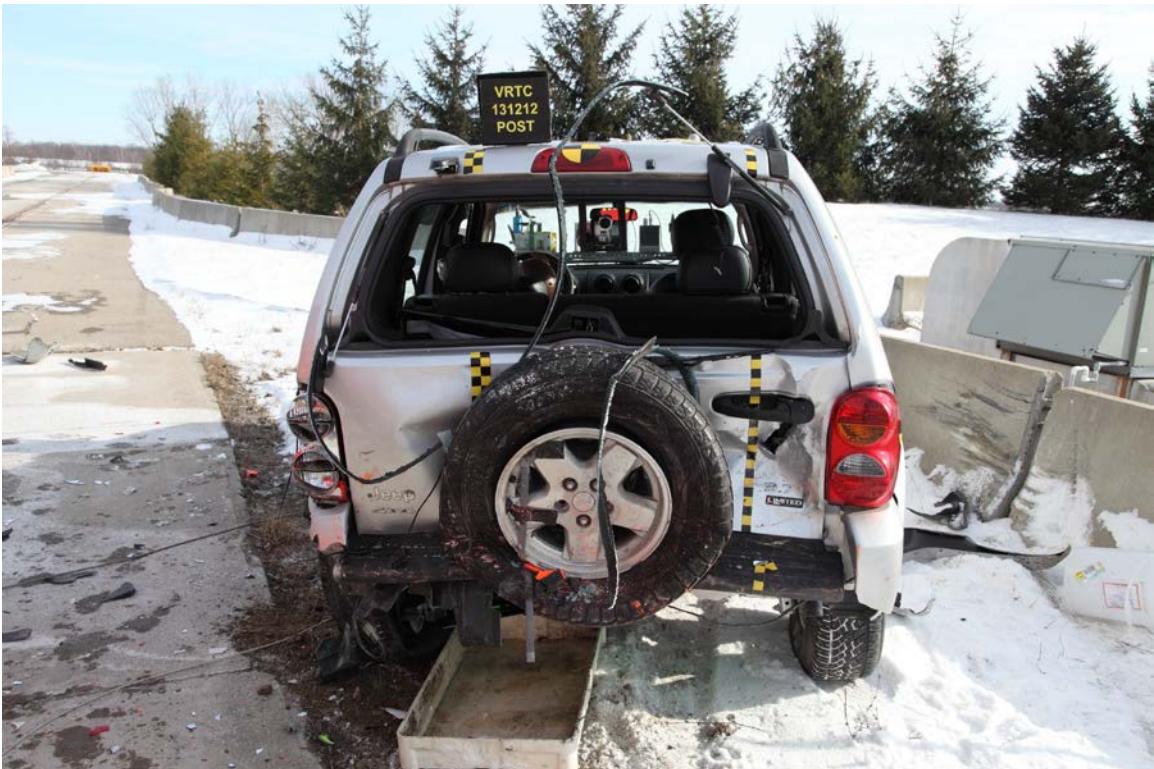
Figure A-8 Post-Test Target Vehicle Rear View

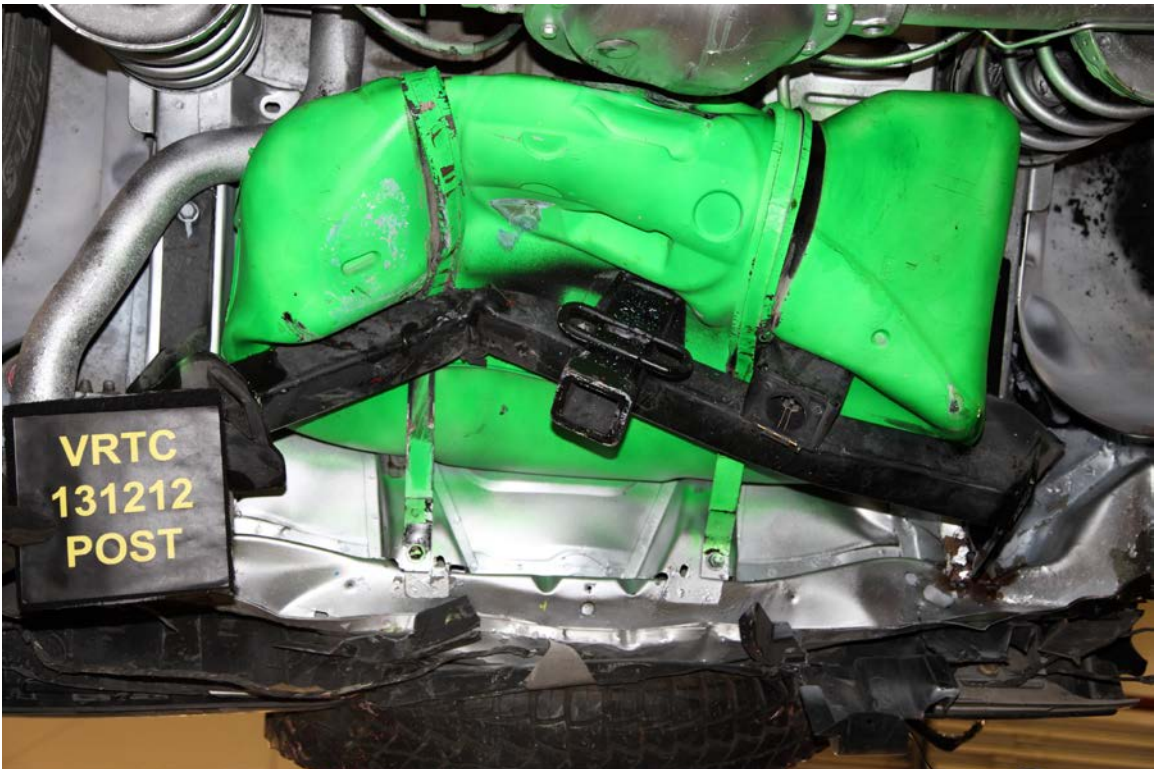
Figure A-20 Post-Test Target Vehicle Fuel Tank Close-up View

¹ A major leak occurred during this portion of the rollover and the fuel tank emptied. No further rollover was conducted.

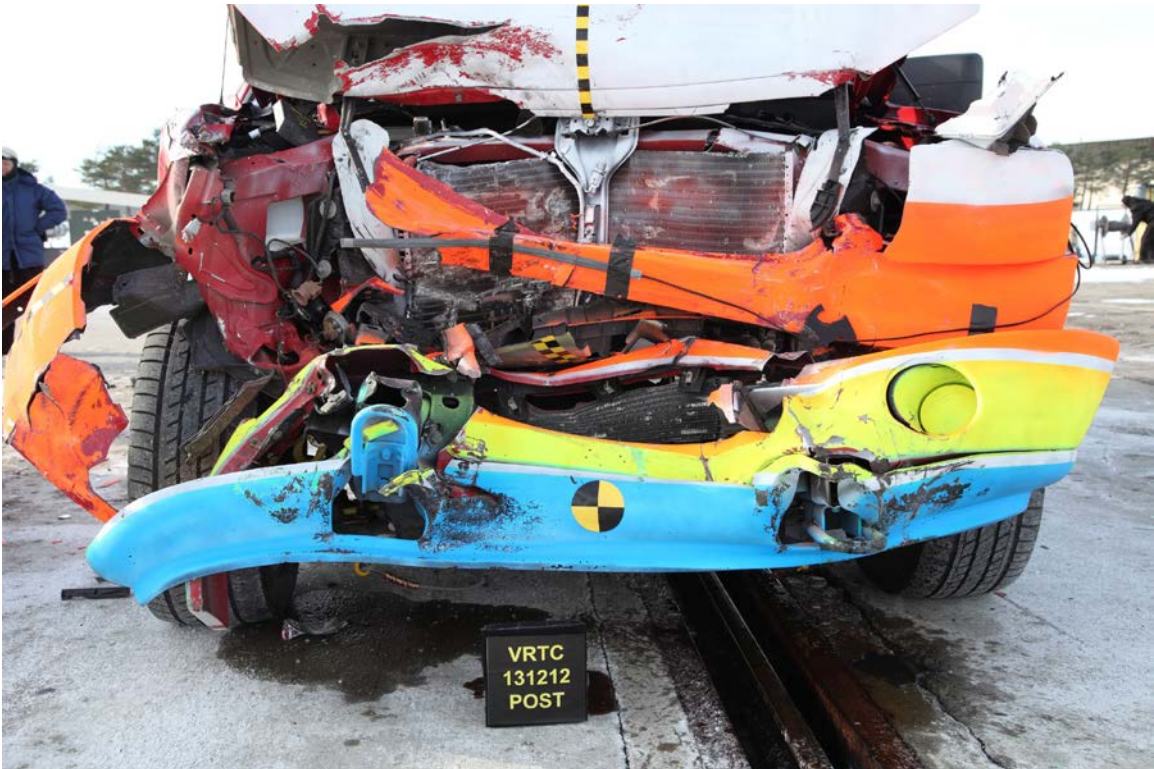
Figure A-29 Post-Test Bullet Vehicle Frontal View

Pre-test	Post-test	Crush
L	1524	N/A	N/A
C1	5704	5552	152
C2	5804	5505	299
C3	5824	5420	404
CL	5829	5381	448
C4	5824	5322	502
C5	5809	5560	249
C6	5704	5420	284
