**REPORT NUMBER: SPNCAP-MGA-2014-052**

**NEW CAR ASSESSMENT PROGRAM (NCAP)  
Side Impact Pole Test**

**HYUNDAI MOTOR COMPANY  
2014 Hyundai Veloster 3-Dr Coupe  
NHTSA No.: M20144204**

**FINAL REPORT**

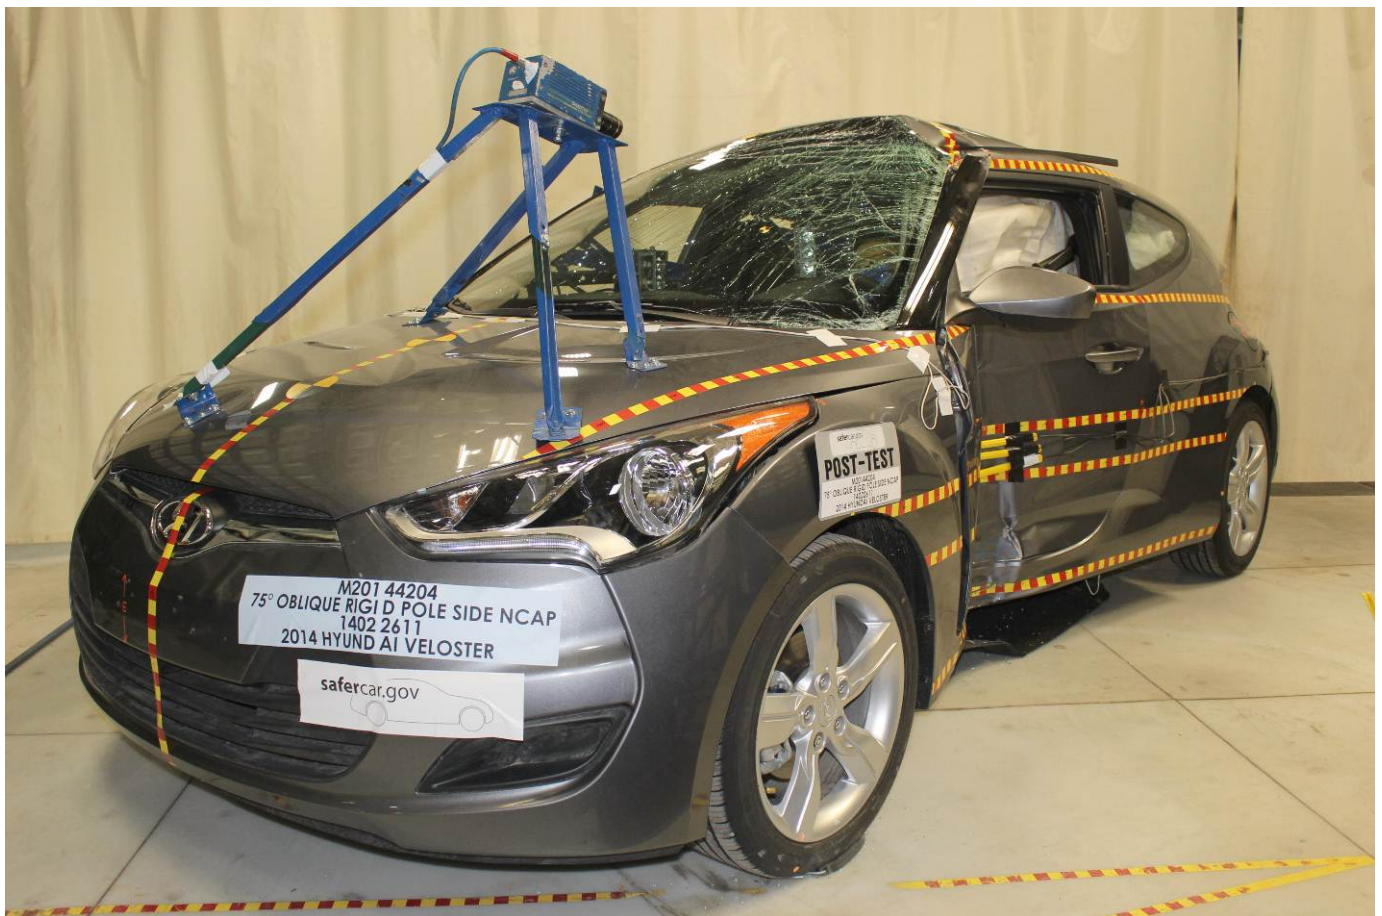
Post-Test Left Front  $\frac{3}{4}$  View of Test Vehicle

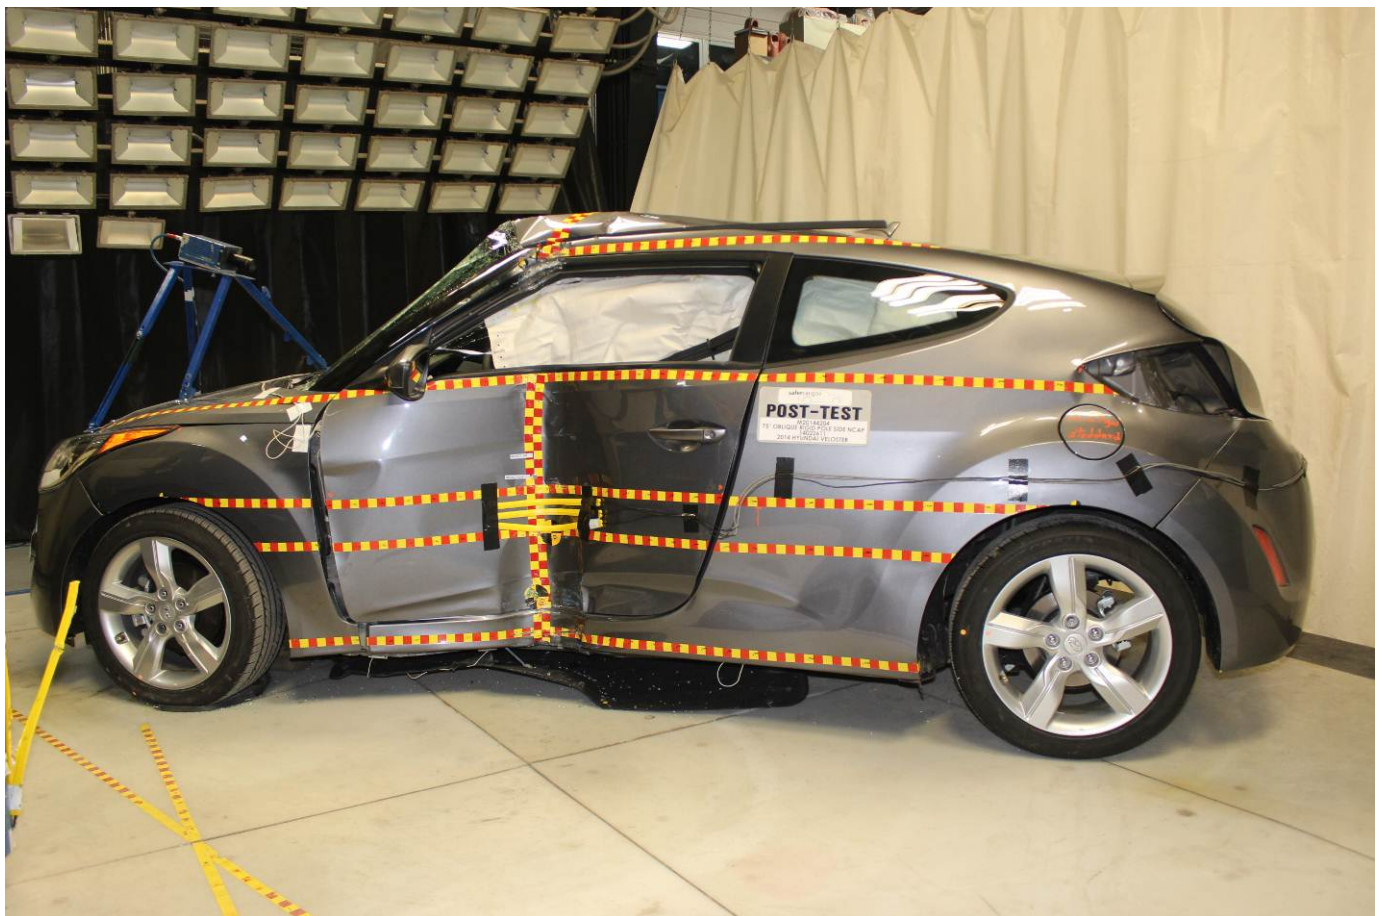
Post-Test Left Side View of Test Vehicle

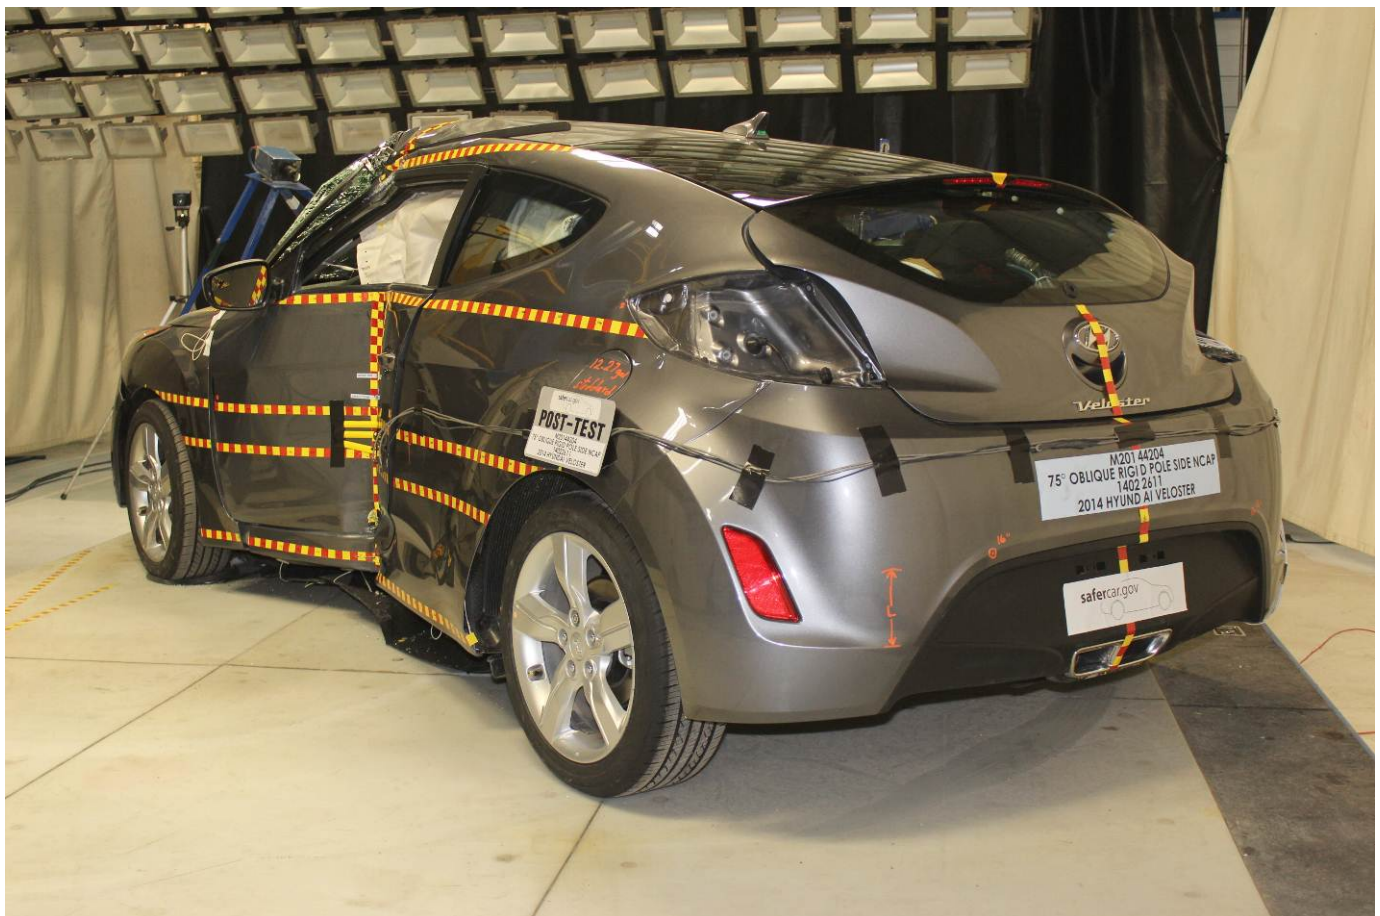
Post-Test Left Rear  $\frac{3}{4}$  View of Test Vehicle

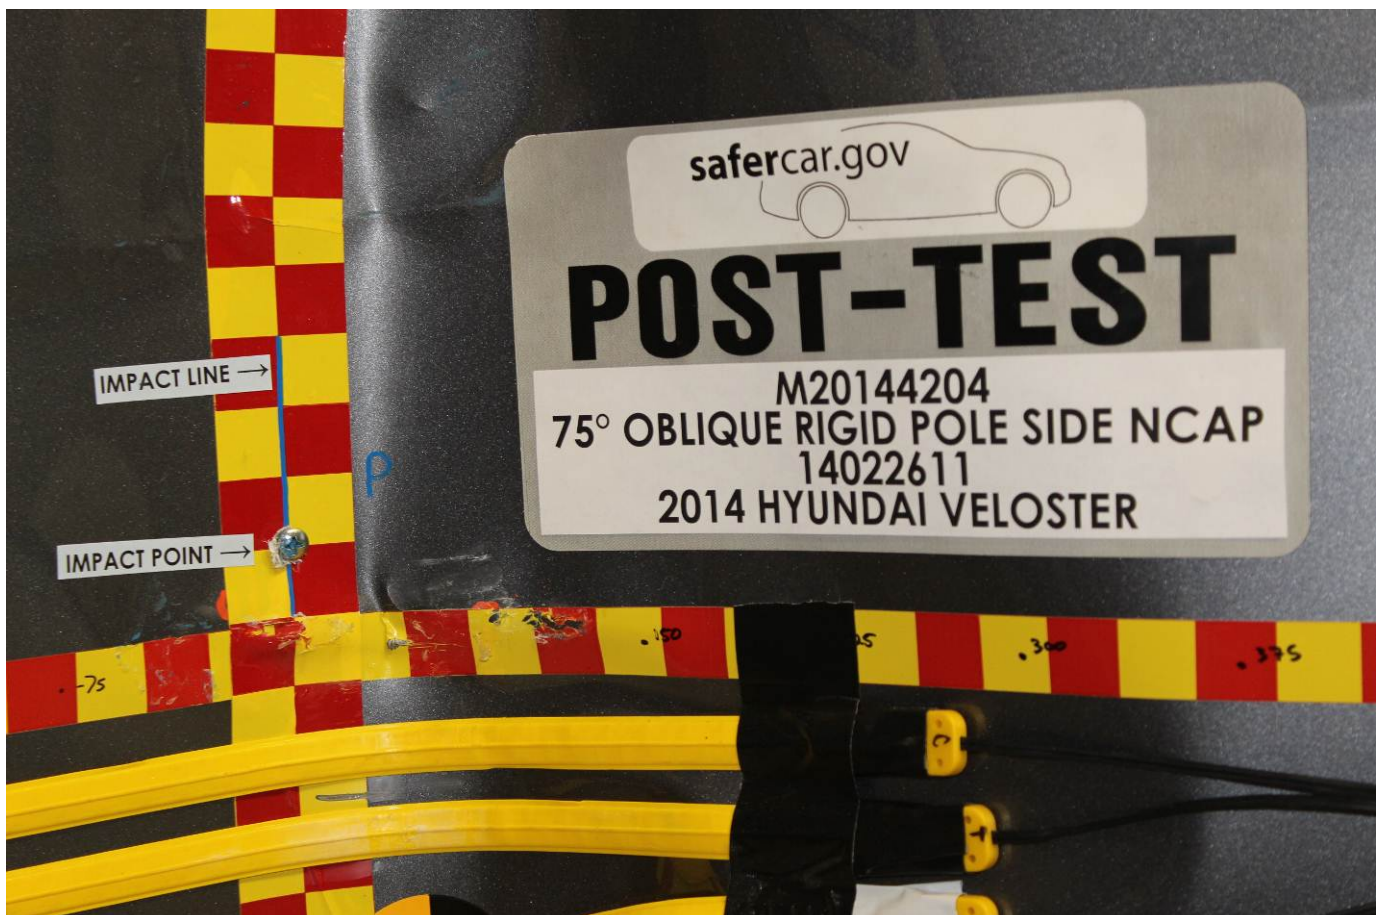
Post-Test Close-Up View of Impact Point Target Showing Impact Location

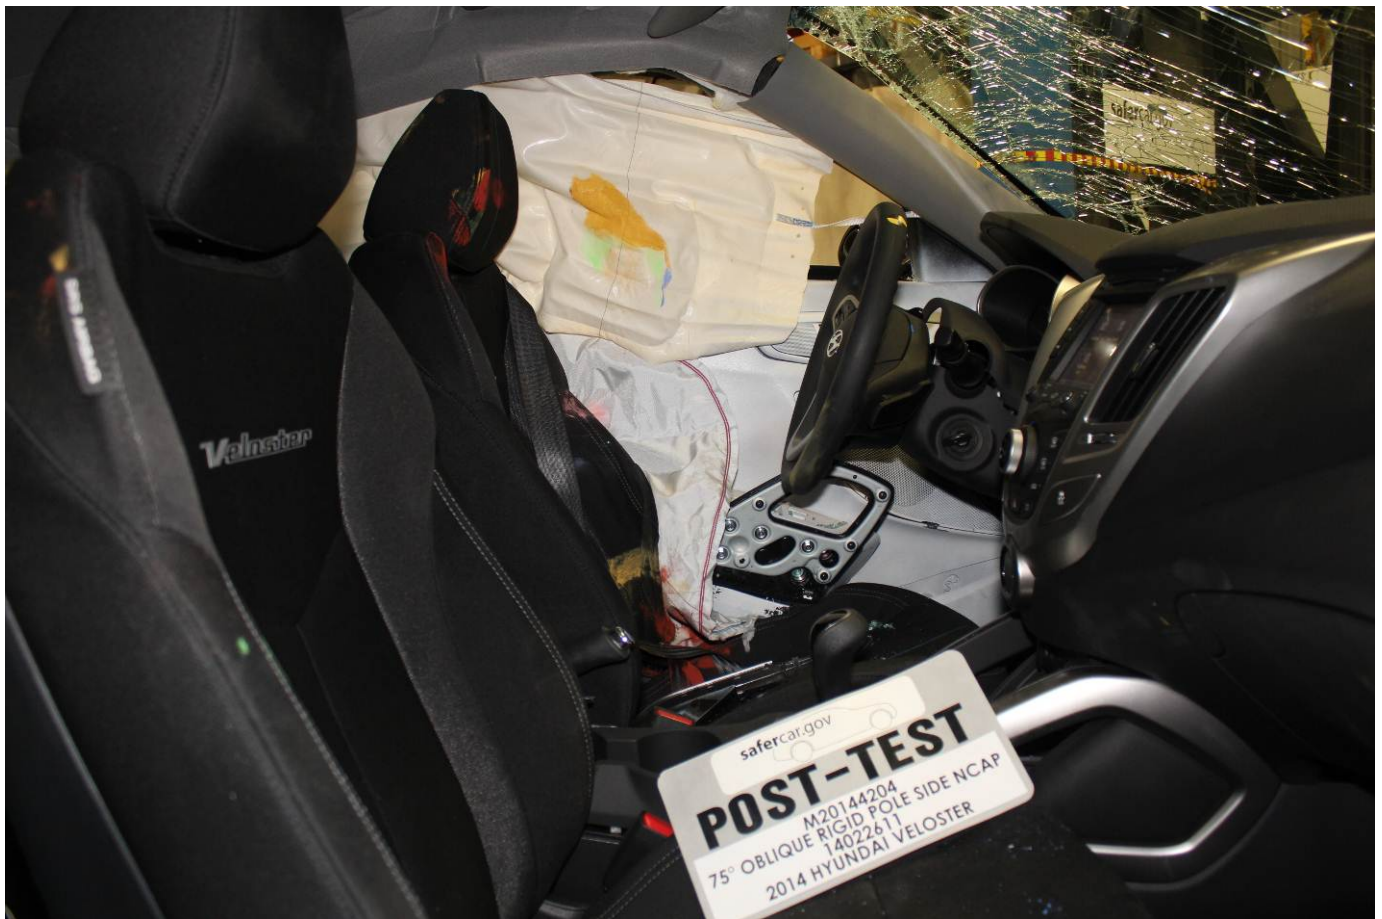
Post-Test Inner Door Panel View Showing Dummy Contact Location

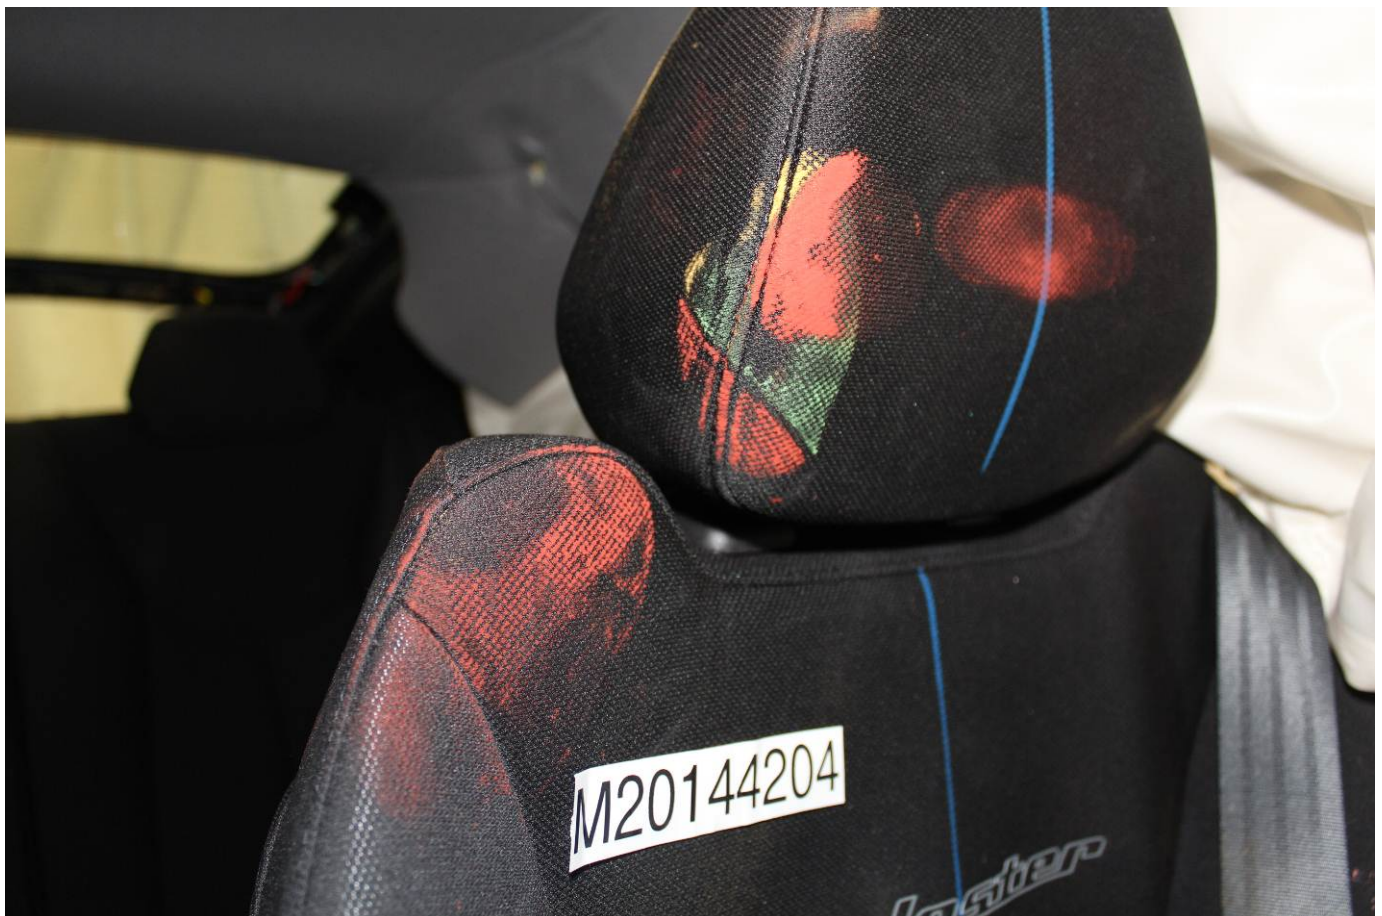
Post-Test Dummy Close-Up Head Contact with Vehicle Interior View

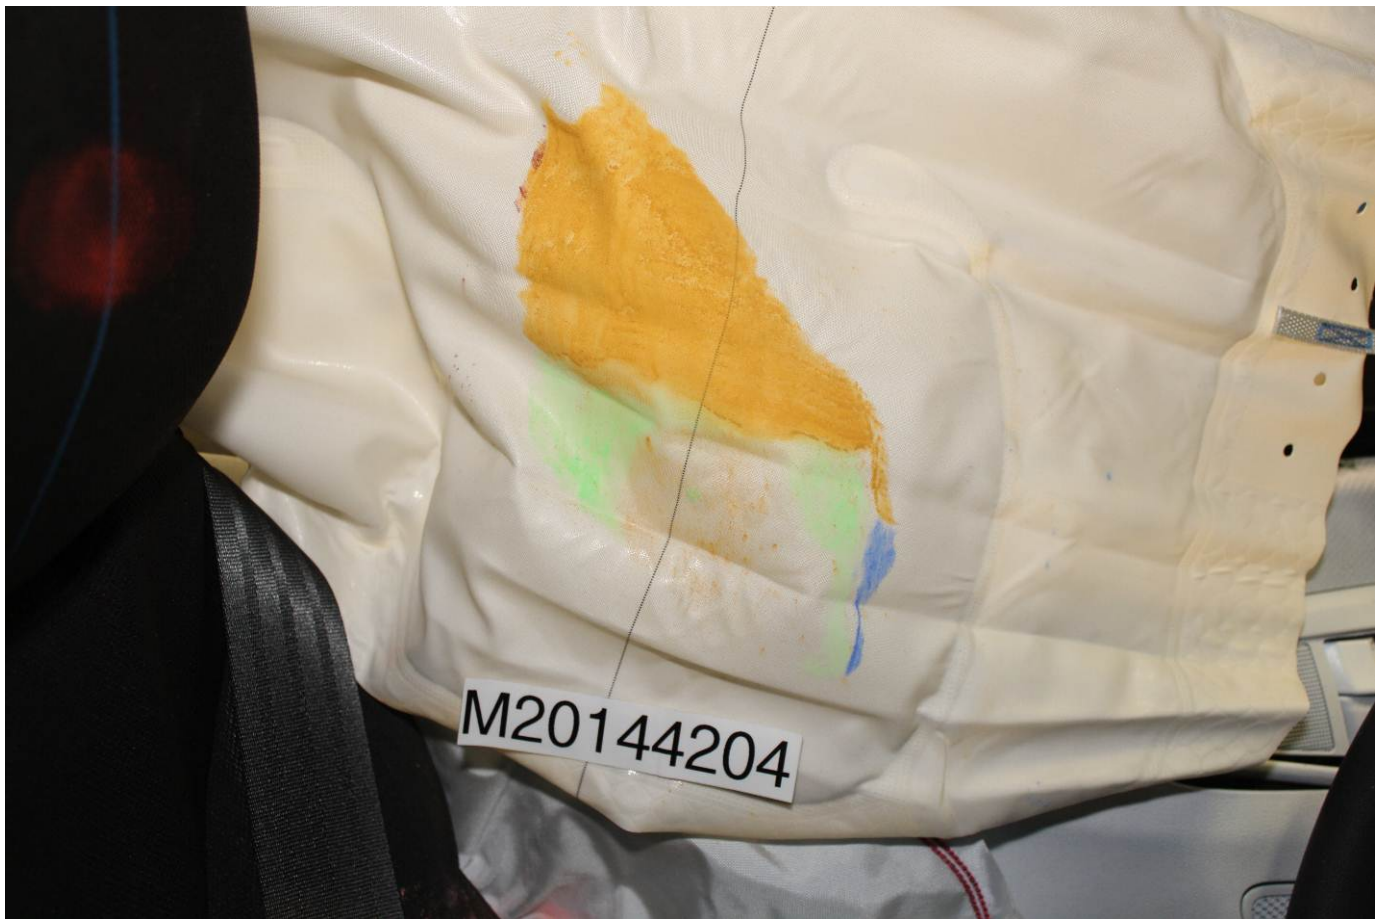
Post-Test Dummy Close-Up Head Contact with Side Air Bag View

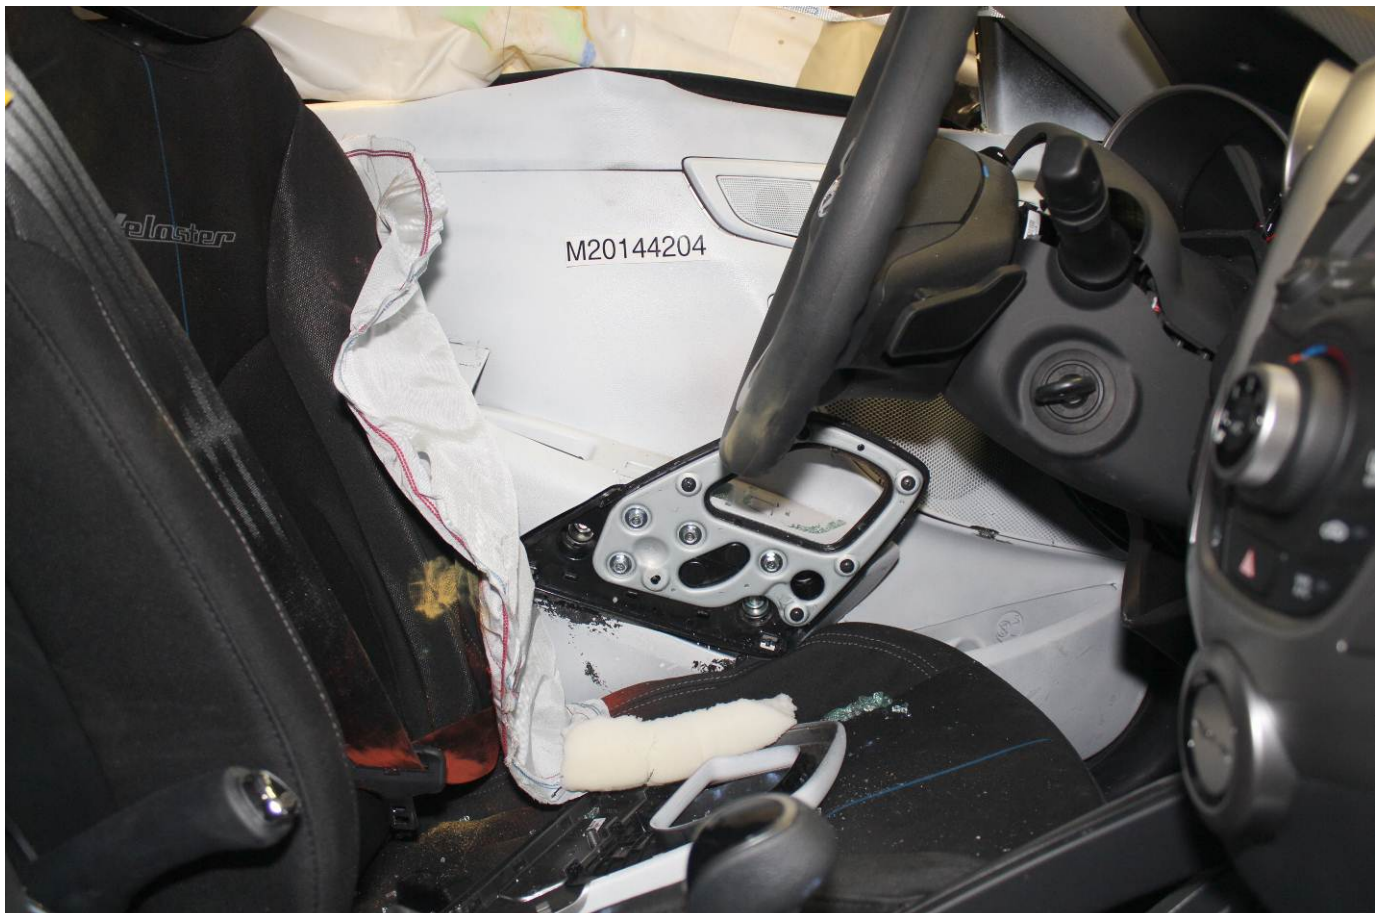
Post-Test View of Shattered Vehicle Inner Door Panel
