**REPORT NUMBER: SINCAP-MGA-2014-057**

**NEW CAR ASSESSMENT PROGRAM (NCAP)  
Moving Deformable Barrier Side Impact Test**

**FORD MOTOR COMPANY  
2014 Ford Transit Connect XLT Wagon SWB  
NHTSA No.: M20140204**

**MGA RESEARCH CORPORATION  
5000 Warren Road  
Burlington, WI 53105**

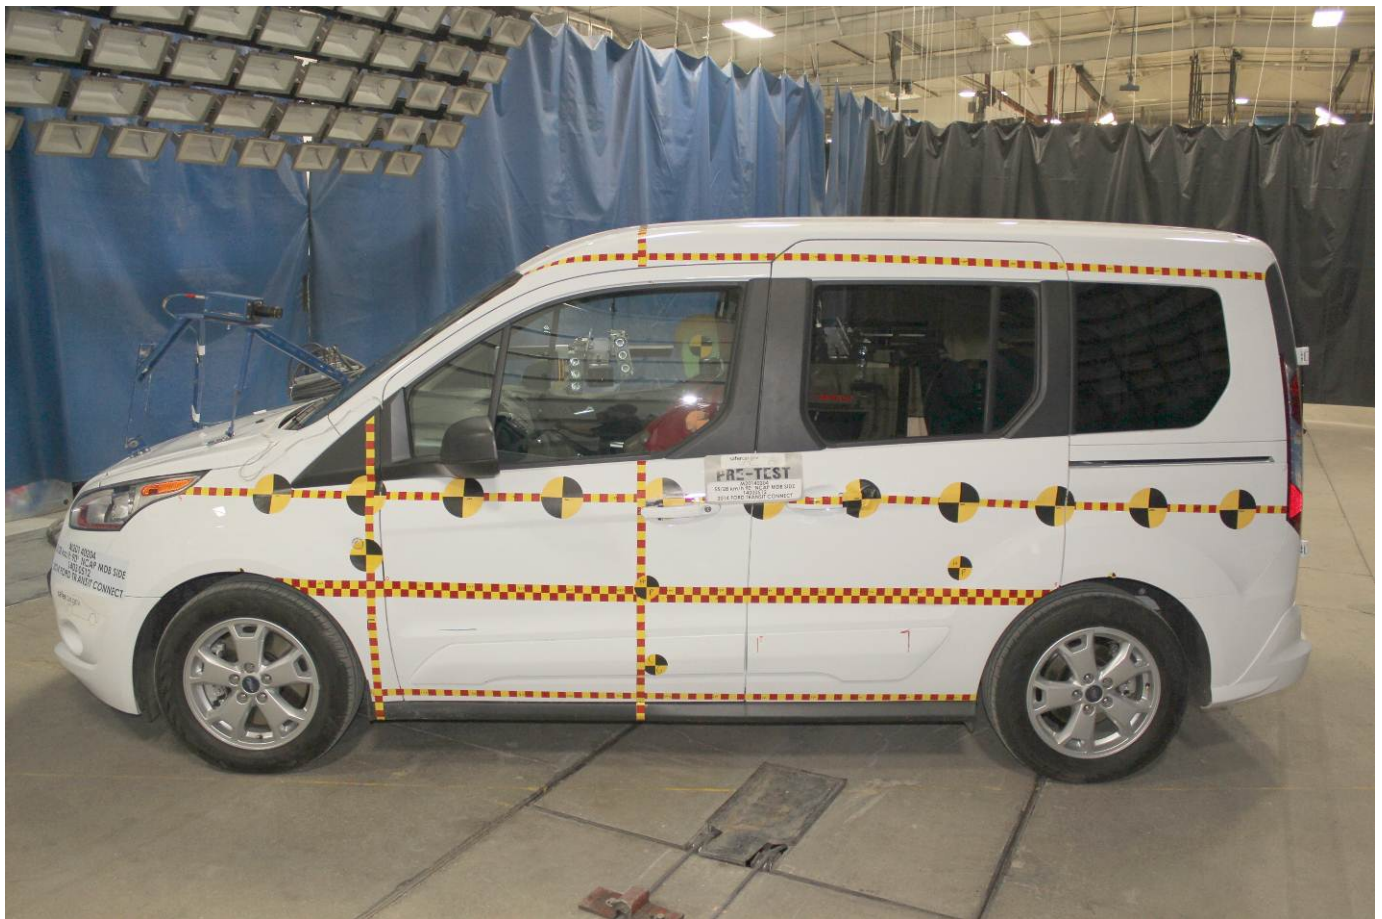
Pre-Test Left Side View of Test Vehicle

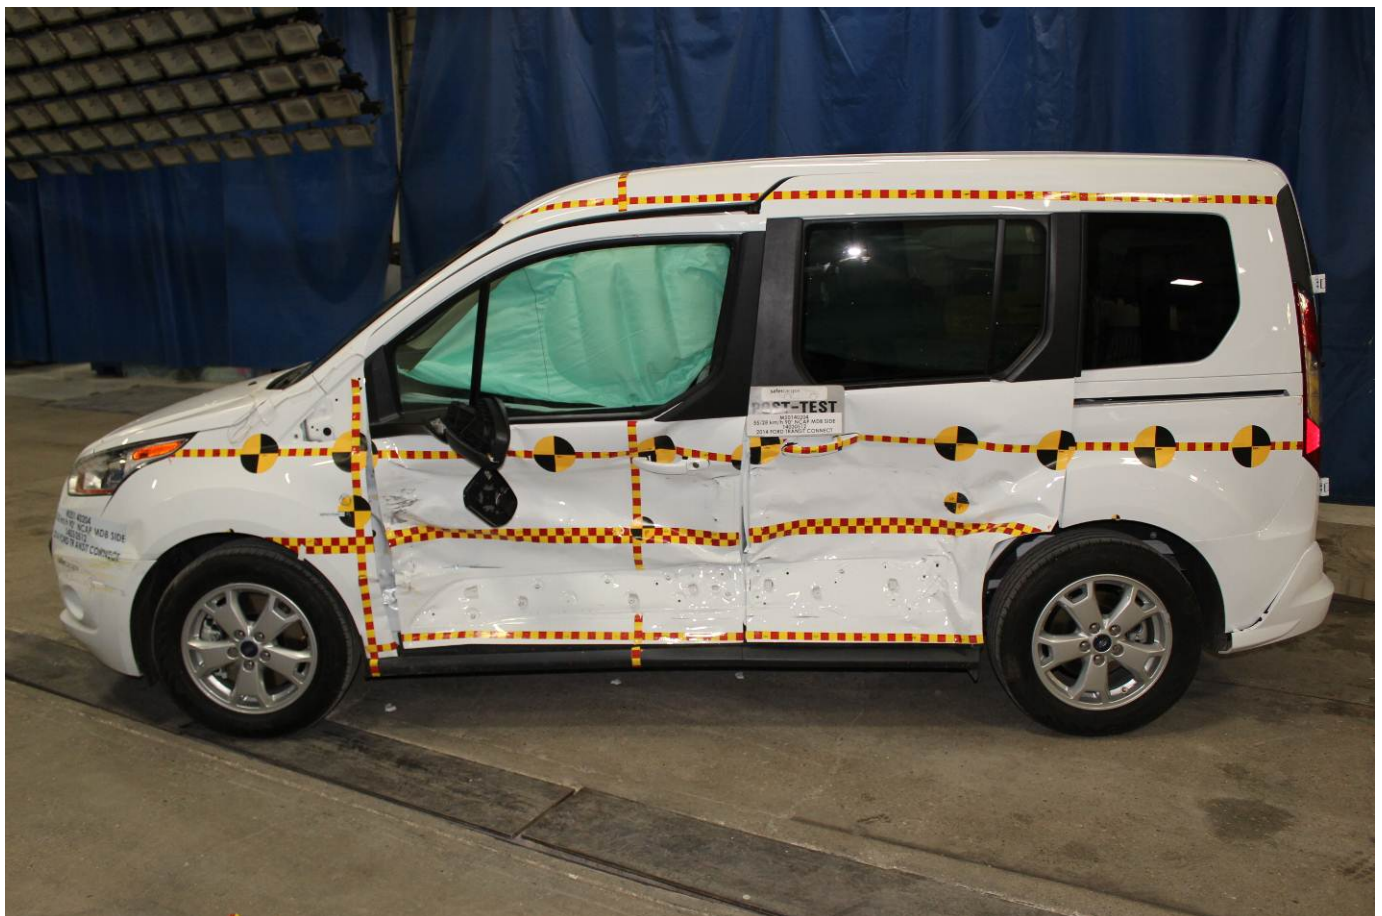
Post-Test Left Side View of Test Vehicle

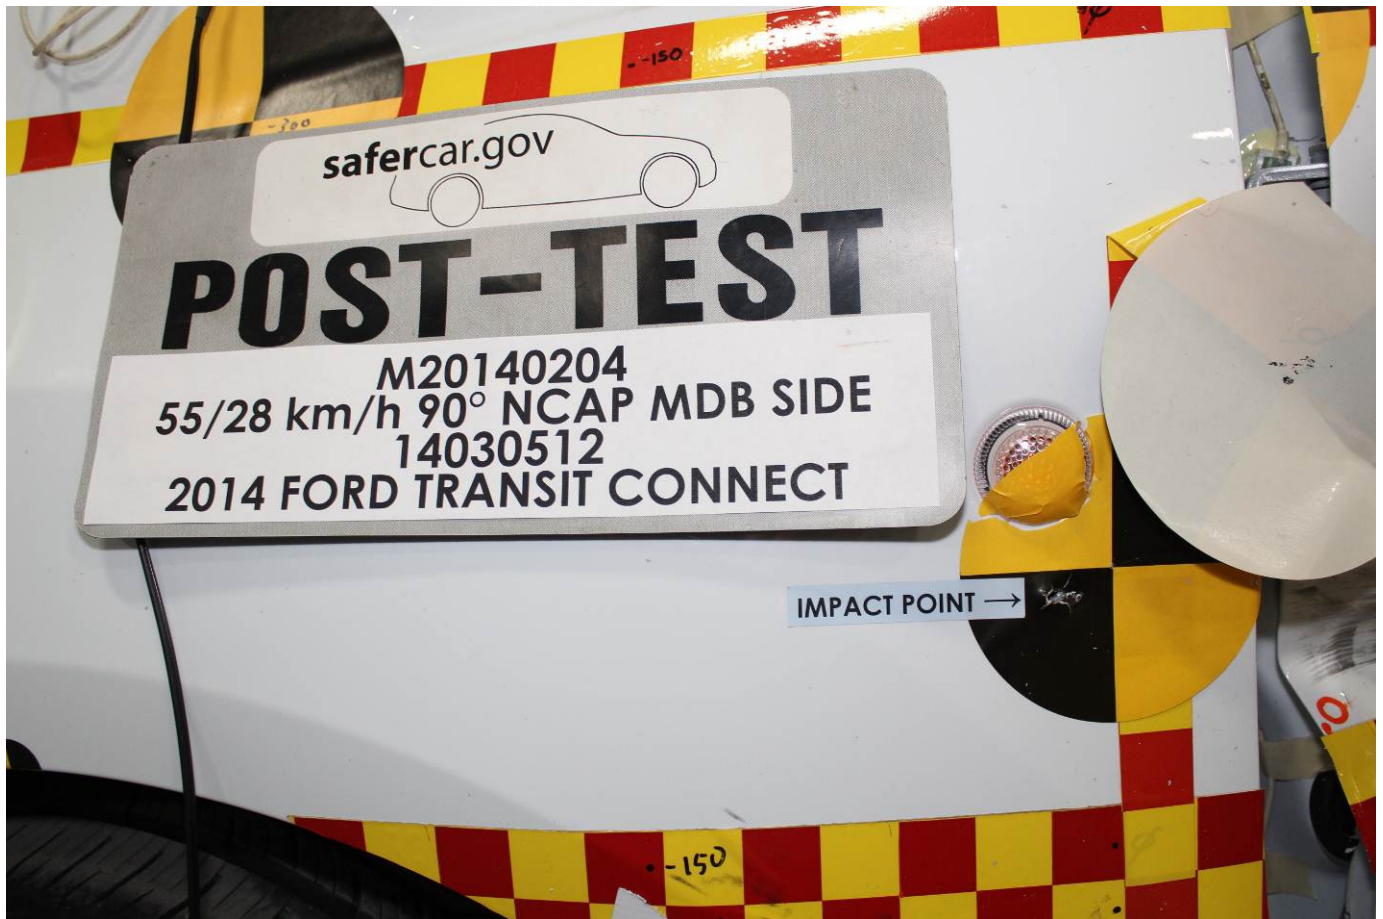
Post-Test Close-Up View of Impact Point Target

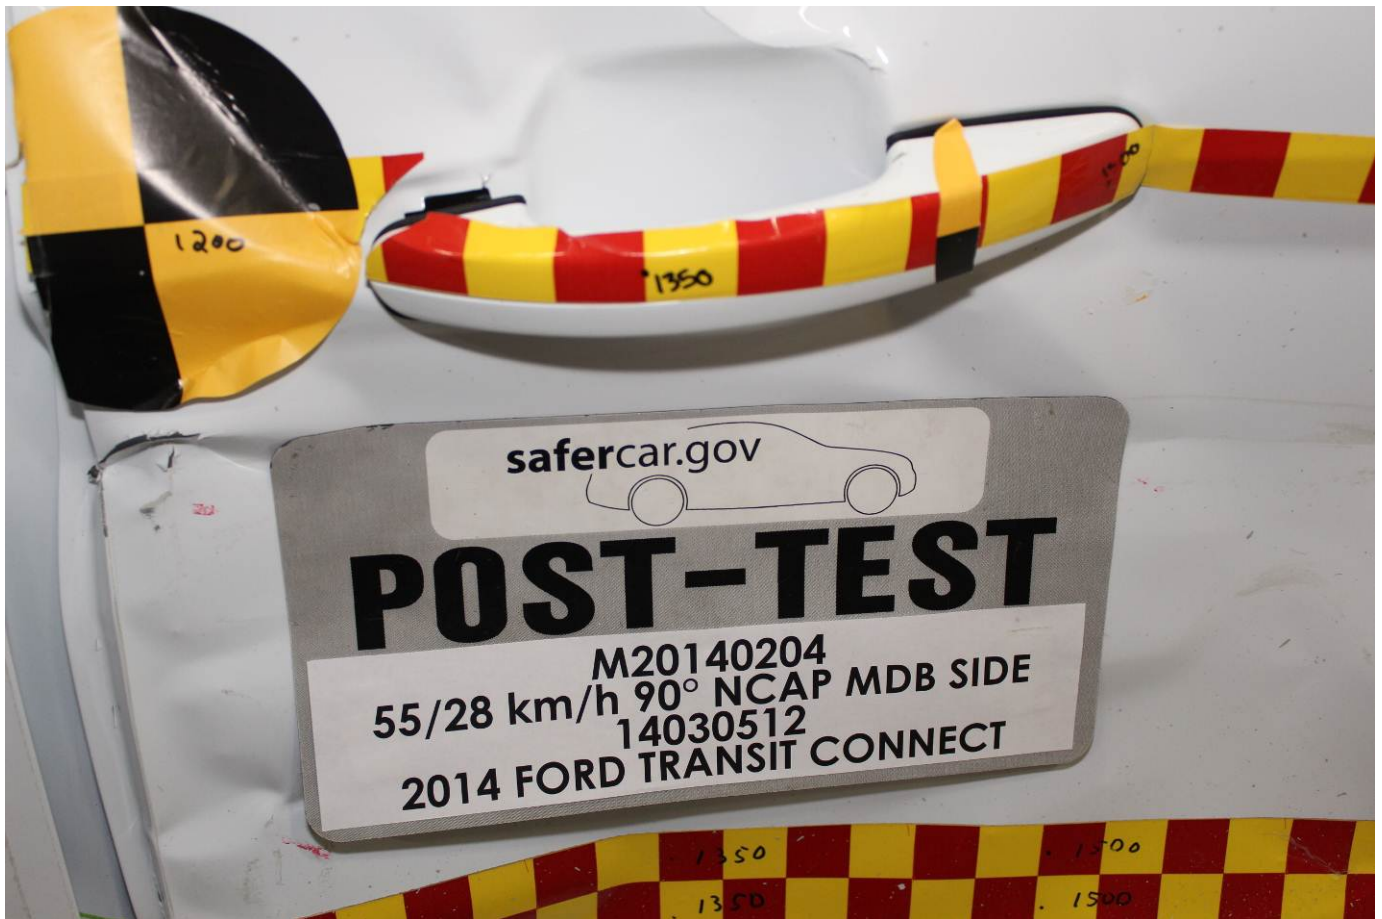
Post-Test Left Rear Door Latch Close-Up

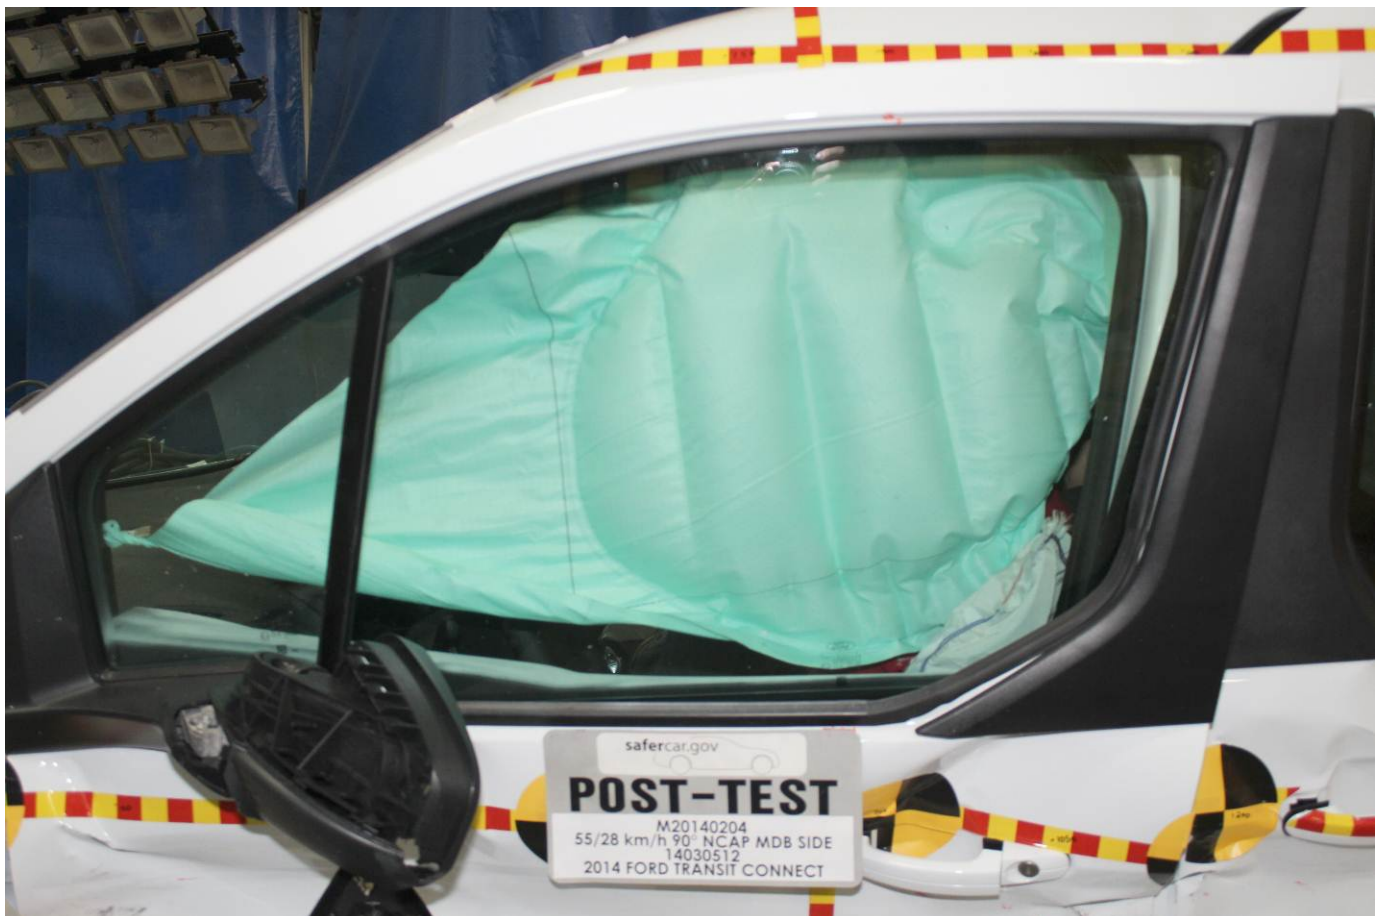
Post-Test Left Side View of Driver Dummy Shoulder and Door Top View

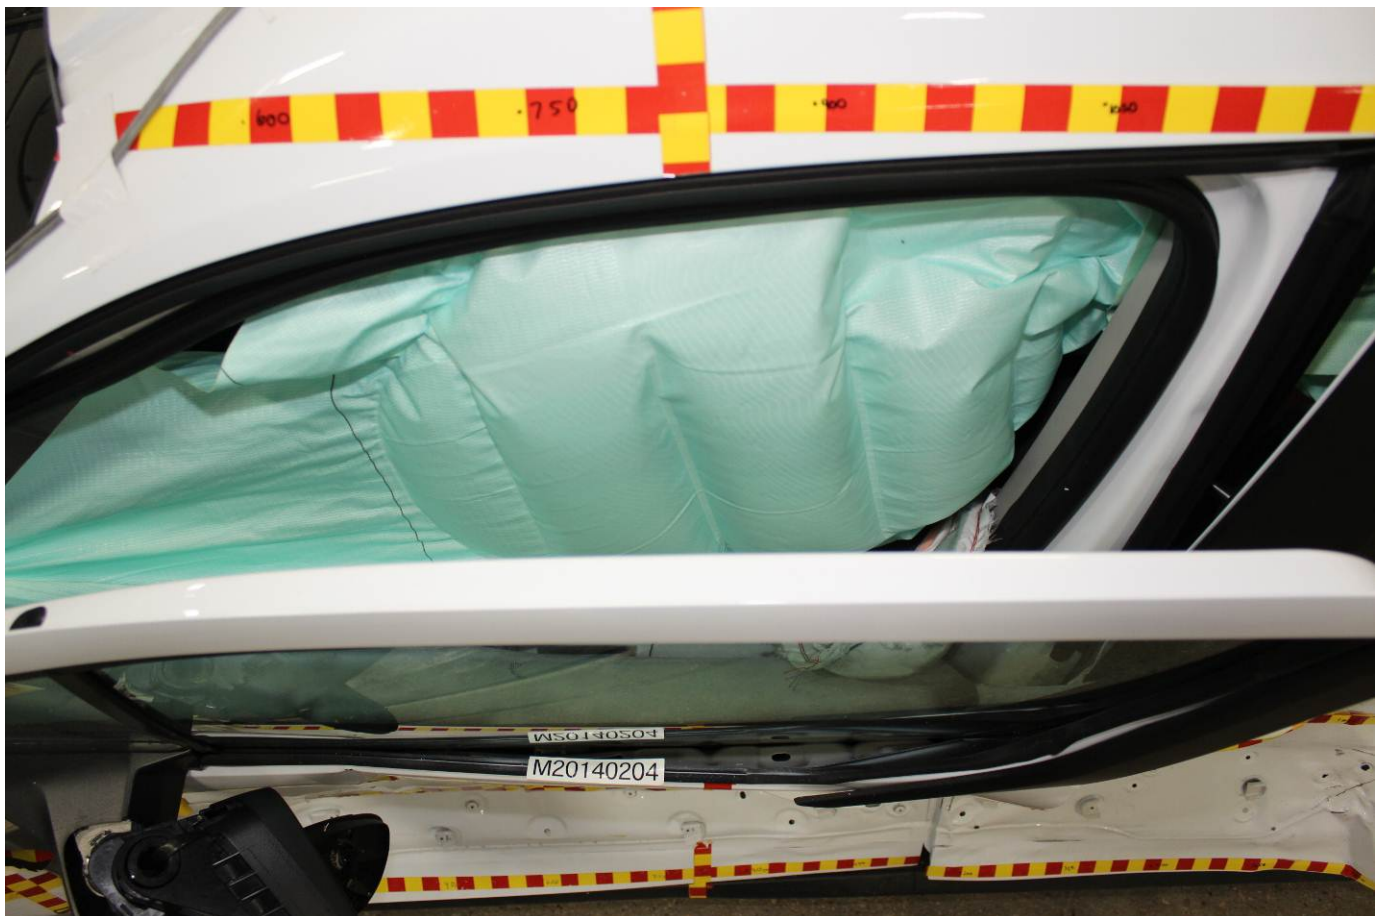
Post-Test Driver Dummy and Door Clearance View

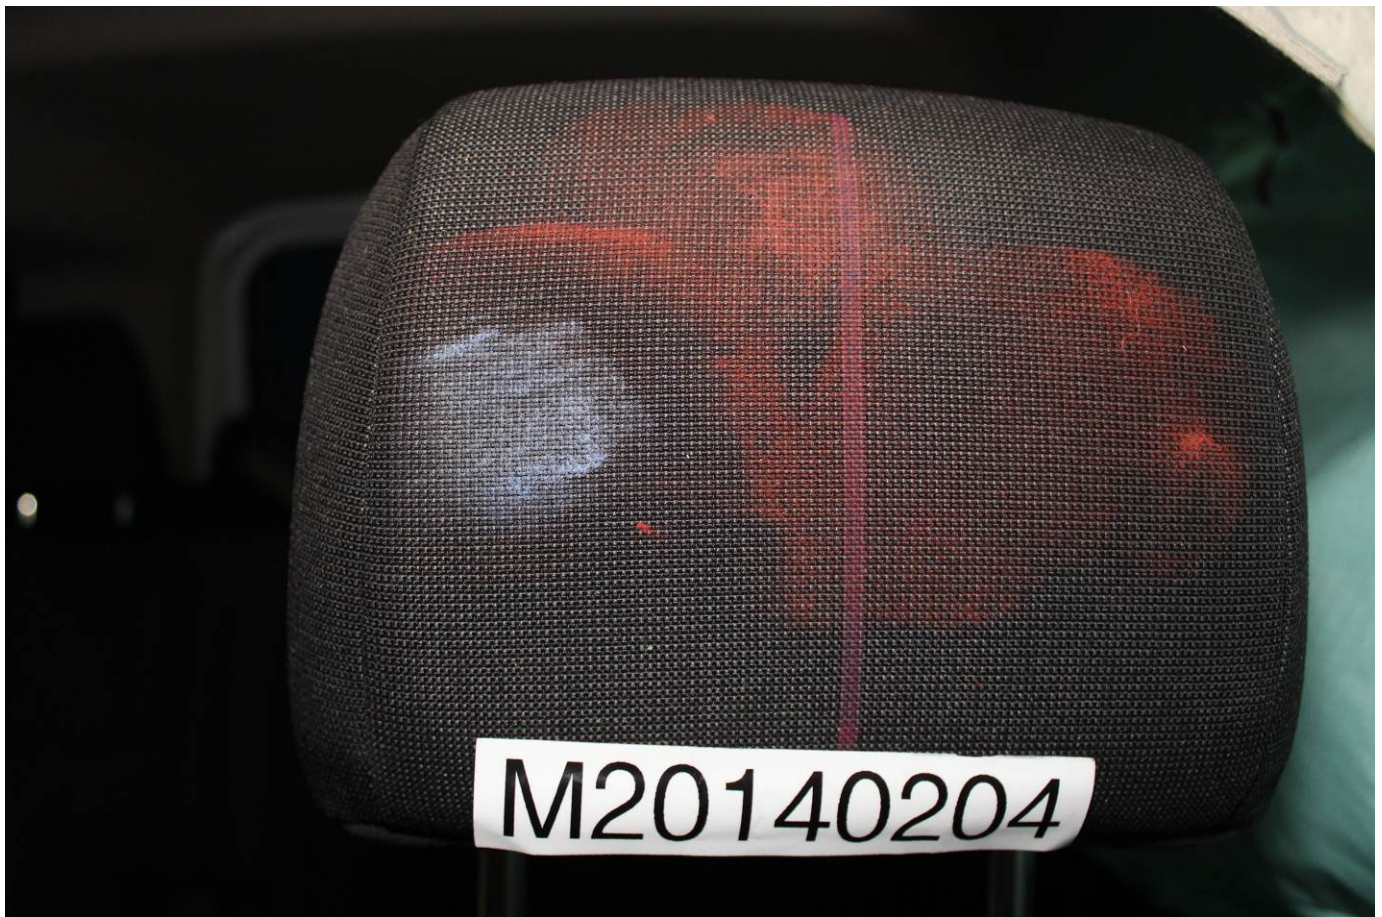
Post-Test Driver Dummy Close-up Head Contact with Vehicle Interior View

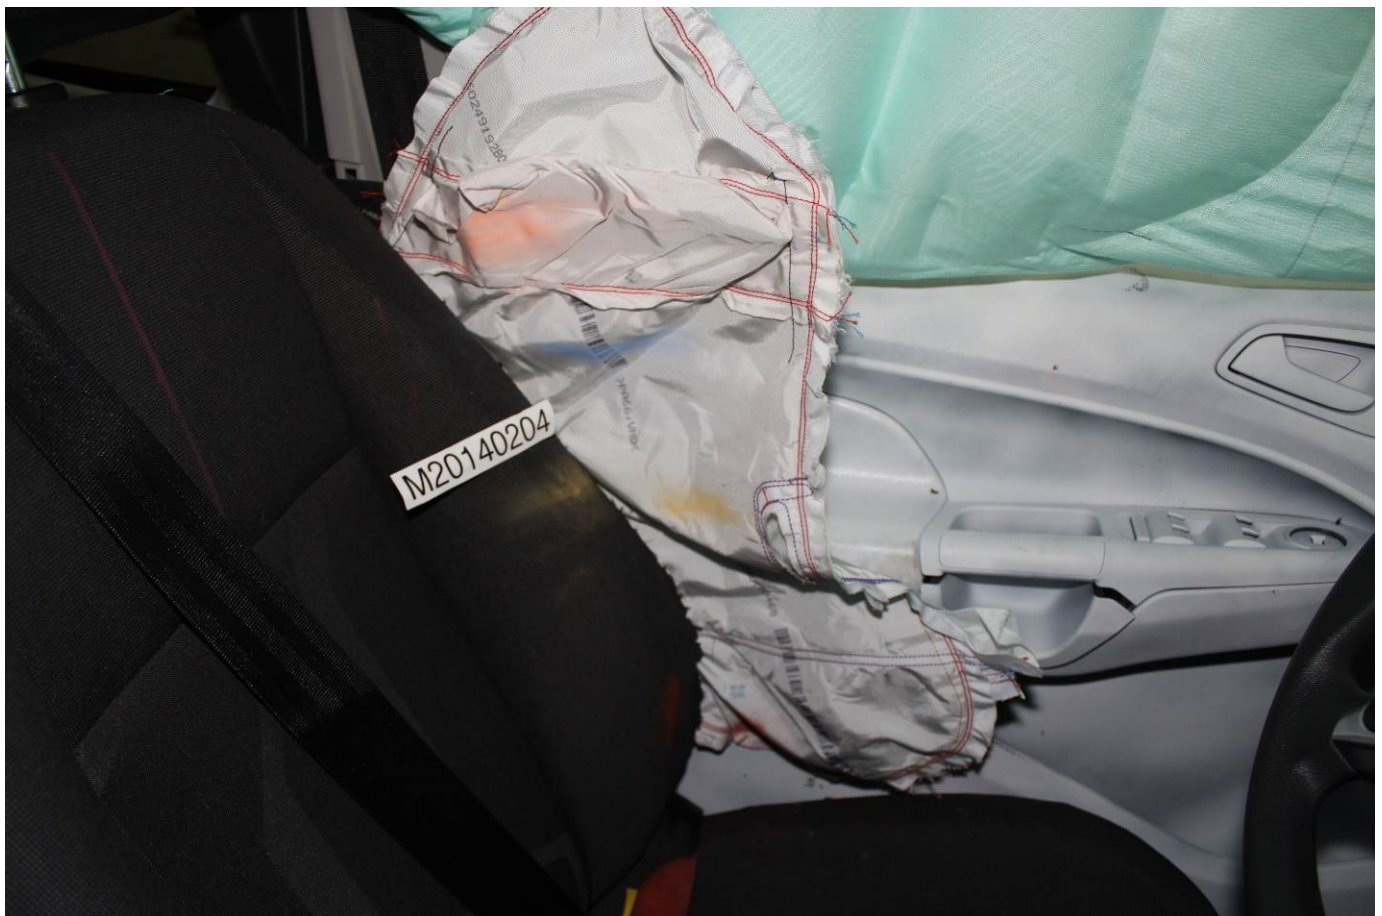
Post-Test Driver Dummy Close-up Torso Contact with Side Airbag View

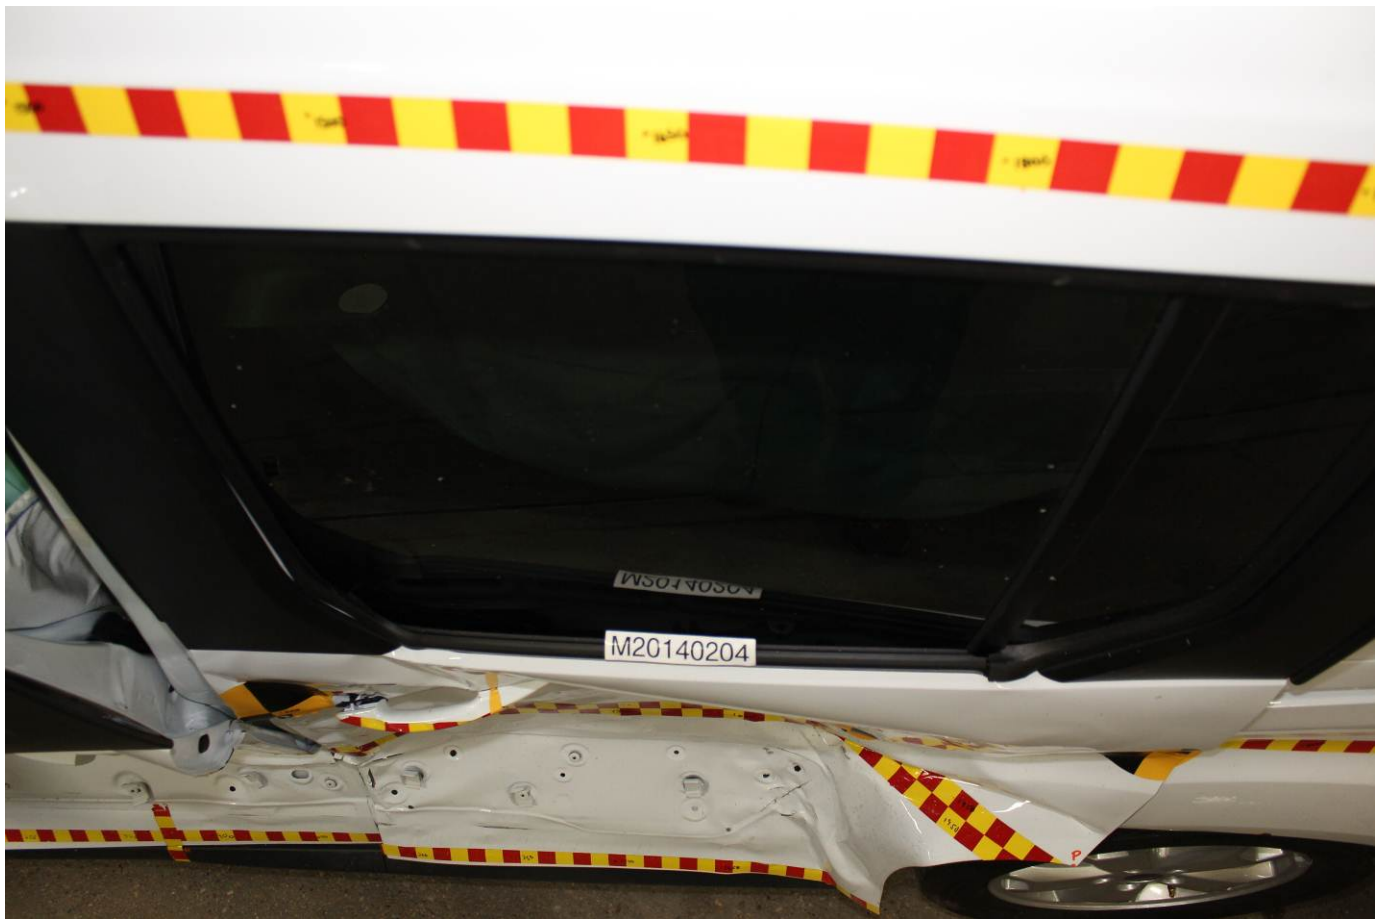
Post-Test Rear Passenger Dummy and Door Clearance View
