**REPORT NUMBER: NCAP-CAL-14-014**

**NEW CAR ASSESSMENT PROGRAM (NCAP)  
FRONTAL BARRIER IMPACT TEST**

**General Motors LLC  
2015 Chevrolet Silverado  
2500 Crew Cab**

**FINAL REPORT**

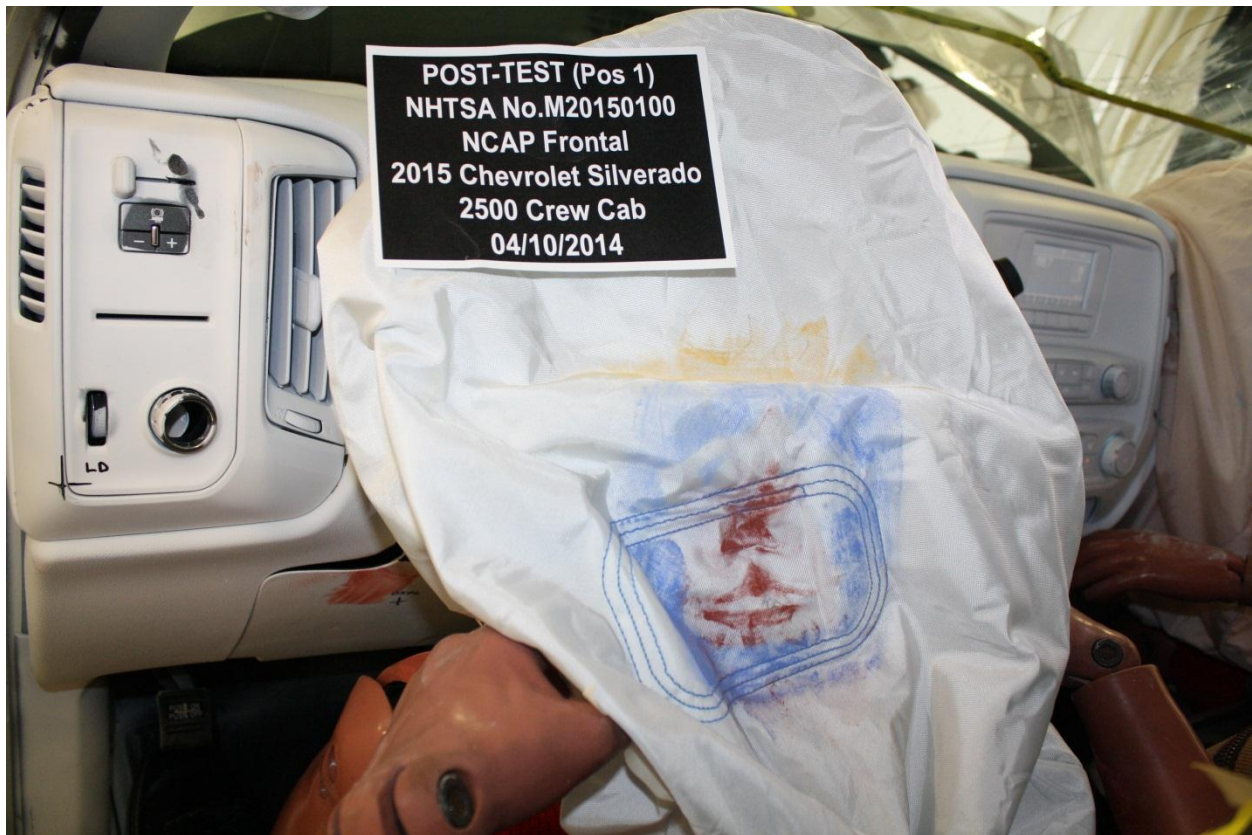
**Figure A-46: Post-Test Driver Dummy Contact With Airbag**

The driver's visible contact points were as follows: The driver's head contacted the frontal airbag and then the head restraint. The upper torso contacted the frontal airbag. Both knees contacted the knee bolster.

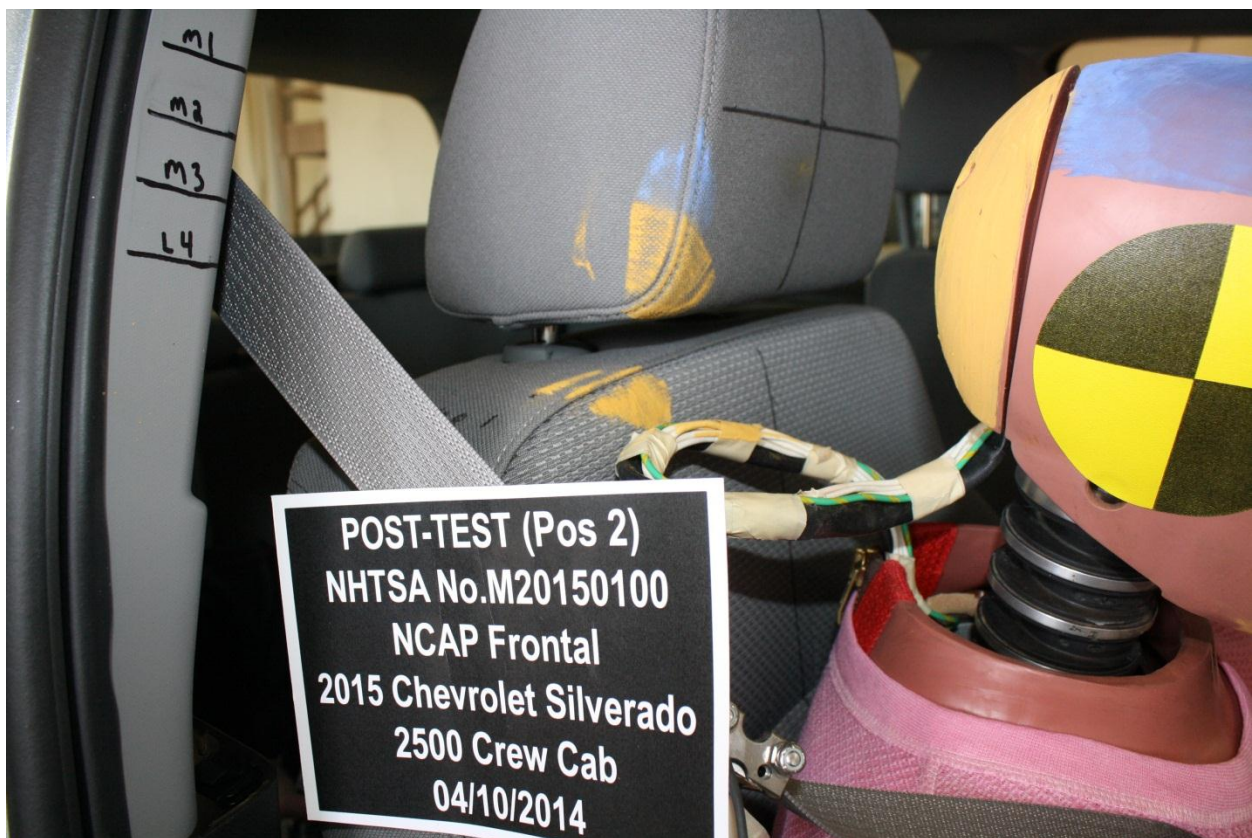
**Figure A-68: Post-Test Passenger Dummy Contact With Headrest**

The passenger's visible contact points were as follows: The passenger's head contacted the frontal airbag and then the head restraint and seat back. The upper torso contacted the frontal airbag. Both knees contacted the glove box.
