**FINAL REPORT NUMBER: SPNCAP-TRC-15-001**

**NEW CAR ASSESSMENT PROGRAM (NCAP)  
SIDE IMPACT POLE TEST**

**General Motors LLC  
2015 Chevrolet Tahoe 4-Door SUV  
NHTSA NUMBER: M20150110**

**PREPARED BY:  
Transportation Research Center Inc.  
10820 State Route 347  
P. O. Box B-67  
East Liberty, OH 43319**

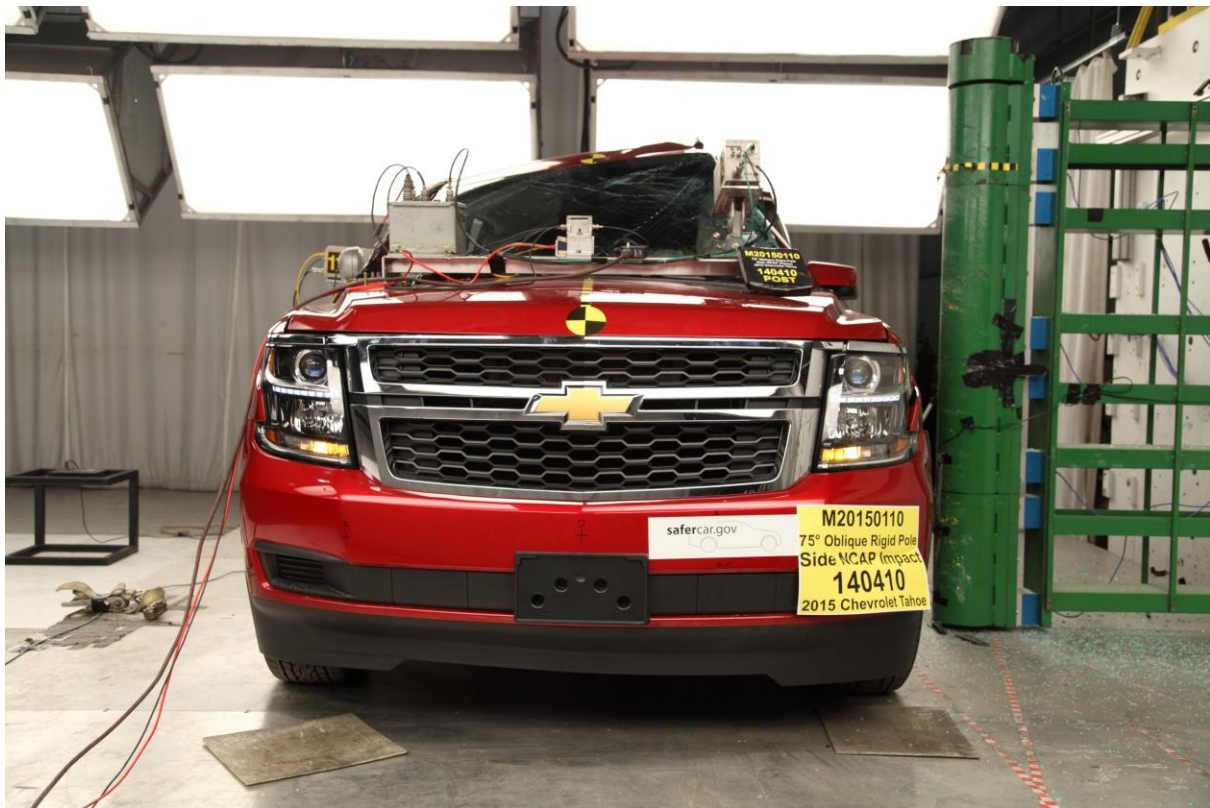
**004** Post-Test Frontal View of Test Vehicle

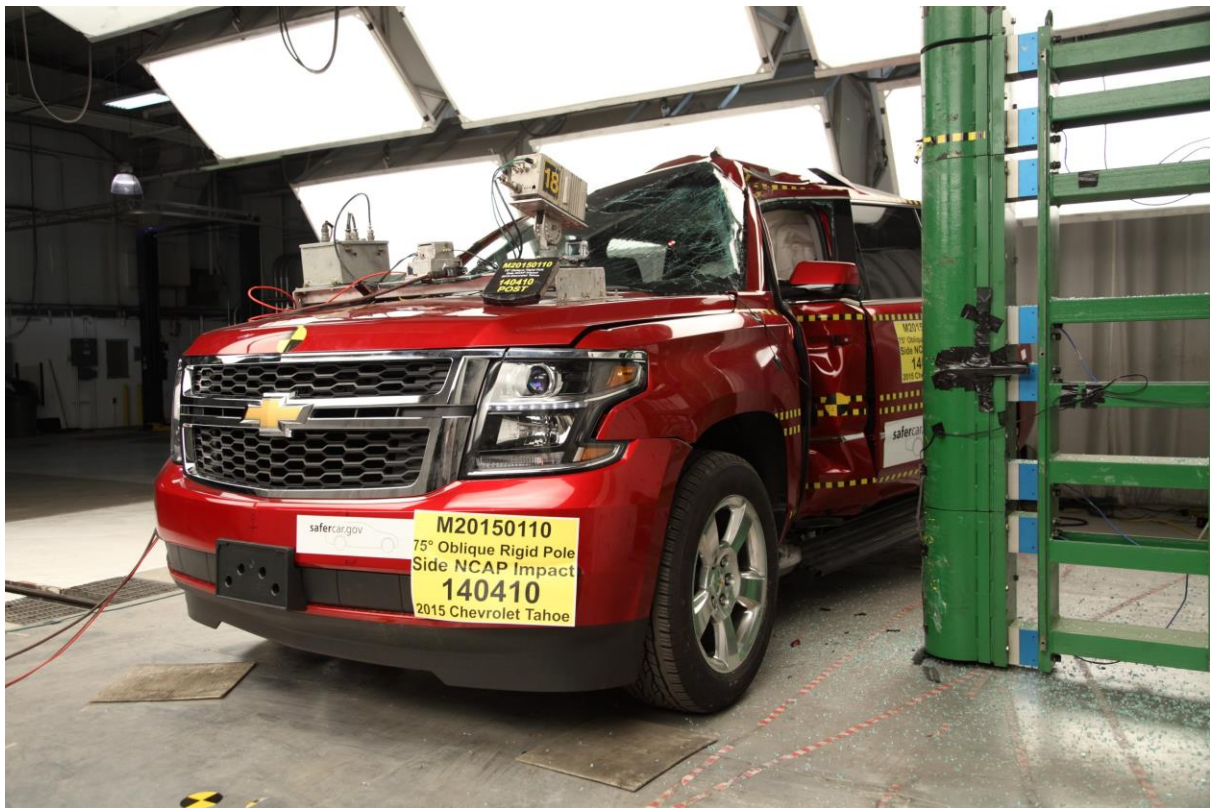
**006** Post-Test Left Front 3-4 View of Test Vehicle

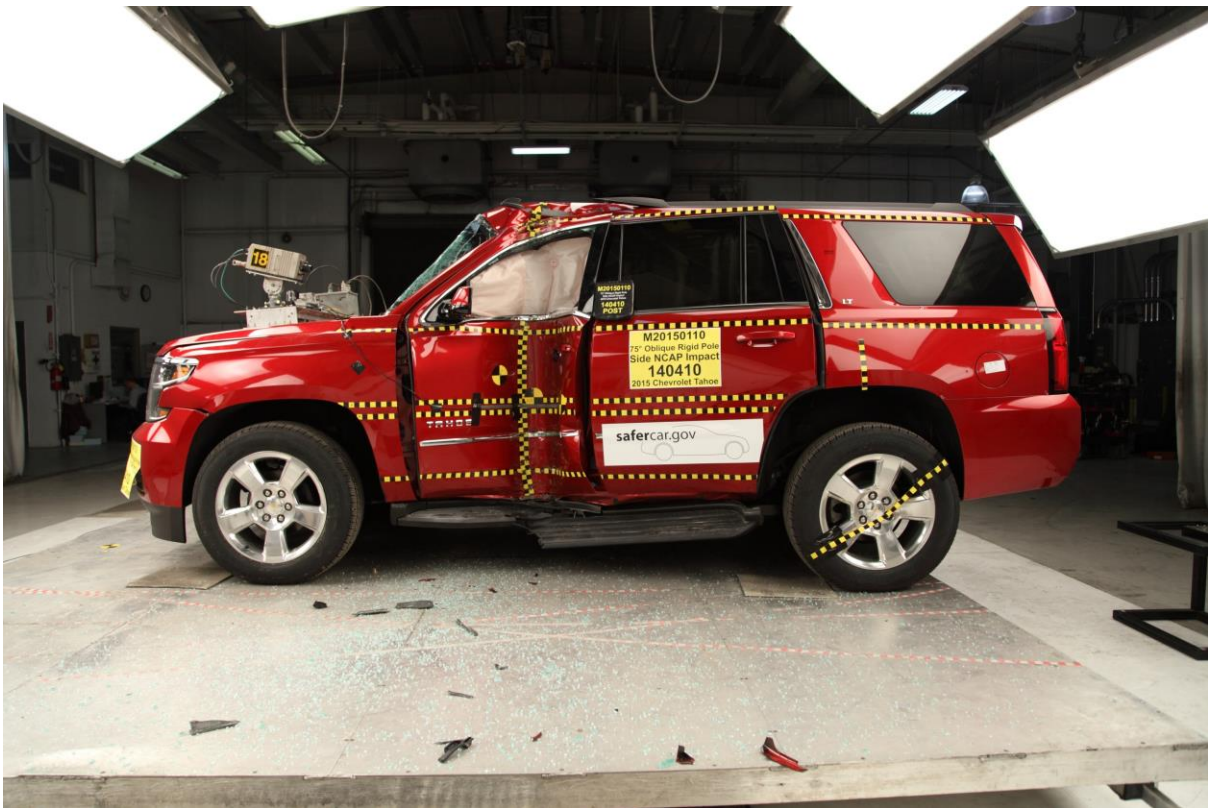
**008** Post-Test Left Side View of Test Vehicle

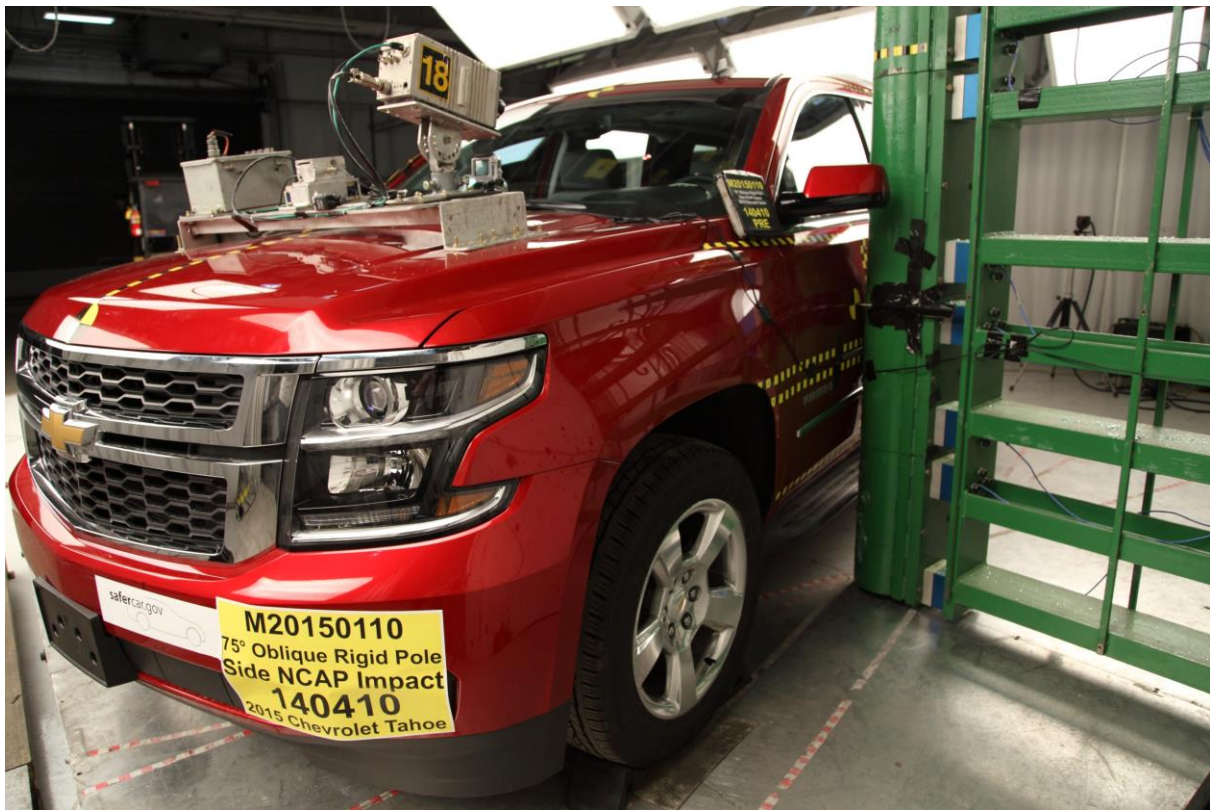
**017** Pre-Test Left Side View of Pole Positioned Against Side of Vehicle

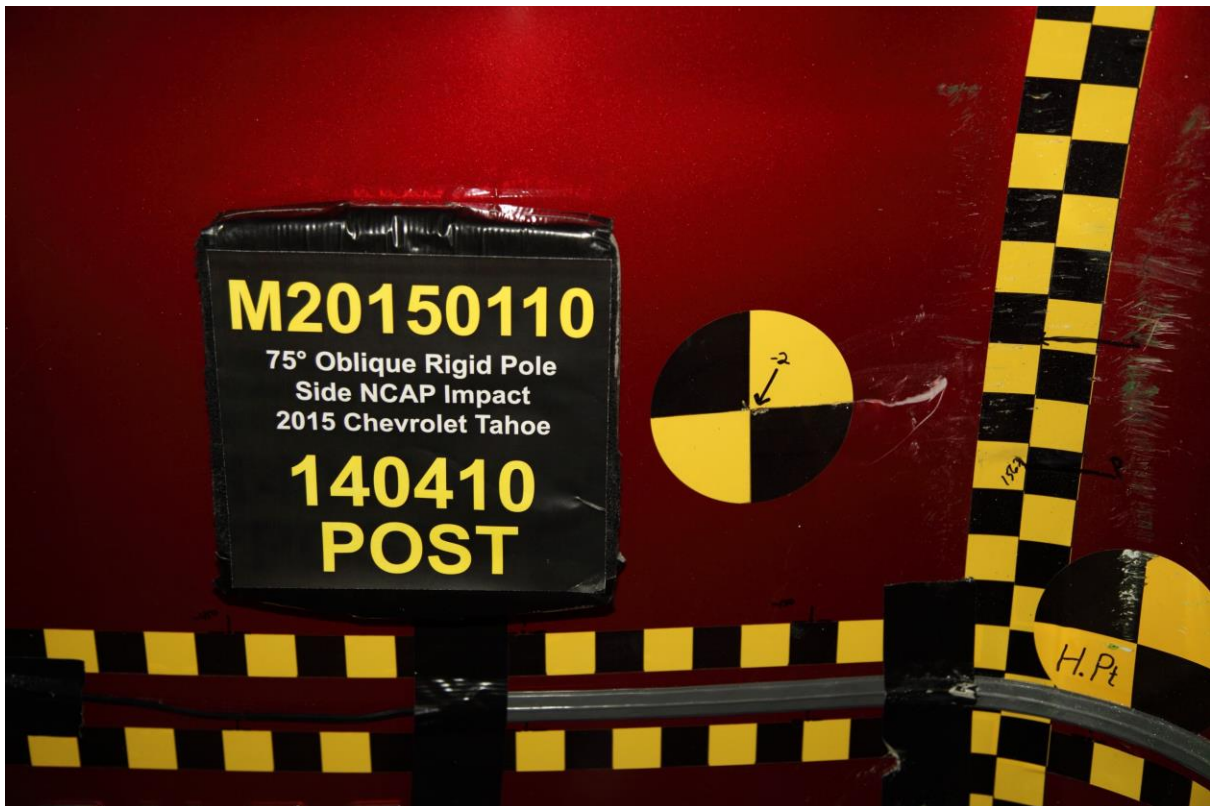
020 Post-Test Close-Up View of Impact Point Target Showing Impact Location

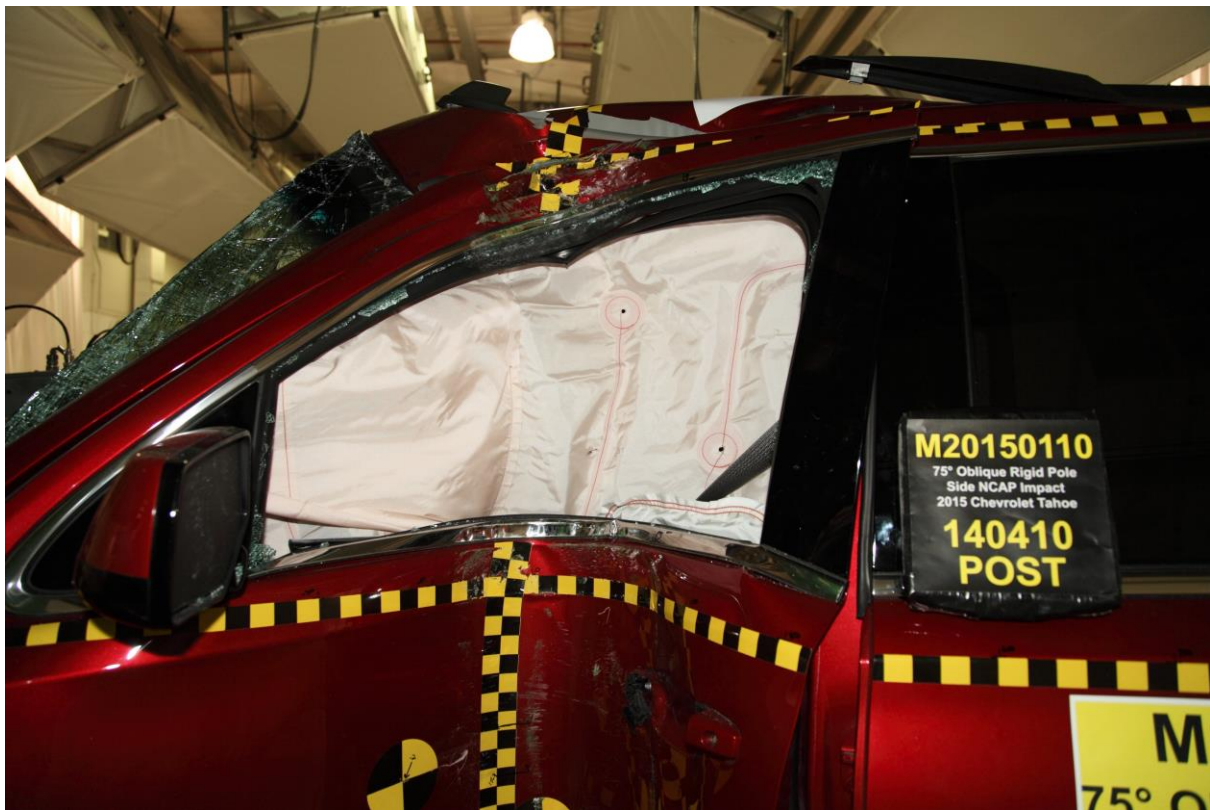
**025** Post-Test Left Side View of Dummy Shoulder and Door Top View

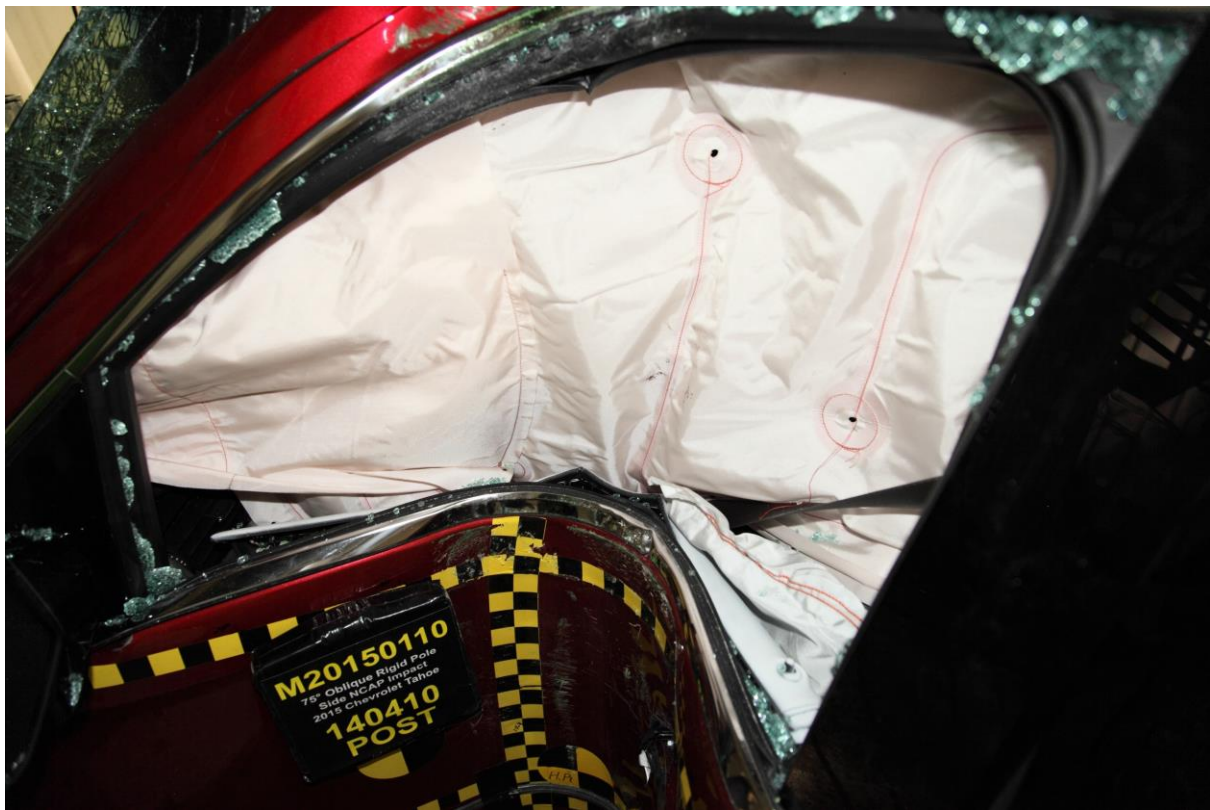
**041** Post-Test Dummy and Door Clearance View

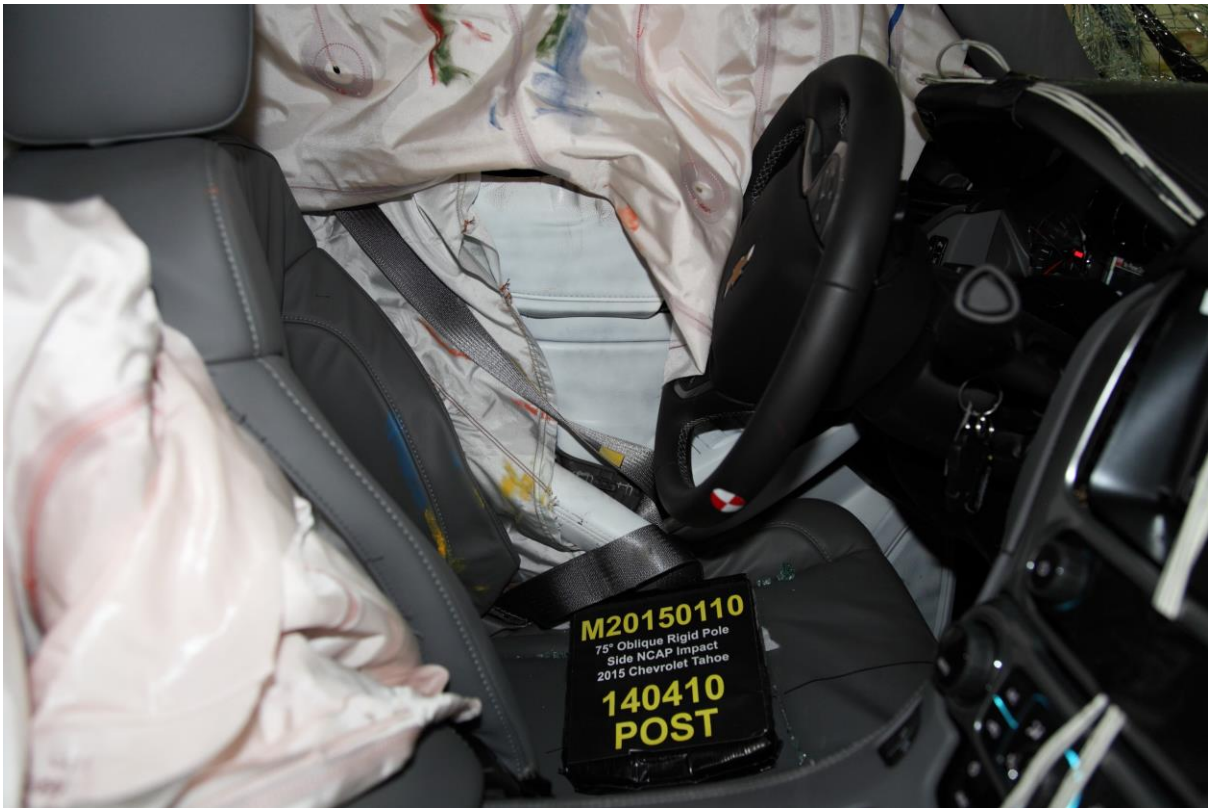
**045** Post-Test Inner Driver Door Panel View Showing Dummy Contact Location

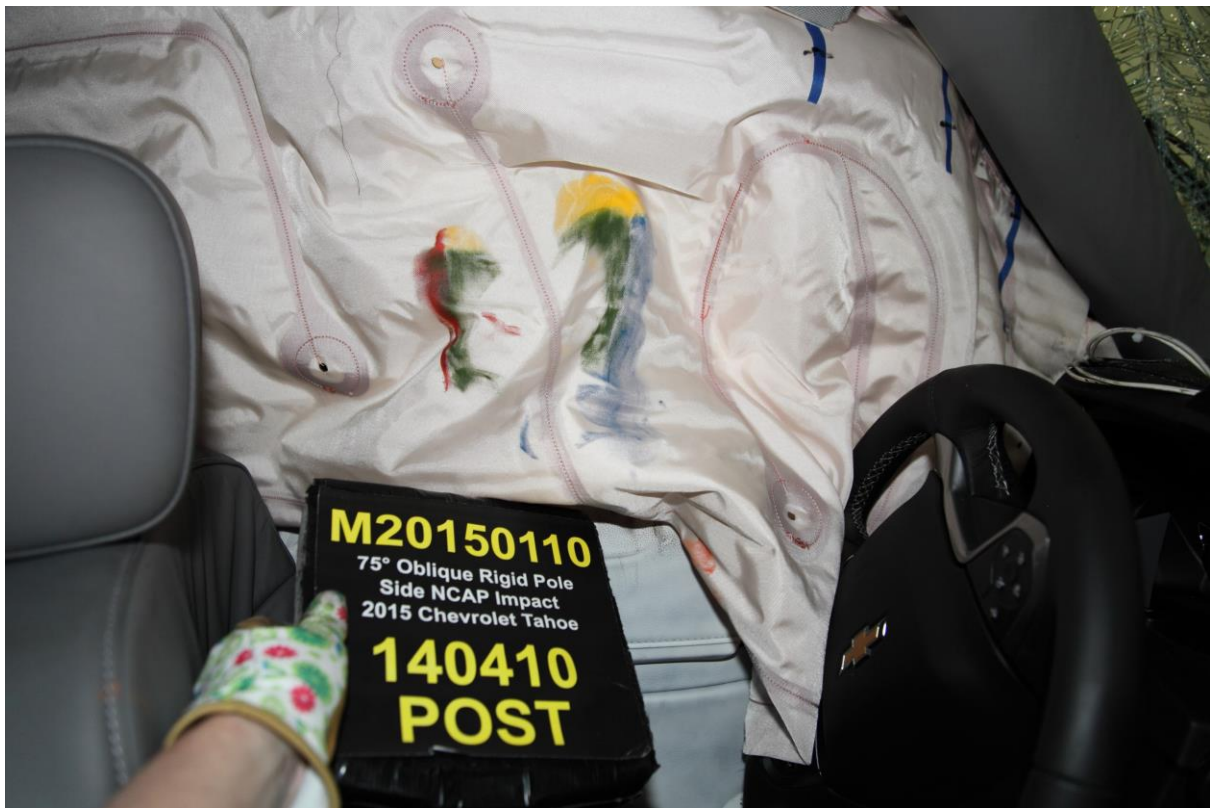
**047** Post-Test Dummy Close-Up Head Contact with Side Airbag View

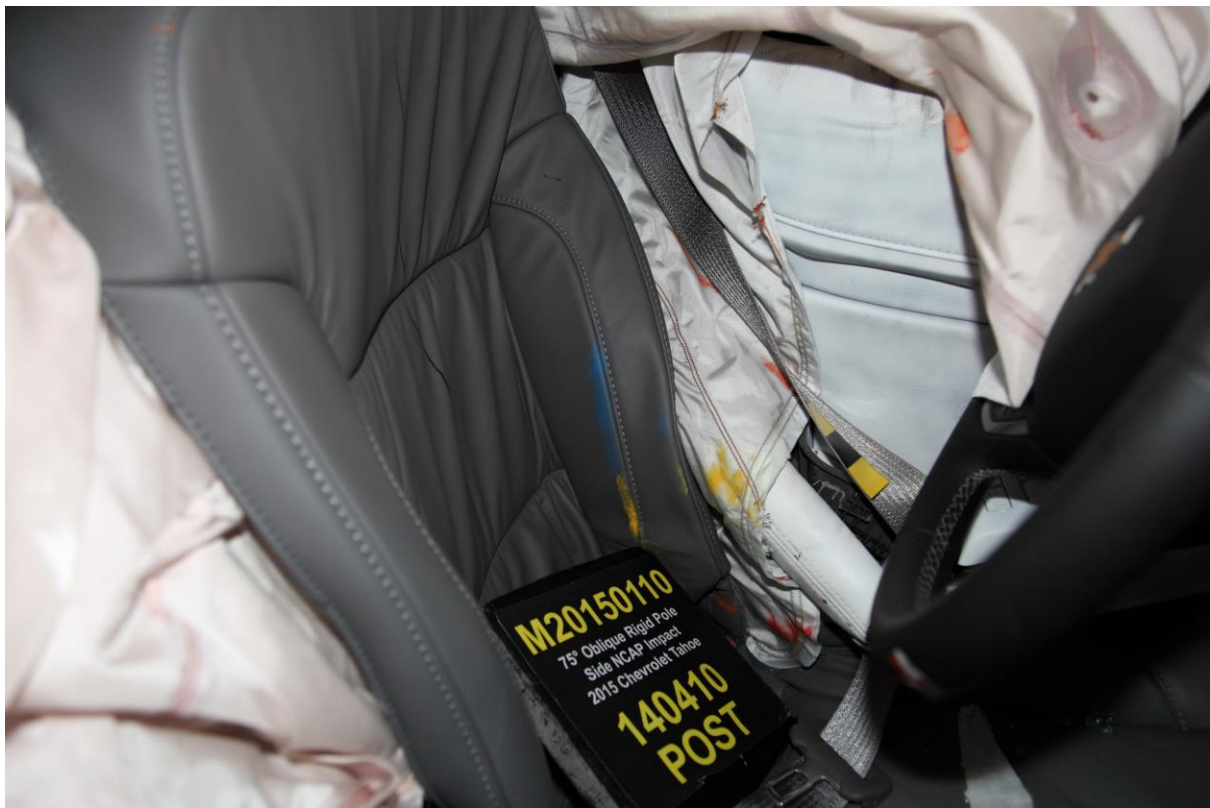
**048** Post-Test Dummy Close-Up Torso Contact with Vehicle Interior View

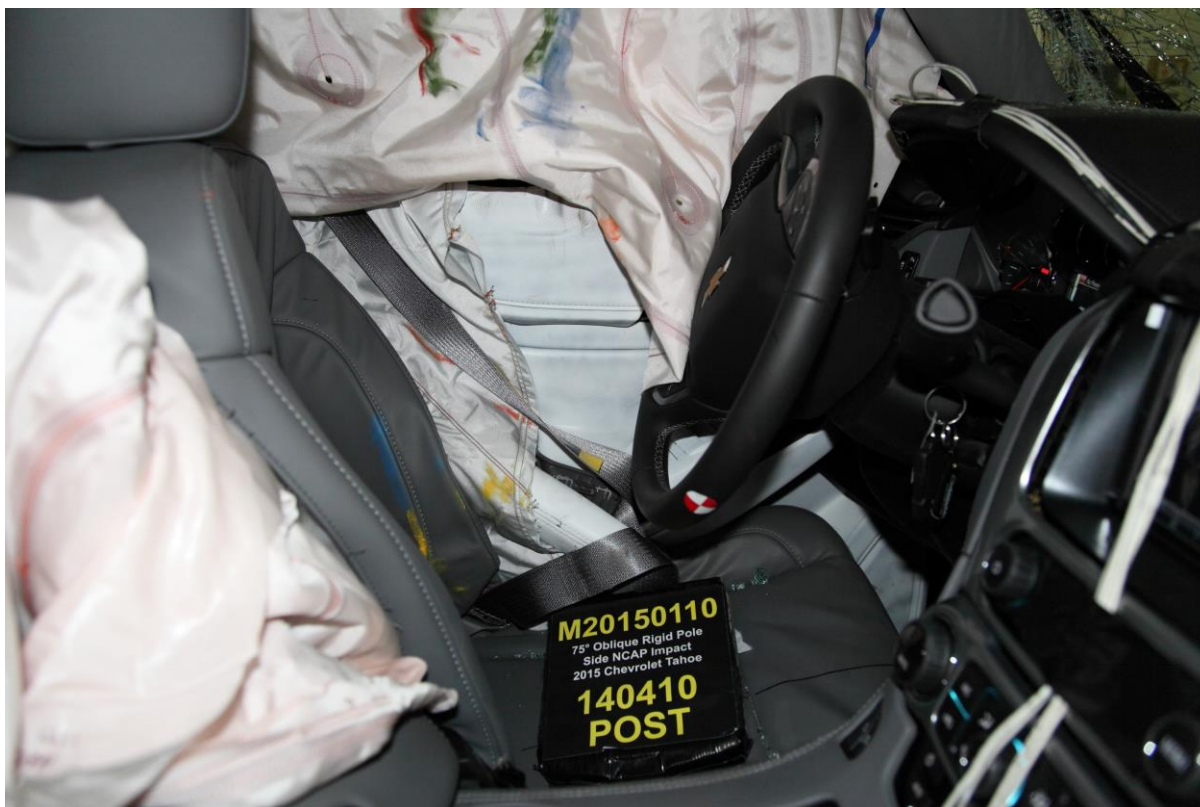
**049** Post-Test Dummy Close-Up Torso Contact with Side Airbag View

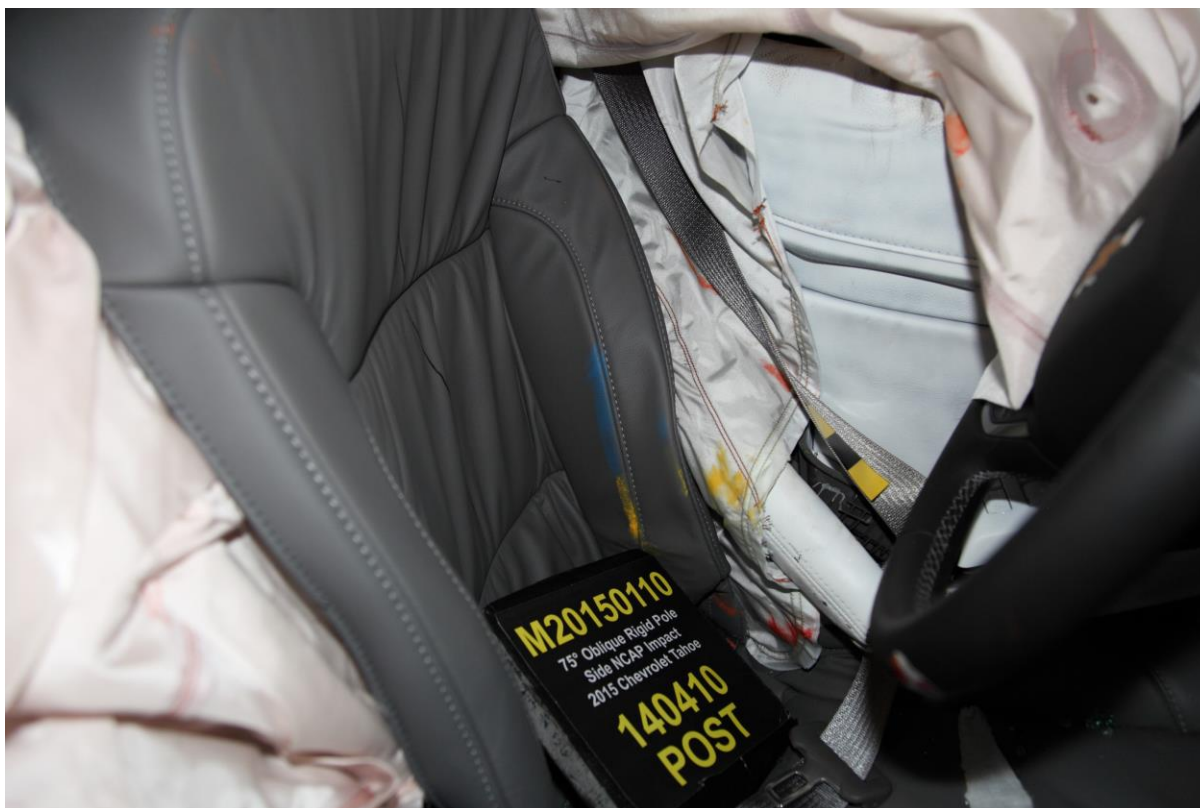
**050** Post-Test Dummy Close-Up Pelvis Contact with Vehicle Interior View

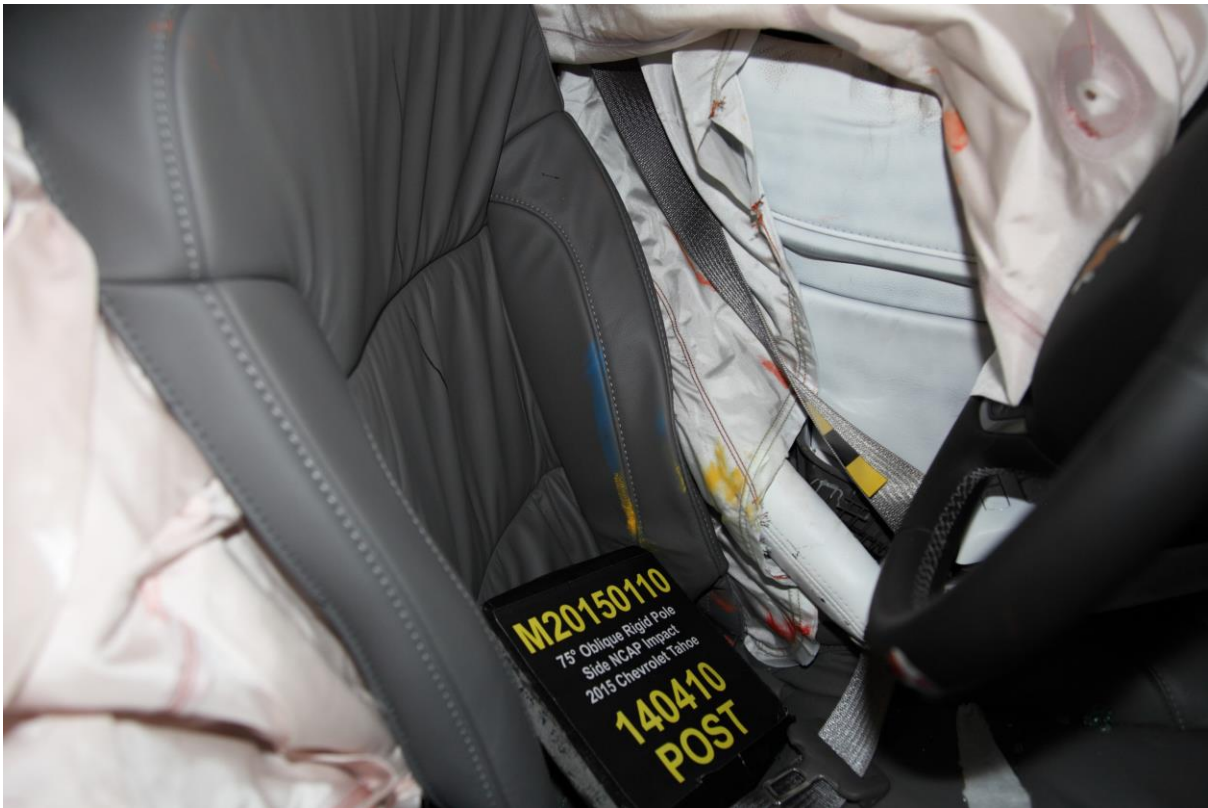
**051** Post-Test Dummy Close-Up Pelvis Contact with Side Airbag View

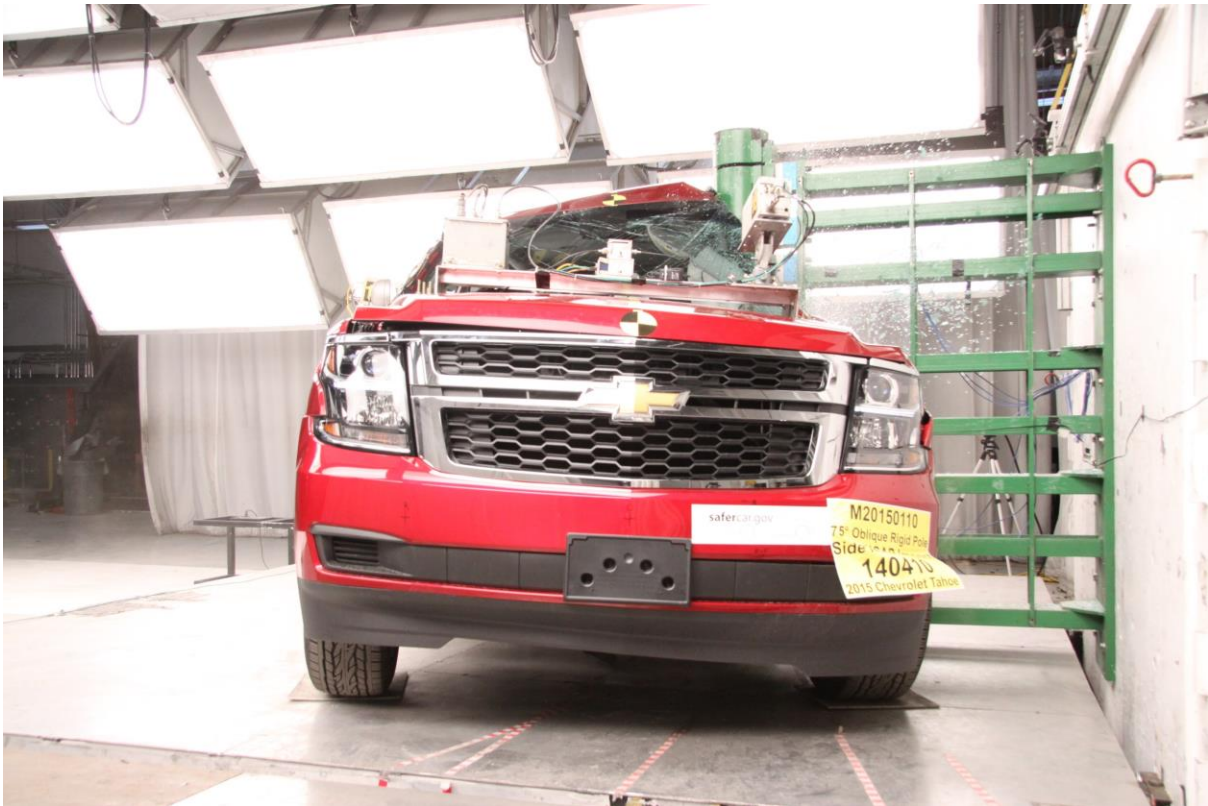
**068** Impact Event
