REPORT NUMBER: TWG-TRC-14-03

NEW CAR ASSESSMENT PROGRAM (NCAP)
SIDE AIRBAG OUT-OF-POSITION INJURY TESTING

Chrysler Group LLC
2014 Jeep Cherokee MPV

NHTSA NUMBER: M20140302TWG2
TRC TEST NUMBER: 140414

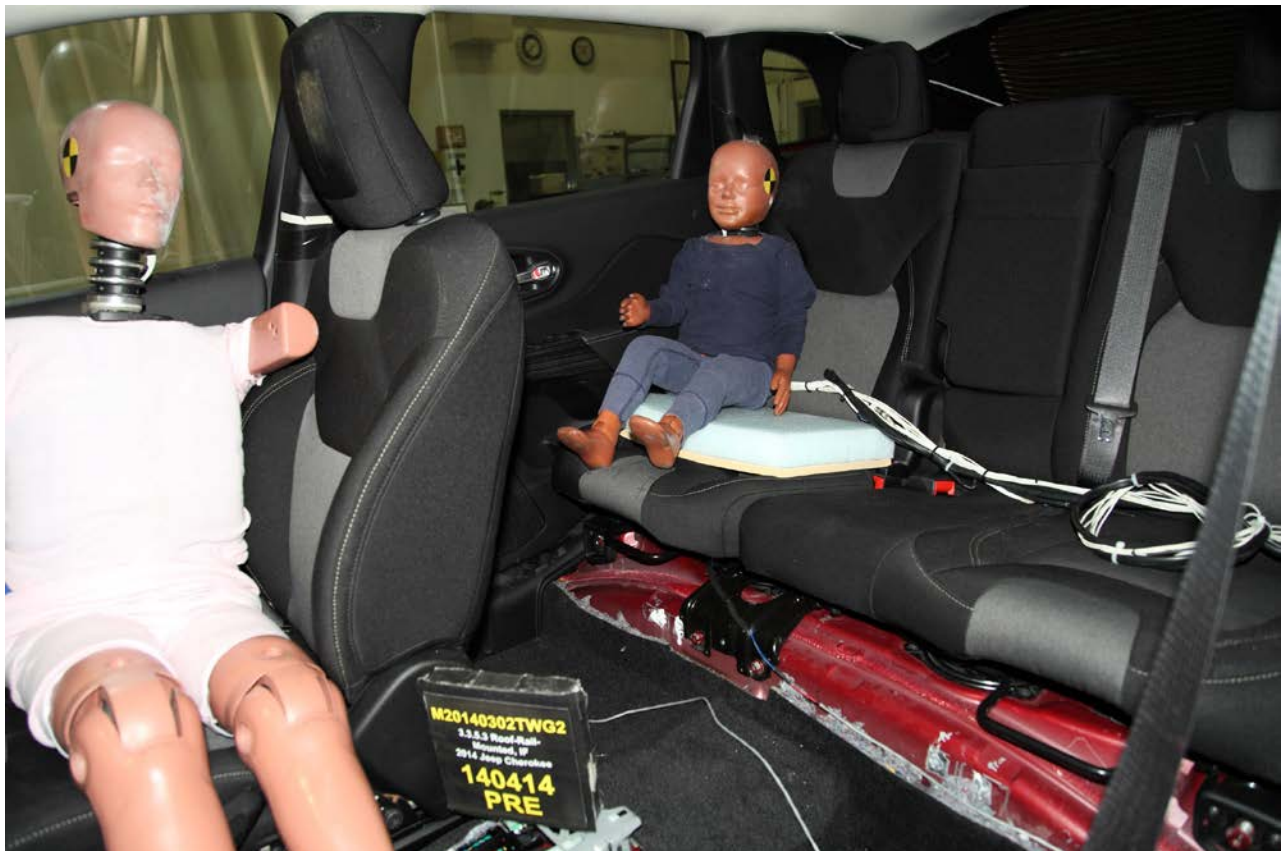
Figure A-6 Pre-Test Front Right Dummy Position – ¾ View

The SID-II's ATD was positioned in the seat dummy facing toward the center of the vehicle with its arm against the seatback. The arm was rotated horizontal in the forward direction with respect to the dummy. The seat was positioned to minimize the vertical distance between the dummy's head and the roof-rail module and to maximize the cushion to head interaction. The seat track test position was 2 detents rearward of full forward. The head was in a neutral orientation and the pelvis was in contact with the door trim panel. The CG of the head was centered in the deployment trajectory of the airbag. A vertical plane through the centerline of the dummy's rib-stiffener and shoulder bolt was parallel to the centerline of the vehicle. This orientation complies with section 3.3.5.3 of the TWG Recommended Procedures for Evaluating Occupant Injury Risk from Deploying Side Airbags, First Revision dated July, 2003.

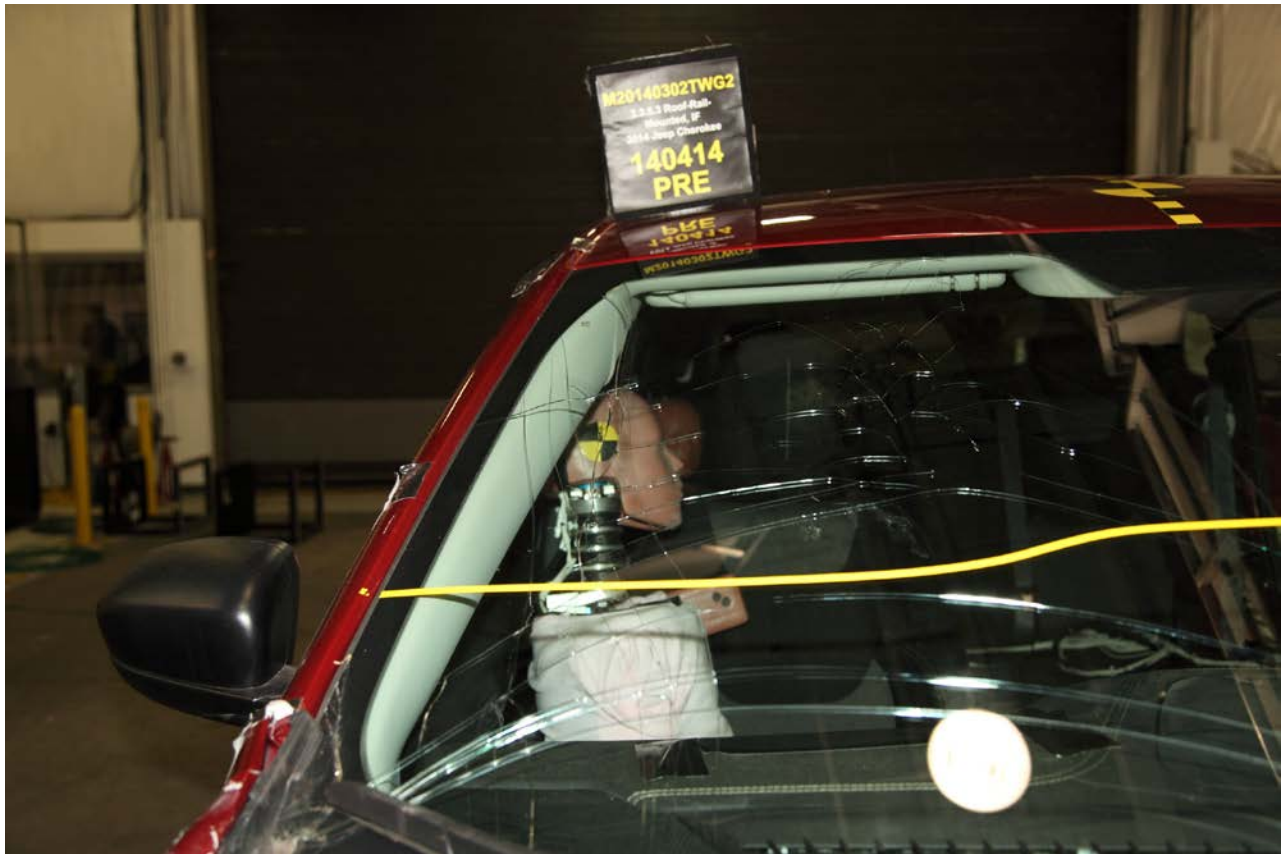
Figure A-7 Pre-Test Front Right Dummy Position – Front View

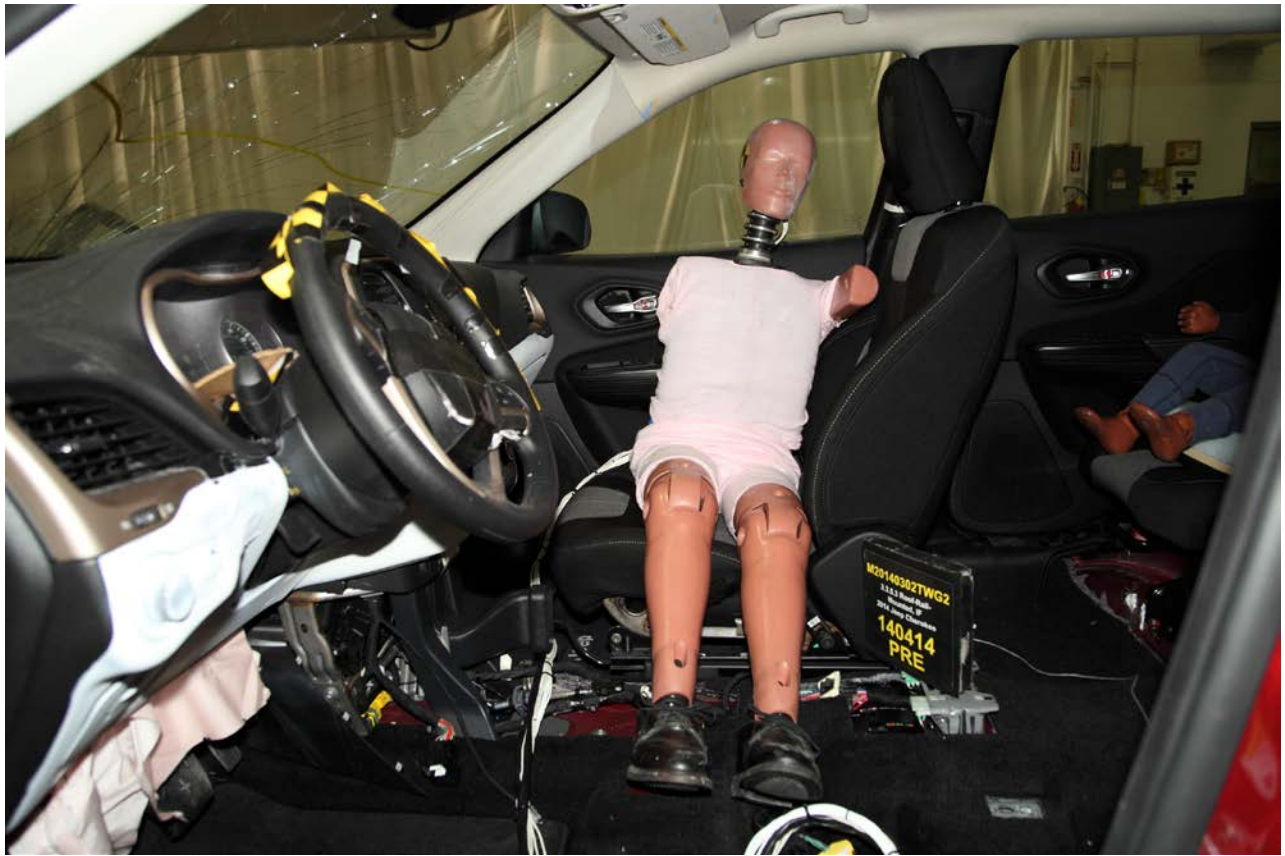
Figure A-8 Pre-Test Front Right Dummy Positioning – Left Side View

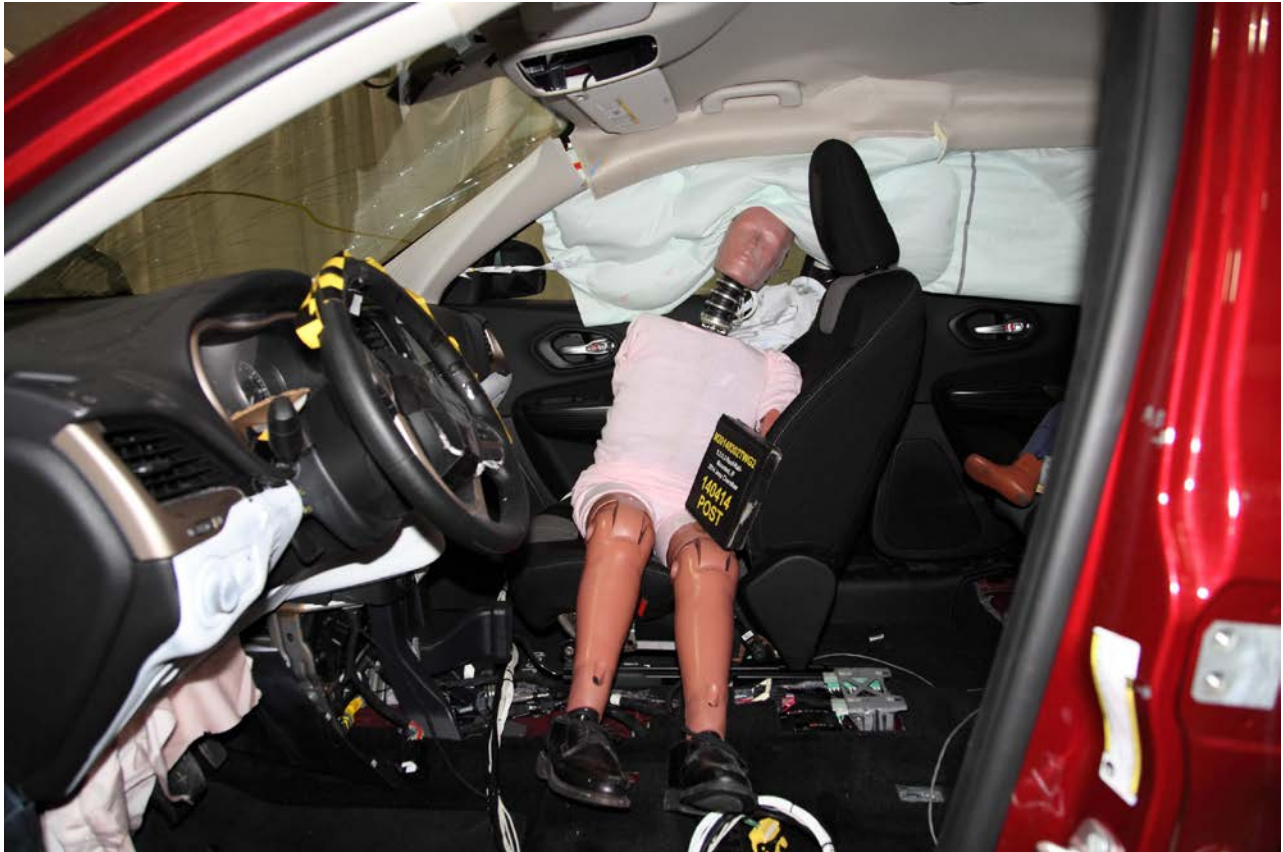
Figure A-9 Post-Test Front Right Dummy Position – Left Side View

Head Contact:	Curtain Airbag
Upper Torso Contact:	Torso Airbag
Lower Torso Contact:	None
Left Knee Contact:	None
Right Knee Contact:	None

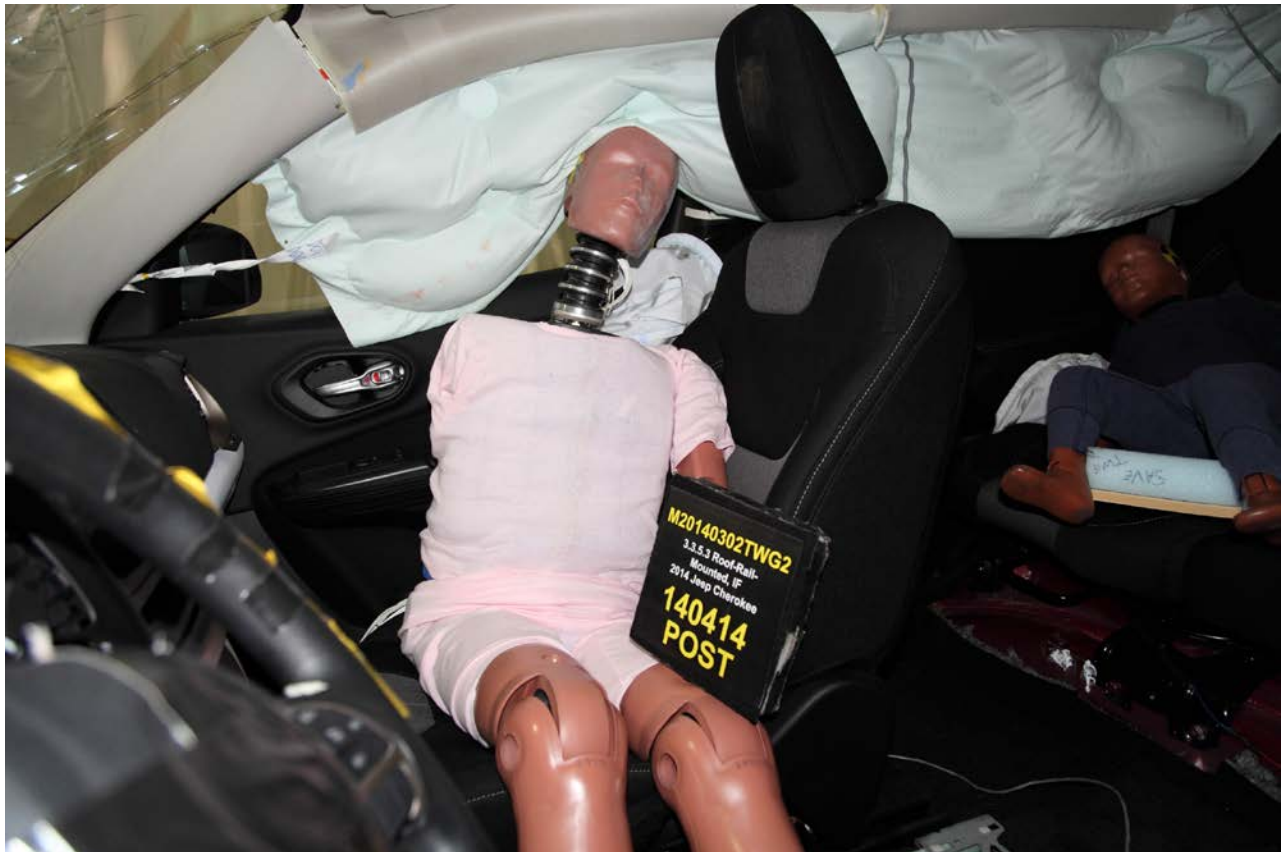
Figure A-10 Post-Test Front Right Dummy Position – ¾ View

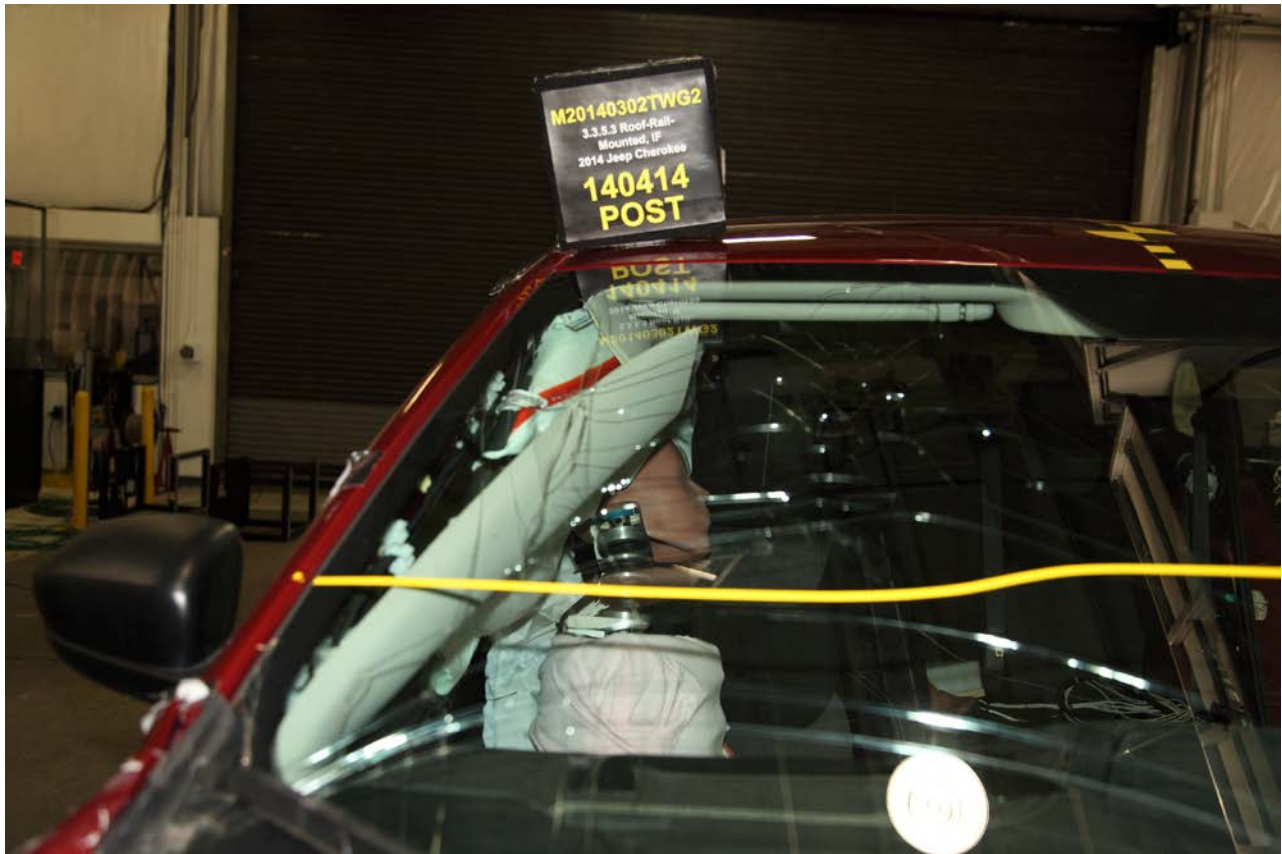
Figure A-11 Post-Test Front Right Dummy Position – Front View

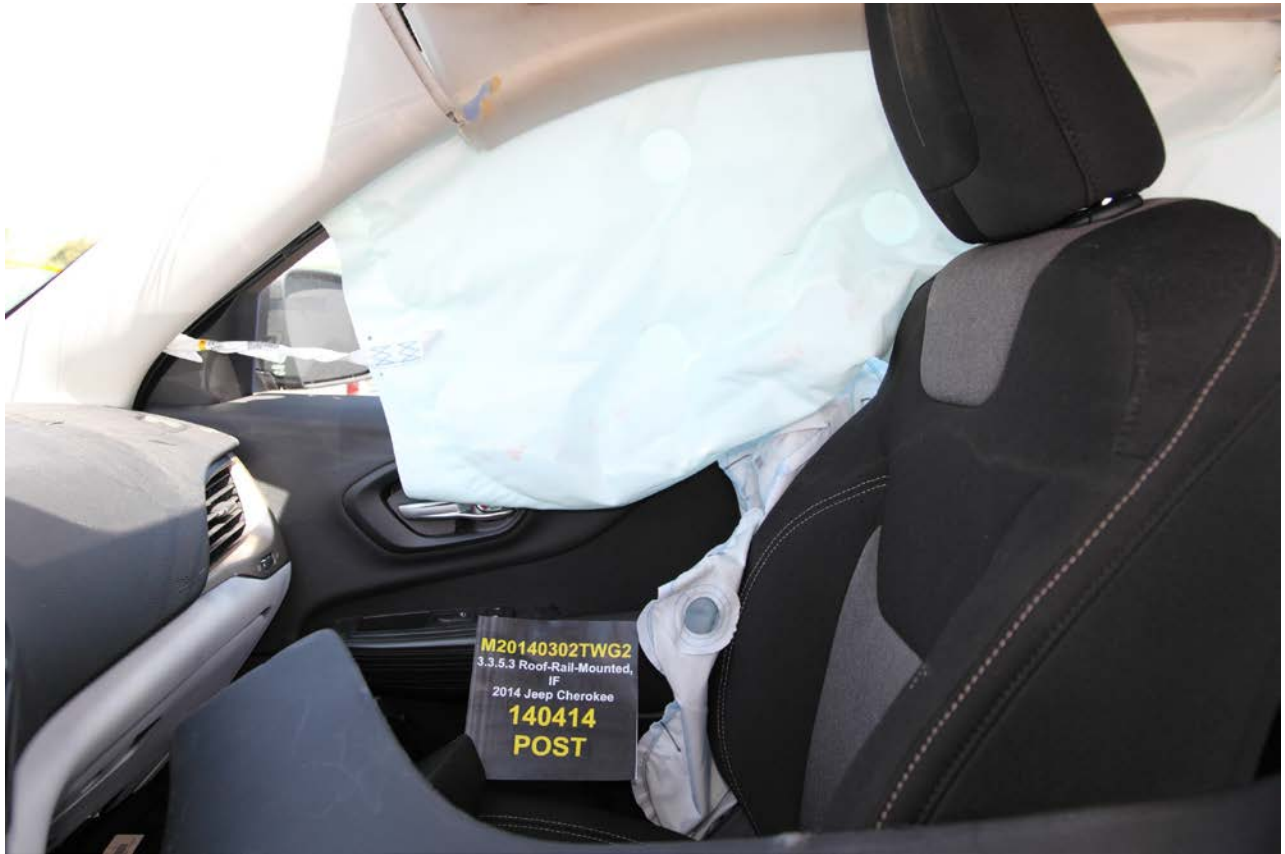
Figure A-12 Post-Test Front Passenger Airbags – Left Side View

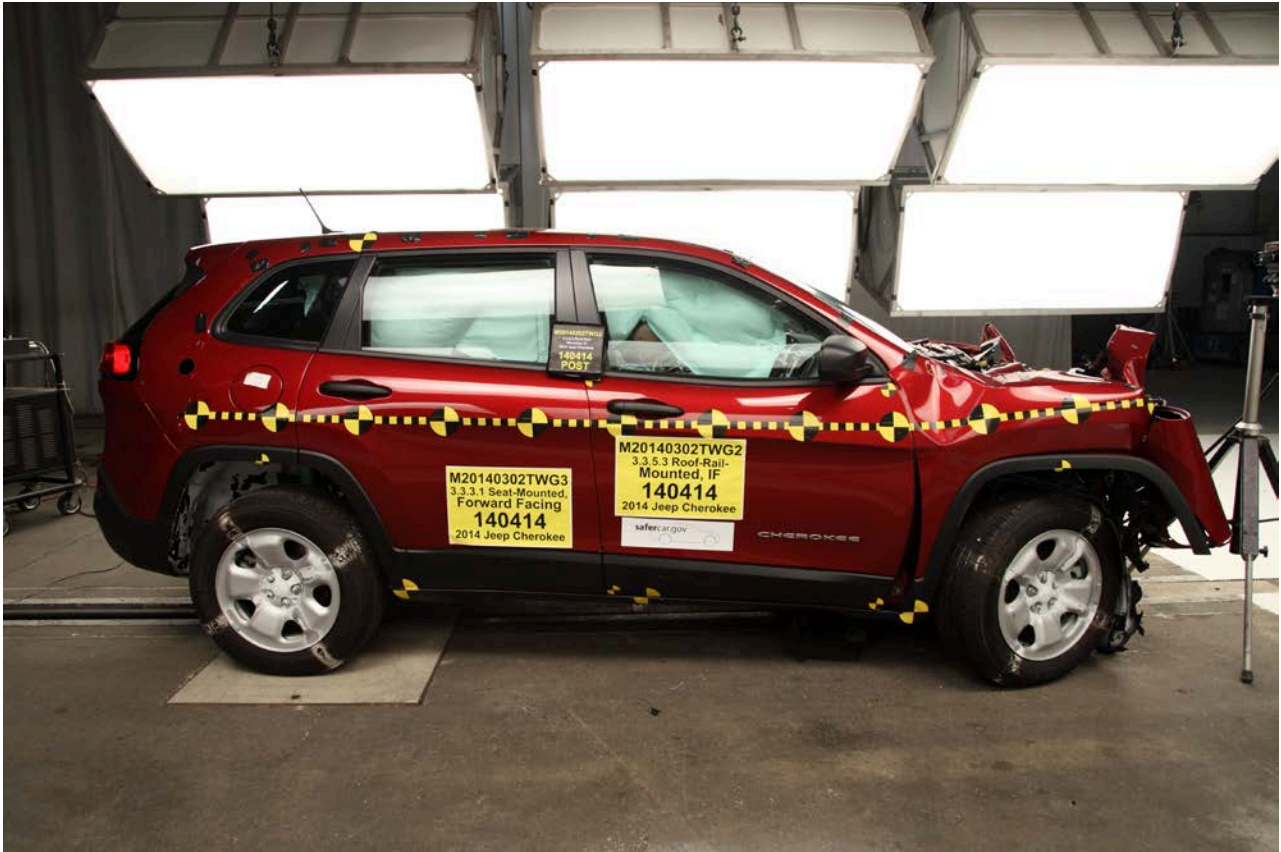
Figure A-13 Post-Test Front Passenger Door – Window View

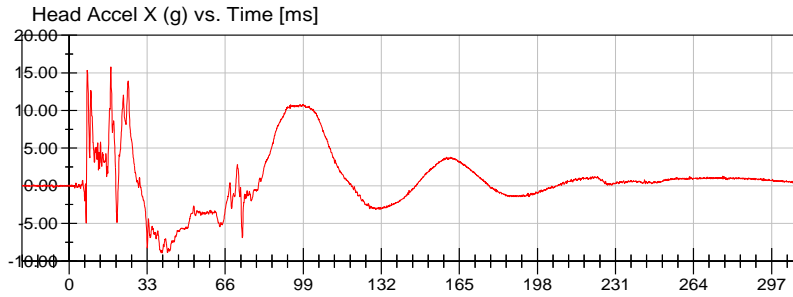
15.77 g at 17.60 ms

-8.93 g at 38.96 ms

Channel	Max	Time (ms)	Min	Time (ms)
Head Ax [g , CFC_1000]	15.775	17.60	-8.927	38.96
Head Ay [g , CFC_1000]	6.950	90.24	-34.246	7.28
Head Az [g , CFC_1000]	55.169	7.28	-9.990	10.72
Upper Neck Fx [N , CFC_1000]	391.729	23.60	-78.471	37.12
Upper Neck Fy [N , CFC_1000]	578.966	49.20	-5.407	0.88
Upper Neck Fz [N , CFC_1000]	900.414	90.88	-1,331.490	16.80
Upper Neck Mx [N-m , CFC_600]	23.849	85.84	-37.282	16.88
Upper Neck My [N-m , CFC_600]	59.951	23.52	-12.921	98.40
Upper Neck Mz [N-m , CFC_600]	18.618	41.44	-8.939	90.88
Lower Neck Fx [N , CFC_1000]	697.603	21.20	-230.284	222.56
Lower Neck Fy [N , CFC_1000]	482.900	16.00	-116.147	240.88
Lower Neck Fz [N , CFC_1000]	6.063	0.64	-1,376.14	17.76
Lower Neck Mx [N-m , CFC_600]	65.830	38.00	-0.492	8.48
Lower Neck My [N-m , CFC_600]	39.549	16.40	-31.506	85.20
Lower Neck Mz [N-m , CFC_600]	34.726	16.08	-32.481	94.48
Airbag Event Passenger Side Curtain Voltage [V]	23.499	1.68

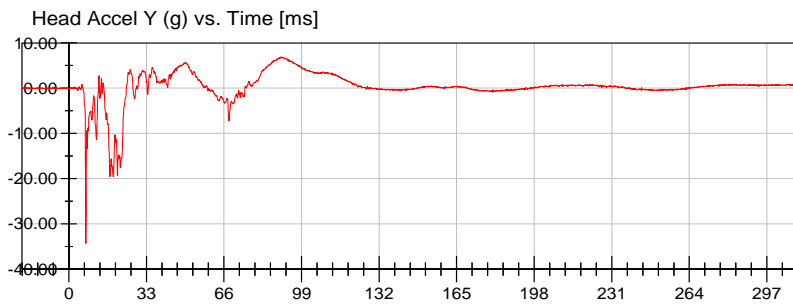
6.95 g at 90.24 ms

-34.25 g at 7.28 ms

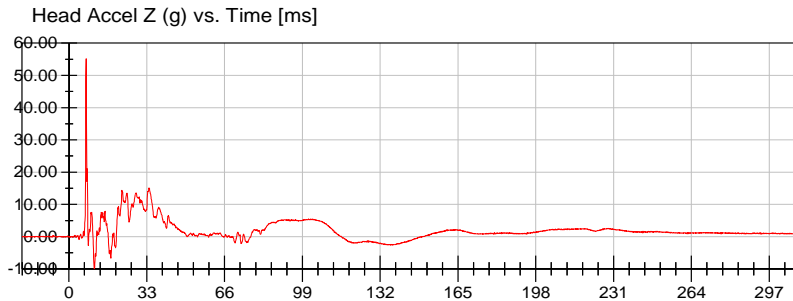
55.17 g at 7.28 ms

-9.99 g at 10.72 ms

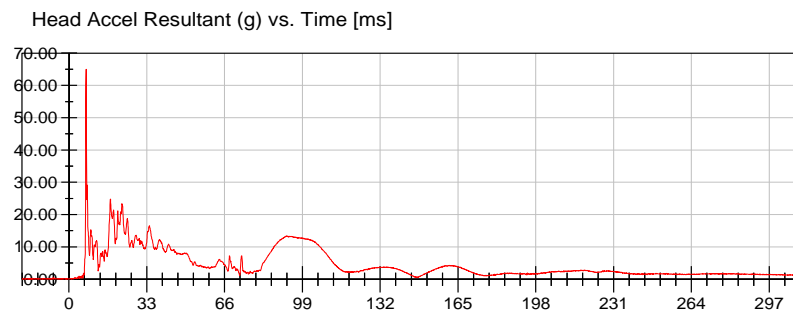
65.02 g at 7.28 ms

0.02 g at -19.84 ms

HIC(15)	t ₁ (msec)	t ₂ (msec)	HIC(36)	t ₁ (msec)	t ₂ (msec)
Position #2 Right Front	13.19	16.72	31.76	21.38	6.88	42.88

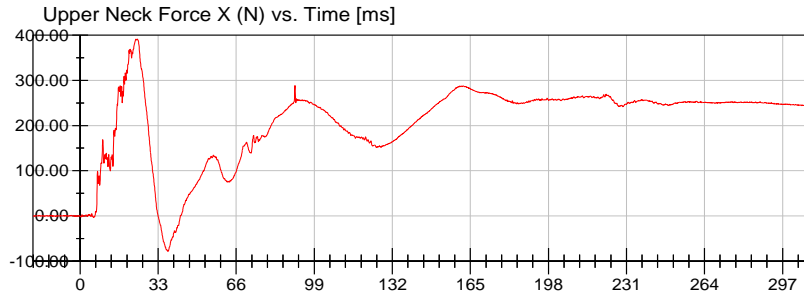
391.73 N at 23.60 ms

-78.47 N at 37.12 ms

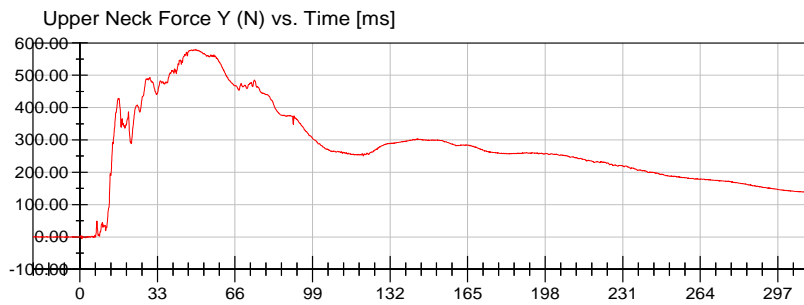
578.97 N at 49.20 ms

-5.41 N at 0.88 ms

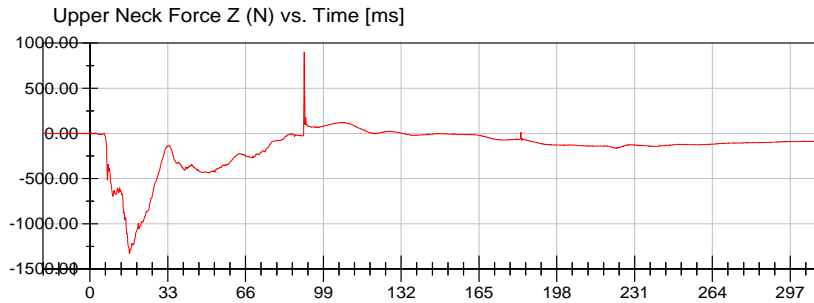
900.41 N at 90.88 ms

-1,331.49 N at 16.80 ms

**Peak Tension (CFC1000) 900.41 N Peak Compression (CFC1000) -1331.49 N
 Critical Values**

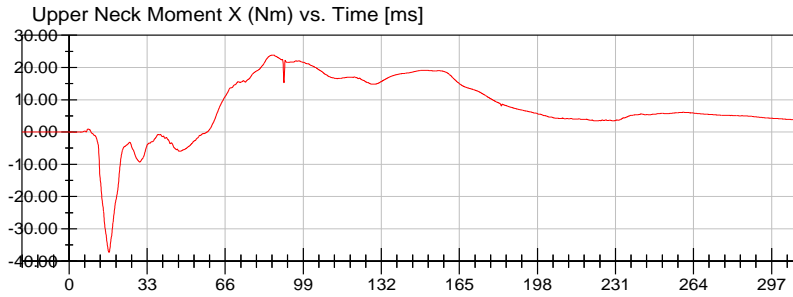
23.85 Nm at 85.84 ms

-37.28 Nm at 16.88 ms

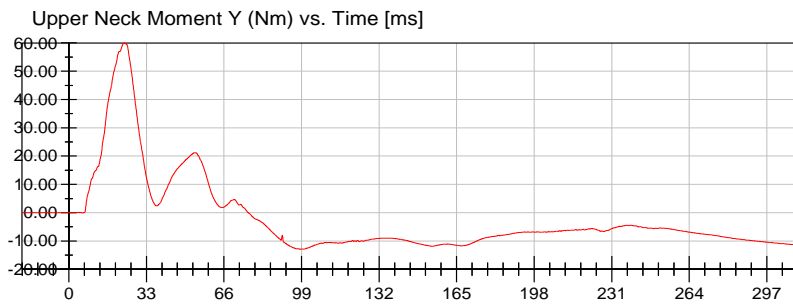
59.95 Nm at 23.52 ms

-12.92 Nm at 98.40 ms

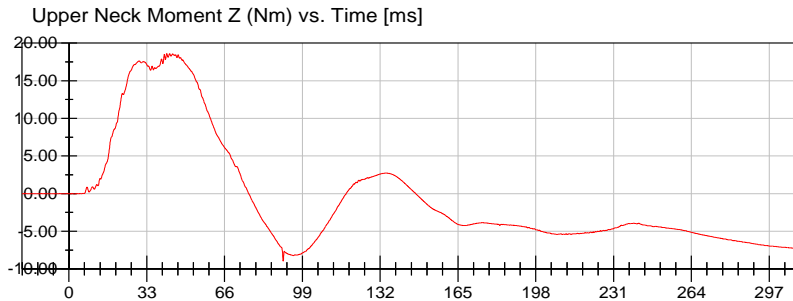
18.62 Nm at 41.44 ms

-8.94 Nm at 90.88 ms

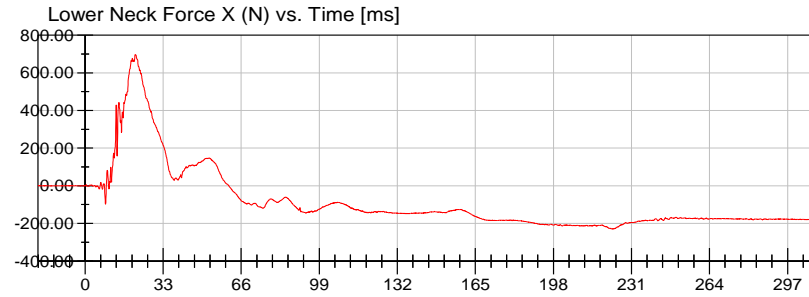
697.60 N at 21.20 ms

-230.28 N at 222.56 ms

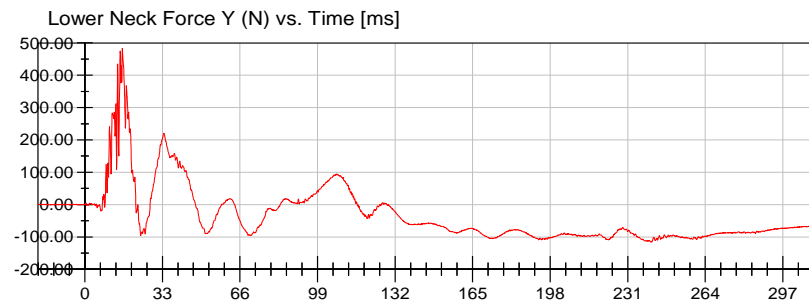
482.90 N at 16.00 ms

-116.15 N at 240.88 ms

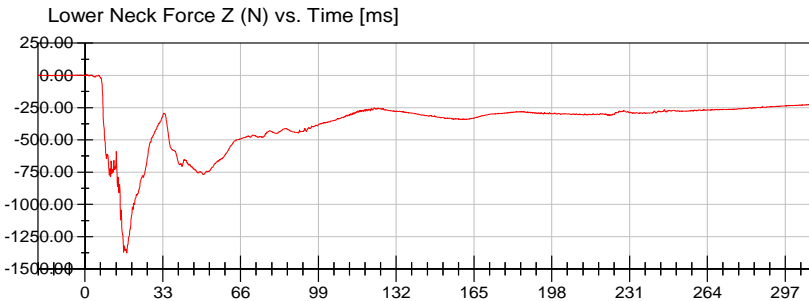
6.06 N at 0.64 ms

-1,376.14 N at 17.76 ms

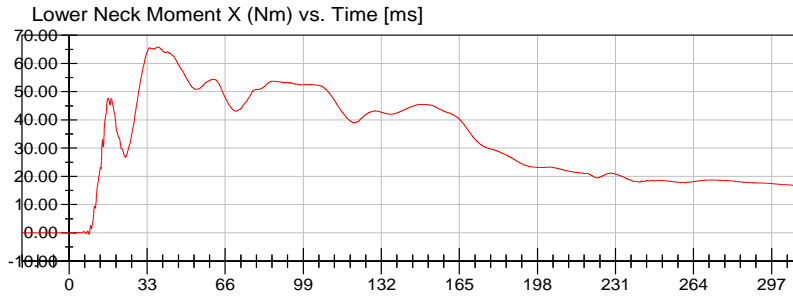
65.83 Nm at 38.00 ms

-0.49 Nm at 8.48 ms

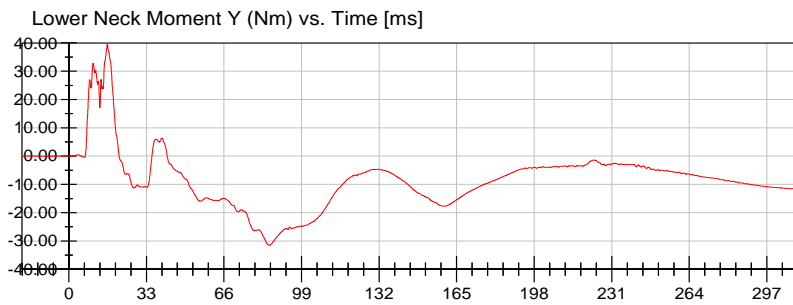
39.55 Nm at 16.40 ms

-31.51 Nm at 85.20 ms

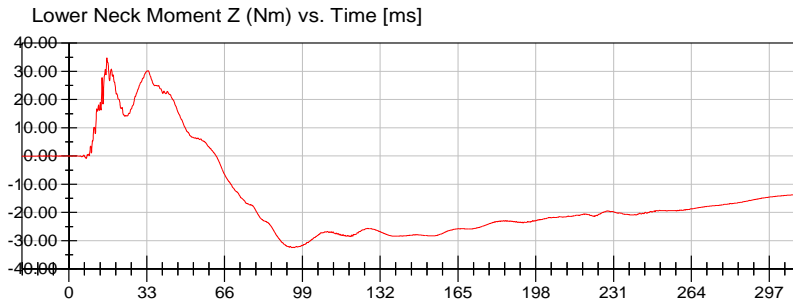
34.73 Nm at 16.08 ms

-32.48 Nm at 94.48 ms

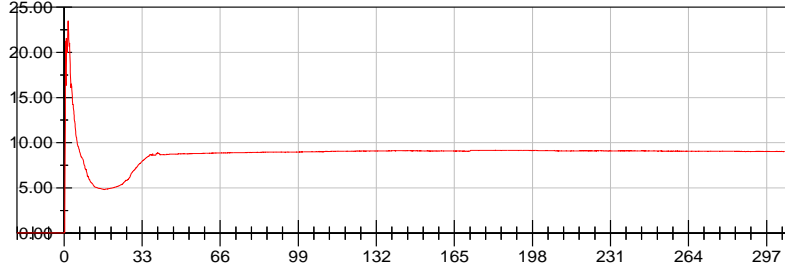
Airbag Event Right Side Passenger Seat (V) vs. Time [ms]

23.50 V at 1.68 ms

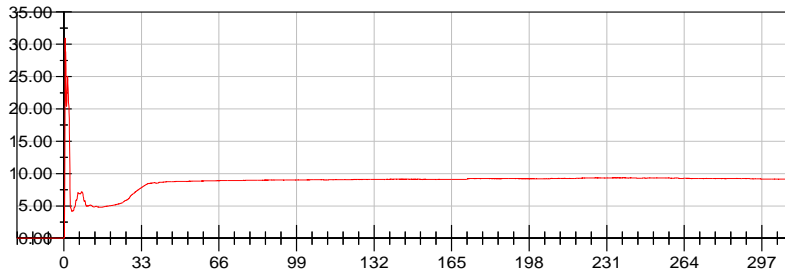
Airbag Event Right Side Passenger Curtain (V) vs. Time [ms]

30.93 V at 0.56 ms

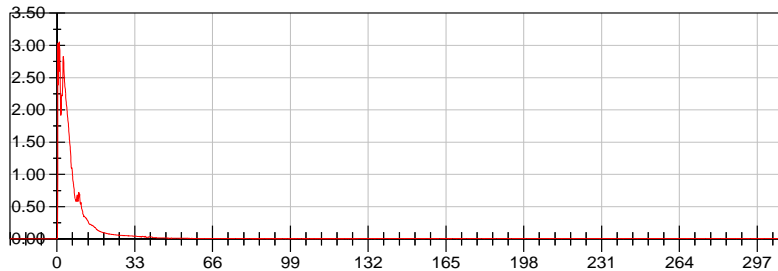
Airbag Event Right Side Passenger Curtain (A) vs. Time [ms]

3.05 A at 1.04 ms

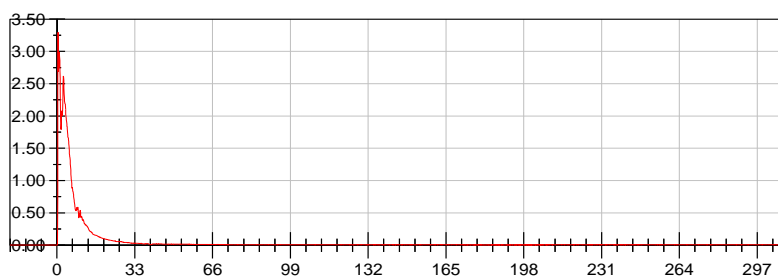
Airbag Event Right Side Passenger Seat (A) vs. Time [ms]

3.29 A at 0.48 ms
