**REPORT NUMBER: SPNCAP-MGA-2014-060**

**NEW CAR ASSESSMENT PROGRAM (NCAP)  
Side Impact Pole Test**

**GENERAL MOTORS LLC  
2015 Chevrolet Silverado 2500 LT Double Cab  
NHTSA No.: M20150104**

**FINAL REPORT**

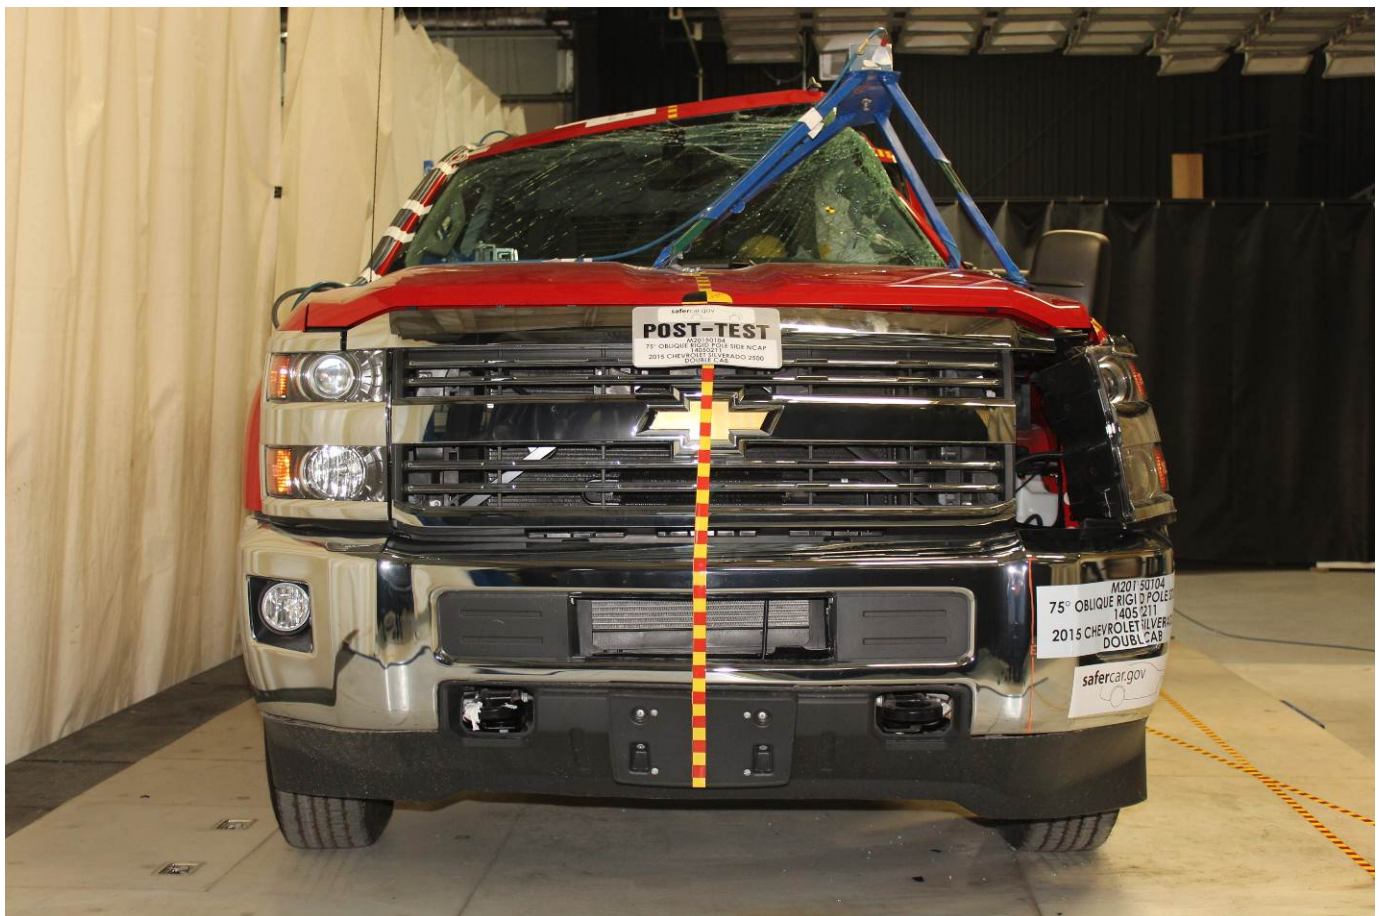
Post-Test Frontal View of Test Vehicle

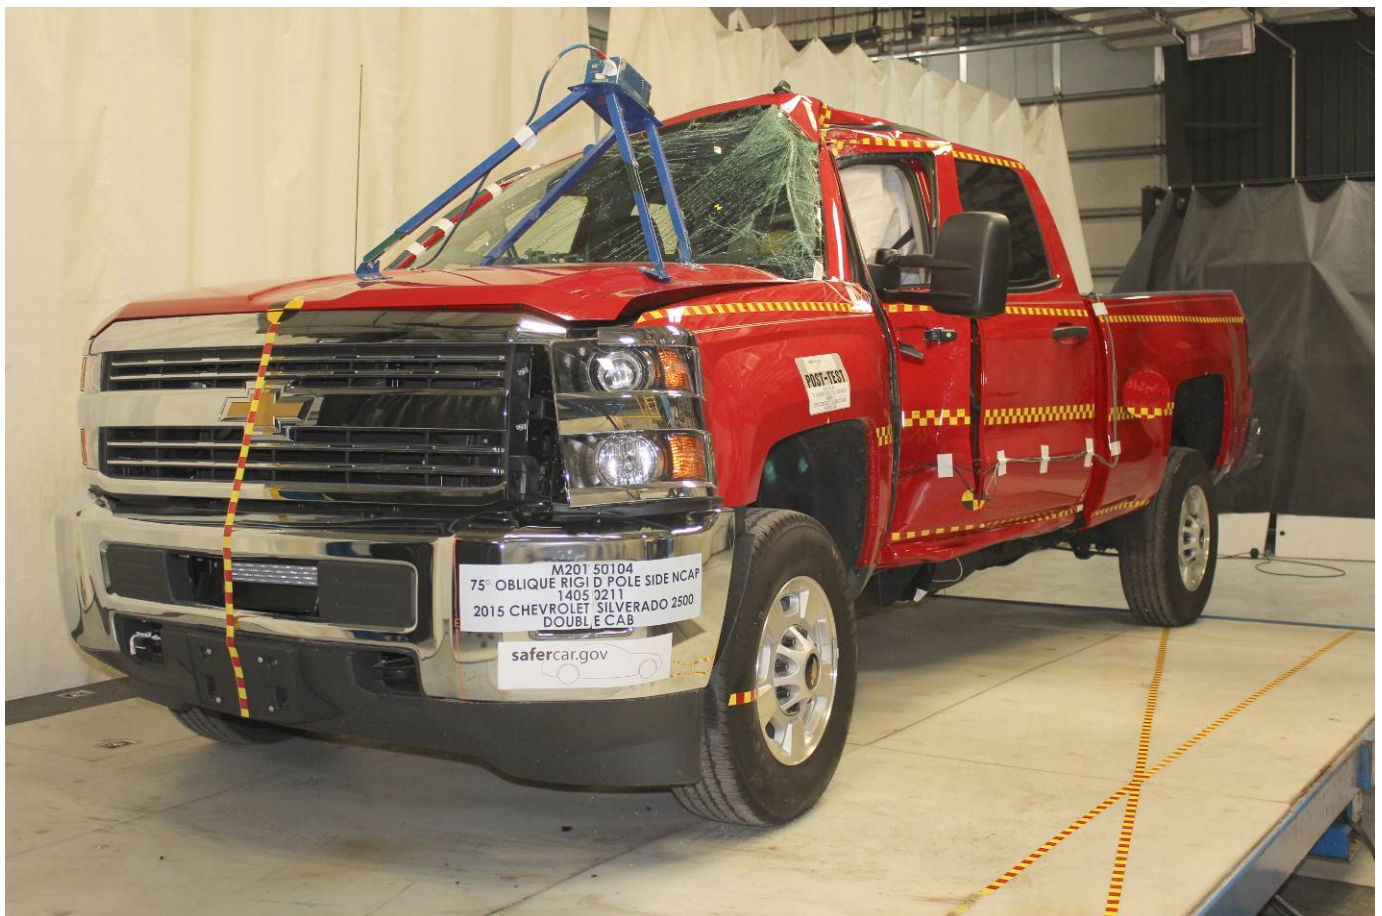
Post-Test Left Front  $\frac{3}{4}$  View of Test Vehicle

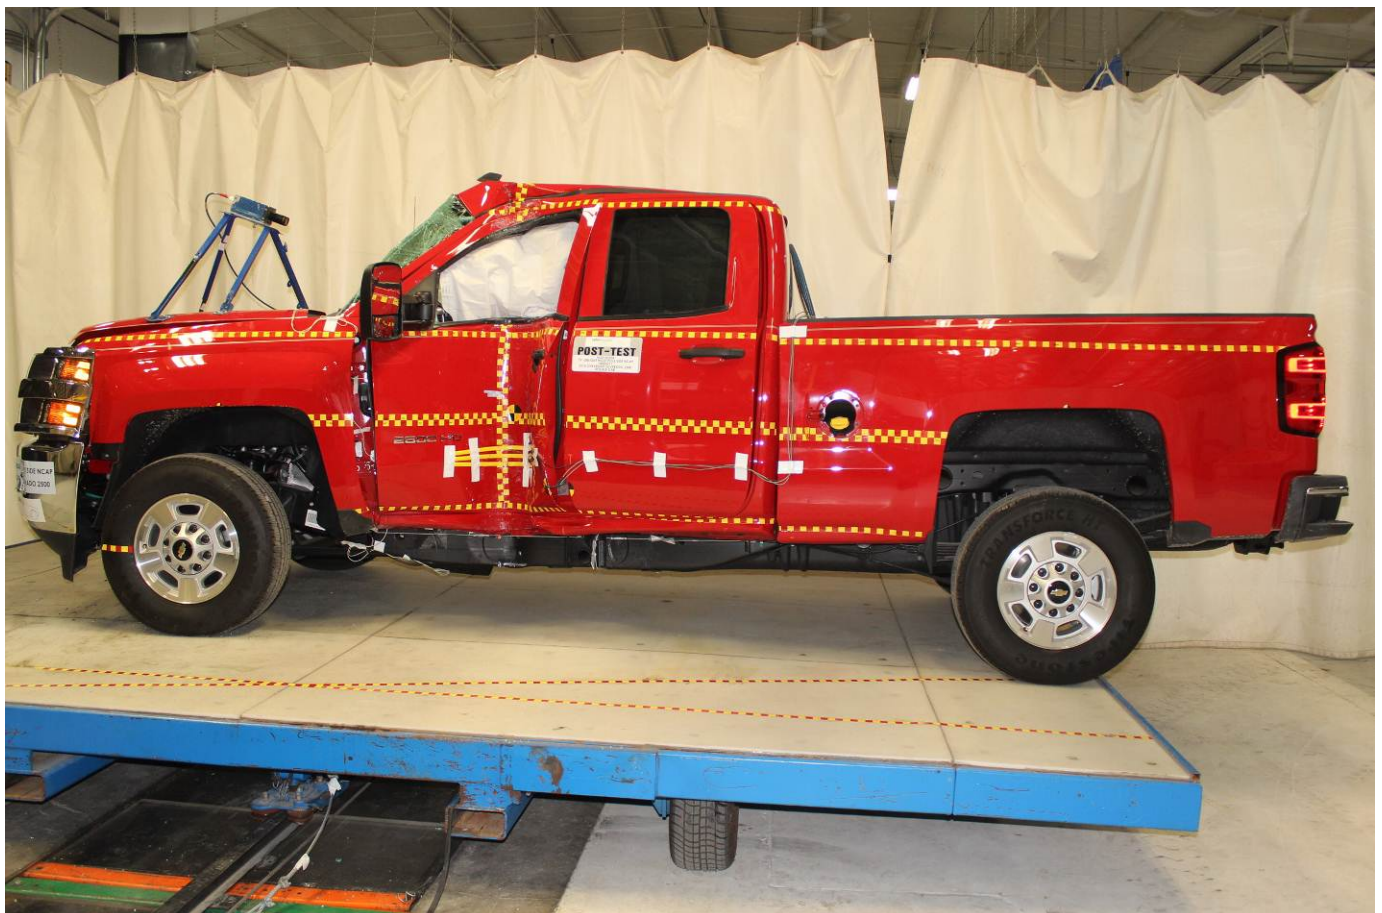
Post-Test Left Side View of Test Vehicle

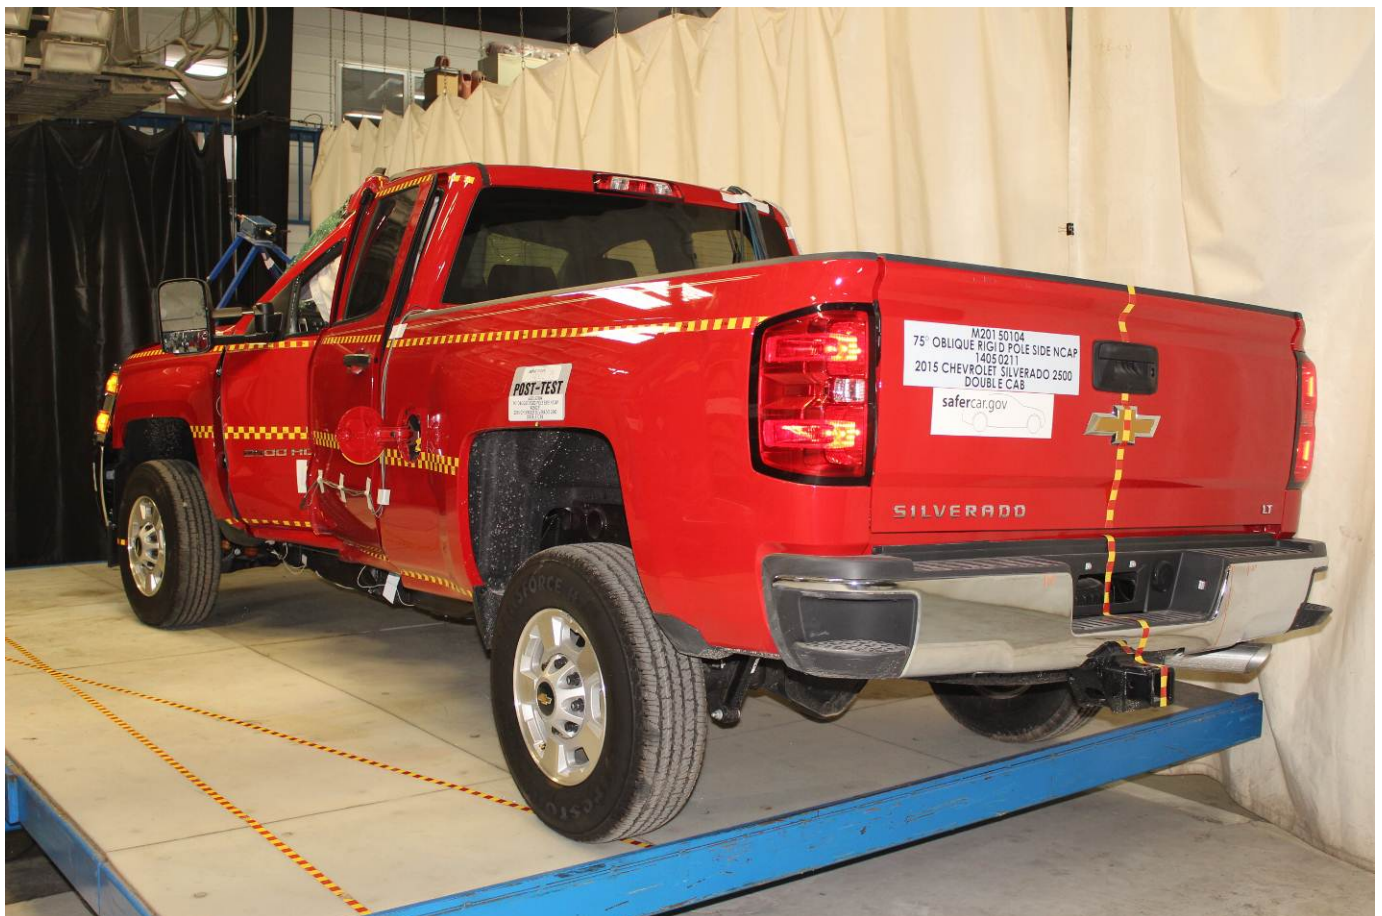
Post-Test Left Rear  $\frac{3}{4}$  View of Test Vehicle

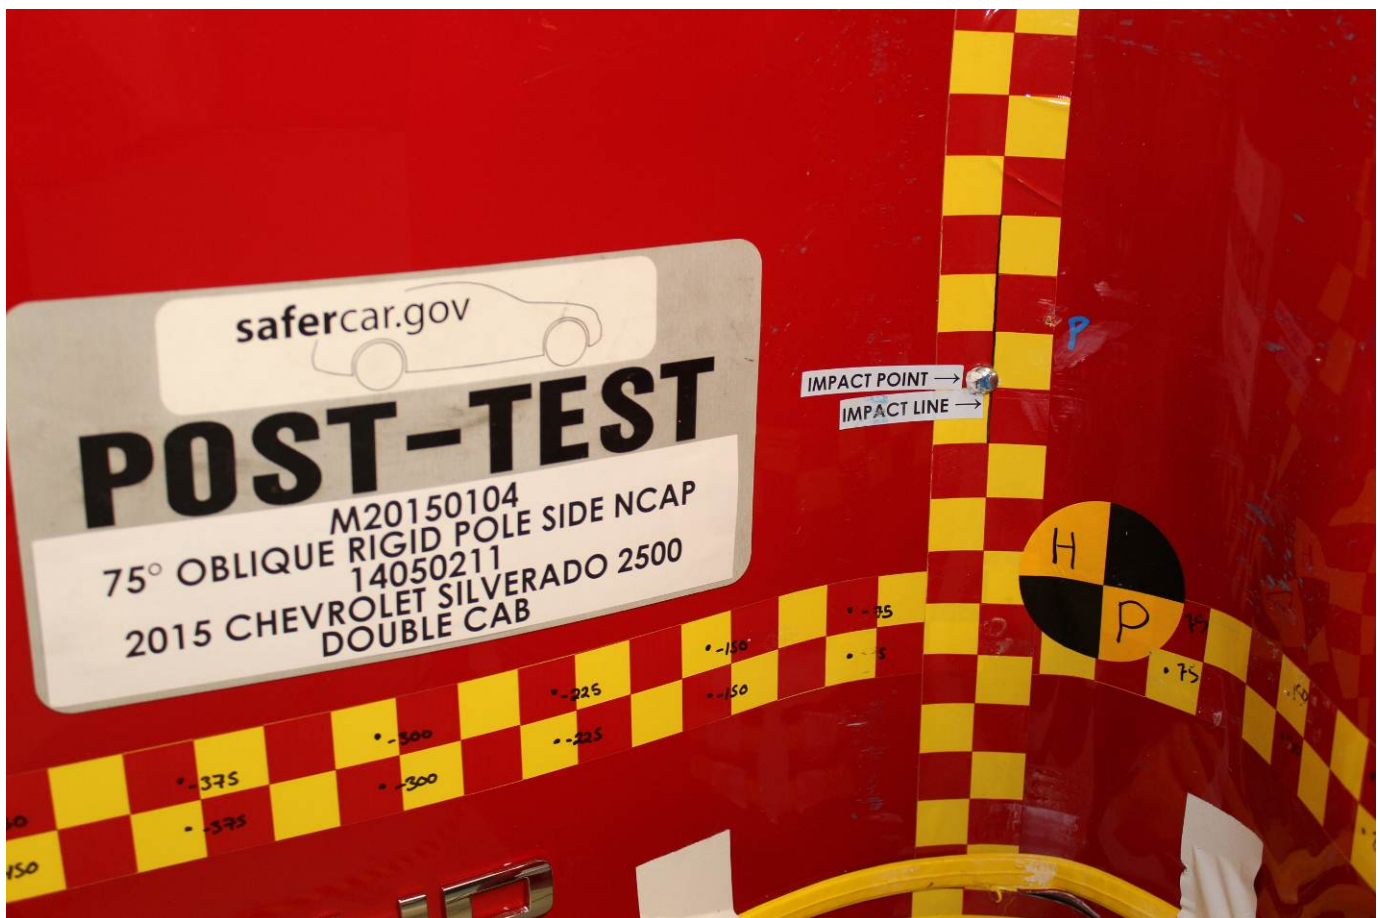
Post-Test Close-Up View of Impact Point Target Showing Impact Location

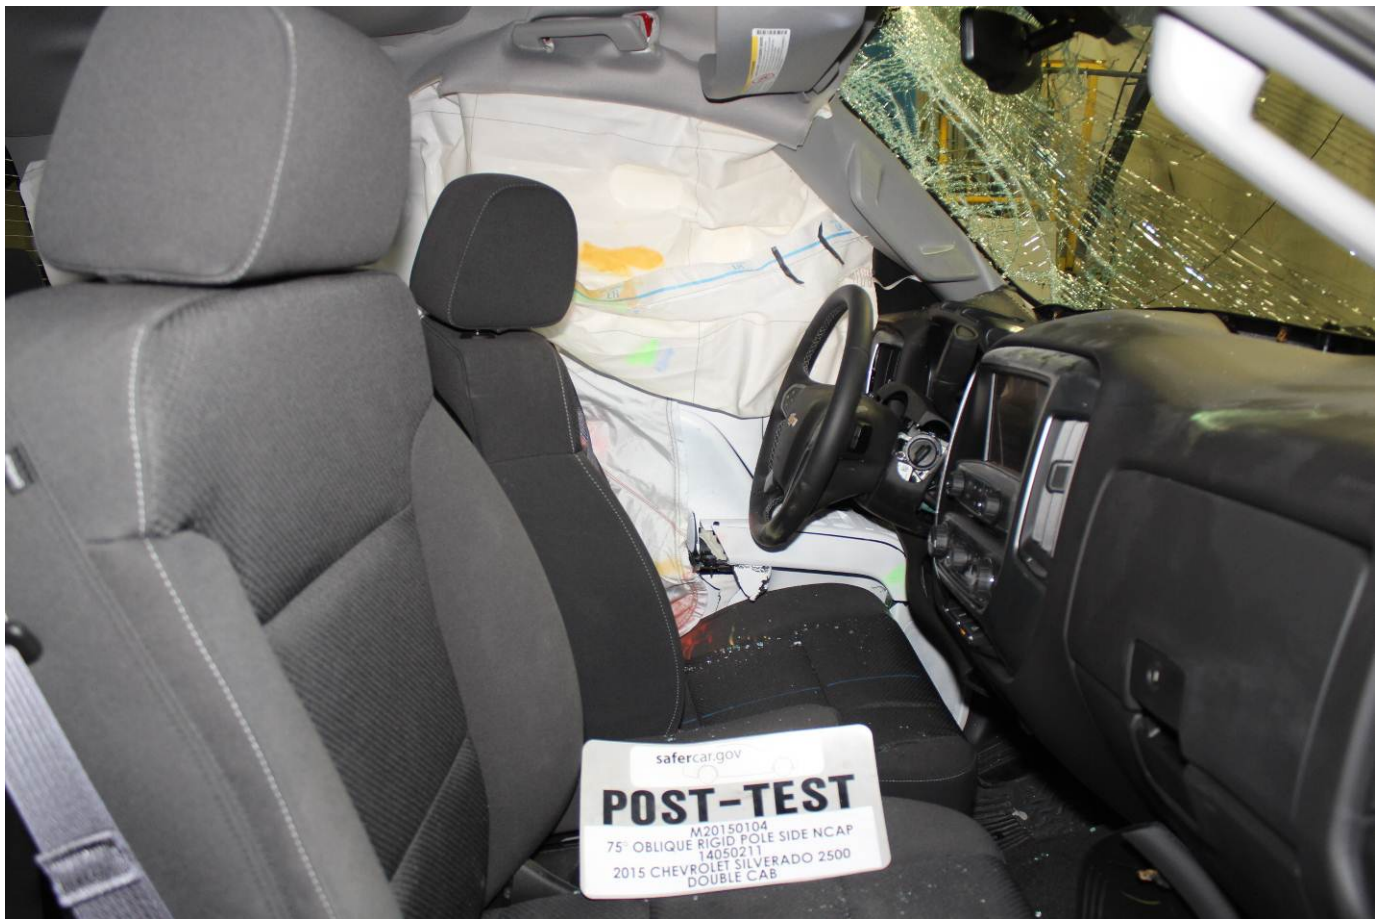
Post-Test Inner Door Panel View Showing Dummy Contact Location

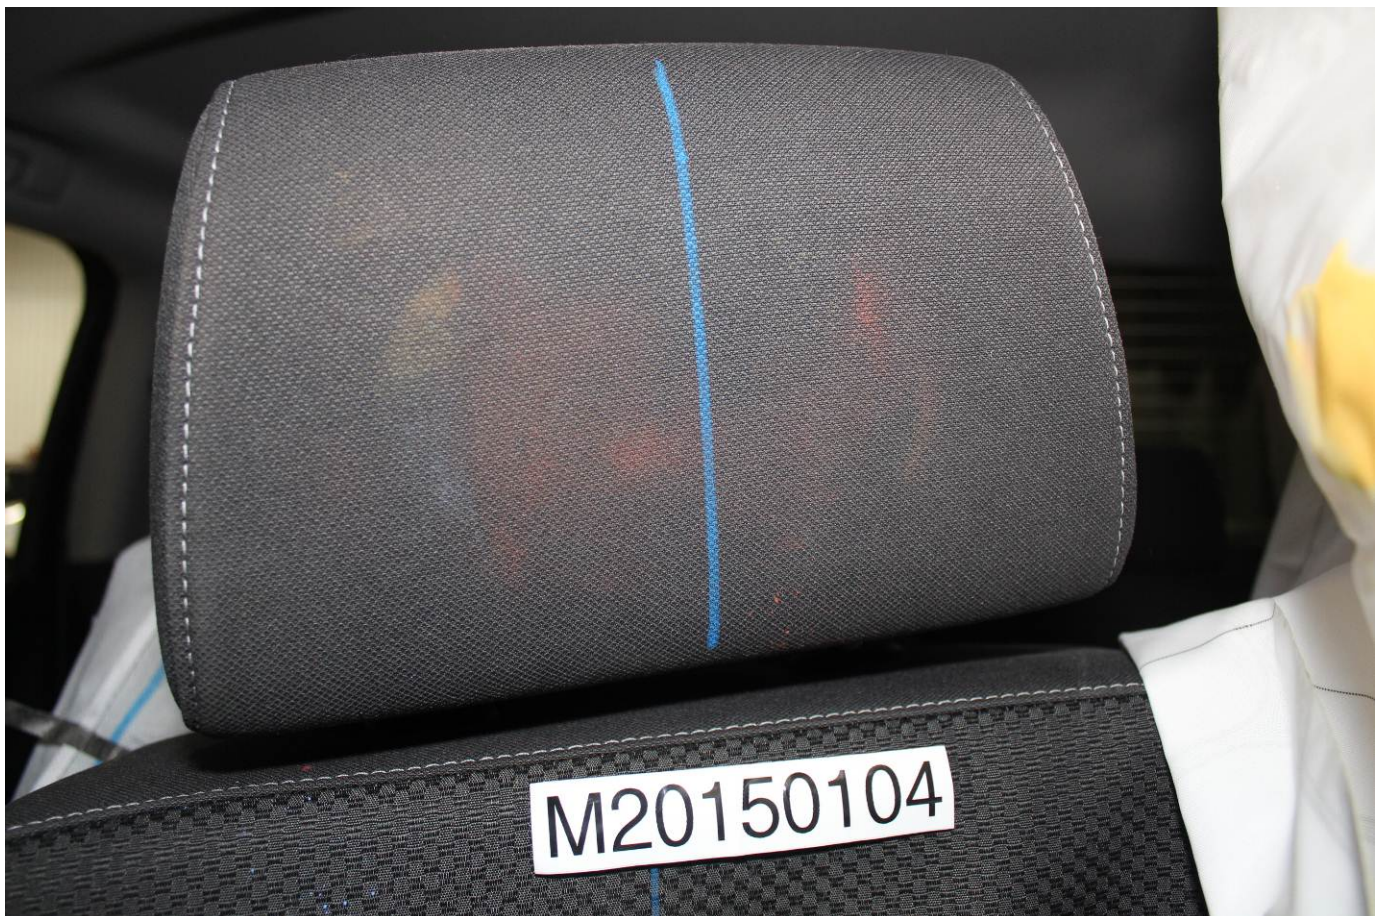
Post-Test Dummy Close-Up Head Contact with Vehicle Interior View

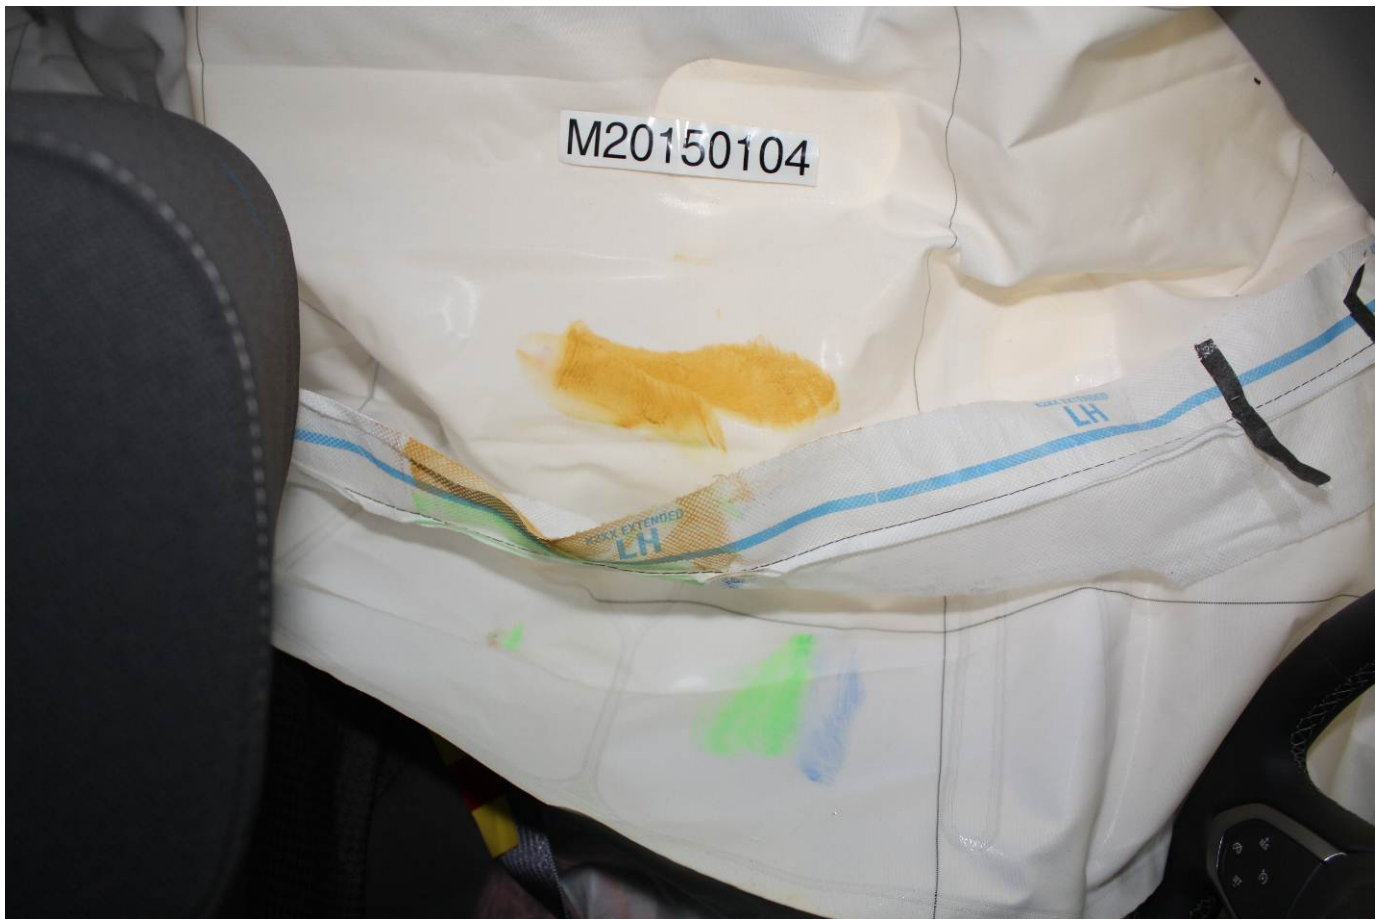
Post-Test Dummy Close-Up Head Contact with Side Air Bag View
