**REPORT NUMBER: SINCAP-MGA-2014-061**

**NEW CAR ASSESSMENT PROGRAM (NCAP)  
Moving Deformable Barrier Side Impact Test**

**GENERAL MOTORS LLC  
2015 Chevrolet Silverado 2500 LT Double Cab  
NHTSA No.: M20150105**

**FINAL REPORT**

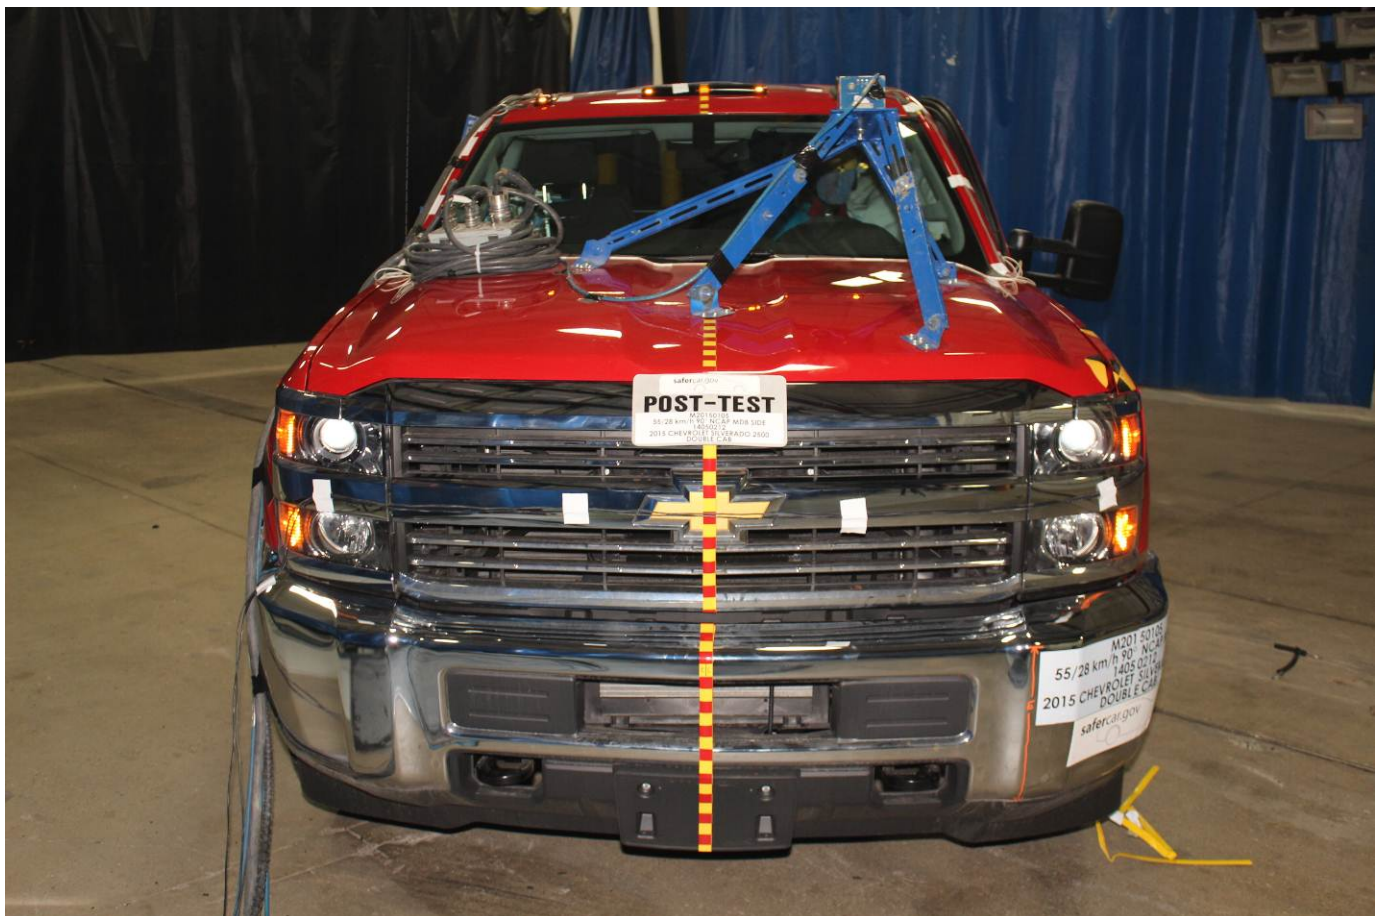
Post-Test Frontal View of Test Vehicle

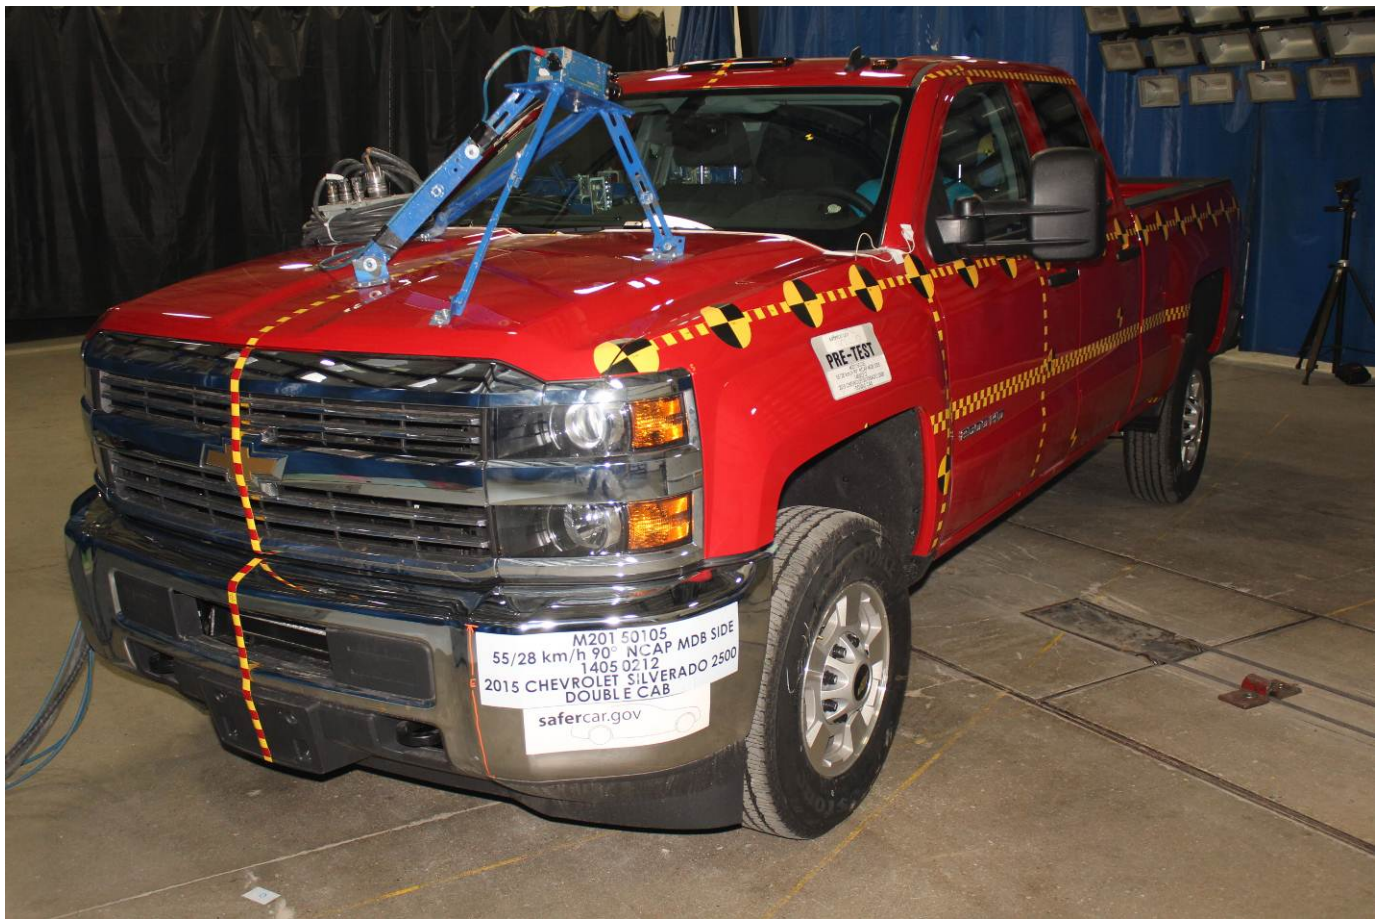
Pre-Test Left Front Three-Quarter View of Test Vehicle

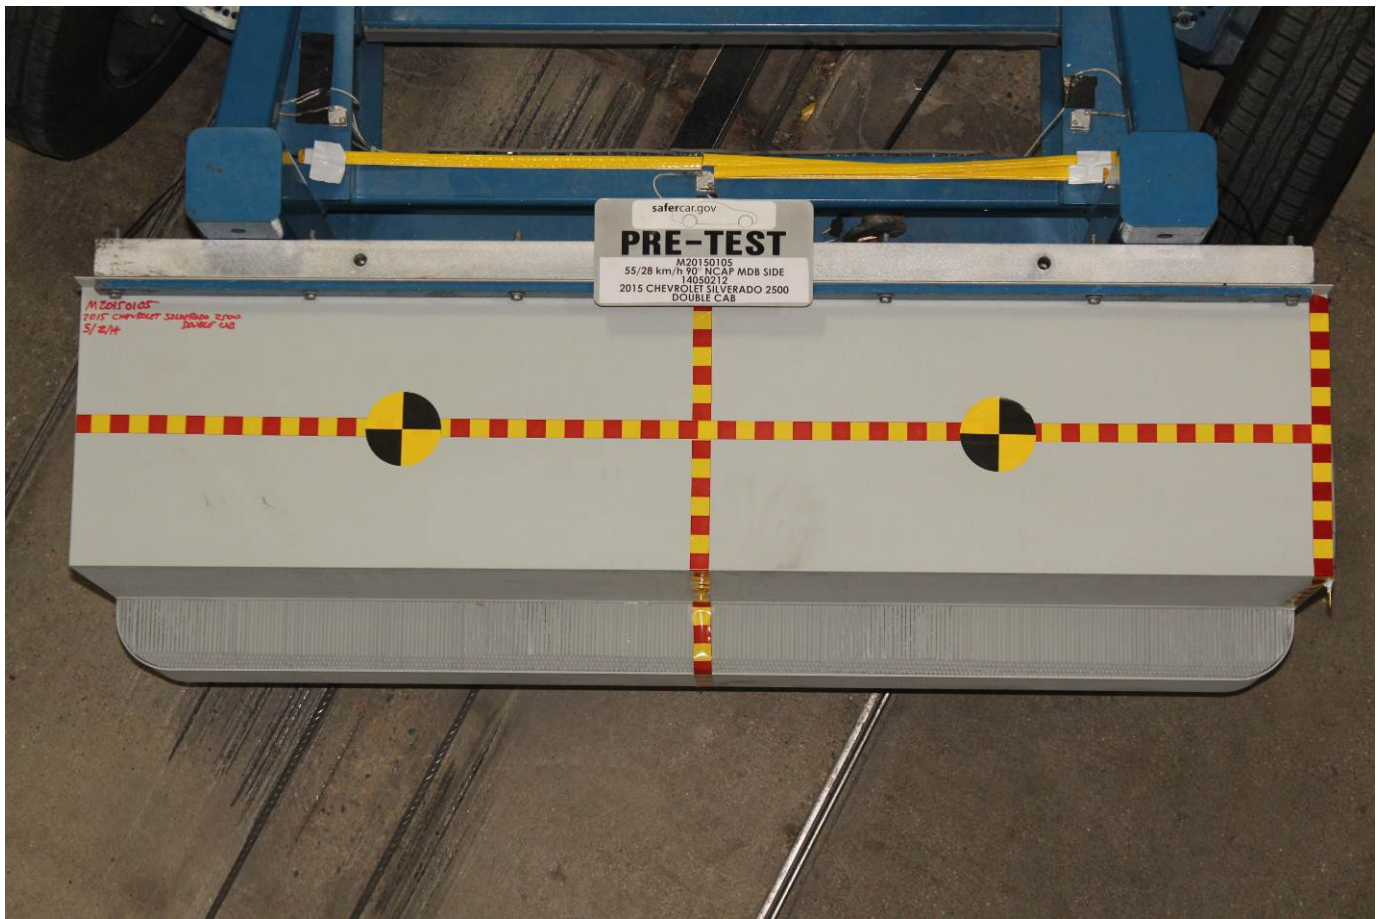
Post-Test Front View of MDB Impactor Face
