REPORT NUMBER: TR-P32096-13-NC

**RESEARCH AND DEVELOPMENT
80 KM/H 70% OVERLAP REAR IMPACT**

**GENERAL MOTORS CORP
1997 OLDSMOBILE CUTLASS SUPREME 4-DOOR SEDAN**

NHTSA NUMBER: PV0101

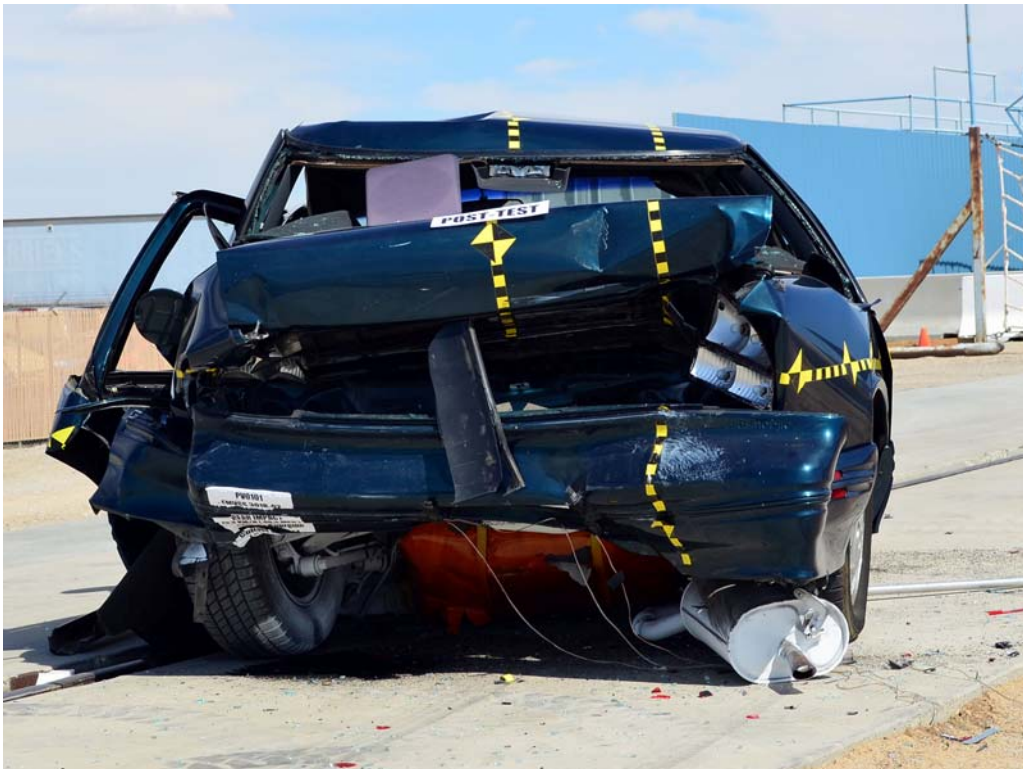
FIGURE 12. Post-Test Rear View of Test Vehicle

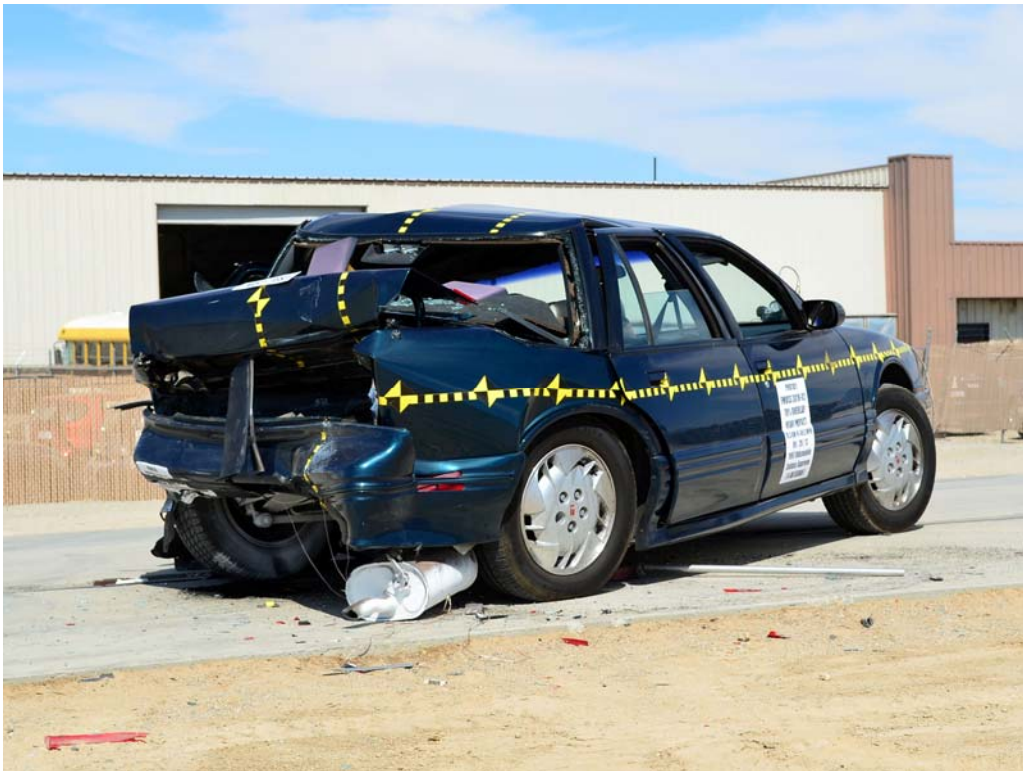
FIGURE 14. Post-Test Right Rear $\frac{3}{4}$ View of Test Vehicle

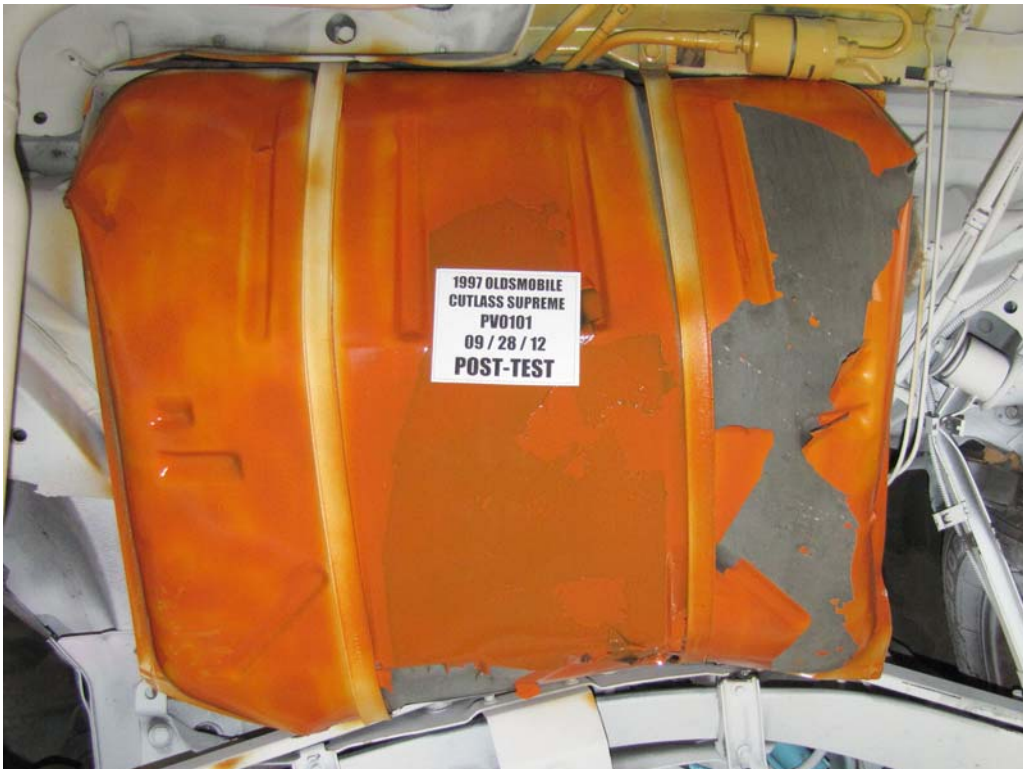
FIGURE 20. Post-Test Underbody, Fuel Tank Location

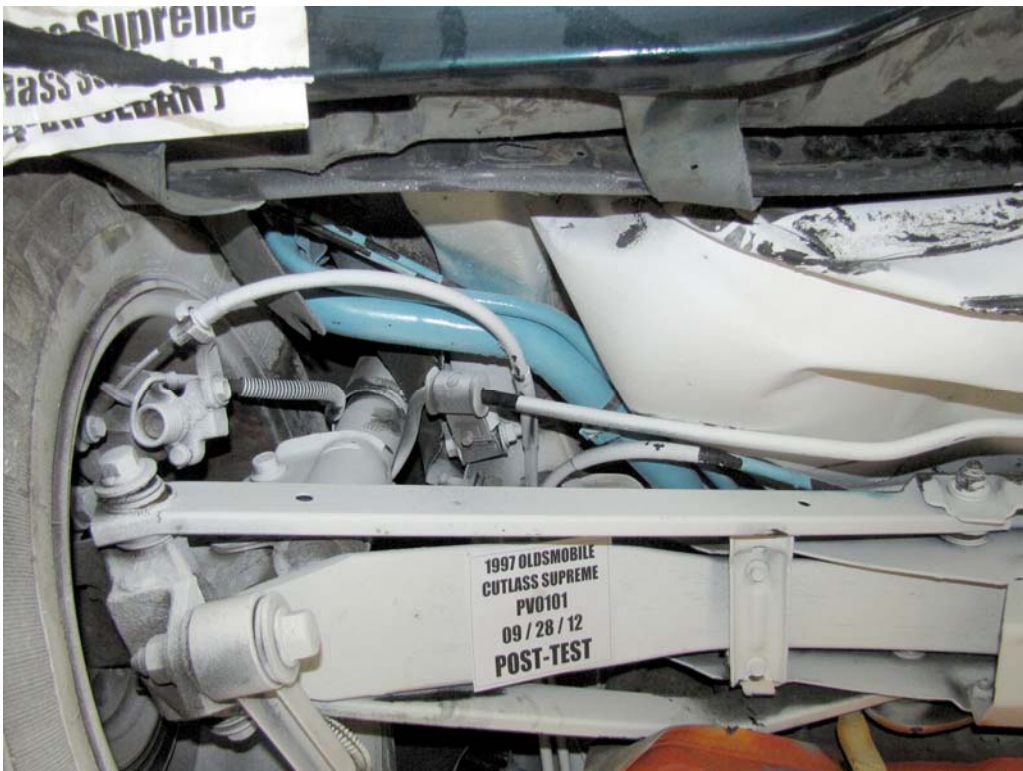
FIGURE 22. Post-Test Underbody, Fuel Filler Neck Location

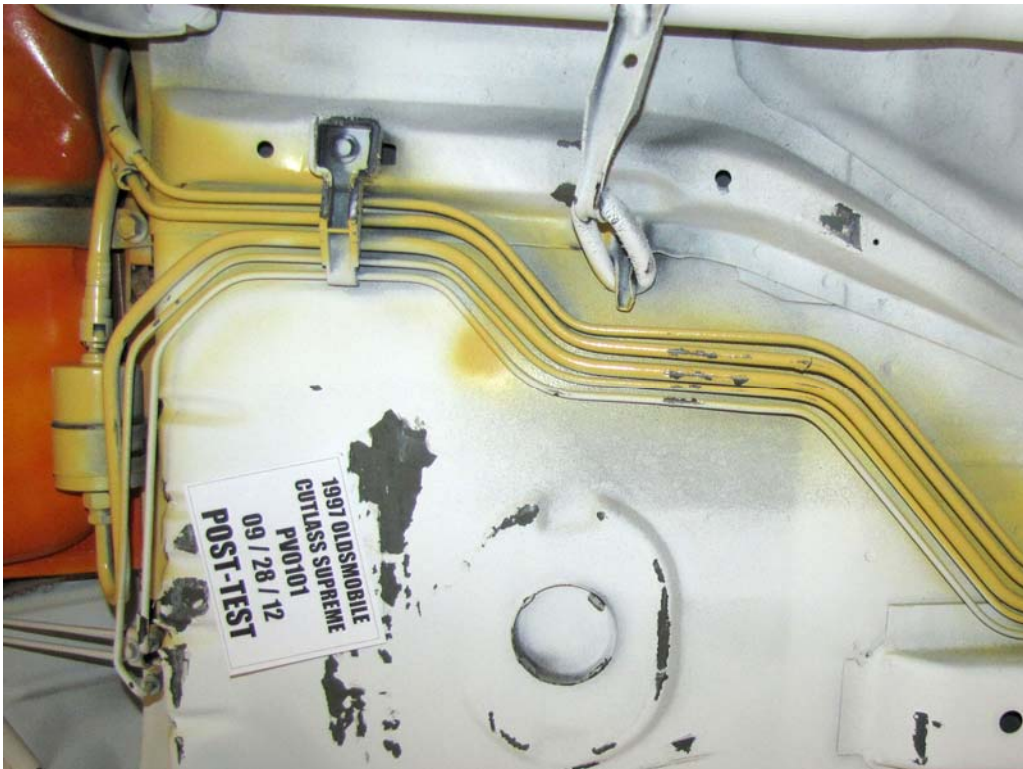
FIGURE 24. Post-Test Underbody, Fuel Line Location

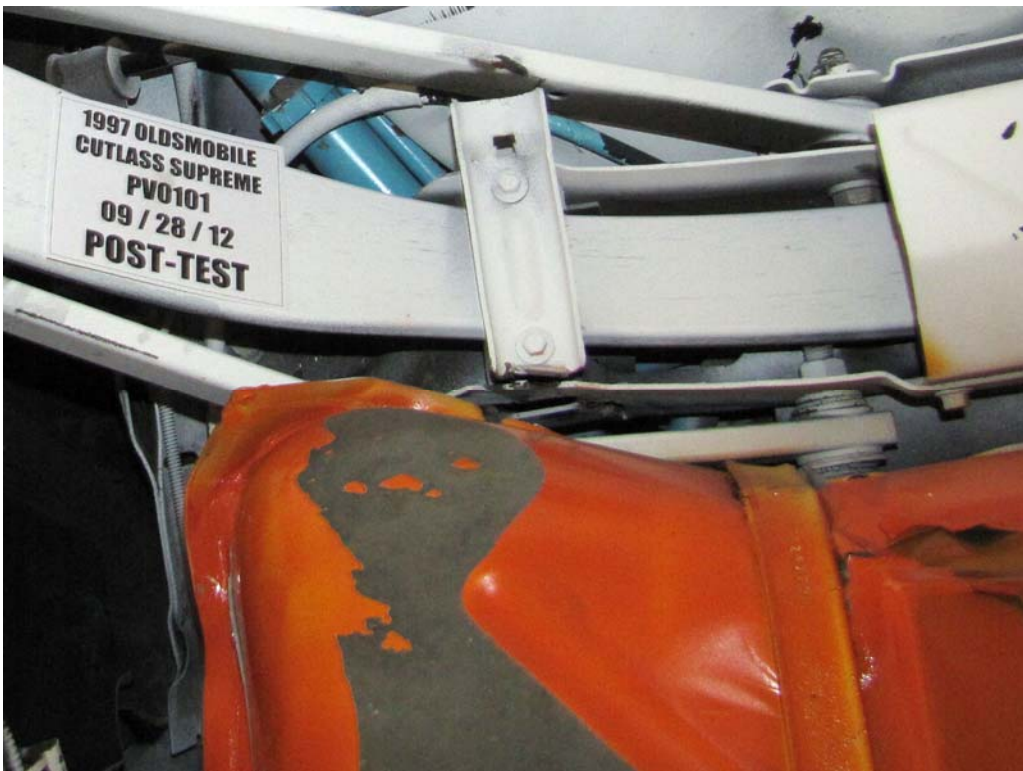
Details of Stoddard solvent spillage: Stoddard solvent leaked from the top of the fuel tank, where the filler neck connects to the tank, during each portion of the static rollover.

Stoddard solvent leaked from the area on the top of the fuel tank during the static rollover. Leaks were visible at every position of the static rollover.

FIGURE 30. Post-Test Stoddard Solvent Spillage Location View
