**REPORT NUMBER: TR-P32096-01-NC**

**RESEARCH AND DEVELOPMENT  
80 KM/H 70% OFFSET REAR IMPACT**

**VOLKSWAGEN DE MEXICO S.A. DE C.V.  
1998 VOLKSWAGEN BEETLE 3-DOOR HATCHBACK**

**REPORT DATE:  
JULY 6, 2012  
FINAL REPORT**

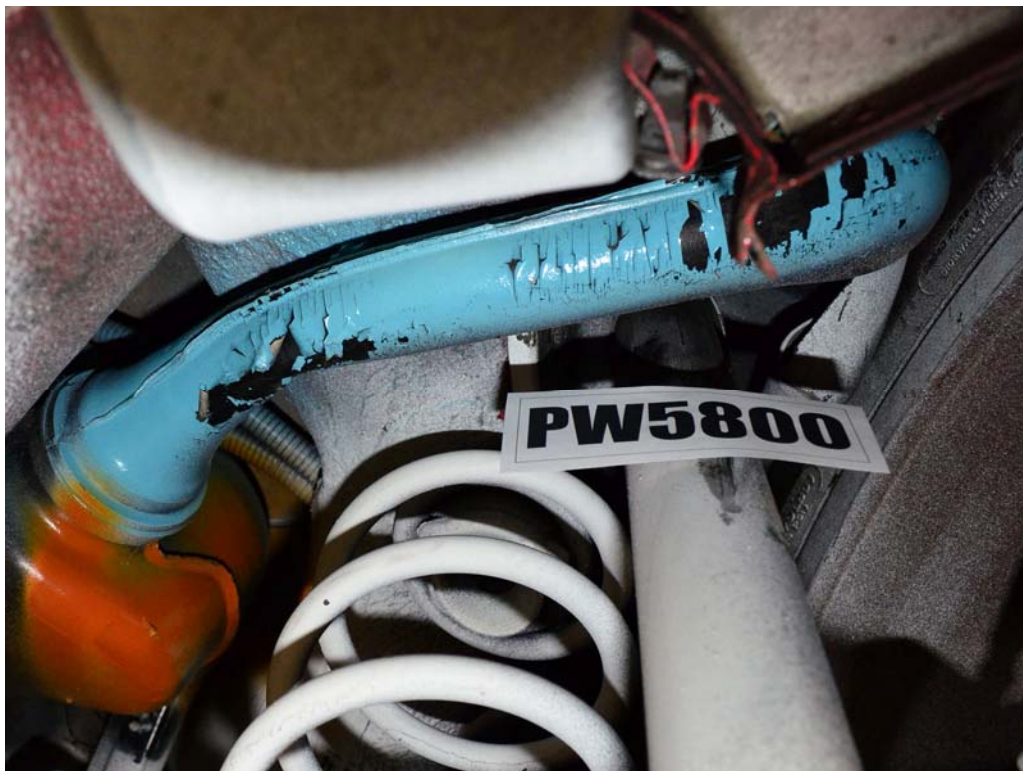
FIGURE 22. Post-Test Underbody, Fuel Filler Neck Location

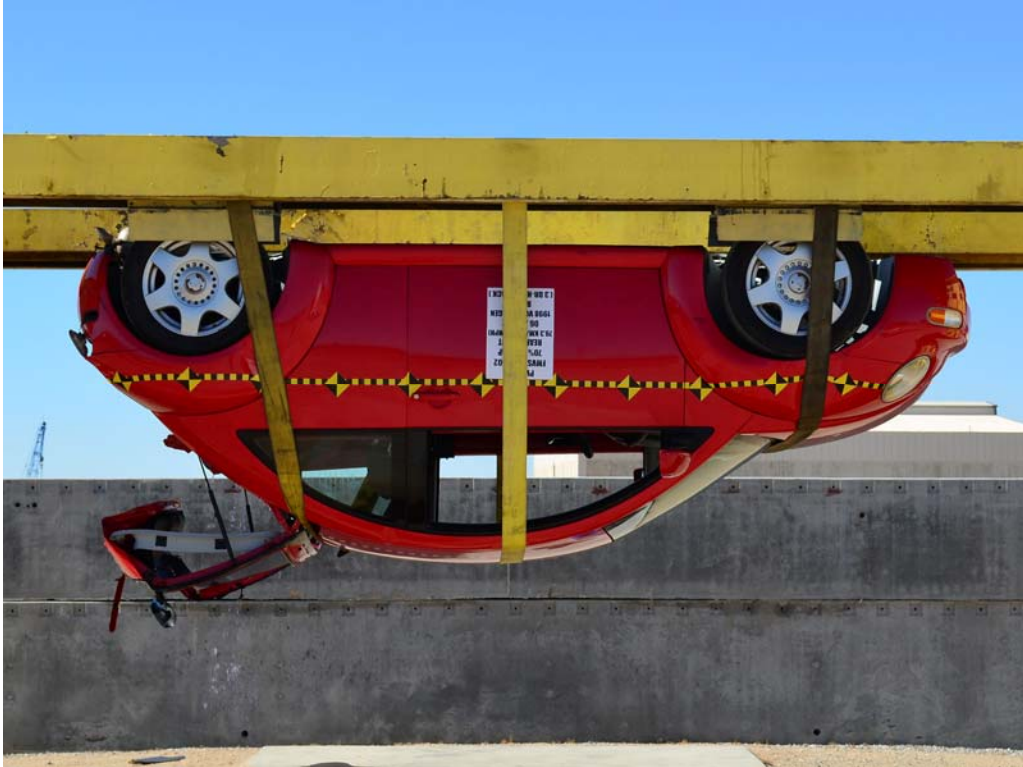
FIGURE 27. Vehicle at 180° on Static Rollover Device

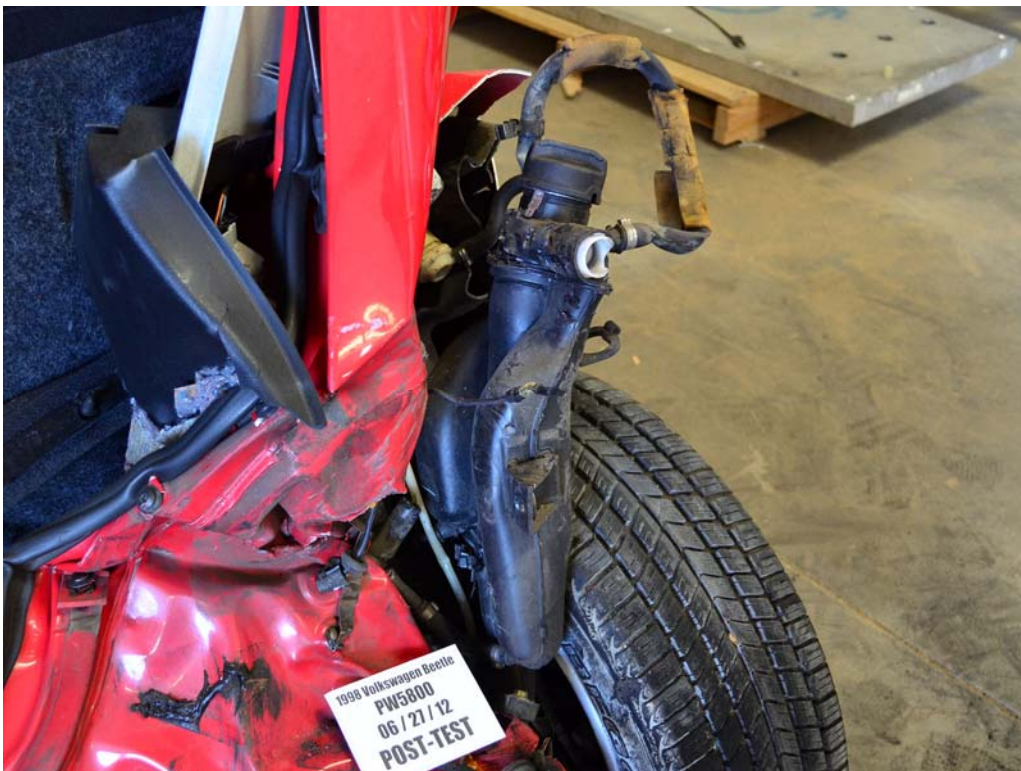
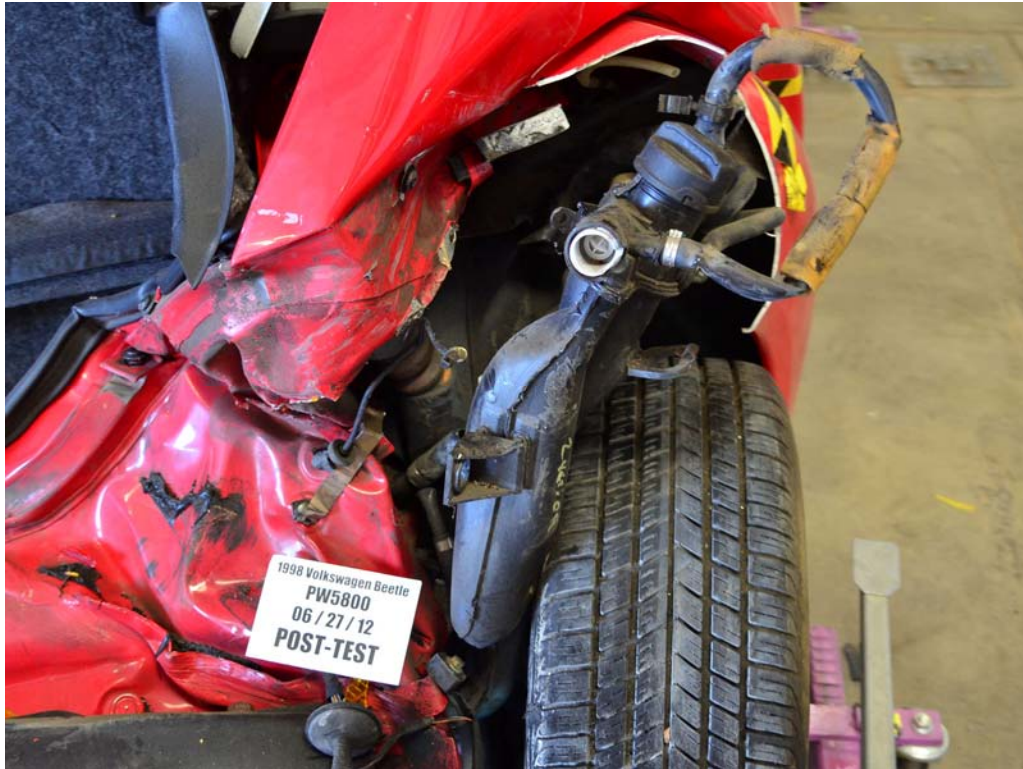
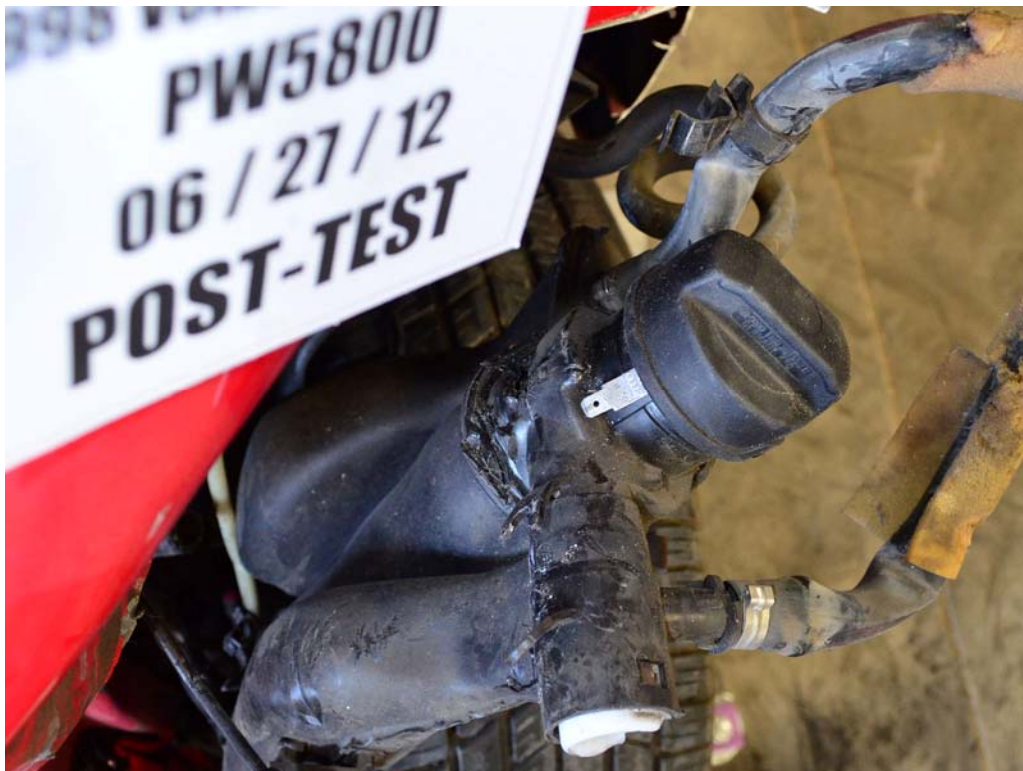
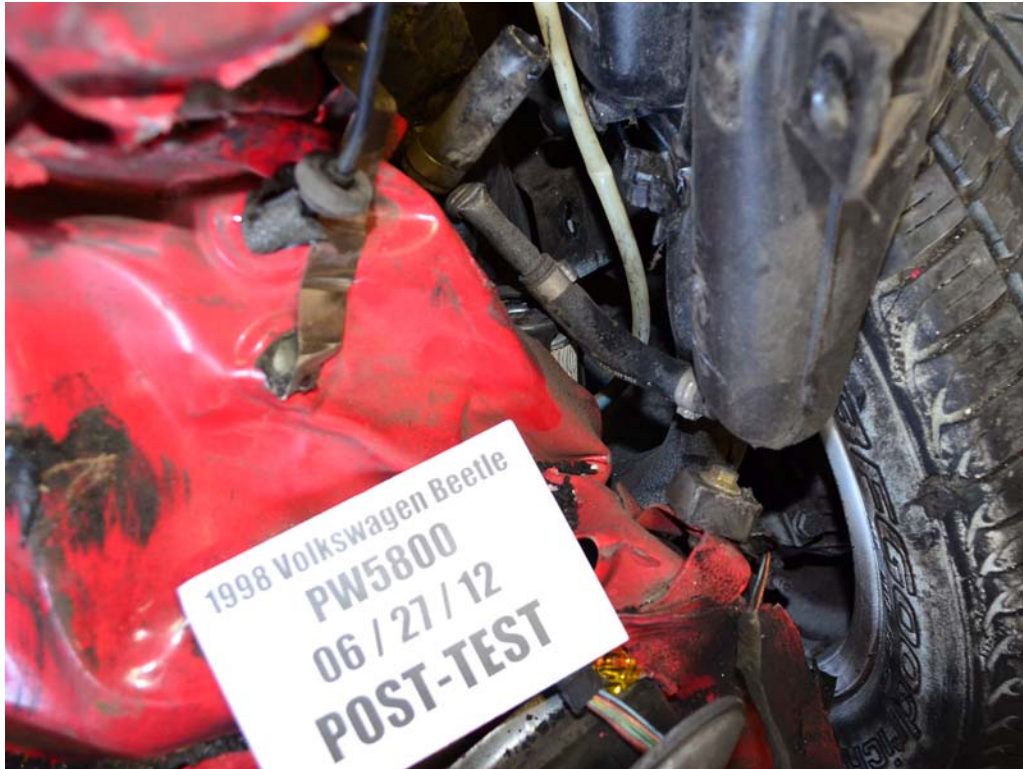
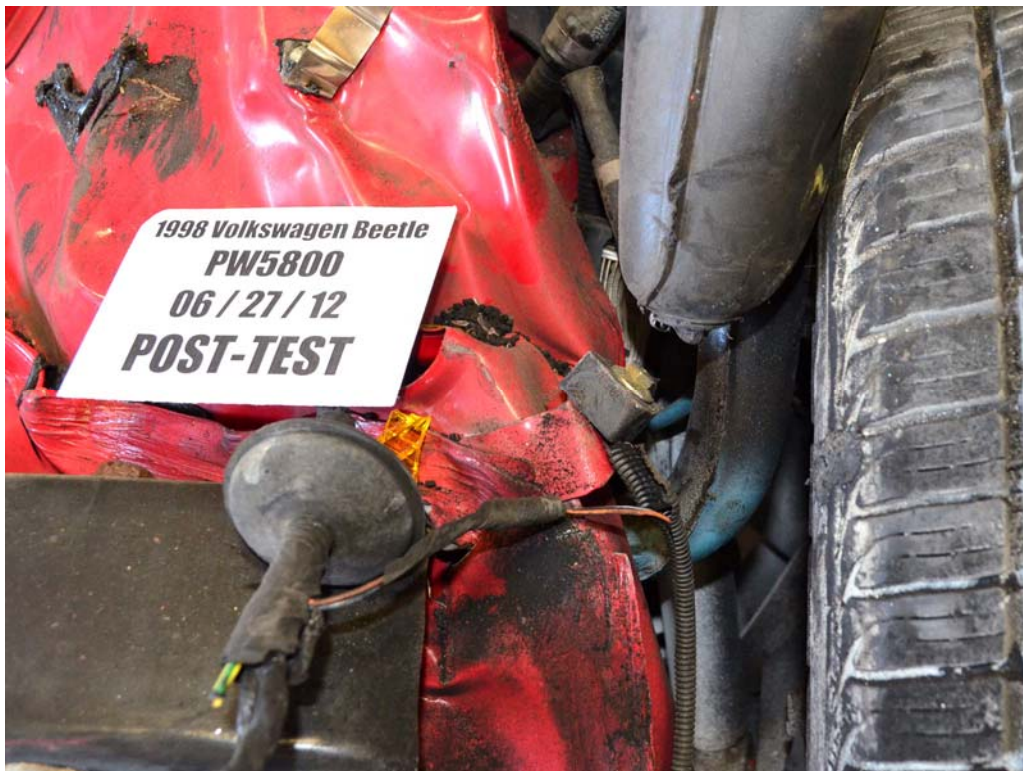
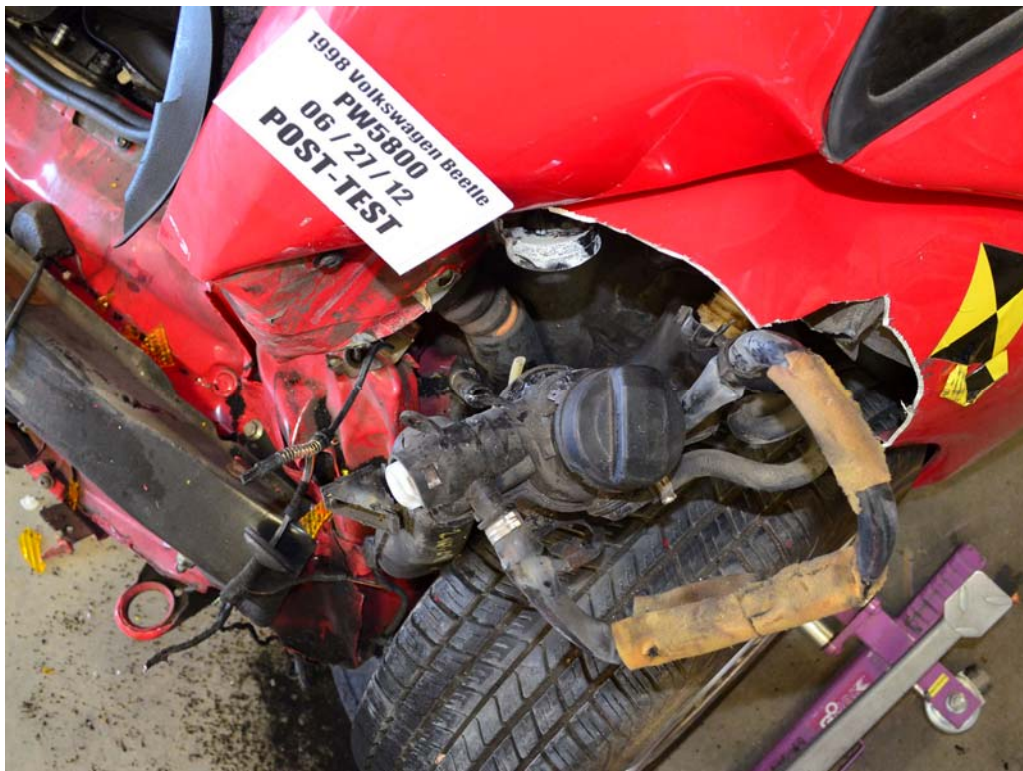
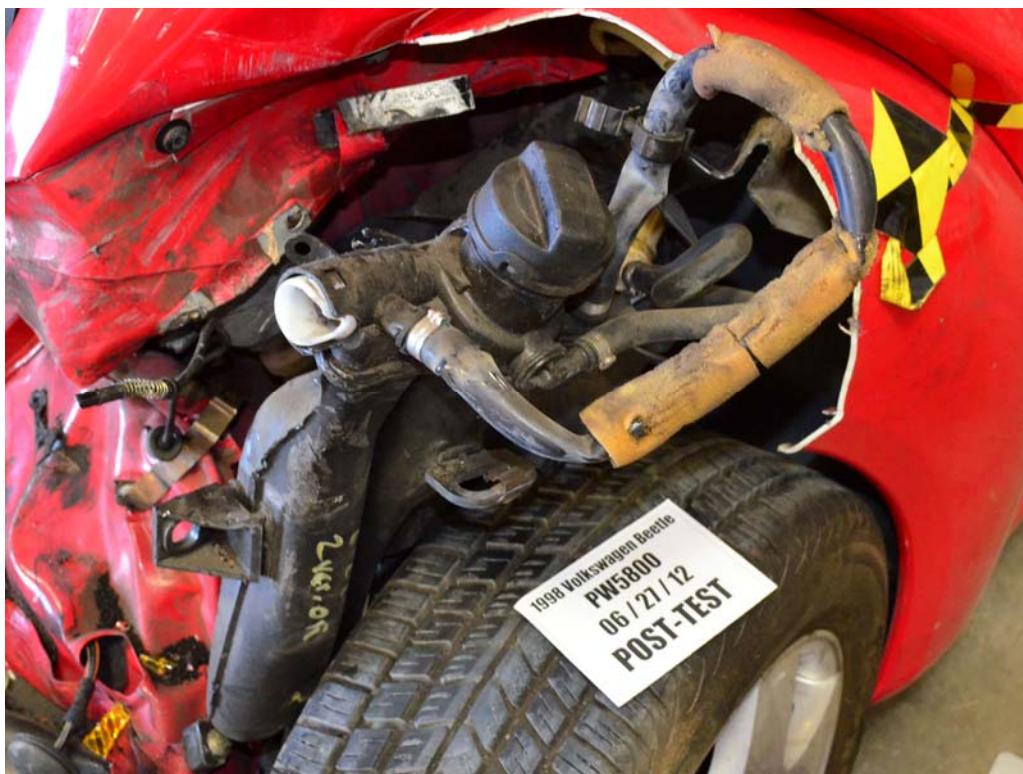
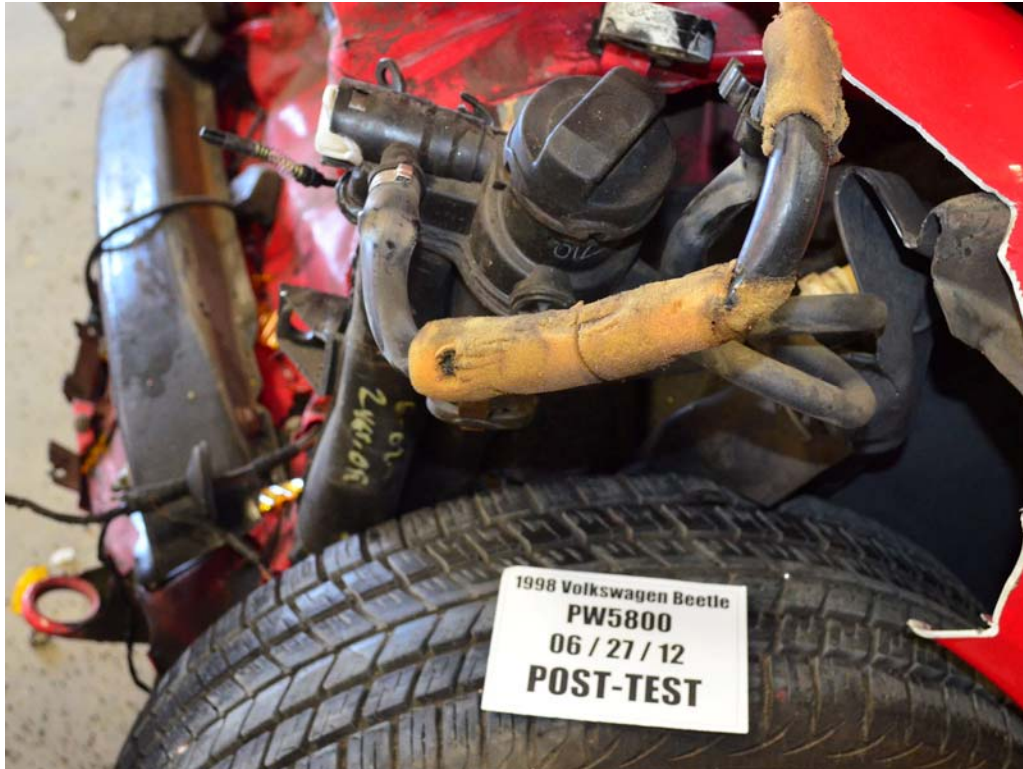
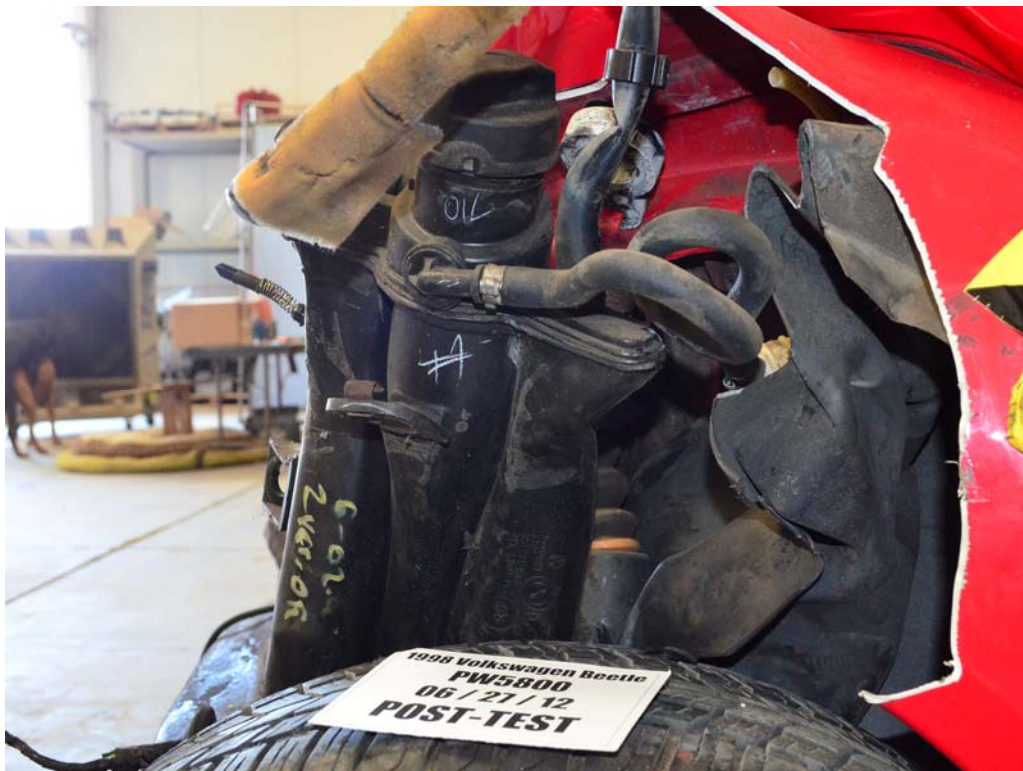
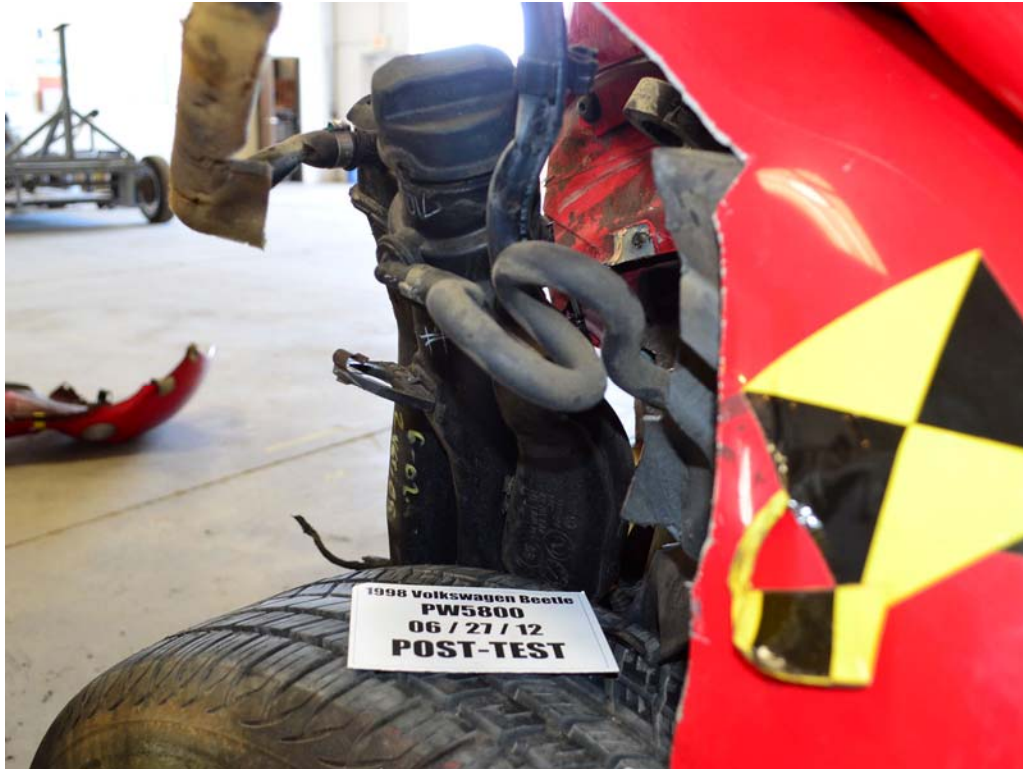
Stoddard solvent leaked from the fuel filler neck area on the right rear fender of the vehicle during portions of the static rollover. Leaks were visible while holding at the 90° position, while moving from 90° to 180°, and while holding at 180°.

FIGURE 30. Post-Test Stoddard Solvent Spillage Location View

FIGURE 31. Post-Test Stoddard Solvent Spillage Location View

FIGURE 32. Post-Test Stoddard Solvent Spillage Location View

FIGURE 33. Post-Test Stoddard Solvent Spillage Location View

FIGURE 34. Post-Test Stoddard Solvent Spillage Location View

FIGURE 35. Post-Test Stoddard Solvent Spillage Location View

FIGURE 36. Post-Test Stoddard Solvent Spillage Location View

FIGURE 37. Post-Test Stoddard Solvent Spillage Location View

FIGURE 38. Post-Test Stoddard Solvent Spillage Location View

FIGURE 39. Post-Test Stoddard Solvent Spillage Location View
