REPORT NUMBER: TR-P32096-08-NC

**RESEARCH AND DEVELOPMENT
80 KM/H 70% OVERLAP REAR IMPACT**

**FORD MOTOR CO.
2000 FORD CONTOUR 4-DOOR SEDAN**

NHTSA NUMBER: PY0200

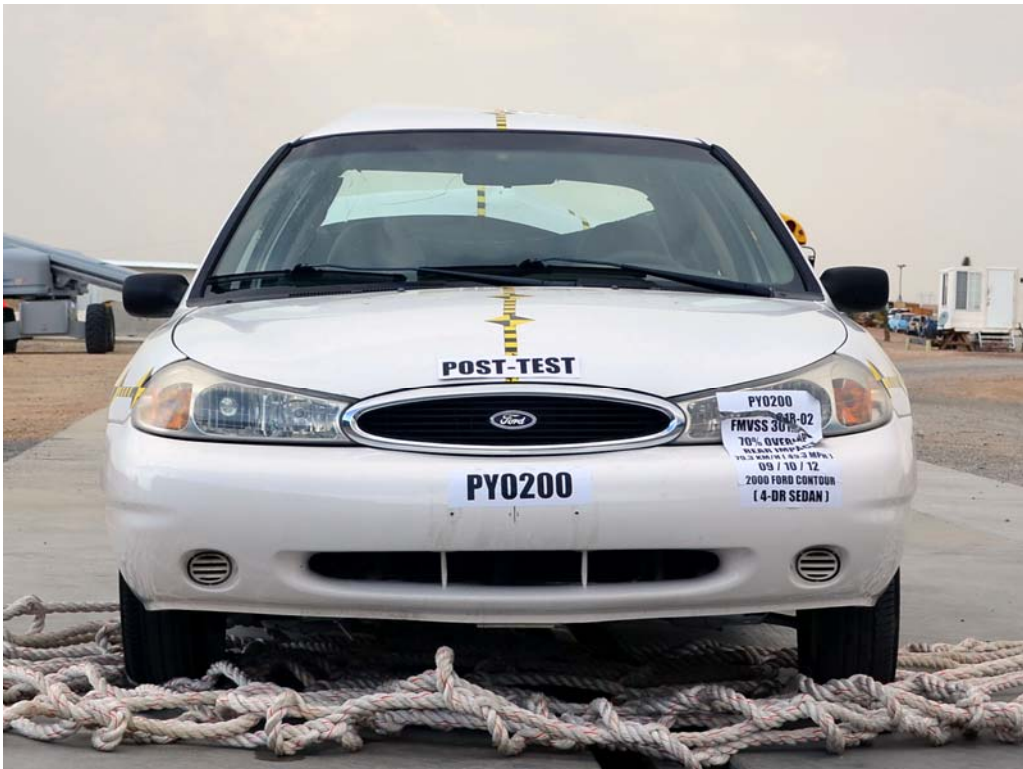
FIGURE 4. Post-Test Front of Test Vehicle

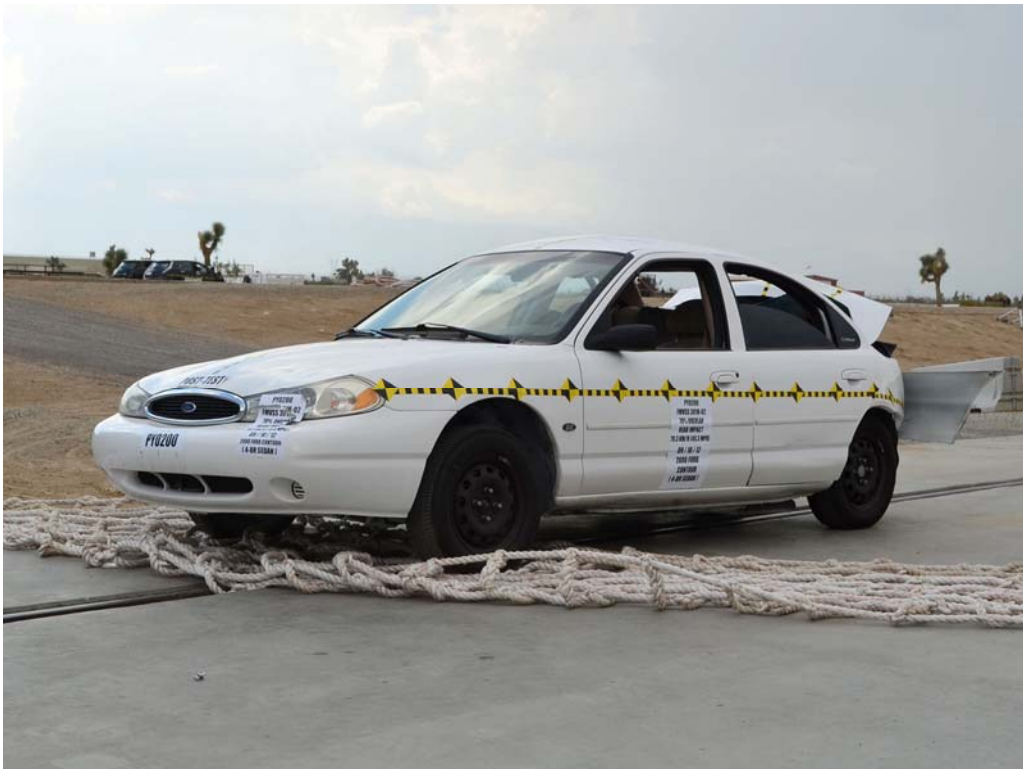
FIGURE 6. Post-Test Left Front $\frac{3}{4}$ View of Test Vehicle

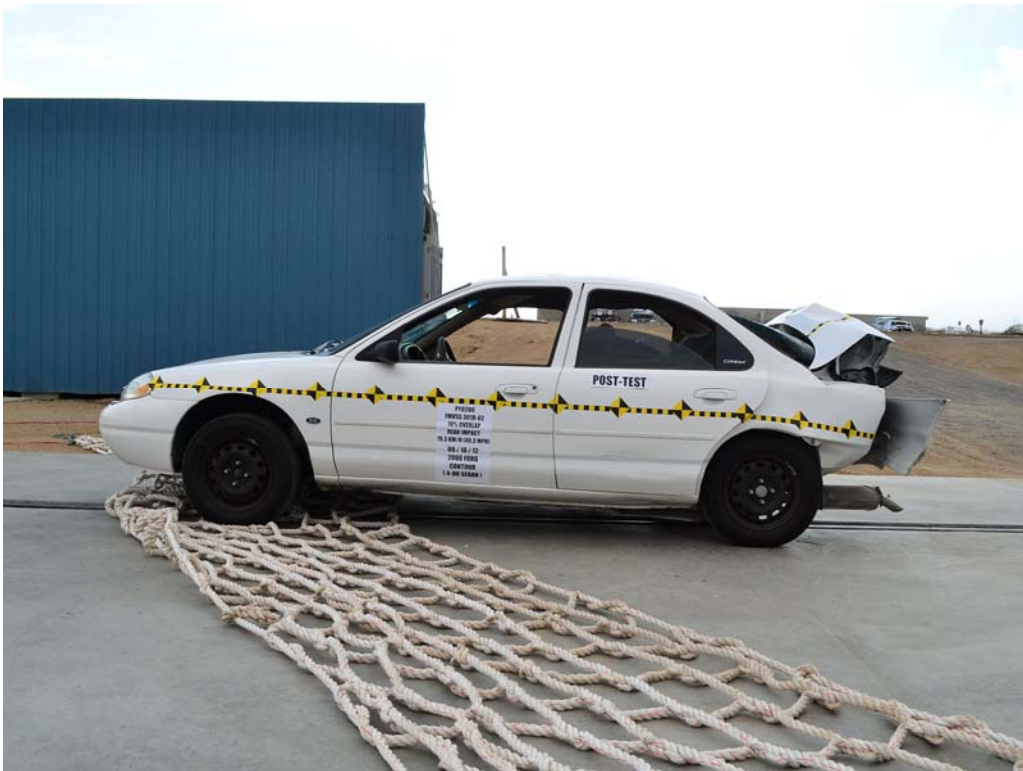
FIGURE 8. Post-Test Left View of Test Vehicle

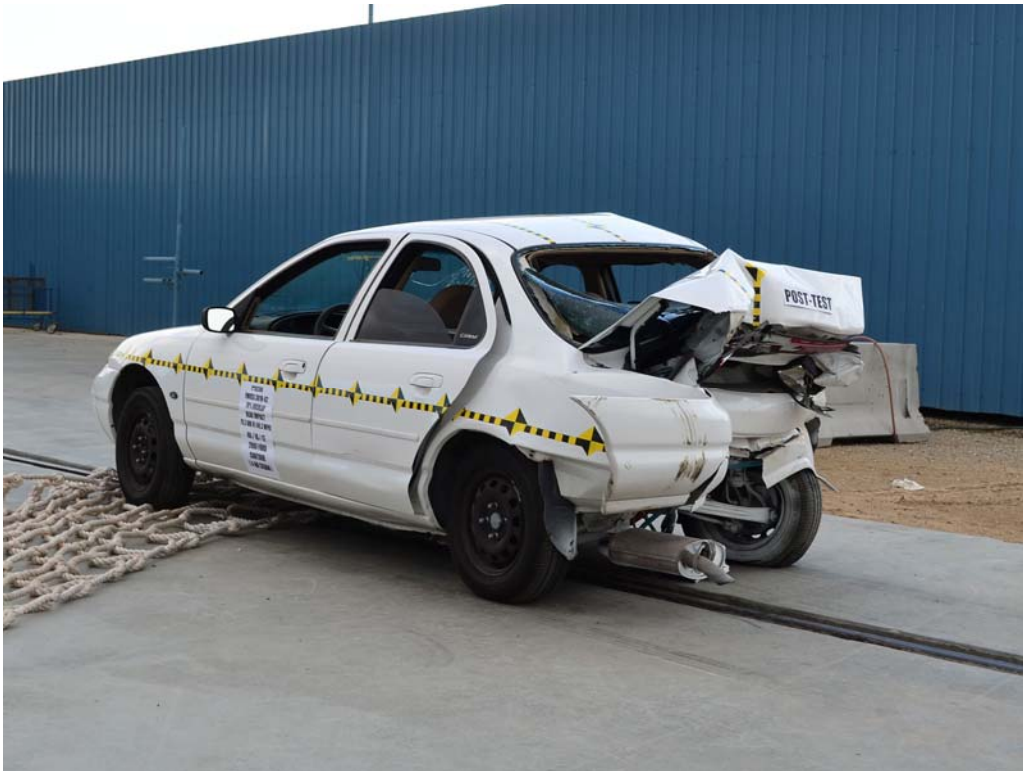
FIGURE 10. Post-Test Left Rear $\frac{3}{4}$ View of Test Vehicle

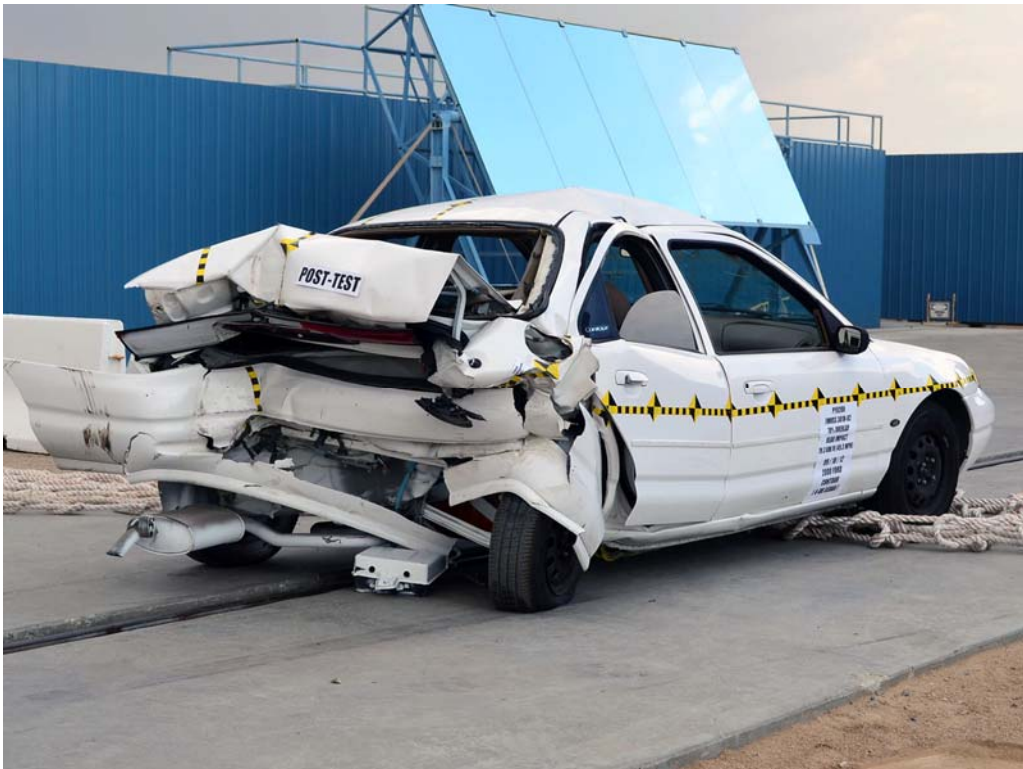
FIGURE 14. Post-Test Right Rear $\frac{3}{4}$ View of Test Vehicle

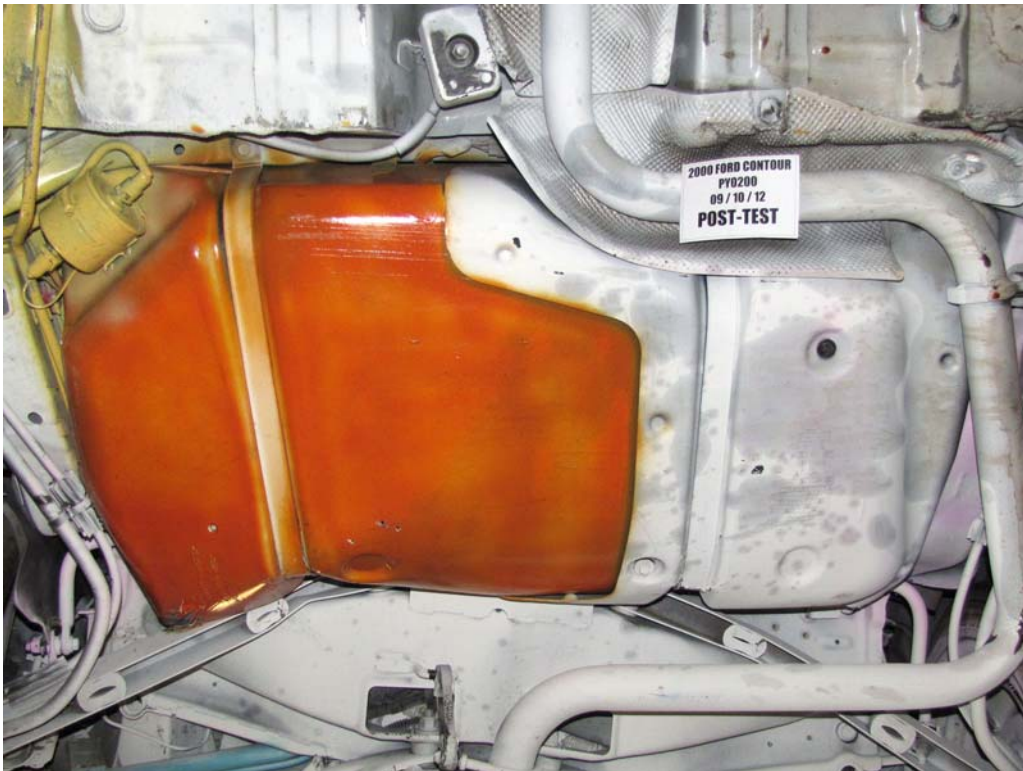
FIGURE 20. Post-Test Underbody, Fuel Tank Location

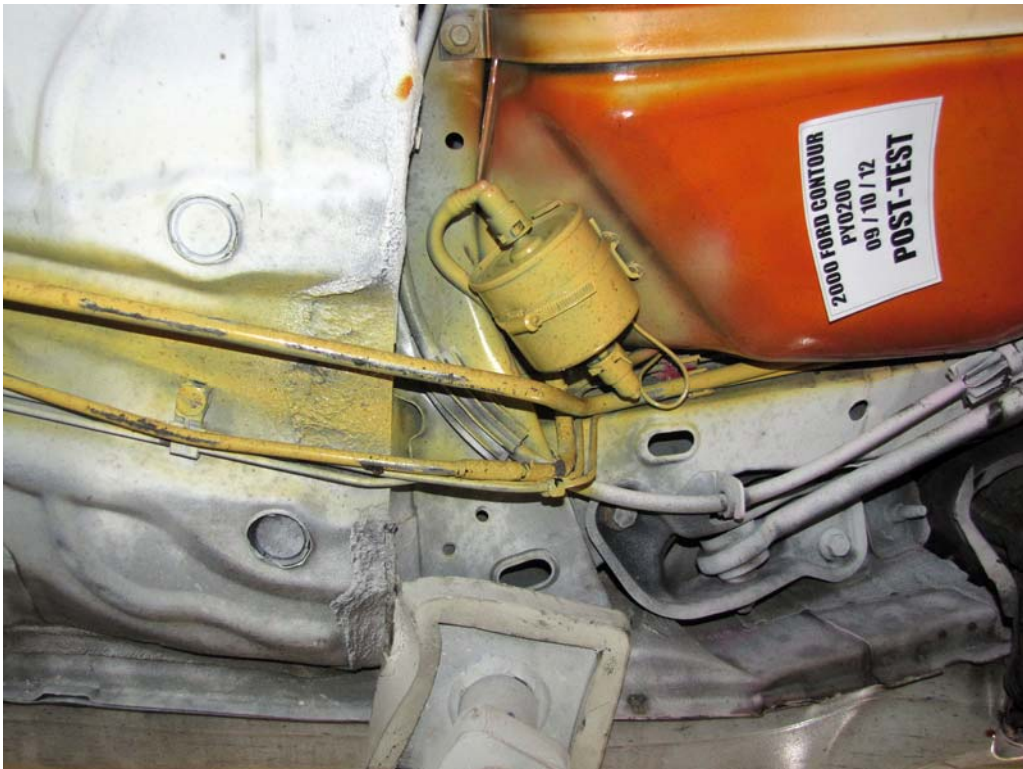
FIGURE 24. Post-Test Underbody, Fuel Line Location

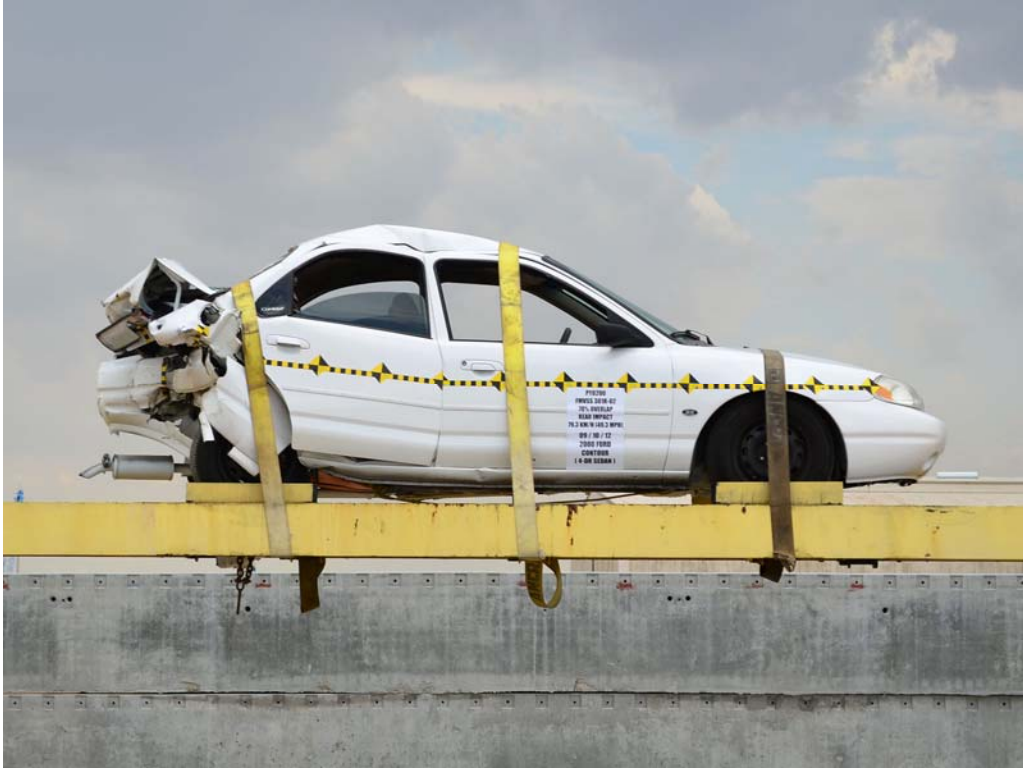
FIGURE 25. Vehicle at 0° on Static Rollover Device

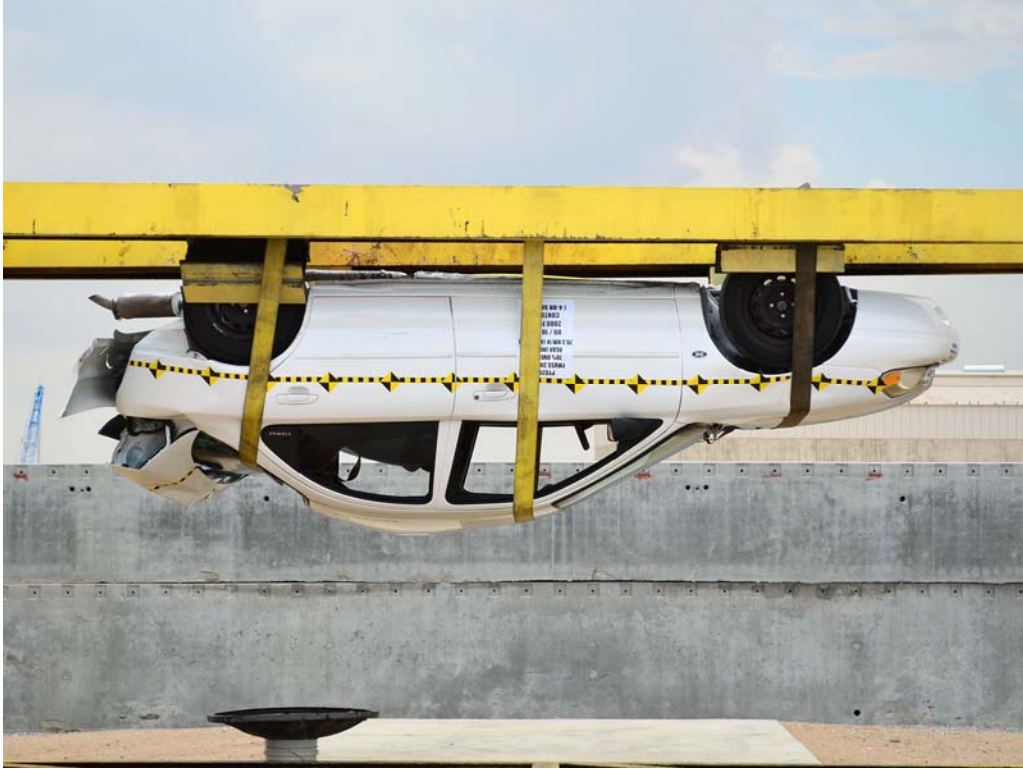
FIGURE 27. Vehicle at 180° on Static Rollover Device

Test Phase	First 5 Minutes	Sixth Minute	Seventh Minute	Eighth Minute
0° To 90°	4131 g	1061 g	373 g	
90° To 180°	2065 g	1520 g	488 g	
180° To 270°	17614 g	114 g		
270° To 360°	287 g

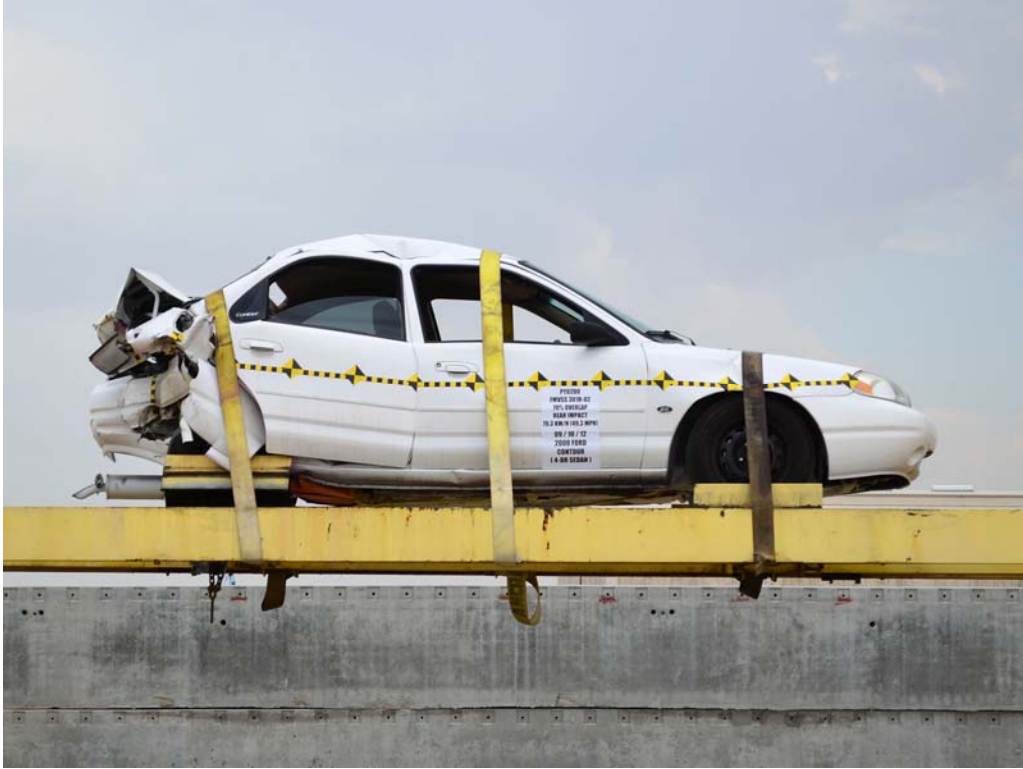
FIGURE 29. Vehicle at 360° on Static Rollover Device

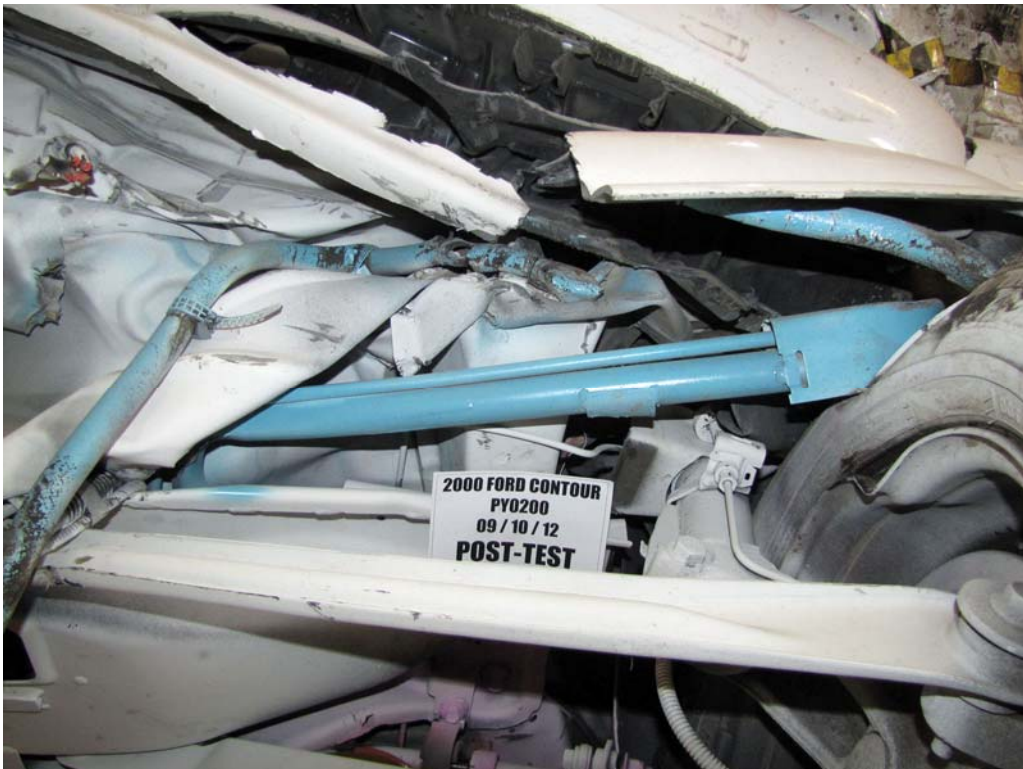
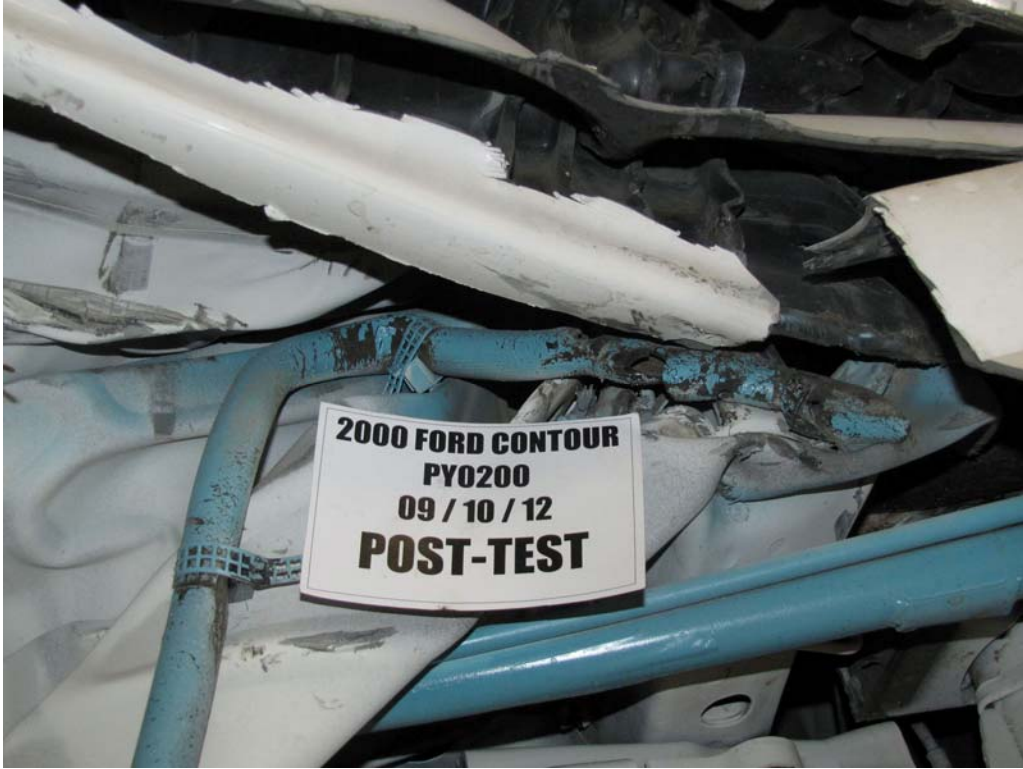
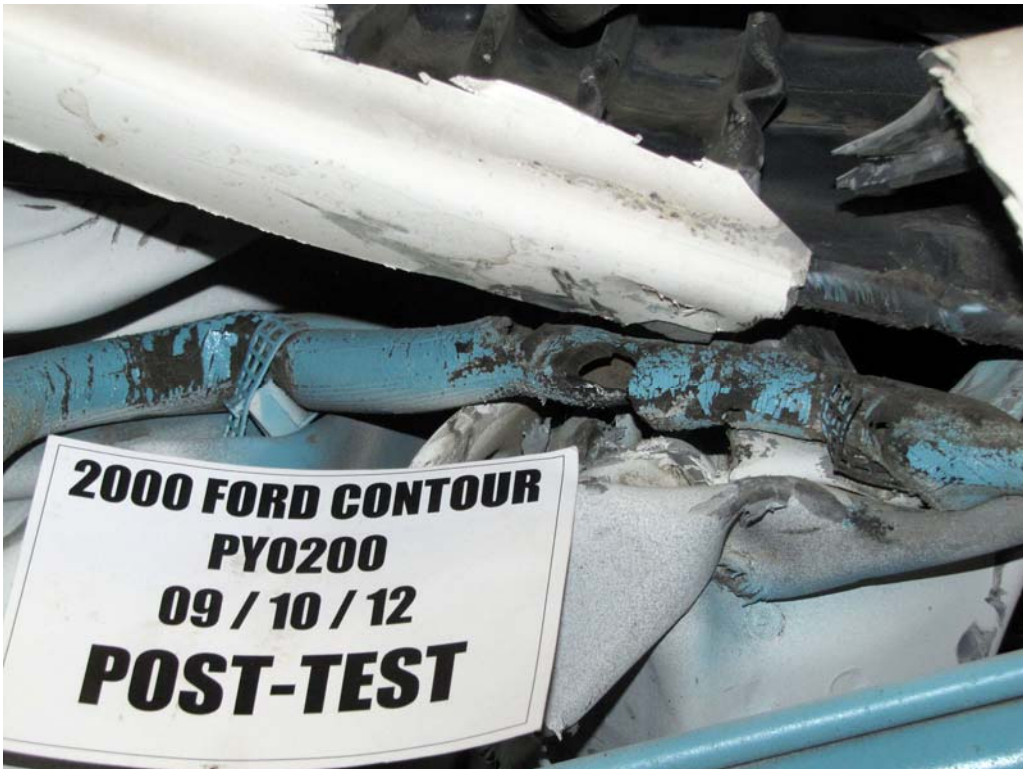
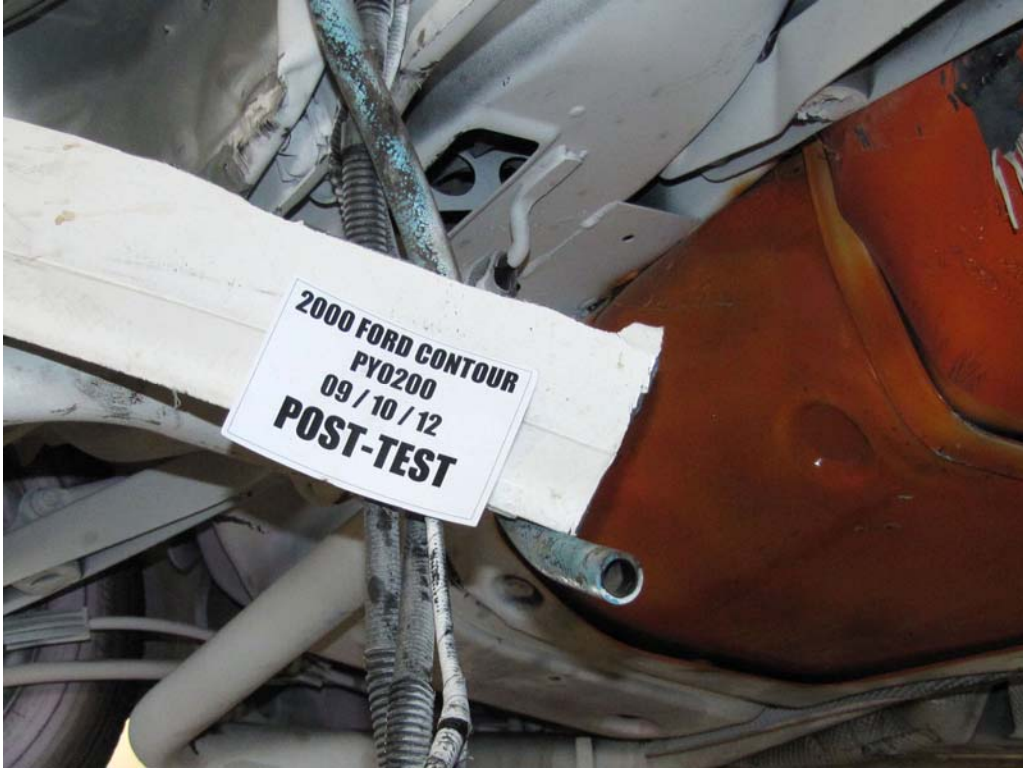
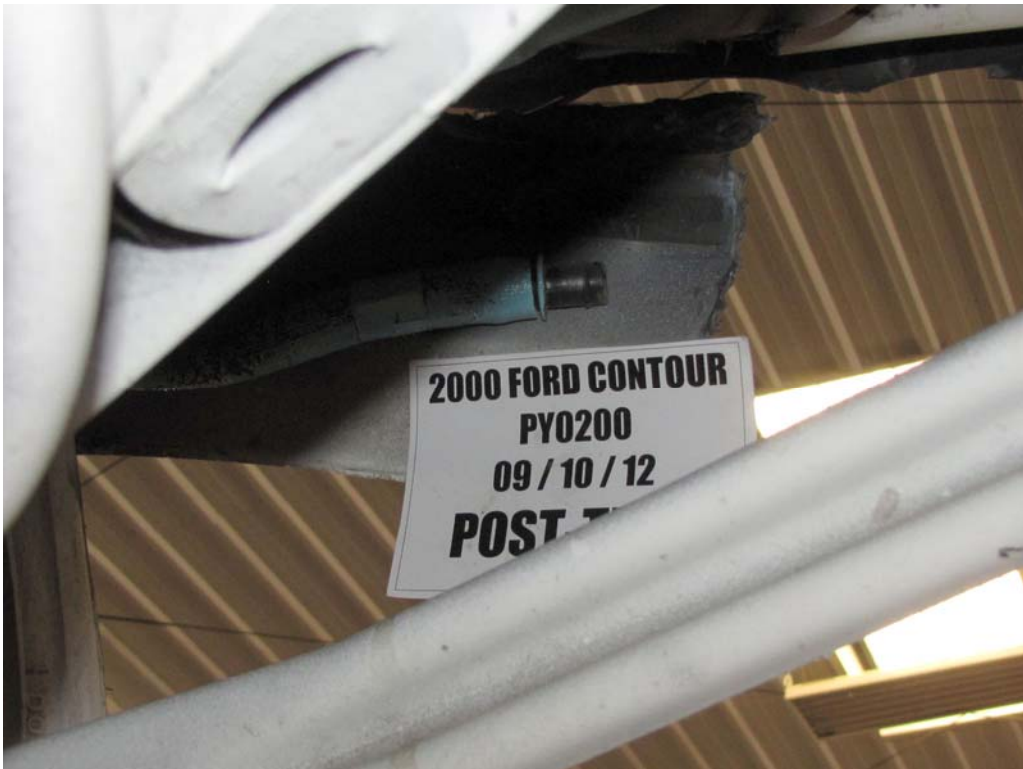
FIGURE 30. Post-Test Stoddard Solvent Spillage Location View

FIGURE 31. Post-Test Stoddard Solvent Spillage Location View

FIGURE 32. Post-Test Stoddard Solvent Spillage Location View

FIGURE 33. Post-Test Stoddard Solvent Spillage Location View

FIGURE 34. Post-Test Stoddard Solvent Spillage Location View

Test Phase	Spillage Location
0° To 90°	Fuel Filler Neck
90° To 180°	Fuel Filler Neck
180° To 270°	Fuel Filler Neck
270° To 360°	Fuel Filler Neck

There was no stoddard solvent leakage immediately after the impact event. Stoddard solvent leaked from the fuel filler neck area on the left rear fender of the vehicle throughout the static rollover test at every position from 0°-360°. The amount of solvent collected at each interval exceeded the allowable limits.
