**REPORT NUMBER: NCAP-MGA-2014-064**

**NEW CAR ASSESSMENT PROGRAM (NCAP)  
Frontal Barrier Impact Test**

**GENERAL MOTORS LLC  
2015 Chevrolet Suburban 4WD 1500 LS SUV  
NHTSA No.: M20150106**

**FINAL REPORT**

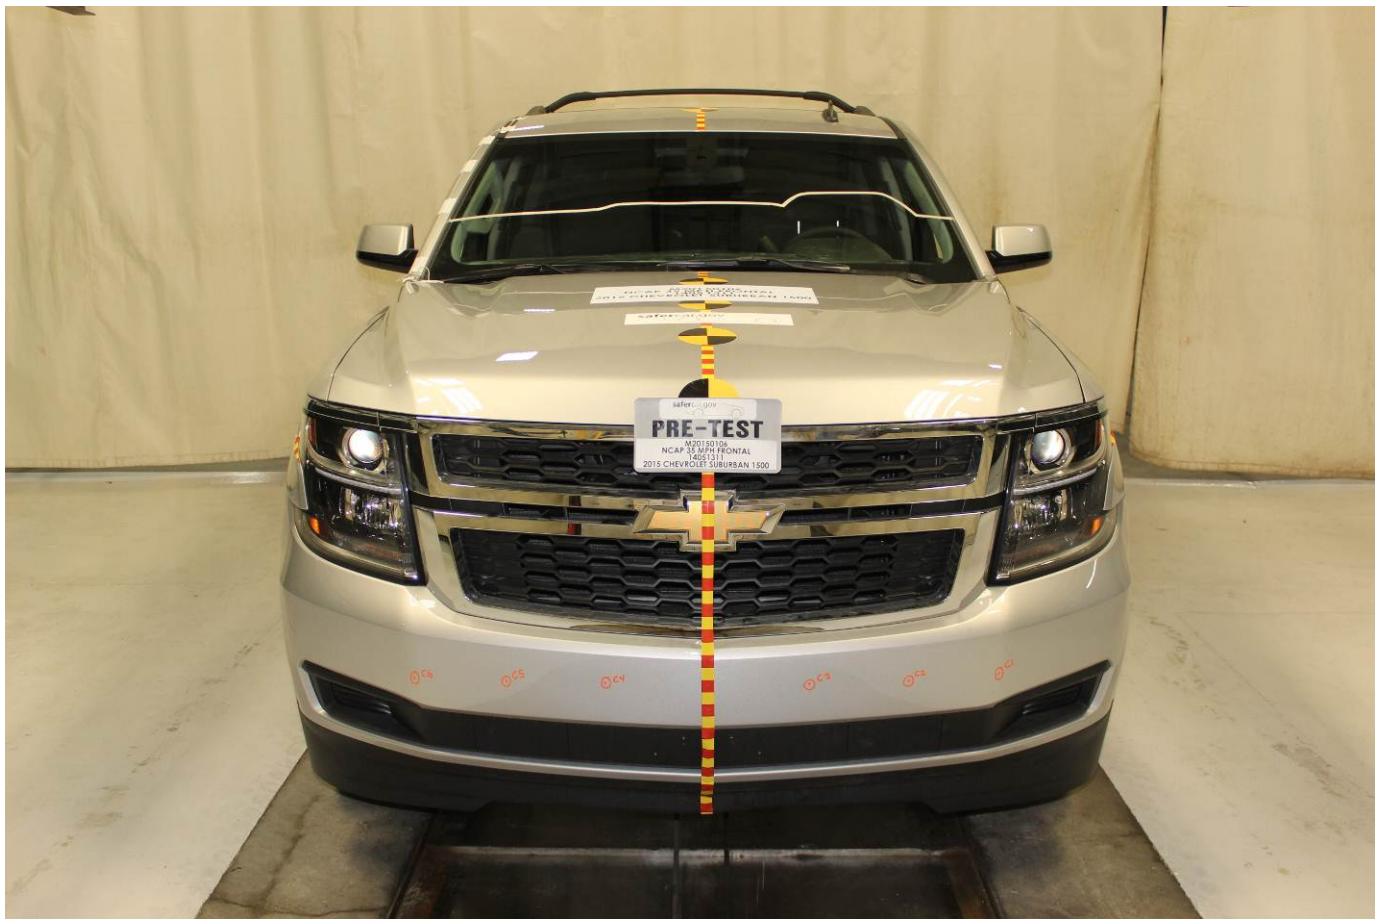
Pre-Test Front View of Test Vehicle

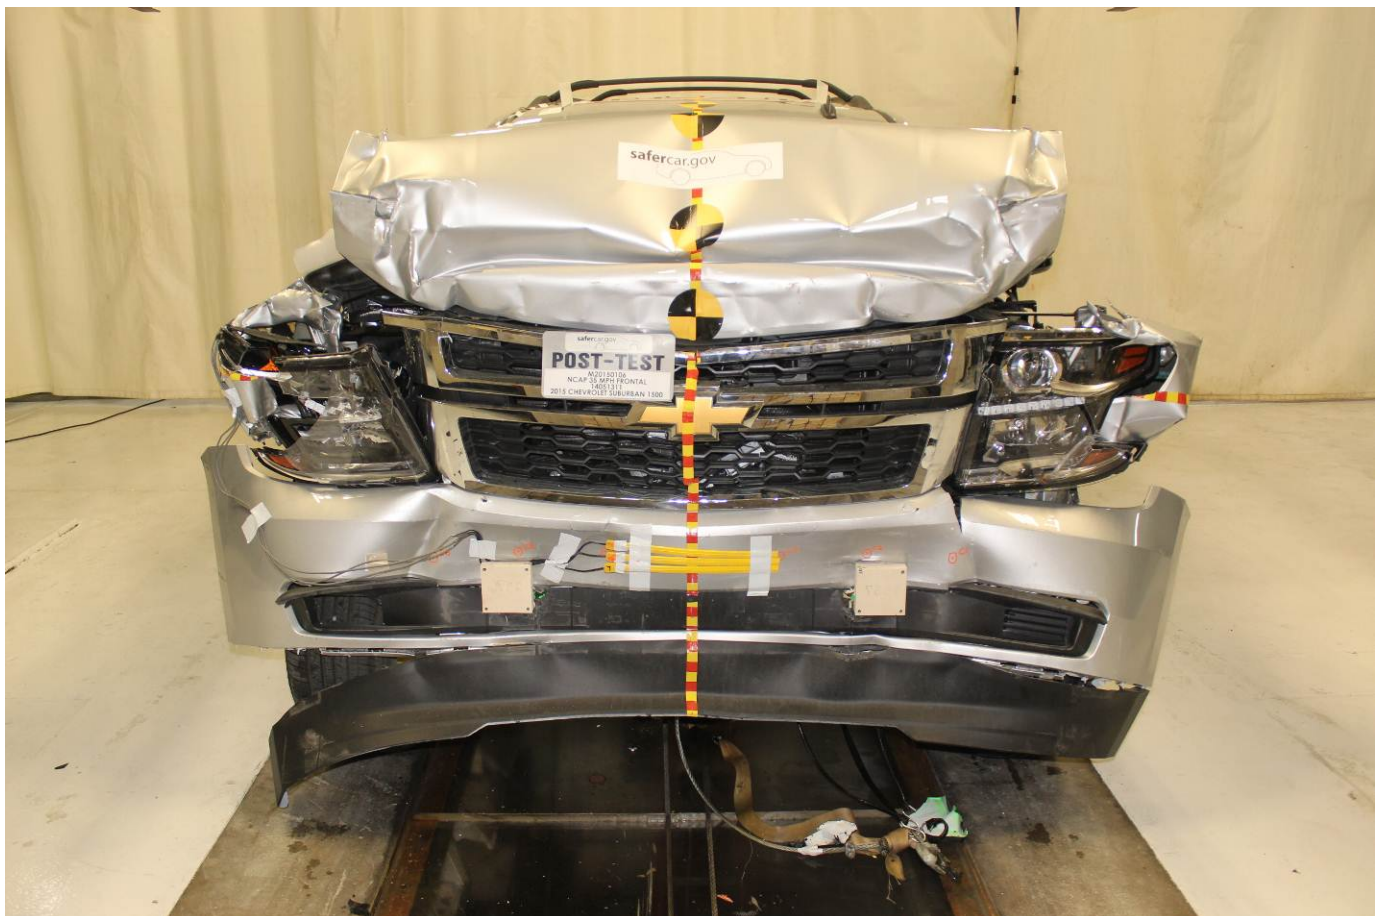
Post-Test Front View of Test Vehicle

The maximum static crush of the vehicle was 976 mm and both the driver and passenger side doors remained closed during the impact event and were operable after the impact.

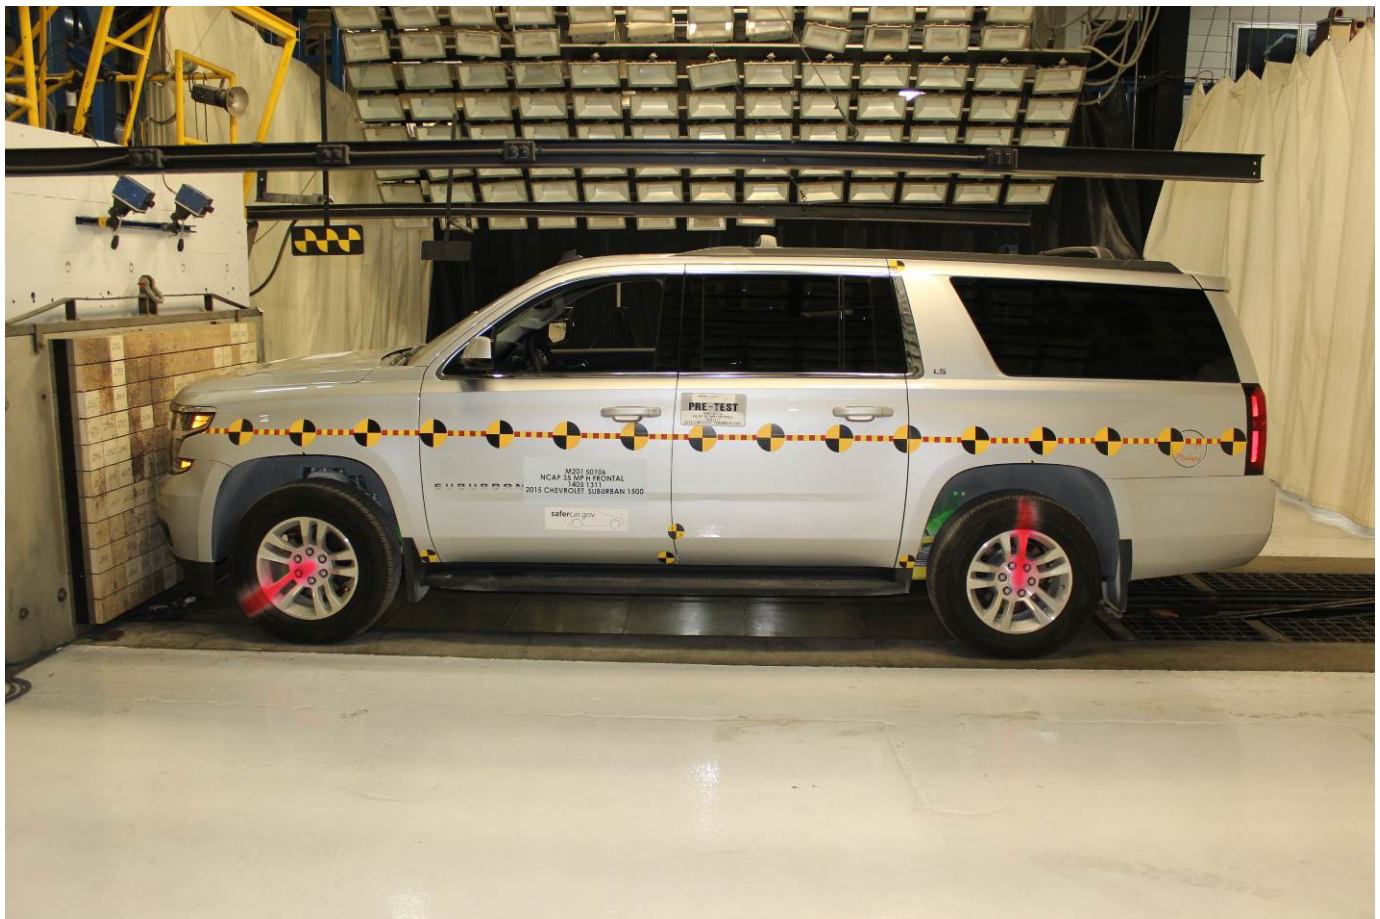
Pre-Test Left View of Test Vehicle

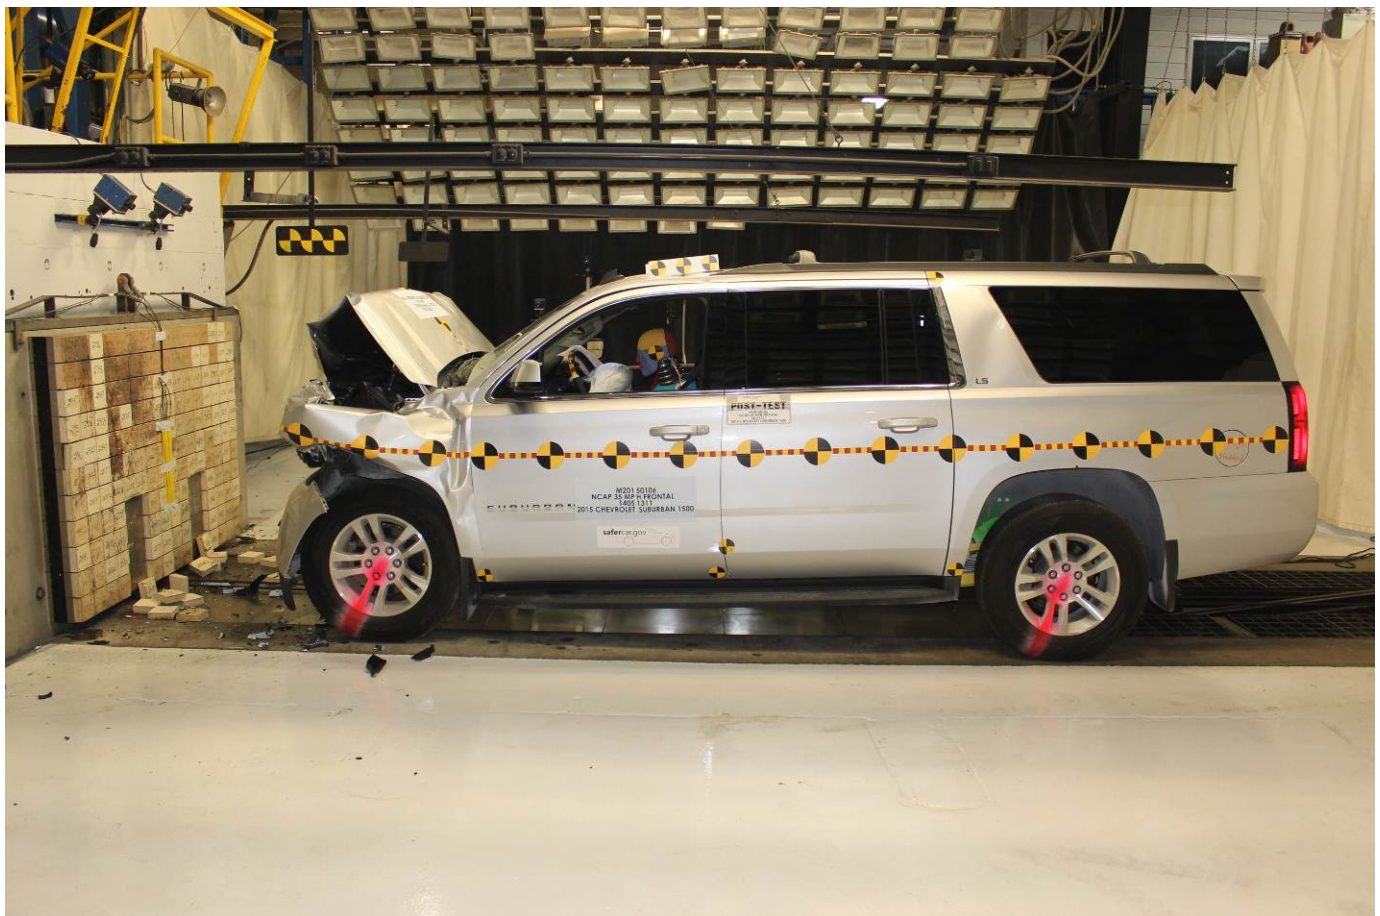
Post-Test Left View of Test Vehicle

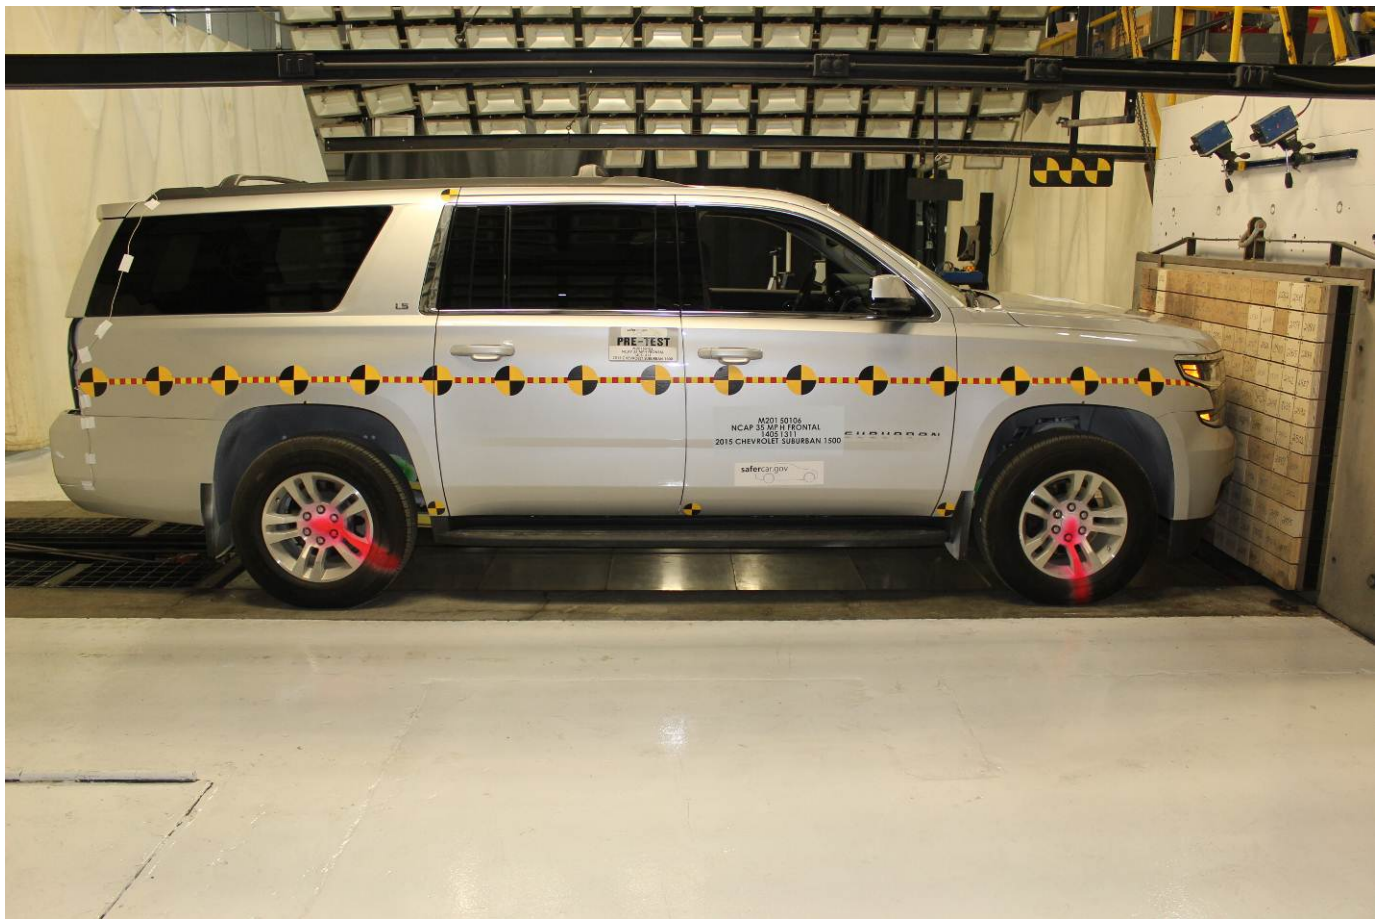
Pre-Test Right View of Test Vehicle

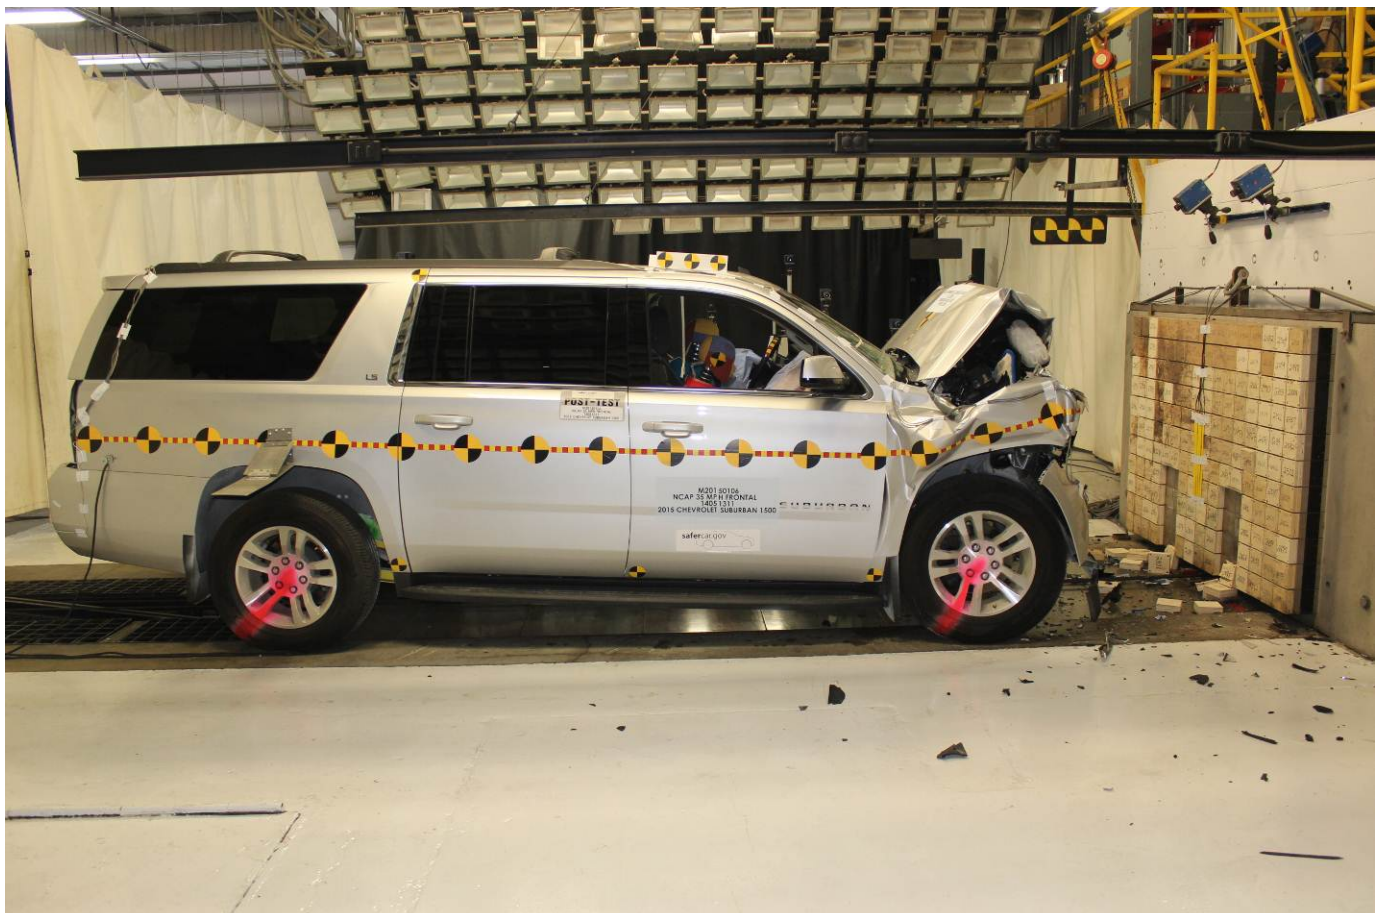
Post-Test Right View of Test Vehicle

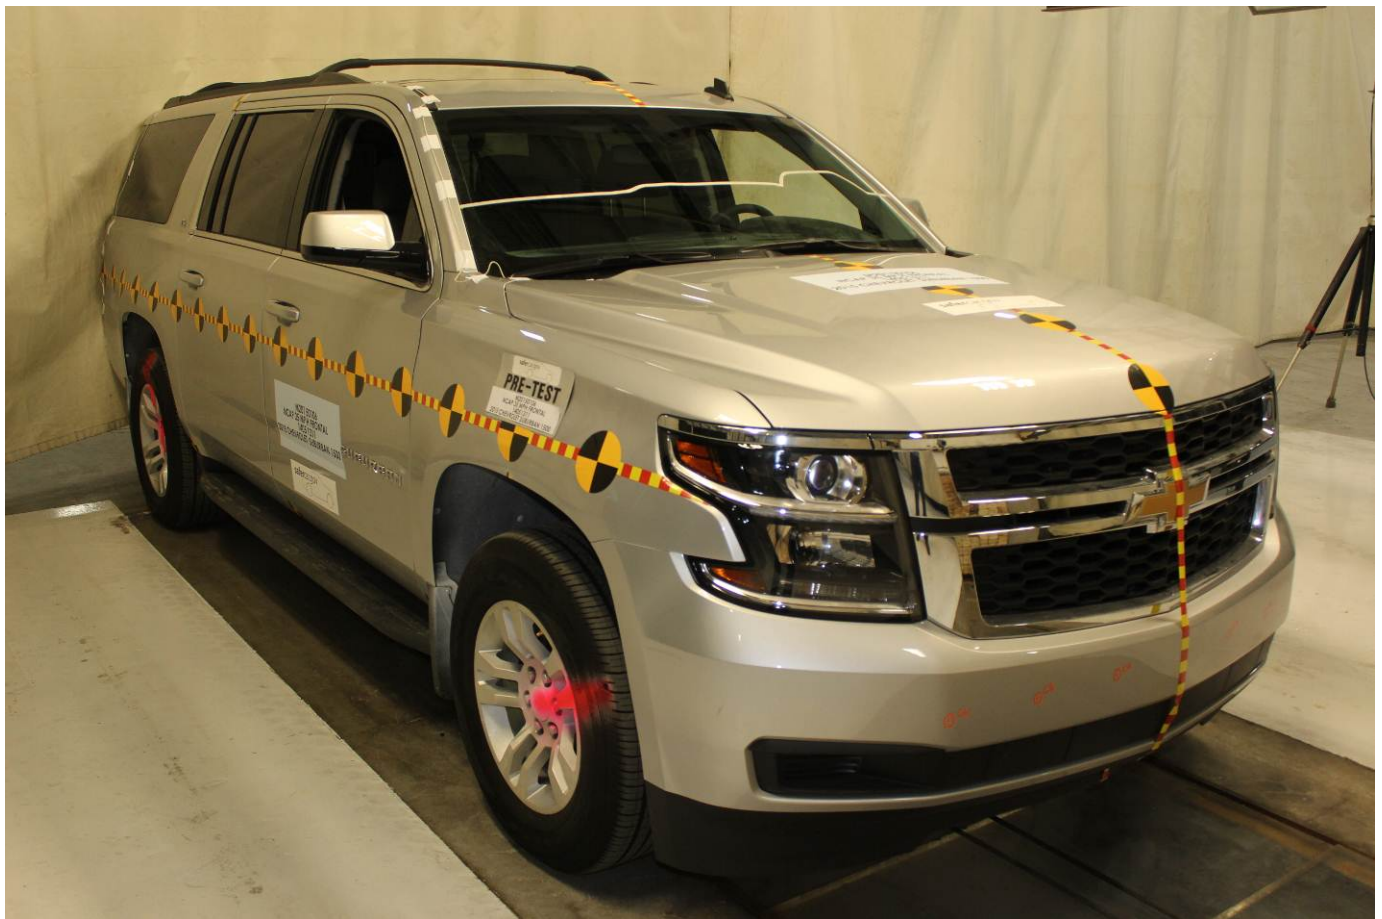
Pre-Test Right Front 3-4 View

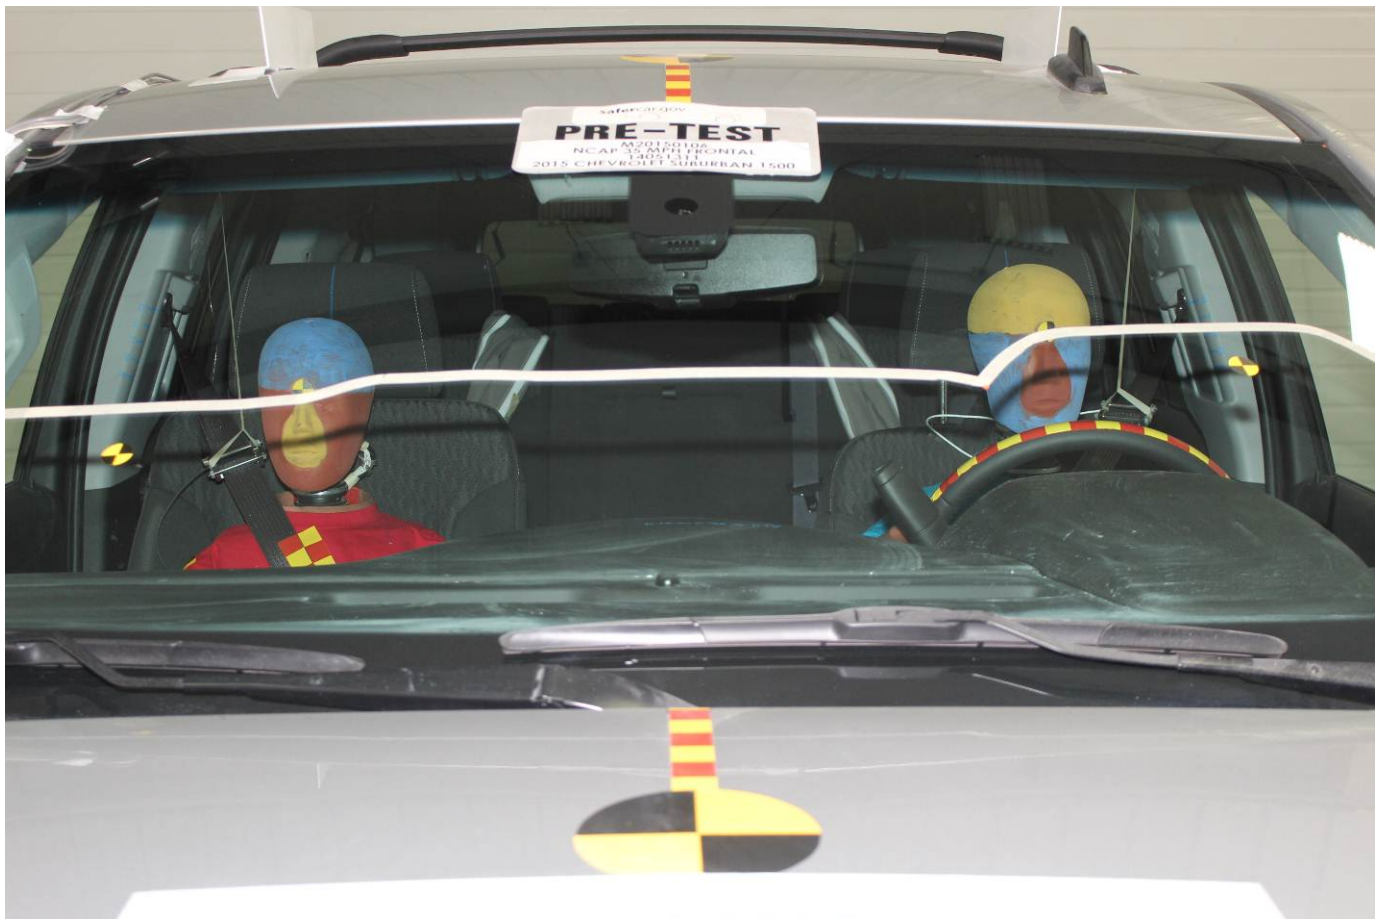
Pre-Test Windshield View

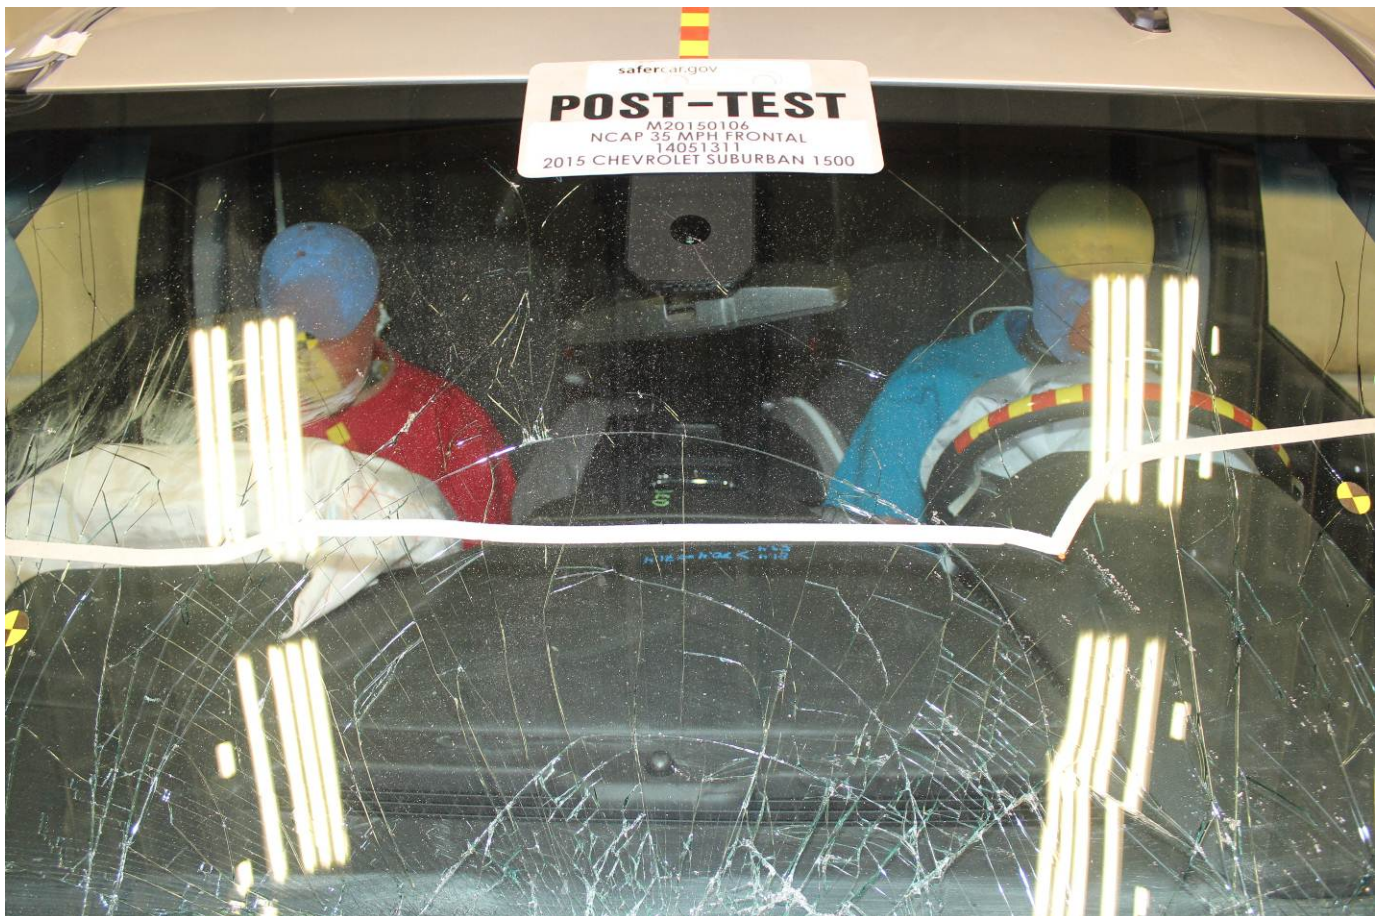
Post-Test Windshield View

There was 89 percent windshield retention and no intrusion into the protected zone of the windshield during the event. There was no Stoddard Solvent leakage after the event or during any phase of the static rollover.

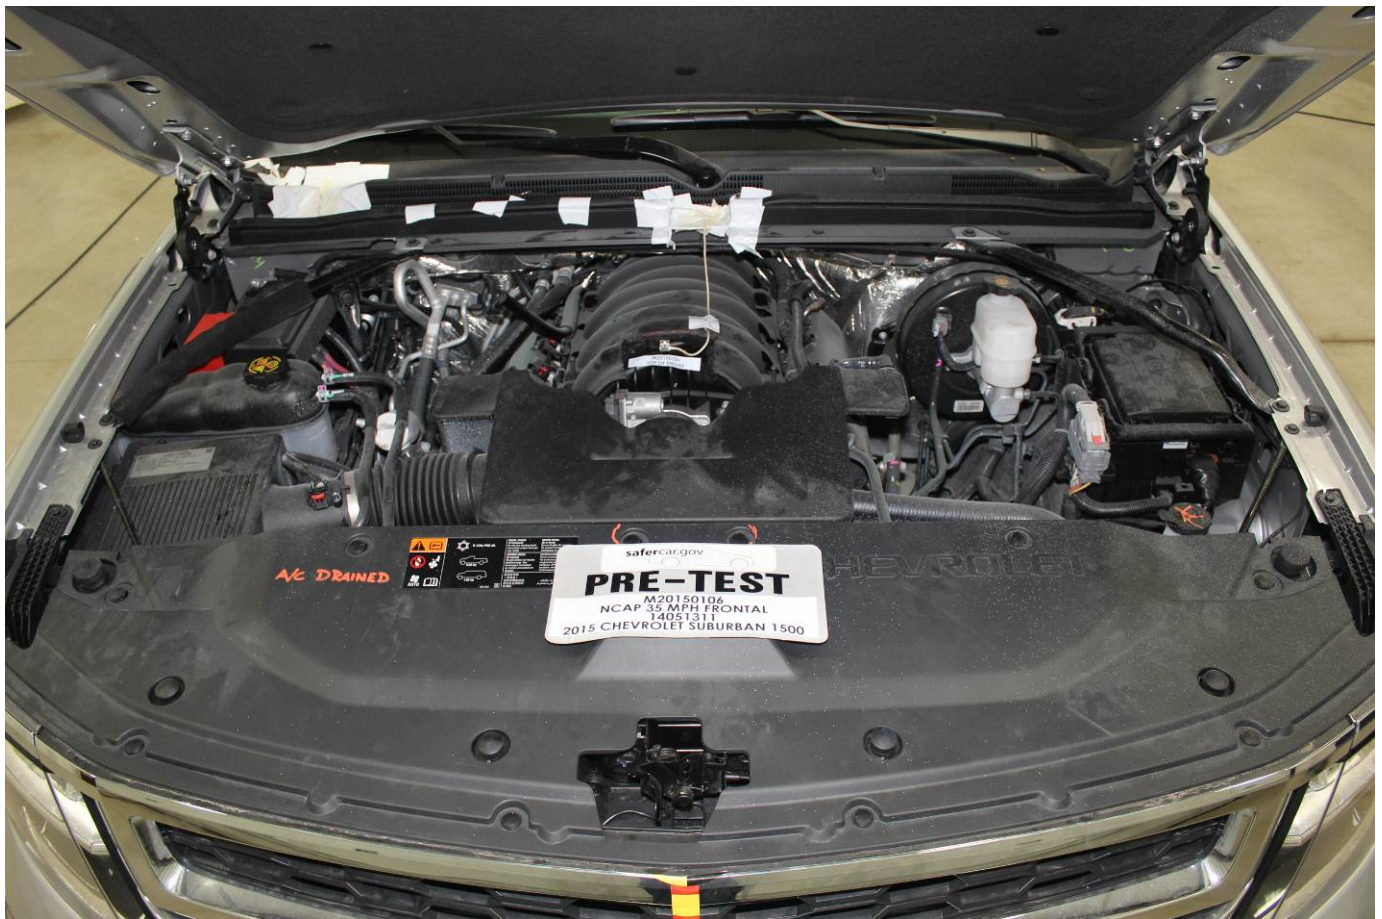
Pre-Test Engine Compartment View

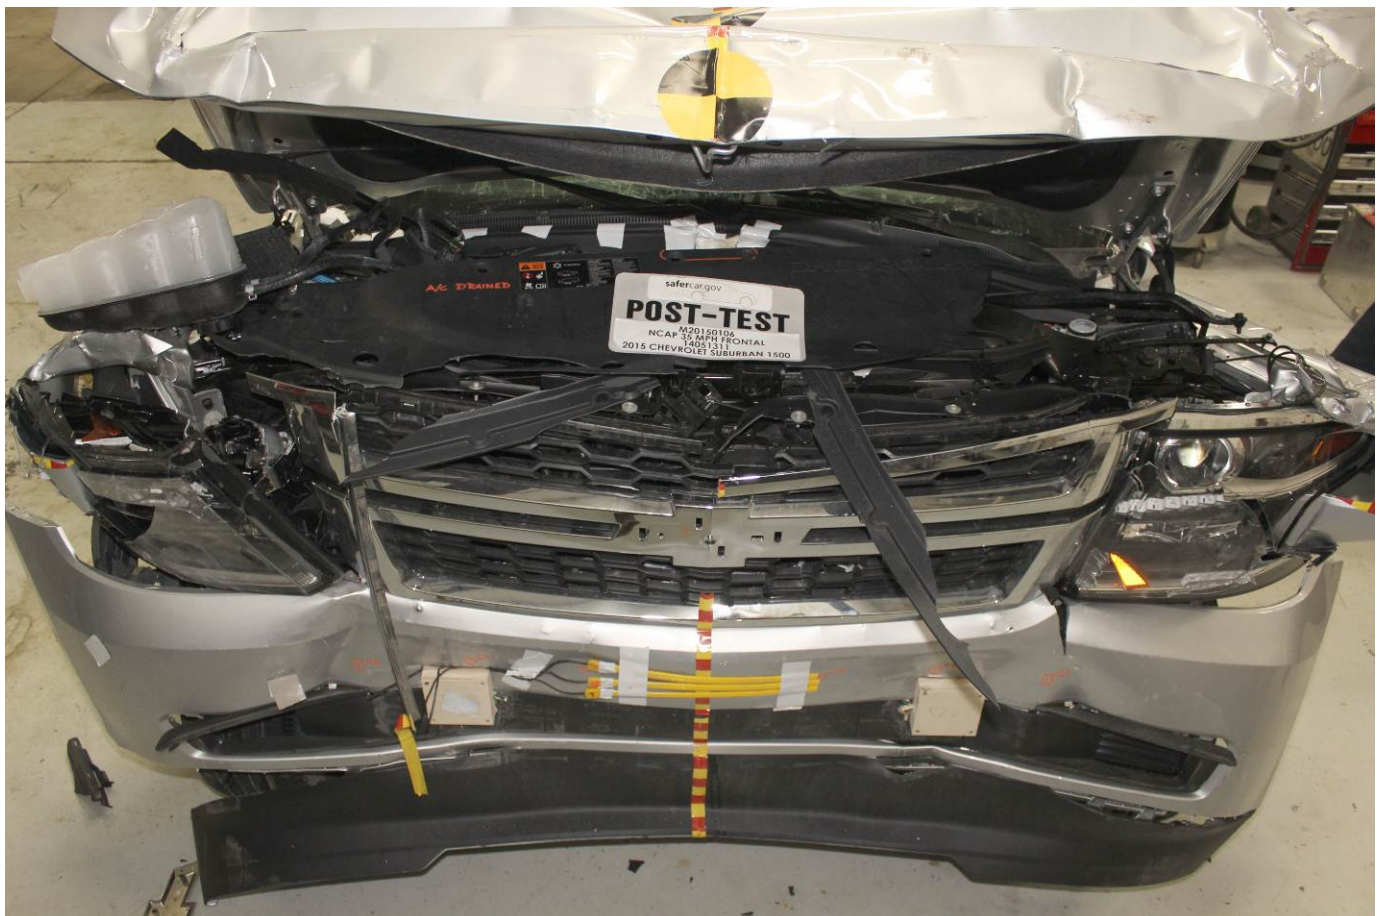
Post-Test Engine Compartment View

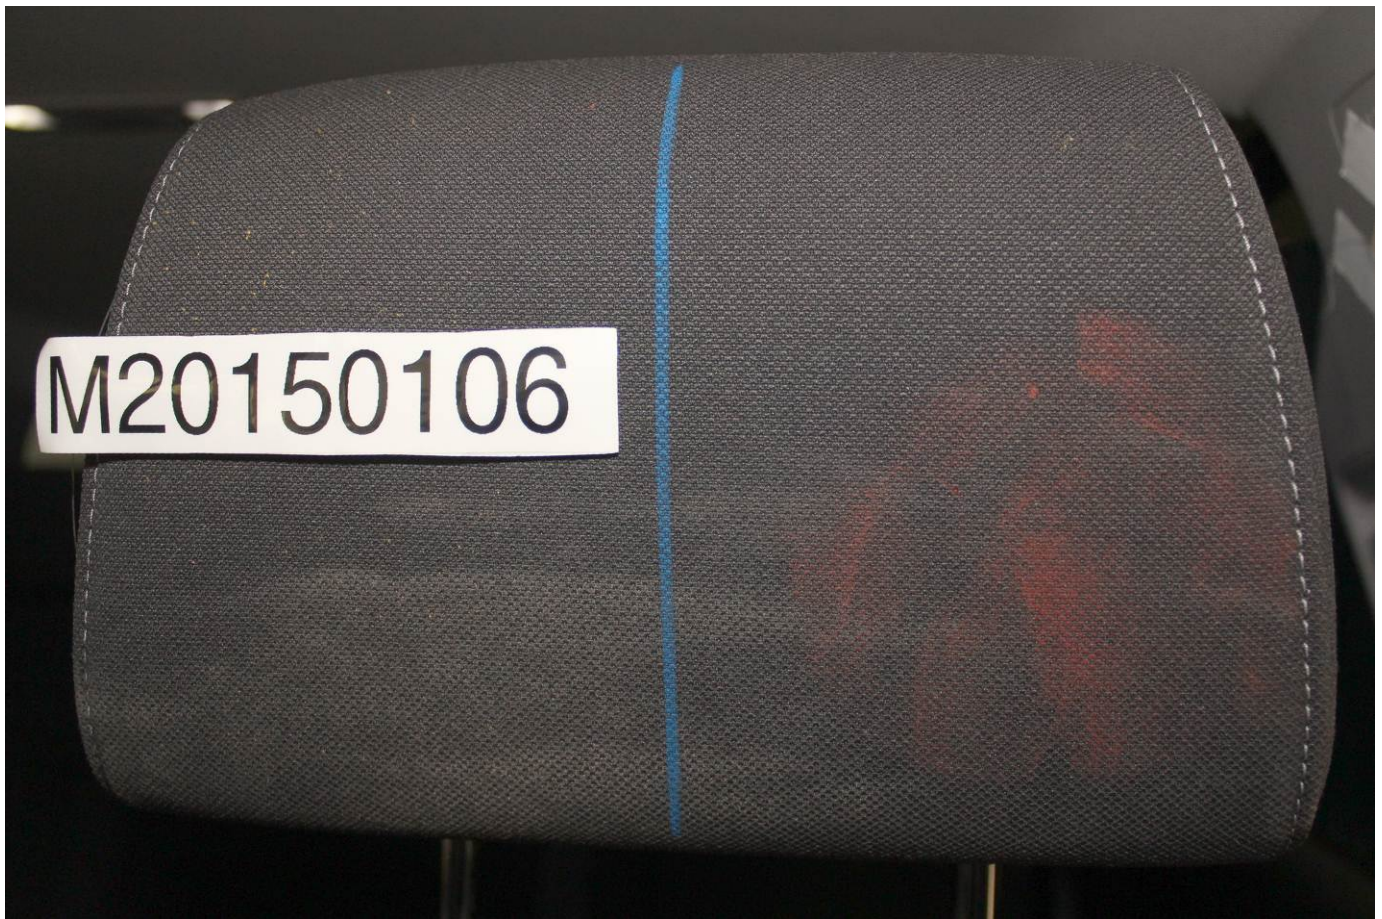
Post-Test Driver Dummy Contact with Headrest

The driver's visible contact points were as follows: The driver's head and chest contacted the airbag. The driver's head also contacted the headrest. The driver's knees contacted the knee bolster. The passenger's visible contact points were as follows: The passenger's head and chest contacted the airbag. The passenger's head also contacted the headrest. The passenger's knees contacted the glovebox and frontal airbag.

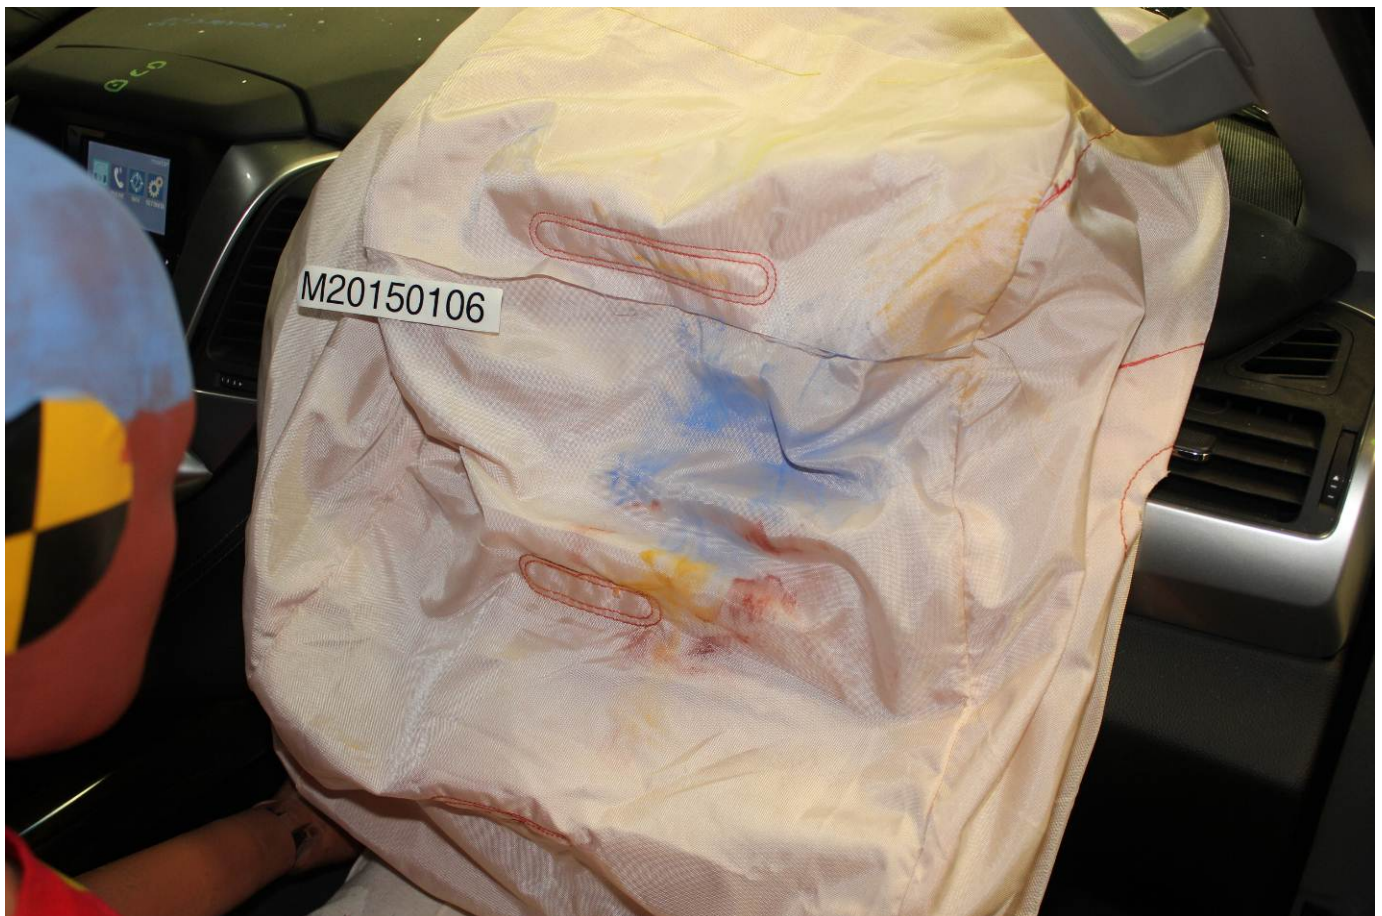
Post-Test Passenger Dummy Contact with Airbag

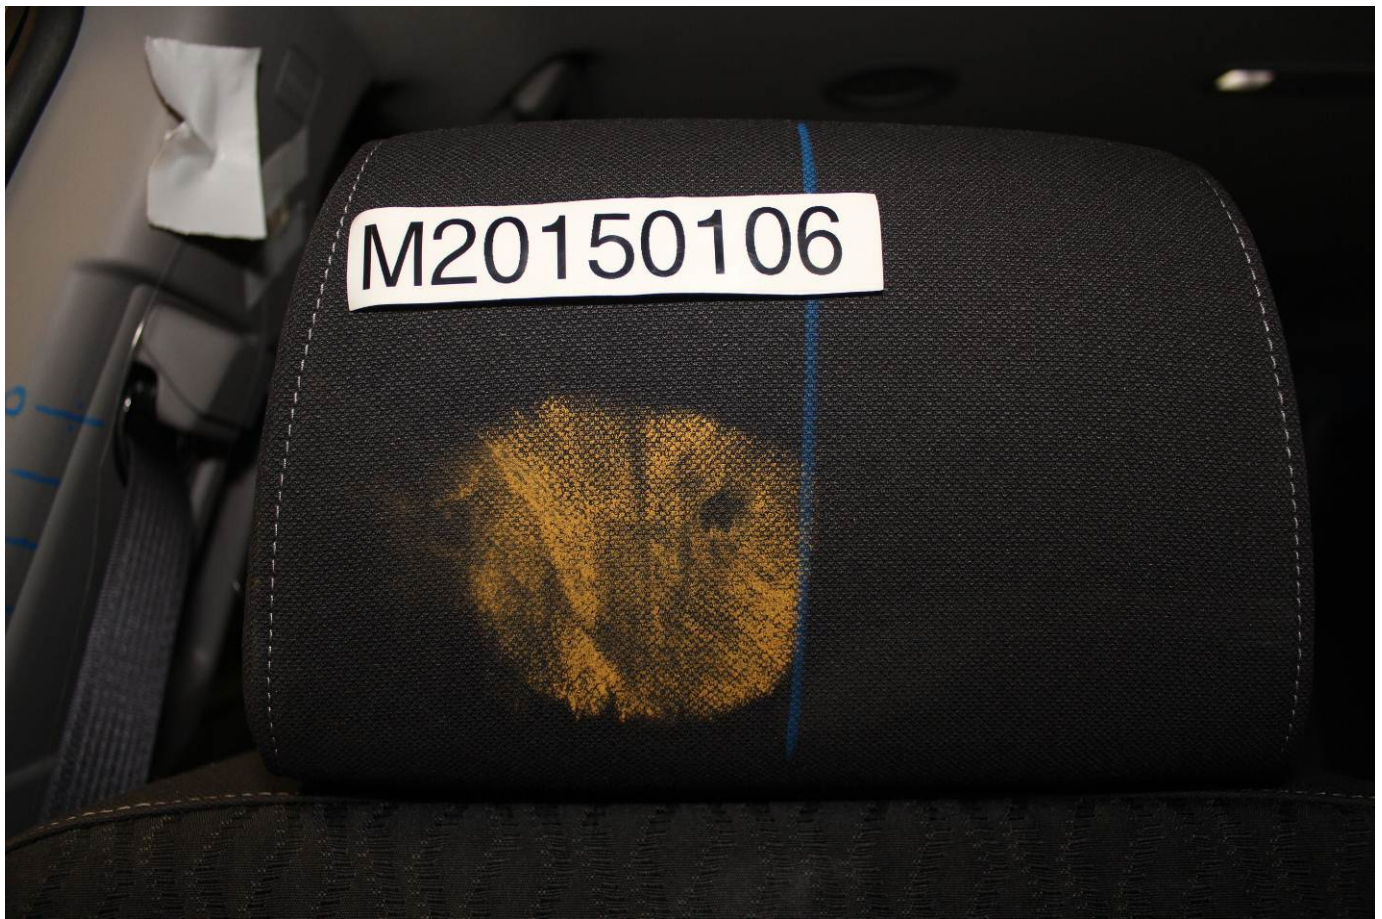
Post-Test Passenger Dummy Contact with Headrest

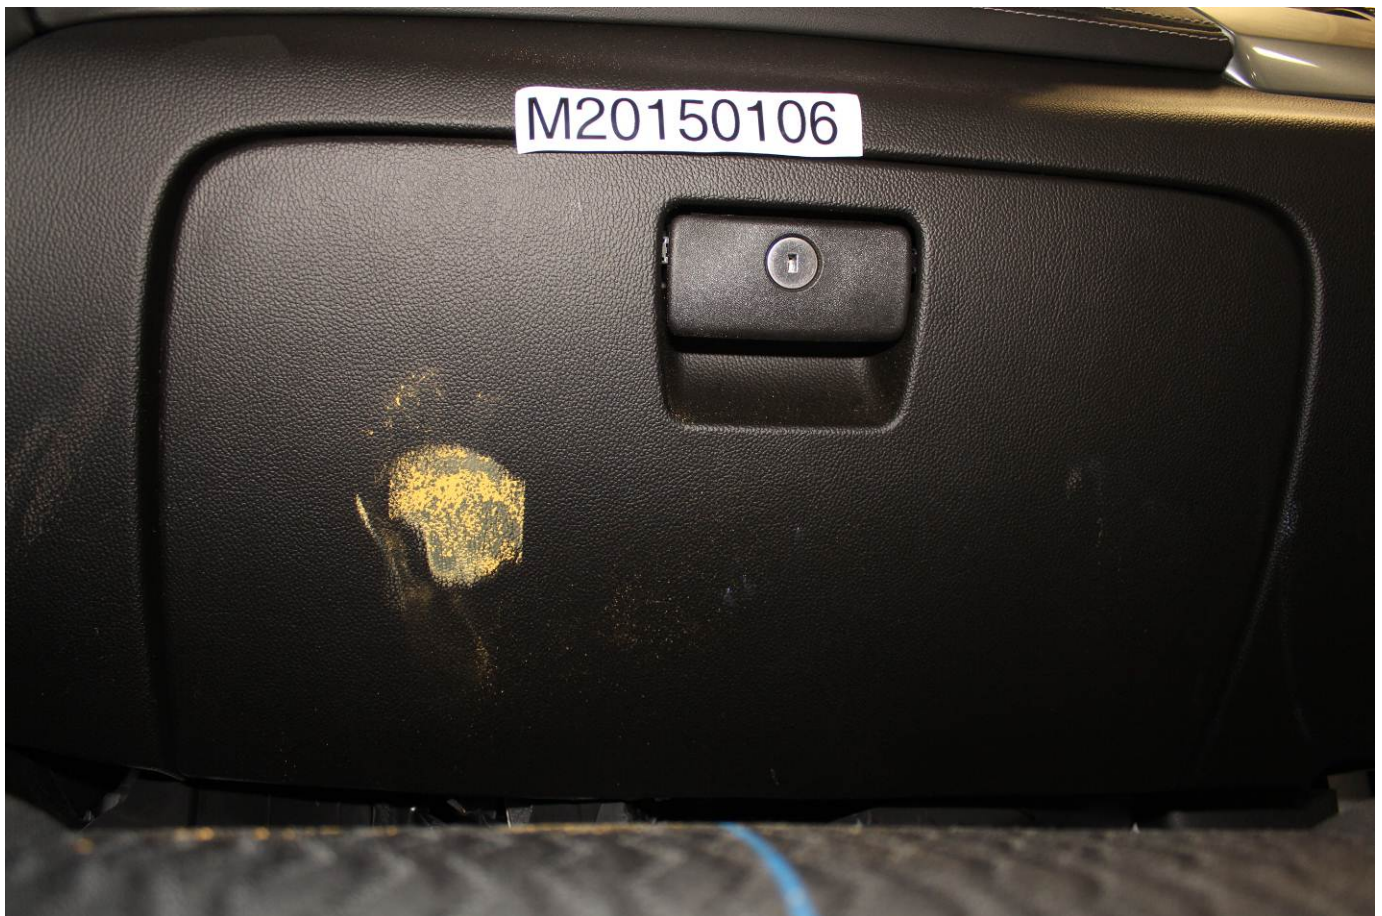
Post-Test Passenger Dummy Contact with Glovebox

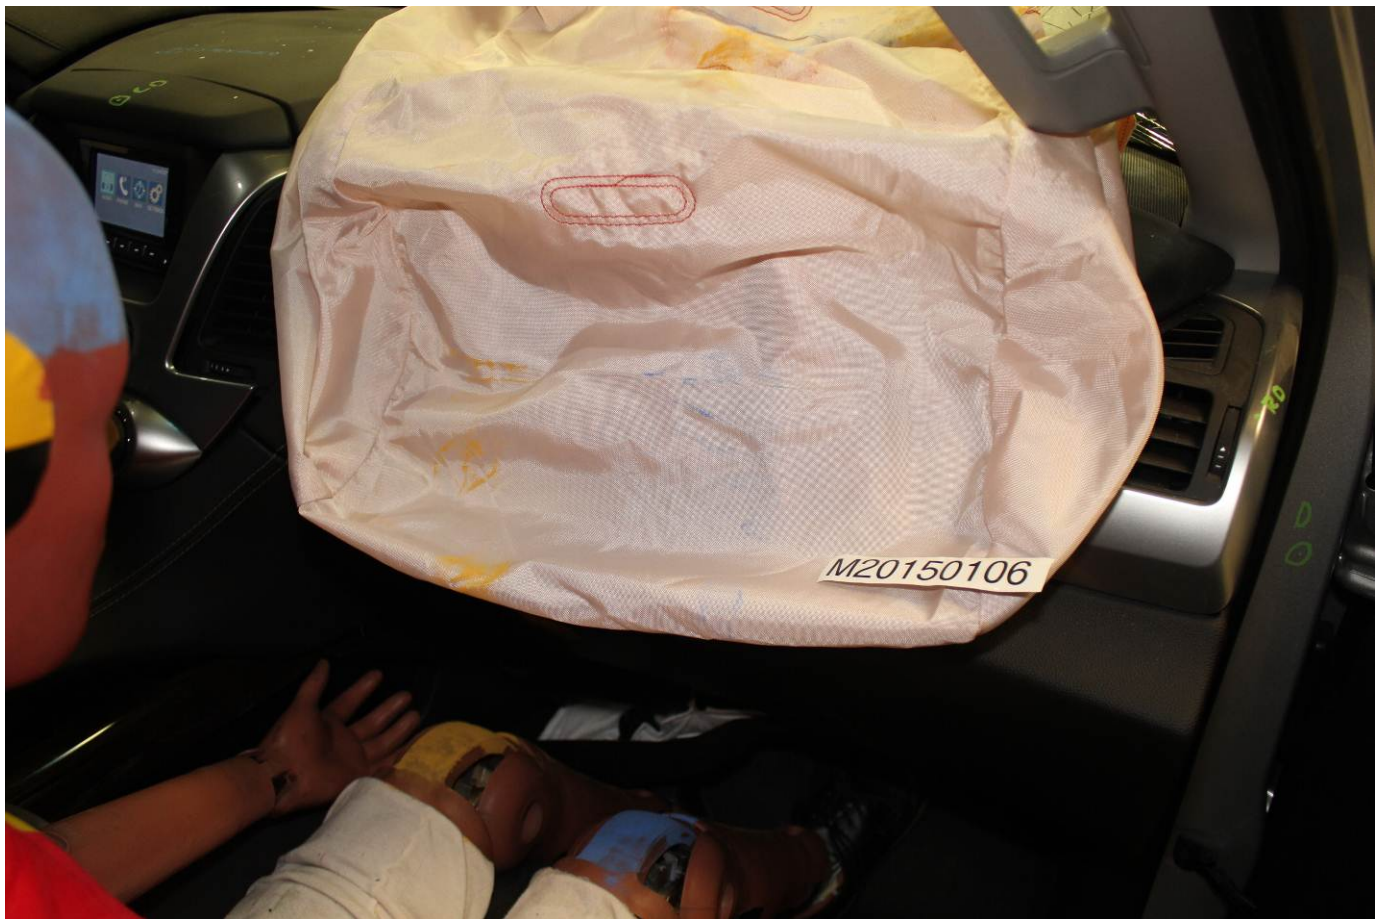
Post-Test Passenger Dummy Contact with Frontal Airbag

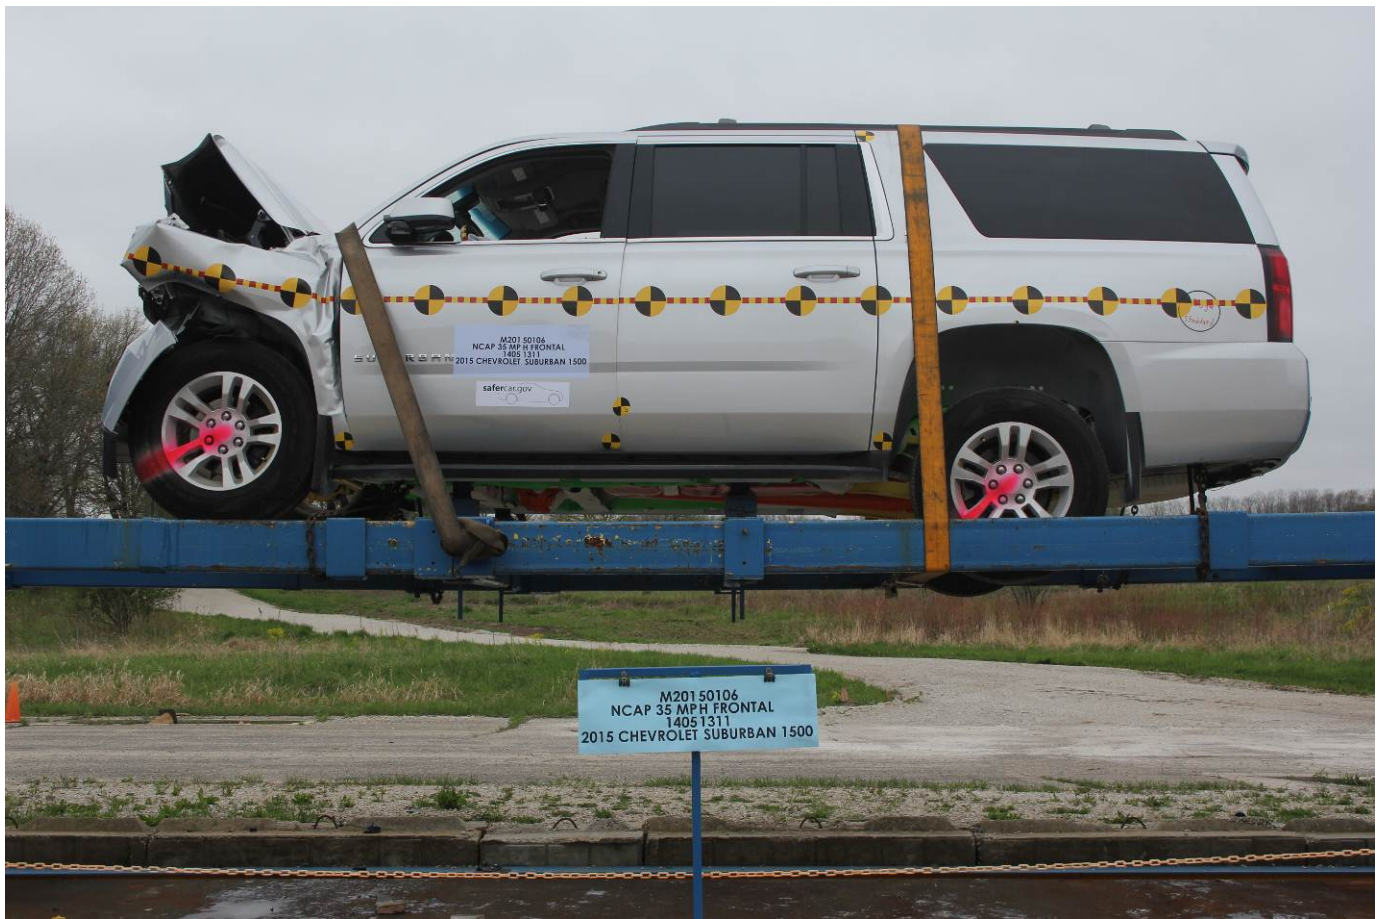
Vehicle at 0 Degree on Static Rollover Device

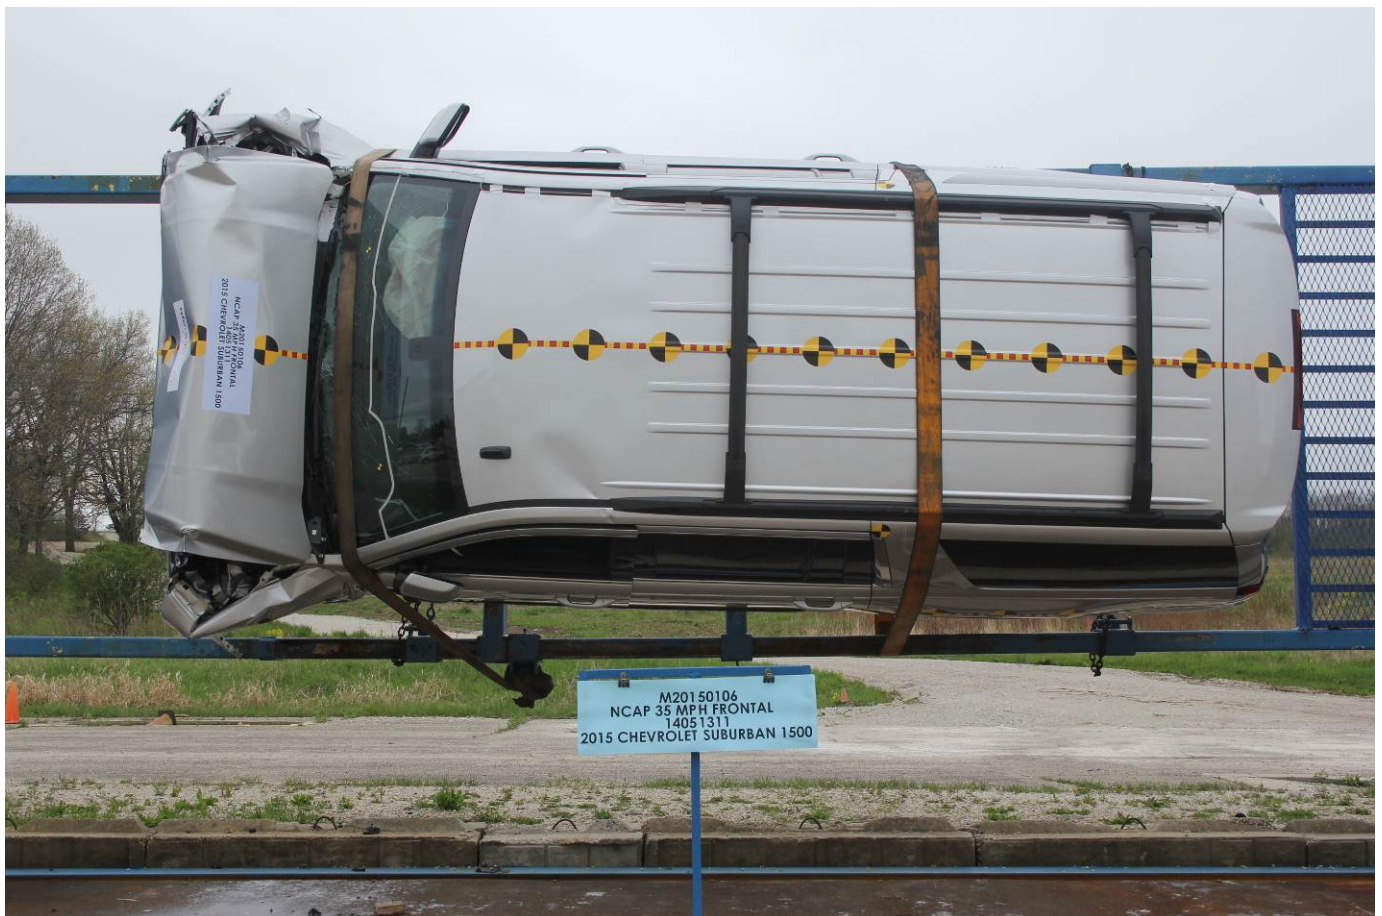
Vehicle at 90 Degrees on Static Rollover Device
