**REPORT NUMBER: NCAP-MGA-2014-064**

**NEW CAR ASSESSMENT PROGRAM (NCAP)  
Frontal Barrier Impact Test**

**GENERAL MOTORS LLC  
2015 Chevrolet Suburban 4WD 1500 LS SUV  
NHTSA No.: M20150106**

**FINAL REPORT**

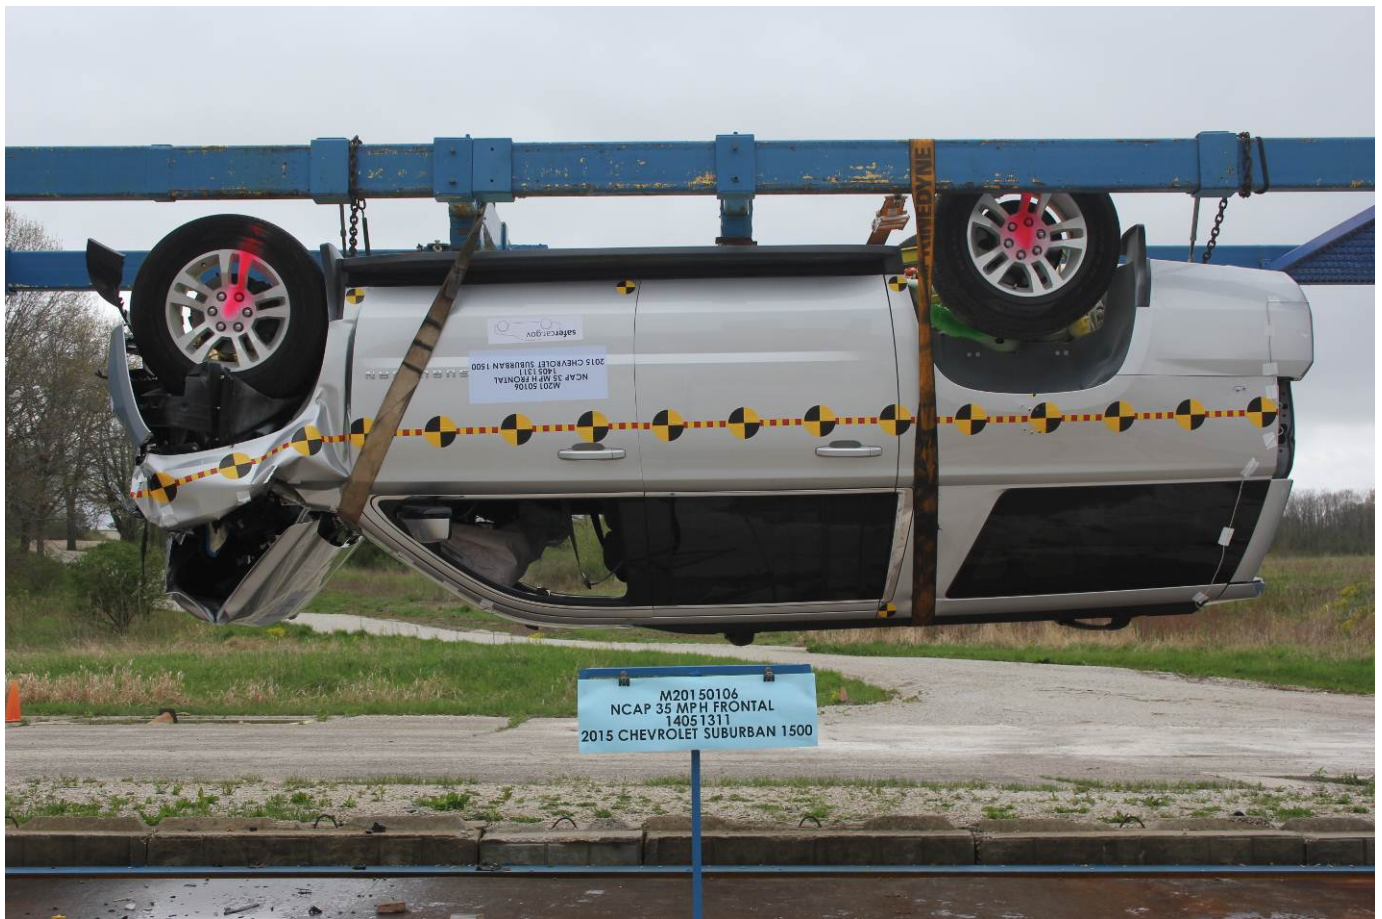
Vehicle at 180 Degrees on Static Rollover Device

There was 89 percent windshield retention and no intrusion into the protected zone of the windshield during the event. There was no Stoddard Solvent leakage after the event or during any phase of the static rollover.

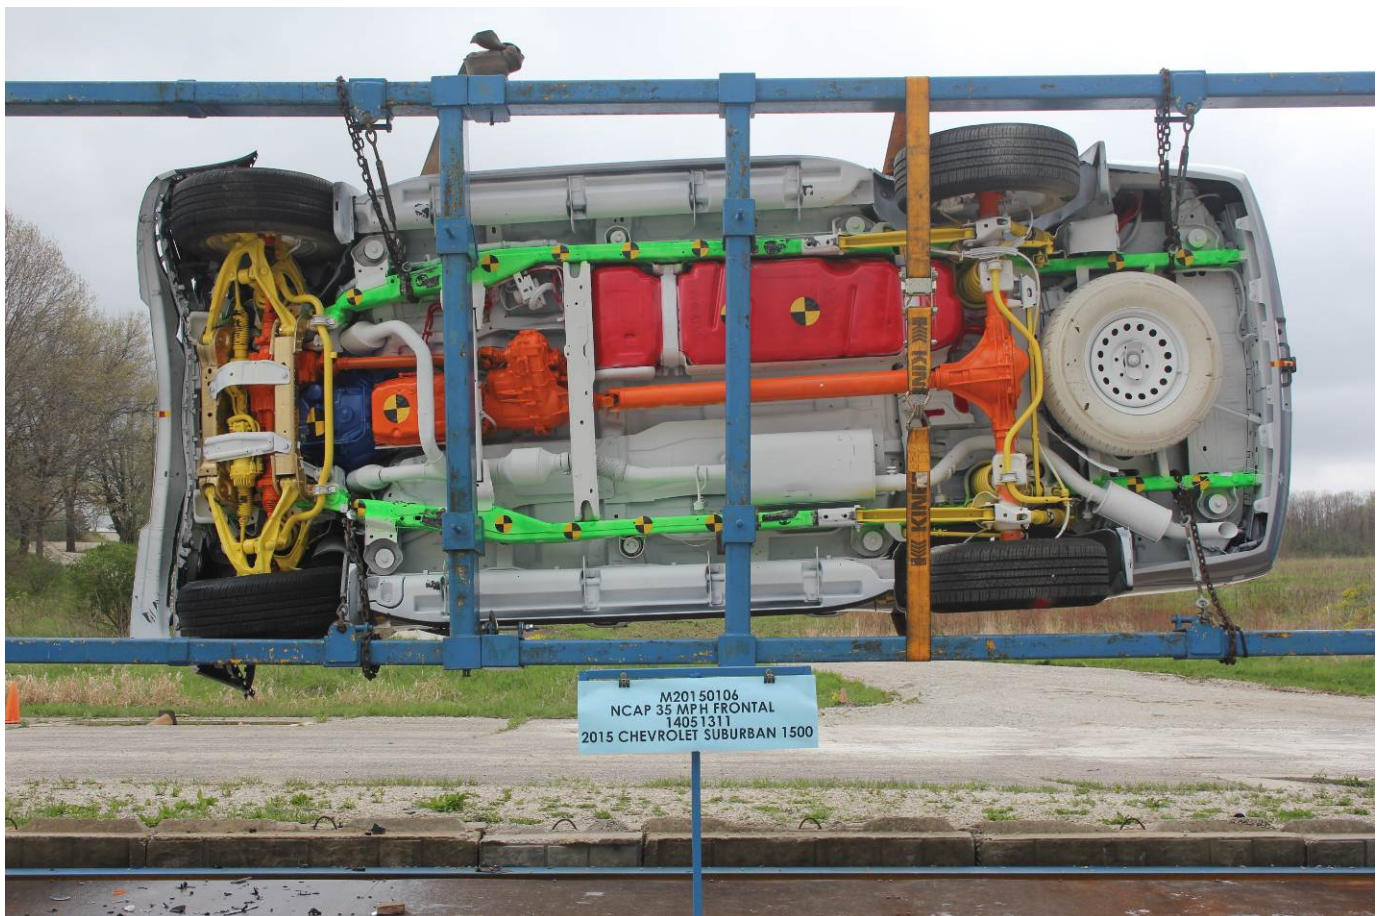
Vehicle at 270 Degrees on Static Rollover Device

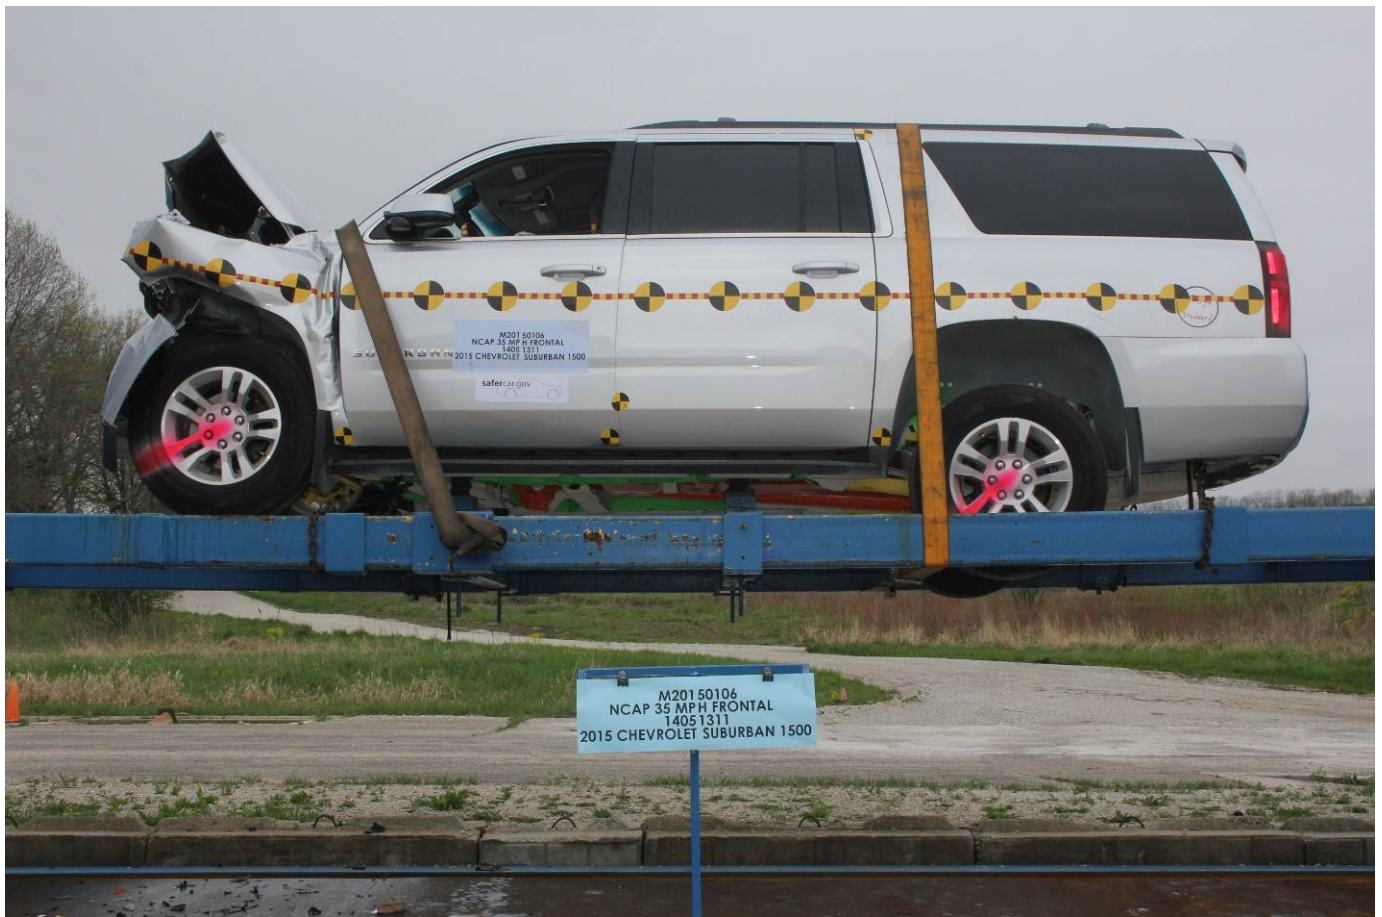
Vehicle at 360 Degrees on Static Rollover Device
