**REPORT NUMBER: SPNCAP-MGA-2014-065**

**NEW CAR ASSESSMENT PROGRAM (NCAP)  
Side Impact Pole Test**

**GENERAL MOTORS LLC  
2015 Chevrolet Suburban 1500 LS SUV  
NHTSA No.: M20150107**

**FINAL REPORT**

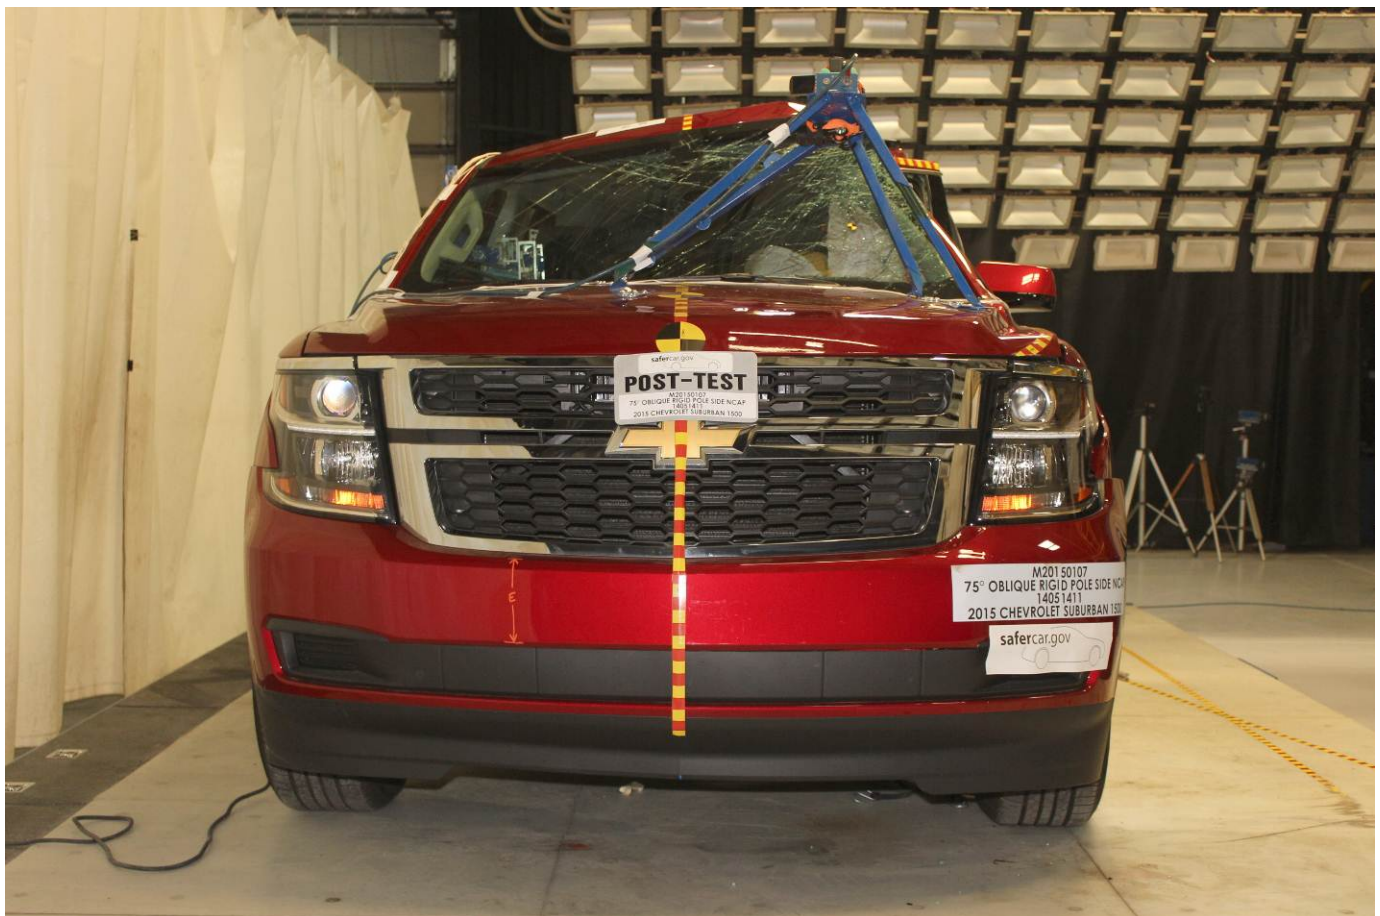
Post-Test Frontal View of Test Vehicle

| Critical Areas of Performance | Observations and Conclusions |
|---|---|
| Windshield Damage | Cracked |

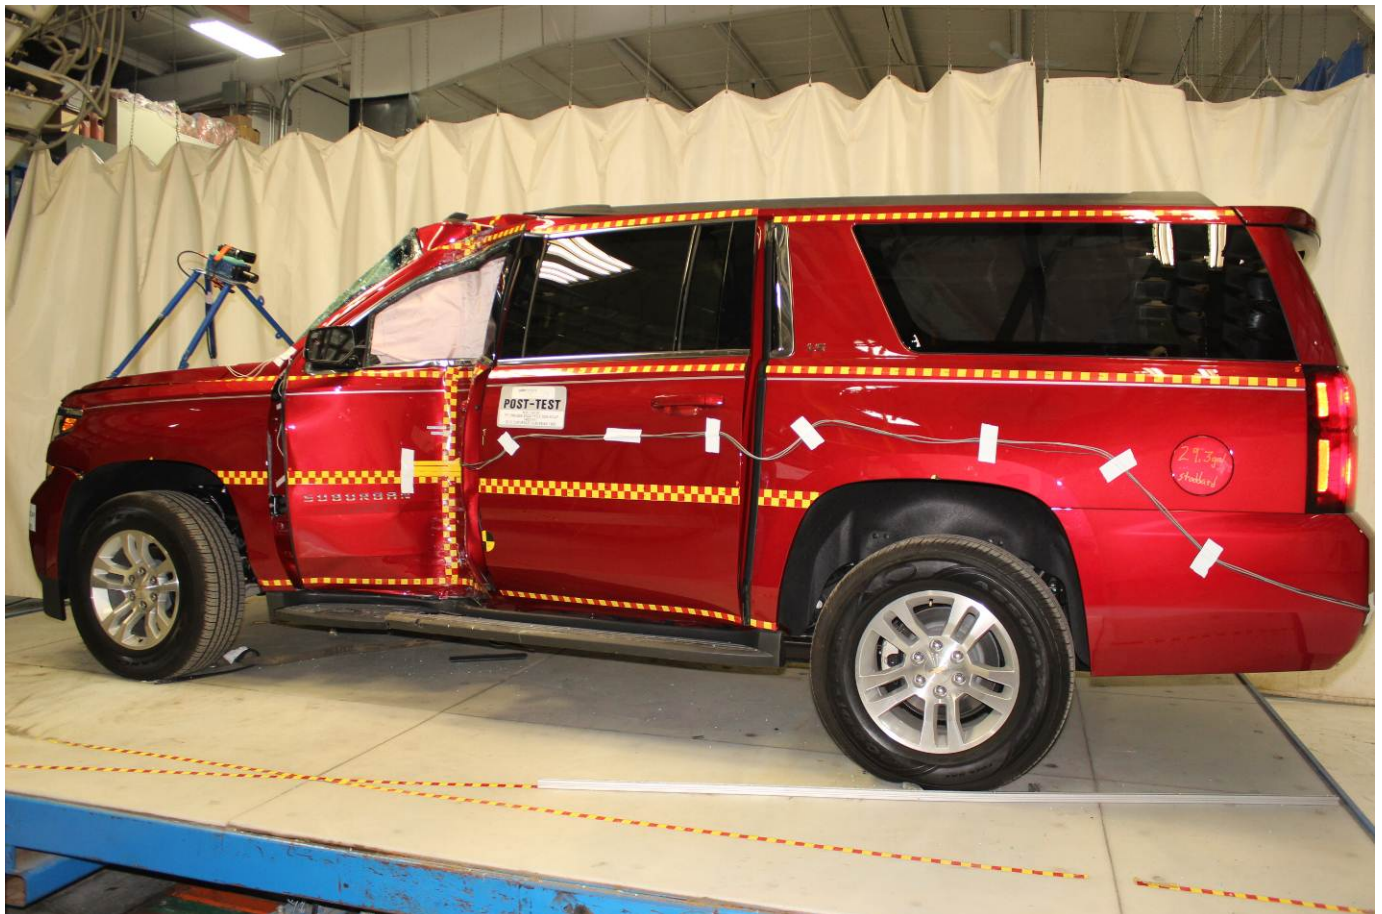
Post-Test Left Side View of Test Vehicle

| Critical Areas of Performance | Observations and Conclusions |
|---|---|
| Side Window Damage | Left Front Window Broken |

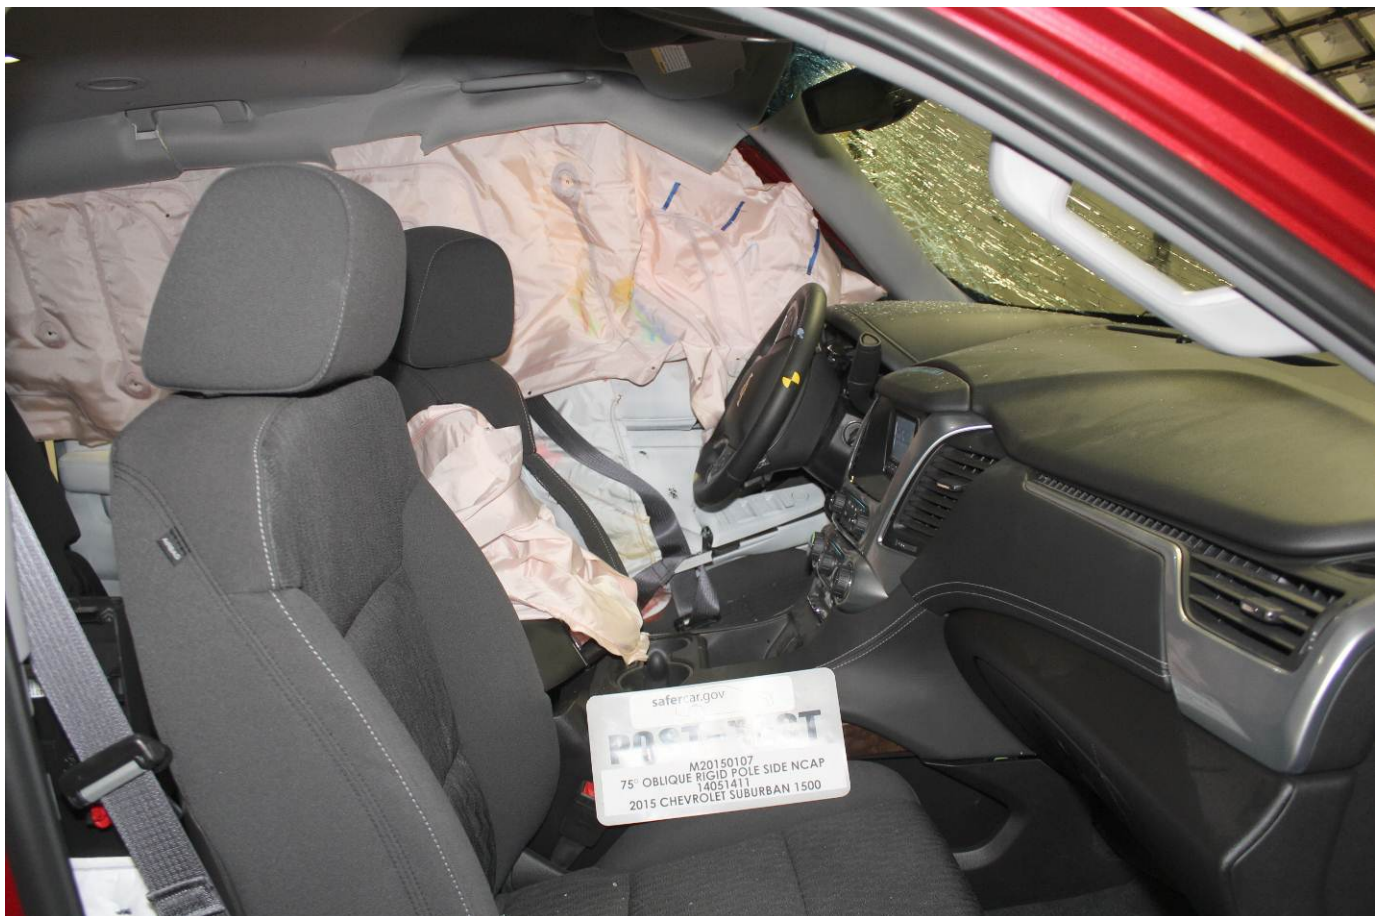
Post-Test Inner Door Panel View Showing Dummy Contact Location

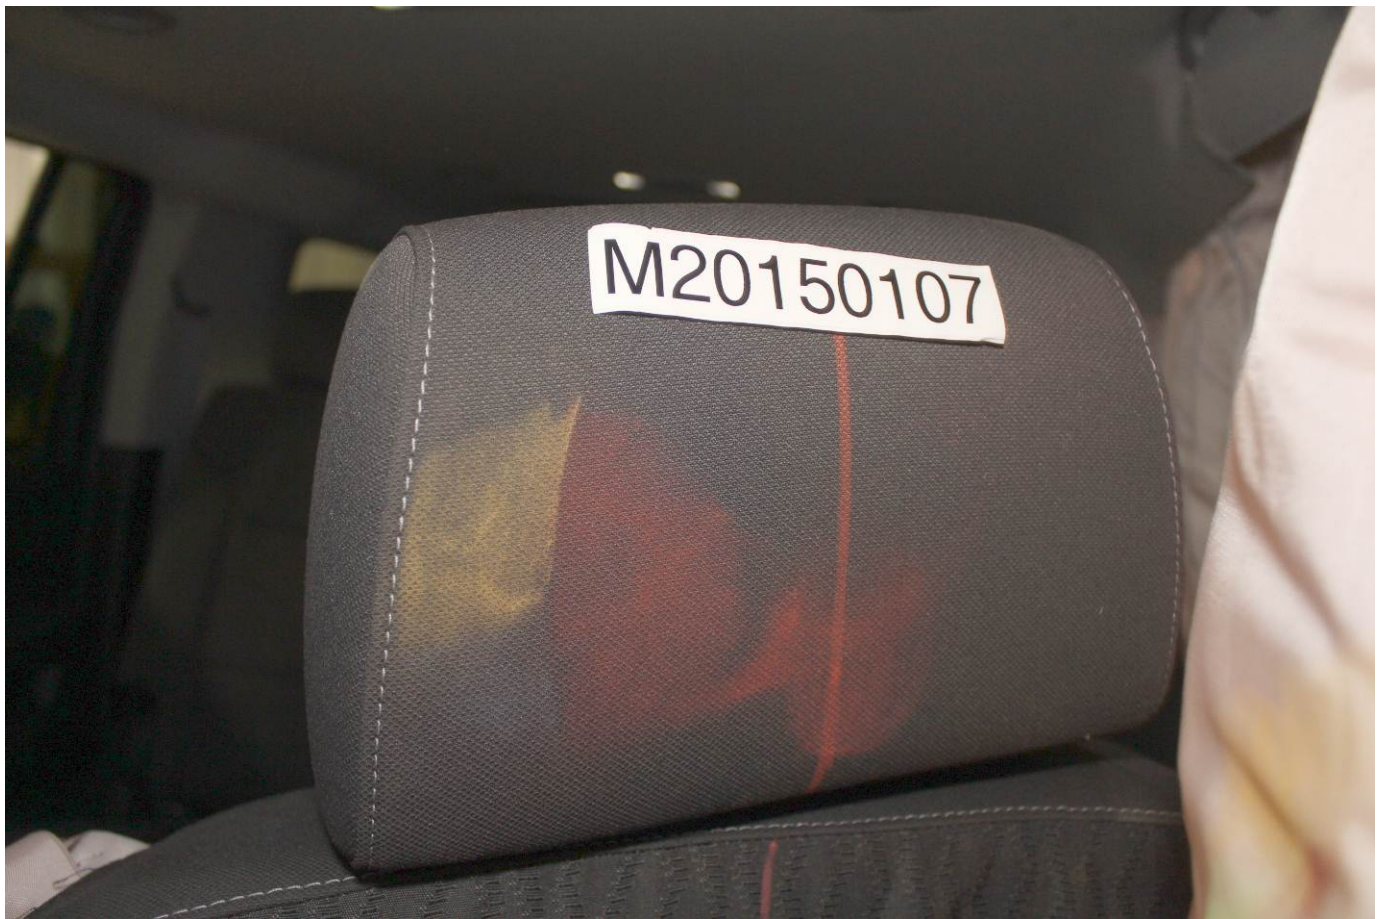
Post-Test Dummy Close-Up Head Contact with Vehicle Interior View

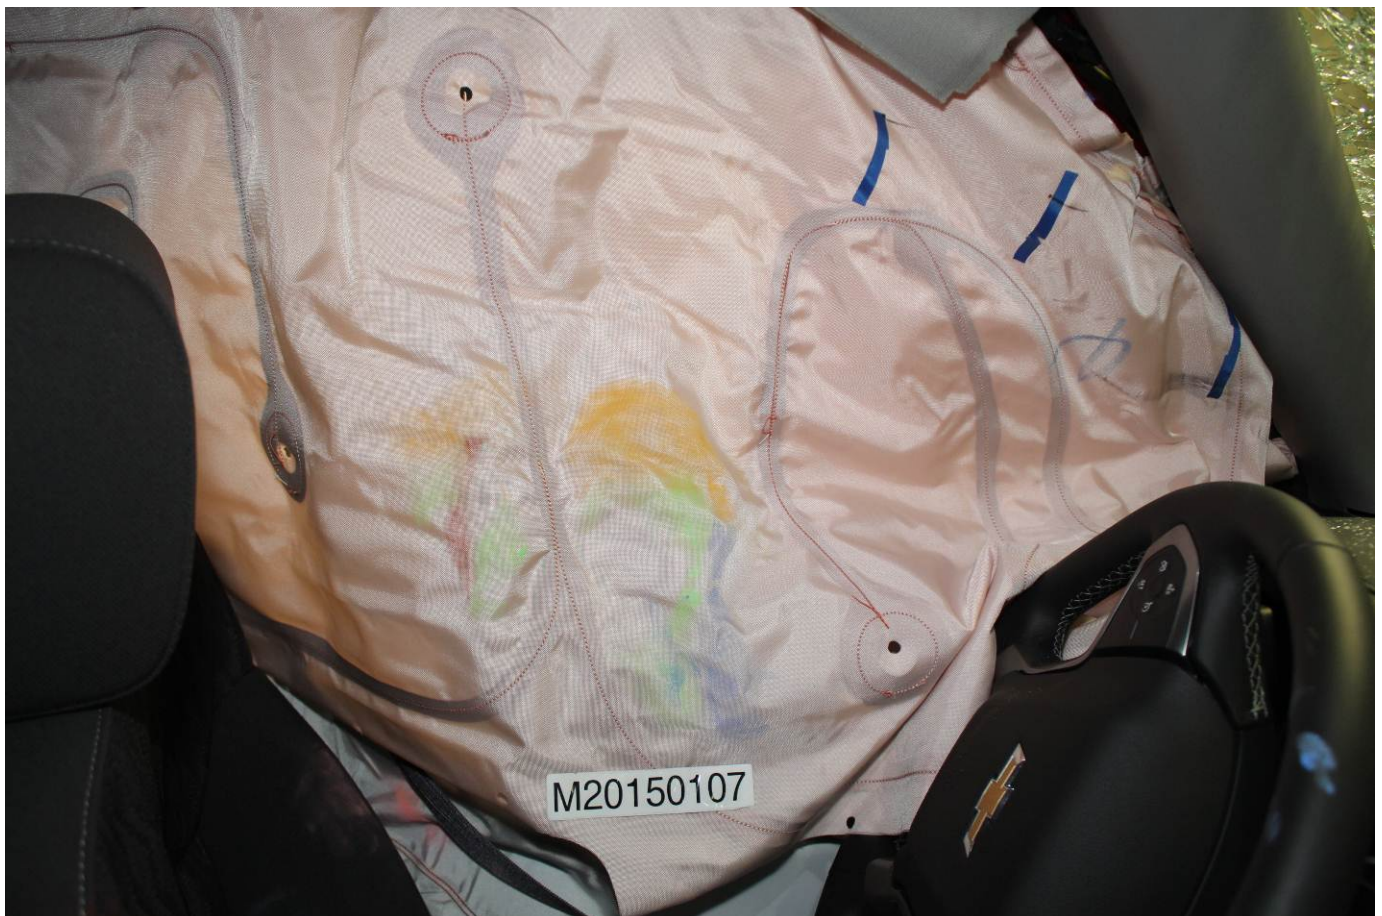
Post-Test Dummy Close-Up Head Contact with Side Air Bag View

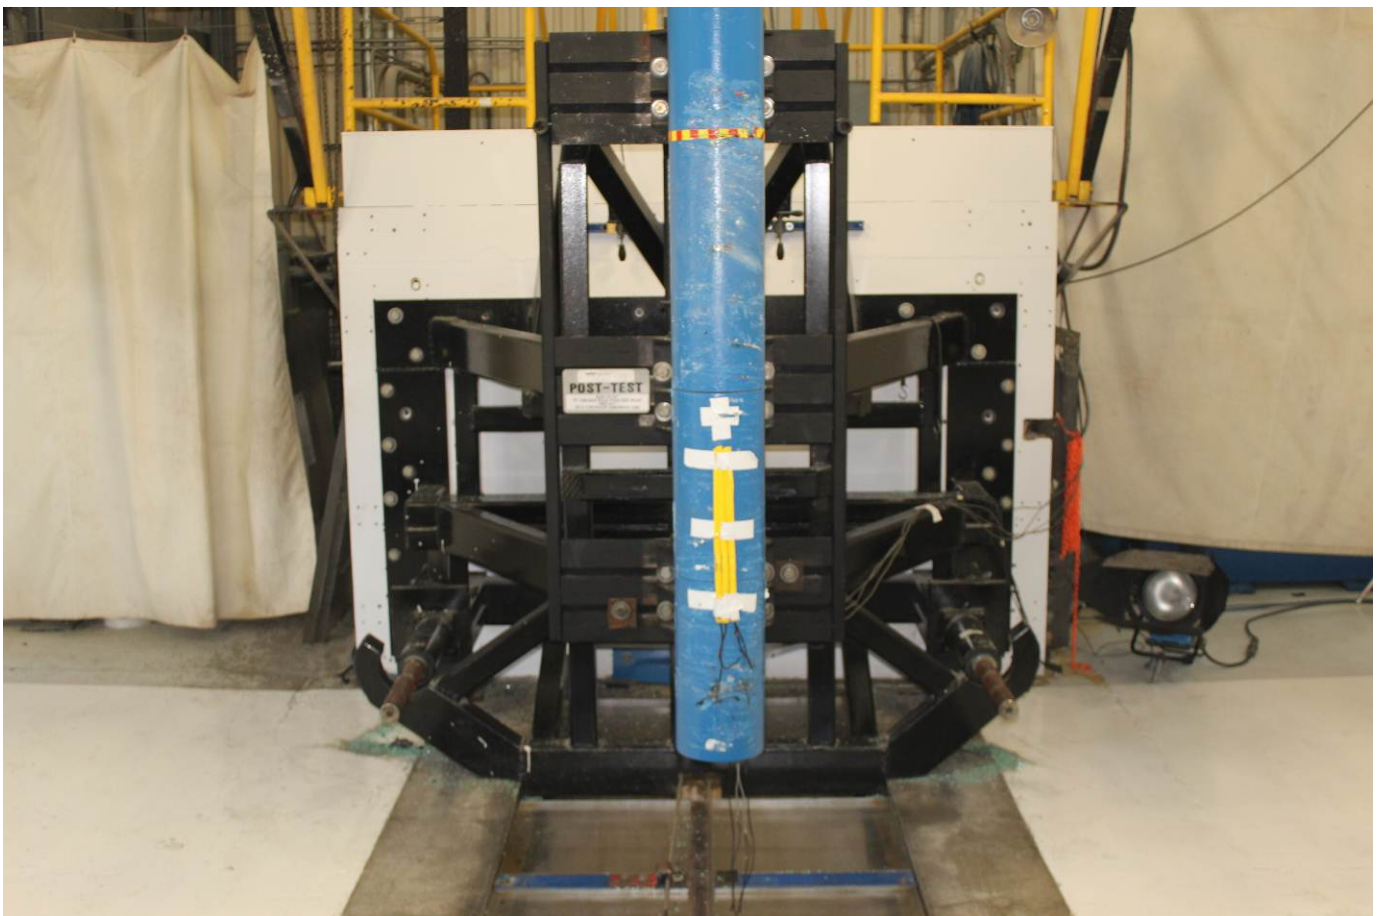
Post-Test Pole Barrier Front View

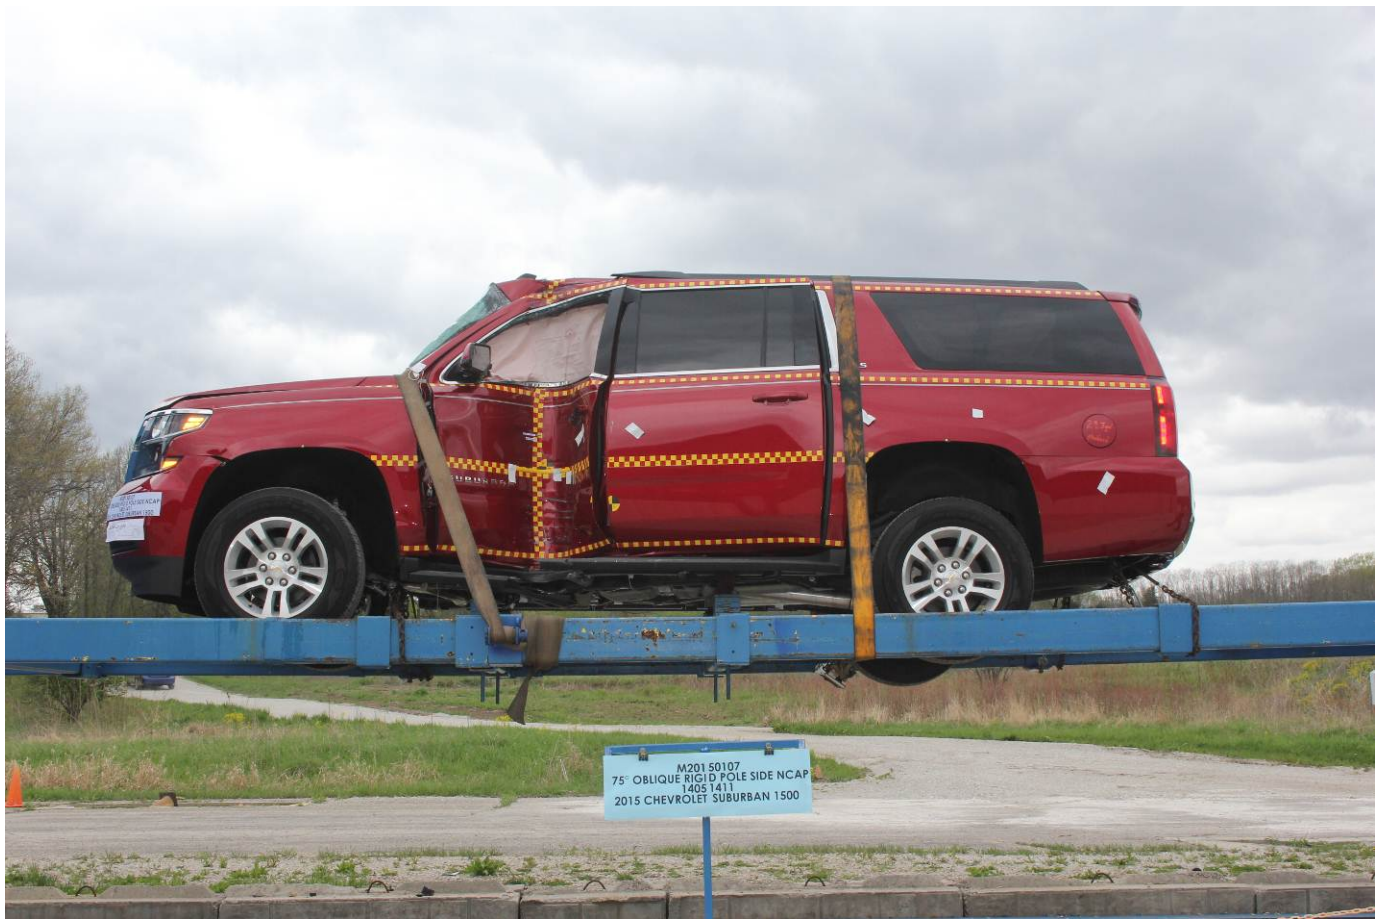
FMVSS No. 301 Static Rollover 0 Degrees

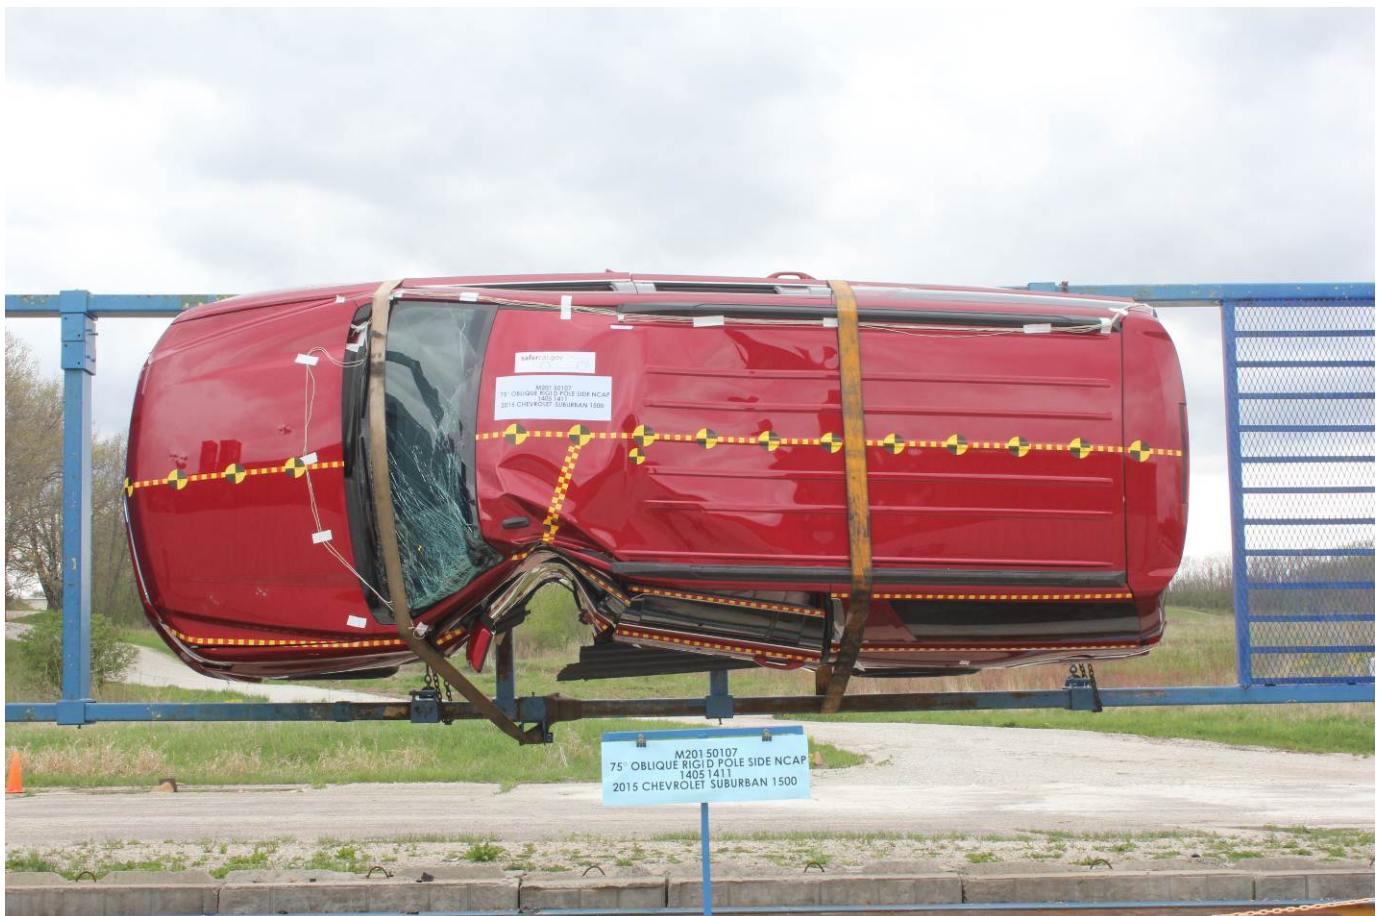
FMVSS No. 301 Static Rollover 90 Degrees

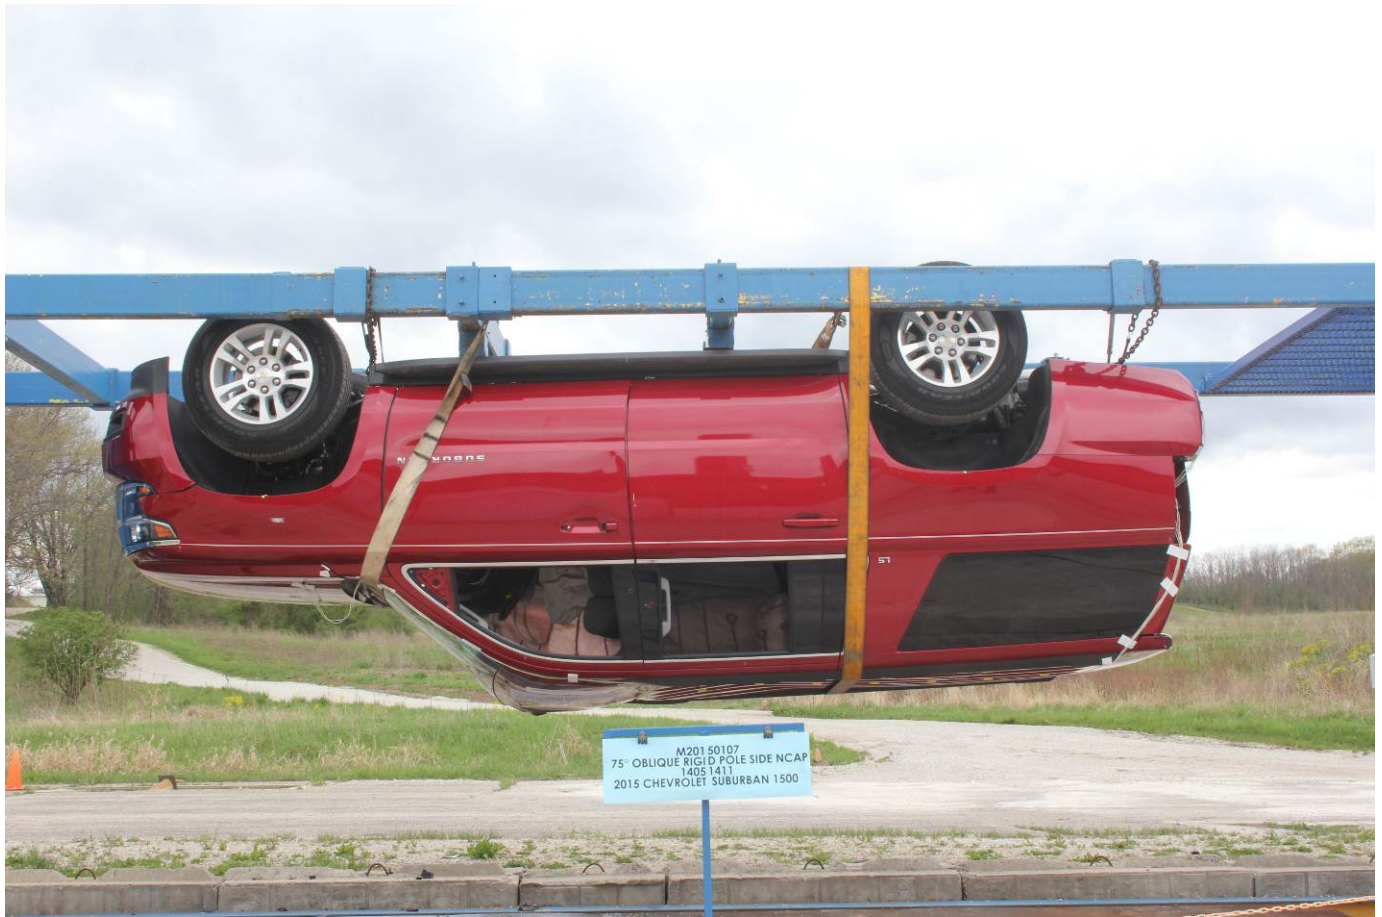
FMVSS No. 301 Static Rollover 180 Degrees

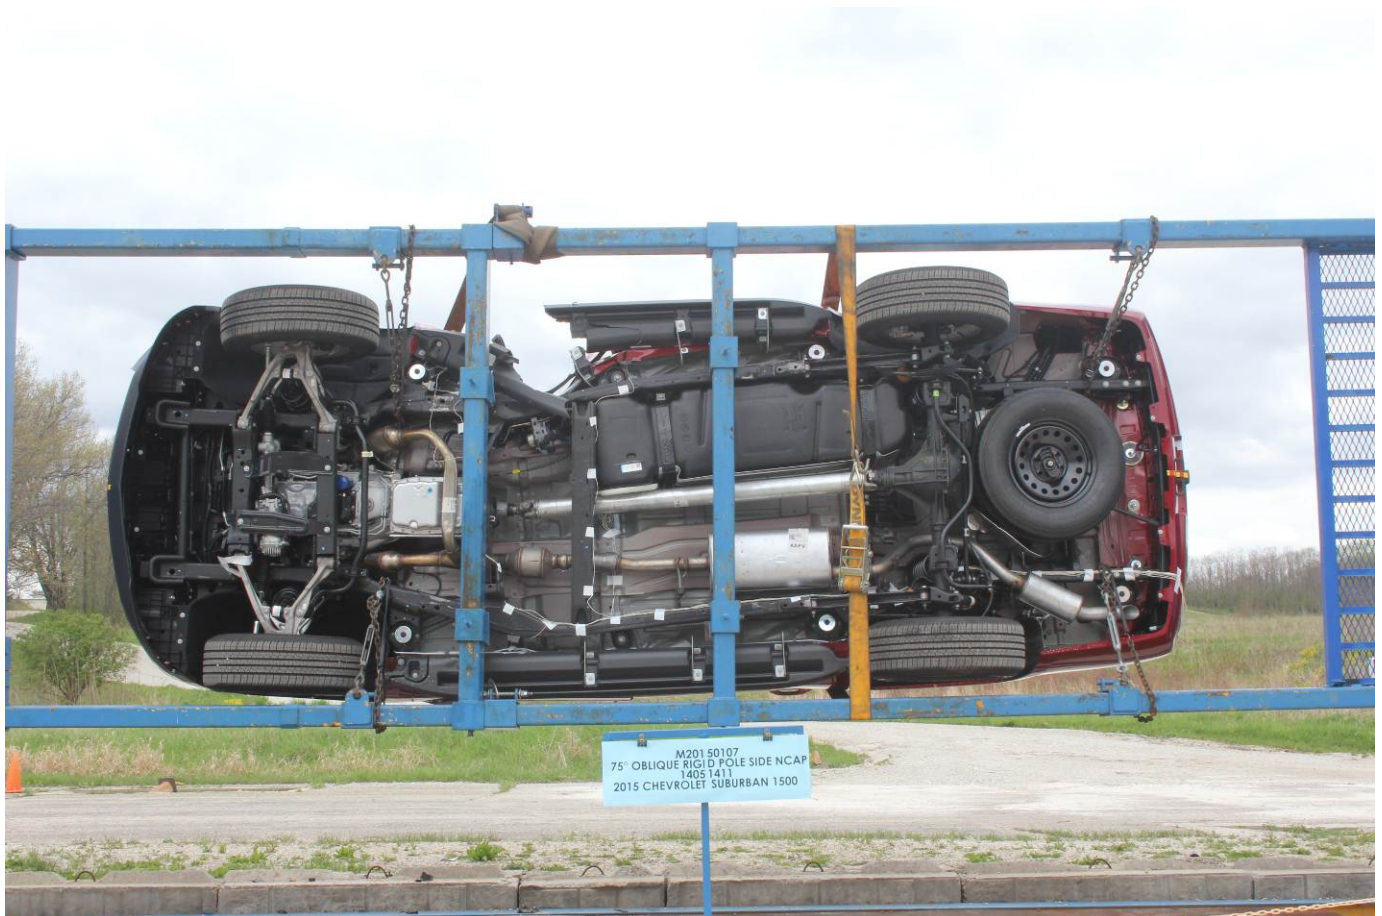
FMVSS No. 301 Static Rollover 270 Degrees

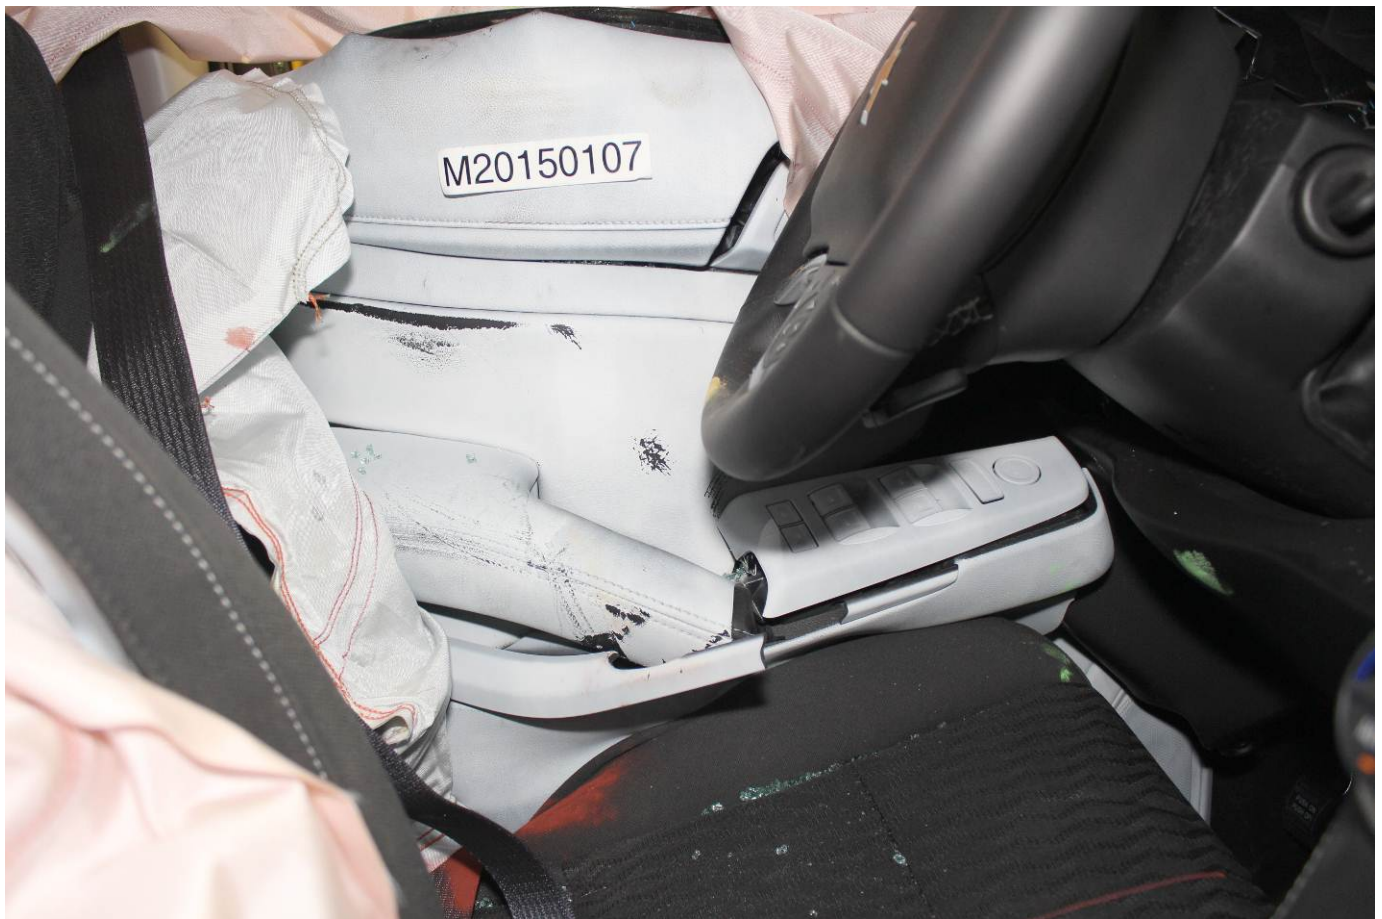
Post-Test View of Shattered Vehicle Inner Door Panel
